## 5. OVERVIEW OF THE PROPOSAL

The strengthening and partial reconstruction of portions of the R27, Sections 7 and 8, between the Western/Northern Cape Provincial border (km 40.0) and Calvinia (km 70.0) will comprise of the following main components (Figure 3):

**Botanical Assessment for the proposed  
strengthening (partial reconstruction)  
of National Route 27 Sections 7 & 8 between  
the Western Cape Province/ Northern Cape Province  
Border and Calvinia**

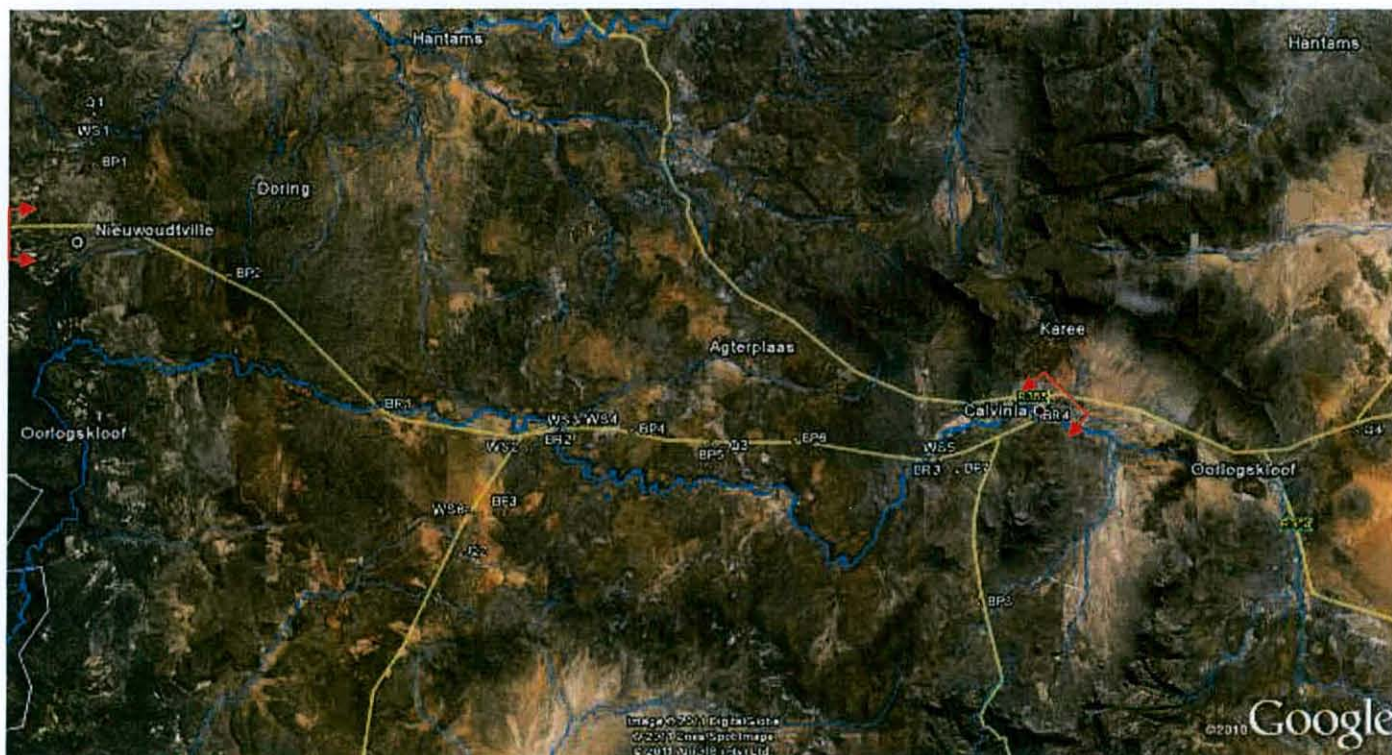
**Figure 3.** Aerial image of the proposed road upgrade with locality of quarries (Q), borrow pits (BP), bridges (BR) and water sources (WS)

- Road works: The upgrading of the approximately 73-km road section by strengthening the existing layers and limited widening of the road;

- Bridges and culverts: The widening of three (of the four) bridges and the possible widening or reconstruction of some of the major culverts; and
- Borrow pits: The development of a number of borrow areas for the sourcing of road-building material and crushed aggregates. Seven potential borrow pits were identified for this assessment.

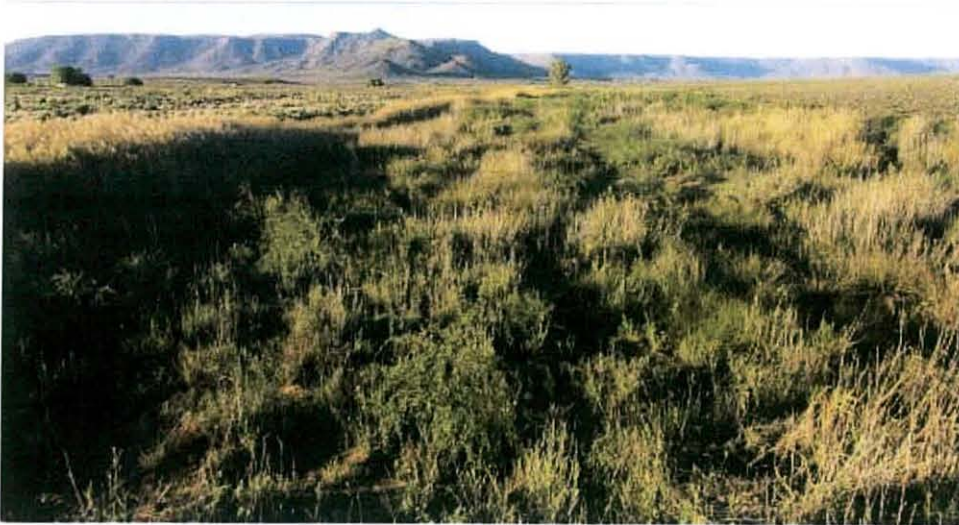
**Figure 4.** A view of the wide Oorlogskloof River Valley near Calvinia with the Hantams Mountains in the background

The study area is largely located on the Nieuwoudtville/Onder-Bokkeveld Plateau between Calvinia and Nieuwoudtville. The area lies within the Olifants-Doring River catchment, with the Oorlogskloof River and its tributaries flowing parallel to the R27 road (Figure 4). The surround topography is relatively flat within the wide river valley of the Oorlogskloof, with the Hantams Mountains in the East and the escarpment on the Bokkeveld Mountains in the west. The surrounding farming activities occur along and within the river channels and have moderately modified the riverine habitat. In particular, large shallow farm dams have been constructed near Calvinia to impede winter surface water runoff.

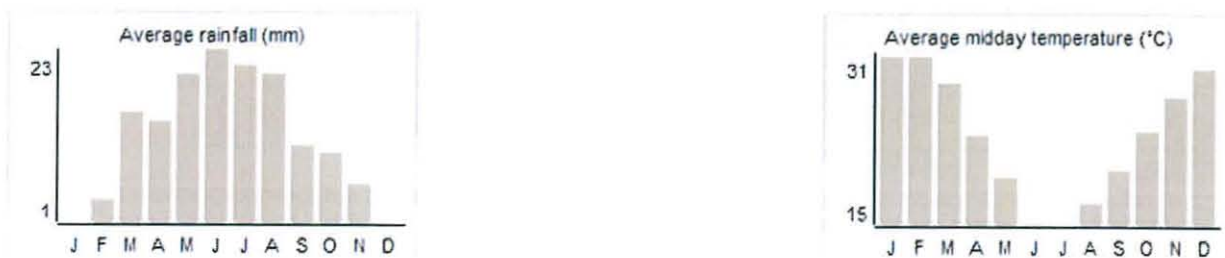
**Figure 5.** Average monthly rainfall for the area (SA Explorer, 2008)

Calvinia has a Mediterranean climate and normally receives about 146mm of rain per year mostly during winter. The area has its lowest rainfall (1mm) in January and the highest (23mm) in June (Figure 5). The average midday temperatures for Calvinia range from 15.3°C in July to 30.6°C in January. The region is the coldest during July when the mercury drops to 1.4°C on average during the night.

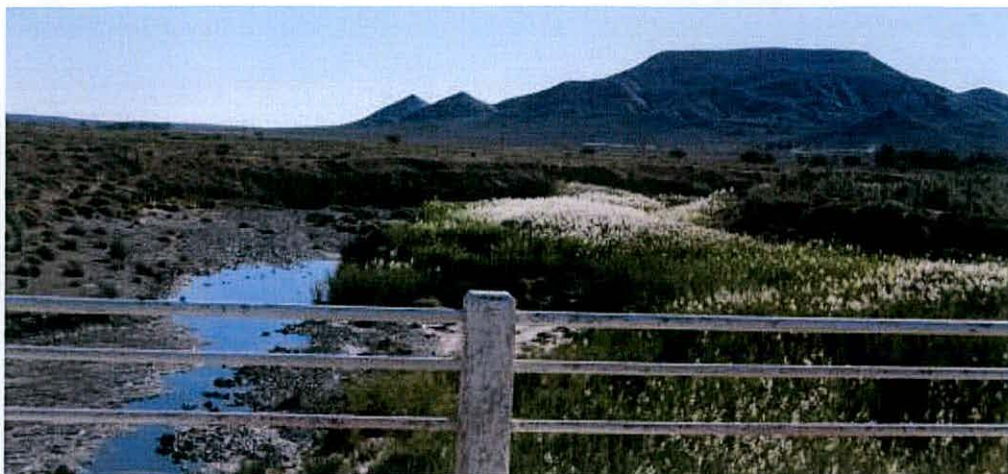
**Figure 8.** The Oorlogskloof River near Calvinia

The main freshwater feature in the study area is the Oorlogskloof River (Figure 8). The river originates in the Roggeveldberge and flows westward past Calvinia and Nieuwoudtville. South of Nieuwoudtville it enters the Koebeeberge and flows through a deep riverine gorge where it is known as the Koebee River. It flows southwards to its confluence with the Doring River, a major tributary of the Olifants River which enters the Atlantic Ocean on the west coast of South Africa. The river is discussed in more detail in the following section. Another Doring River, which is a tributary of the Hantam River, flows north and westward within the Olifants/Doring River System is also included within the study area.

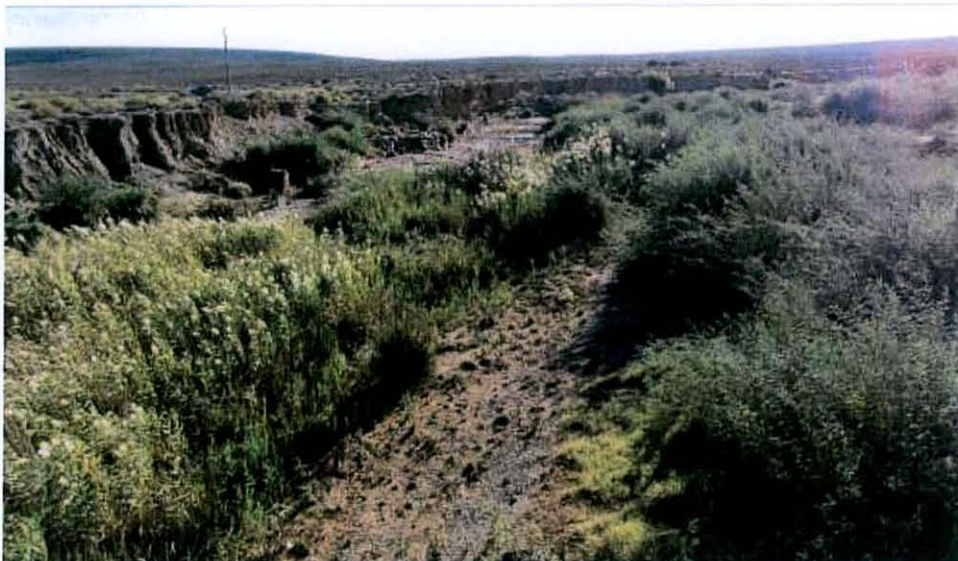
**Figure 11.** View of the Oorlogskloof River downstream of Calvinia

The Oorlogskloof River downstream of Calvinia is in a moderately modified state with the major impacts being some flow modification, farming within the riparian zone (removal of riparian vegetation and tramping of livestock within the river channel) and a low density of invasive alien vegetation growth (*Prosopis* sp.).

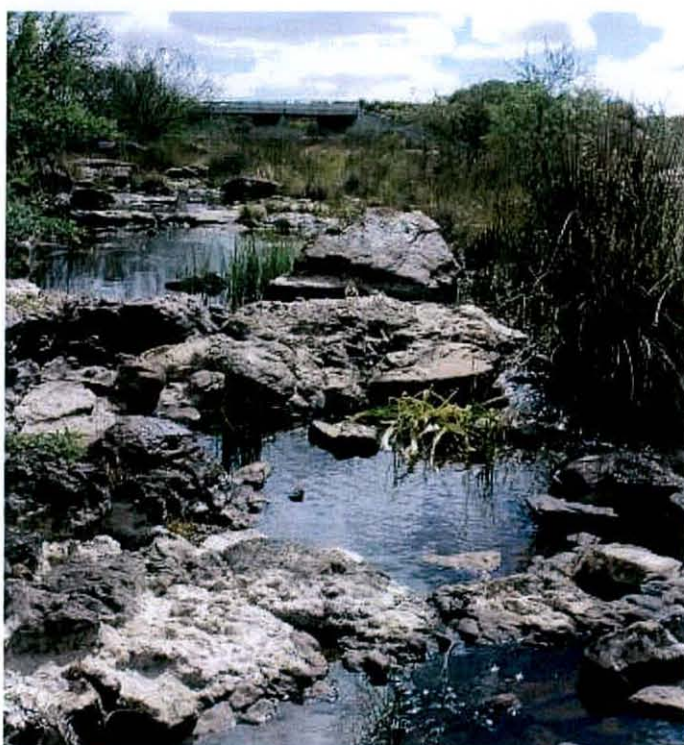
**Figure 12.** The Doring River downstream of the R357 road bridge

The Doring River near Nieuwoudtville (Figure 12) has a largely natural habitat with minimal habitat disturbance activities. The results from the habitat integrity assessment are shown in Table 4.

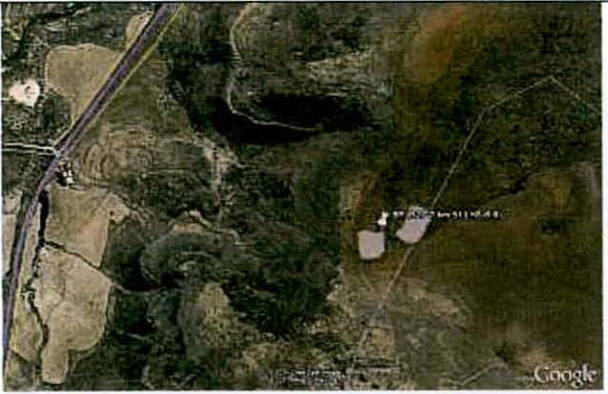
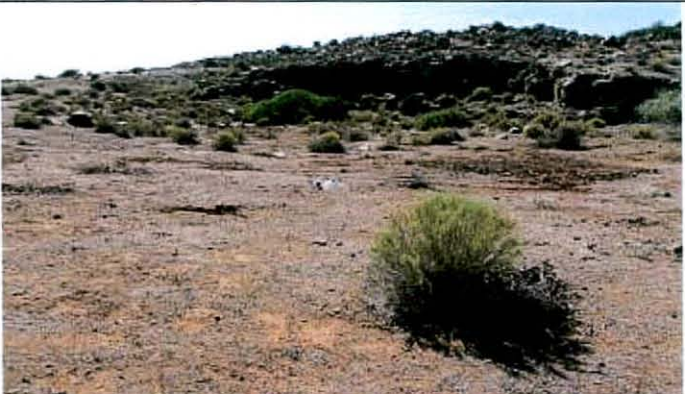
| Borrow Pit Site No. | Google Earth image | Photo | Comment |
|---|--|---|---|
| 1. R27-7<br>km 51 LHS<br>6.9 | | | <p>Kliprivier Farm borrow pit is sited at the top of a small hill, adjacent to an existing borrow pit. There are no expected aquatic ecosystem issues.</p> |

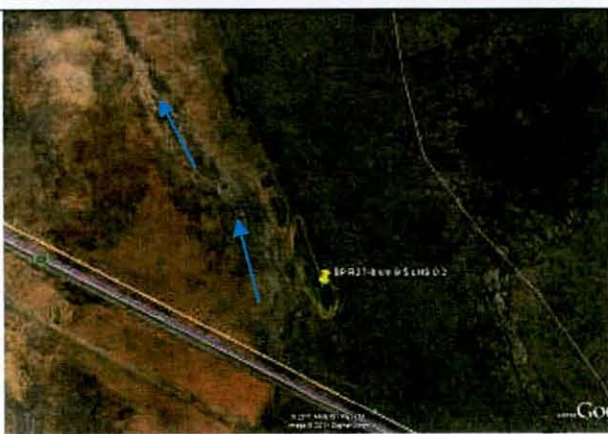
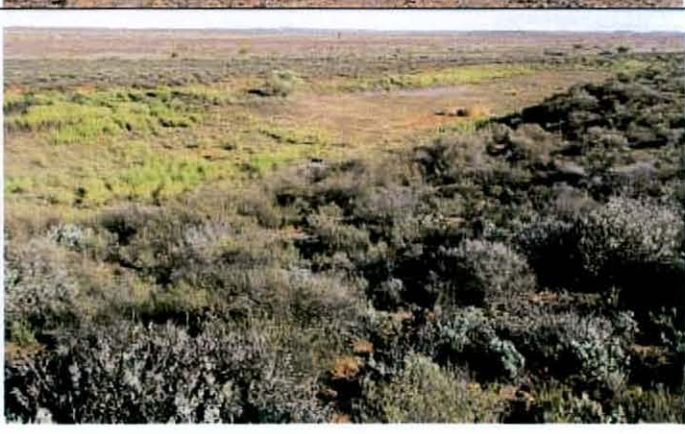
| Borrow Pit Site No. | Google Earth image | Photo | Comment |
|---|--|---|---|
| 2. R27-8<br>km 9.5 LHS<br>0.2 | | | <p>Buffelsvlei Farm borrow pit sited adjacent to a small drainage line. The vegetation around the pit is in good condition and 3 porcupines were sighted in the pit. Aardvark hole inhabited by the porcupines were also found on the south-west bank of the pit. The pit is not linked to the drainage channel and the proposed expansion of the pit is to the north-east, away from the drainage therefore no aquatic ecosystem issues are foreseen at this site. However it is recommended that if this pit is utilized, access to the pit does not disturb the drainage channel and that the pit is meaningfully rehabilitated in terms of its future storage of water.</p> |

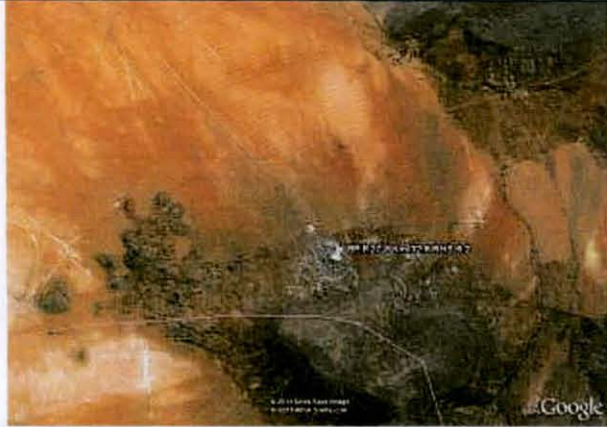
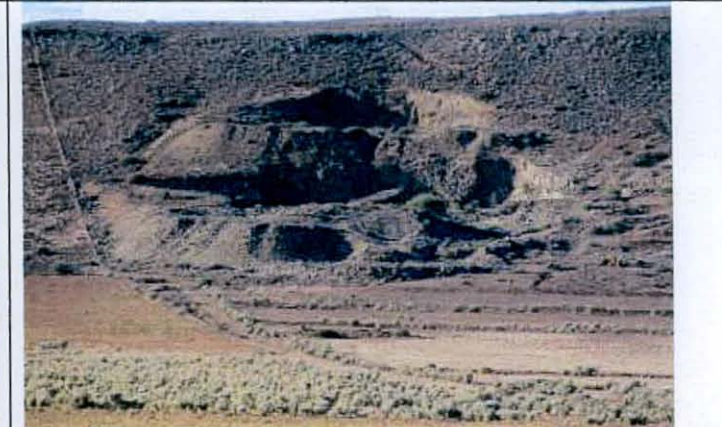
| <p>3. R27-8<br/>Km 32.6<br/>RHS 6.2</p> | | | <p>Iceland Spar Mine Site: The borrow pit is sited at the top of a small hill, at an existing mine with numerous stockpiles. Only the stockpiles will be removed. While there is some drainage down the hill side, there are no expected aquatic ecosystem issues.</p> |

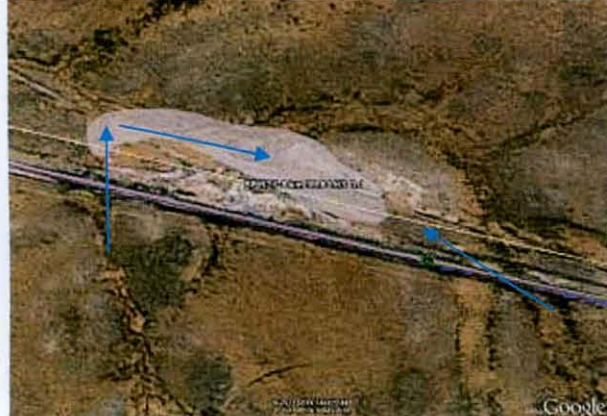
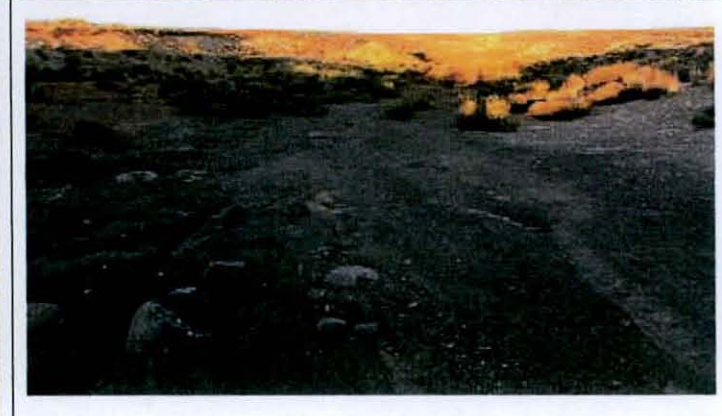
| <p>4. R27-8<br/>km 39.8<br/>LHS 0.1</p> | | | <p>Matjiesfontein Farm: this borrow pit is currently being utilized for the storage of water. With flow from the adjacent drainage channels being diverted into the pit. Should this pit be extended as proposed (white polygon in Google image), the site should be rehabilitated to allow for more efficient use of the water and the landowner should contact DWA regarding authorization for the storage of water in the pit.</p> |

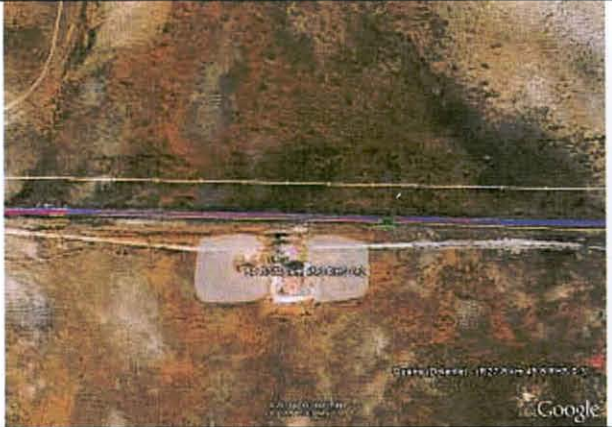
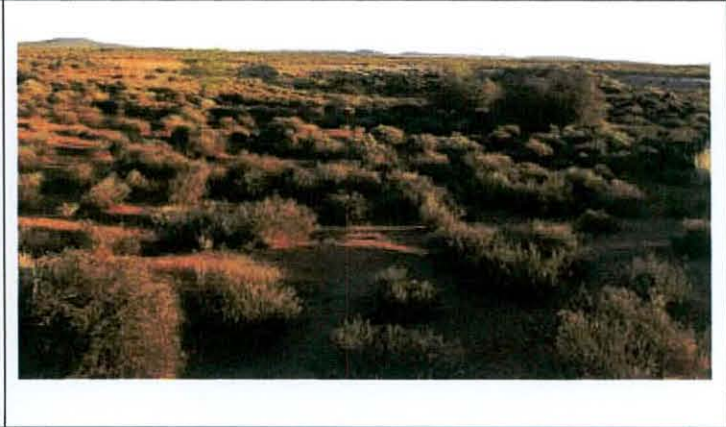
| <p>5. R27-8<br/>km 45.0<br/>RHS 0.2</p> | | | <p>Doega Farm: The site is on previously disturbed ground with no visible drainage or aquatic features. No freshwater issues are expected.</p> |

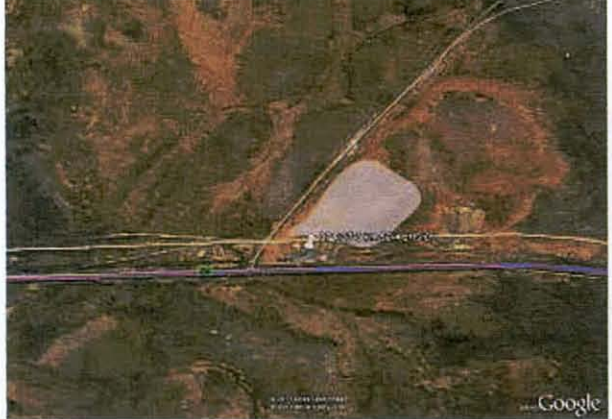
| <p>6. R27-8<br/>km 50.4<br/>LHS 0.1</p> | | | <p>The site is on previously disturbed ground with no visible drainage or aquatic features. No freshwater issues are expected.</p> |

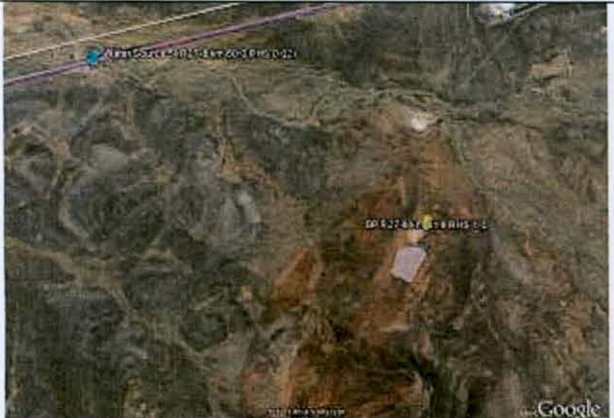
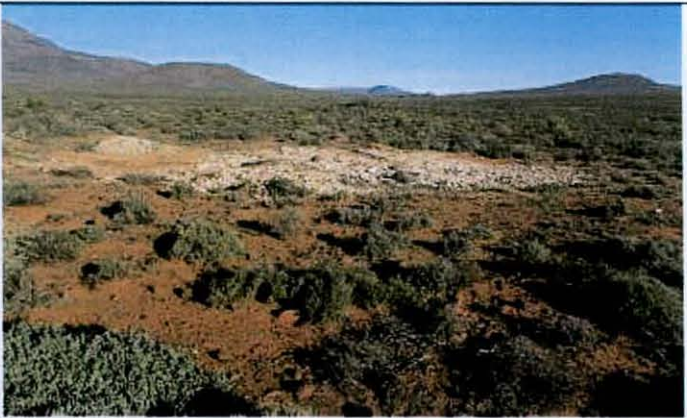
| <p>7. R27-8<br/>km61.6<br/>RHS</p> | | | <p>The site is on previously disturbed ground with no visible drainage or aquatic features. No freshwater issues are expected.</p> |

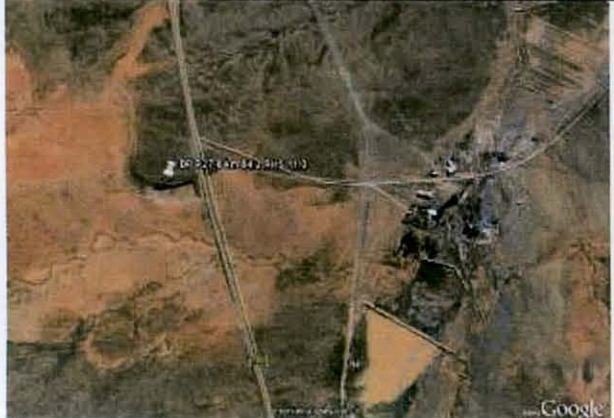
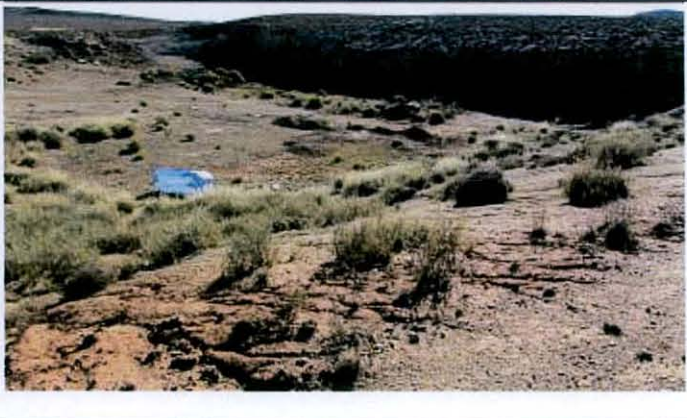
| <p>8. R27-8<br/>km 64.2<br/>RHS 11.0</p> | | | <p>Vlakkefontein Farm: The borrow pit is an existing borrow pit with no visible drainage or water features. There are no expected aquatic ecosystem issues.</p> |

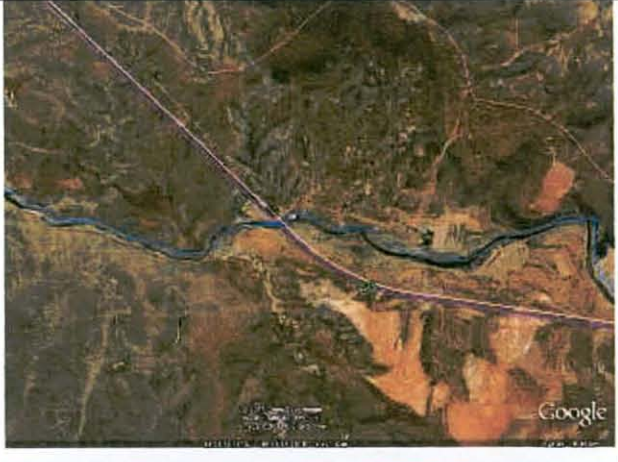
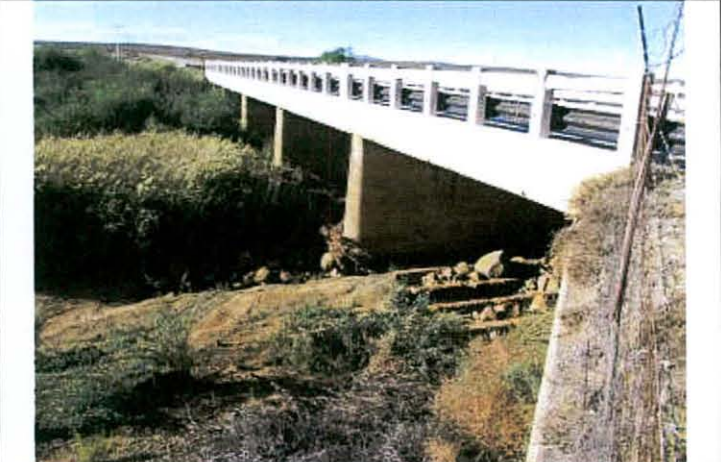
| Bridge Site Number | Google Earth image | Photo | Comment |
|---|--|---|---|
| 1. R27-8<br>km 22.69 | | | <p>Oorlogskloof River Bridge (47.8 m by 10.4m with 4 piers). No major structural works planned. River dominated by phragmites, with some Juncus sp, weedy shrubs and Prosopis sp. The bed was largely dry and consisted of an alluvial substrate with bedrock. The southern bank is highly eroded. No freshwater issues are expected at the bridge, with the recommendations provided in the following section.</p> |

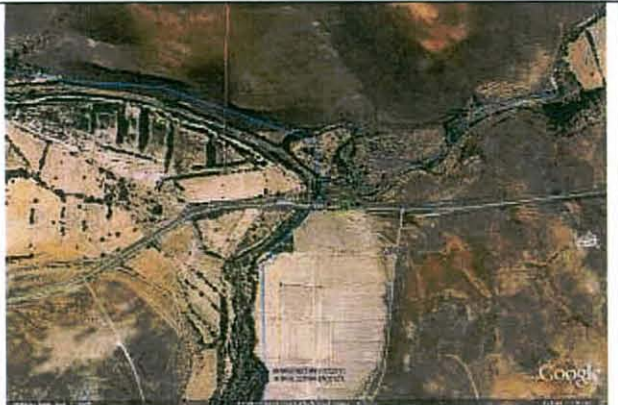
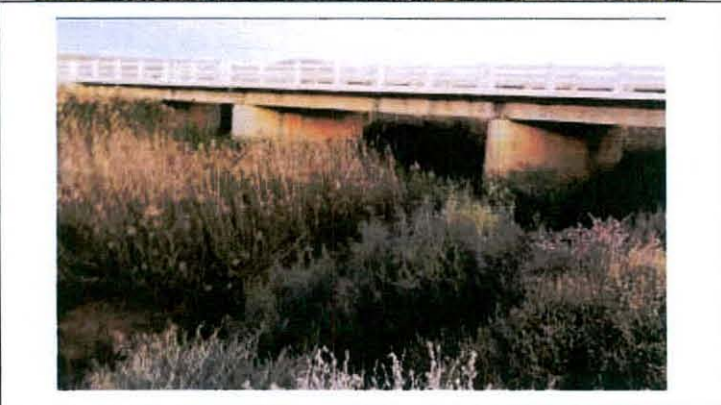
| Bridge Site Number | Google Earth image | Photo | Comment |
|---|--|---|---|
| 2. R27-8<br>km 34.92 | | | <p>Soetwater River Bridge - (30.1 m by 7.86m with 2 piers). Bridge to be widened on both sides by 1.27m.</p> |

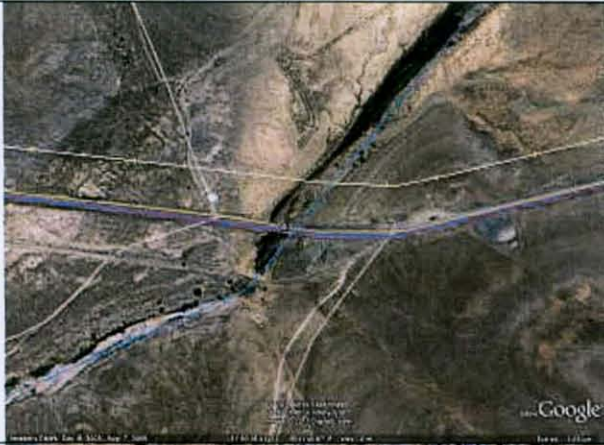
3. R27-8  
km 59.2

Oorlogskloof River Bridge - (48.2 m by 8m with 4 piers). Bridge to be widened on both sides by 1.20m.

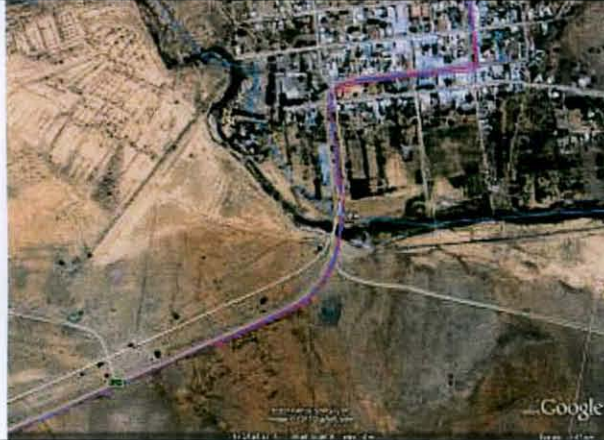
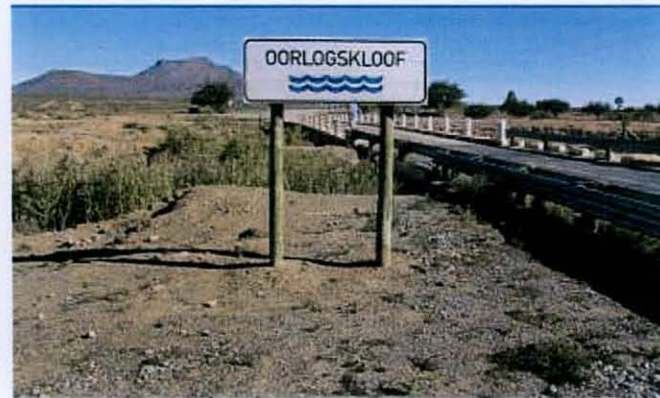
4. R27-8  
km 67.1

Oorlogskloof River Bridge - (84.5 m by 7.1m with 4 piers). Bridge to be widened on one side only.

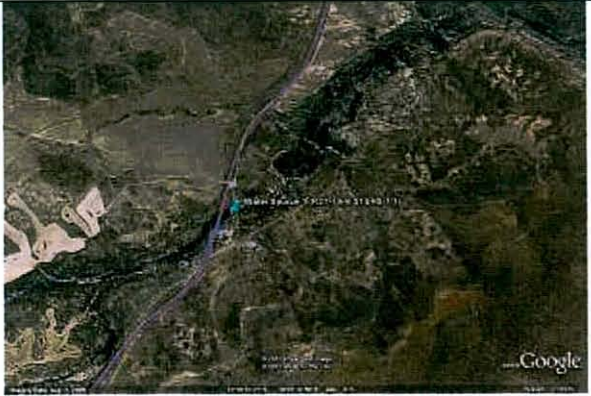
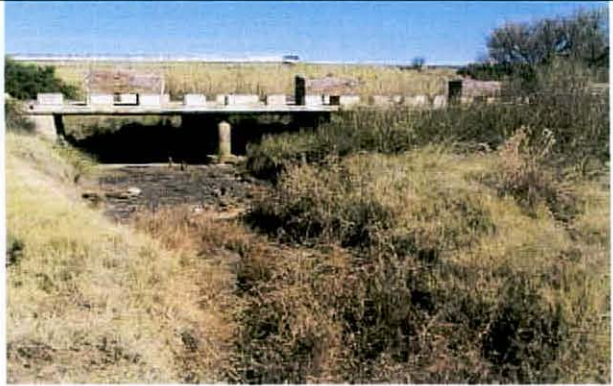
| Water Abstraction Site Number | Google Earth image | Photo | Comment |
|---|--|--|---|
| 1. R27-7 km<br>51 LHS 7.1 | | | <p>Doring River, Kliprivier Farm: The river channel at the R27 bridge is dominated by <i>Phragmites</i> reeds, with some <i>Juncus</i> sp and grass sp. downstream The bed was dry and consisted of an alluvial substrate with bedrock. This proposed water source is 350m upstream of the Nieuwoudtville waterfall, an important tourism feature for the area. The river also consists largely of river valley bottom wetland habitat and has been identified as a Freshwater Ecosystem Protected Area. It is therefore advised that an alternative water source be utilized for this area. The river flow is also of a seasonal nature and would not be a reliable water source as construction activities may need to take place during the dry season. Authorization will need to be given from DWA for the intended water abstraction.</p> |

**Proposed mitigation:** It is recommended that an alternative water source be sought.

The only proposed activity of concern is the proposed abstraction of water from the Doring River for Construction purposes. Due to the conservation and tourism value of the Doring River downstream of the proposed abstraction site, it is recommended that an alternative water source be found. A water use authorization application will need to be submitted to the Department of Water Affairs Western Cape Regional Office for approval of the water use aspects of the proposed activities, and in particular the proposed construction activities associated with the upgrade of the bridges.

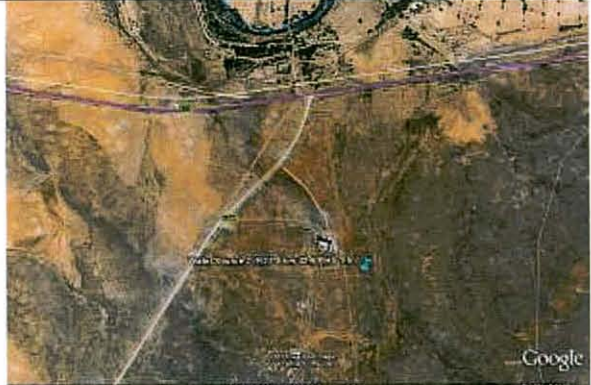
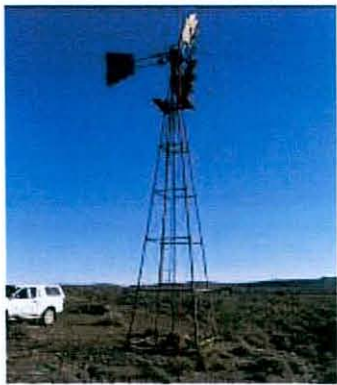
| Water Abstraction Site Number | Google Earth image | Photo | Comment |
|---|--|--|---|
| 2. R27-8 km<br>32.6 RHS 1.5 | | | <p>Soetwater Farm: Water is to be taken from an existing water pump. If the water to be abstracted is within the existing authorization for Soetwater Farm then no additional authorization from DWA is required.</p> |

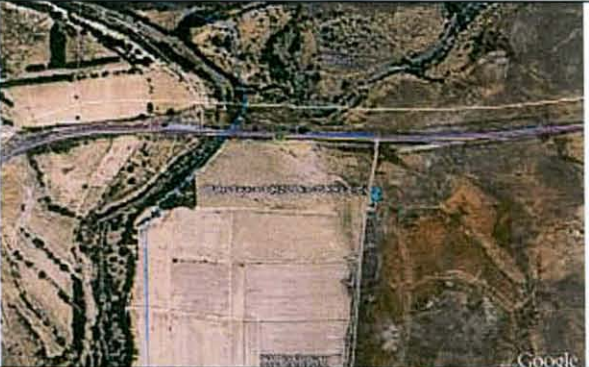
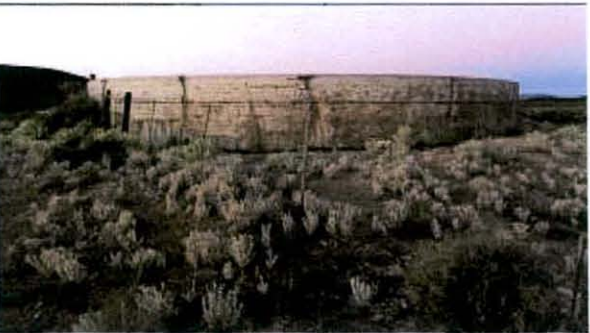
| <p>3 R27-8 km<br/>35 RHS 0.15</p> | | | <p>Toekoms Farm: Water is to be taken from an existing water pump. If the water to be abstracted is within the existing authorization for Soetwater Farm then no additional authorization from DWA is required.</p> |

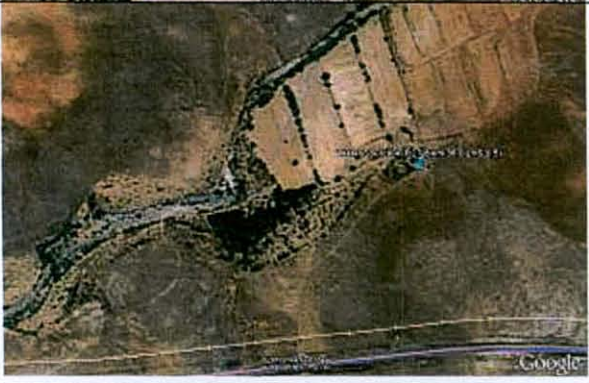
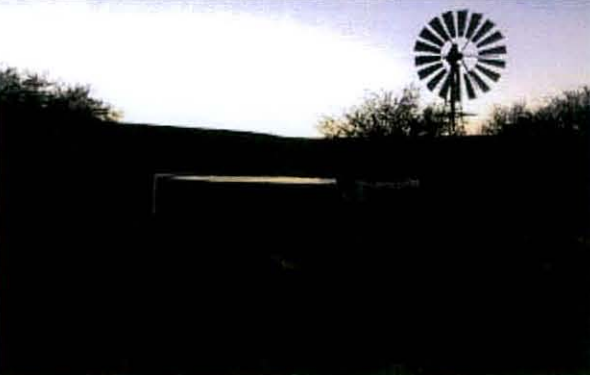
| <p>4 R27-8 km<br/>36.0 LHS 0.5</p> | | | <p>Soetwater Farm: Water is to be taken from an existing water pump. If the water to be abstracted is within the existing authorization for Soetwater Farm then no additional authorization from DWA is required.</p> |

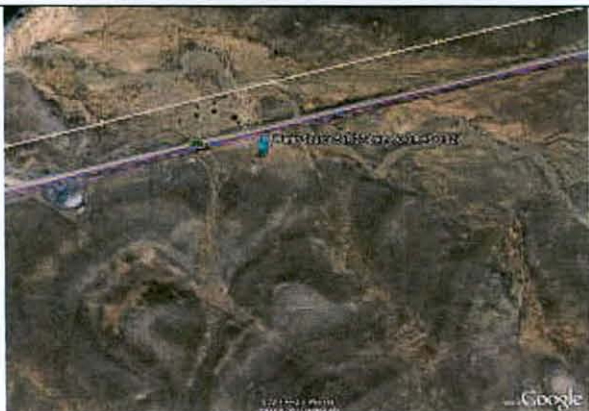
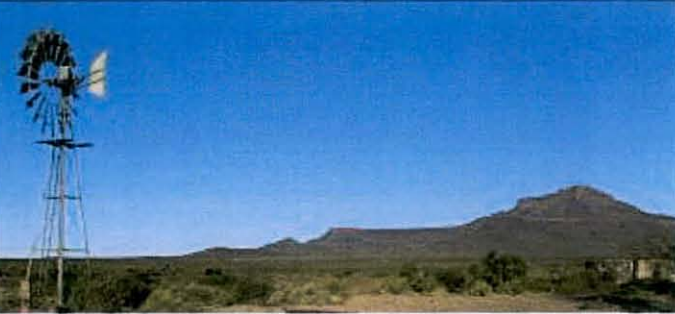
| <p>5. R27-8 km<br/>60.0 RHS<br/>0.02</p> | | | <p>Rivier Farm: Water is to be taken from an existing water pump. If the water to be abstracted is within the existing authorization for Soetwater Farm then no additional authorization from DWA is required.</p> |

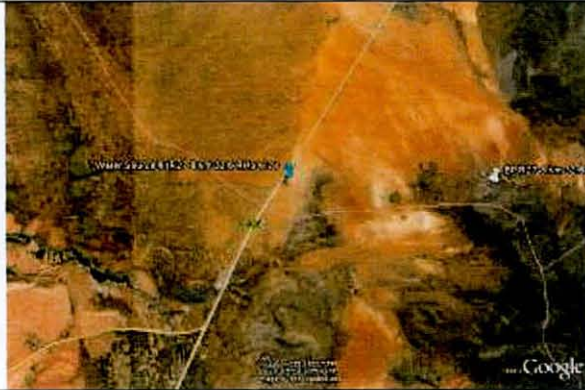
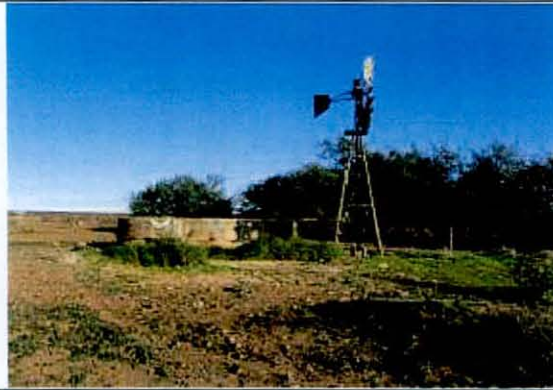
6 R27-8 km  
32.6 RHS 6.2

Bloedzuigerfontein farm: Water is to be taken from an existing water pump. If the water to be abstracted is within the existing authorization for Soetwater Farm then no additional authorization from DWA is required.

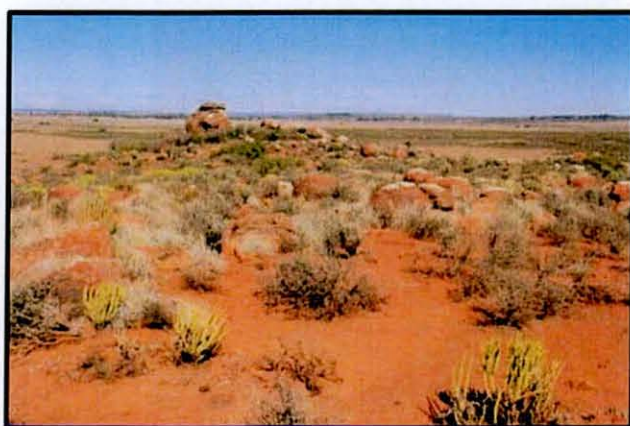
**Figure 6.** A typical dolerite 'koppie' outcrop near Nieuwoudtville with characteristic red soil.

Dolerite is notably found at the abandoned mine mentioned above (page 7) as well as at some of the identified borrow pits east of Nieuwoudtville.

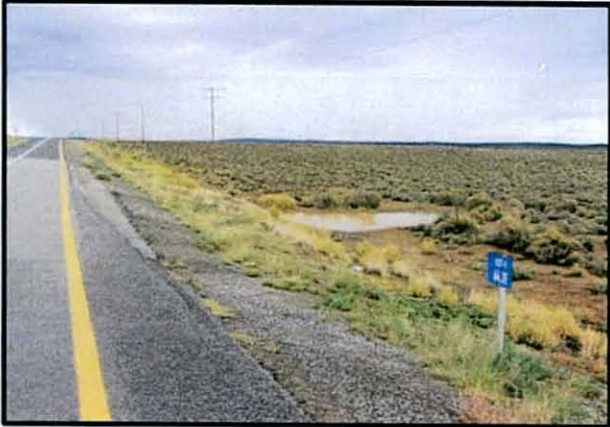
| <p><b>CN3</b><br/>S 31° 29' 29.5"<br/>E 19° 44' 39.1"</p> | <p><b>Calvinia Mosaic</b><br/><br/><b>Hantam Karoo</b></p> | <p>This waypoint is at the R 355 / R 27 intersection at R27-8 64.2 E. The road reserve close to the road on both sides is highly disturbed with abundant weeds. <i>Galenia africana</i> is prevalent with <i>Cucumis myriocarpus</i> subsp. <i>leptodermis</i> present. On the south-west side of the intersection is a stand of <i>Eriosephalus</i> sp. together with <i>Ruschia</i> cf. <i>intricata</i>, <i>Psilocaulon junceum</i> and <i>Osteospermum</i> sp.</p> | |

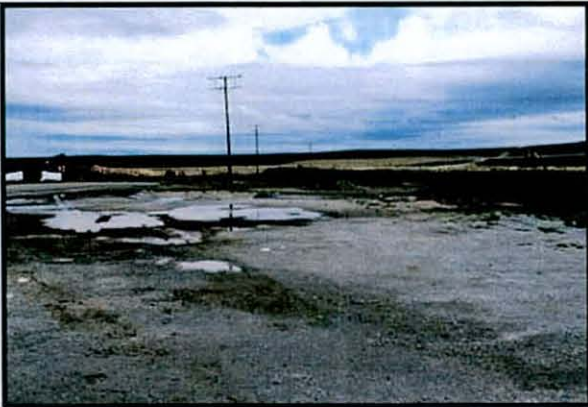
| <p><b>CN7</b><br/>S 31° 30' 18.2"<br/>E 19° 41' 50.4"</p> | <p><b>Calvinia Mosaic</b><br/><br/><b>Hantam Karoo</b></p> | <p>Lay-by area on north side of road at R 27-8 59.4E which is highly disturbed. Piles of gravel are present and the area is used for road-works. The south side of the road has short shrubby vegetation with a mowed grassy verge.</p> | |

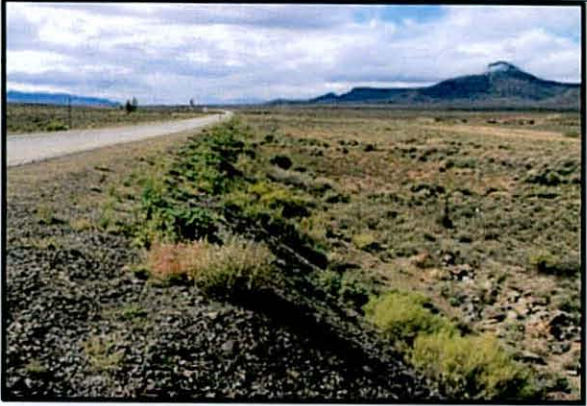
| <p><b>CN8</b><br/>S 31° 30' 16.9"<br/>E 19° 41' 16.9"</p> | <p><b>Calvinia Mosaic</b><br/><b>Hantam Karoo</b></p> | <p>A steep slope is found on the south side of the road here, near marker R27-8 58.6E. Owing to the road fill the vegetation is weedy.</p> | |

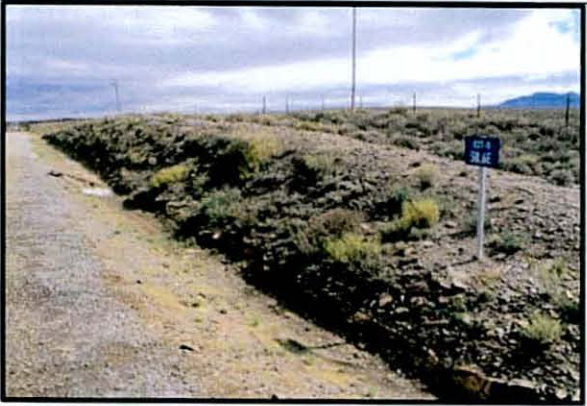
| | <p><b>Calvinia Mosaic</b><br/><b>Hantam Karoo</b></p> | <p>On the north side at waypoint CN8 the road cuts through shale sediments. The vegetation on the road verge is weedy but closer to the fence is less disturbed and is continuous with the natural community on the adjacent private property.</p> | |

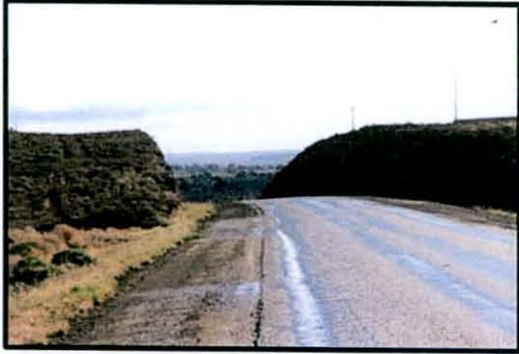
| | <p><i>Erodium cicutarium</i> –<br/><i>Eriocephalus purpureus</i><br/>Hantam Karoo</p> <p>Hantam Karoo</p> | <p>Near waypoint CN16 the road cuts through shale sediments of the Ecca Group.</p> | |

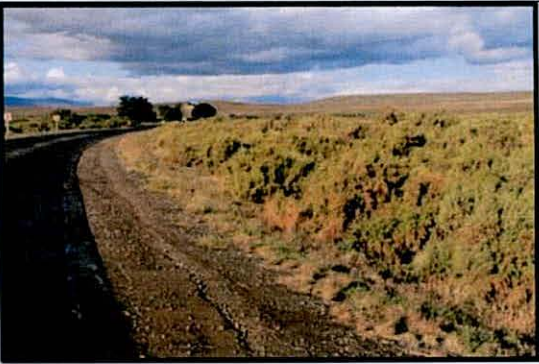
| <p><b>CN18</b><br/>S 31° 29' 18.9"<br/>E 19° 26' 12.5"</p> | <p><i>Leipoldtia schulzei</i> –<br/><i>Erioccephalus purpureus</i><br/>Hantam Karoo<br/><br/>Hantam Karoo</p> | <p>This waypoint is a short distance to the west of the 1959 Oorlogskloof River bridge. On both the south (see photo) and north sides of the road there are dense stands of <i>Salsola aphylla</i> (gannabos), extending to the river banks at the bridge. On the north side there are also numerous mesquite trees (<i>Prosopis glandulosa</i>).</p> | |

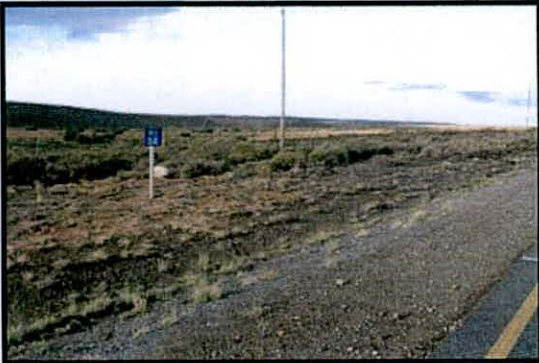
| <p><b>CN19</b><br/>S 31° 29' 03.9"<br/>E 19° 20' 16.1"</p> | <p><i>Leipoldtia schulzei</i> –<br/><i>Erioccephalus purpureus</i><br/>Hantam Karoo<br/><br/>Hantam Karoo</p> | <p>At road marker R27-8 25 E. A change in the vegetation was noted at this waypoint. It is noticeably taller and dominated by <i>Pteronia pallens</i>. Other species include <i>Psilocalon junceum</i>, <i>Zygophyllum</i> sp., <i>Ruschia intricata</i>, <i>Atriplex lindleyi</i> subsp. <i>inflata</i>, <i>Salsola tuberculata</i>.</p> | |

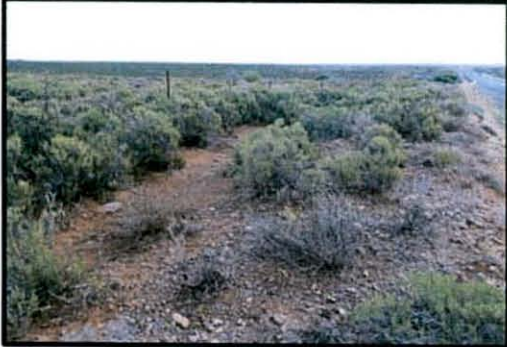
| | <p><i>Leipoldtia schulzei</i> –<br/><i>Eriocephalus purpureus</i><br/>Hantam Karoo</p> <p>Hantam Karoo</p> | <p>Calcrete is found in the soil here on the south side of the road at waypoint CN19. This correlates well with the presence of <i>Pteronia pallens</i>.</p> | |

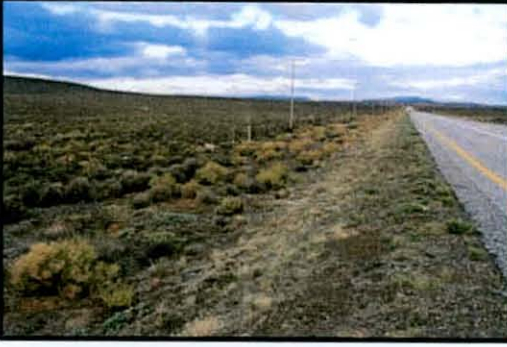
| <p>CN20<br/>S 31° 27' 31.4"<br/>E 19° 17' 38.6"</p> | <p>Grootfontein Mosaic</p> <p>Hantam Karoo</p> | <p>At the R27-8 19.8E road marker the vegetation in the road reserve is highly disturbed with <i>Galenia africana</i>, <i>Augea capensis</i> and <i>Pentzia incana</i> prominent. Other species include <i>Ruschia</i> sp., <i>Eriocephalus ericoides</i>, <i>Asparagus</i> sp., <i>Salsola kali</i> and <i>Erodium cicutarium</i>.</p> | |

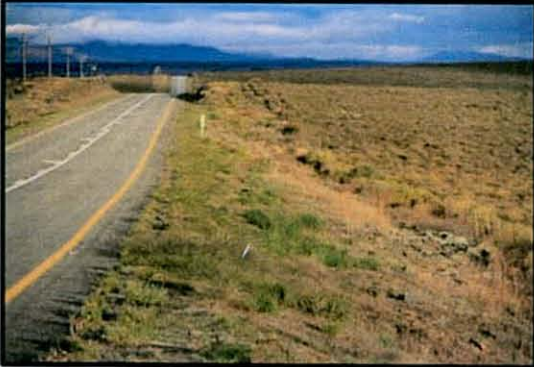
| <p>CN21<br/>S 31° 26' 00.3"<br/>E 19° 15' 49.3"</p> | <p>Grootfontein Mosaic</p> <p>Hantam Karoo</p> | <p>Approximately 20km east of Nieuwoudtville westwards the road has been resurfaced. At the R27-8 19.8E road marker the vegetation in the road reserve is highly disturbed from the edge of the road up to the fence. There appears to be a correlation between the newer road surface and the roadside disturbance. The vegetation is dominated by grasses, <i>Galenia africana</i> and <i>Salsola kali</i>, all indicating the high level of disturbance.</p> | |

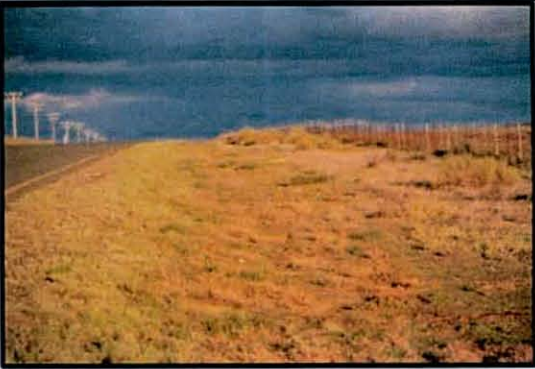
| <p><b>CN22</b><br/>S 31° 24' 14.6"<br/>E 19° 12' 59.3"</p> | <p><b>Grootfontein Mosaic</b><br/><br/><b>Hantam Karoo</b></p> | <p>At the R27-8 10.2E road marker the road reserve is mowed almost to the fence. A 'row' of <i>Ruschia</i> sp. shrubs about 1m wide is found along the fence. <i>Brunsvigia bosmaniae</i> is present; being a geophyte it survives the mowing. Even <i>Galenia africana</i> is sparse at this location.</p> | |

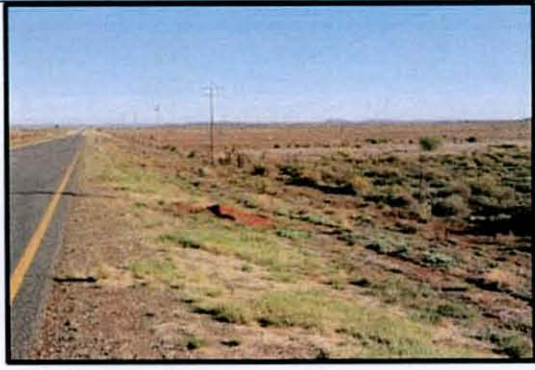
| <p><b>CN24</b><br/>S 31° 24' 05.5"<br/>E 19° 12' 39.6"</p> | <p><b>Nieuwoudtville Mosaic</b><br/><br/><b>Hantam Karoo</b></p> | <p>At road marker R27-8 9.6E (near Borrow Pit 2). The road reserve on both sides is highly disturbed. On the north side the road verge is mowed for width of 5 m. The natural shrubby vegetation is dominated by <i>Pentzia incana</i>. Other species include <i>Augea capensis</i>, <i>Chrysocoma ciliata</i>, <i>Stipagrostis namaquense</i>, <i>Eragrostis curvula</i>, <i>Oxalis pes-caprae</i>, <i>Mesembryanthemum guerichianum</i>, <i>Galenia africana</i>, <i>Atriplex semibaccata</i>.</p> | |

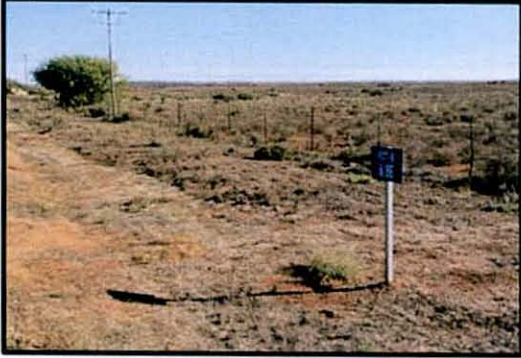
| <p><b>CN25</b><br/>S 31° 23' 25.1"<br/>E 19° 11' 04.8"</p> | <p><b>Nieuwoudtville Mosaic</b><br/><br/><b>Hantam Karoo</b></p> | <p>This location is at the R27-8 6.8E road marker where the road reserve is highly disturbed. The vegetation is principally dry annual grasses with <i>Psilocalon junceum</i>, <i>Lycium</i> sp., <i>Asparagus capensis</i>, <i>Atriplex nummularia</i>, <i>Atriplex semibaccata</i>, <i>Salsola kali</i>, <i>Mesembryanthemum guerichianum</i> and <i>Brunsvigia bosmaniae</i>.</p> | |

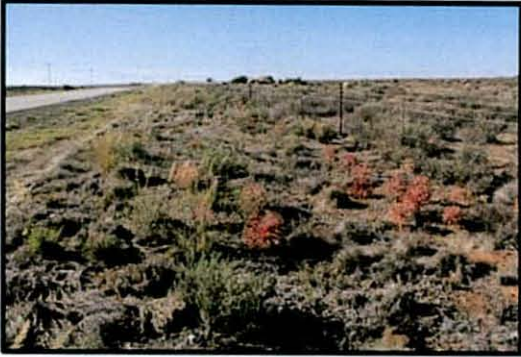
| <p><b>CN26</b><br/>S 31° 23' 04.7"<br/>E 19° 10' 17.2"</p> | <p><b>Nieuwoudtville Mosaic</b><br/><br/><b>Nieuwoudtville—<br/>Roggeveld Dolerite<br/>Renosterveld</b></p> | <p>At this road marker (R27-8 5.4E) the soil is derived from dolerite. The vegetation has numerous species but shows signs of intense disturbance. Species recorded include <i>Brunsvigia bosmaniae</i>, <i>Boo phone haemanthoides</i>, <i>Chrysocoma ciliata</i>, <i>Oxalis</i> sp. (pink flowers), <i>Trachyandra</i> cf. <i>falcata</i>, <i>Asparagus capensis</i>, <i>Berkheya</i> sp., <i>Oxalis</i> sp. (yellow flowers), <i>Salsola kali</i>, <i>Psilocalon junceum</i>, <i>Malephora crassa</i>, <i>Atriplex semibaccata</i>, <i>Eragrostis curvula</i>, <i>Hermannia</i> sp.</p> | |

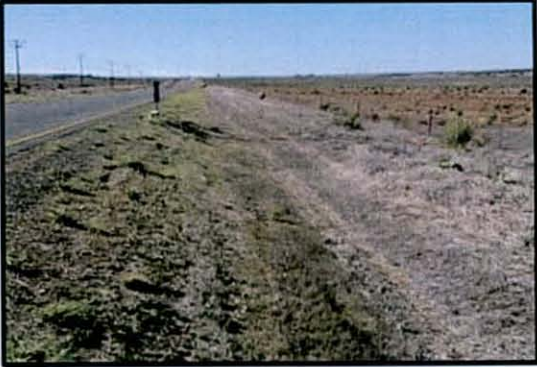
| <p><b>CN27</b><br/>S 31° 22' 35.1"<br/>E 19° 09' 08.8"</p> | <p><b>Nieuwoudtville Mosaic</b><br/><br/><b>Nieuwoudtville Shale Renosterveld</b></p> | <p>This location is at the R 27-8 3.4E marker. The road reserve is in poor condition. The vegetation consists mainly of dry grass and weedy species. No Nieuwoudtville Shale Renosterveld is present and the adjacent private land has also been cleared of natural vegetation.</p> | |

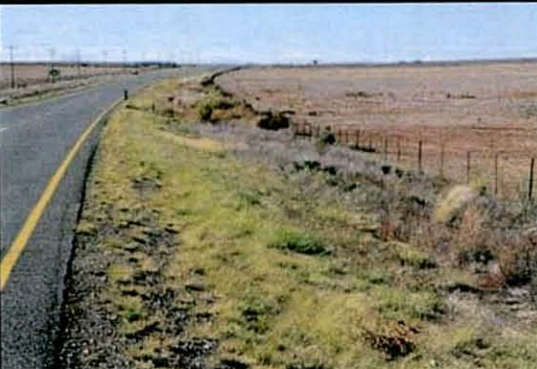
| <p><b>CN28</b><br/>S 31° 22' 16.0"<br/>E 19° 08' 21.4"</p> | <p><b>Nieuwoudtville Mosaic</b><br/><br/><b>Nieuwoudtville Shale Renosterveld</b></p> | <p>Near road marker R27-8 2.0 E. The road reserve is in poor condition. The verge is mowed and is populated by <i>Eragrostis curvula</i>. Other species recorded are <i>Galenia africana</i>, <i>Gomphocarpus fruticosus</i> and <i>Erodium moschatum</i>.</p> | |

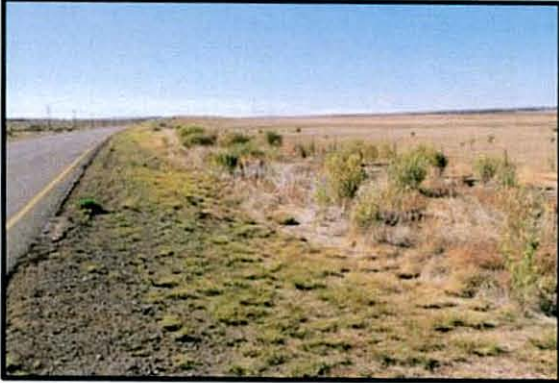
| <p><b>CN29</b> S 31° 22'<br/>09.8" E 19° 07'<br/>43.7"</p> | <p><b>Nieuwoudtville Mosaic</b></p> <p><b>Nieuwoudtville Shale</b></p> <p><b>Renosterveld</b></p> | <p>This location is close to the R 27-8 1.0E marker at the entrance to the Nieuwoudtville Landfill. The road reserve is highly transformed and disturbed. The vegetation is dominated by grass and exotic static or sea lavender (<i>Limonium sinuatum</i>) that has no doubt escaped from the nearby town. Other species recorded here include <i>Gomphocarpus fruticosus</i>, <i>Eragrostis curvula</i>, <i>Avena fatua</i> and <i>Salsola kali</i>.</p> | |

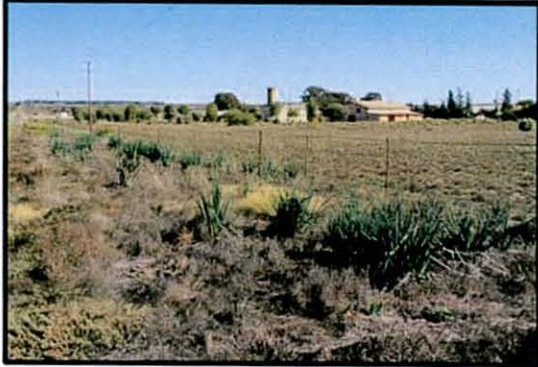
| <p><b>CN30</b><br/>S 31° 22' 10.6"<br/>E 19° 07' 05.1"</p> | <p><b>Nieuwoudtville Mosaic</b></p> <p><b>Nieuwoudtville Shale</b></p> <p><b>Renosterveld</b></p> | <p>This location is on the outskirts of Nieuwoudtville. Stands of <i>Albuca canadensis</i> are found on both sides of the road. According to Vlok &amp; Schutte-Vlok (2010) presence of this species in abundance indicates intense disturbance and this is clearly the case here. The road reserve is dominated by grass and other weedy species contribute to the vegetation matrix.</p> | |
