CONSULTATION IN TERMS OF SECTION 40 OF THE MINERAL AND PETROLEUM RESOURCES DEVELOPMENT ACT 2002, (ACT 28 OF 2002) FOR THE APPROVAL OF AN ENVIRONMENTAL MANAGEMENT PLAN FOR MINING PERMIT IN RESPECT OF GRAVEL (BORROW PIT 9, 11 AND 12) ON ERF 1733, ERF 1271 AND ERF 1272 OF THE FARM COLESBERGKOP, SITUATED IN THE MAGISTERIAL DISTRICT OF COLESBERG, NORTHERN CAPE REGION.

APPLICANT: SOUTH AFRICA NATIONAL ROAD AGENCY LIMITED (SANRAL)

REHABILITATION AND UPGRADING OF SECTION 7 OF NATIONAL ROUTE 9 BETWEEN WOLWEFONTEIN AND COLESBERG: ENVIRONMENTAL MANAGEMENT PROGRAMME FOR THREE ADDITIONAL BORROW PITS

**REHABILITATION AND UPGRADING OF
SECTION 7 OF NATIONAL ROUTE 9
BETWEEN WOLWEFONTEIN AND COLESBERG
ENVIRONMENTAL MANAGEMENT PROGRAMME
FOR THE EXPANSION OF
THREE ABANDONED BORROW PITS**

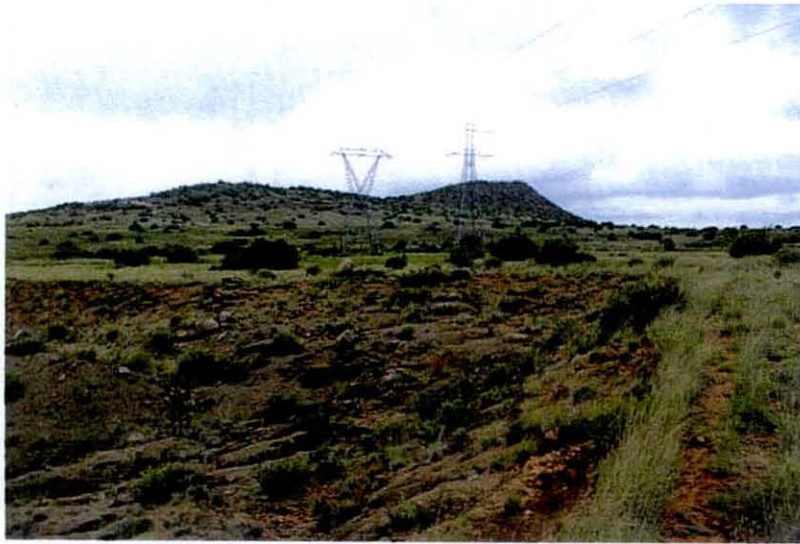
Plate B9.1 Borrow Pit 9 (DR3080/5.0/0.2L). Photograph taken along the eastern edge of the existing excavation looking south.

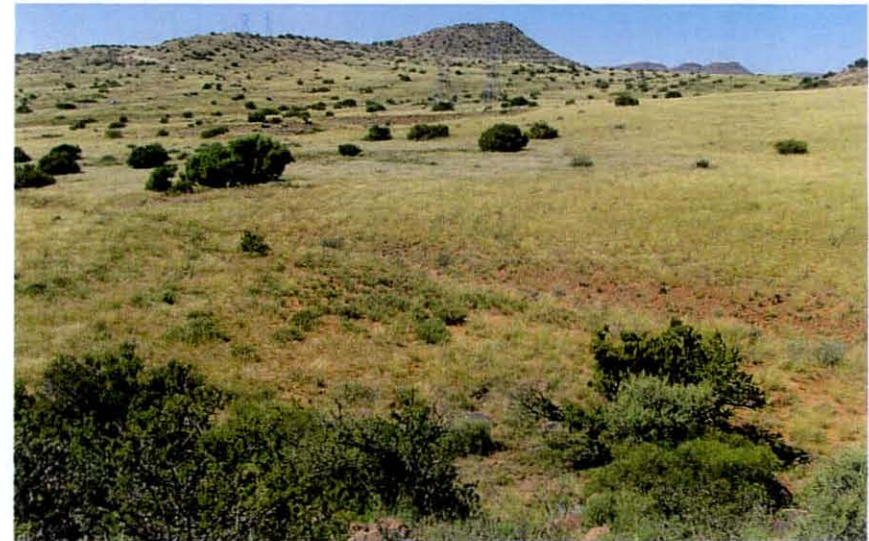
Plate B9.2 Picture taken across the proposed extension area looking south towards the existing excavation.

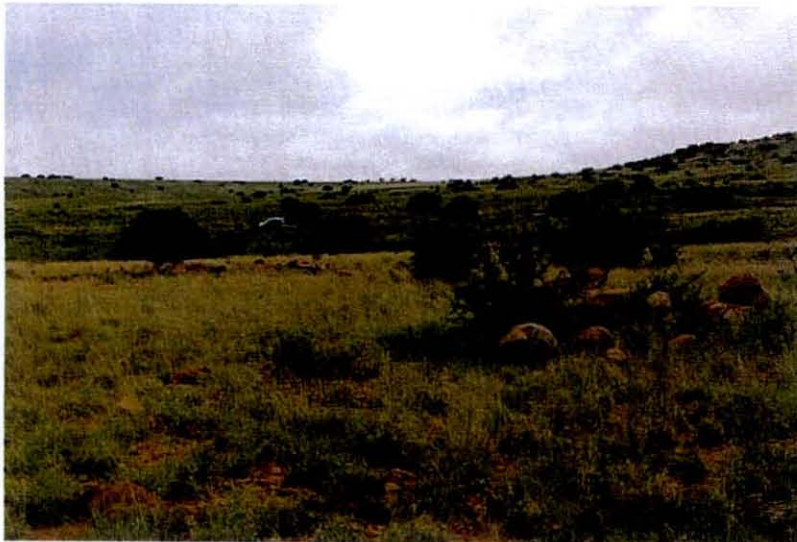
Plate B9.3 Picture taken from the edge of the existing excavation looking east towards DR3080.

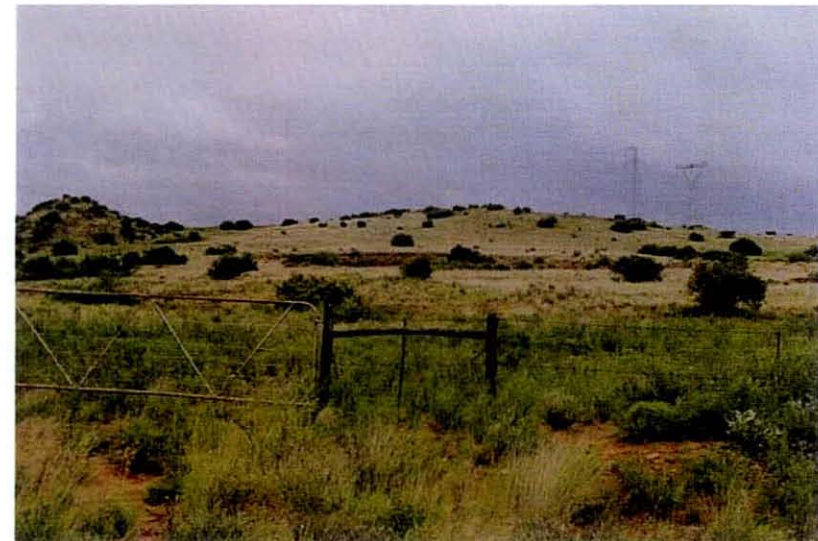
Plate B9.4 Borrow pit 9 (DR3080/5.0/0.2L) taken looking west from DR3080.

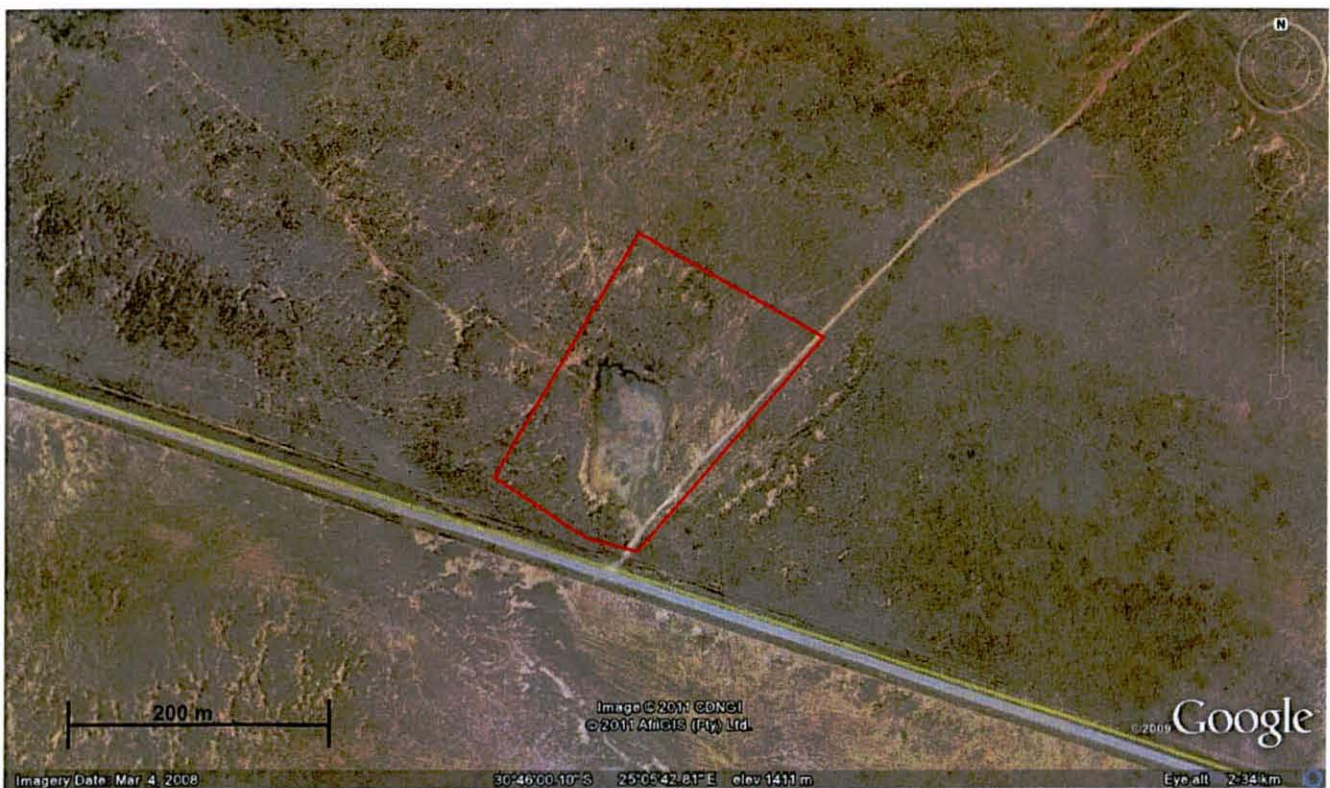
Figure B11.2 Google Earth Image showing the proposed extended mining area at BP 11.

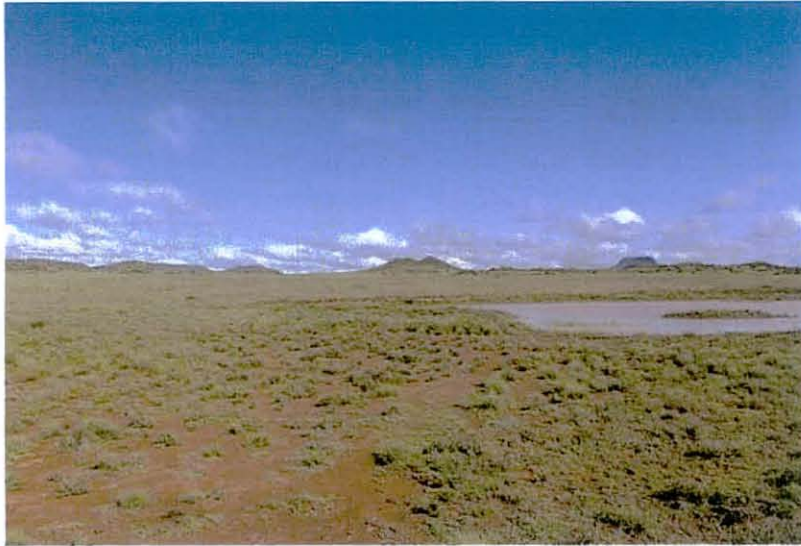
Plate B11.1 Picture taken from the southeastern corner of the proposed Borrow Pit 11 extension looking north-northwest along the N9.

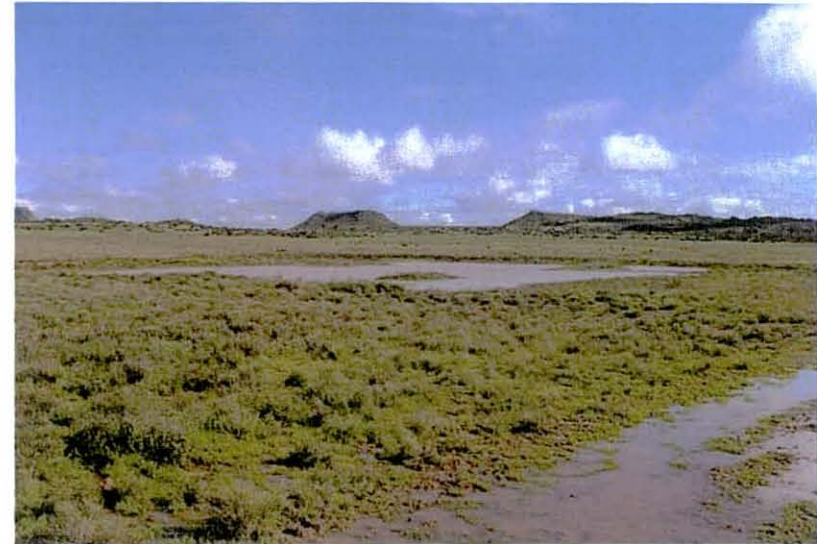
Plate B11.2 Picture taken across the existing excavation looking north towards the proposed northern extension area.

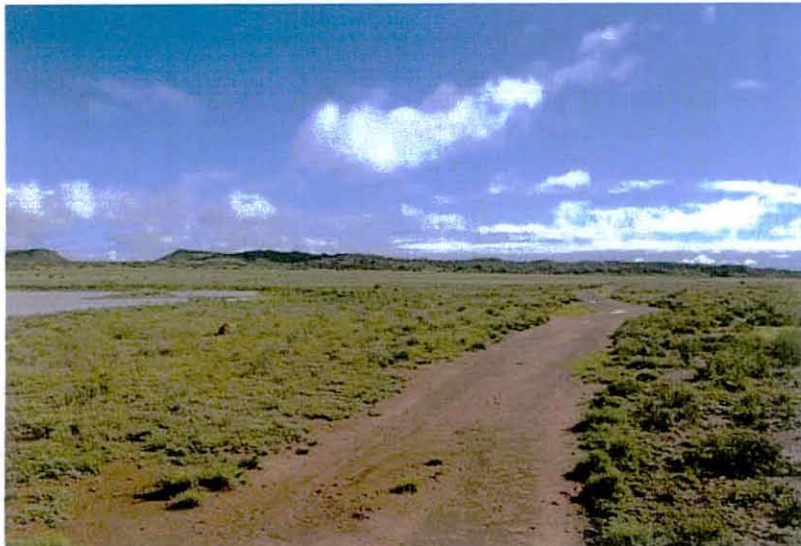
Plate B11.3 Picture taken from the existing dirt track along the eastern edge of Borrow Pit 11 looking northeast.

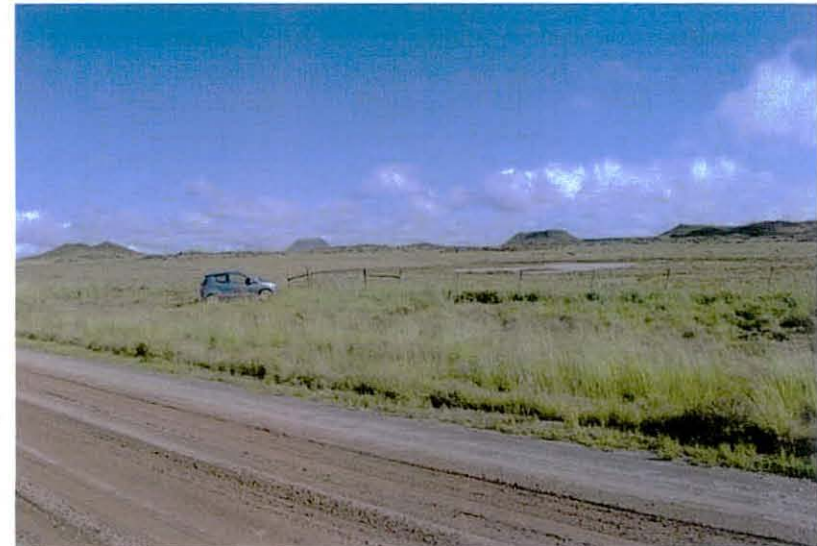
Plate B11.4 Picture of the existing access gate taken from the Oorlogspoor Road looking northwest across the existing borrow pit excavation.

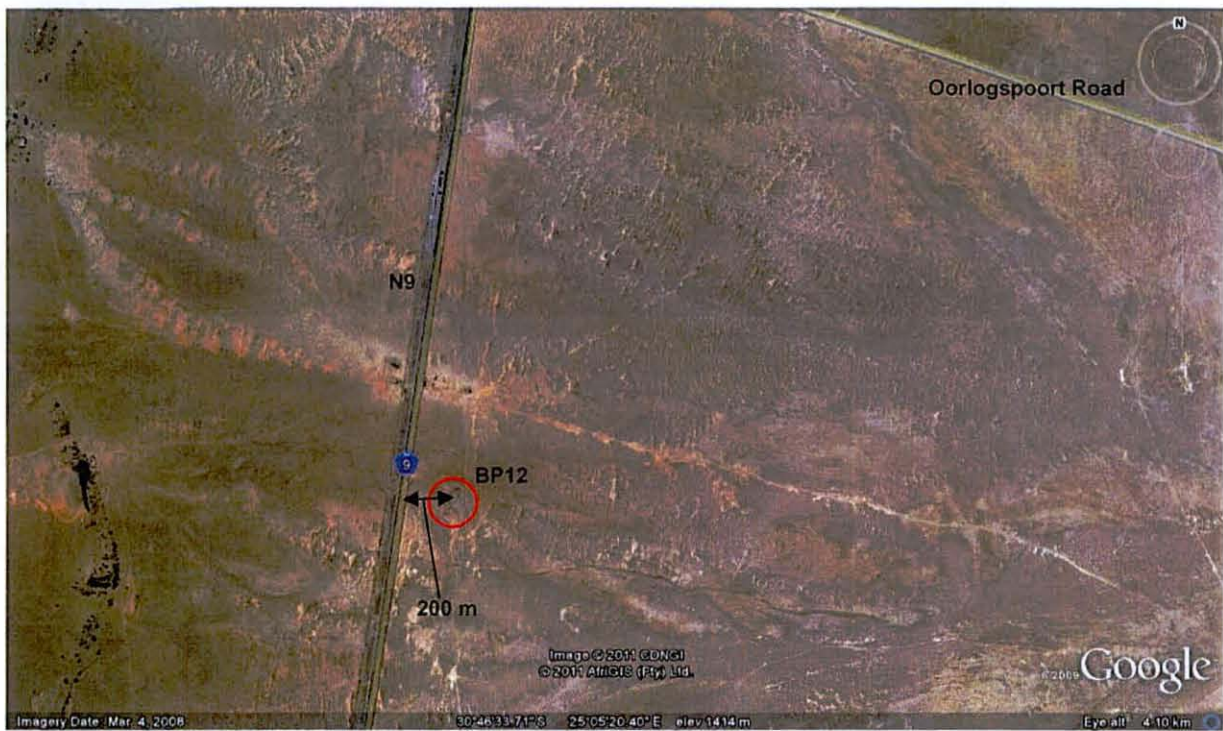
Figure B12.1 Google Earth image showing the location of Borrow Pit 12 N9_7/89.9/0.2R approximately 4.5 km south of Colesberg along the N9.

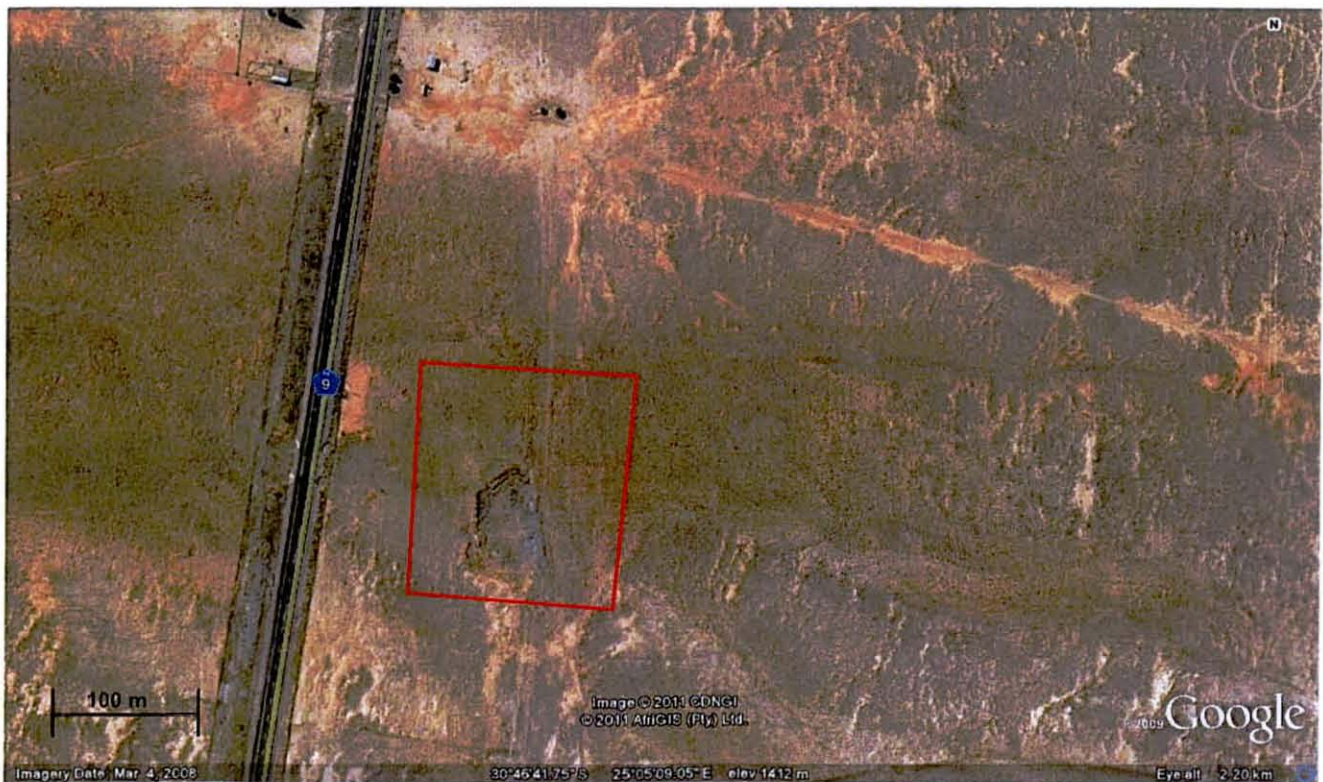
Figure B12.2 Google Earth image showing the proposed mining area at Borrow Pit 12 N9_7/89.9/0.2R.

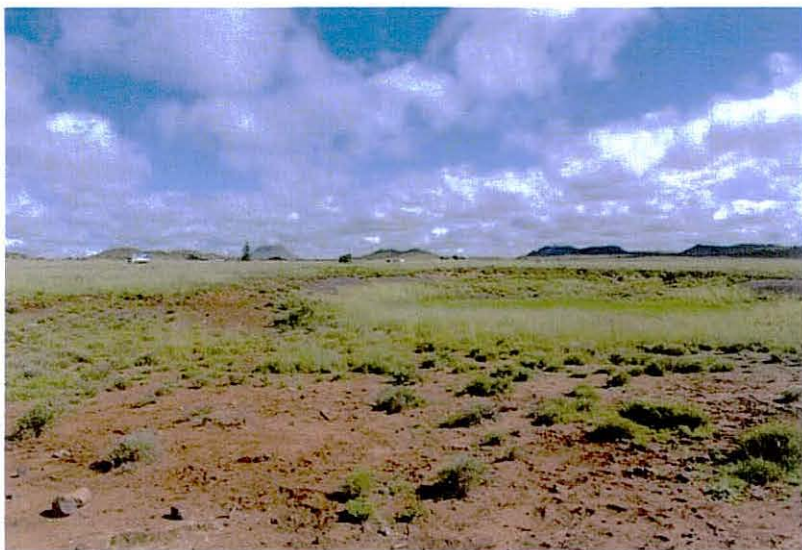
Plate B12.1 The existing excavation at Borrow Pit 12. Photo taken looking north along the N9.

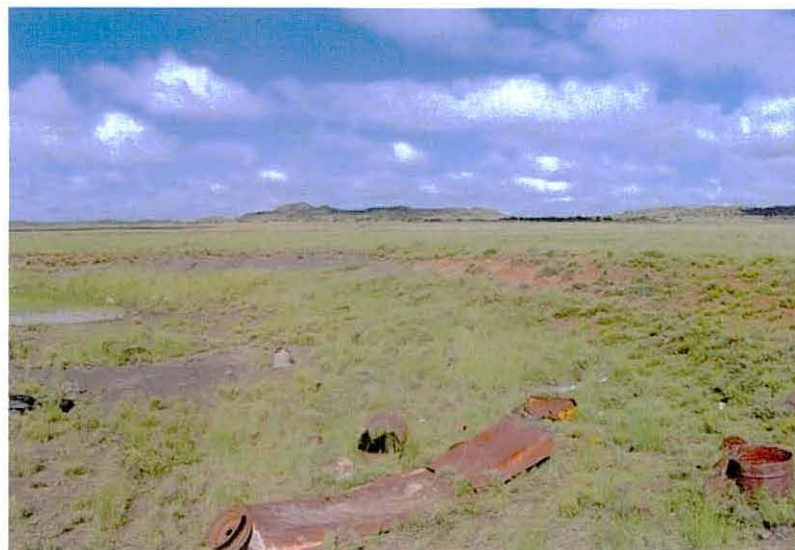
Plate B12.2 The existing excavation at Borrow Pit 12. Photo taken looking northeast.

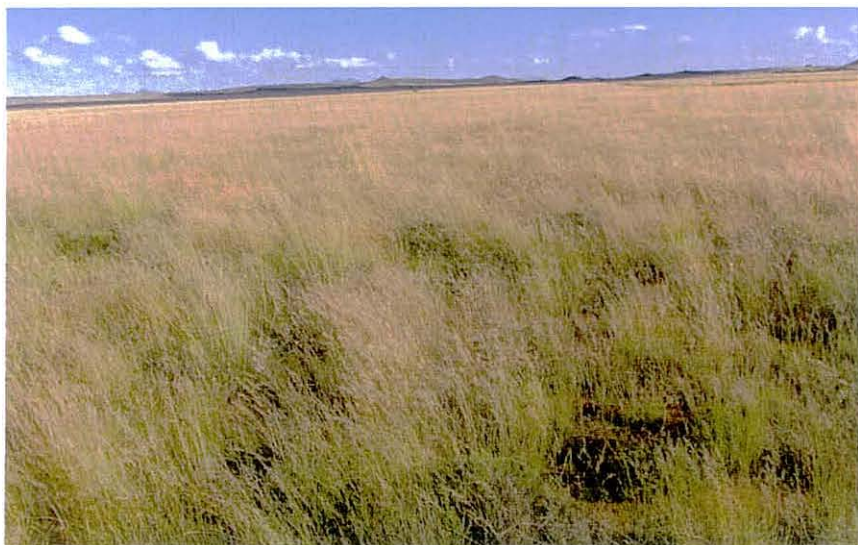
Plate B12.3 Photo of the proposed extension area looking south from the northern edge of the extension area.

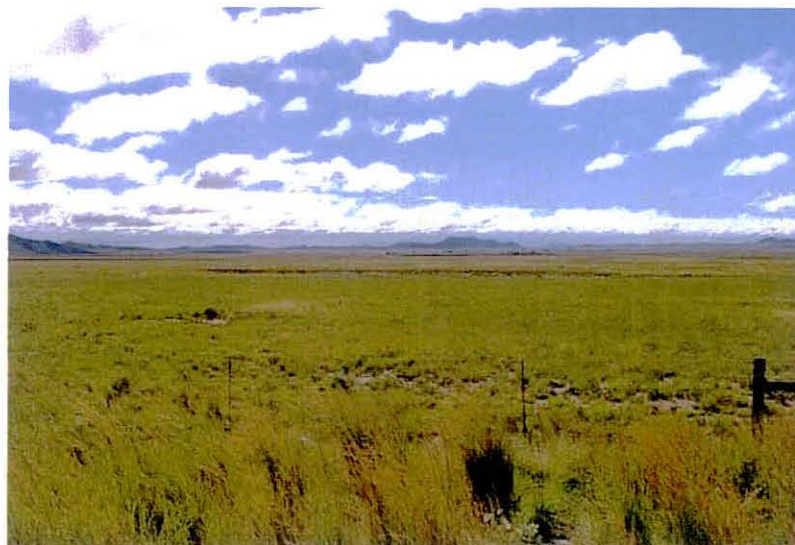
Plate B12.4 Photo taken from the N9 towards Borrow Pit 12 looking east.
