**CONSULTATION IN TERMS OF SECTION 40 OF THE MPRDA OF 2002:
ENVIRONMENTAL MANAGEMENT PLAN (EMP); BORROW PITS ASSOCIATED
WITH THE ROAD REHABILITATION PROJECT OF THE DR08012 ROAD
BETWEEN MALUTI AND QACHAS NEK**

**ENVIRONMENTAL MANAGEMENT PLAN FOR THE
PROPOSED BORROW PITS ASSOCIATED WITH
THE UPGRADING OF THE ROAD BETWEEN
MALUTI AND QACHAS NEK IN THE EASTERN
CAPE**

NOVEMBER 2009

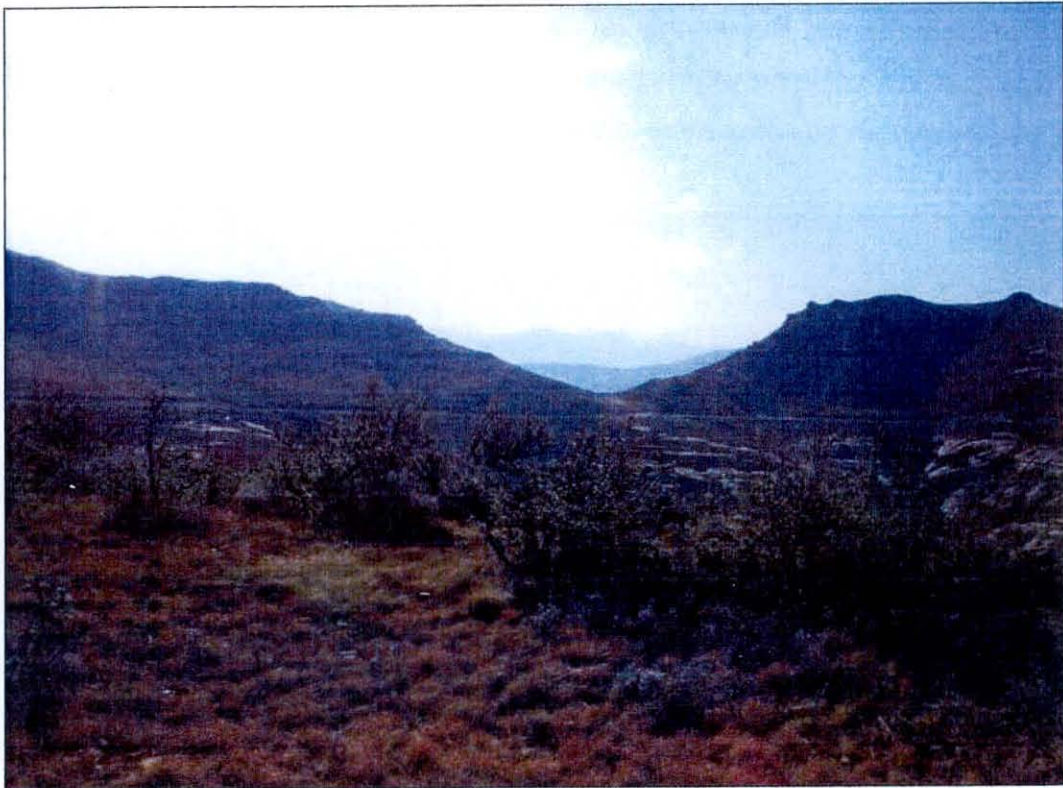
The vegetation on the site has been disturbed by previous mining operations which have caused an irregular mosaic of grasses on the site. The shrubs that occur on

the site, *Leucosidea sericea* (Oldwood), are associated with the stockpile of stone that is a remnant of the old mining operations.

View of the tussock grassland with small shrubs

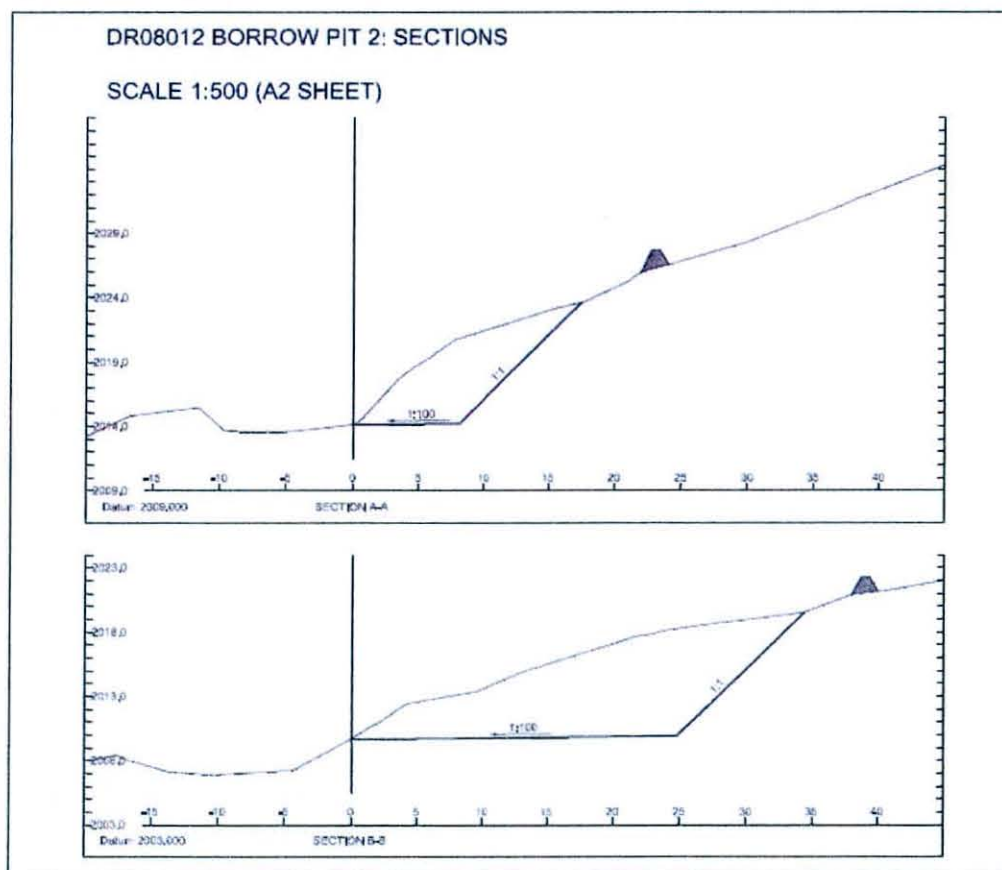
Recommendations: Care must be taken in the layout and design to ensure that the working of the borrow pit is done in definite mining directions which can be rehabilitated successfully. The rehabilitation should include the shaping and the rehabilitation of the benches formed by the mining operation. This should happen on an ongoing basis as the mining operation proceeds through the site. A full surveyor drawing showing the profile and mining plan is attached in Appendix B.

Planned final profile

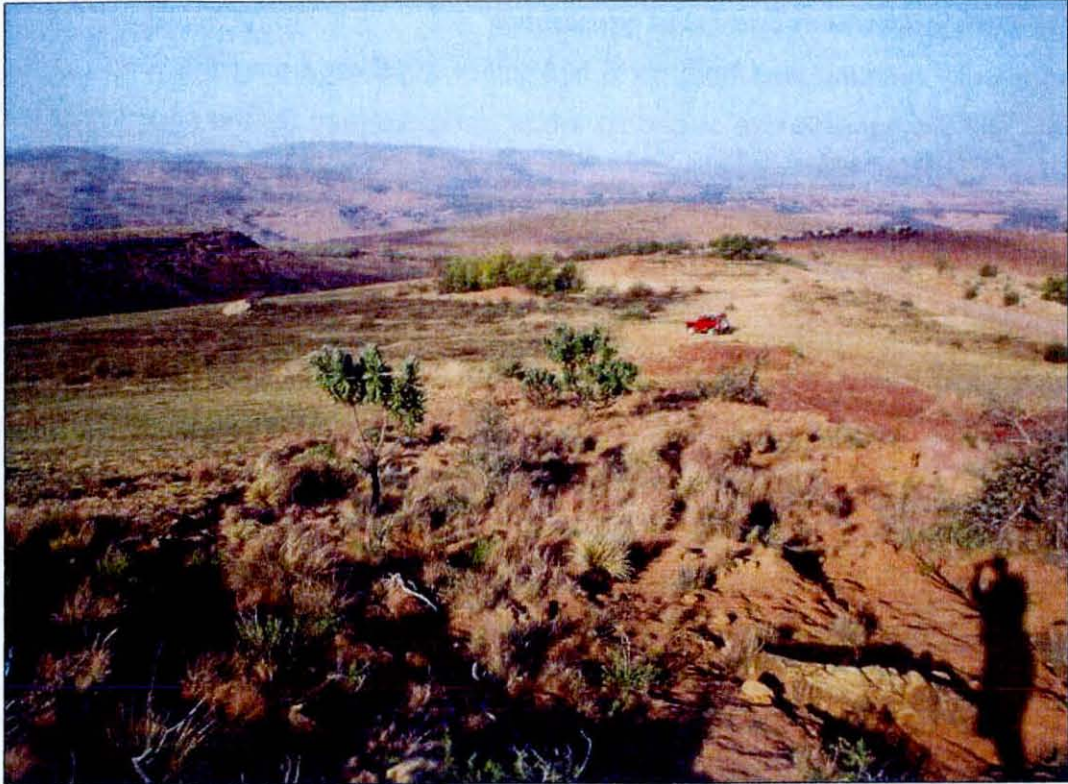
View over the borrow pit site

The areas to the northwest of the borrow pit site are typical this vegetation type with the southeast of the area denuded of most of the occurring vegetation due to the site being illegally mined. This removal of vegetation from the site has caused parts of the site to be severely eroded. A small stand of exotic *Acacia dealbata* (Silver Wattle) has also encroached on the disturbed areas on the site.

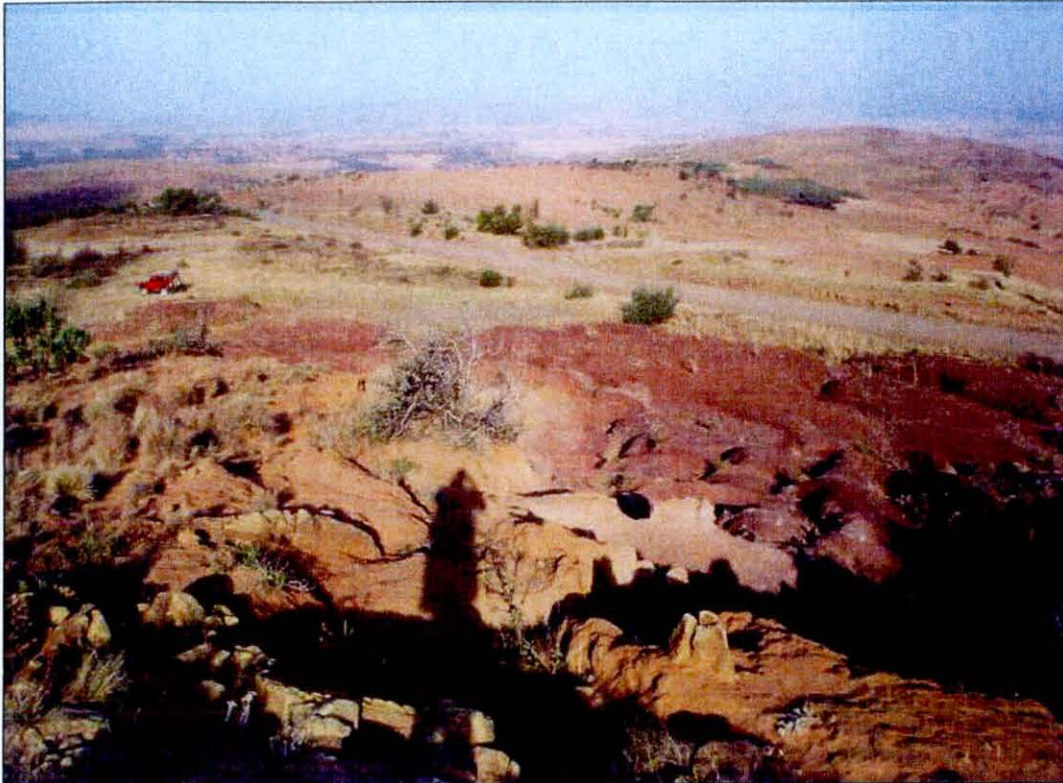
View of the severe erosion within the borrow pit site

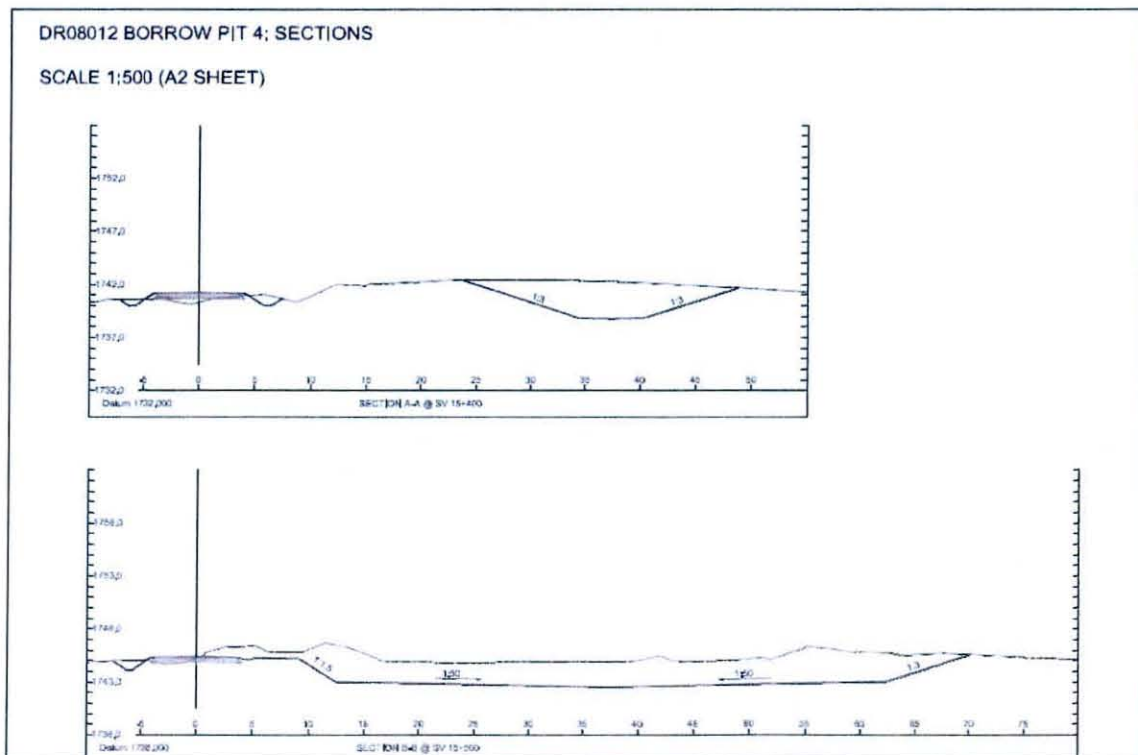
Recommendations: Care must be taken in the layout and design to ensure that the working of the borrow pit is done in defined mining directions which can be rehabilitated successfully. The rehabilitation must include the shaping of the topography of the borrow pit upon completion of the operations. This should take place on an ongoing basis as the mining operation proceeds through the site. The site must also be vegetated with an indigenous grass seed mix upon completion of the operations. A full surveyor drawing showing the profile and mining plan is attached in Appendix B.

Planned final profile

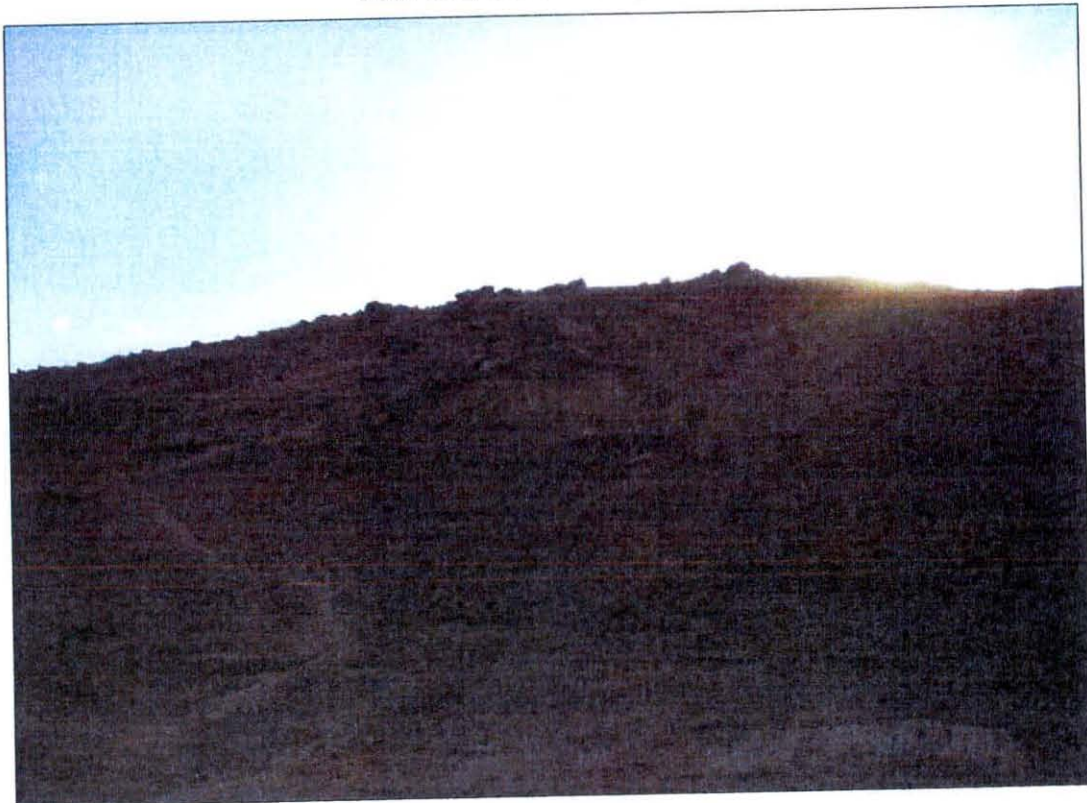
View over the borrow pit site

The illegal mining on the site has resulted in the presence of various scars being present on the borrow pit site. Some of these mining scars have resulted in erosion

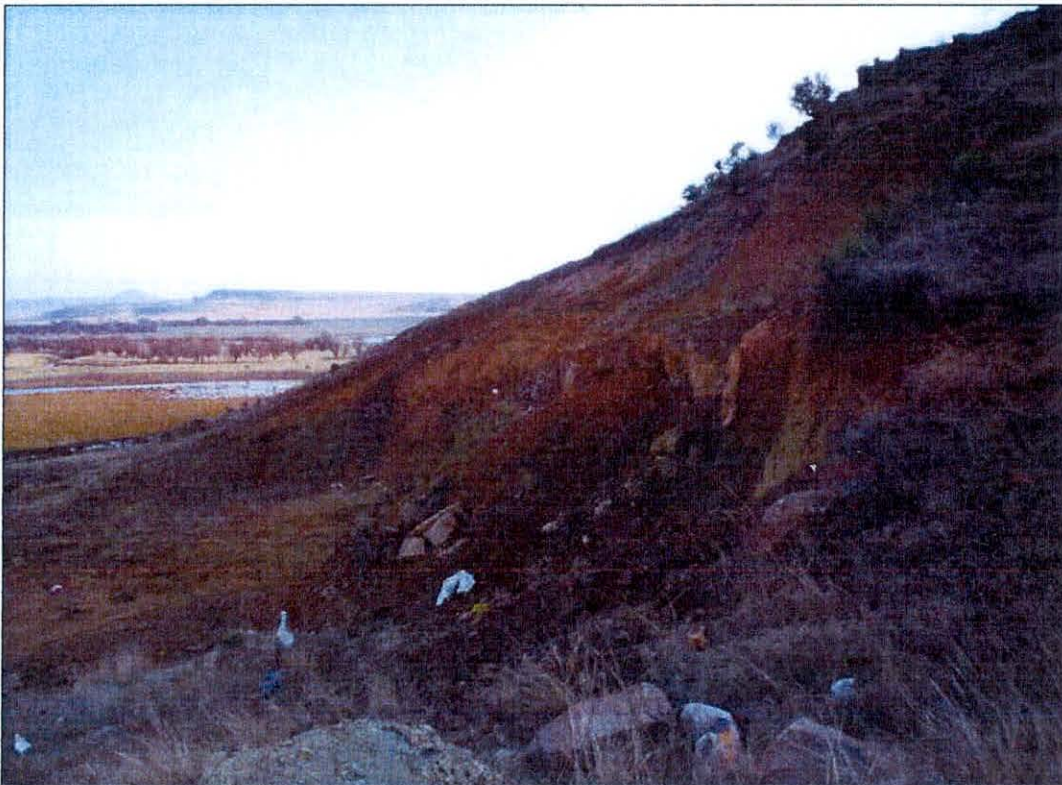
The topography of the surrounding area is characterized by a medium slope towards the north and a floodplain towards the south. The borrow pit is located on the medium slope on the boundary with the floodplain.

View of the topography of the site

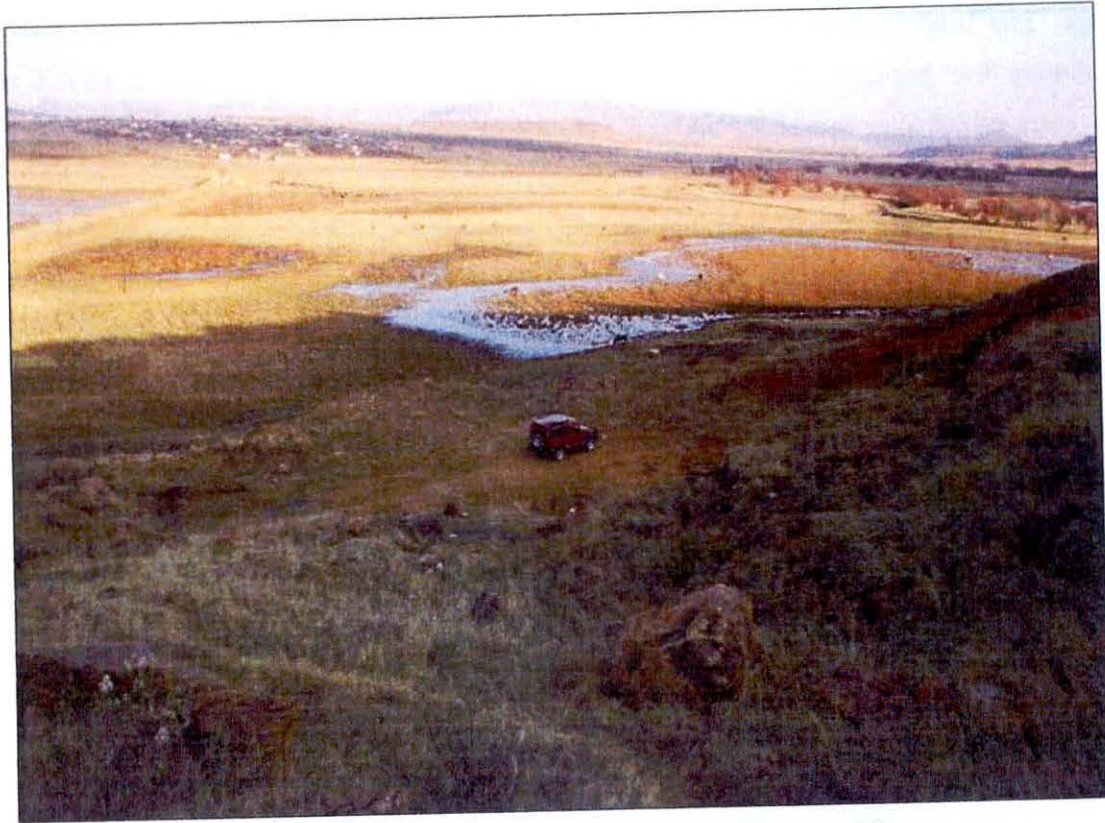
There are no natural drainage lines that originate or run through the site. The erosion dongas that are on the site are as a result of the illegal mining operations that have taken place on the site and do not represent a natural drainage course in any way. The nearest natural drainage line is located immediately south of the borrow pit and is the flood plain associated with the Kinira River.

View of the flood plain associated with the Kinira River

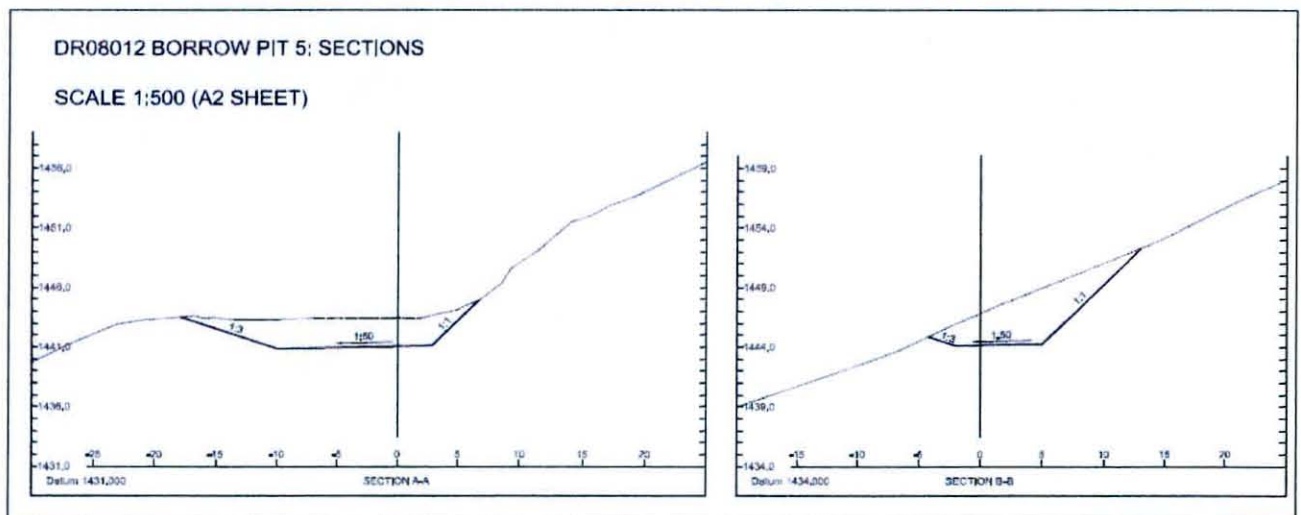
Recommendations: Care must be taken in the layout and design to ensure that the working of the borrow pit is done in defined mining directions which can be rehabilitated successfully. The rehabilitation must include the shaping of the topography of the borrow pit upon completion of the operations. This should take place on an ongoing basis as the mining operation proceeds through the site. The site must also be vegetated with an indigenous grass seed mix upon completion of the operations. A full surveyor drawing showing the profile and mining plan is attached in Appendix B.

Planned final profile

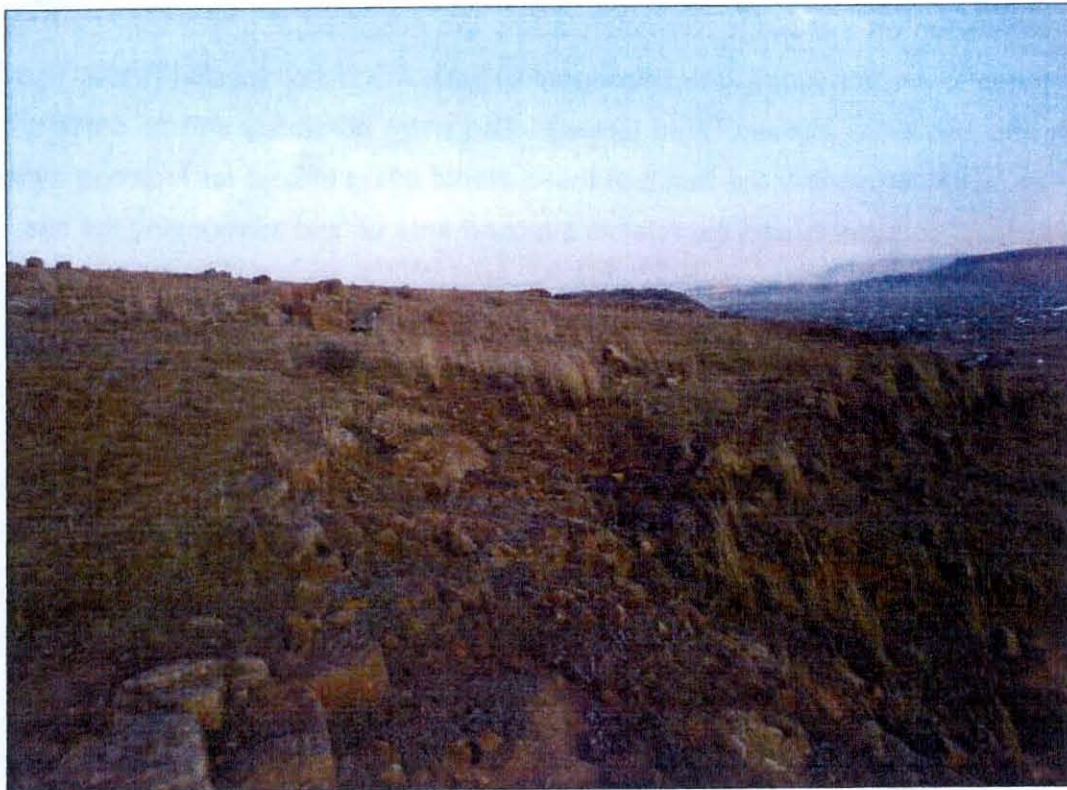
View over the borrow pit site

Previous mining activities on the site have resulted in the presence of a high vertical mining face which is deemed to be very unsafe. The site is currently used as grazing for the livestock from the local community.

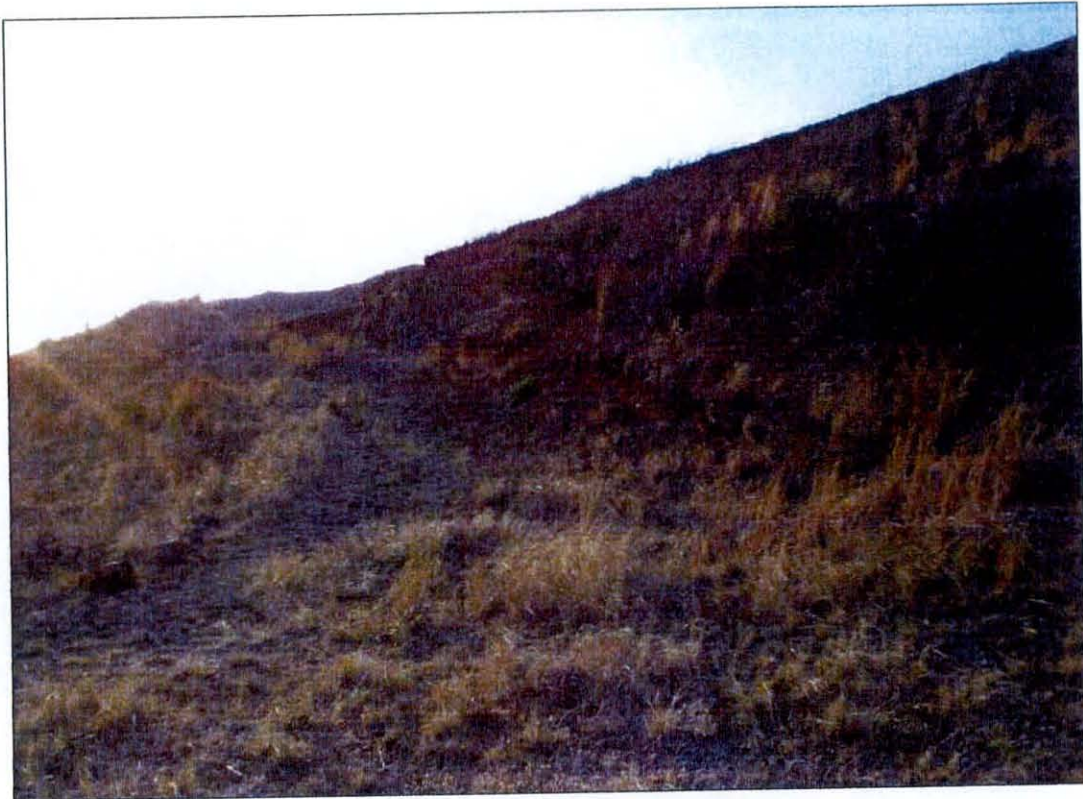
View of the dangerous vertical face

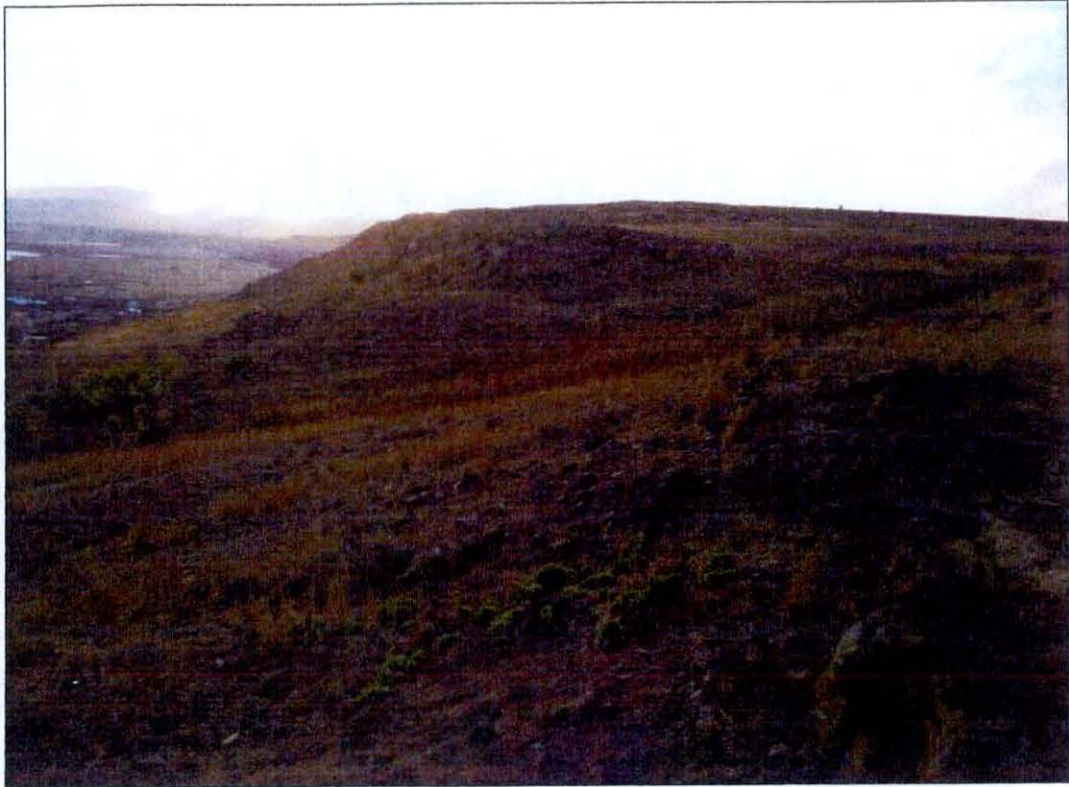
The topography of the surrounding area is characterized by steep slopes to the northeast and the southwest with a relatively flat plateau extending between the 1500m contour. It is the intention to extend the planned benches of the borrow pit into these slopes in a southwesterly direction.

View of the topography of the site

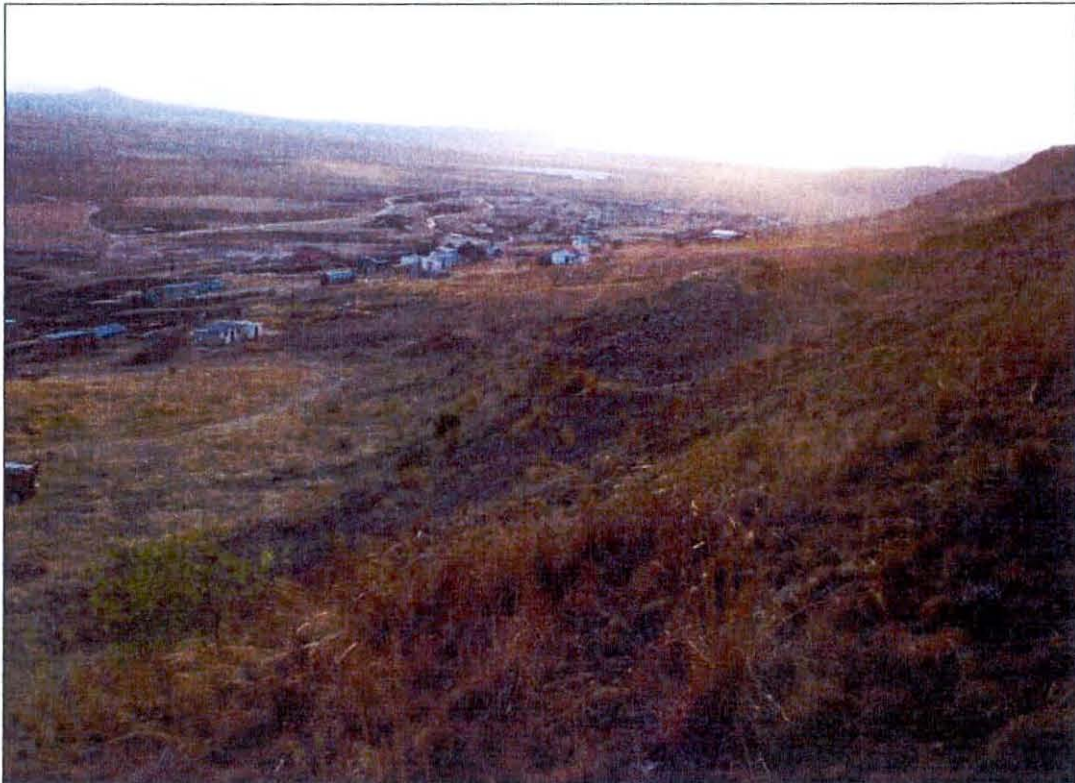
There are no natural drainage lines that originate or run through the site. The nearest natural drainage line is located approximately 35m to the northwest of the site. Water from this drainage line feeds into the Kinira River approximately 550m to the northwest of the site.

View of the flood plain associated with the Kinira River

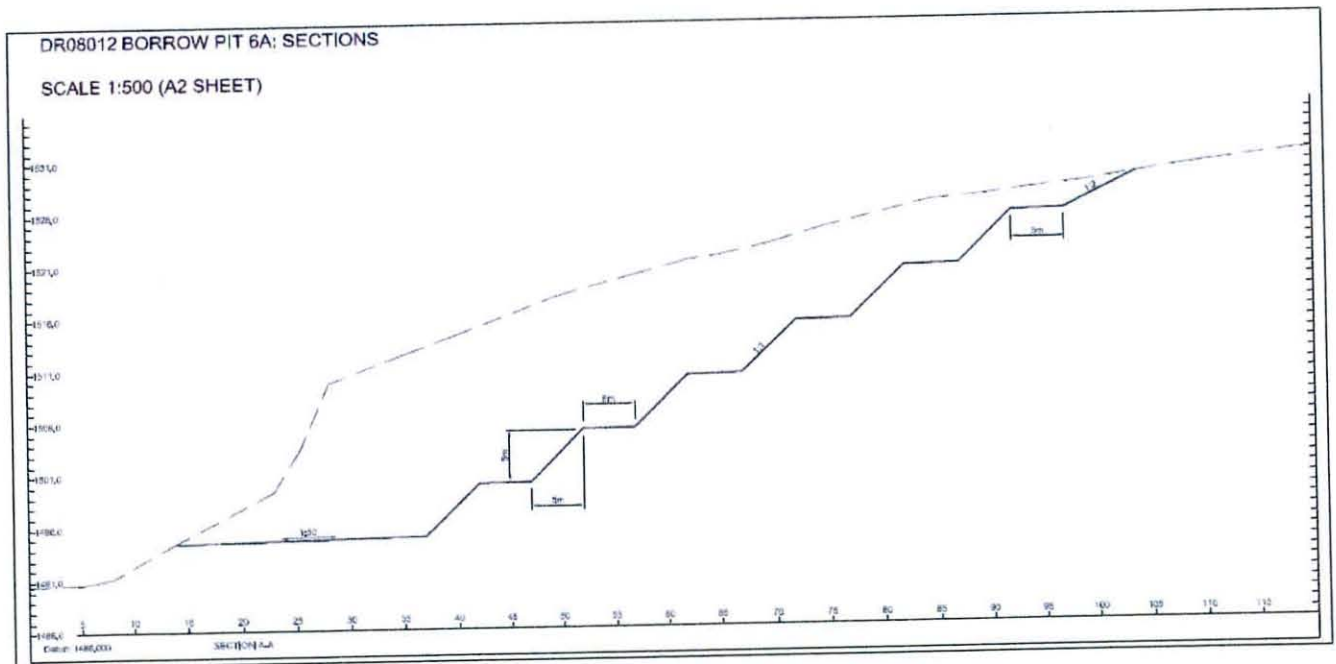
Recommendations: Care must be taken in the layout and design to ensure that the working of the borrow pit is done in defined mining directions which can be rehabilitated successfully. The mining face of the borrow pit must be benched during the operations which will enable successful shaping upon completion. The site must be revegetated with an indigenous grass seed mix upon completion of the operations to aid in the blending of the site with the surrounding environment. A full surveyor drawing showing the profile and mining plan is attached in Appendix B.

Planned benching of the borrow pit

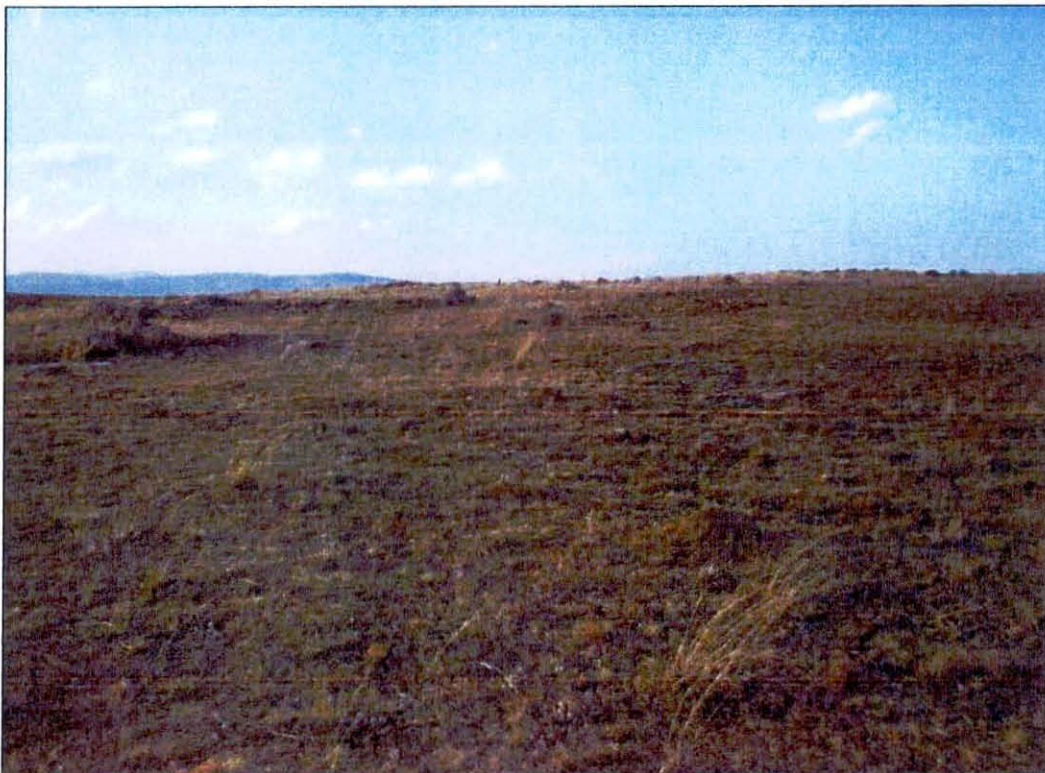
View over the borrow pit site

The vegetation on the borrow pit area is also showing signs of heavy overgrazing by the livestock from the local community. This has resulted in the grass on the site having a low grazing quality.

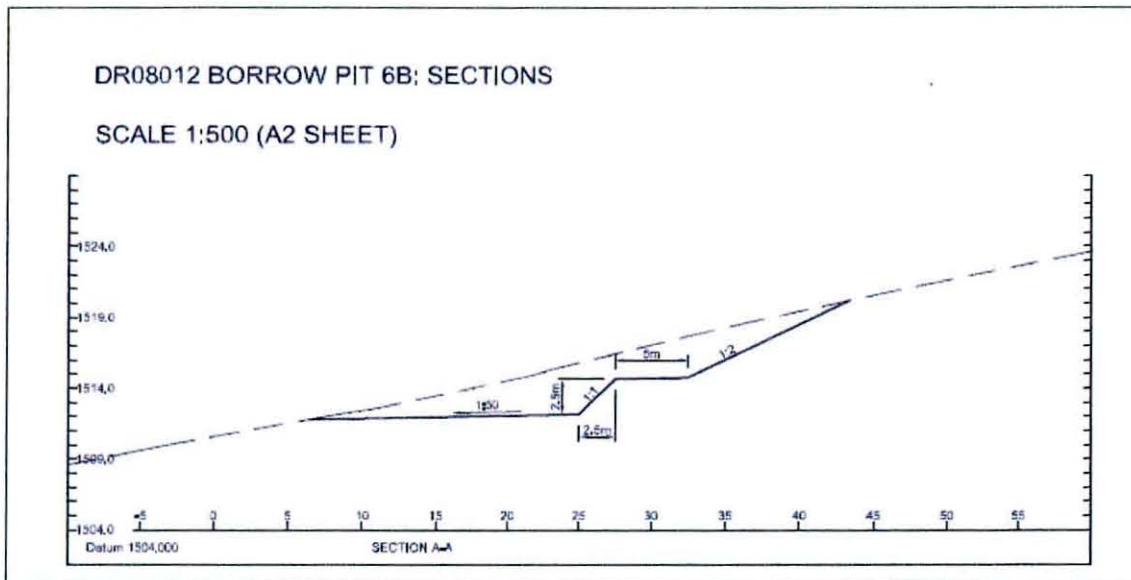
Recommendations: Care must be taken in the layout and design to ensure that the working of the borrow pit is done in defined mining directions which can be rehabilitated successfully. The mining face of the borrow pit must be benched during the operations which will enable successful shaping upon completion. The site must be revegetated with an indigenous grass seed mix upon completion of the operations to aid in the blending of the site with the surrounding environment. A full surveyor drawing showing the profile and mining plan is attached in Appendix B.

Planned benching of the borrow pit

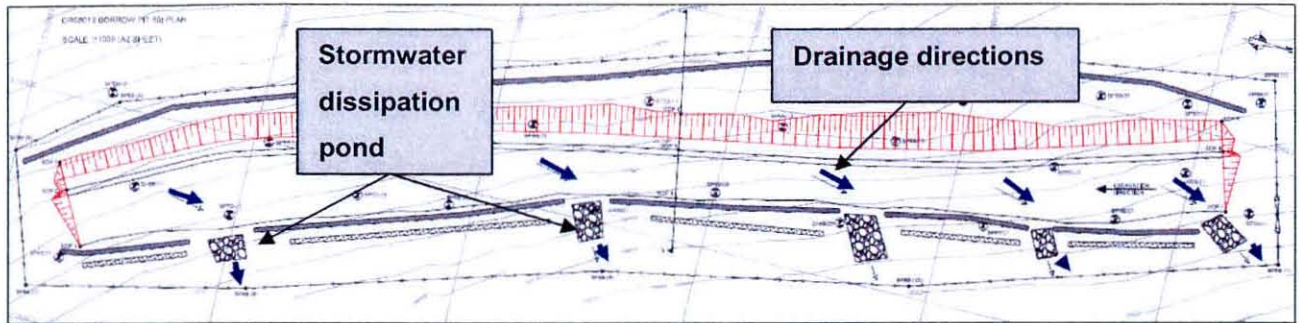
Recommendations: An earth berm will be constructed along the northwestern (up-slope) boundary of the site. This berm will prevent any run-off from the surrounding area to enter the site. The stormwater run-off from within the site will be collected in the bottom of the borrow pit and channeled towards a stone filled stormwater dissipation pond which will release the water to the northeast in the direction of the nearby Kinira River. A full survey drawing showing the layout of the planned stormwater drainage on the site is attached in Appendix A.

View of the proposed drainage for the borrow pit

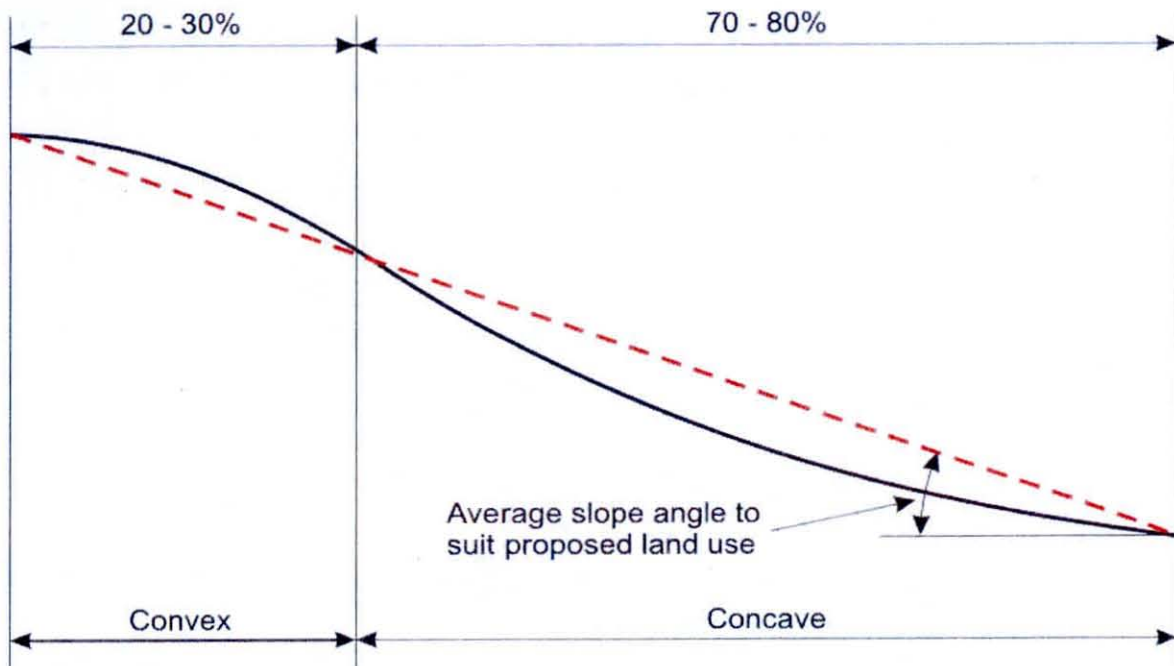
(a) Preferred Profile

There will be a definite alteration of the topography/ landscape. Mitigation shall include reshaping (see sketch b below) the mined area to blend in as much as possible with the adjacent ground contour. After topsoiling and revegetation it is expected that the impact will be minimal.

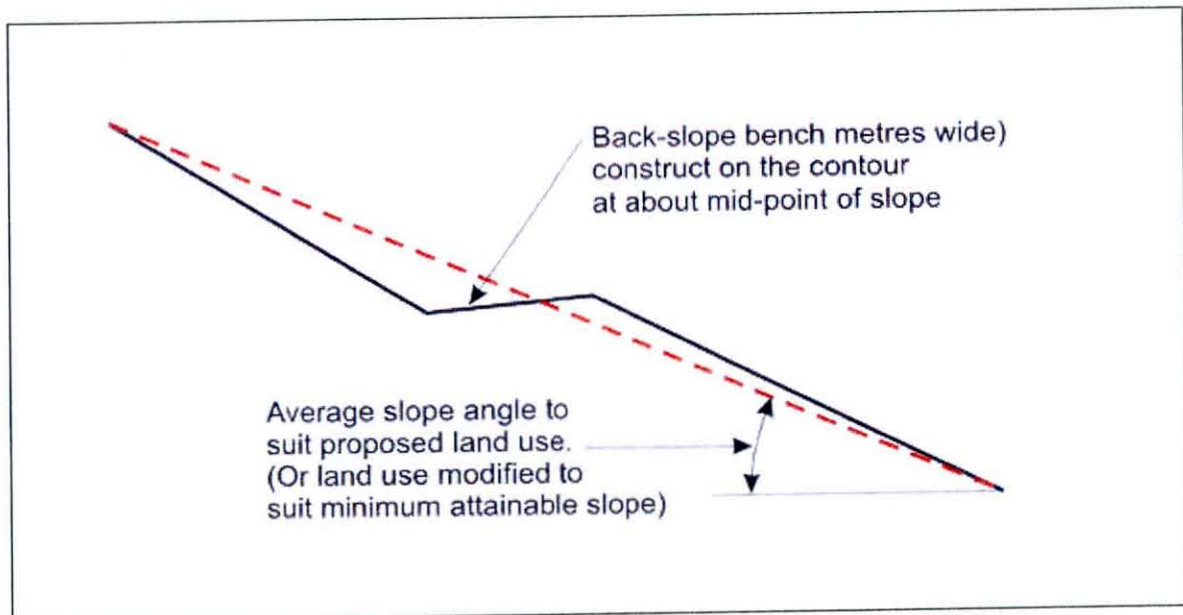
(b) Profile design when external features limit spreading distance

The borrow pit floor shall be gently sloped so that water is not left to pond and which will allow for easy drainage.
