**APPENDIX C
ENVIRONMENTAL AWARENESS PLAN**

APPENDIX D
MATERIALS TESTING RESULTS

**PROJECT:
QACHAS NEK ROAD**

HERITAGE IMPACT ASSESSMENT OF
UPGRADING OF DISTRICT ROAD DR 08012
FROM MALUTI TO QACHAS NEK,
MATATIELE,
EASTERN CAPE PROVINCE, SOUTH AFRICA

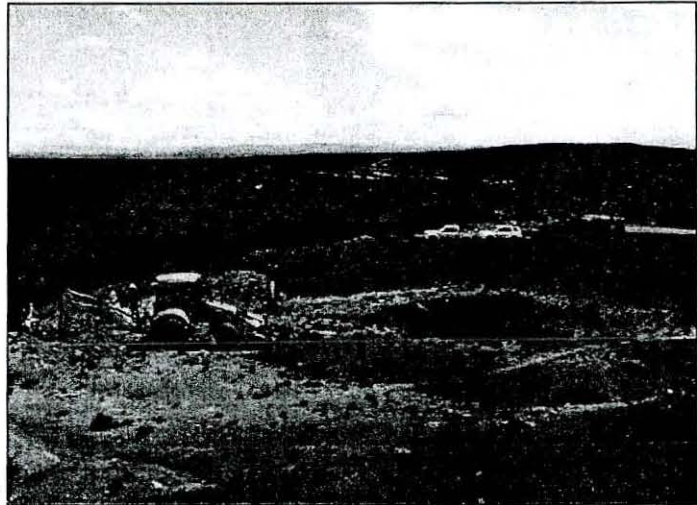
CO-ORDINATES

S 30° 09,827' E 28° 41,053'

**LABORATORY RESULTS**

MQ Sample	Trial Hole	Depth (m)	Material	GM	PI	LS%	Mat. Class	MDD kg/m	CBR Swell %	CBR @ %			
										90	93	95	98
69	3A	1,7	Yel Ol Hi Wthd Mudstone	2.1	11	5.0	G7	1884	0.4	10	15	20	30
70	3B	0,5	Yel Ol Hi Wthd Mudstone	2.6	11	5.0	G7	2136	0.3	12	17	23	36
71	3E	1,0	Yel Ol Hi Wthd Mudstone	1.2	7	3.0	G9	1800	0.5	5	9	12	18
72	3F	1,0	Yel OL Hi Wthd Mudstone	2.5	10	5.0	G8	1935	0.4	8	12	16	24
73	3G	2,0	Maroon Hi Wthd Mudstone	2.0	11	5.0	G10	2158	0.4	3	5	7	11

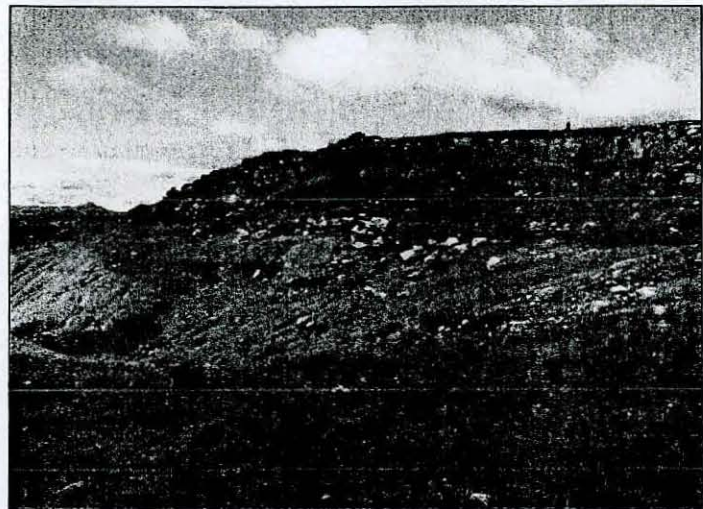
Borrow Pit 5 is a large existing borrow pit comprising mudstone which has been intruded by a dolerite sill and has a plateau crest of hard sandstone. Dolerite is relatively soft with easy excavation. The mudstone is harder and may require blasting to loosen for excavation. A large centrally located promontory of mudstone could provide reasonably good selected material but here again blasting will be required. Possibly crushing too. Additional mudstone reserves are located on the eastern side of the road opposite though there are graves to contend with to the far west. The 1m sandstone capping will require blasting for excavation should borrowing cut deeper into the hillside.

S 30° 13' 57.38" E 28° 45' 40.37"

LABORATORY RESULTS

MQ Sample	Trial Hole	Depth (m)	Material	GM	PI	LS%	Mat. Class	MDD kg/m	CBR Swell %	CBR @ %			
										90	93	95	98
80	5A	2.5	Grey mod wthd mudstone	2.4	11	5.0	G7	2075	0.3	10	15	20	33
81	5B	4	Ol br highly wthd dolerite	1.4	12	5.5	G7	1877	0.4	10	15	19	33
82	5C	3.5	Ol Br highly wthd dolerite	0.5	19	9.5	-	1636	1.8	3	5	7	8
83	5E	7	Grey mod wthd mudstone	1.8	16	8.0	-	1892	1.4	5	9	12	22
84	5F	2.5	Grey mod wthd mudstone	2.4	13	6.0	G8	1986	0.7	7	11	15	22
