**ENVIRONMENTAL MANAGEMENT PROGRAMMES
FOR THE RE-USE/EXTENSION OF
THREE EXISTING BORROW PITS
FOR
USE IN ROAD SHOULDER STABILIZATION OF THE CURRENT
SANRAL CONTRACT: NRA-N012-080-2009/1
Rehabilitation of National Route 12 Section 8
Strydenberg km 0.0 to Hopetown km 52.0
Three borrow pits: (now including the 4th)**

- Hopetown Municipal Borrow Pit, BP-HM
- Ganna Bridge Borrow Pit, BP-GB
- Strydenberg Municipal Borrow Pit, BP-SM
- **Karee Tree Borrow Pit, BP-KT**

Environmental Management Programme For Borrow Pits (Compiled i.t.o. Section 106 of the Mineral and Petroleum Resources Development Act, 2002 (Act 28 of 2002); Government Notice R762 dated 25 June 2004; and Section 39(1) and Regulation 49 of the MPRDA)

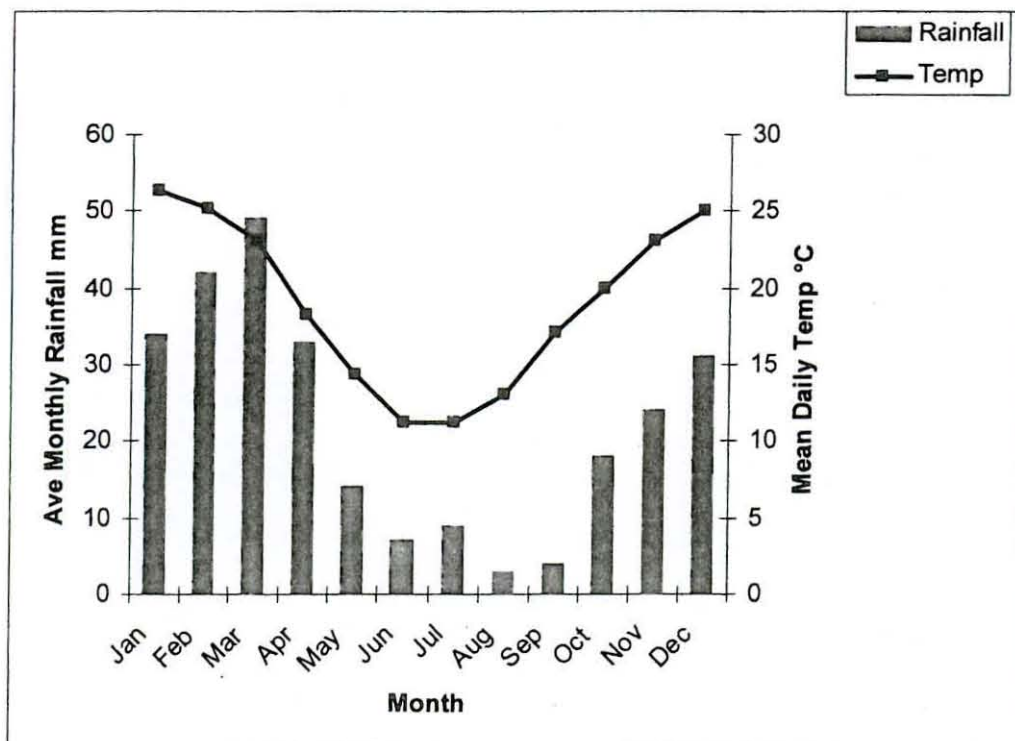
Climatograph for Kareekloof, Strydenburg:

The tables below for Kareekloof at Strydenburg best reflect the climate of the site.

Rainfall mm	Temp °C
Jan	34	26.3
Feb	42	25.2
Mar	49	23.1
Apr	33	18.2
May	14	14.4
Jun	7	11.2
Jul	9	11.2
Aug	3	13.1
Sep	4	17.1
Oct	18	19.9
Nov	24	23.1
Dec	31	25.1
	268

MAR = 268mm/yr

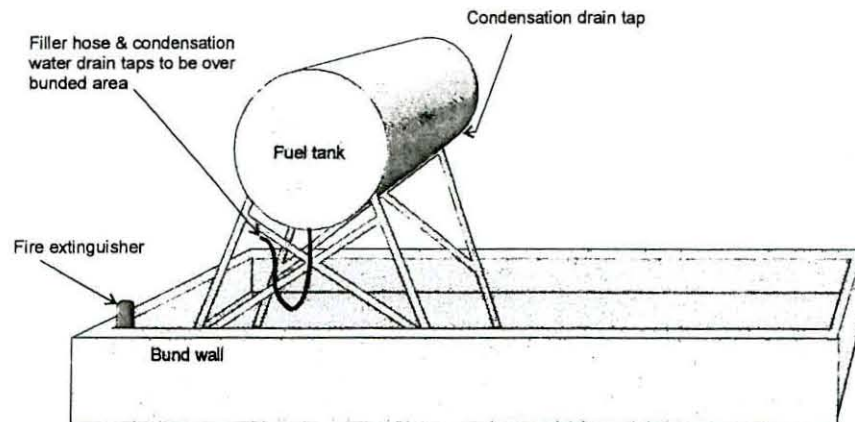
Diagram 1: Bunded fuel tank construction principles (preferably a steel bath (not a brick structure) for lower establishment and rehabilitation impact)

Such tanks shall be provided with a concreted floor and bund wall capable of receiving 1,2 x the capacity of the tank in the event of leakage or spillage.

Capacity of such tanks at any site shall in total not exceed 4 000 litres

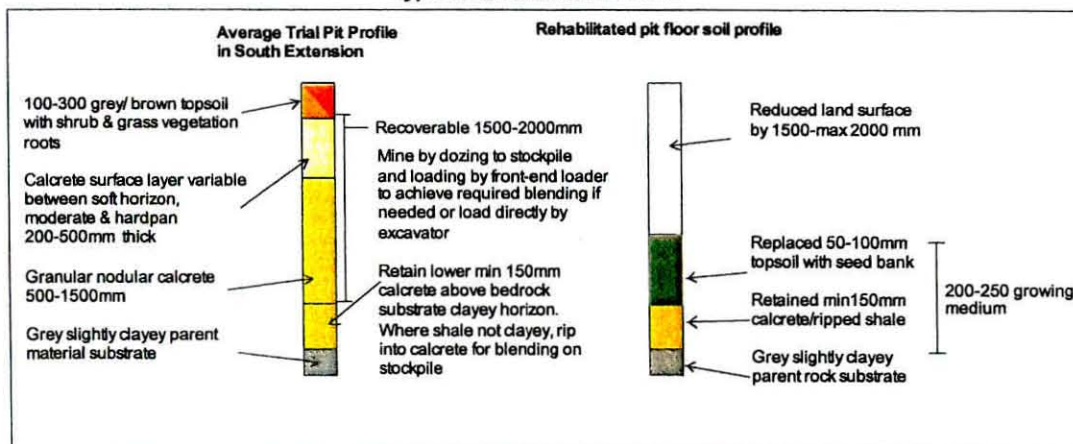
Typical Soil & Subsoil Profile

Reserves of the extension: At 1750mm recoverable gravel depth, the borrow pit extension area yields the following reserve : $2,2\text{ha} = 22\,000\text{m}^2 \times 1,75\text{m deep} = 38\,500\text{m}^3$ tight + estimated 1500m^3 from existing southern pit = **TOTAL $40\,000\text{m}^3$ tight**

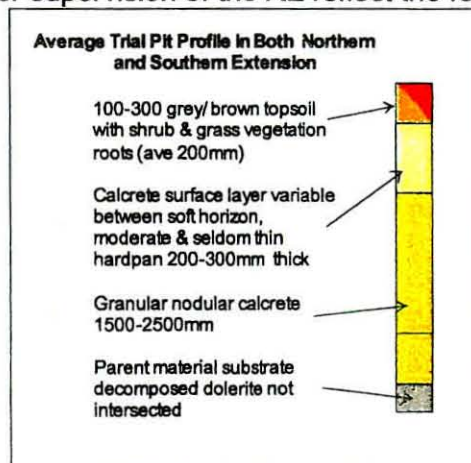
The material on site consists of a large, very thick, surface deposit of calcrete which has developed as a pedocrete from leaching of calcium carbonate from the parent rock (dolerite) below. As a typical pedocrete it has a finite depth which in this case is thicker than 2,5m thick and typically shows vertical and lateral variation between a thin hard (hard-pan) calcrete and softer laminar or nodular calcrete material with soils or remnants of parent decomposed dolerite. The further consideration is that of clay content derived from the parent rock and which must be present to bind the material but not excessively clayey to exceed the plasticity limit. (Plasticity index (PI)).

Eight Trial Pits dug under supervision of the RE reflect the following average profile:
