Property Value Analysis for Kuyasa

1. UNDERMINING AT KUYASA COLLIERY

SPECIALIST STUDY: HERITAGE SCOPING (BASIC ASSESSMENT) REPORT: INPUT INTO EIA, IWWMP AND IWULA FOR THE PROPOSED KUYASA IPP POWER GENERATION PLANT ON PORTIONS OF THE FARMS HAVERGLEN 269 IR AND HAVERKLIP 265 IR NEAR DELMAS, MPUMALANGA PROVINCE

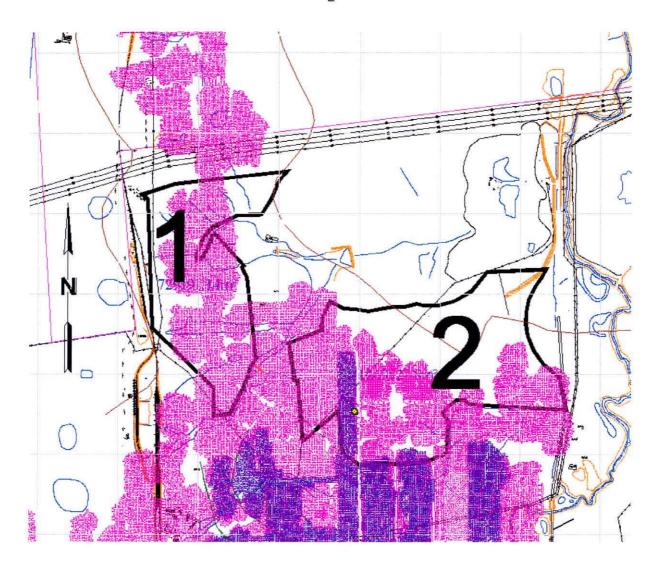
Figure 1. Undermining of Site 5 (from Saxum report)

Saxum indicated that the coal seam specific pillar factor of safety (FOS) will vary from 1.77 to the west of the site to 1.84 on the east, if no additional loadings occur.

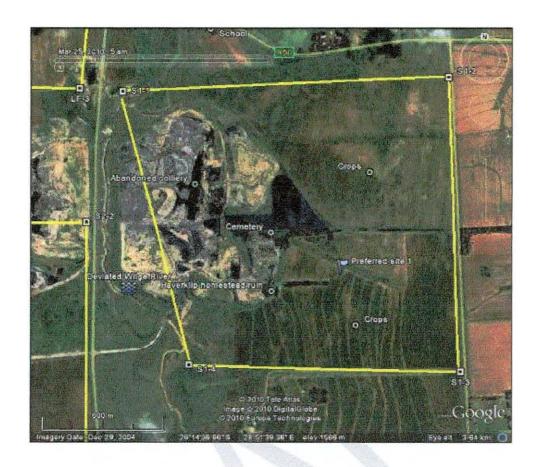
The Preferred Power Plant Site 1, on which the small Haverklip cemetery and homestead ruin occur, consists of an abandoned open-cast colliery and cultivated fields (crops). Access is via the original farm road. Planted vegetation (eucalyptus trees) demarcates the location of the original farmstead.

FIGURE 5: Google Earth image (2004) of the Preferred Site 1 (yellow)

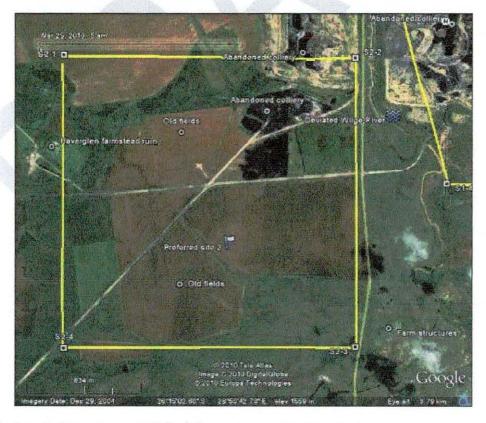
The Preferred Power Plant Site 2, which is subdivided through a number of gravel roads and a conveyor belt to the Delmas Colliery, consists of an abandoned open-cast colliery and cultivated fields (crops) with patches of unimproved grassland.

FIGURE 6: Google Earth image (2004) of the Preferred Site 2 (yellow)

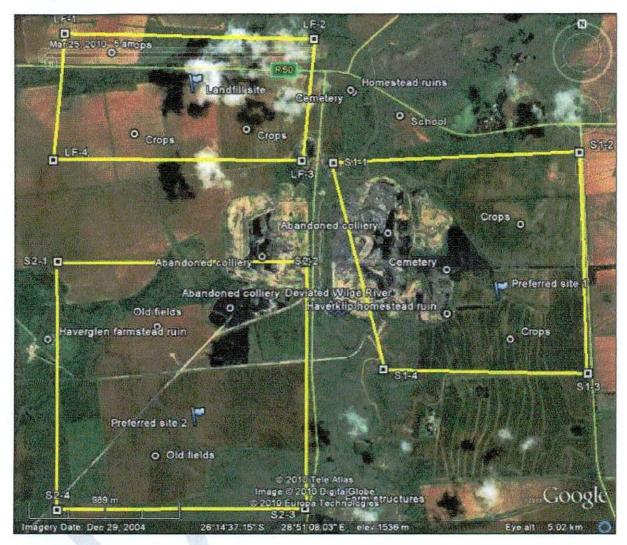
FIGURE 13: Google Earth image (2004) of the three sites (yellow) that were investigated with identifiable heritage characteristics

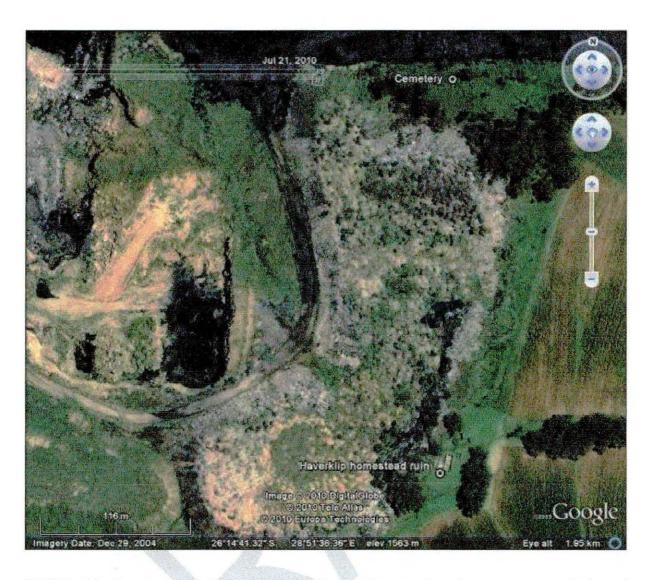
FIGURE 14: Google Earth image (2004) indicating the location of the cemetery (top) and homestead ruin (bottom) on the Preferred Site 1

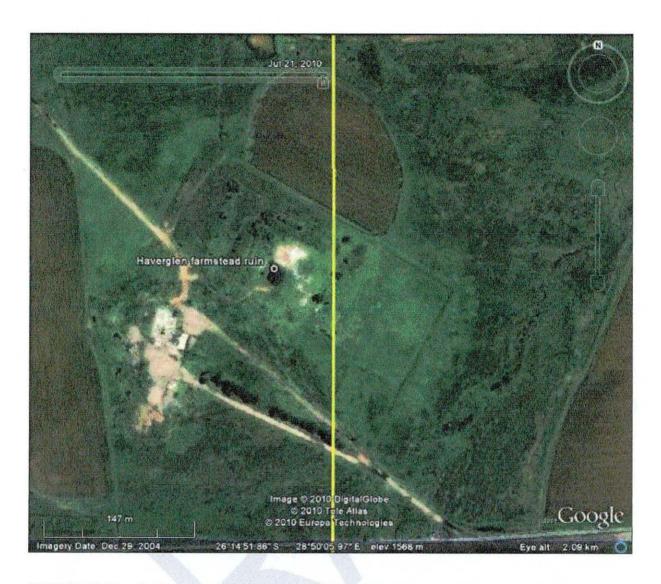
FIGURE 17: Google Earth image (2004) of a portion of the Preferred Site 2 (the yellow line is the western boundary) indicating the location of the Haverglen farmstead ruin

S 3(2) NHRA heritage resource	(a) Identification		(b)	(c) Impact		(d) Recommended
	Site	GPS	Significance	Study area	Impact type, certainty and significance	impact management
Buildings, structures, places and equipment of cultural significance	Haverglen farmstead ruin	26°14'51.03"S 28°50'3.96"E	Low local	Just outside Preferred Site 2	Possible destruction – low negative impact	No action – the place is younger than 60 years and no demolition permit is needed
