SAHRA Gunstfontein WEF Site Visit Report: 9-10 June 2016

Ms. Natasha Higgitt
nhiggitt@sahra.org.za
SAHRIS Case ID: 8383

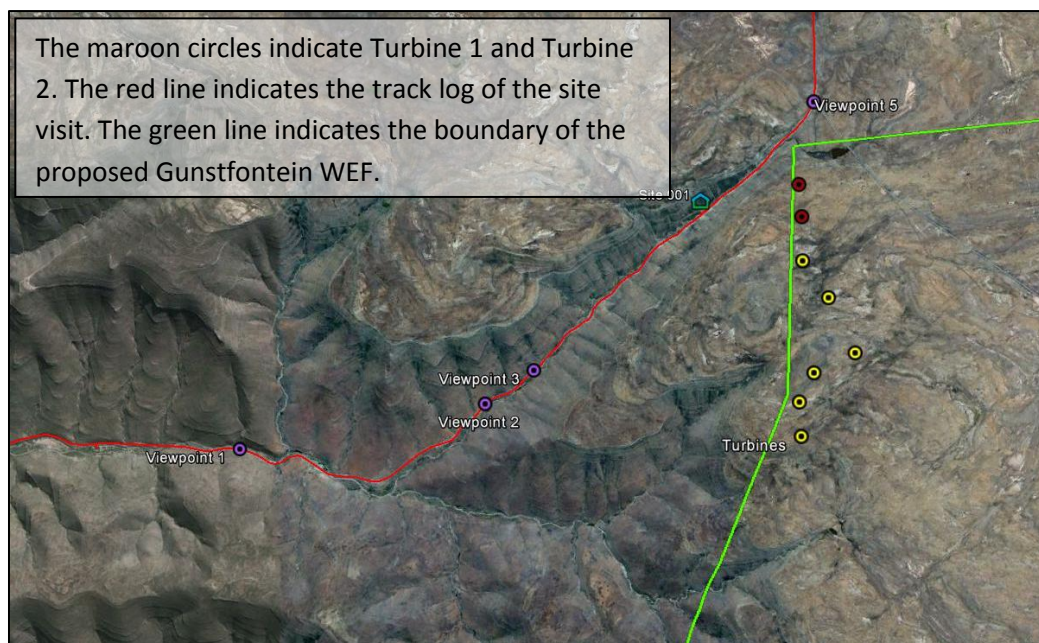
Figure 1: Track log of site visit and points assessed

A site visit was conducted on the 9-10 June 2016 by Natasha Higgitt (Heritage Case officer) and Ragna Redelstorff (SAHRA Heritage Officer Palaeontology). A total of four points along the Verlatenkloof Pass were visited. These points were the result of the identification of visual impact zones as indicated in the response by Savannah on 6 April (See Appendix B). Photomontages were supplied by the Visual Impact Specialist and were compared to on-site conditions. The track log and points assessed are depicted in Figure 1 below.

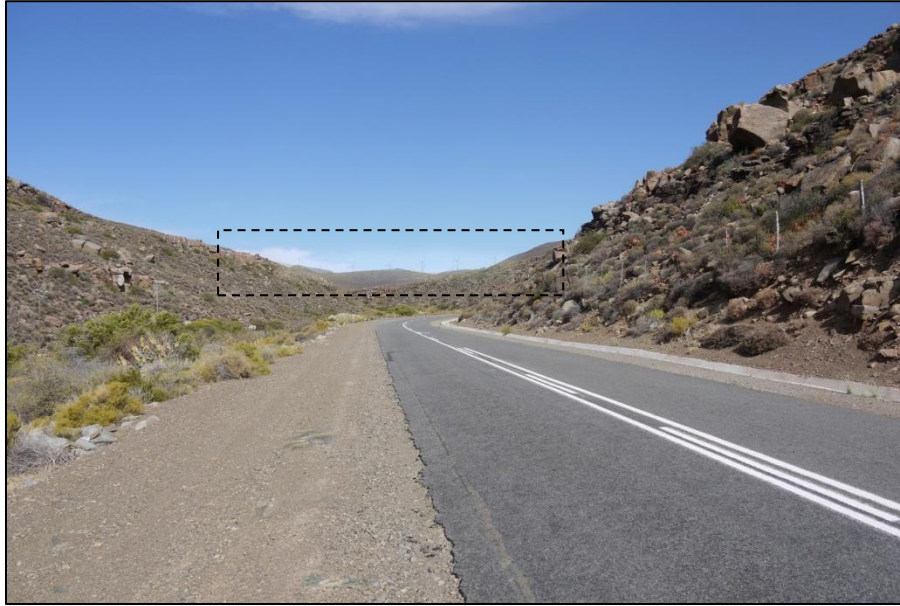
Figure 2: View Point 1 Original Layout photomontage provided by the Visual Impact Assessment Specialist

View Point 1 is located just after the start of the pass in the direction of Sutherland. According to the photomontage, a total of six wind turbines would be visible at this point when the original layout is considered as shown in Figure 2 below. Photographs of current on-site conditions taken by SAHRA APM staff are included in Figure 3 below for comparison.

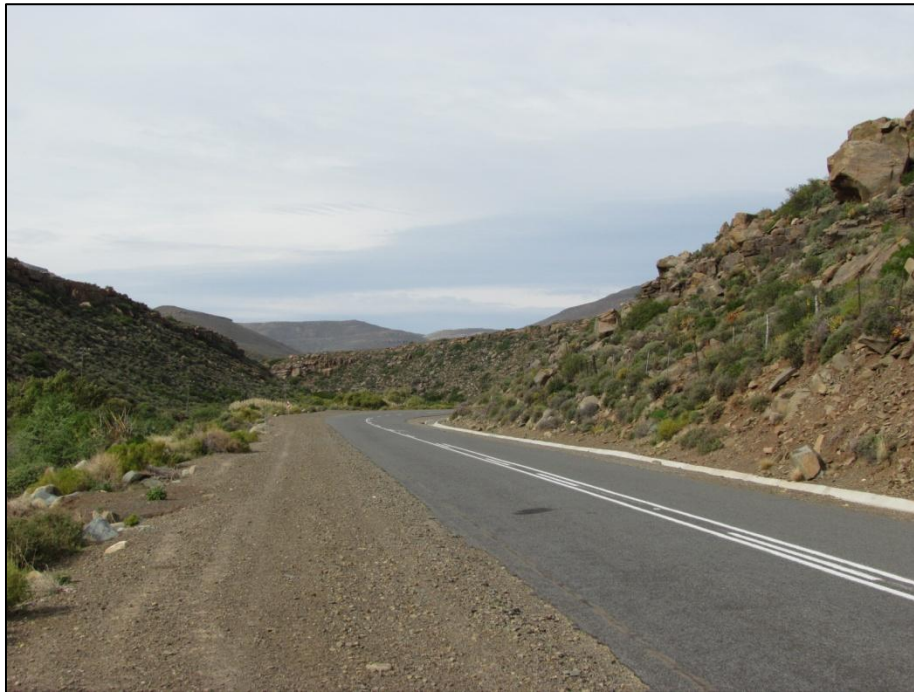
Figure 3: Photograph of on-site conditions taken by SAHRA APM Staff

The wind turbines would be visible from the pass for approximately 2 km which equates to approximately 1 minute 30 seconds driving at 70 km/h (Speed limit of the pass). Very little difference can be seen if one compares the adjusted layout as shown in Figure 4 below to the original layout.

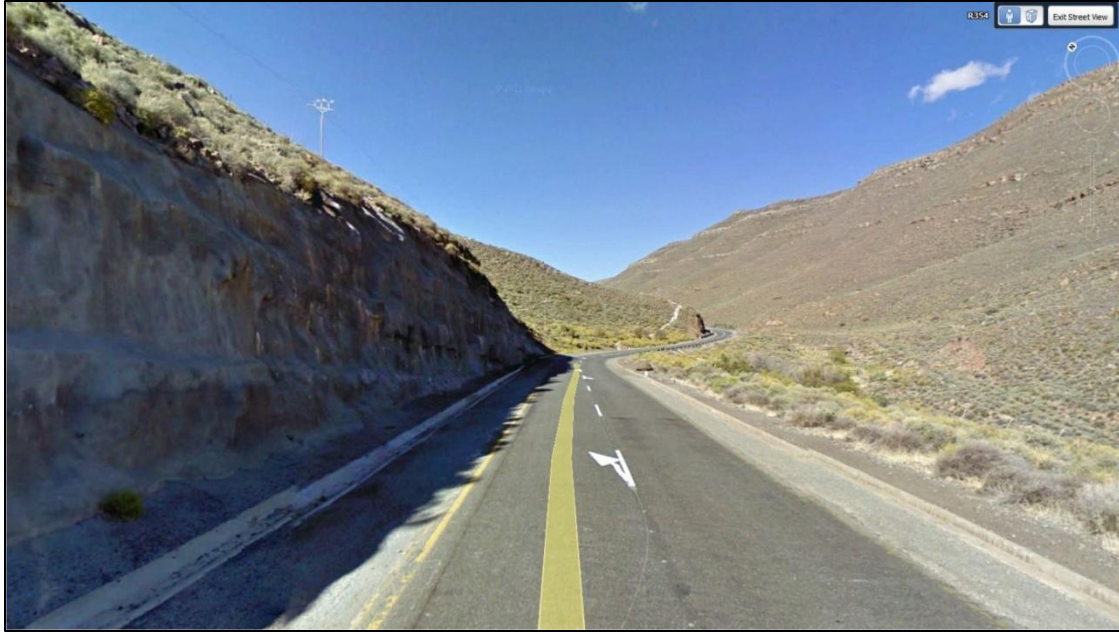
Figure 5: View Point 2 as supplied by the VIA Specialist

View Point 2 is located within the pass. This point was chosen as a point of concern as the viewshed supplied by the Visual Impact Specialist showed that 1-2 blades may be visible at this point. As shown in Figure 5 below, no wind turbines would be visible from this point, or at the very least, only the tips of the blades may be visible. Photographs taken by SAHRA APM staff as shown in Figure 6 show that on-site conditions are the same as the Google Earth image as supplied by the VIA Specialist.

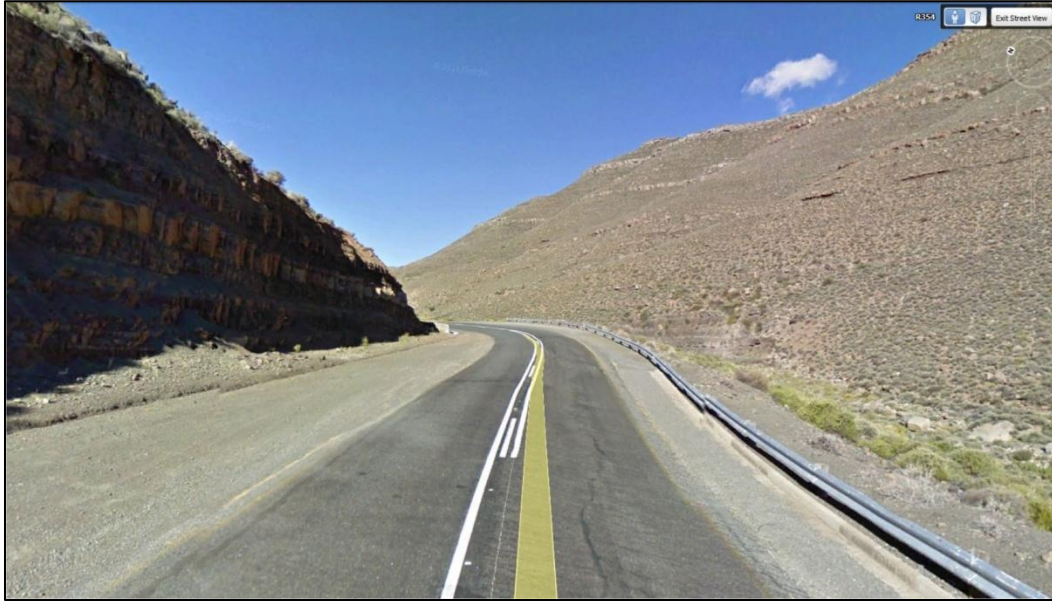
Figure 7: View Point 3 as supplied by VIA Specialist

View Point 3 was chosen as a point of concern for the same reasons as View Point 2. As shown in Figure 7 below, no wind turbines would be visible from this point, or at the very least, only the tips of the blades may be visible. Photographs taken by SAHRA APM staff as shown in Figure 8 show that on-site conditions are the same as the Google Earth image as supplied by the VIA Specialist.

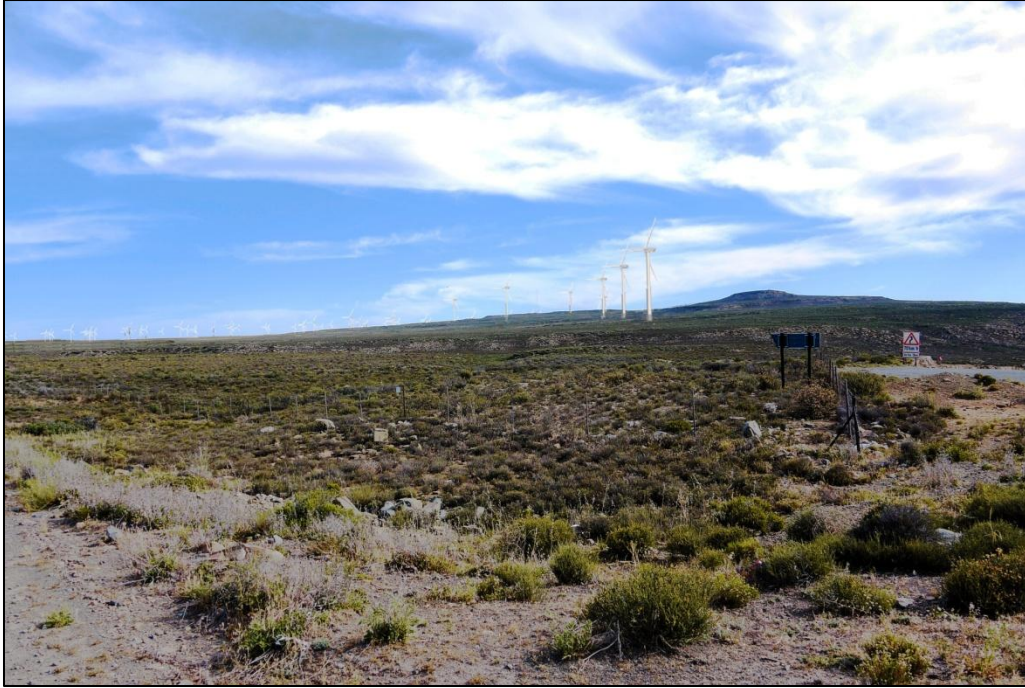
Figure 9: View Point 5 Photomontage as supplied by the VIA Specialist

View Point 5 has the smallest distance between the Verlatenkloof Pass and the closest turbine as per the original layout. The closest turbine would have been 420 m from the road as shown in Figure 9 below. On-site conditions are the same as the conditions shown in the photomontages as seen in Figure 10.

The original layout shows several turbines in close proximity to the pass. The adjusted layout, which takes the SAHRA comments and further discussion into consideration, shows the closest two turbines have been removed (See Figure 11 below).

- The closest two wind turbines (Turbine 1 and Turbine 2) to the R356 will be removed from the proposed layout in order to maintain a bufferzone of 1.6 km from the historical Verlatenkloof Pass (as proposed by ACED and agreed upon by SAHRA APM Unit through discussion);
- Should the two turbines be relocated to another area, the access route and location of the turbines must be subjected to a walk-down by a qualified archaeologist and palaeontologist to ensure that no heritage resources are impacted by construction activities. A Walk-Down report must be completed and submitted to SAHRA for comment prior to construction. No construction may occur without comments from SAHRA.

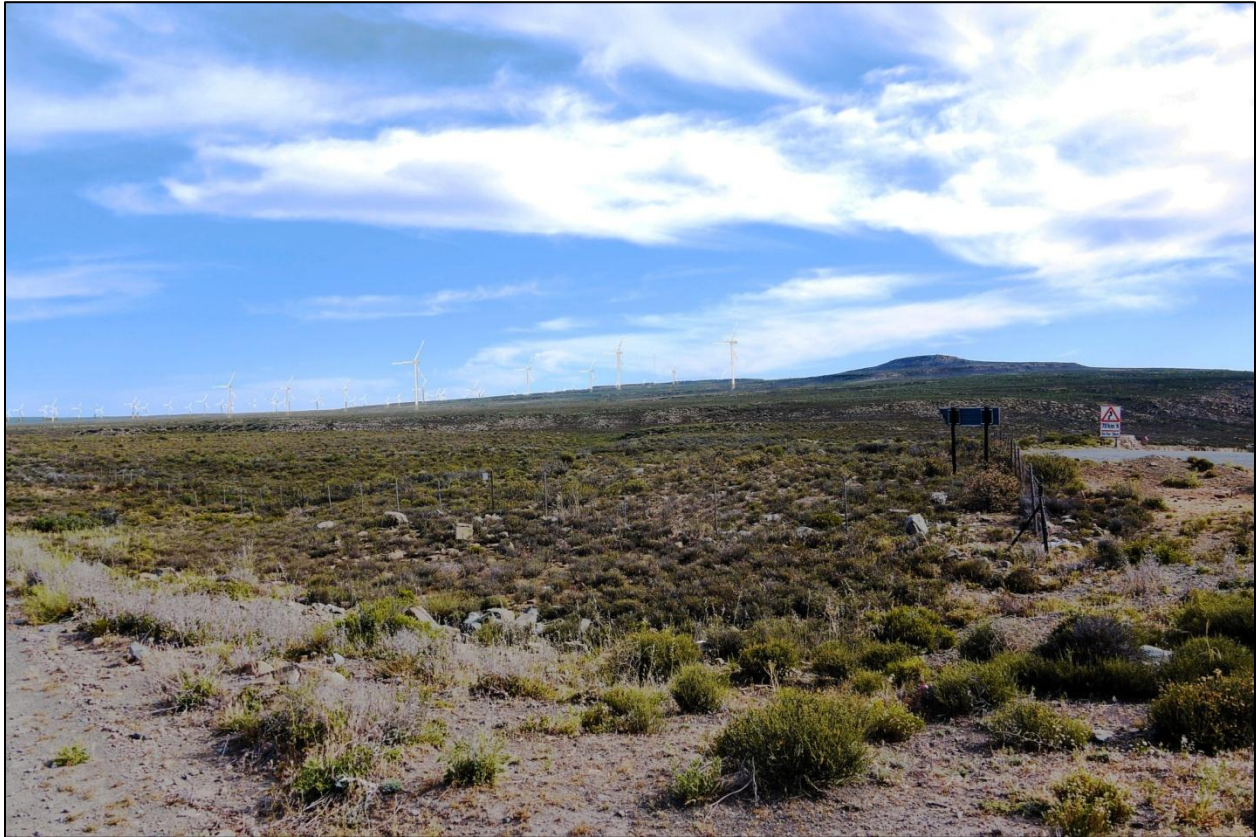
Figure 11: Adjusted layout at View Point 5

While the adjusted layout will not change the visual impact within the pass, it makes a considerable change to the visual impact to the remainder of the scenic route R356 after the pass. By removing the closest two turbines, the visual impact of the WEF on the route at the top of the pass decreases as the turbines are now located at least 1.6 km from View Point 5.

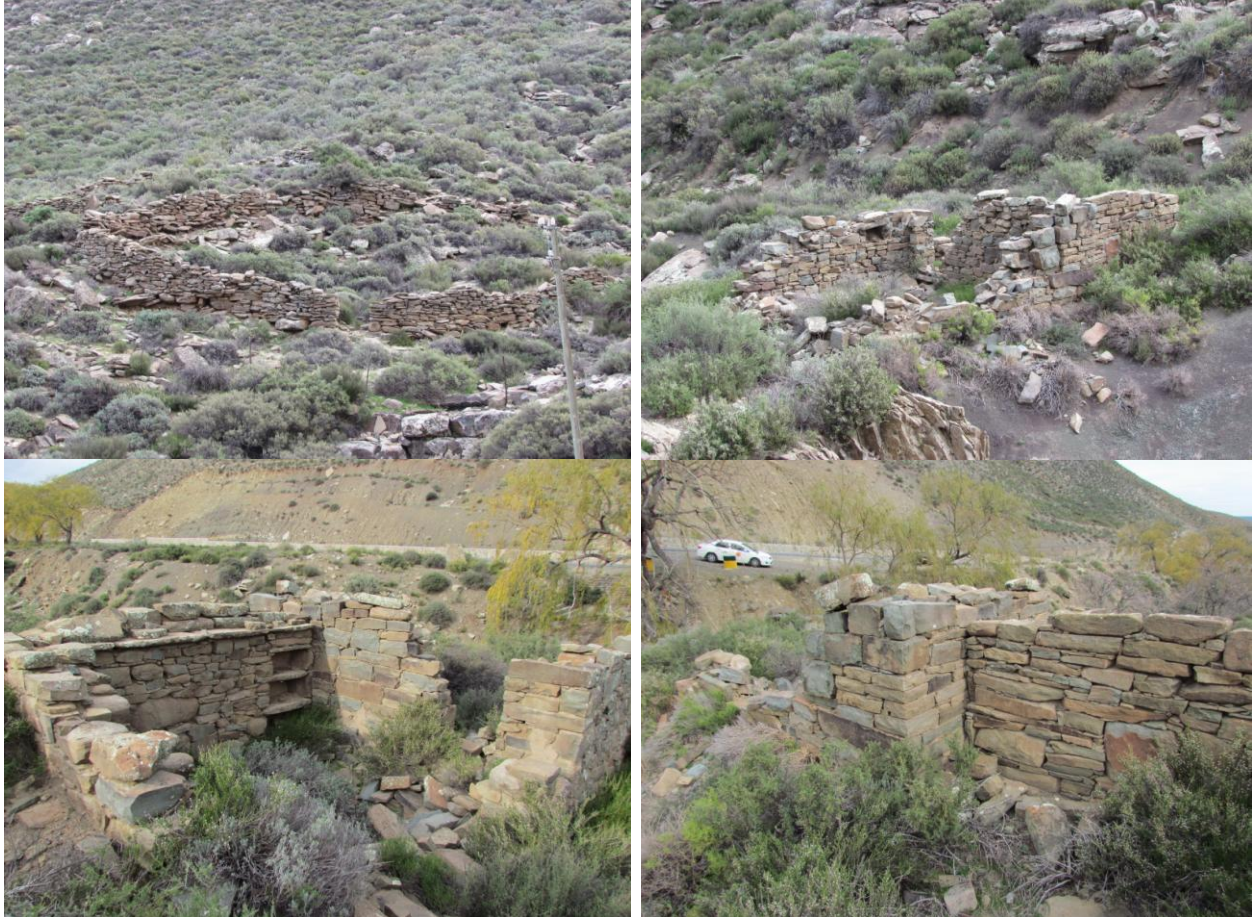
A stone walled complex was identified along the road near the top of the pass as indicated as Site 001 in Figure 1 above. The complex (See Figure 12 below) included two dry packed stone wall kraals located on the opposite slope to the road. The kraals were located on private property and could not be accessed. A third stone walled structure was recorded within the drainage line of the pass. The third structure consisted of two rooms measuring approximately 3m x 3m for the larger room and 3 m x 1.5 m for the smaller room. The larger room had a set of shelves or “muurkas” set into a wall with a long lintel above it. The smaller room had two windows/openings in the walls. No artefacts or midden could be identified in close proximity and it is assumed that any material culture may have been washed down the drainage line. Additionally, a line of approximately 10 willow trees was present on the opposite bank of the non-perennial river. The willow trees appear to have been planted at the same time as all the trees seemed to have been the same height and have similar girth.

Tim Hart of Archaeology Contracts Office (ACO) was consulted regarding the structure as he has conducted many surveys in the surrounding area. According to Mr. Hart, the structure appears to be of

similar age to the pass itself and may have been a toll house to collect money from travelers making use of the pass. According to a 1901 British War map (Figure 13 below) no structures were identified along the pass indicating that the structure may have either not yet been constructed, or it may not have been considered relevant and was therefore not featured on the map.

Figure 12: Top left: Dry packed stone kraal, top right: view of the stone structure from the opposite bank of the river, bottom left: view of the largest room with well built shelves and lintel, bottom right: showing the precise stone working on the corner of the smallest room.

With regards to the visual impact of the proposed Gunstfontein WEF on Site 001, the facility will be hidden behind the ridge opposite the site and should not directly or visually impact the site.
