5.1 PHYSICAL BASELINE

The proposed solar power plant will be situated in an arid, rural environment, the remaining portion of portion 14 (a portion of portion 4) of Olyven Kolk Farm, No. 187 which is situated in the Siyanda District of the Northern Cape Province. The site is located approximately 126 km south west of Upington and is accessible from the R27 (tarred road) along the Sishen -Saldanha railway line service road (gravel road). The nearest town to the site is Kenhardt, which lies approximately 44 km north east of the site. The proposed site is approximately 400 m from the Eskom 400 kV Aries Substation. The total area of the site is 1,010.47 ha.

TITLE:
Figure 5.1
Site Settings of Olyven Kolk

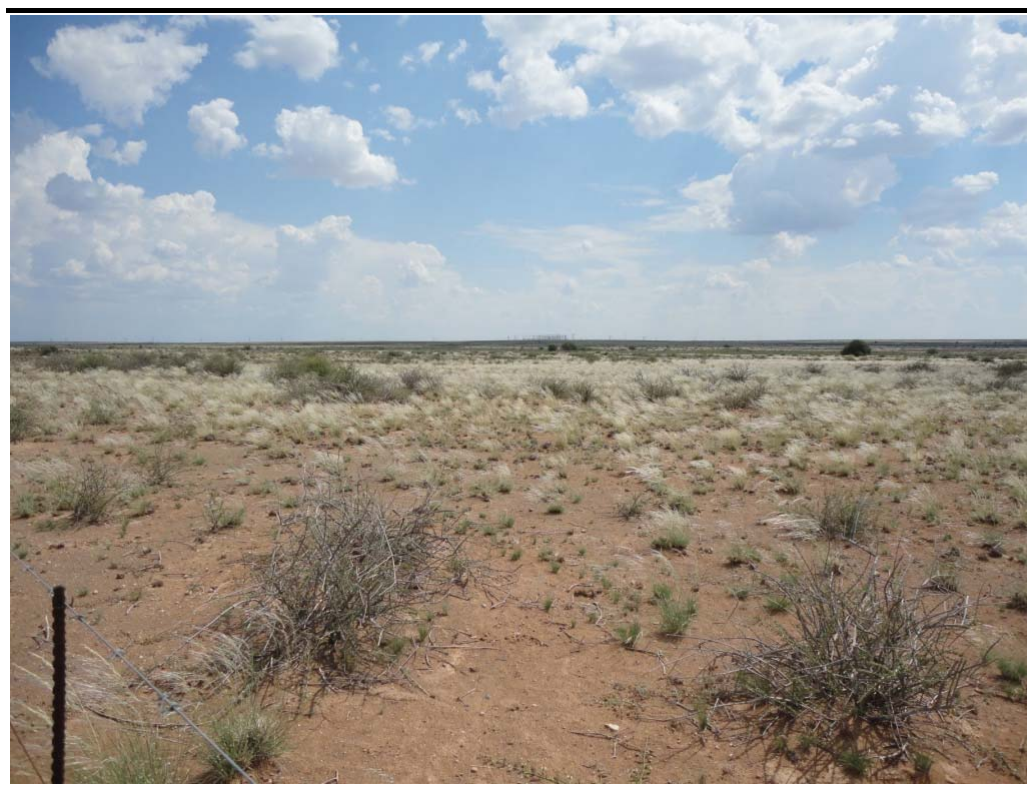
Figure 5.2

Flat Terrain

laborer's cottage and sheds located within the site. *Figure 5.2* shows the flat terrain of the landscape looking north into the site from the railway.

The landscape of the site and surrounds is relatively flat and slopes to the north north east, with an elevation difference of approximately 40 m over a distance of 4.6 km, which equates to an average slope of approximately half a degree. The highest areas are found to the north west of the site with lowest areas in the north east. To the south of the Sishen- Saldanha railway the landscape is undulating.

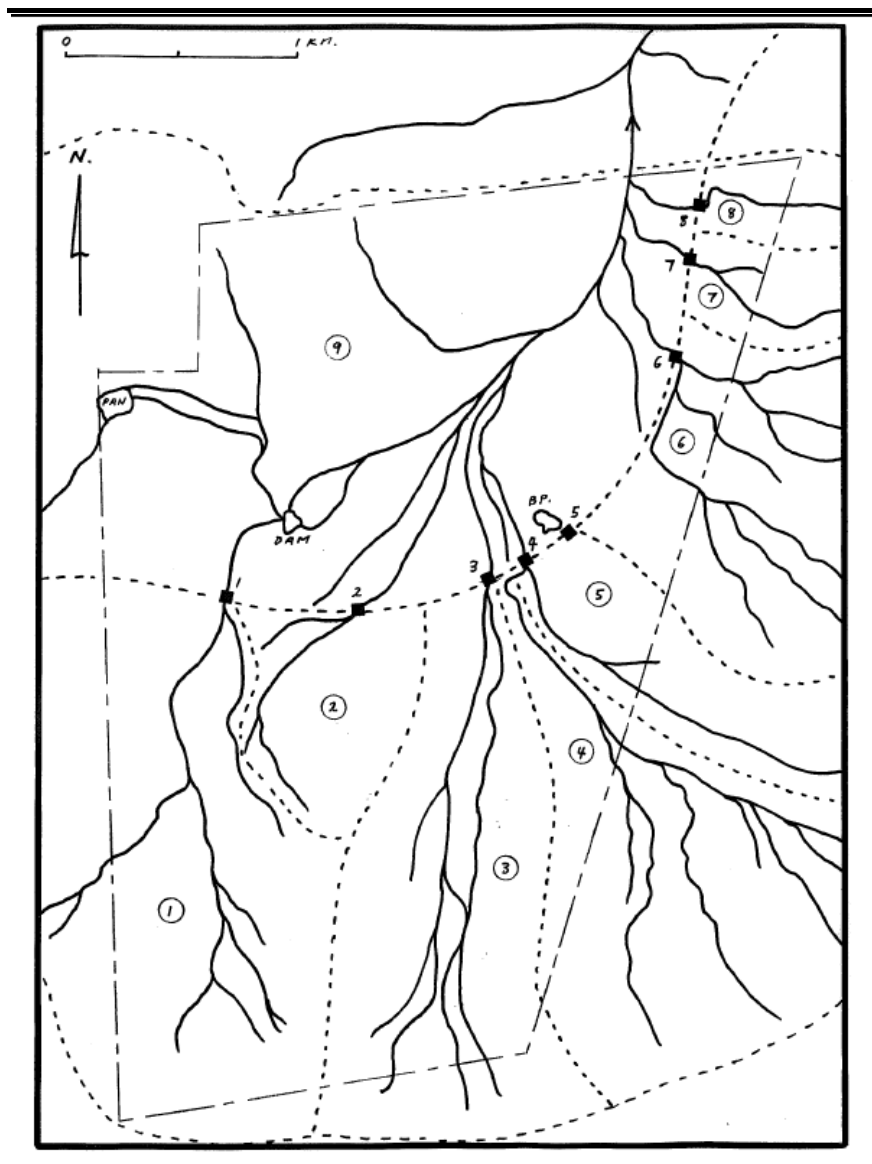
Figure 5.4 Drainage Pattern, Culverts and Catchments

The railway acts as a cut-off across the entire site which concentrates the flows through culverts beneath the railway. Berms have been placed above many of these culverts to divert water into them and have thus further modified the natural drainage pattern. Concentrated water flows will clearly occur where these culverts discharge. They however discharge directly onto the service road and no provision is made for water flows over or under the road. Each of the culverts caters for a distinct catchment area and these are added to by the catchment area to the north of the railway. These catchments and the corresponding culvert positions are shown *Figure 5.4* below.

Key: Culverts are shown as square boxes along the railway line. Catchment areas are illustrated by numbers positioned beside the drainage lines.

There are no perennial streams on the site and it is expected that running water would only be found during and immediately after significant rainstorms. The site however, was visited soon after a period of good rains but no surface water whatsoever was observed. A small, shallow dam has been excavated towards the north west corner of the site as shown in Figure 5.4. It is not expected to hold water very often or for very long.

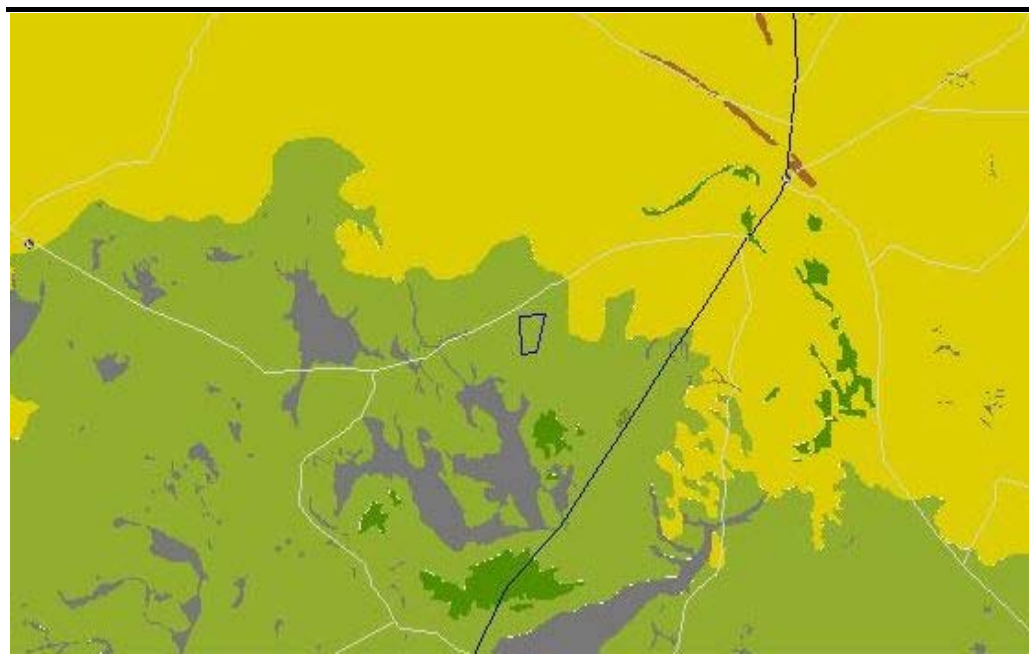
Figure 5.5 Vegetation Map of Southern Africa showing Vegetation Types

Source: Source: Mucina et al. 2006, Key: Green area in which the site falls in Bushmanland Basin Scrub vegetation. See *Annex F* for detailed key.

The national vegetation map has been mapped at a very coarse scale and the map does not adequately reflect the vegetation pattern on the ground. This is exemplified by the fact that despite being classified as a shrubland, a significant proportion of the site is in fact grassland with very little shrub cover. Several different habitats with characteristic plant communities can be discerned at the site. These are:

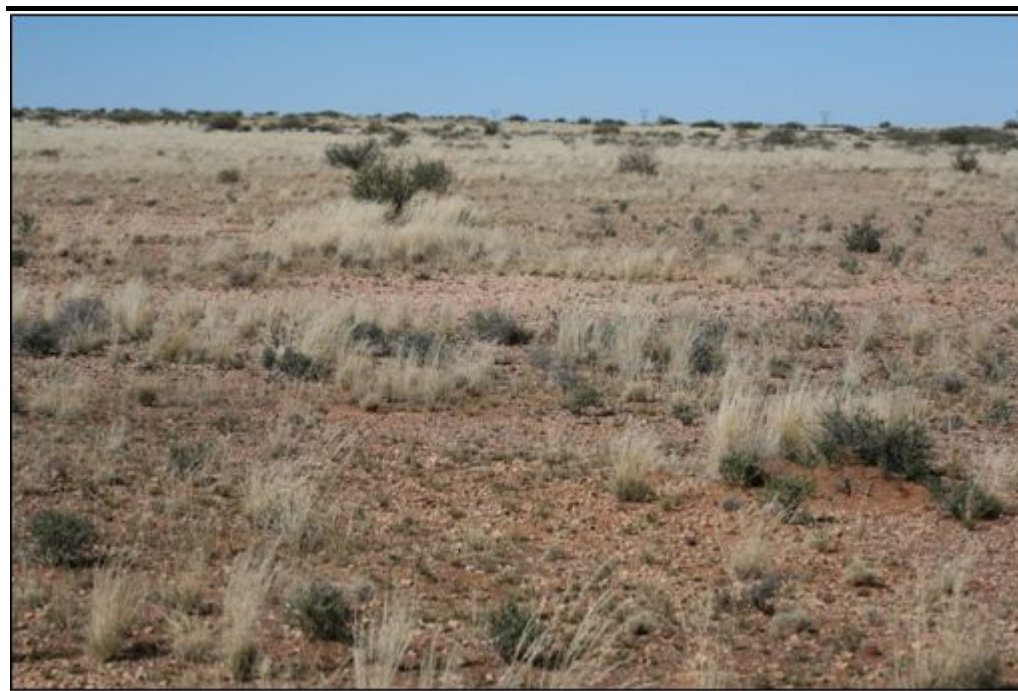
Figure 5.7 *Calcareous Grassland*

This is the shortest and most open vegetation type at the site, and apart from scattered shrubs, rarely exceeds 40 cm in stature.

The soil is usually very shallow with a lot of expose calcrete on the surface. The vegetation is low and open and dominated by *Stipagrostis* spp.

Areas of calcareous grassland occur scattered across the site, wherever the underlying calcrete is near to the surface or has been exposed. Plant cover is generally quite low and dominated by bushman grasses such as *Stipagrostis ciliata* and *S.obtusa*. Species richness in these areas is generally quite low as a result of the paucity of the shrub species present. An above average richness of geophytes was however observed. Since these areas usually occur in flat to very gently sloping areas, the risk of erosion or other detrimental disturbance effects is low. This community is considered to be of Low to Moderate Sensitivity.

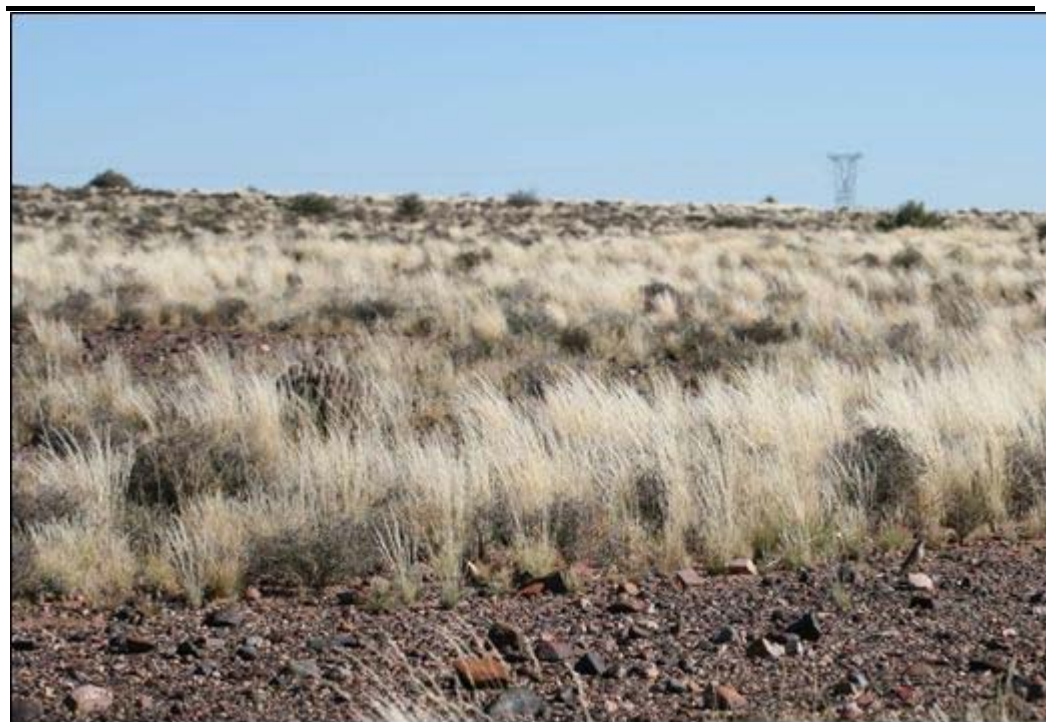
Figure 5.8 *Mixed Rocky Shrubland*

This is the dominant plant community across the majority of the site and is typically dominated by shrubs such as *Eriocephalus* and *Pteronia* with a grass component consisting largely of various *Stipagrostis* species as well as *Aristida congesta*.

This community was also the only one observed to contain species of conservation concern such as *Hoodia gordonii* and *Aloe claviflora*. *H. gordonii* is listed as a protected species under NEMBA (Act 10 of 2004) as well as provincial legislation while *Aloe claviflora* is protected in the Northern Cape Province in terms of the Northern Cape Nature Conservation Act, No. 9 of 2009.

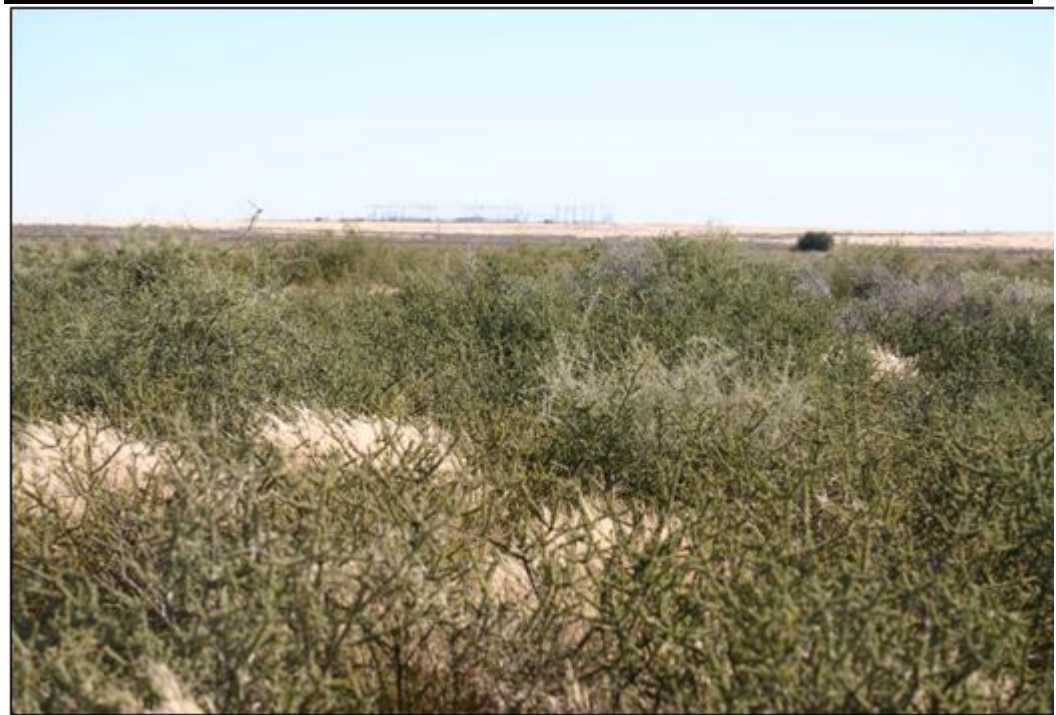
Figure 5.9 *Rhigozum Thicket*

Only occurs on the deeper soils which occur in the low-lying and drainage areas of the site. The community is dominated by *Rhigozum trichotomum*, *Lycium* spp and *Phaeoptilium spinosum*.

As previously indicated, the lower slopes and bottomlands of the site are the only areas which contain an appreciable amount of topsoil. These areas are dominated by taller shrubs such as *Rhigozum trichotomum*, *Lycium cinereum* and *Phaeoptilium spinosum* with an understorey of forbs and grasses. Common and dominant grasses within these areas included *Stipagrostis ciliata*, *Schmidtia kalahariensis* and *Eragrostis porosa*. The presence of this community is also indicative of the drainage areas of the site which are broad and diffuse as a result of the low overall slope of the area. Drainage lines at the site are not well developed as a result of the low slope and position of the site near the top of the catchment. These areas are the most impacted by livestock grazing as indicated by the high density of *Lycium* and *Rhigozum* which are known indicators of grazing pressure and degradation. However, since this community represents a widespread plant community which occurs on coarse sandy soils throughout Bushmanland, it is not broadly characteristic of drainage lines per se.

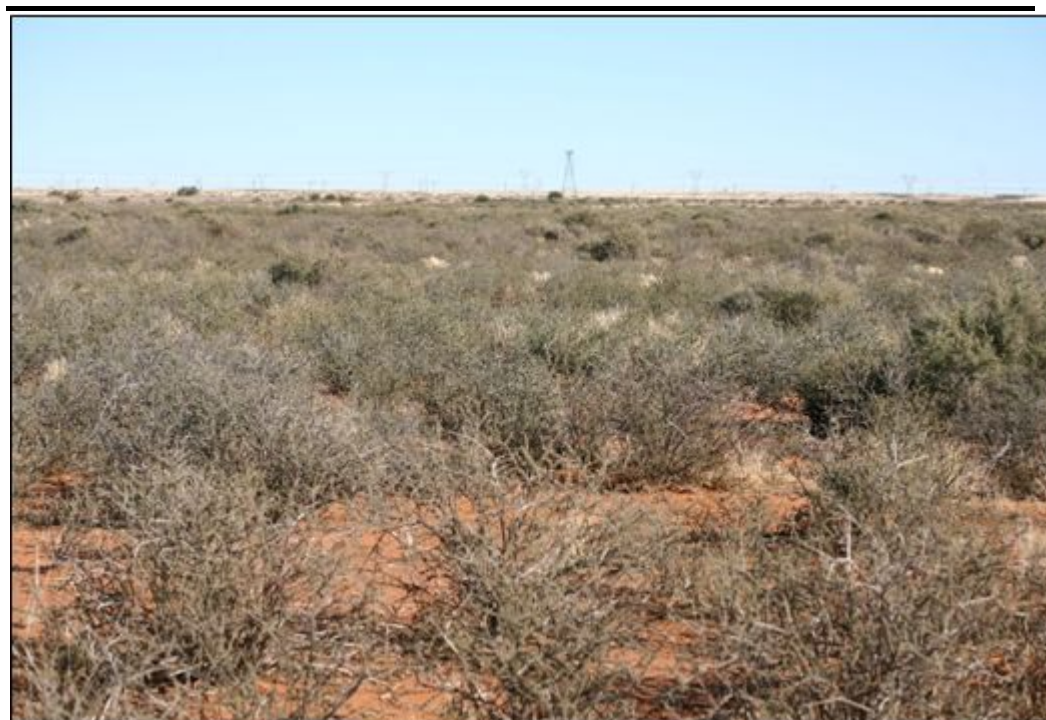
Figure 5.10 *Rhigozum* thicket community with a poorly developed grass layer

Poor developed grass layer is likely to be a result of heavy grazing and/or suppression of the grass layer by the dense *Rhigozum* stands.

The areas dominated by *Rhigozum* contained the lowest abundance of other plant species which can be ascribed to the negative effects of grazing as well as the suppression of the other plant species by *Rhigozum*. No plant species of conservation concern were observed within this habitat. Typically, the dominant woody shrub species in this community are around 1 m in height but may be as tall as 2 m indicating that at least the taller elements would probably need to be reduced in height to prevent shading the PV arrays.

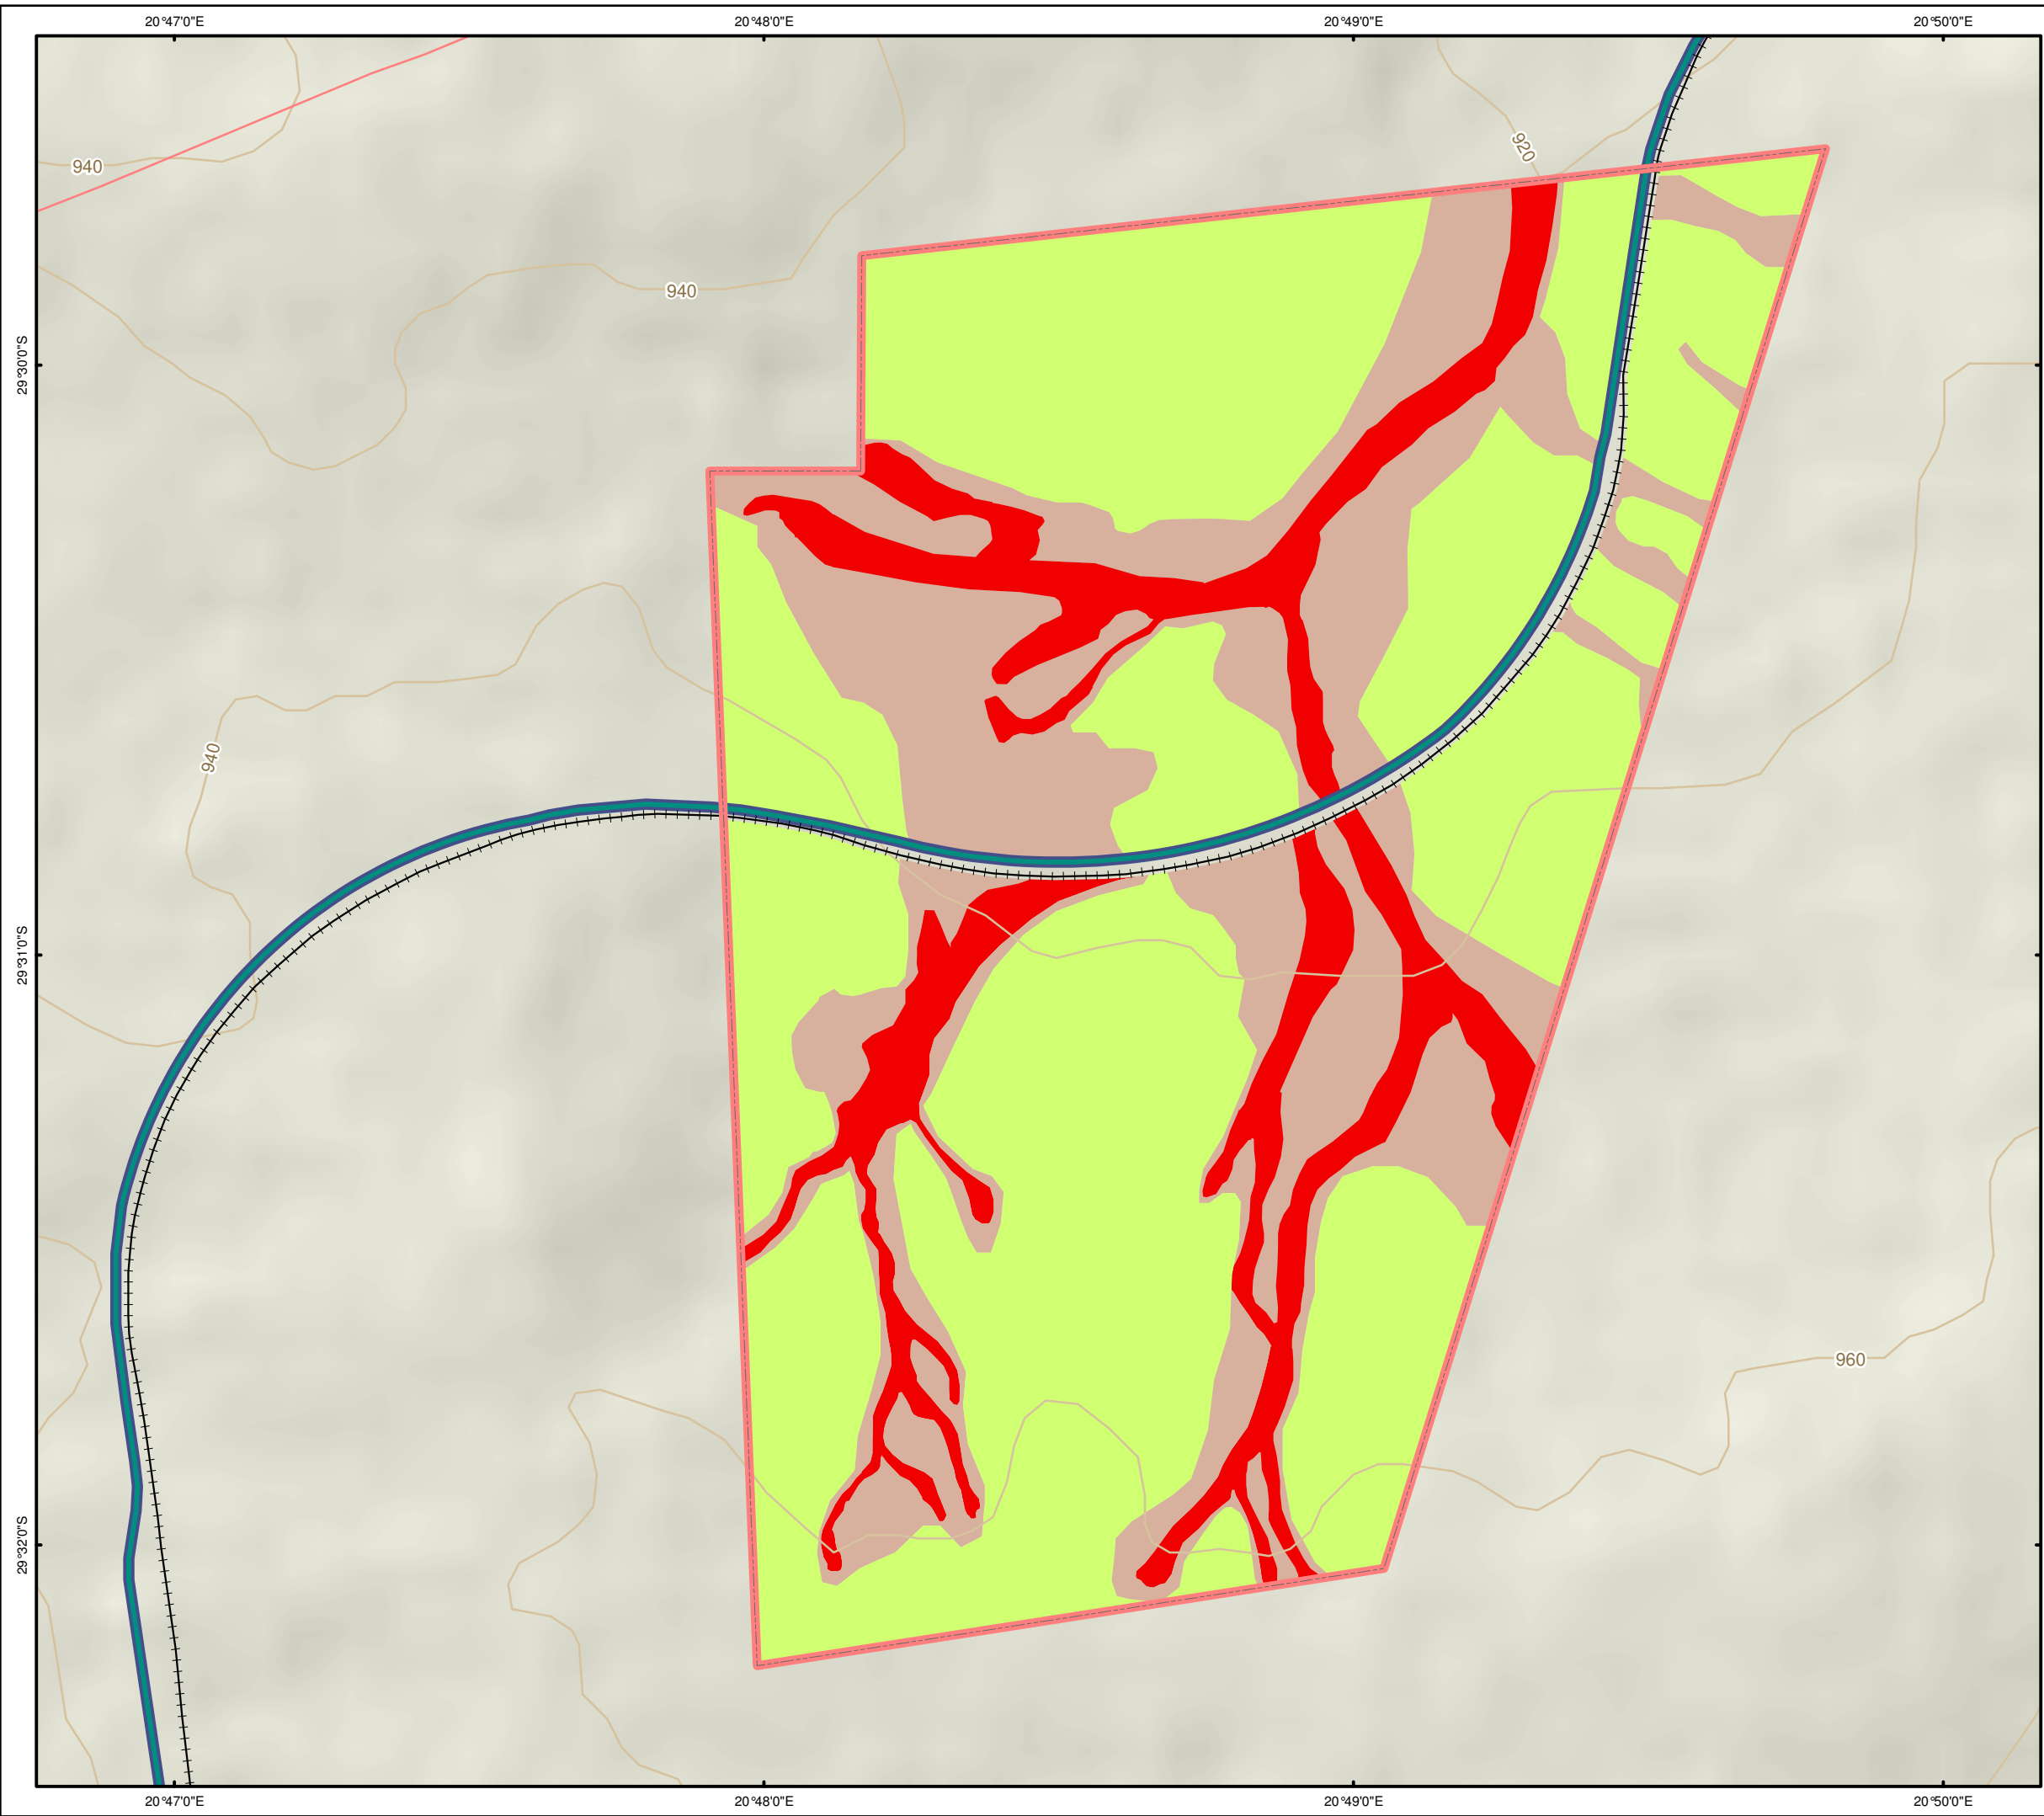
TITLE:
Figure 5.11
Ecological Sensitivity of the
Olyven Kolk Site

Figure 5.11 illustrates the ecological sensitivity of the site.

In terms of the distribution of the different ecological sensitivity categories at the site, those areas with deeper soils comprising the lower slopes and bottomlands of the site are classified as **High** Sensitivity. These essentially correspond to areas referred to as drainage lines. The poorly developed nature of the drainage areas at the site, can be ascribed to the position of the site at the very top of the catchment with little potential for runoff accumulation. Nevertheless, a cautious and conservative approach is warranted regarding the development potential of these areas. From a species richness perspective, these areas are not significant as plant diversity within these areas is low. Due

to the deeper soils and landscape position of these areas, these areas would however be vulnerable to disturbance as this would render them susceptible to erosion. These areas are also important from a functional perspective because they provide cover for larger mammal species and would also serve as movement corridors. The presence of different vegetation units within an area is also ecologically important because each unit offers different resources and opportunities for the fauna at the site thereby contributing to the overall diversity of the area. While parts of the site have been classified as **High Sensitivity**, it should be noted that this is to a large extent relative to the other parts of the site. In absolute terms the site in general is low sensitivity when compared to high-biodiversity-value ecosystems with a high threat status or high levels of endemism.

The middle and upper slopes of the site as well as those low-lying areas with a calcrete substrate are classified as **Low to Medium Sensitivity**. These areas would be more tolerant of disturbance as there is little soil cover that could be displaced and the risk of erosion would be low. Some of these areas do however contain the highest levels of plant diversity present at the site, including at least two protected species (*Hoodia gordonii* and *Aloe claviflora*). Development within these areas could proceed with minimal overall ecological impact, provided that due attention is paid to translocating individuals of the protected species and other standard mitigation measures are applied.

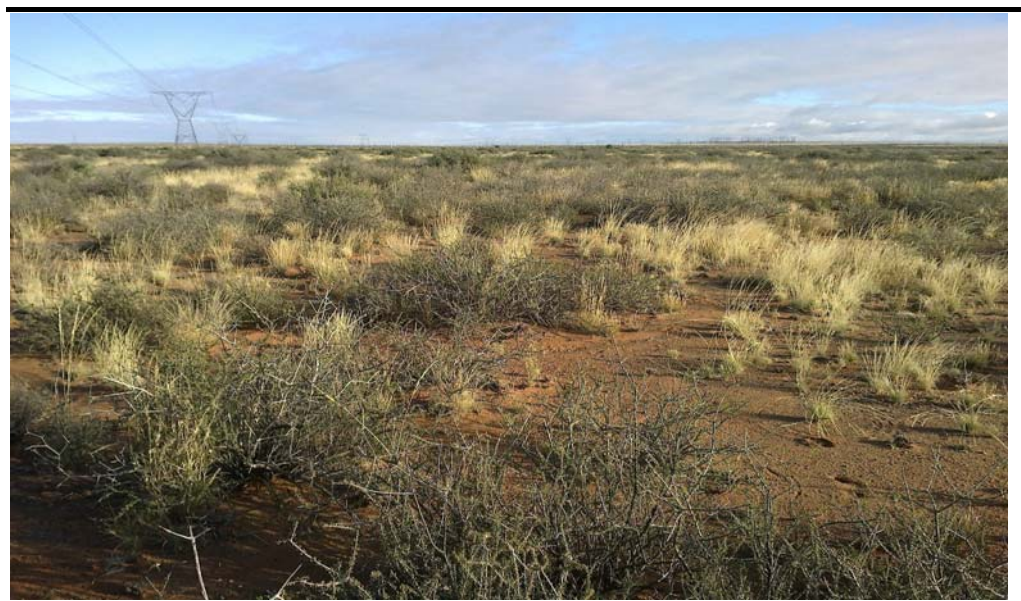
Figure 5.12 *Typical flat, open Karoo Vegetation*

Note: 400 kV transmission lines in the background

The habitat on site from an avian perspective is relatively uniform, dominated by open, flat, sandy Karoo veld (*Figure 5.12*), with thicker, woody growth along the main drainage lines. The lattice-type steel pylons which support the Eskom transmission power lines provide nesting habitat for birds that would normally nest in trees (e.g. passerines, corvids, raptors), and for birds that normally use nests built by these tree-nesting species (e.g. falcons).

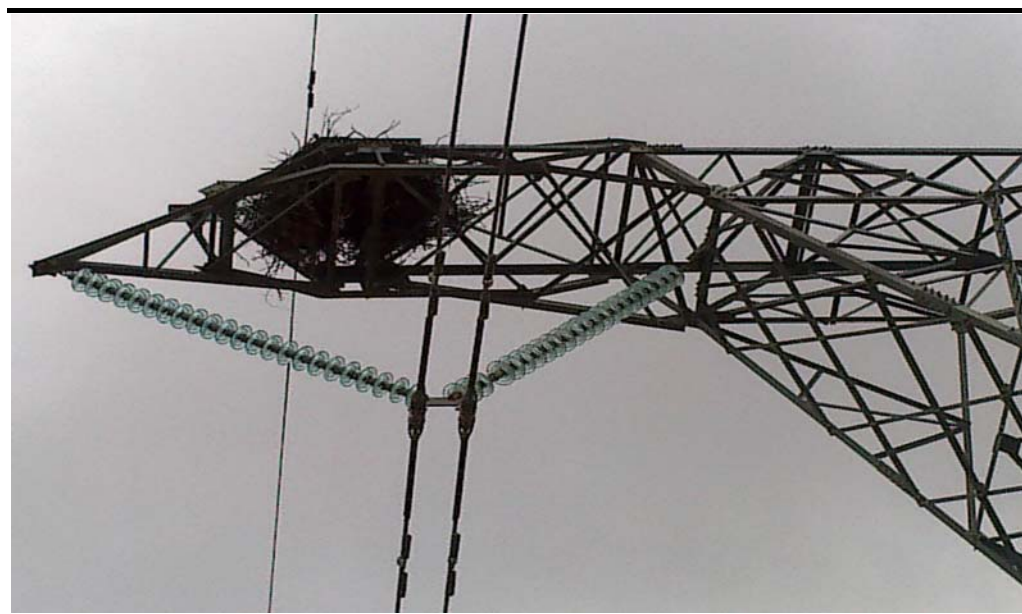
Figure 5.13 *Martial Eagle Nest on the Aries-Helios 400 kV Transmission Line*

Eighteen bird species were recorded during the site visit. Significant observations included an adult Martial Eagle *Polemaetus bellicosus* perched near a nest in a transmission pylon on the western boundary of the site and a pair of Lanner Falcons at an old Martial Eagle nest on a pylon to the east of the site. The locations of these nests are shown in *Figure 5.14*.

Martial Eagle occupy a breeding territory approximately centred on the Aries substation. This has not generally been a productive territory, with breeding recorded only once in the period 2002 to 2006 (Jenkins *et al.* 2007). The presence of an adult eagle near a well built-up nest structure and some fresh droppings or whitewash accumulated under the nest pylon (Aries-Helios tower 11) suggests that the site may well be active this season.

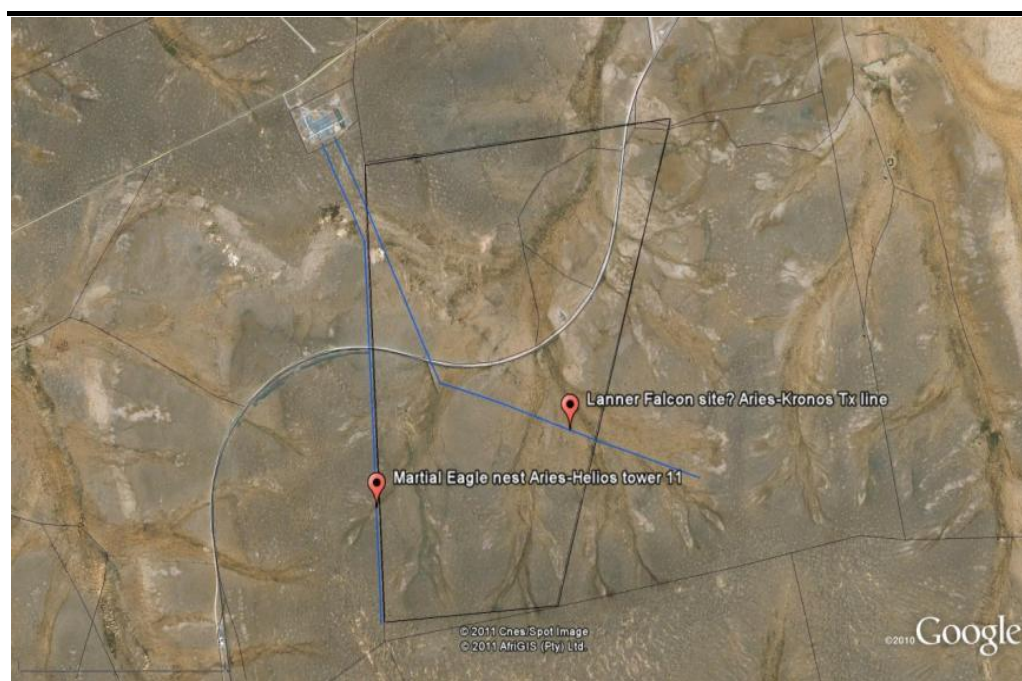
Figure 5.14 *Distribution of Raptor Nests within the Site*

Note: These nests are found on Eskom transmission lines

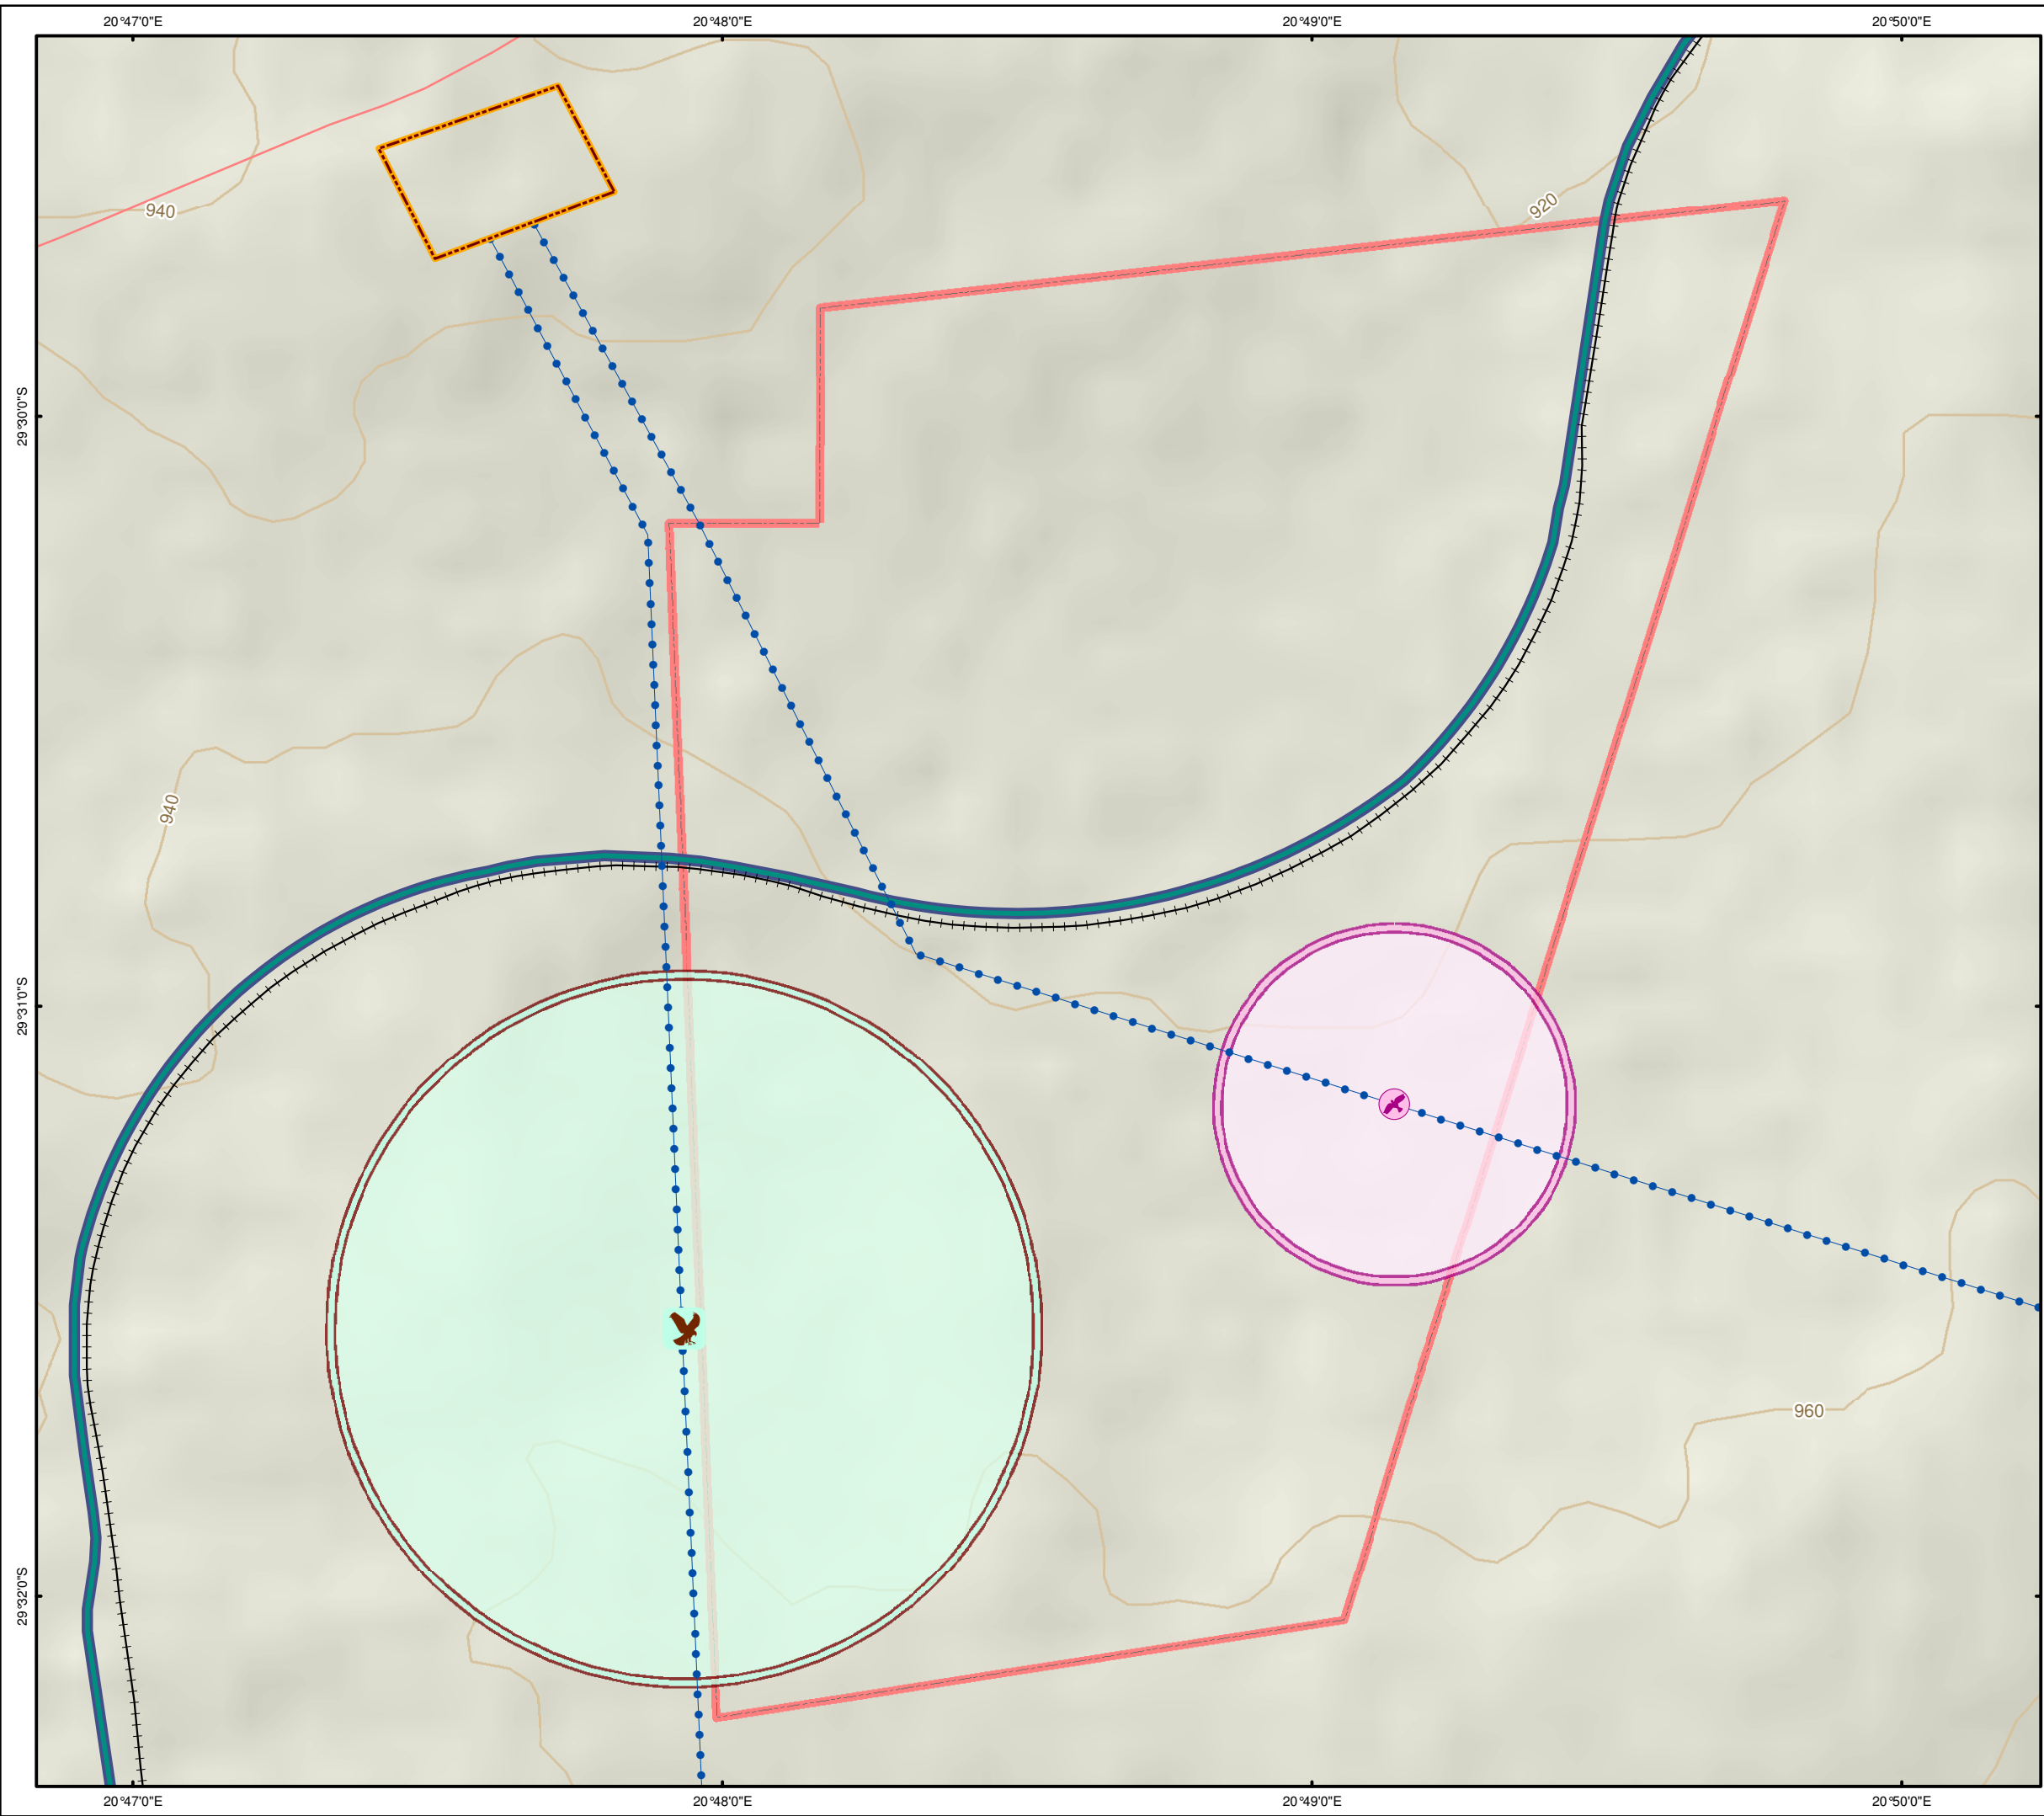
Figure 5.15
Bird Exclusion Zones

- Within a 1 km radius of the Martial Eagle nest site; and
- Within a 500 m radius of the Lanner Falcon nest site.

These areas to be excluded are shown in *Figure 5.15* and discussed further in *Annex G*. Avoidance of these areas is advised as far as possible, whilst still ensuring that the project is feasible. If required, relocation measures as suggested by the expert may be followed.

pylons within the proposed development area. These birds (especially the eagles) will be significantly disturbed by the construction process, possibly to the extent of breeding failure or even territory abandonment. Based on their sensitivity it is considered that the development should be excluded from:
