Report on the floristic and ecological assessment of the proposed expansion of the Cillie graveyard, Northern Cape Province.

October 2012

Darius van Rensburg

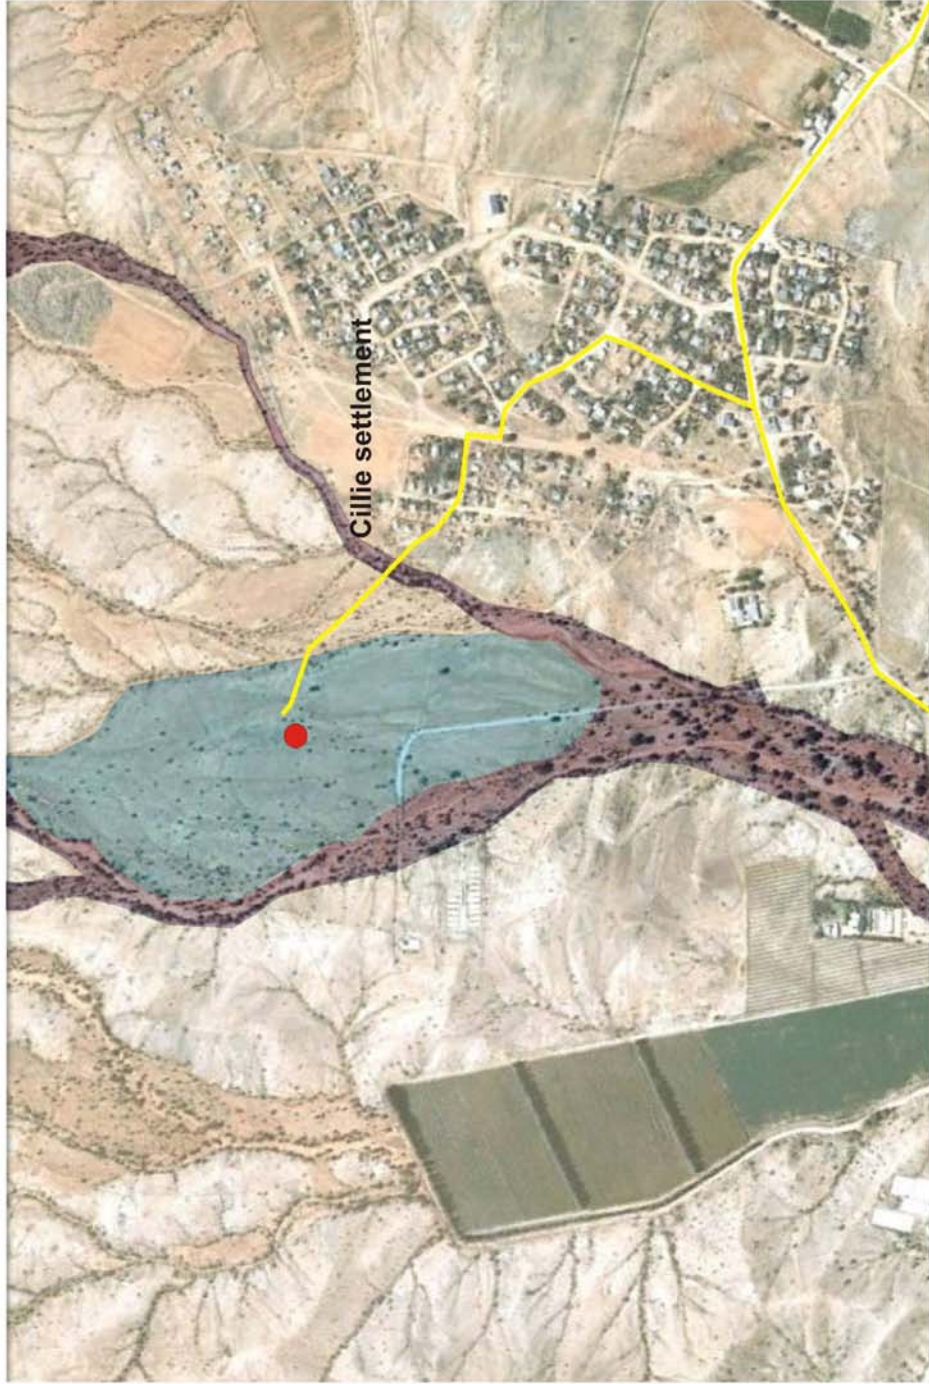
Map 1: The location of the proposed expansion of the Cillie graveyard. The dirt roads providing access to the site is indicated. The ephemeral stream is indicated as well as the resulting extensive streamwash. The streamwash is associated with sediment deposition.

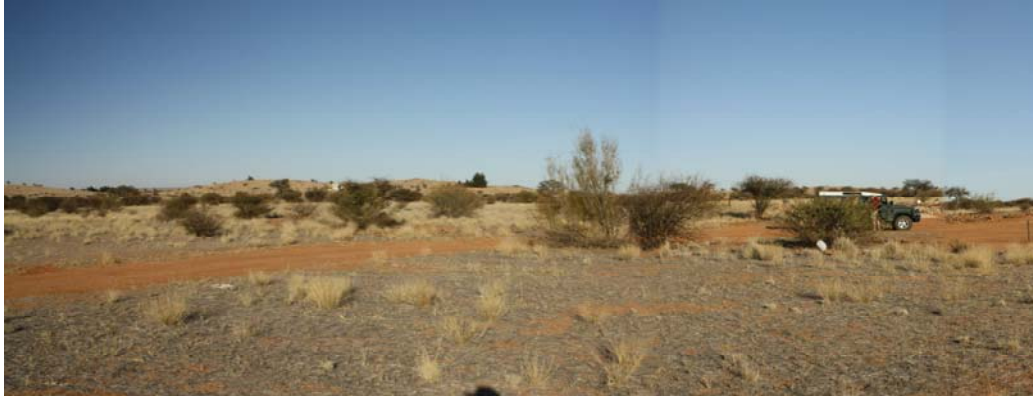
Figure 1: Panorama of the western portion of the site. Note the low percentage vegetation cover, small trees disturbance cause by dirt roads.

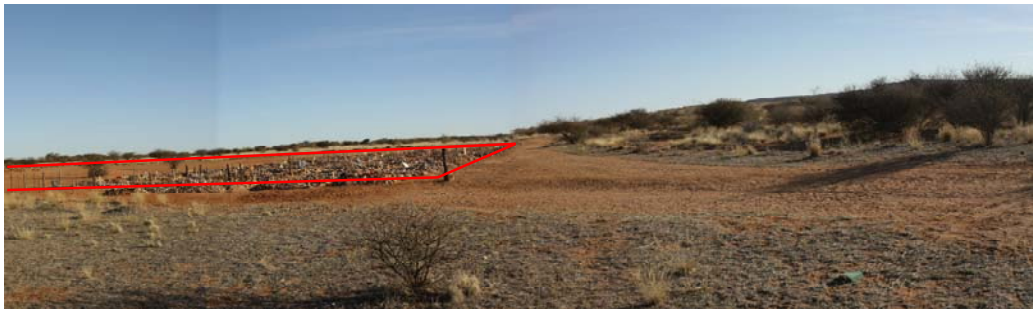
Figure 2: Panorama of the northern portion of the site. Note the existing graveyard (red figure) as well as the disturbance caused by the dirt road.

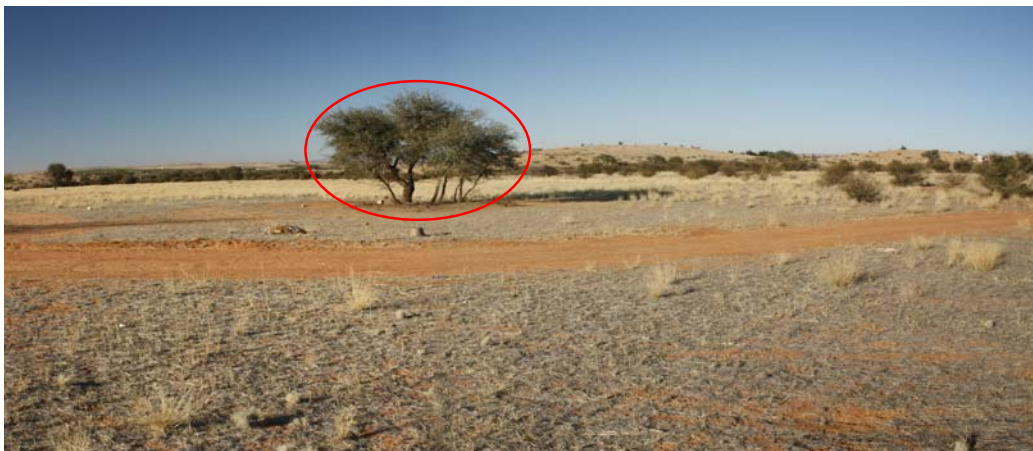
Figure 3: Panorama of the southern portion of the site. Note the disturbance by the dirt road. The protected Camel Thorn Tree (*Acacia erioloba*) occurring on the site is also indicated.

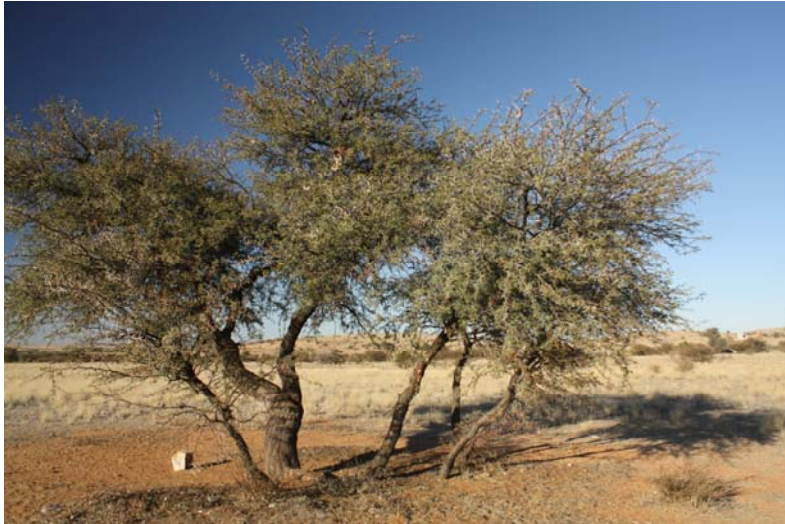
Figure 4: The large specimen of the protected Camel Thorn Tree (*Acacia erioloba*) occurring on the site. This specimen must be kept intact on the site or a permit must be acquired to remove it.

Two species of protected trees were noted on the site. These are one large specimen of Camel Thorn Tree (*Acacia erioloba*) and one juvenile specimen of Shepherds Tree (*Boscia albitrunca*). Although these species are widespread they remain protected. The two trees occurring on the site should be left intact if possible. Should this not be possible a permit must be obtained to remove them.

- The implementation of erosion measures is recommended.
- The area should be monitored for signs of erosion. Should any erosion occur prevention measures should be put in place.
- The specimens of protected trees on the site, Shepherds Tree (*Boscia albitrunca*) and Camel Thorn Tree (*Acacia erioloba*), should be kept intact. If this is not possible permits should be acquired to remove them.
- The use of the Mesquite Tree (*Prosopis glandulosa*) as a shade tree should not be permitted.
- The use of indigenous shade trees should be investigated. This will also aid in stabilisation of the soil.
- No animals may be captured, hunted or harmed in any way during construction or operation of the facility.

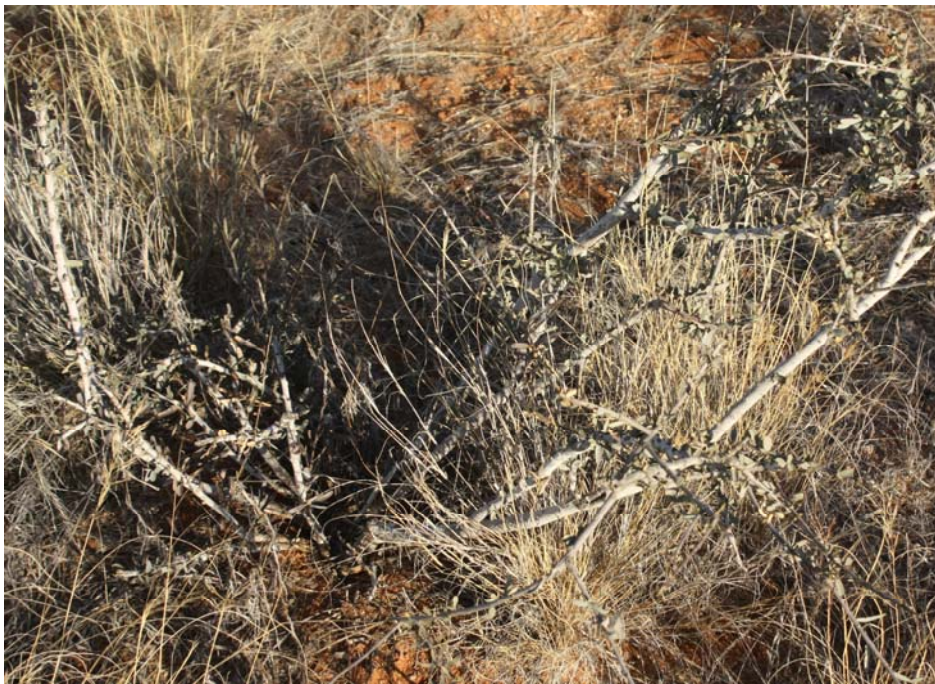
Figure 5: The juvenile of the protected Shepherd's Tree (*Boscia albitrunca*) occurring on the site. This specimen must be kept intact on the site or a permit must be acquired to remove it.

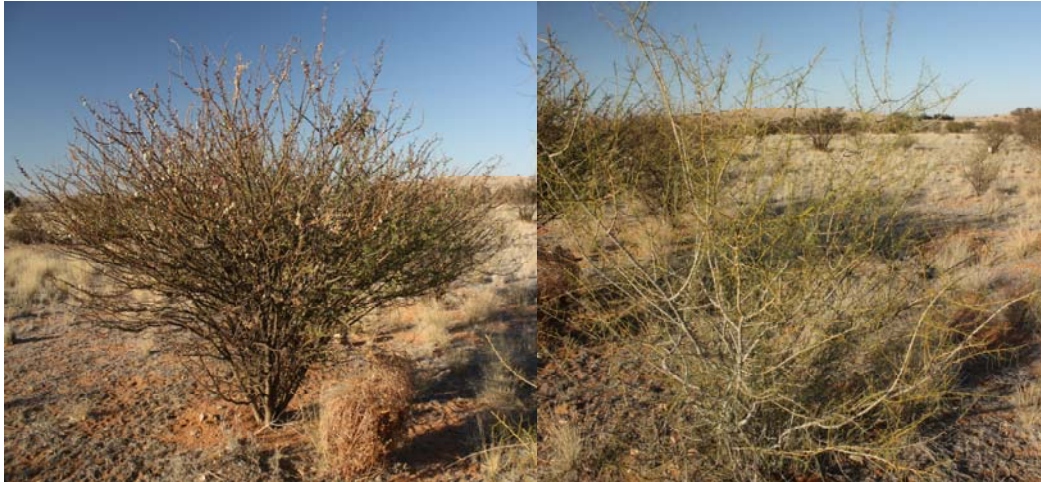
Figure 6: Other trees occurring on the site. On the left is *Acacia melifera* subsp. *detinens* and on the right is *Parkinsonia africana*. These species are widespread and not of a concern to the development.
