BASIC ASSESSMENT REPORT

**CROCODILE RIVER SUBSTATION AND
POWERLINE
SUBMISSION**

PROJECT DETAILS						
TITLE:	Crocodile River Substation and Powerline					
REPORT STATUS:	Basic Impact Assessment Report – submission					
LOCATION:	The Remaining Extent of Portion 14 of the farm Boschrand 283 JT, The Remaining Extent of farm Riverside 308 JT, Portion 1 of the farm Riverside 308 JT and Erven 7, 8, 10, 11, and 29 of Mataffin, Mpumalanga. The secondary substations will be located on Riverside Park Ext 27&29.					
COORDINATES:	Latitude (S):			Longitude (E):		
Start	25°	28'	02.60"	30°	55'	48.97"
End	25°	26'	30.41"	30°	56'	59.43"
EAP:	Enpact Environmental Consultants CC PO Box 12027, Nelspruit, 1200 Tel: 064 870 6968 or 082 801 7803 E-mail: info@enpact.co.za					
REPORT COMPILED BY:	Maryke André Enpact Environmental Consultants CC E-mail: info@enpact.co.za					
REVIEWED BY:	Heinrich Kammeyer Enpact Environmental Consultants CC E-mail: heinrich@enpact.co.za					
APPLICANT:	City of Mbombela local municipality

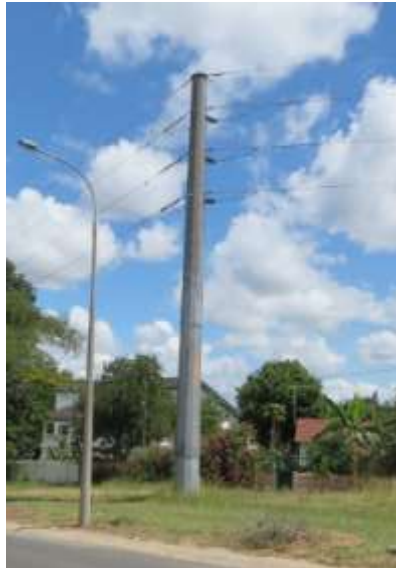
- Some of the new poles will be erected on the same footprints as that of existing 11 kV lines located in the same area.
- The footprints for the steel poles are very small – at most 15 x 15m impacted during construction.
- The powerline poles will look similar to those located adjacent Enos Mabuza Drive:

The line will mostly be fixed to round self-supporting steel poles but where height or distance requires it, lattice type structures will be used for example at the crossing of the Crocodile River. Both of these structures will be bolted to concrete foundations. Footprints will not be more than 15m x 15m.

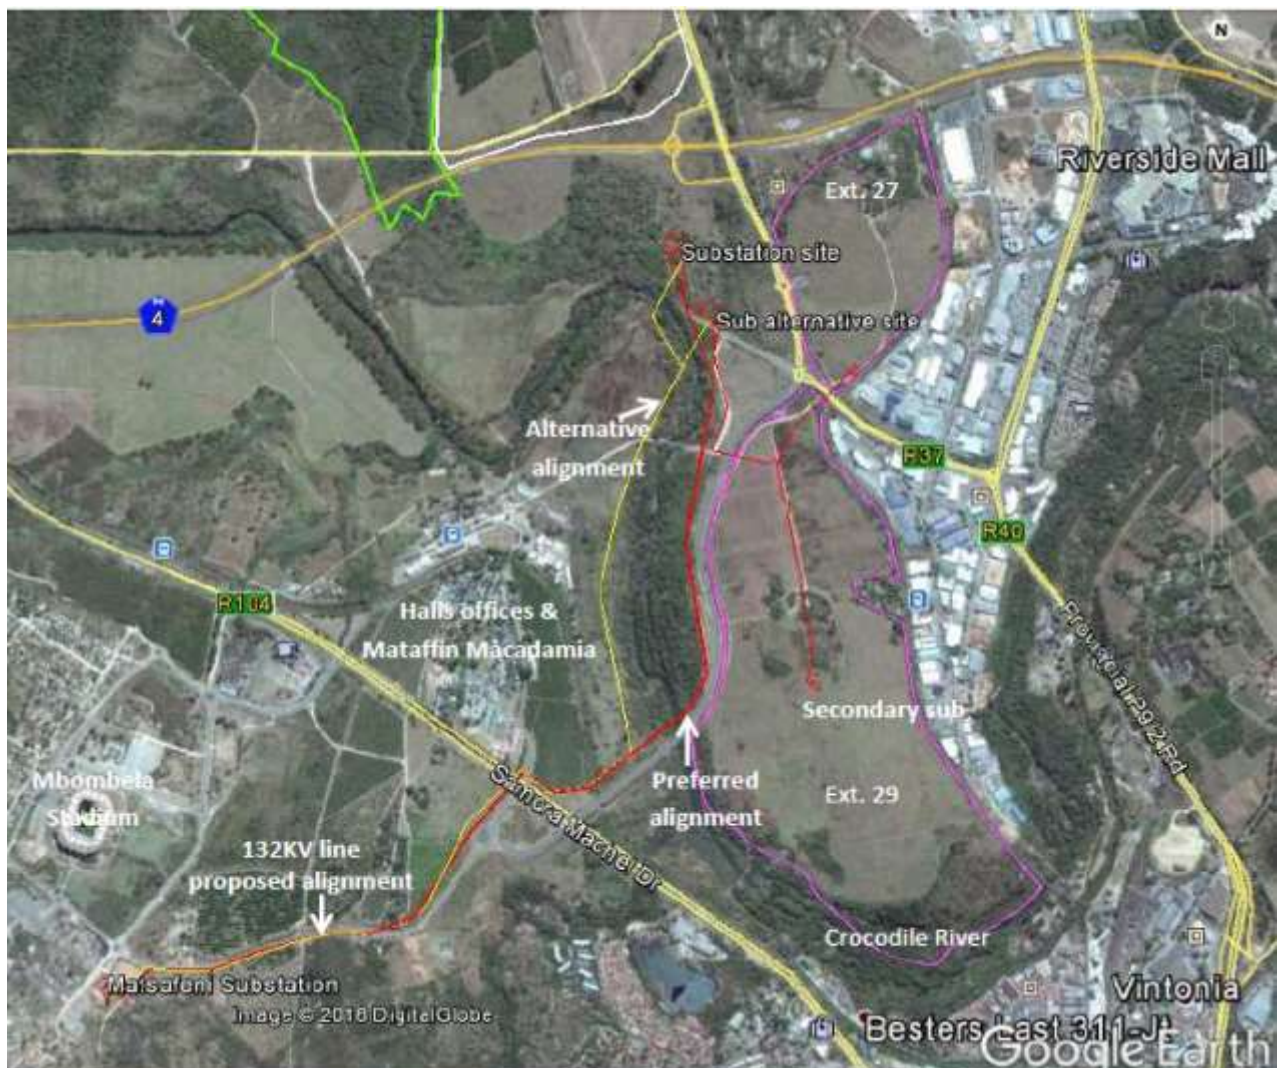
Figure 1: Powerline and substation alternative layout

Layout alternatives were considered for the 132 kV powerline as well as the substation.

Most of the proposed powerline routes transect transformed or degraded habitat and the only natural habitat remaining is at the two proposed Crocodile River crossings, on the western side of the P166. The following descriptions must be read with the map in figure 1 above.

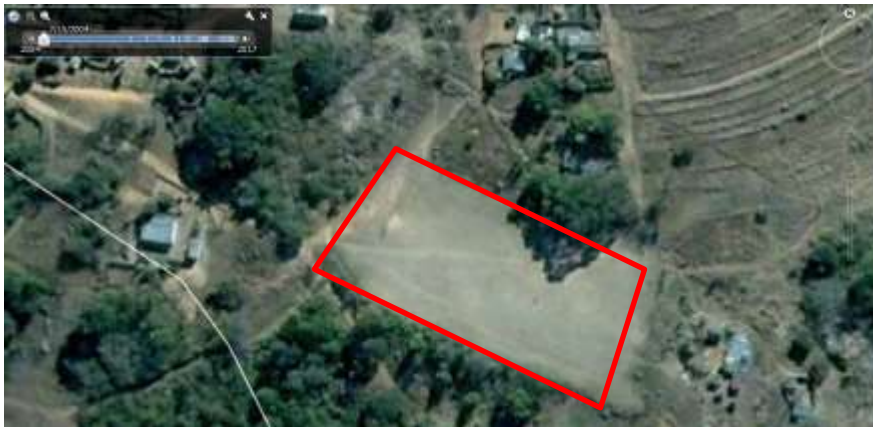
Substation preferred site: This site is located 160 m from the Crocodile River at its nearest point and was formerly a soccer field. There was a residential area for farm workers adjacent east and north of the site. The houses were demolished after the residents were relocated and the field was left to return to a more natural state. It is however still only a grassed area as can be seen on aerial imagery. This image is from 2004 Google imagery and clearly shows the site as transformed:

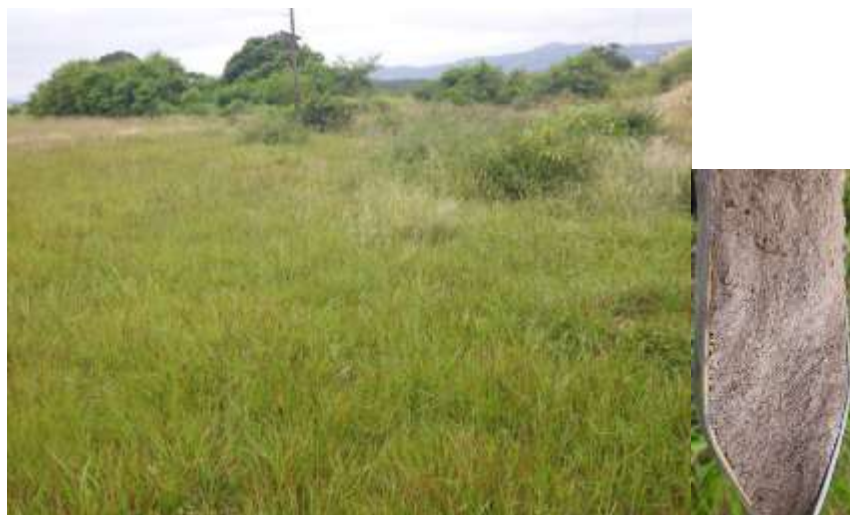
a) Seepage Wetlands

Distribution: Seepage wetlands were common and widely distributed in the Study Area in 2018. However, comparison of aerial imagery from 1936 with Google Earth imagery from 2017 shows that many of these wetlands have been modified significantly. For example, there used to be an extensive seepage wetland immediately south of the proposed Substation x27, but this area has since been transformed by roads and industrial development, and much of this wetland no longer exists, although there are a few remnants of this wetland that remain. Two Seepage Wetlands could be impacted directly by the proposed development as follows:

- **Seep 1:** left bank of the Crocodile River, and west of the P166 road. This is a lateral seepage wetland which appears to be driven by seepage from irrigated sugar upslope of the wetland. The wetland is dominated by *Phragmites mauritianus*, and to a less extent *Typha capensis*.
- **Seep 2:** on the right bank of the Crocodile River, adjacent to the P166 road bridge that crosses the Crocodile River. This wetland is characterised by intermittent saturation.

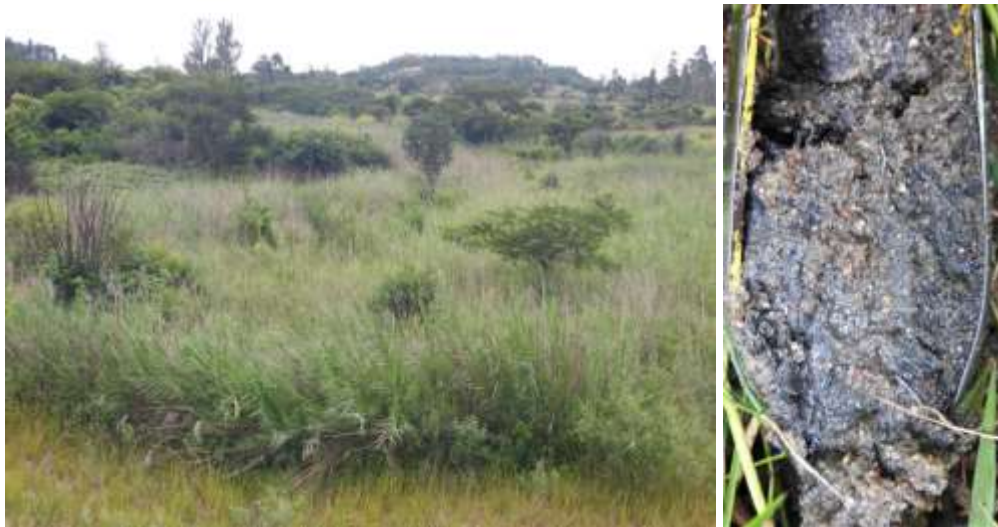
b) Valley Bottom Wetlands (no channel)

Distribution: The Study Area contained one Valley Bottom Wetland (no channel), located immediately east of the proposed Substation 1. Comparison of aerial imagery from 1936, with Google Earth imagery from 2017 shows that the size of this wetland has remained largely unchanged over the years. Refer to report attached for images.

Size:	Small (1.2 ha)
Flow type:	Permanent saturation, seasonal inundation
Soils:	Unconsolidated coarse sands mixed with black, anoxic clays and organics
Flora:	Plant species diversity was low, with a total of 49 species recorded.
Hydrophytes:	<i>Cyclosaurus interruptus</i> , <i>Thelypteris confluens</i> , <i>Typha capensis</i> , <i>Ludwigia octovalvis</i>
Grasses:	<i>Cynodon nlemfuens</i> *, <i>Leersia hexandra</i> , <i>Paspalum distichum</i> *, <i>Paspalum urvillei</i> *
Reeds	<i>Arundo donax</i> *, <i>Phragmites mauritianus</i>
Sedges:	<i>Cyperus dives</i> , <i>Cyperus esculentus</i> *, <i>Cyperus fastigiatus</i> , <i>Kyllinga melanosperma</i>
Herbs:	<i>Nidorella auriculata</i> , <i>Pulicaria scabra</i> , <i>Ecliptera prostrata</i> *, <i>Persicaria decipiens</i> , <i>Persicaria senegalensis</i> , <i>Ranunculus multifidus</i> *, <i>Verbena bonariensis</i> *
Geophytes:	<i>Calocasia esculenta</i> **

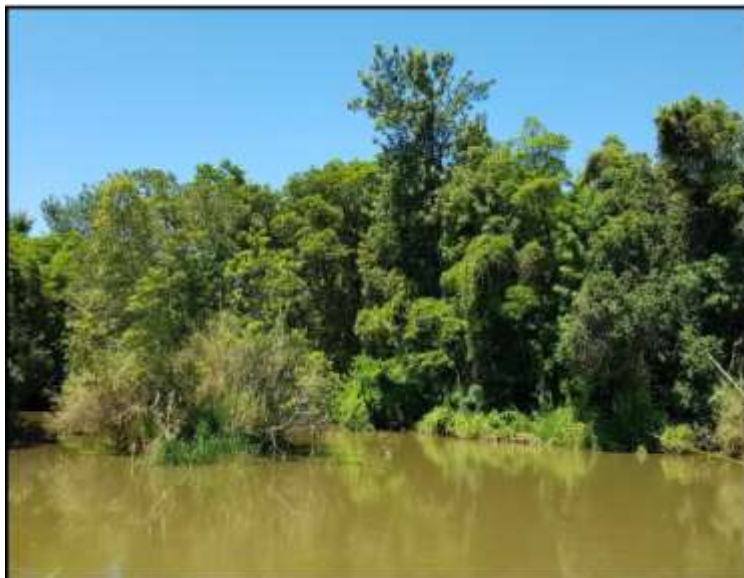
Lower Foothill Marginal Zone, near the P166 road bridge [2018-01-15].

Distribution: The Crocodile River passes through the Study Area over a distance of 3.1 km, and the river here is classified as a Lower Foothill. Photographs of the marginal and upper (non-marginal) zones near the PO166 road bridge are shown in photos above. The proposed powerline will cross the Crocodile River at one of three alternative locations:

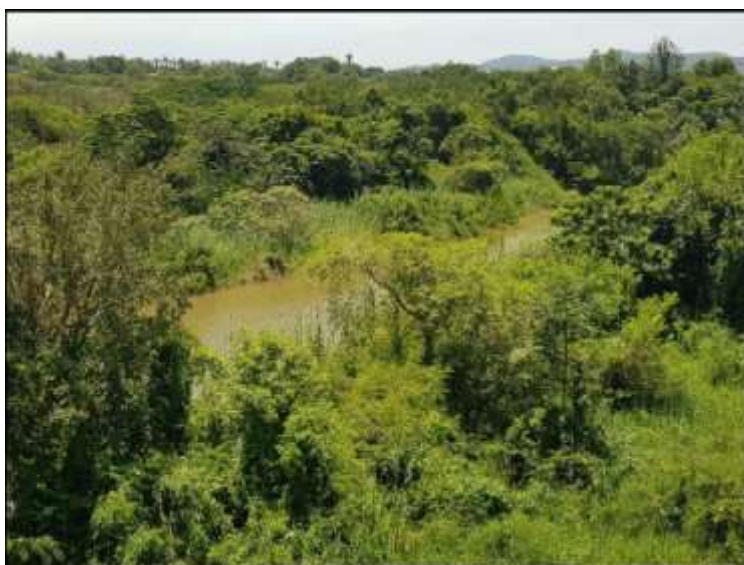
Lower Foothill Upper Zones (Non-Marginal), near the P166 road bridge [2018-01-15].

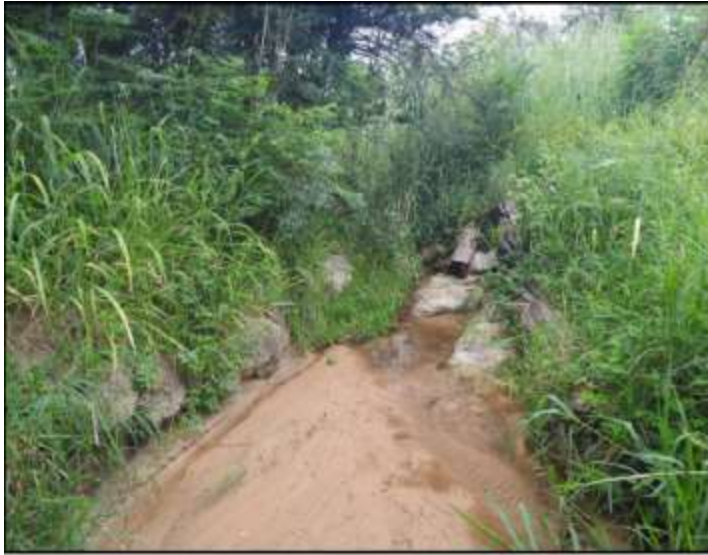
Photo of a drainage line in the project area

The Study Area contained a few episodic to seasonally active drainage lines, one feeding the Valley Bottom wetland near the proposed Substation 1. Here, bed substrates were characterised by highly mobile coarse sands with no evidence of mottling. These systems are unlikely to be affected by the proposed development and were therefore not considered in detail in this report.

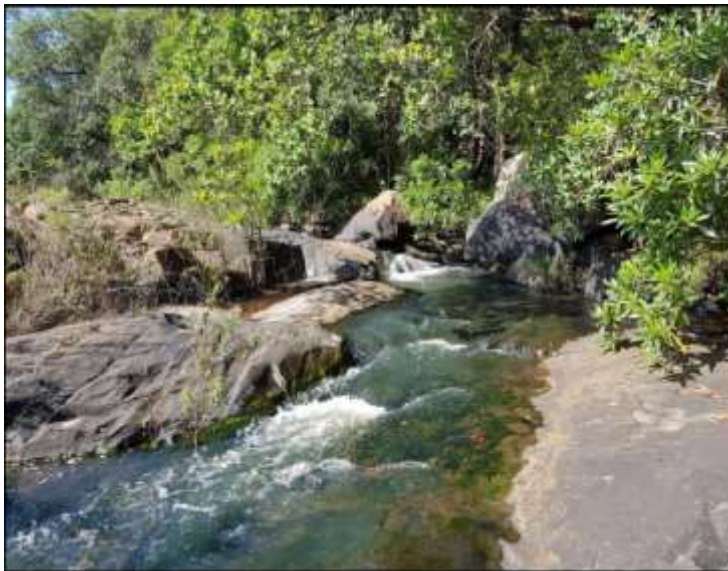
Upper Foothill (lower Gladdespruit)

The Study Area included the lower reaches of the Gladdespruit, at its confluence with the Crocodile River. The river here is characterised by granite bedrock with a waterfall, cascades and isolated pools, and a well-wooded riparian zone. This system was unlikely to be affected by the proposed development and was therefore not considered in detail in this report.

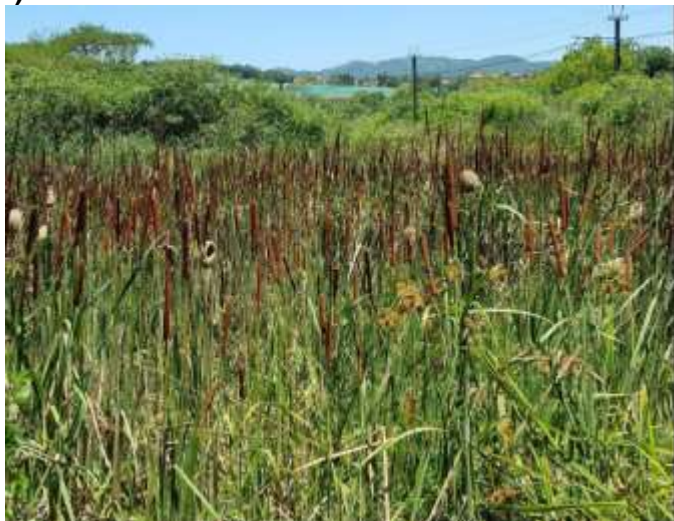
Abandoned settling pond, dominated by bulrush *Typha capensis*

The Study Area contained a number of farm dams used for irrigation, some of which were no longer in use, as well as a series of dysfunctional settling ponds near the confluence of the Gladdespruit and Crocodile River. These systems are unlikely to be affected by the proposed development and were therefore not considered in detail in this report.

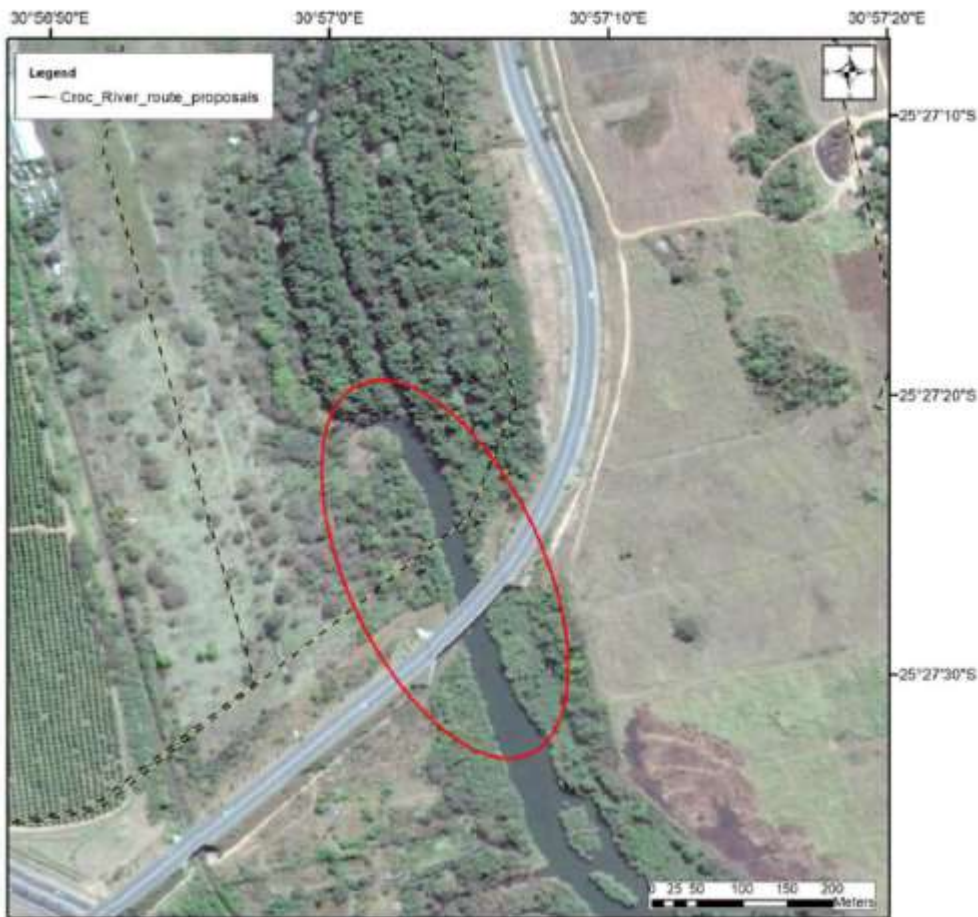
The Present Ecological State of riparian vegetation in the Crocodile River at the P166 road bridge was rated as borderline between *Largely and Seriously Modified* (Category D/E: 40%). The main causes of degradation were associated with inundation from a diversion weir, cultivation of pecan trees within the riparian zone, reduction in high flow events caused by operation of Kwena Dam and small dams throughout the catchment, and high levels of invasion of alien vegetation associated with general disturbance. Refer to the report for a more detailed account of the PES which includes a description of the species in the marginal and non-marginal zones.

Google Earth image of the Crocodile River at P166 road bridge. Red lines show the extent of the vegetation assessment [Image date: 13/06/2017].

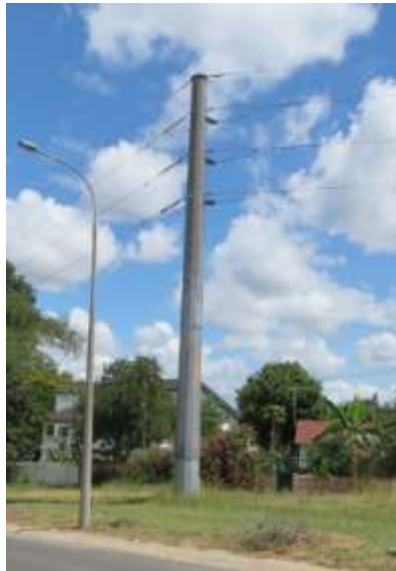
- Some of the new poles will be erected on the same footprints as that of existing 11 kV lines located in the same area.
- The footprints for the steel poles are very small – at most 15 x 15m impacted during construction.
- The powerline poles will look similar to those located adjacent Enos Mabuza Drive:
