**PUBLIC PARTICIPATION REPORT FOR
THE PROPOSED DEMOLITION OF THE
CROWNWOOD ROAD BRIDGE IN
ORMONDE, CITY OF JOHANNESBURG,
GAUTENG PROVINCE.**

**THE PROPOSED DEMOLISHING OF THE OLD CROWNWOOD ROAD BRIDGE, LOCATED IN THETA,
JOHANNESBURG SOUTH, CITY OF JOHANNESBURG METROPOLITAN MUNICIPALITY,
GAUTENG PROVINCE**

Report No: 2020/JvS/006

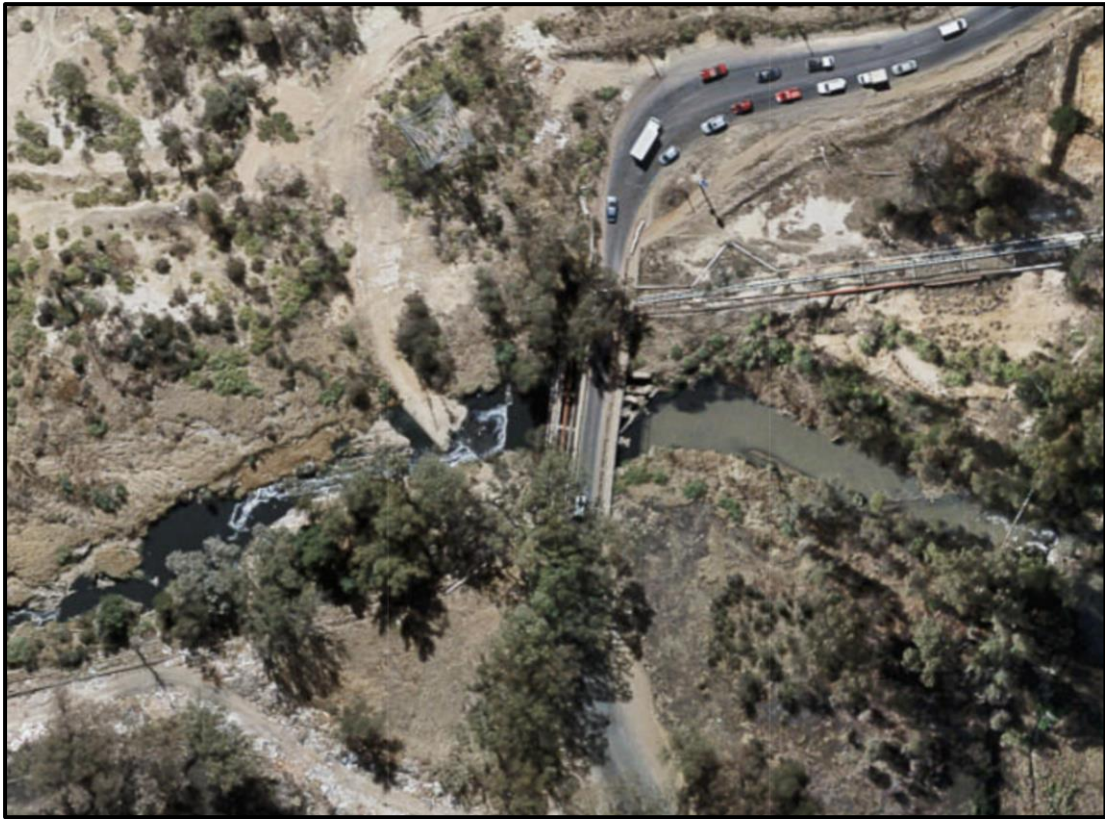
The Old Crownwood Road Bridge, seen from the air (2018)
(Image: Google Earth)

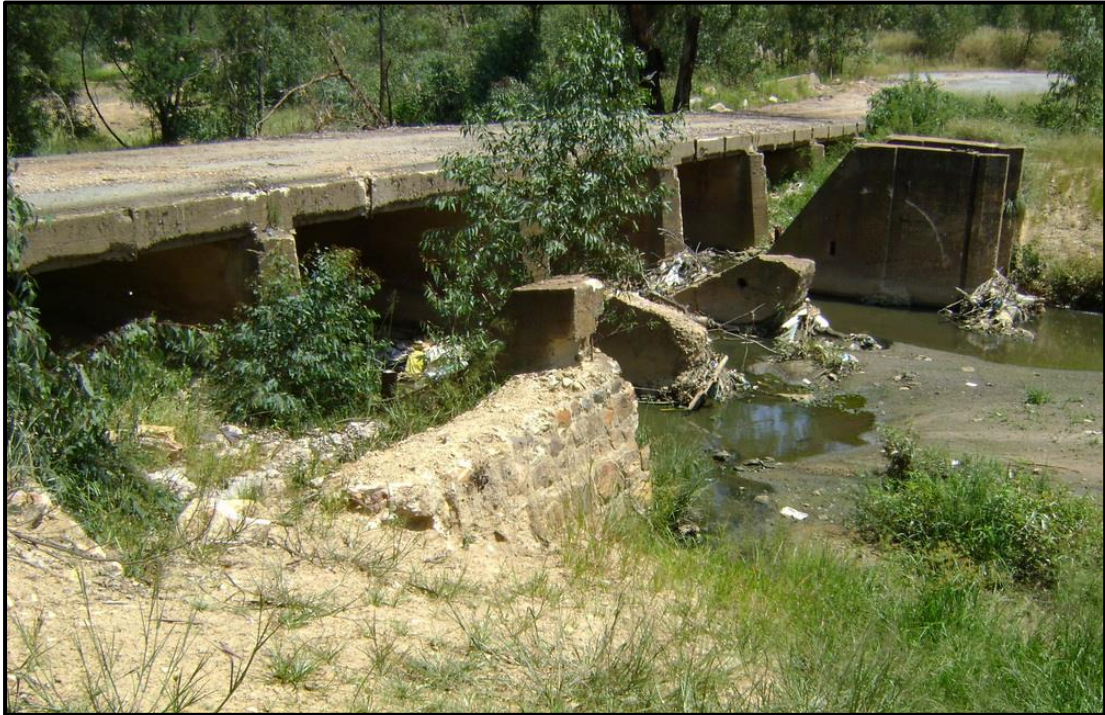
Figure 9. The older features in relation the (old) bridge

Details of the various features are indicated below in Fig. 10. Some (Fig. 10.1) seems to be retaining walls abutting to an older stone-built wall, which might have been an old dam wall (Fig. 10.2). The two larger segments of these structures (Fig. 10.3) seems to have housed some kind of sluice-gate. This is confirmed by their location close to each other, as well as some vertical grooves on the inside and the location of various bolts and ringbolts in strategic positions (Fig. 10.4 – 10.6).

It is postulated that this structure originally consisted of a small dam retaining wall. As (sludge) pipes had to be installed between the various slimes-dams (see aerial photographs in Fig. 7 & 8 above, these larger structures were built to accommodate it and the whole system was incorporated into the older, then existing dam.

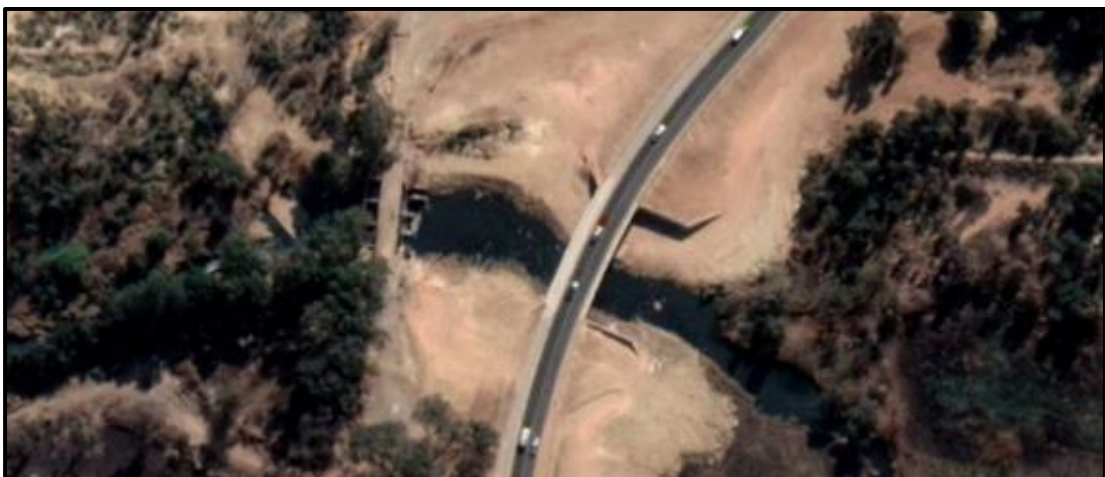
Figure 11. The old bridge on the left and new one on the right (Image: Google Earth)

Eventually, in 2019, the old bridge was replaced by the new one located a short distance to the east (Fig. 11).

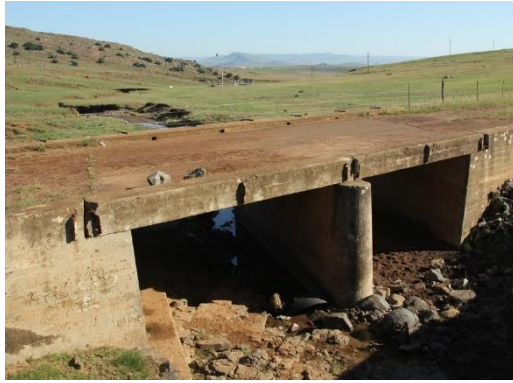
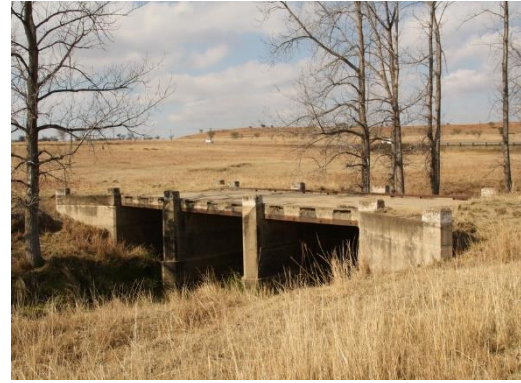
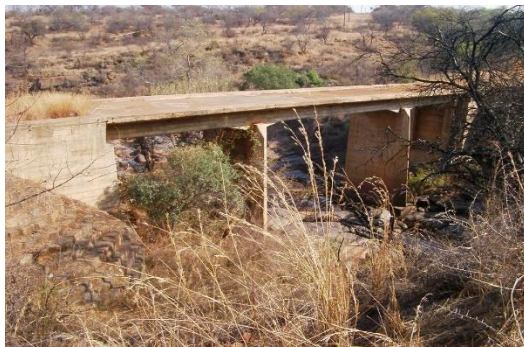
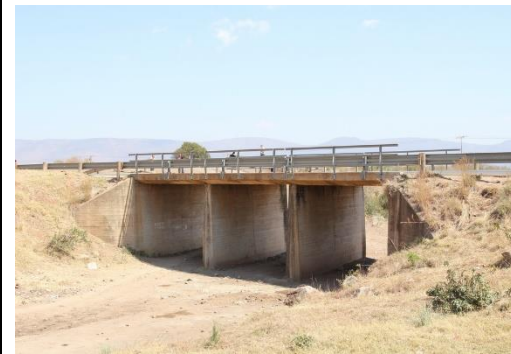
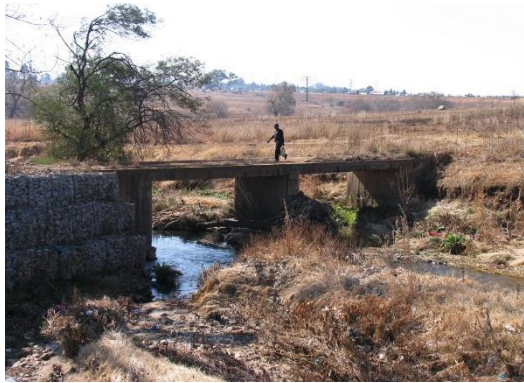
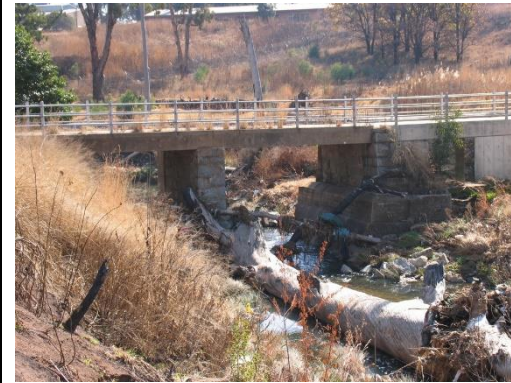
Figure 14. Examples of bridges of similar material and construction across the country

This is probably the most common type of bridge built in the country – see Fig. 14 below.

It has also been shown in this report that bridges of similar construction and age are to be found in a number of places all over the South African countryside. Fortunately, most of them are in good condition due to continued use.

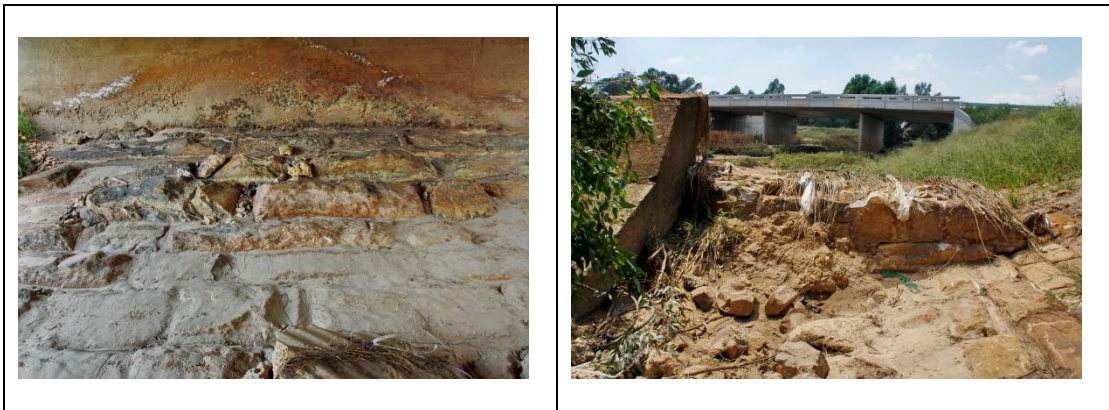
This was constructed from cast concrete. It probably rests on a foundation, currently below water level, which goes down to bedrock.

At its foundation is a layer of sandstone blocks of various sizes that are held in place with cement. This forms part of an older spillway located at the old dam wall located adjacent to the bridge.

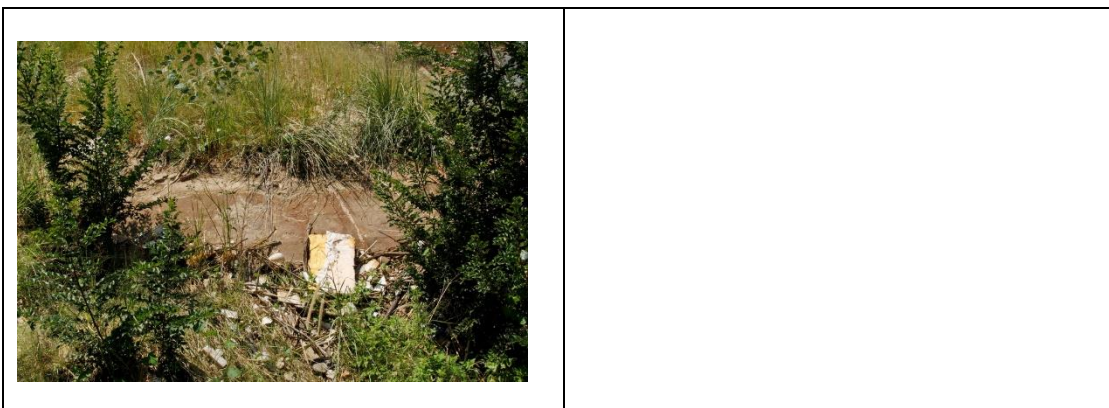
Abutment wingwall:

- Extensions of a retaining wall as part of an abutment; used to contain the fill of an approach embankment.

Due to excessive plant growth and erosion, it is difficult to get a clear picture of this. It is probably soil that was banked down and supported in place with concrete plinths.

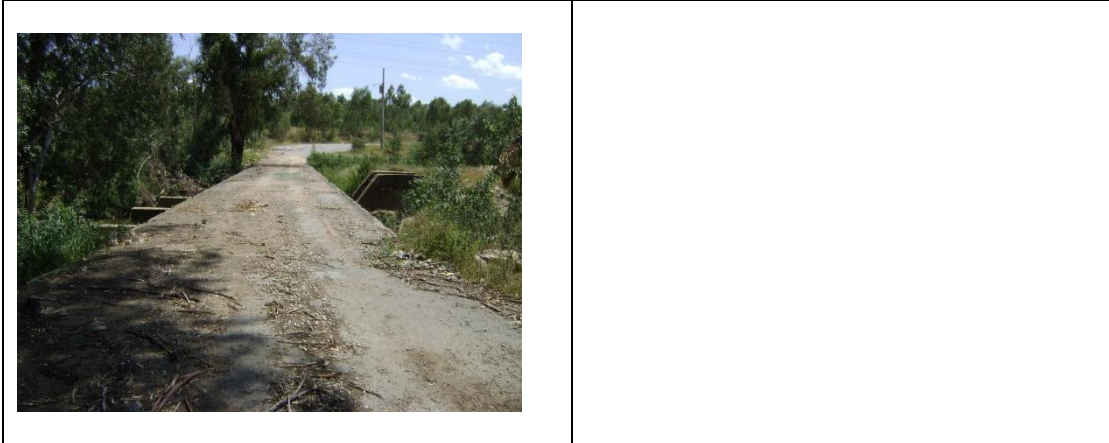
Approach road:

- The road leading up to the bridge on both sides.

This is currently a tarmac road, carrying vehicular traffic in a south to north direction.

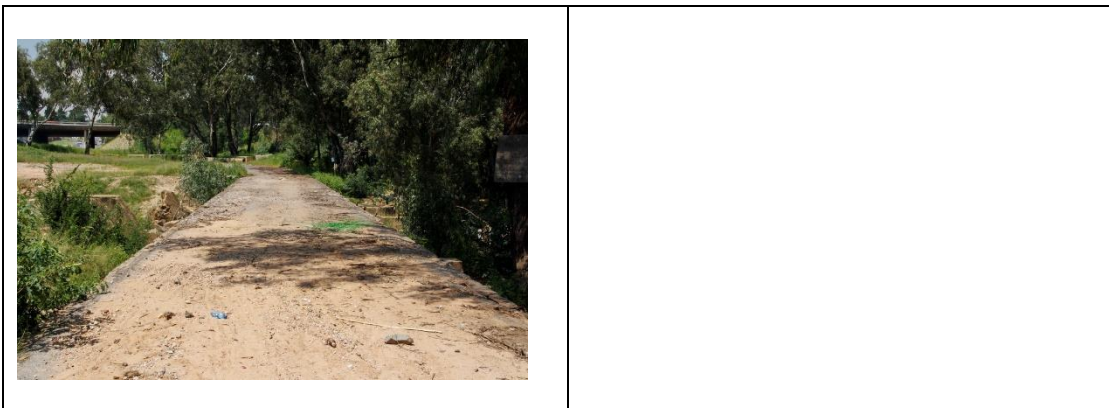
Bridge deck:

- The roadway portion of a bridge that supports the traffic.

The bridge deck consists of concrete, which is also part of the construction of the bridge and is then covered with a layer of tarmac. The total length of the bridge deck is just over 45 m.

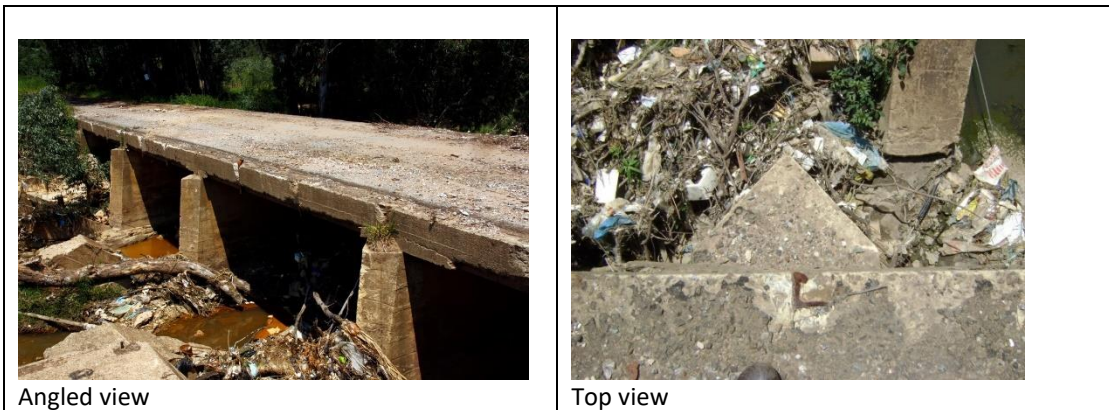
Columns:

- Vertical structure member used to support the load of the bridge deck.

Seven columns support the bridge deck. It is from cast concrete and is set at a slight angle to the bridge deck in order to be parallel to the stream bed. They vary in height according to their location in relation to the riverbanks, becoming longer towards the centre of the river.

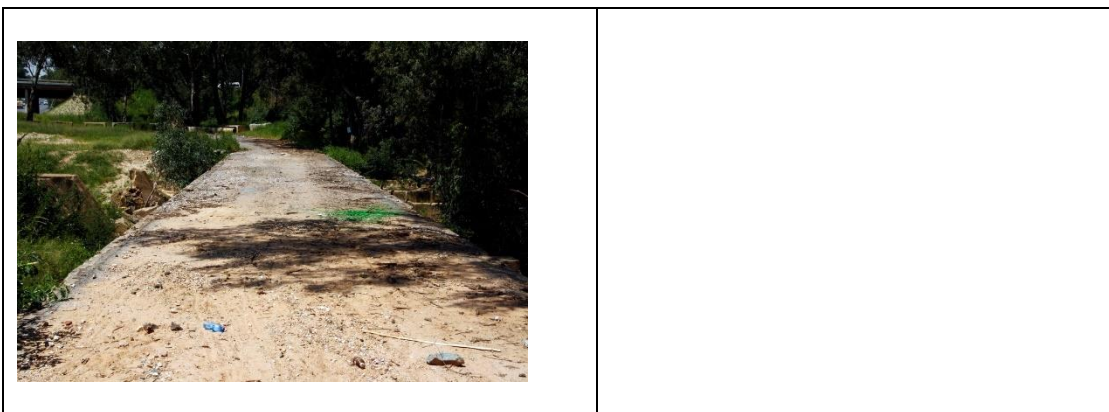
Deck floor:

- The top layer on which the traffic crosses.

This consists of a layer of tarmac laid directly on the concrete bridge deck.

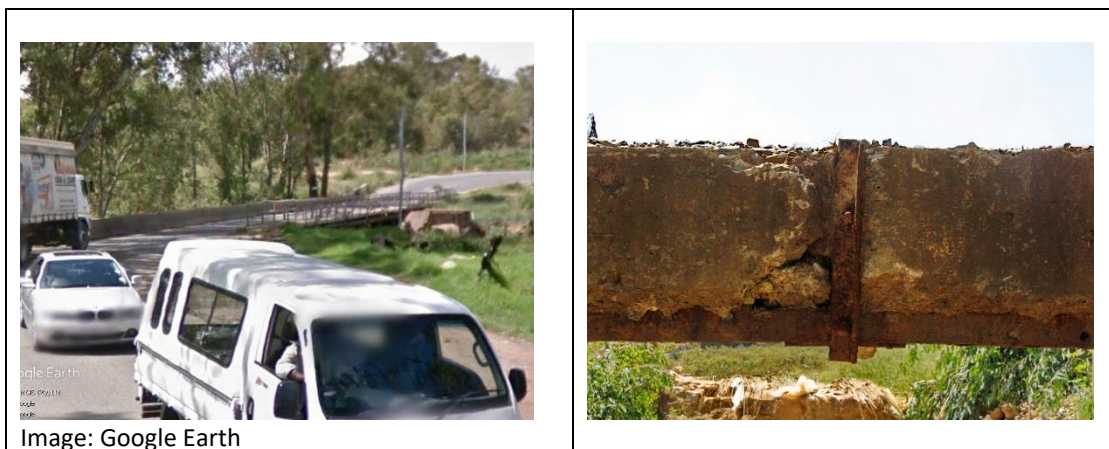
Railings:

- Consists of steel structure made up of a number of upright sections or stanchions, on which horizontal railings are suspended.

Unfortunately, all of this has been removed (see below). However, by using historic images (Google Earth) it is possible to get an idea of what it used to be. On the upstream side of the river it used to be metal stanchions with some form of cross members. On the downstream side, at the pipe packs, it was cast concrete, which probably replaced the original metal structure and the remains of the stanchions can still be seen on that side. There were at least 15 upright stanchions to a side.

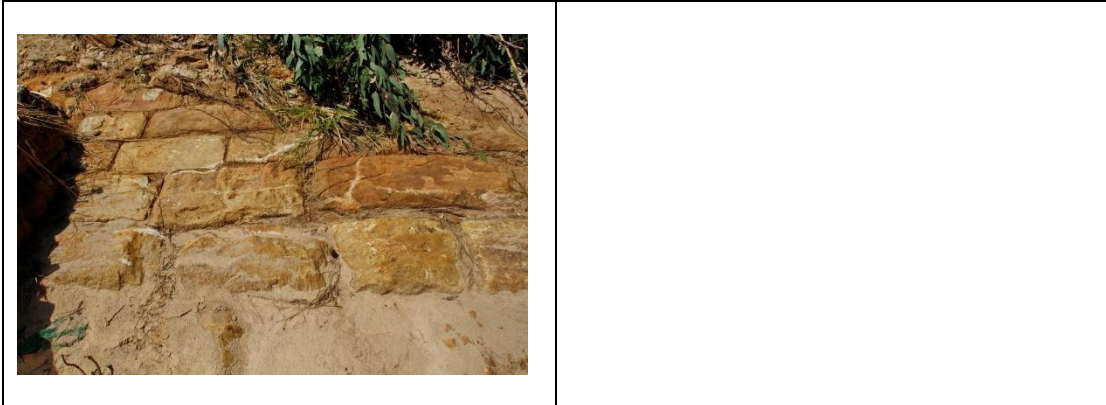
Revetment:

- A facing of masonry or stones to protect an embankment from erosion.

This could only be determined on the upstream, left-hand bank of the bridge.
