*JOHANN van der MERWE (Pty) Ltd*  
CONSULTING APPLIED EARTH AND ENVIRONMENTAL SCIENTISTS

**PROJECT No: M20/3870**

**FACTUAL REPORT ON A PHASE 1 GEOTECHNICAL INVESTIGATION CARRIED OUT FOR THE PROPOSED RESORT AND RESIDENTIAL DEVELOPMENT ON: PORTIONS 2 AND 3 OF TENBOSCH 661-JU, NKOMAZI LOCAL MUNICIPALITY, MPUMALANGA PROVINCE**

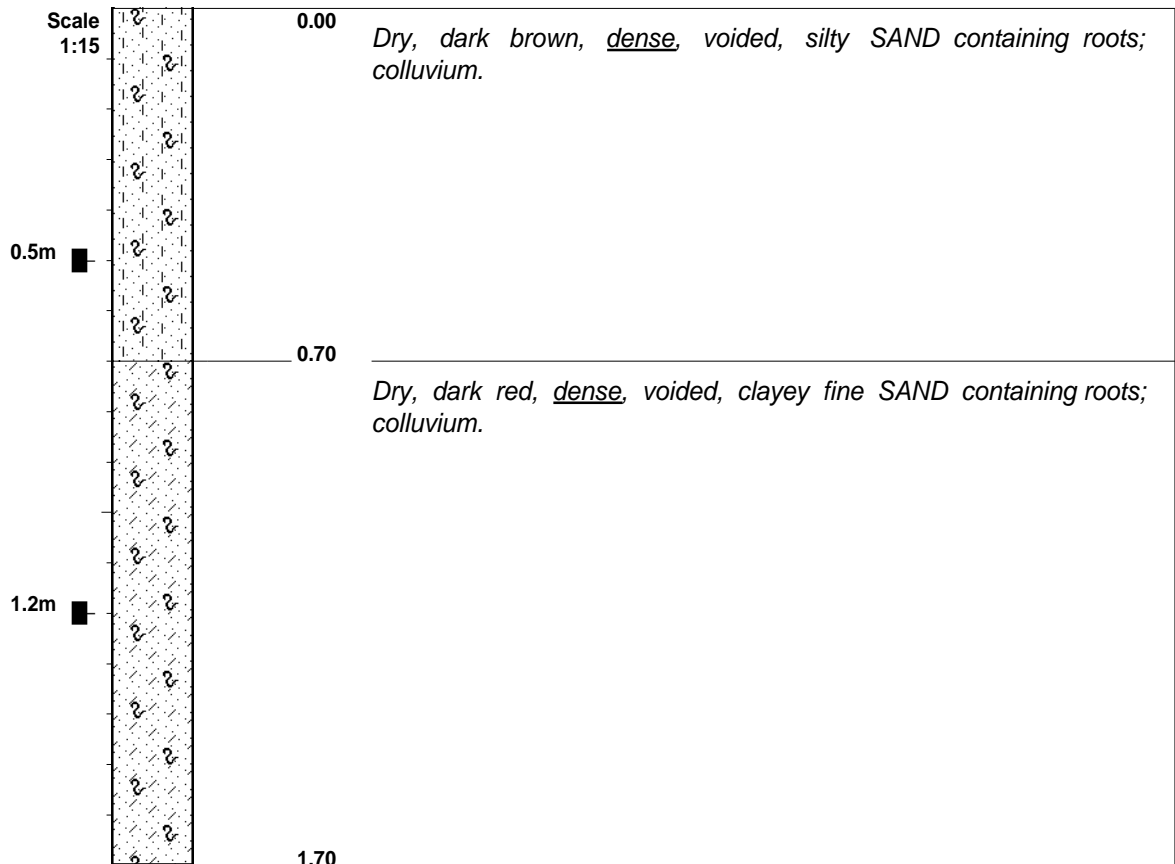
**JOB NUMBER: M20/3870**

- 1) No refusal of backactor at 1,7m.
- 2) No water seepage encountered.
- 3) Undisturbed block samples taken at 0,5m and 1,2m.
