TEN BOSCH - KOMATIPOORT

Wetland and Riparian Zone Identification and Assessment

September 2020

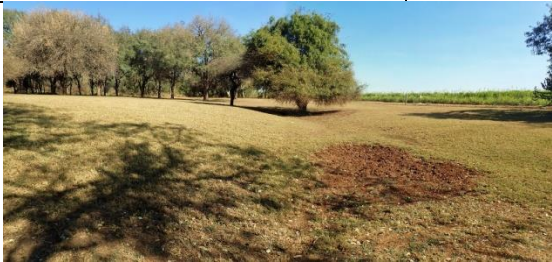
Nr.	Type	Location	Description
TB01	Ephemeral drainage	25°24'00.82 S 31°57'23.55 E	The drainage forms part of a recreational area. The catchment consists mainly of sugar cane cultivation and bushveld. The drainage line's elevation is shallow at first but gets steeper as it drains towards the Crocodile River.
The following species occur: <i>Tabernaemontana elegans</i> <i>Sclerocarya birrea</i> <i>Acacia xanthophloea</i> <i>Trichilia emetica</i> <i>Diospyros mespiliformis</i> <i>Gymnosporia senegalensis</i> <i>Phyllanthus reticulatus</i> <i>Philenoptera violacea</i> <i>Panicum maximum</i> <i>Cynodon dactylon</i> <i>Melinis repens</i> <i>Urochloa mosambicensis</i> <i>Berchemia zeyheri</i> <i>Lantana camara</i> * <i>Melia azedarach</i> *			Impacts: <ul style="list-style-type: none"> • Dumping of garden refuse • Head-cut erosion as a result of high flows during rain events • Infrastructure footprint extends into the drainage area • Road crossing • Vegetation clearing, impacting the roughness coefficient of the system • Exotic vegetation

<p>Upstream portion managed for recreational activities</p>

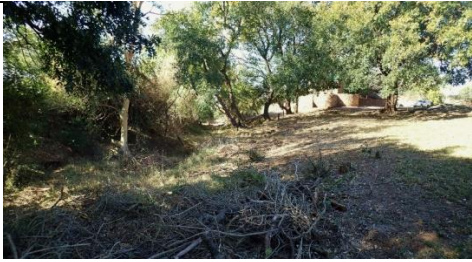
<p>The incised downstream area, before it drains into the Crocodile River</p>	
Nr.	Type	Location	Description
TB02	Ephemeral drainage	25°24'02.57 S 31°57'37.33 E	This feature is dry with a steep gradient. The upstream portion is rocky with a meandering channel. It is expected that high energy flows do occur during rain events.
The vegetation cover consist of the following species: <i>Rhoicissus tridentata</i>			Impacts: <ul style="list-style-type: none"> • Dam in the downstream portion

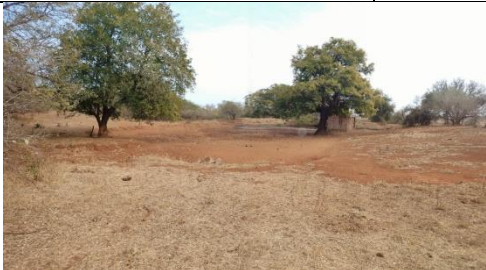
<p>Dry dam showing overgrazing and trampling</p>		  <p>Upstream portion with good vegetation cover</p>	
Nr.	Type	Location	Description
TB04	Ephemeral drainage	25°24'16.10 S 31°58'15.41 E	<p>The drainage line is small and is situated close to the footprint of the dam. Good vegetation cover exists adjacent to the dam.</p> <p>Impacts:</p> <ul style="list-style-type: none"> • Road crossing • Dam • Overgrazing and trampling along the edge of the dam footprint
<p>Dominant species: <i>Strichnos madagascariensis</i> <i>Diospyros mespiliformis</i> <i>Dalbergia melanoxylon</i> <i>Acacia nigrescens</i> <i>A. robusta</i></p>

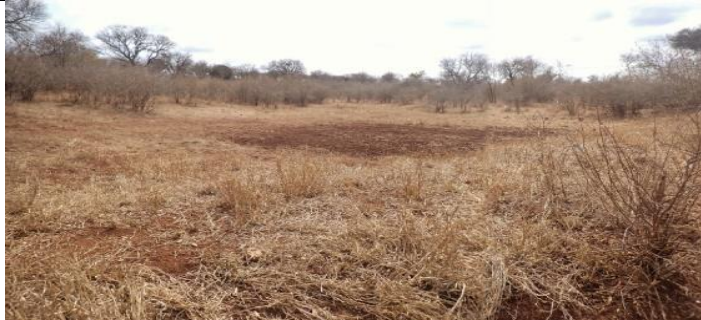
<p>Dry dam basin with upstream drainage visible</p>			
Nr.	Type	Location	Description
TB05	Ephemeral drainage	25°24'28.55 S 31°58'03.41 E	This linear drainage line is narrow, with good vegetation cover, and water is conveyed in a controlled manner with little erosion visible.
<p>Dominant species: <i>Euclea natalensis</i> <i>Combretum imberbe</i> <i>Dichrostachys cinerea</i> <i>Grewia hexamita</i> <i>Lippia javanica</i> <i>Searsia pentheri</i></p> <p><i>Panicum maximum</i> <i>Cynodon dactylon</i> <i>Digitaria eriantha</i> <i>Aristida congesta</i> <i>Heteropogon contortusw</i> <i>Pogonarthia squarrosa</i></p>		<p>Impacts:</p> <ul style="list-style-type: none"> • Road crossing • Dam • Overgrazing and trampling along the edge of the dam footprint • Surface erosion in the upstream portion (the result of flows during rain events)

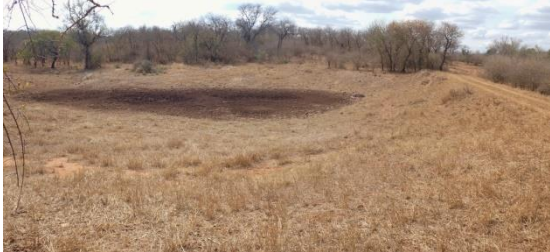
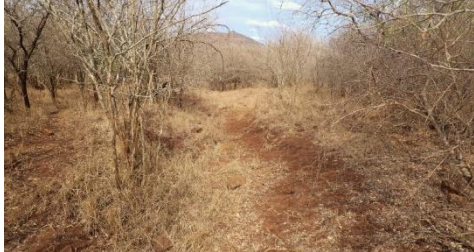
<p>Dam at the lower end of drainage</p>	<p>Channel formation in the linear upstream drainage</p>
Nr.	Type	Location	Description
TB06	Ephemeral Pan	25°24'33.20 S 31°57'34.36 E	An ephemeral pan feature was found with an indication of wetness. A dyke occurs which acts as a barrier resulting in the damming water in the upstream portion.
<p>Dominant species <i>Urochloa mosambicensis</i> <i>Cynodon dactylon</i></p>		<p>Impacts:</p> <ul style="list-style-type: none"> • Road crossing • Trampling and grazing

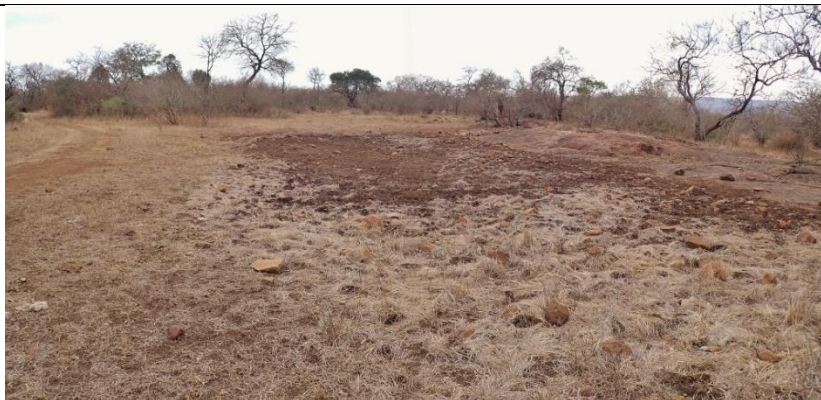
Pan feature, developed due to the rocky dyke formation damming up water in the upstream portion during the rainy season

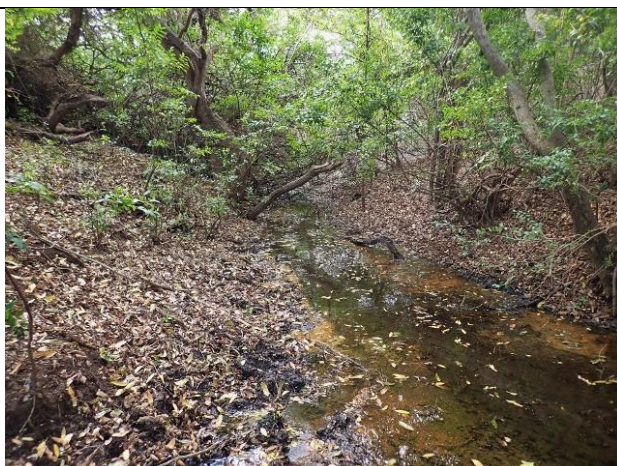
Figure 5-10: View of Site TB08 Riparian Area

This site is located at 25°24'49.99 S, 31°57'44.13 E. The riparian zone extends upstream from above the dam, and downstream, where it joins the Crocodile River (Figure 5-10 and Figure 5-11).

Dam in upstream portion of riparian area

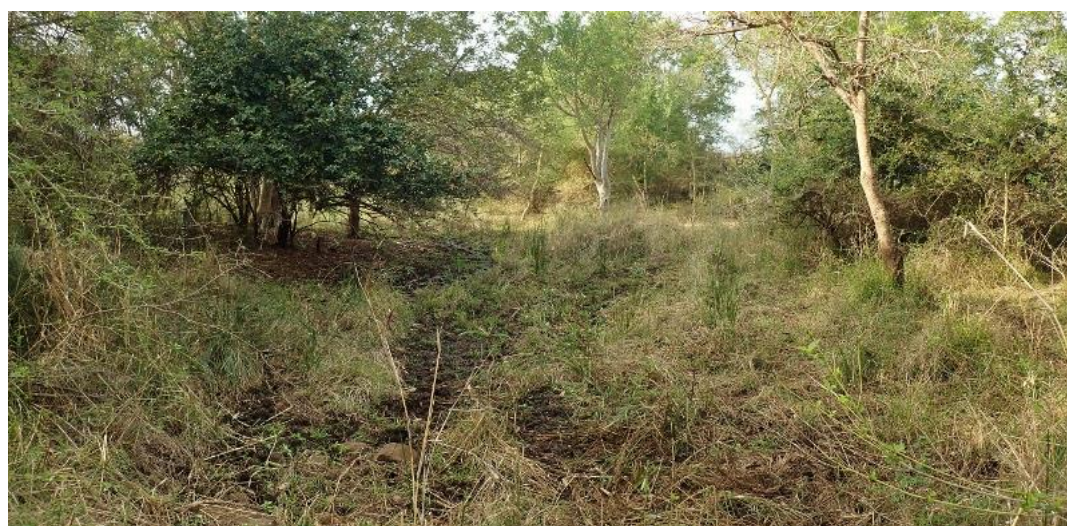
Figure 5-15: Visual indicating the wetland habitat dominated by woody species and lush vegetation

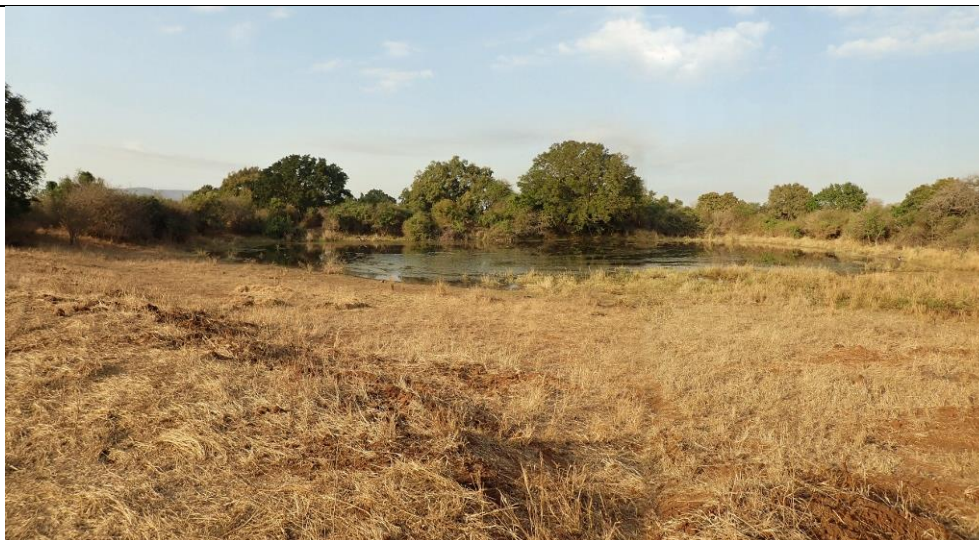
Panoramic view of the dam constructed in the wetland

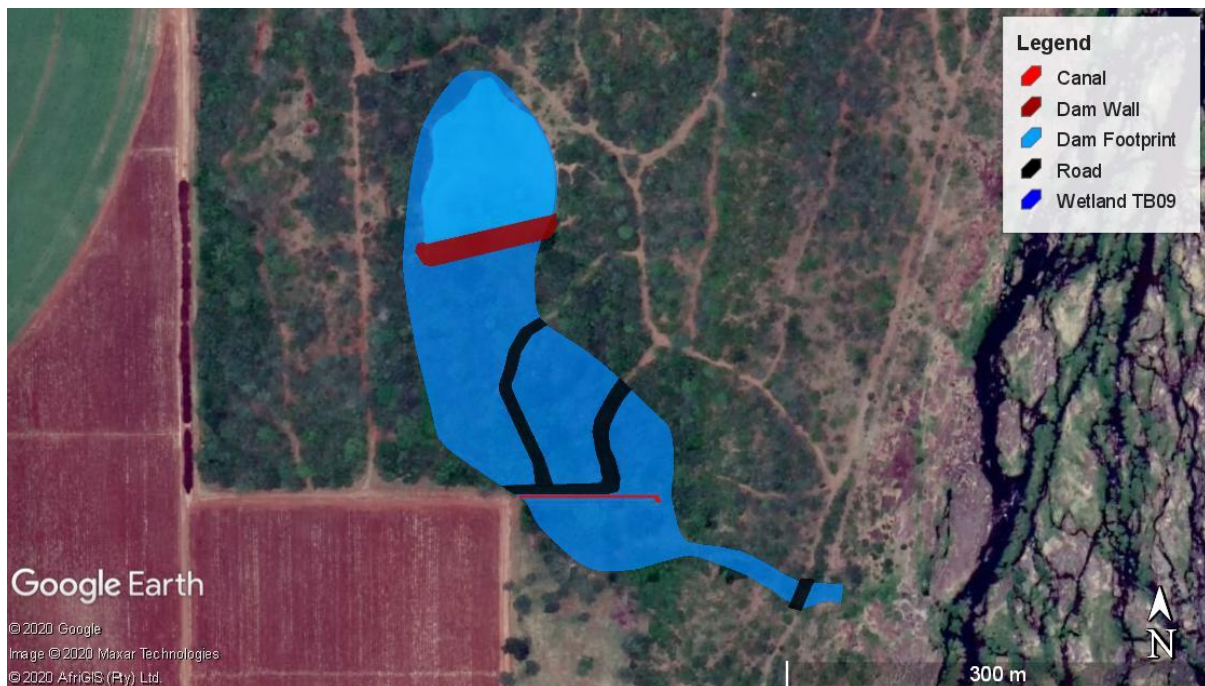
Figure 5-17: Map indicating the location of the different impacts in the wetland

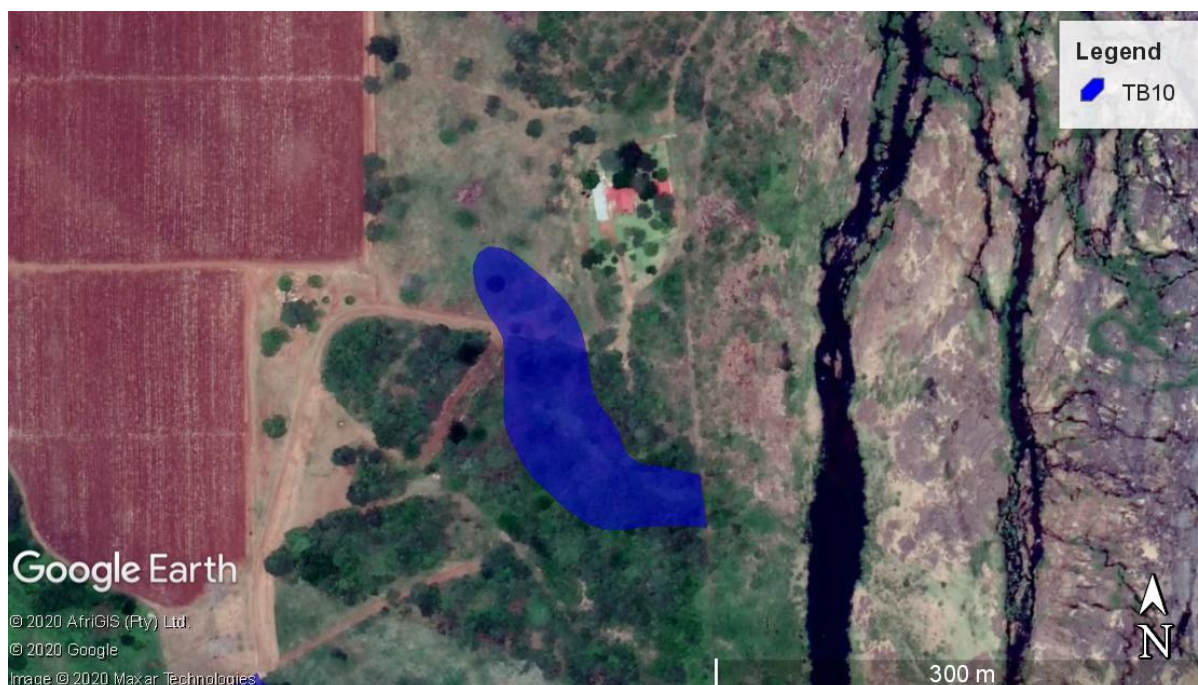
Figure 5-19: Google Earth image of wetland TB10

This site is located at 25°25'16.35 S, 31°57'31.93 E. The wetland extends upstream of the earthen dam, to where it flows into the Crocodile River (Figure 5-19). The wetland is characterised by vegetation conducive to wet conditions. Facultative tree species occur in large numbers, and obligate and facultative herbs, sedges and graminoids are present (Figure 5-20).

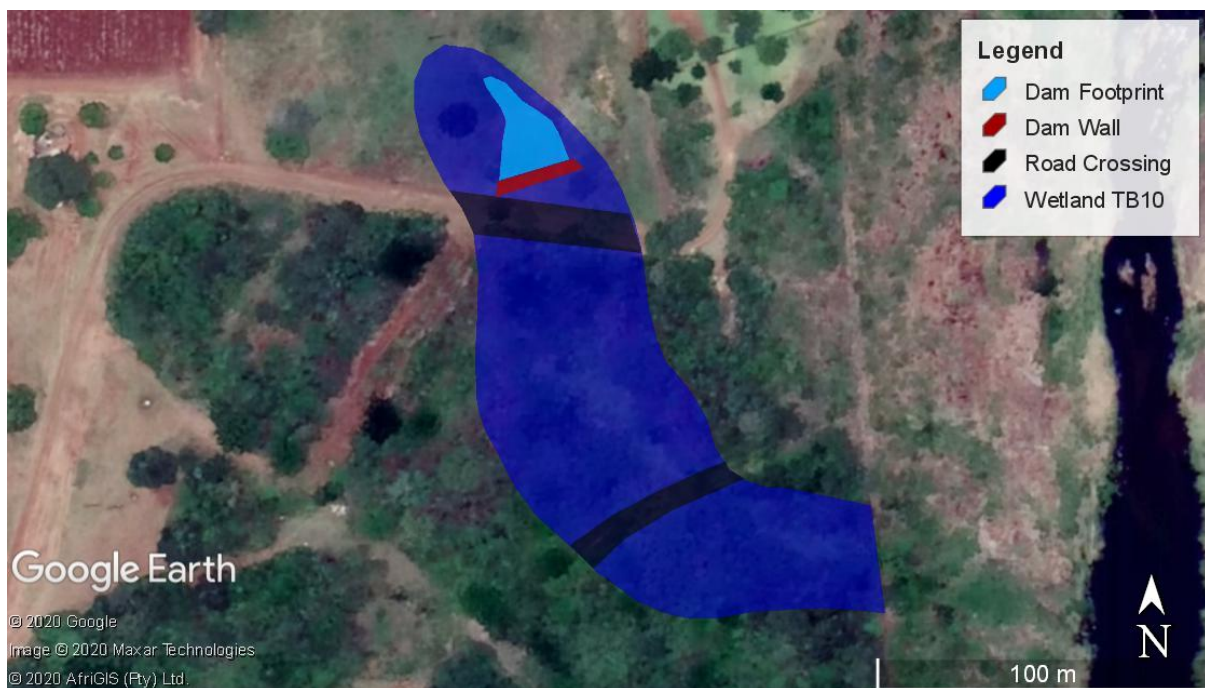
Figure 5-22: Google Earth image indicating the position of the impacts

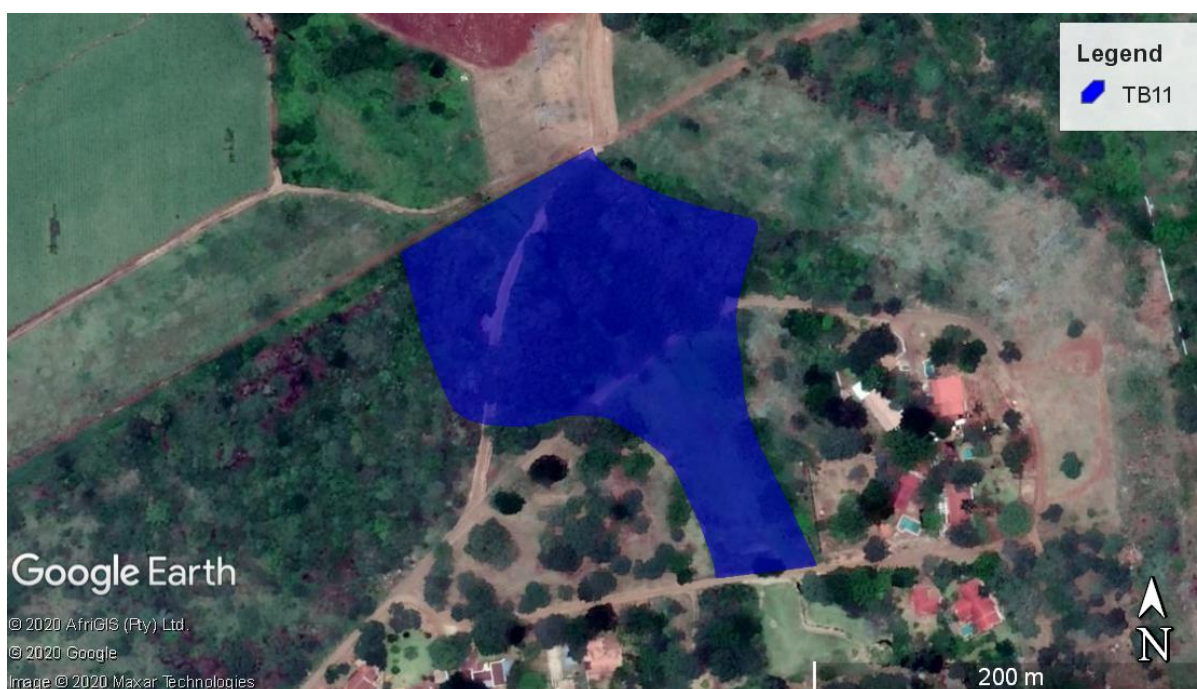
Figure 5-24: Google Earth image of wetland TB11

This site is located at 25°25'24.07 S, 31°57'29.20 E. The wetland extends upstream from the road and downstream to the third road crossing, close to the Komatipoort municipal area (Figure 5-24). This wetland reflects many characteristics of a swamp forest. A swamp forest is a wetland ecosystem characterised by mineral soils with poor drainage, and tree-dominated vegetation (Figure 5-25).

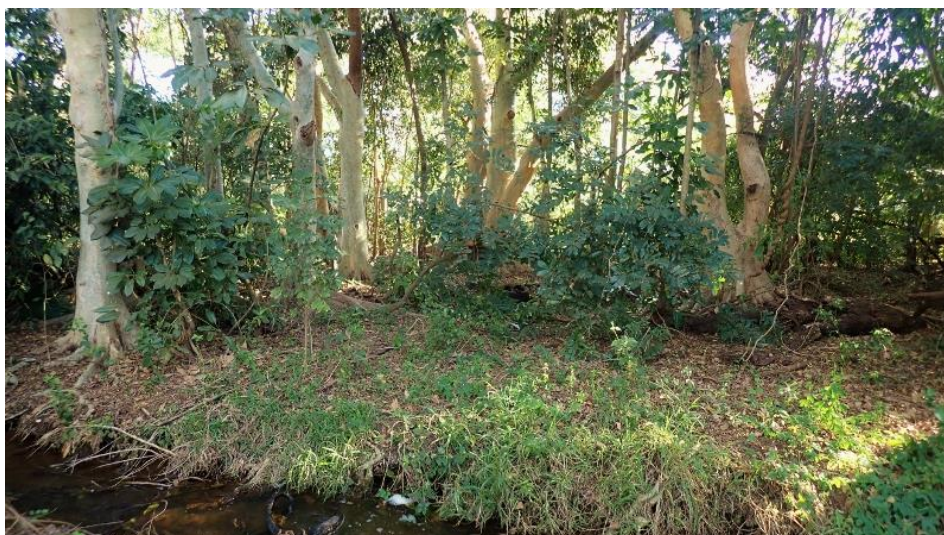
Figure 5-25: Visuals of the typical wetland habitat found in a swamp forest

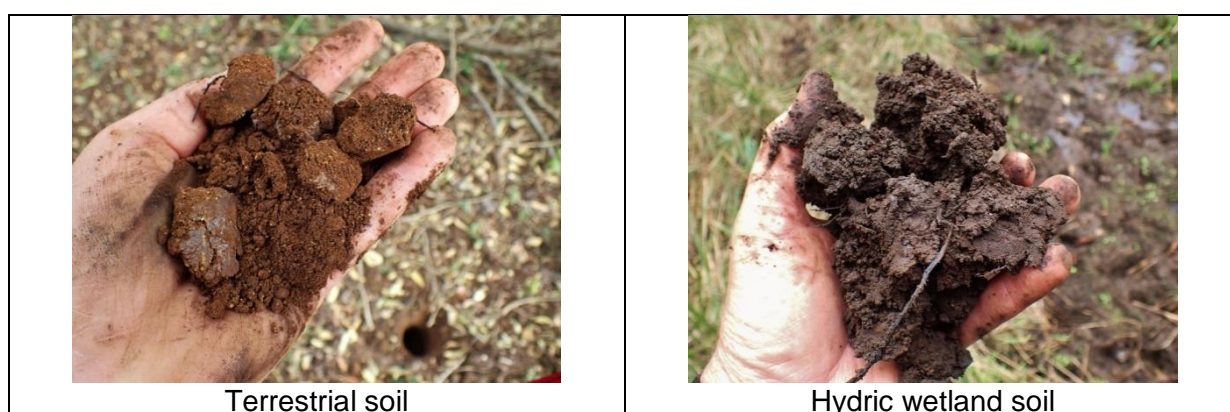
Baseline soil information was used to confirm wetland and terrestrial properties within the wetland. The soils in the wetland showed signs of wetness within 50 cm of the surface and displayed typical hydromorphic characteristics varying between temporarily, seasonally and permanently wet profiles. The permanently wet soils varied from a dark, highly organic soil to that of a grey colour. In some areas gleyed soils occurred as a result of prolonged saturation with water; the grey colour is due to the absence of iron compounds. Seasonally wet soils display mottling due to localisation of iron oxides. The soils outside the wetland area are typical terrestrial soils with a uniform red colour, indicating good aeration (Figure 5-26).

Figure 5-26: Photos indicating the different hydric features of the soil found in the wetland

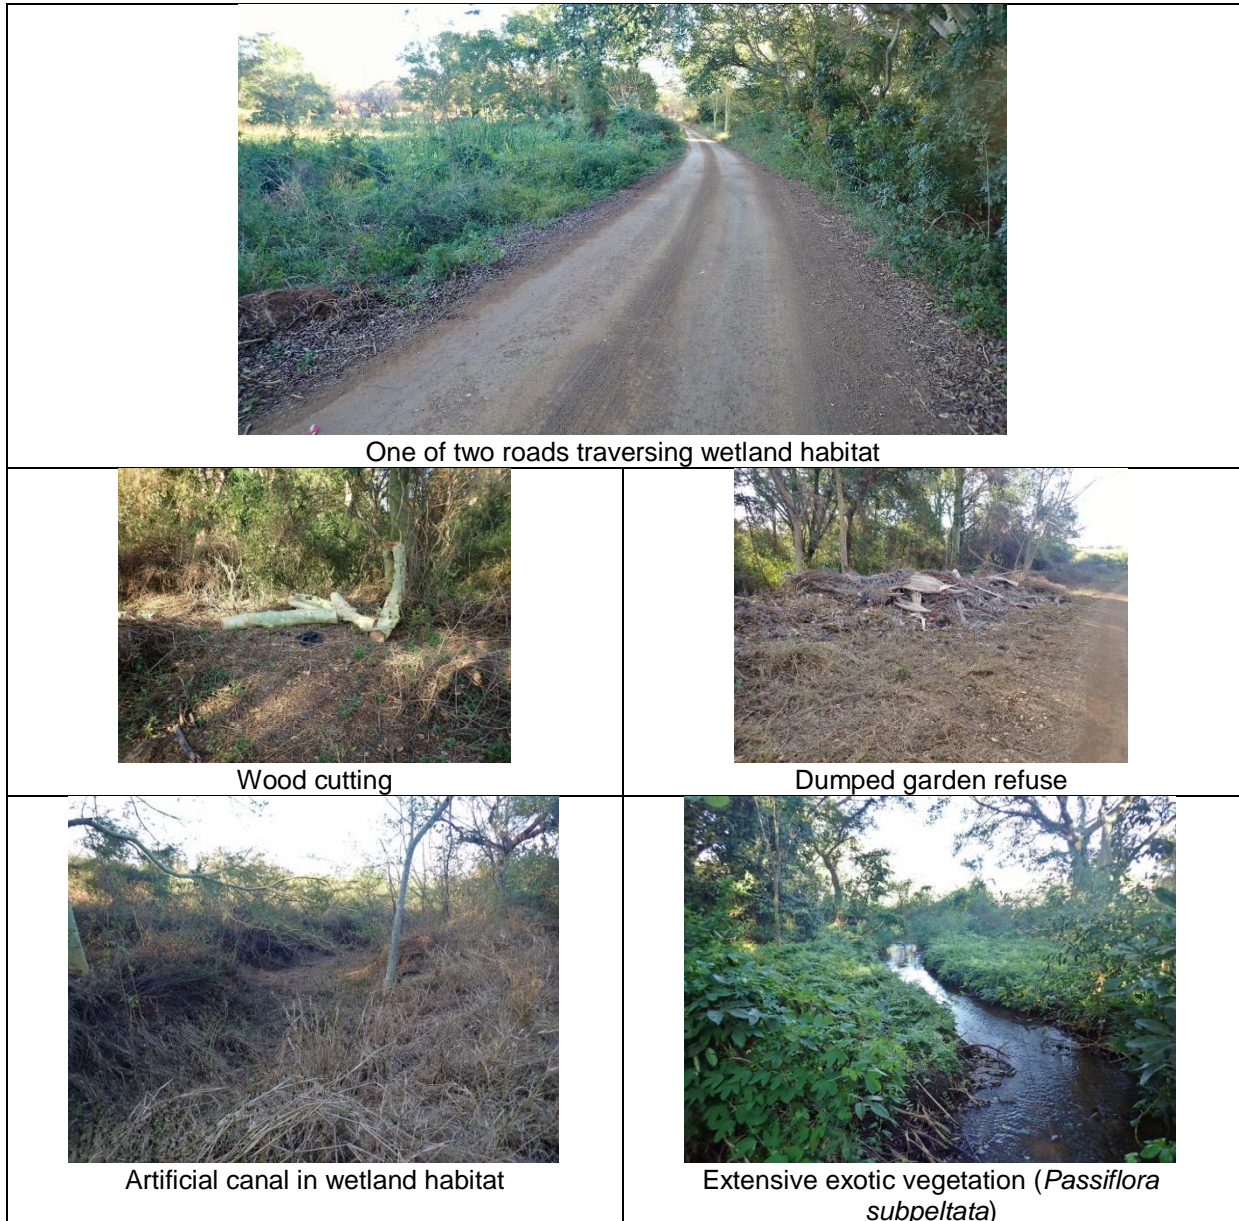
To determine the integrity of the wetland, and the condition of the site, the direct and indirect disturbances, etc. were taken into account. The primary disturbance in the catchment is sugarcane crops comprising 93% of the surface area. The wetland has been altered by road crossings (11%) and an artificial canal (0.1%). The untransformed area (88.9%) is dominated by trees and shrubs, with scattered clumps of grass and sedges. The wetland has good forest cover with little sign of erosion.

Figure 5-27: Activities in wetland areas that can be detrimental to wetland integrity

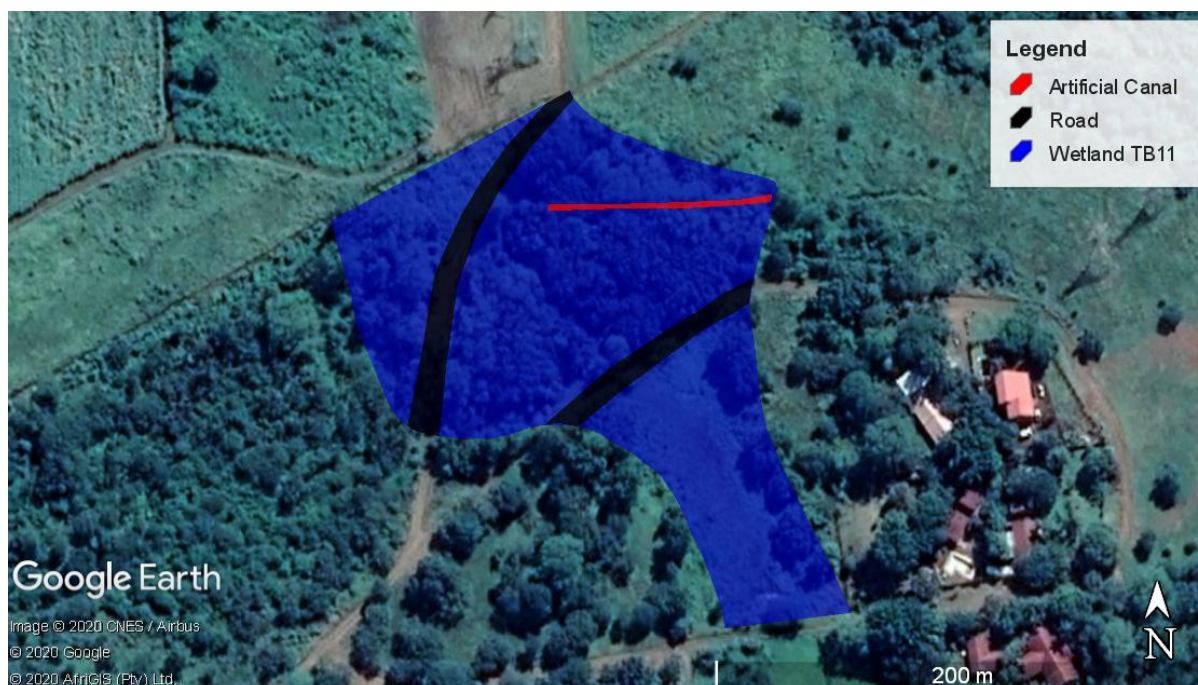
Figure 5-28: Google Earth map indicating the location of impacts

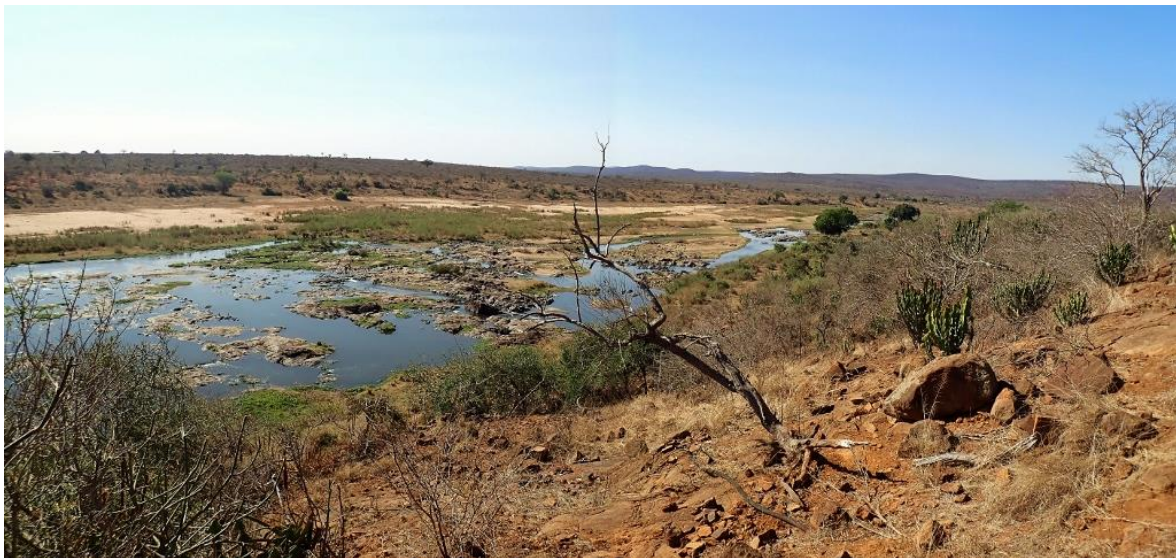
Figure 5-30: Panoramic view of the riparian area TB12

The Crocodile River site is located at 25°23'59.36" S, 31°58'31.48" E. A panoramic view of the study area can be seen in Figure 5-30. Figure 5-31 is a Google aerial photo indicating the extent of this riparian zone.

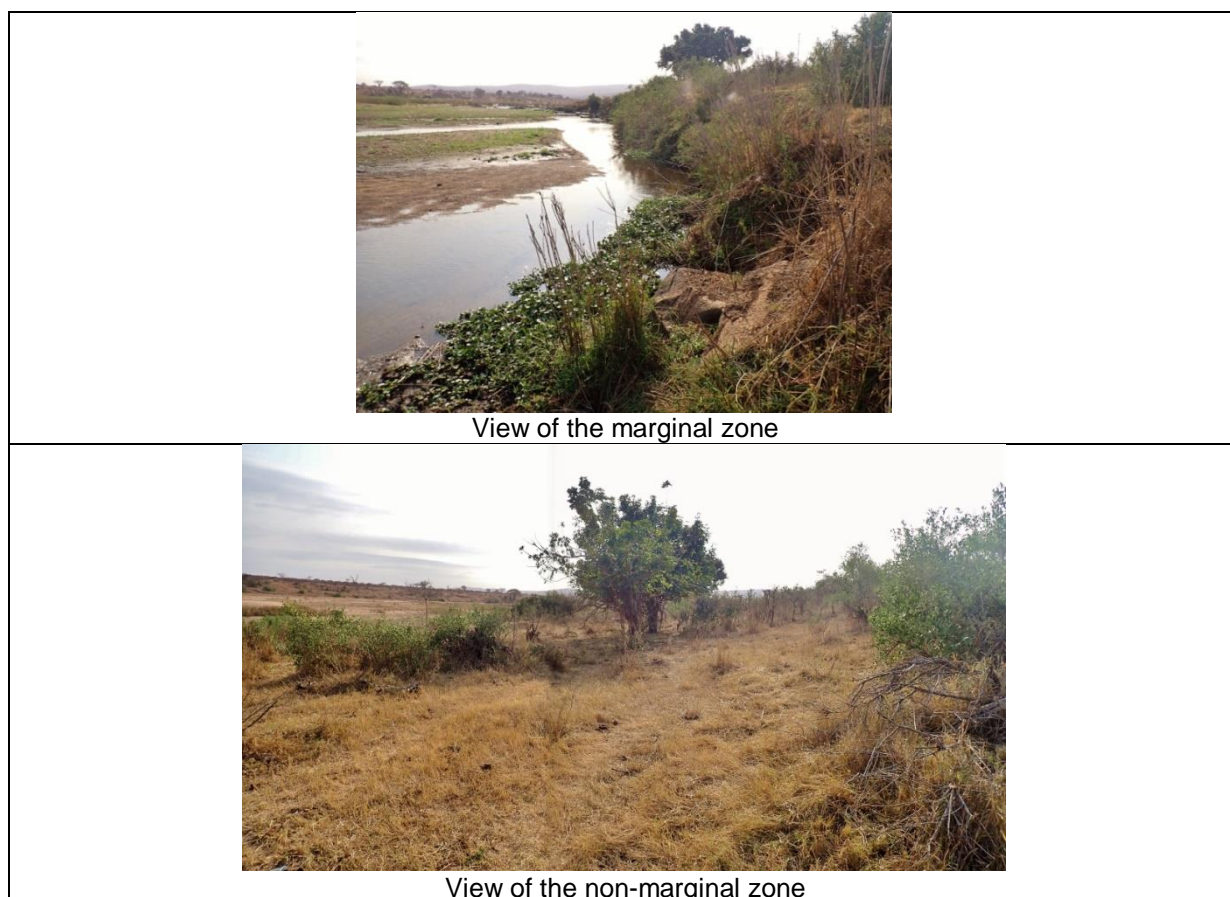
Figure 5-32: Photos of selected VEGRAI site

The dominant vegetation consists of grass and scattered shrub species. Grazing and trampling have resulted in bare soil surface areas and trees being stunted due to continuous grazing and browsing. It appears that the woody species are trying to recover after past flood events. The substrate consists mainly of alluvial material and rocky dykes crossing the riverine area. The following woody species are dominant: *Euclea natalensis*, *Combretum imberbe*, *Dichrostachys cinerea*, *Gymnosporia senegalensis*, *Ziziphus mucronata*, *Acacia nigrescens*, *Philenoptera violacea*, *Phyllanthus reticulatus*, *Peltophorum africanum*, *Pluchea dioscoridis*, etc. Grass species, such as *Sporobolus africanus*, *Cynodon dactylon*, *Setaria sphacelata*, *Panicum deustum* and *Panicum maximum*, occur. *Cyperus sexangularis* and *Schoenoplectus* spp. are the dominant sedges. Some exotic vegetation, such as *Senna didymobotrya*, *Conyza bonariensis*, *Melia azedarach*, *Solanum mauritanum*, *Lantana camara*, *Parthenium hysterophorus*, *Sesbania punicea*, etc. were also found.

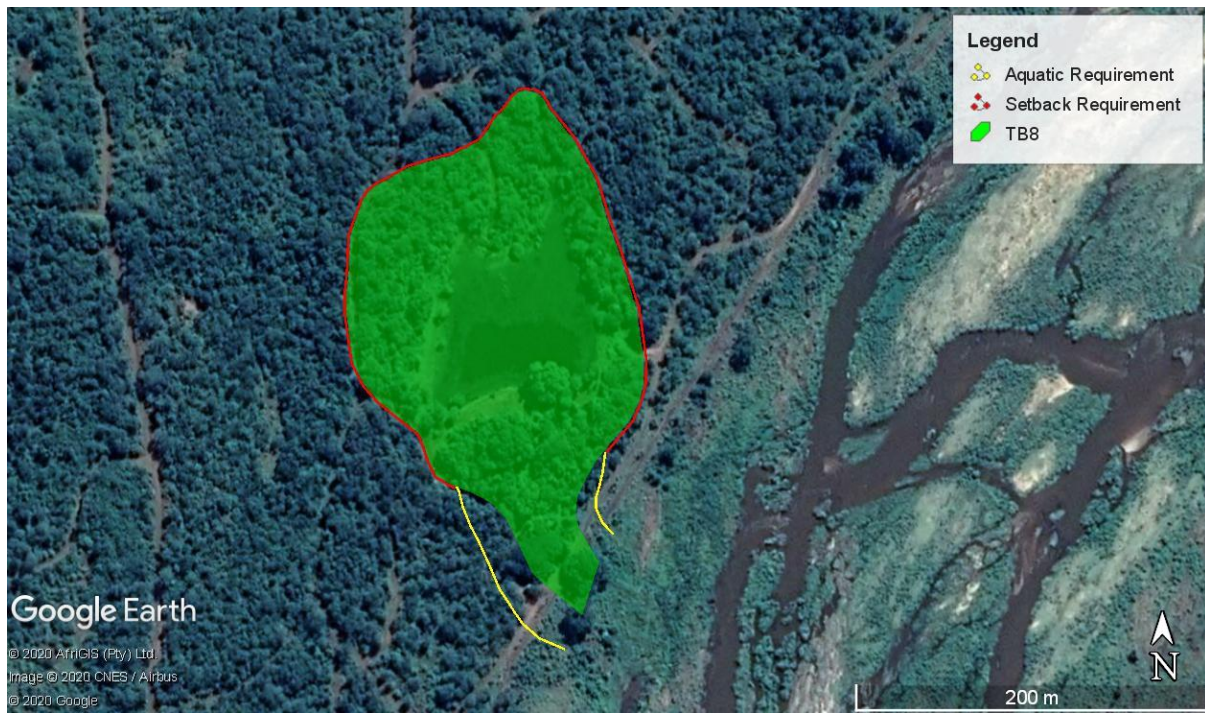
Figure 5-35: Delineation of the TB08 aquatic requirement, and the setback requirement as the buffer edge

- TB01-07 (Ephemeral): 15 m
- TB08 (Riparian): 35 m
- TB09 (Wetland): 20 m
- TB10 (Wetland): 20 m
- TB11 (Wetland): 20 m
- TB12 (Riparian): 60 m

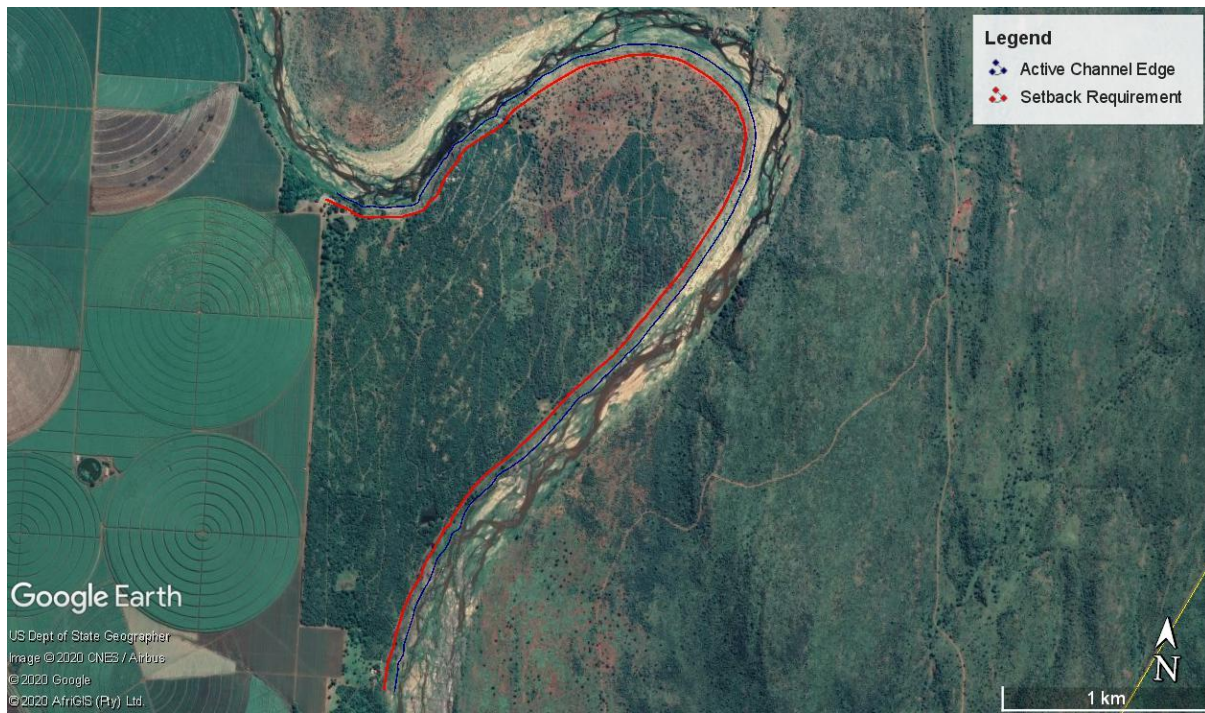
Figure 5-37: Delineation of the TB12-Riparian site's riparian zone and the aquatic requirement as the buffer edge
