JULY 2020
FINAL BASIC ASSESSMENT REPORT
CONSTRUCTION OF THE D59 BRIDGE
KZN DEPARTMENT OF TRANSPORT
EIA REF NO: DC22/0005/2020

EVP1243

KZN DOT

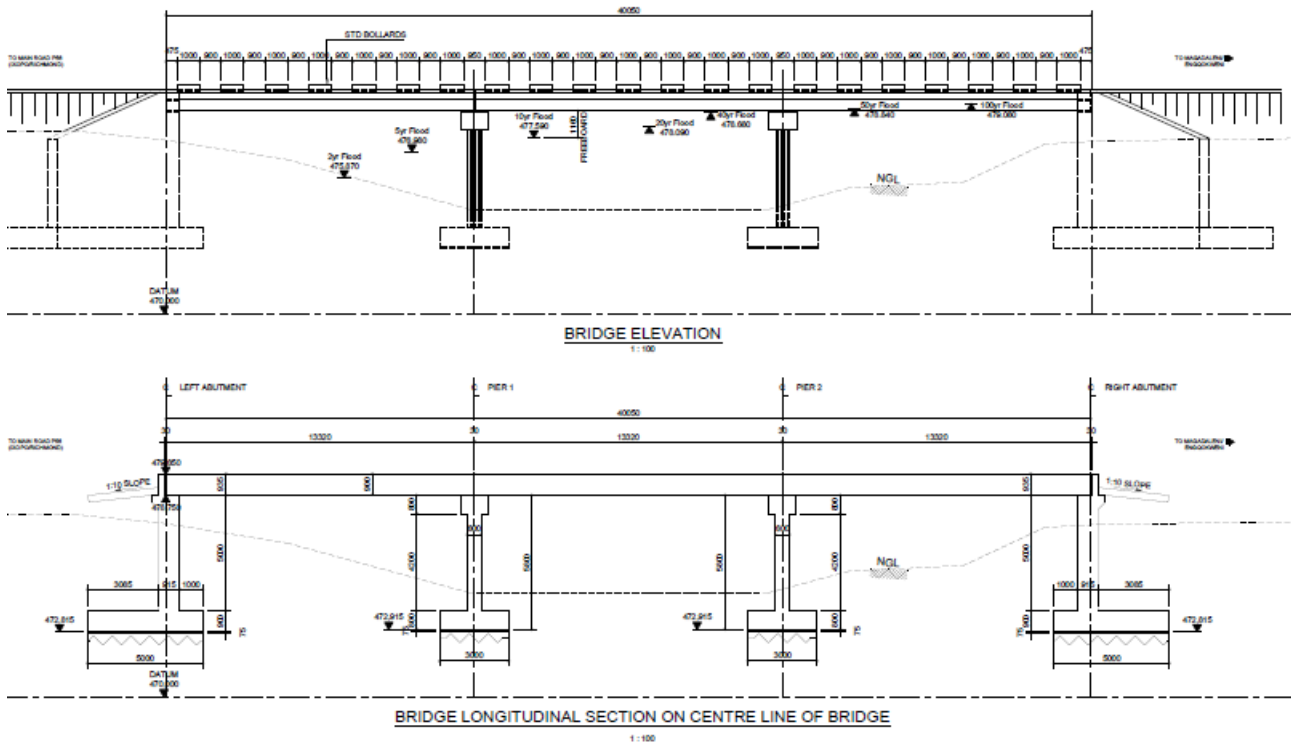
Figure 1: The D59 Bridge Longitudinal Cross Section

The figures below illustrate the proposed design of the D59 Bridge (provided in Appendix A).

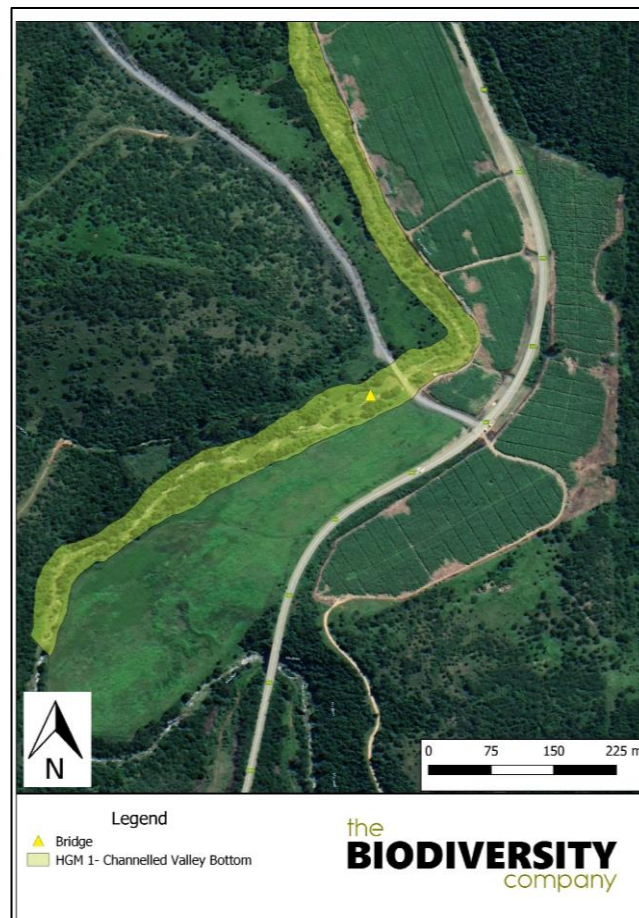
Figure 5: The delineated wetland areas (The Biodiversity Company Water Resources Assessment, 2019. Appendix B).

The status of the wetland was determined to be largely natural (present ecological state Class B) and unlikely to deteriorate. The wetland areas were marginally impacted upon by agricultural practices in the area. The average ecosystem services have been determined to be “Intermediate” with the ecological importance and sensitivity being Moderate (C). A buffer zone of 15m has been calculated for the delineated wetland and the proposed activities. The Channelled Valley Bottom wetland delineated on site has been presented below.

The PES of the wetland was determined to be largely natural (Class B). This indicated that the wetland area had suffered minor changes change in ecosystem processes and the loss of natural habitats is reversible and the natural habitat remains predominantly intact. This modification can be attributed chiefly to agricultural

practices within the local catchment. The vegetation of the wetland area was monospecific stands of *Typha capensis* and *Phragmites australis*. The current causeway allows water to flow through and over the low-level causeway; this may temporarily alter the wetland hydrology in peak flows; however, this can be likened to a natural hydrological pattern in the wet seasons (The Biodiversity Company Water Resources Assessment, 2019).

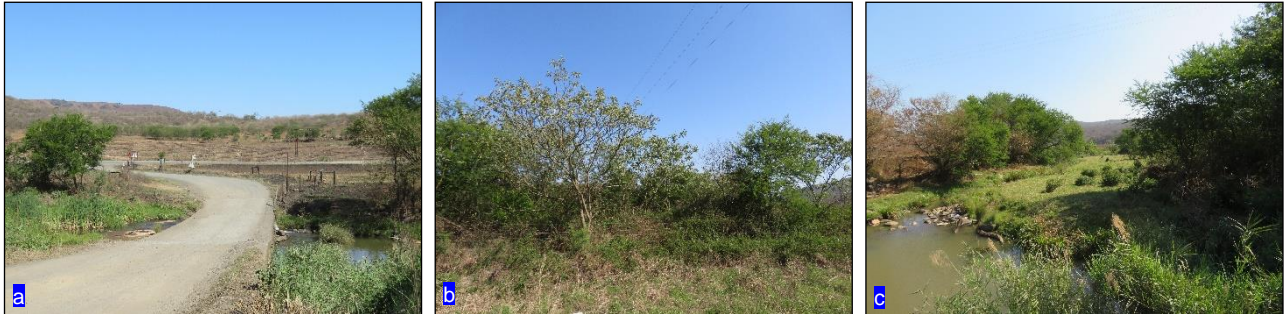
Figure 5: (a): The current crossing, facing east. (b): The vegetation on the western bank of the river. A mix of indigenous and alien species. (c): A view of the proposed bridge site from the existing crossing structure, facing south.

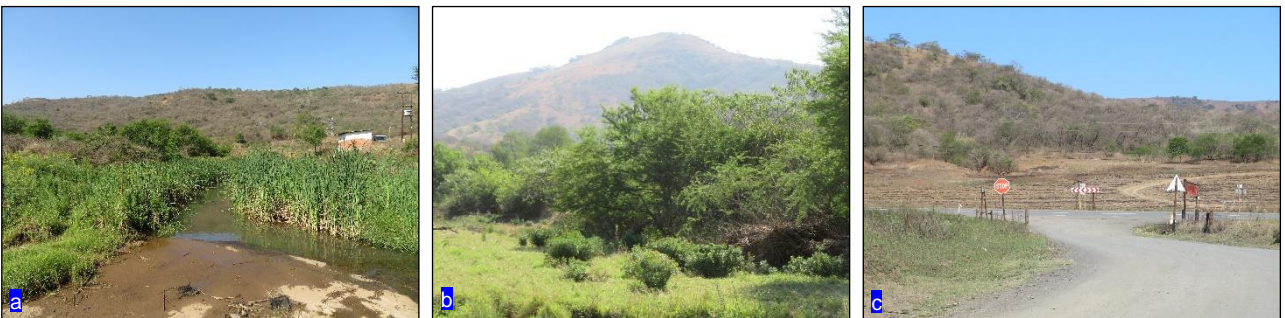
Figure 6: (a): The wetland upstream of the existing crossing structure. Sediment has built up within the wetland against the current structure. (b): The riparian area on the northern bank of the proposed crossing site. (c): The existing intersection where the D59 Road joins the R56 Main Road on a corner (See Figure 3 and 4).

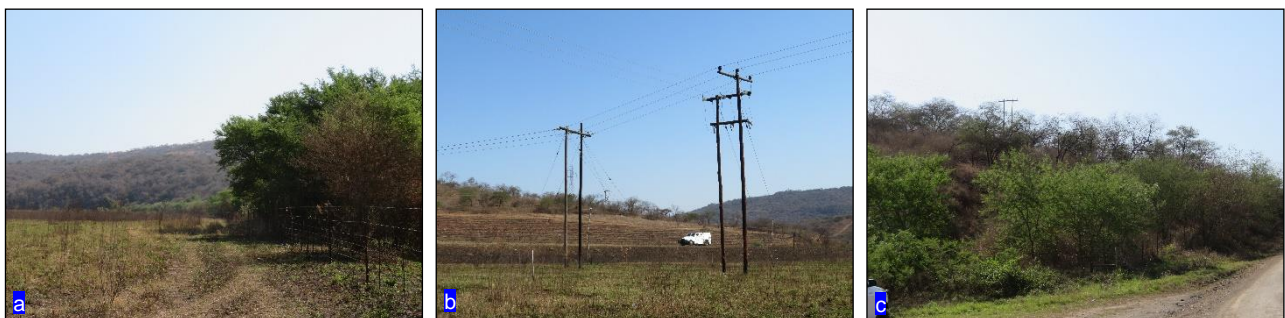
Figure 7: (a): The southern access road portion of land was not planted with sugar cane in 2019, the year of the assessment. This area has been left bare. (b): Powerlines that may require relocation adjacent to the R56 Road. (c): The section of vegetation that will be cleared for the northern access road re-alignment.
