Assessment of the impact of sand mining on agricultural potential on Portion 2 of RE of Farm number 199, near Clanwilliam

1 Introduction and brief

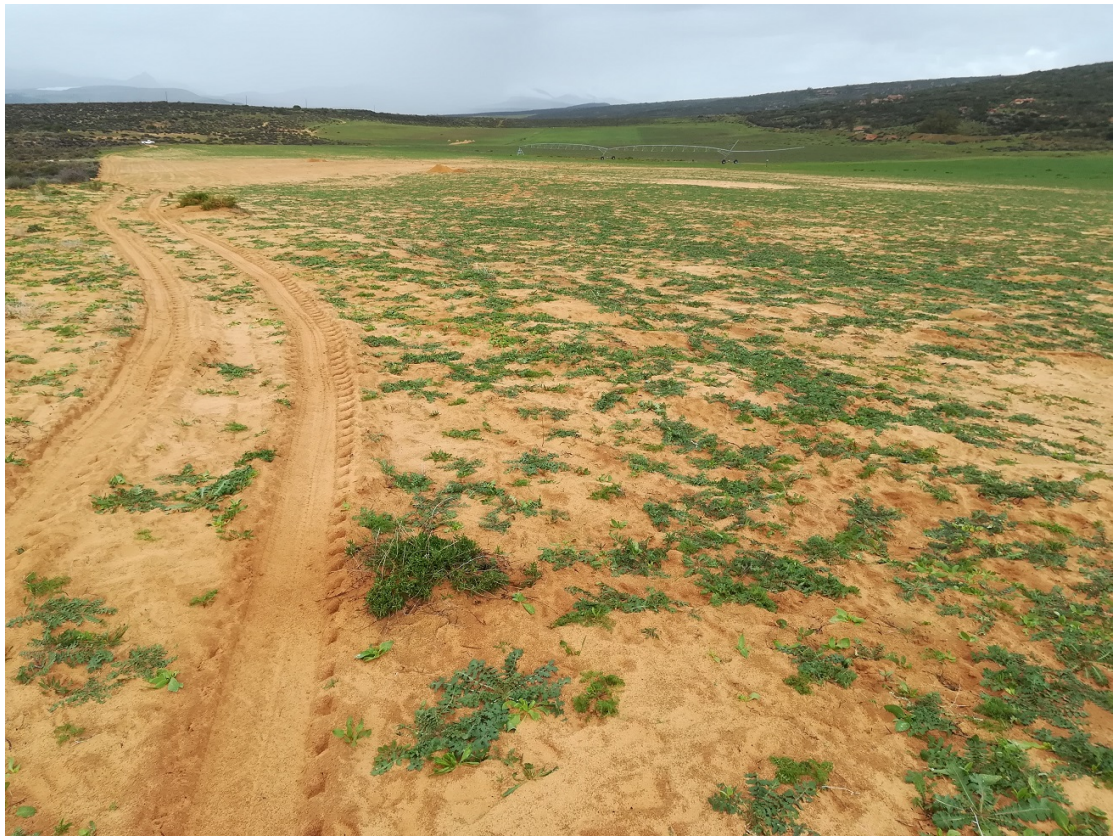
Figure 3. View of typical site conditions, looking in a south easterly direction down the mining area, with one centre pivot in the background.

Photographs of soils and site conditions are shown in Figures 3 and 4.

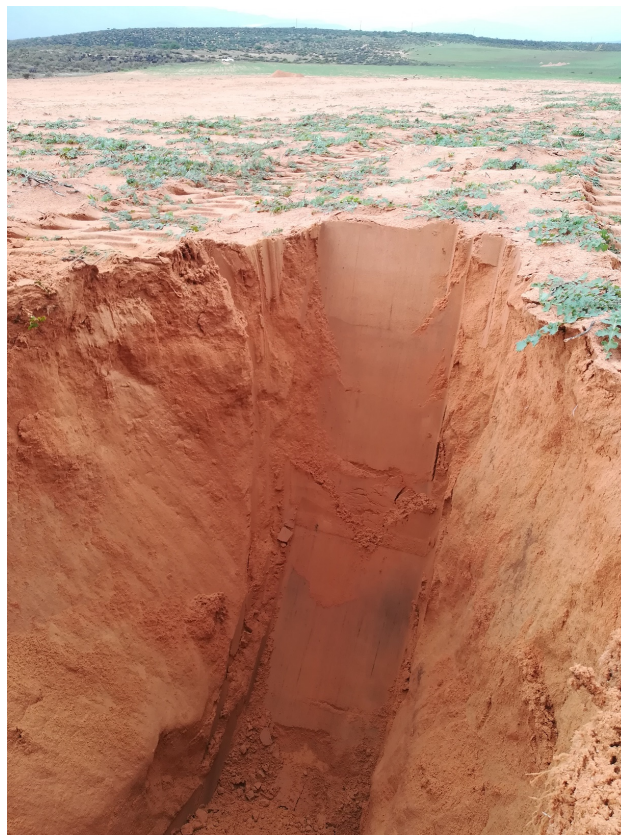
Figure 4. Test pit showing the Clovelly 1100 soil that occurs across the site.

The underlying geology of the area is quartzitic sandstone with minor grit, conglomerate and shale lenses of the Piekenierskloof Formation; Table Mountain Group, covered by aeolian sand. The soils are very deep, well-drained, orange-yellow coloured, very sandy soils. They are of the Clovelly 1100 soil family, as classified by the South African soil classification system. Soils are identical in all three of the investigated test pits and are
