DRAFT BASIC ASSESSMENT REPORT AND ENVIRONMENTAL MANAGEMENT PROGRAMME REPORT FOR

DEVELOPMENT OF A FUEL DEPOT ON A PORTION OF PORTION 1 OF THE FARM LEEUSPRUIT 385 JU, UNDER NKOMAZI LOCAL MUNICIPALITY IN MPUMALANGA PROVINCE

REF No:1/3/1/16/1E-470

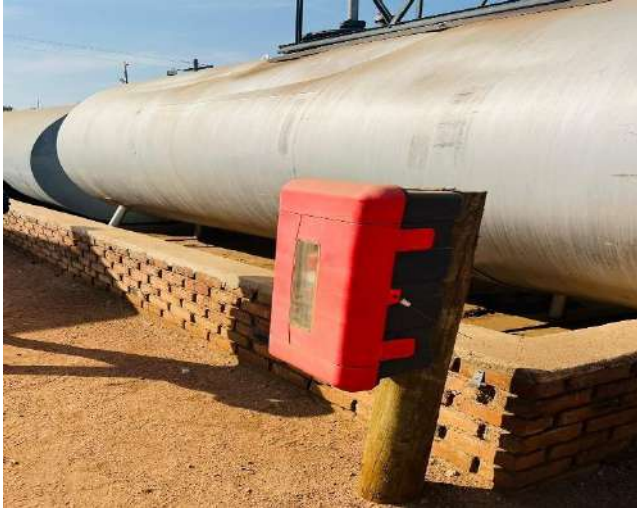
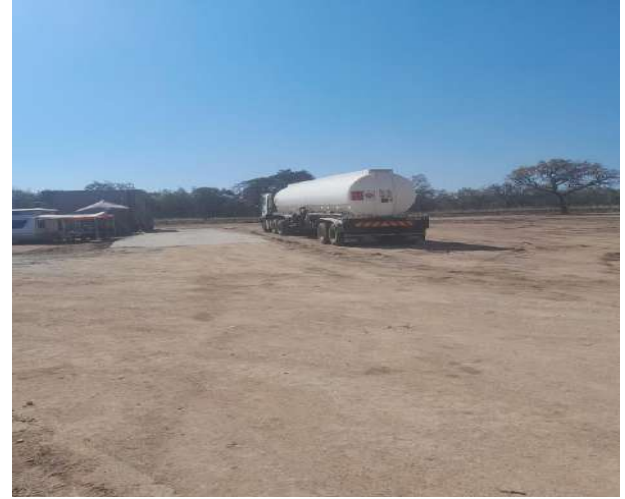
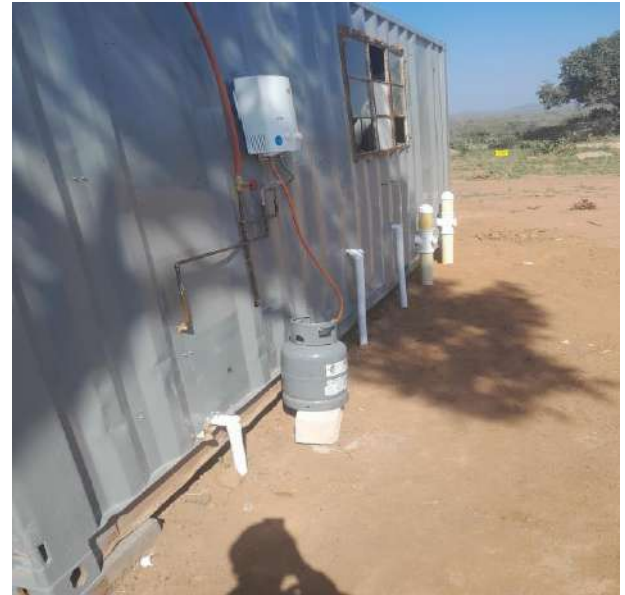
Figure 2: Proposed Layout (Singo Consulting (Pty) Ltd, 2023)

The land use scheme is zoned as agricultural in terms of Nkomazi Spatial Planning and Land Use Management By-Law, 2015. However, rezoning application of land use scheme has been lodged to the Nkomazi Local Municipality and waiting for the outcome of this EA application. The proposed development will occupy 1.052 of the 5.2 Hectares of the application area and will comprise the following infrastructures in Figure 2.

Aboveground Storage Tanks Area (500 m3)

Generator Area

Loading and offloading area

Pumps

Parking Area

Ablution Facility with Septic Tank

Singo Consulting (Pty) Ltd, the independent consulting firm, has been appointed by Ithuba Petroleum (Pty) Ltd, the Wholesale Licence Holder, to conduct socio-economic and environmental impacts assessment, compile Basic Assessment Report (BAR), develop Environmental Management Programme Report (EMPr) and apply Water Use Authorization for the proposed fuel depot for diesel on a portion of portion 1 of the farm Leeuspruit 385 JU under Nkomazi Local Municipality of the Ehlanzeni District Municipality in Mpumalanga Province (Figure 1). Ithuba Petroleum (Pty) Ltd has a wholesale licence (W/2016/0141) issued by the Department of Mineral Resources and Energy (Previously known as Department of Energy). The developmental footprint of the proposed development covers only 1.052 hectares of 5.2 hectares. The proposed infrastructures are as follows: Aboveground storage tanks (500m³) for storing 50ppm diesel, Loading and offloading area, Parking Area, Generator Area, Office Area, Ablution facility (Toilet with septic tank) (Figure 2).

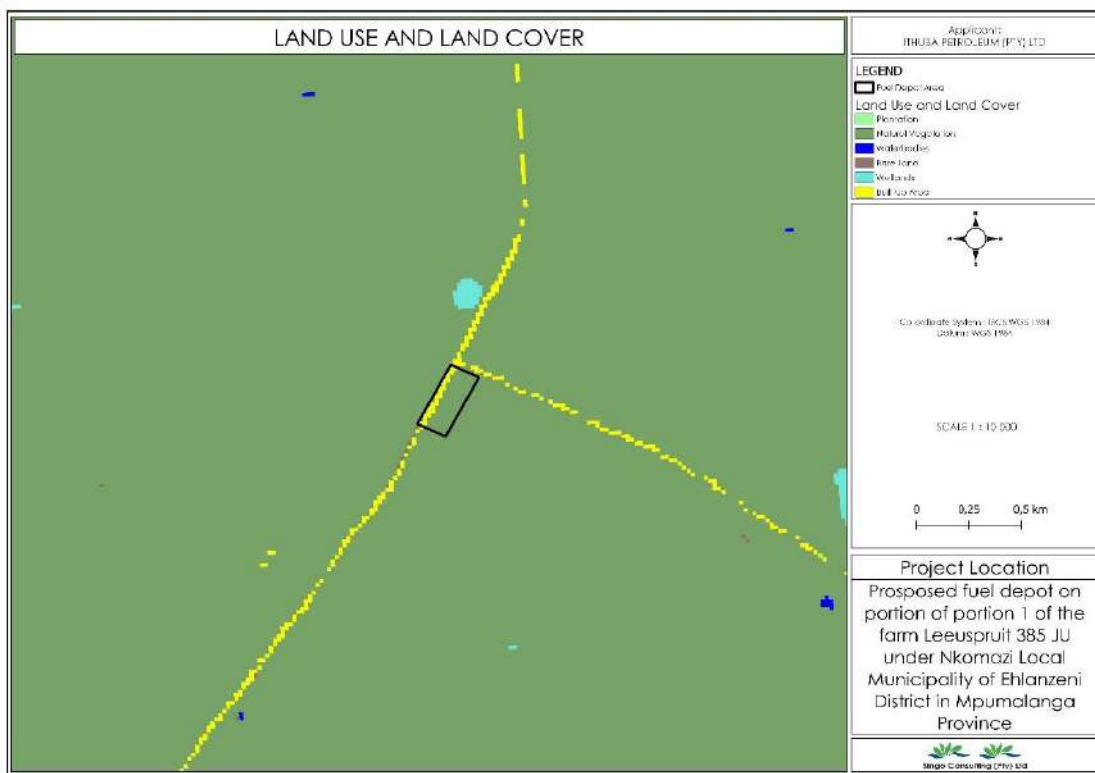
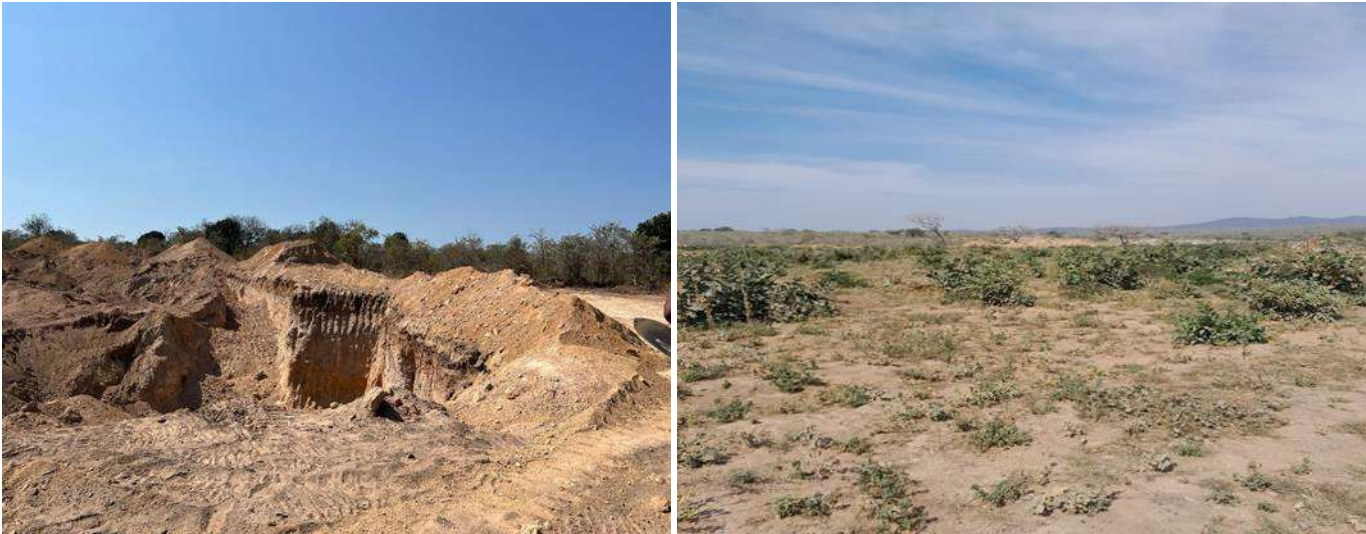
Figure 4: Land Use and Land Cover

The proposed site falls within natural vegetation and a road (built-up) according to the Department of Forestry, Fisheries, and the environment South Africa National Land Cover 2018 (Figure 4). There are no infrastructures observed within the proposed site (Developmental footprint). The proposed site is surrounded by sand mining (South) and lodges (South, East, West and North sides).

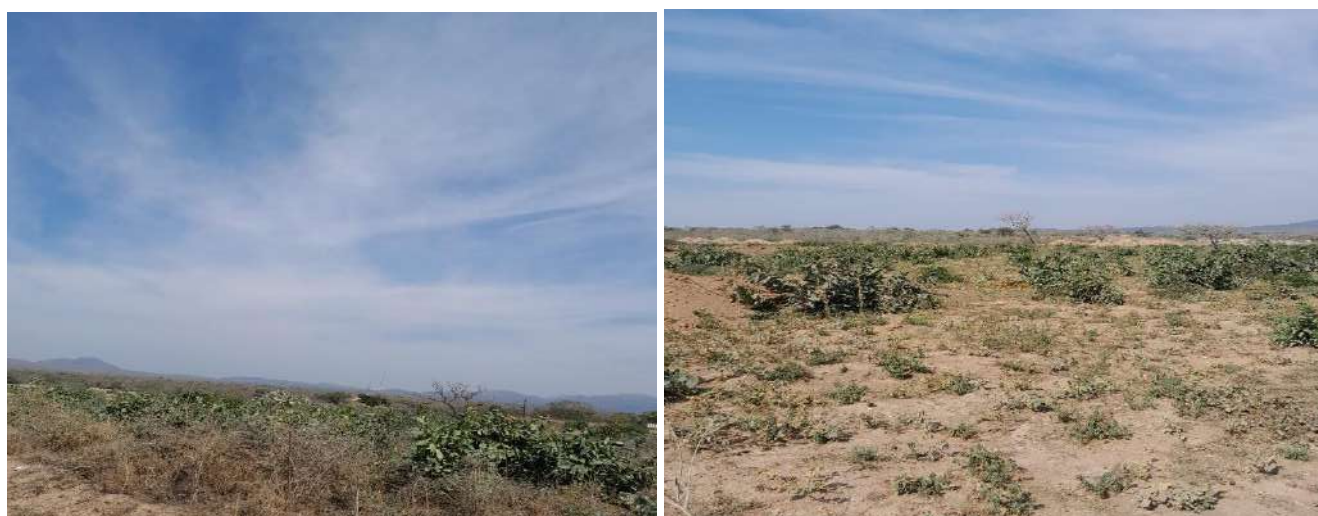
Figure 20: Site Pictures

There are three airports/aerodrome found around the proposed site (Figure 19). Malelane airport and Riverside airport (Malelane aerodrome) are located between 8km and 15km from the proposed site. Komati poort airport is located at approximately 29km North East of the proposed site. There is no evidence of airport/aerodrome within the proposed site (Figure 20)

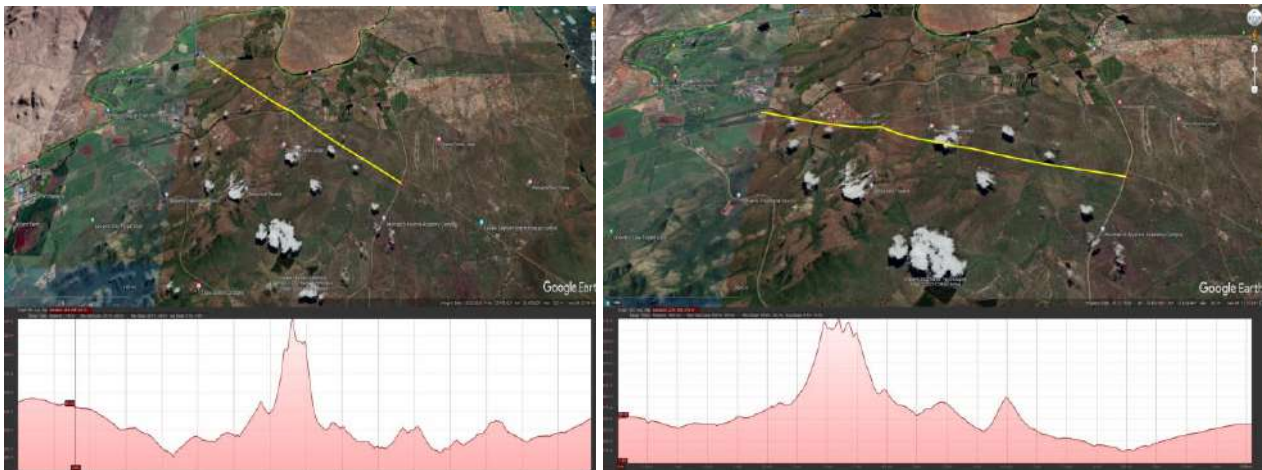
Figure 21: Elevation relative to Airports (A) Malelane Aerodrome and (B) Malelane Airport

The elevations between the proposed site and the nearby airports/aerodrome(8km-15km) were modelled using google earth pro. According to Figure 21, there are mountains (447masl) between the proposed site and airports.

The analysis has determined that the proposed development and associated infrastructure would not interfere radar, communications, or navigation infrastructure in the environs of the Malelane aerodrome nor present any material additional risk to operations at the airport within the contemplation of the 2020 Protocol. The roof and tanks will be painted with grey colour to avoid glint and glare risk and is perpendicular to the runways of both airports/aerodrome (Not along the runway direction). There is a mountain between proposed site and both airports/aerodromes. That means the airplane will pass the proposed area at elevation above 447masl and the maximum height of the proposed infrastructures is 3m. On this basis, therefore, it is recommended that the Sensitivity Classification of the proposed Development area be amended to 'low'. No Civil Aviation Compliance Statement is therefore required.

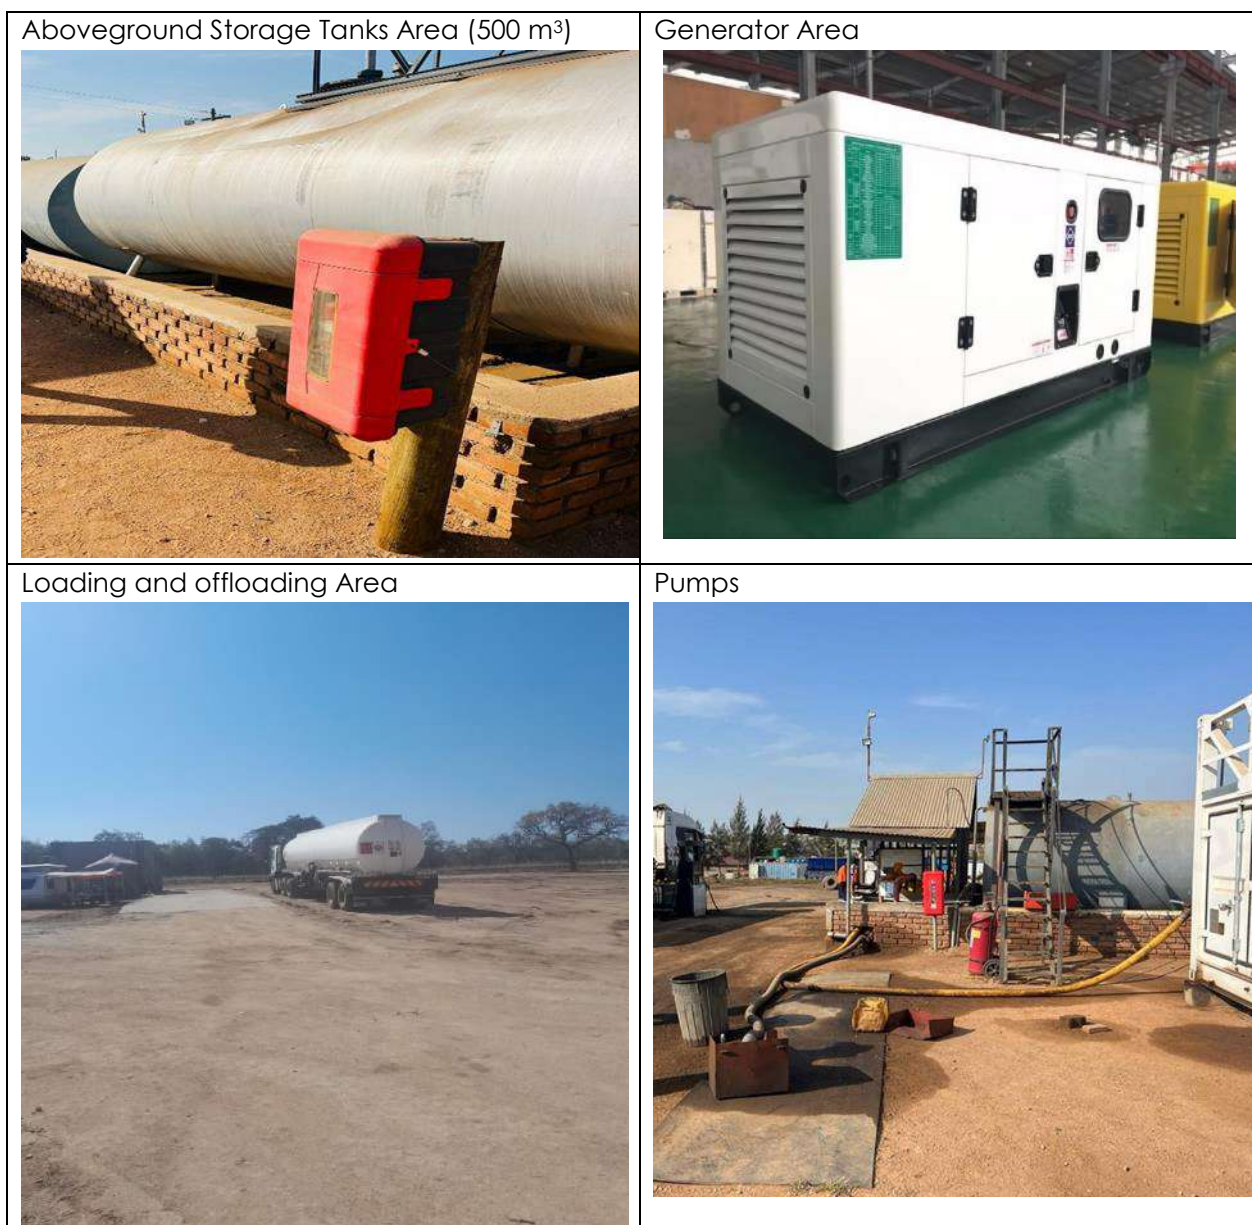
Figure 23: Proposed Layout

The proposed development will occupy 1.052 of the 5.2 Hectares of the application area and will comprise the following infrastructures on Table 6 (Typical Example) and Figure 2 (Conceptual design) below.

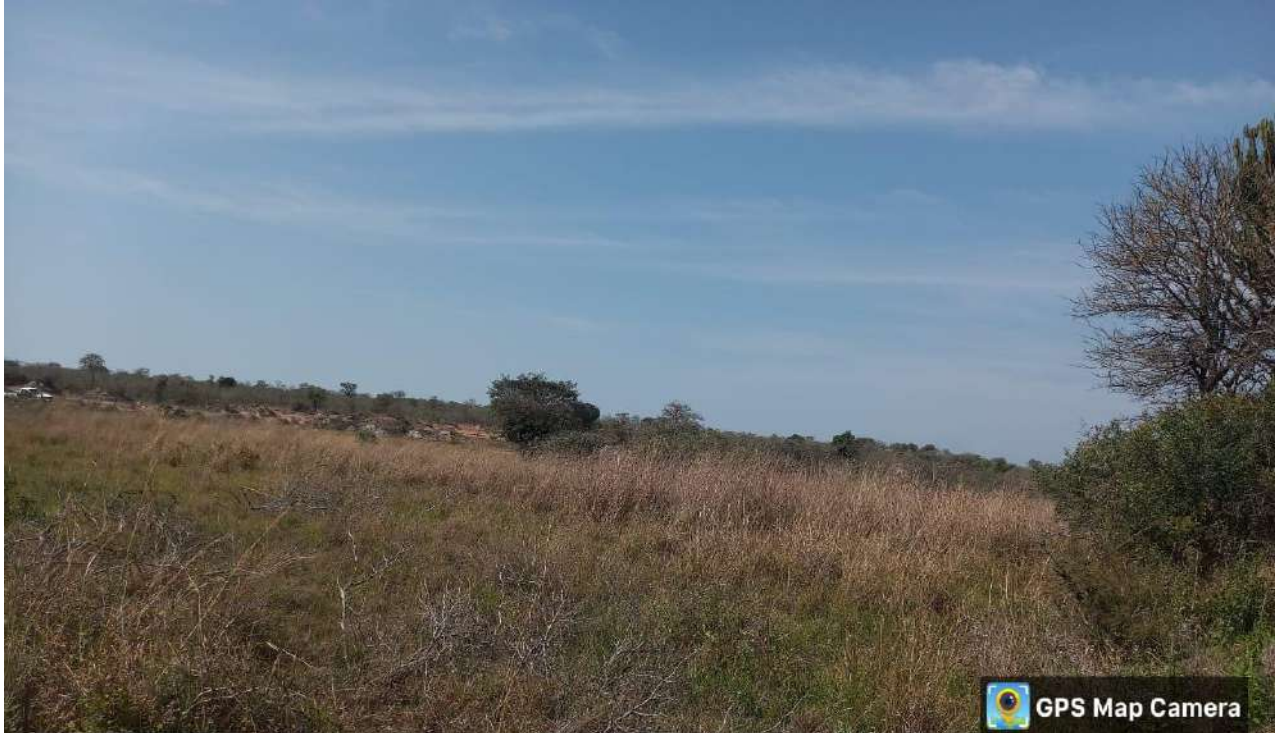
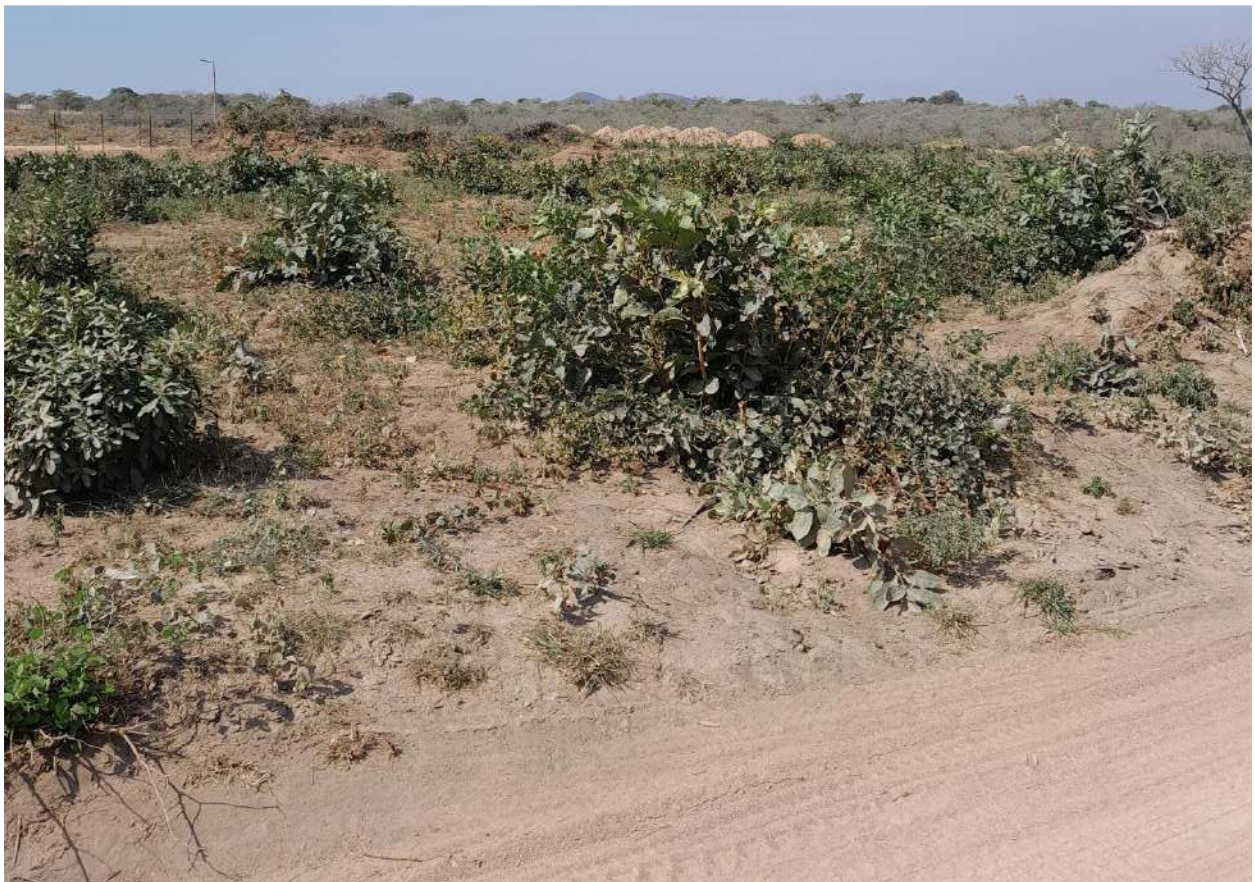
Figure 13: Surroundings of the proposed project area. (Singo Consulting (Pty) Ltd, 2023)

During ground truthing, it was observed that the project area consists of natural vegetation and some wetland in close proximity of the project area (**Figure 13**). The natural areas characterised by natural vegetation should be avoided to avoid unnecessary disturbance of sensitive areas. The area consists of natural vegetation and support ecological function of the proposed area. The only area that is modified is due to the sand mining next to the project area that is been conducted by the adjacent landowner. The heavily modified areas are disturbed to an extent that they cannot be reinstated to their natural state (see **Figure 14**).

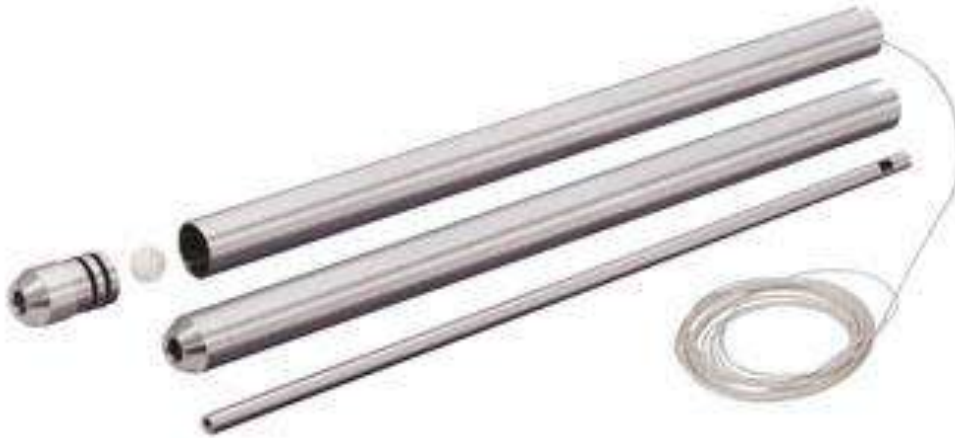
Figure 2: Stainless steel bailer, picture extracted from (*Solist, n.d.*). A bailer uses a simple ball check valve to seal a sample of the groundwater table at the bottom to raise it up

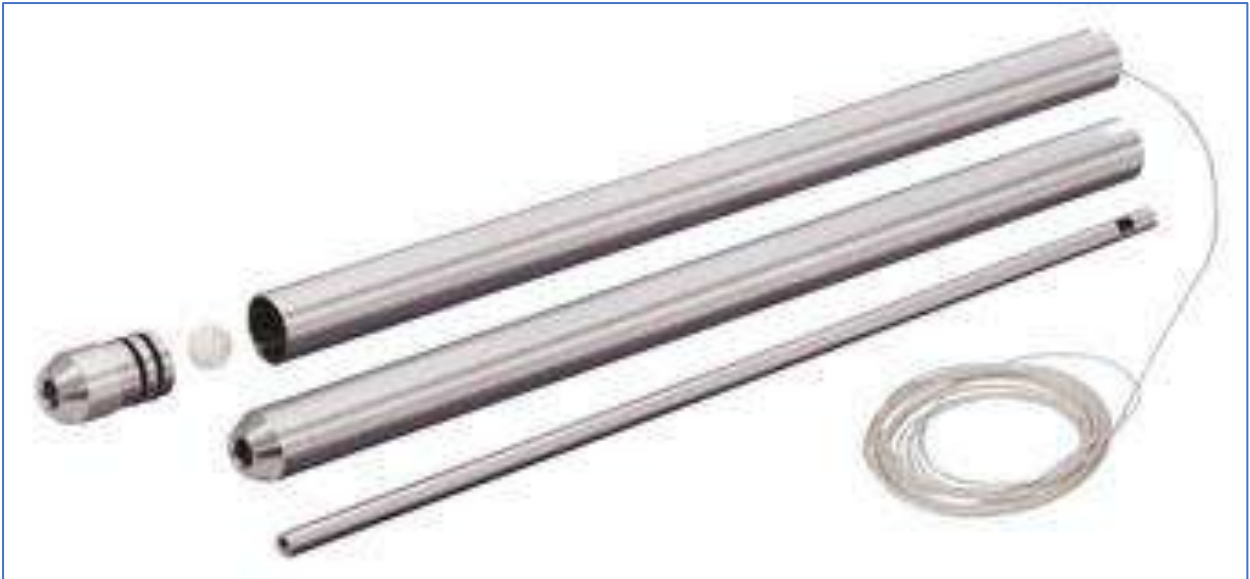
Figure 12: Stainless steel bailer, picture extracted from (Solist, n.d.).

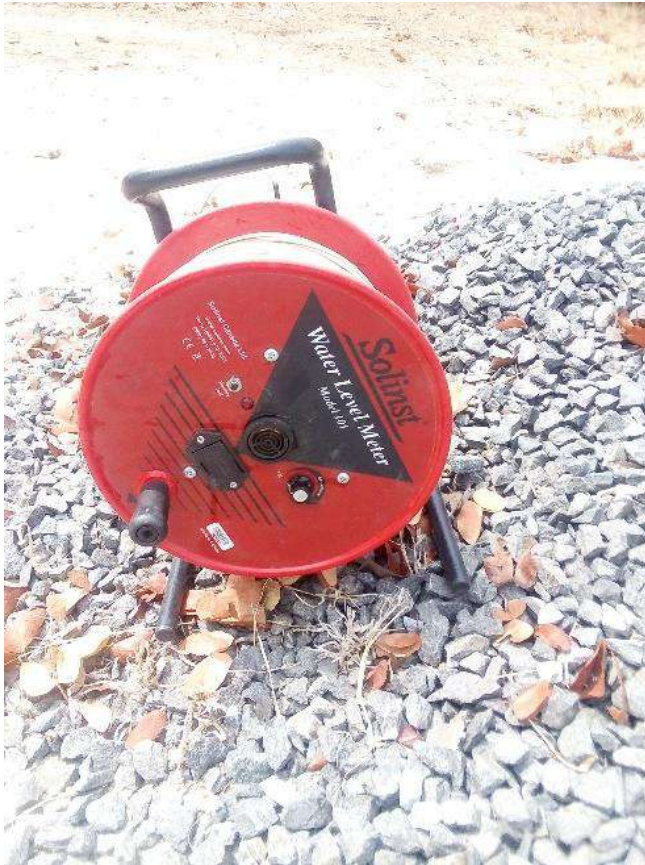
Figure 13: Water level Meter

When sampling groundwater, it is critical to measure the depth of the water. Water levels can aid in determining the level of the water table. To obtain an accurate measurement of the water level, it is necessary to use an effect water level meter every time before sampling or purging the borehole. The equipment listed below is useful in open-hole boreholes that are not surrounded by pumping equipment.

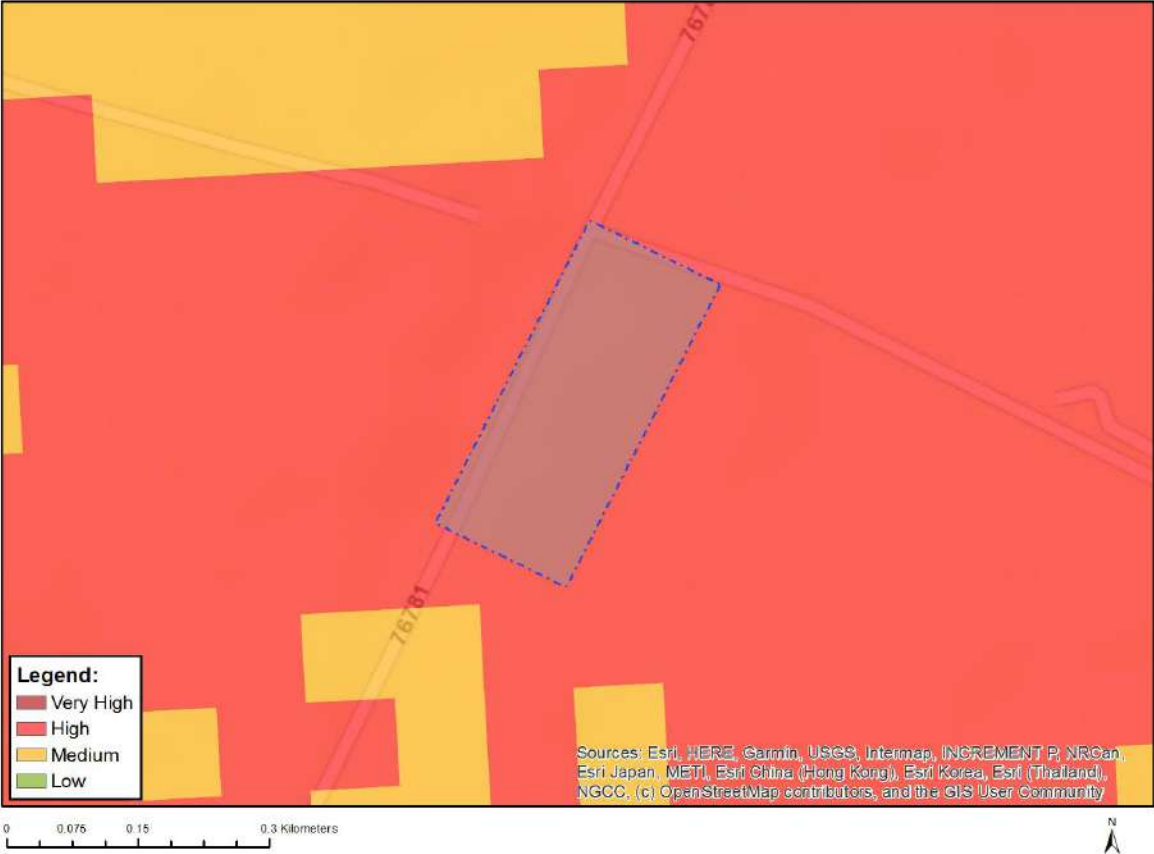
MAP OF RELATIVE AGRICULTURE THEME SENSITIVITY

Sensitivity	Feature(s)
High	Land capability;09. Moderate-High/10. Moderate-High

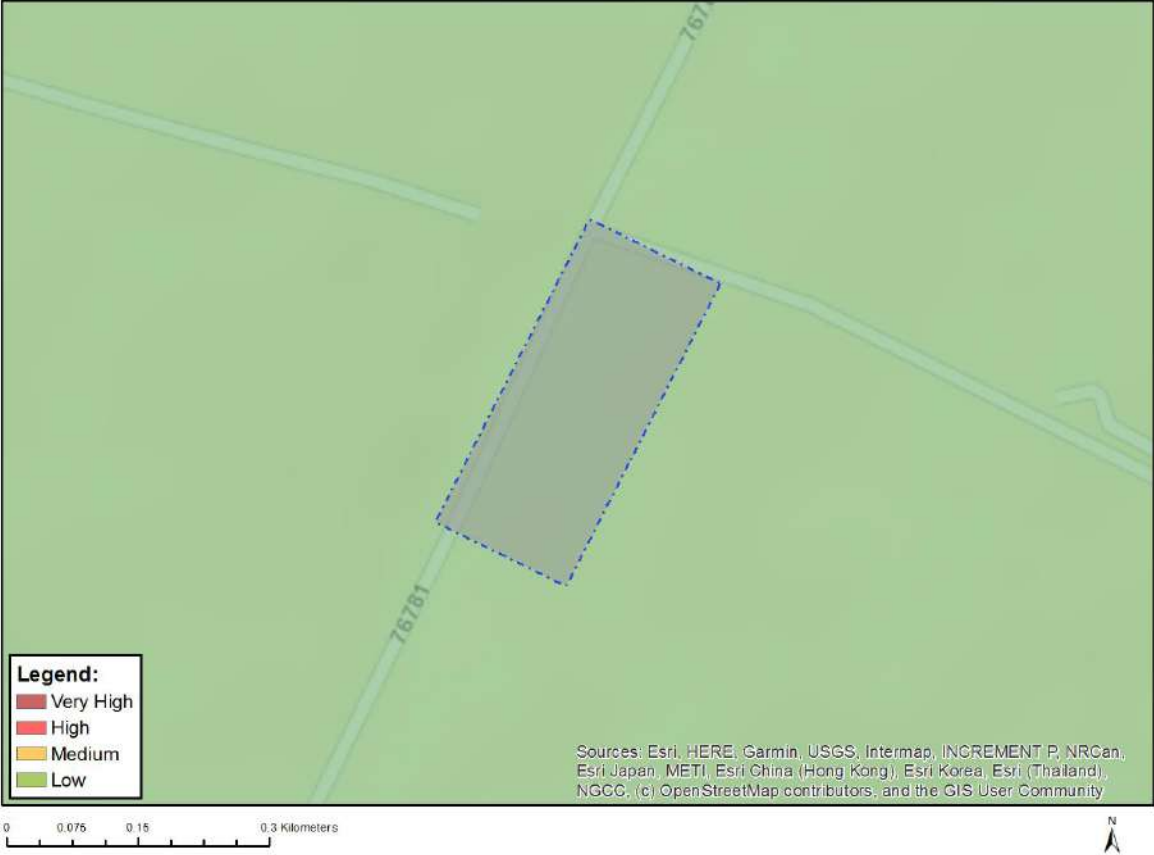
MAP OF RELATIVE ARCHAEOLOGICAL AND CULTURAL HERITAGE THEME SENSITIVITY

Sensitivity	Feature(s)
Low	Low sensitivity

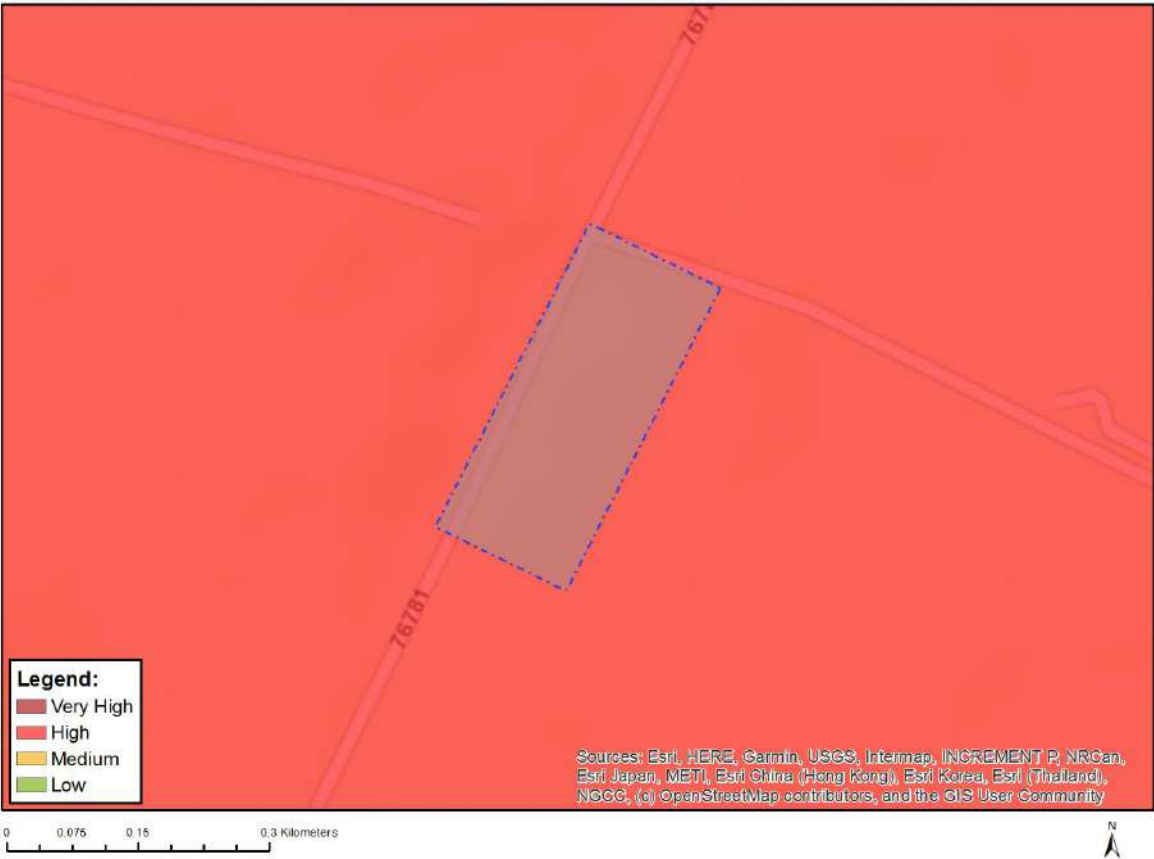
MAP OF RELATIVE CIVIL AVIATION THEME SENSITIVITY

Sensitivity	Feature(s)
High	Within 8 km of other civil aviation aerodrome

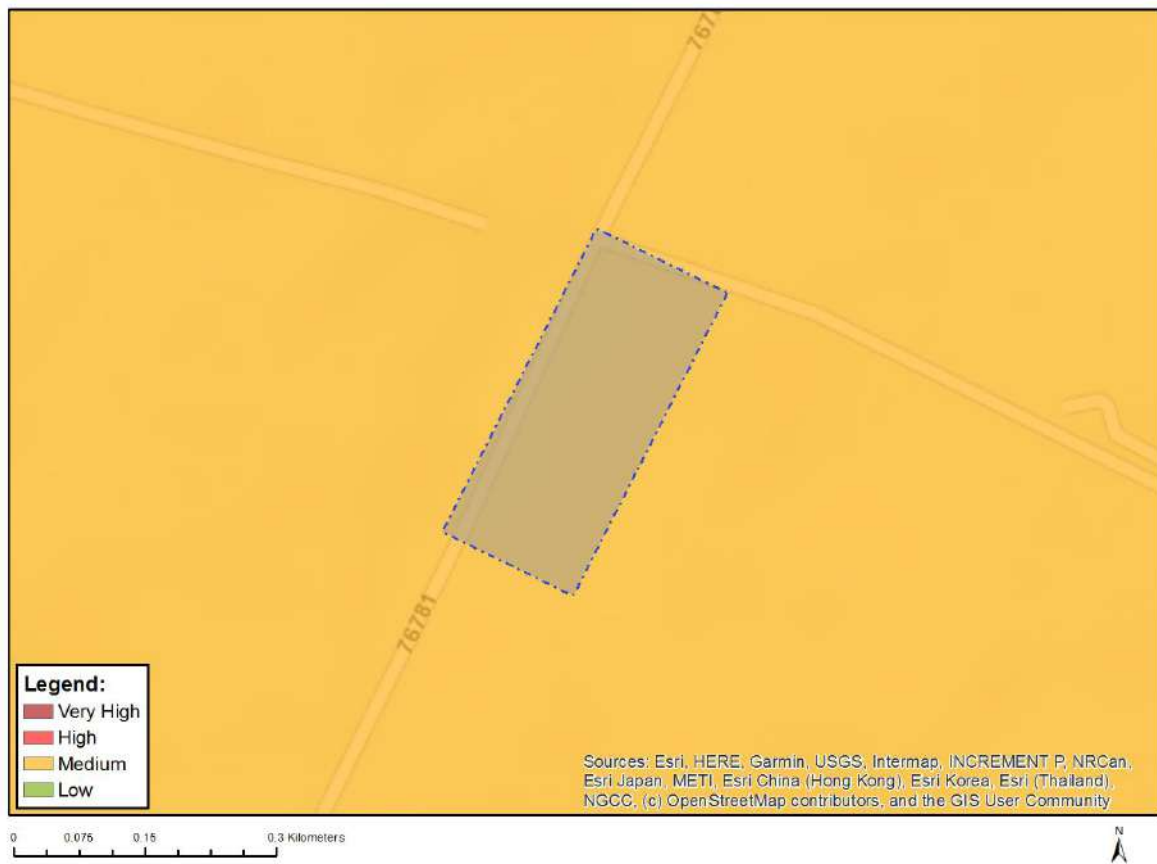
MAP OF RELATIVE PLANT SPECIES THEME SENSITIVITY

Sensitivity	Feature(s)
Medium	Sensitive species 1252
Medium	Caesalpinia rostrata
Medium	Sensitive species 274
Medium	Nesaea alata
Medium	Barleria oxyphylla
Medium	Sensitive species 1204
