DRAFT BASIC ASSESSMENT REPORT

PROPOSED BHOKWE COMMUNITY SANITATION PROJECT,
VRYHEID, LOCATED WITHININ ABAQULUSI MUNICIPALITY,
KWAZULU-NATAL

**For the Proposed Bhokwe Community Sanitation Project within the AbaQulusi
 Municipality**

EIA Ref No.: DC26/0001/2020

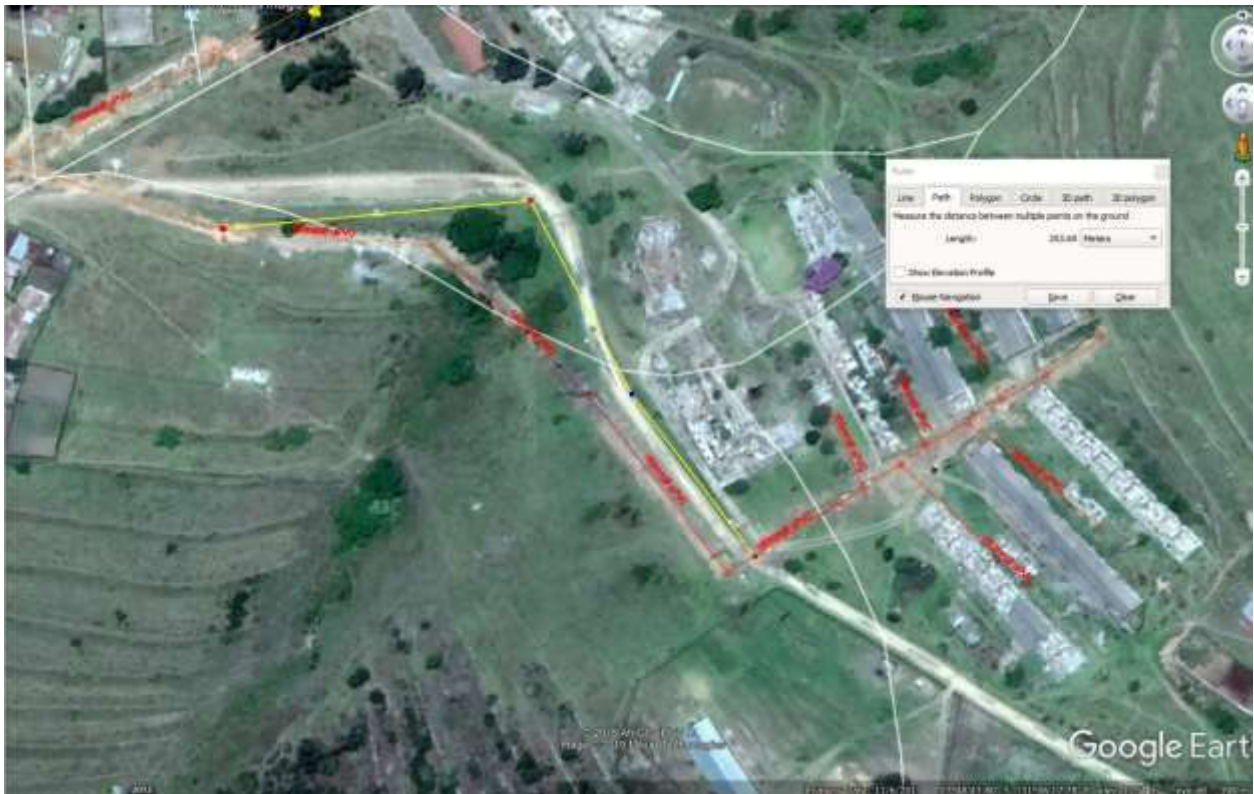
- The geotechnical investigation had refusal at 2.7m. This indicates that directional drilling and pipe jacking will be excluded as it is not an option. Open trench would be used, together with blasting. This would cause damage to both the roadway and neighboring wetland.
- The pipe will be laid at a depth of approximately 6m. This will lead to probable maintenance issues arising if there is a problem or leak within the pipe route.
- The pipe bridge will have flanged steel and will be epoxy coated. It is more robust and stronger than uPVC piping. It will also be laid above ground. Possible leakages is low and maintenance is quick. Any leaks will be visible if it is above ground.

The alternative pipe route alternative is illustrated in yellow while the preferred route is depicted in red.

Figure 6: Alternative wetland crossing design

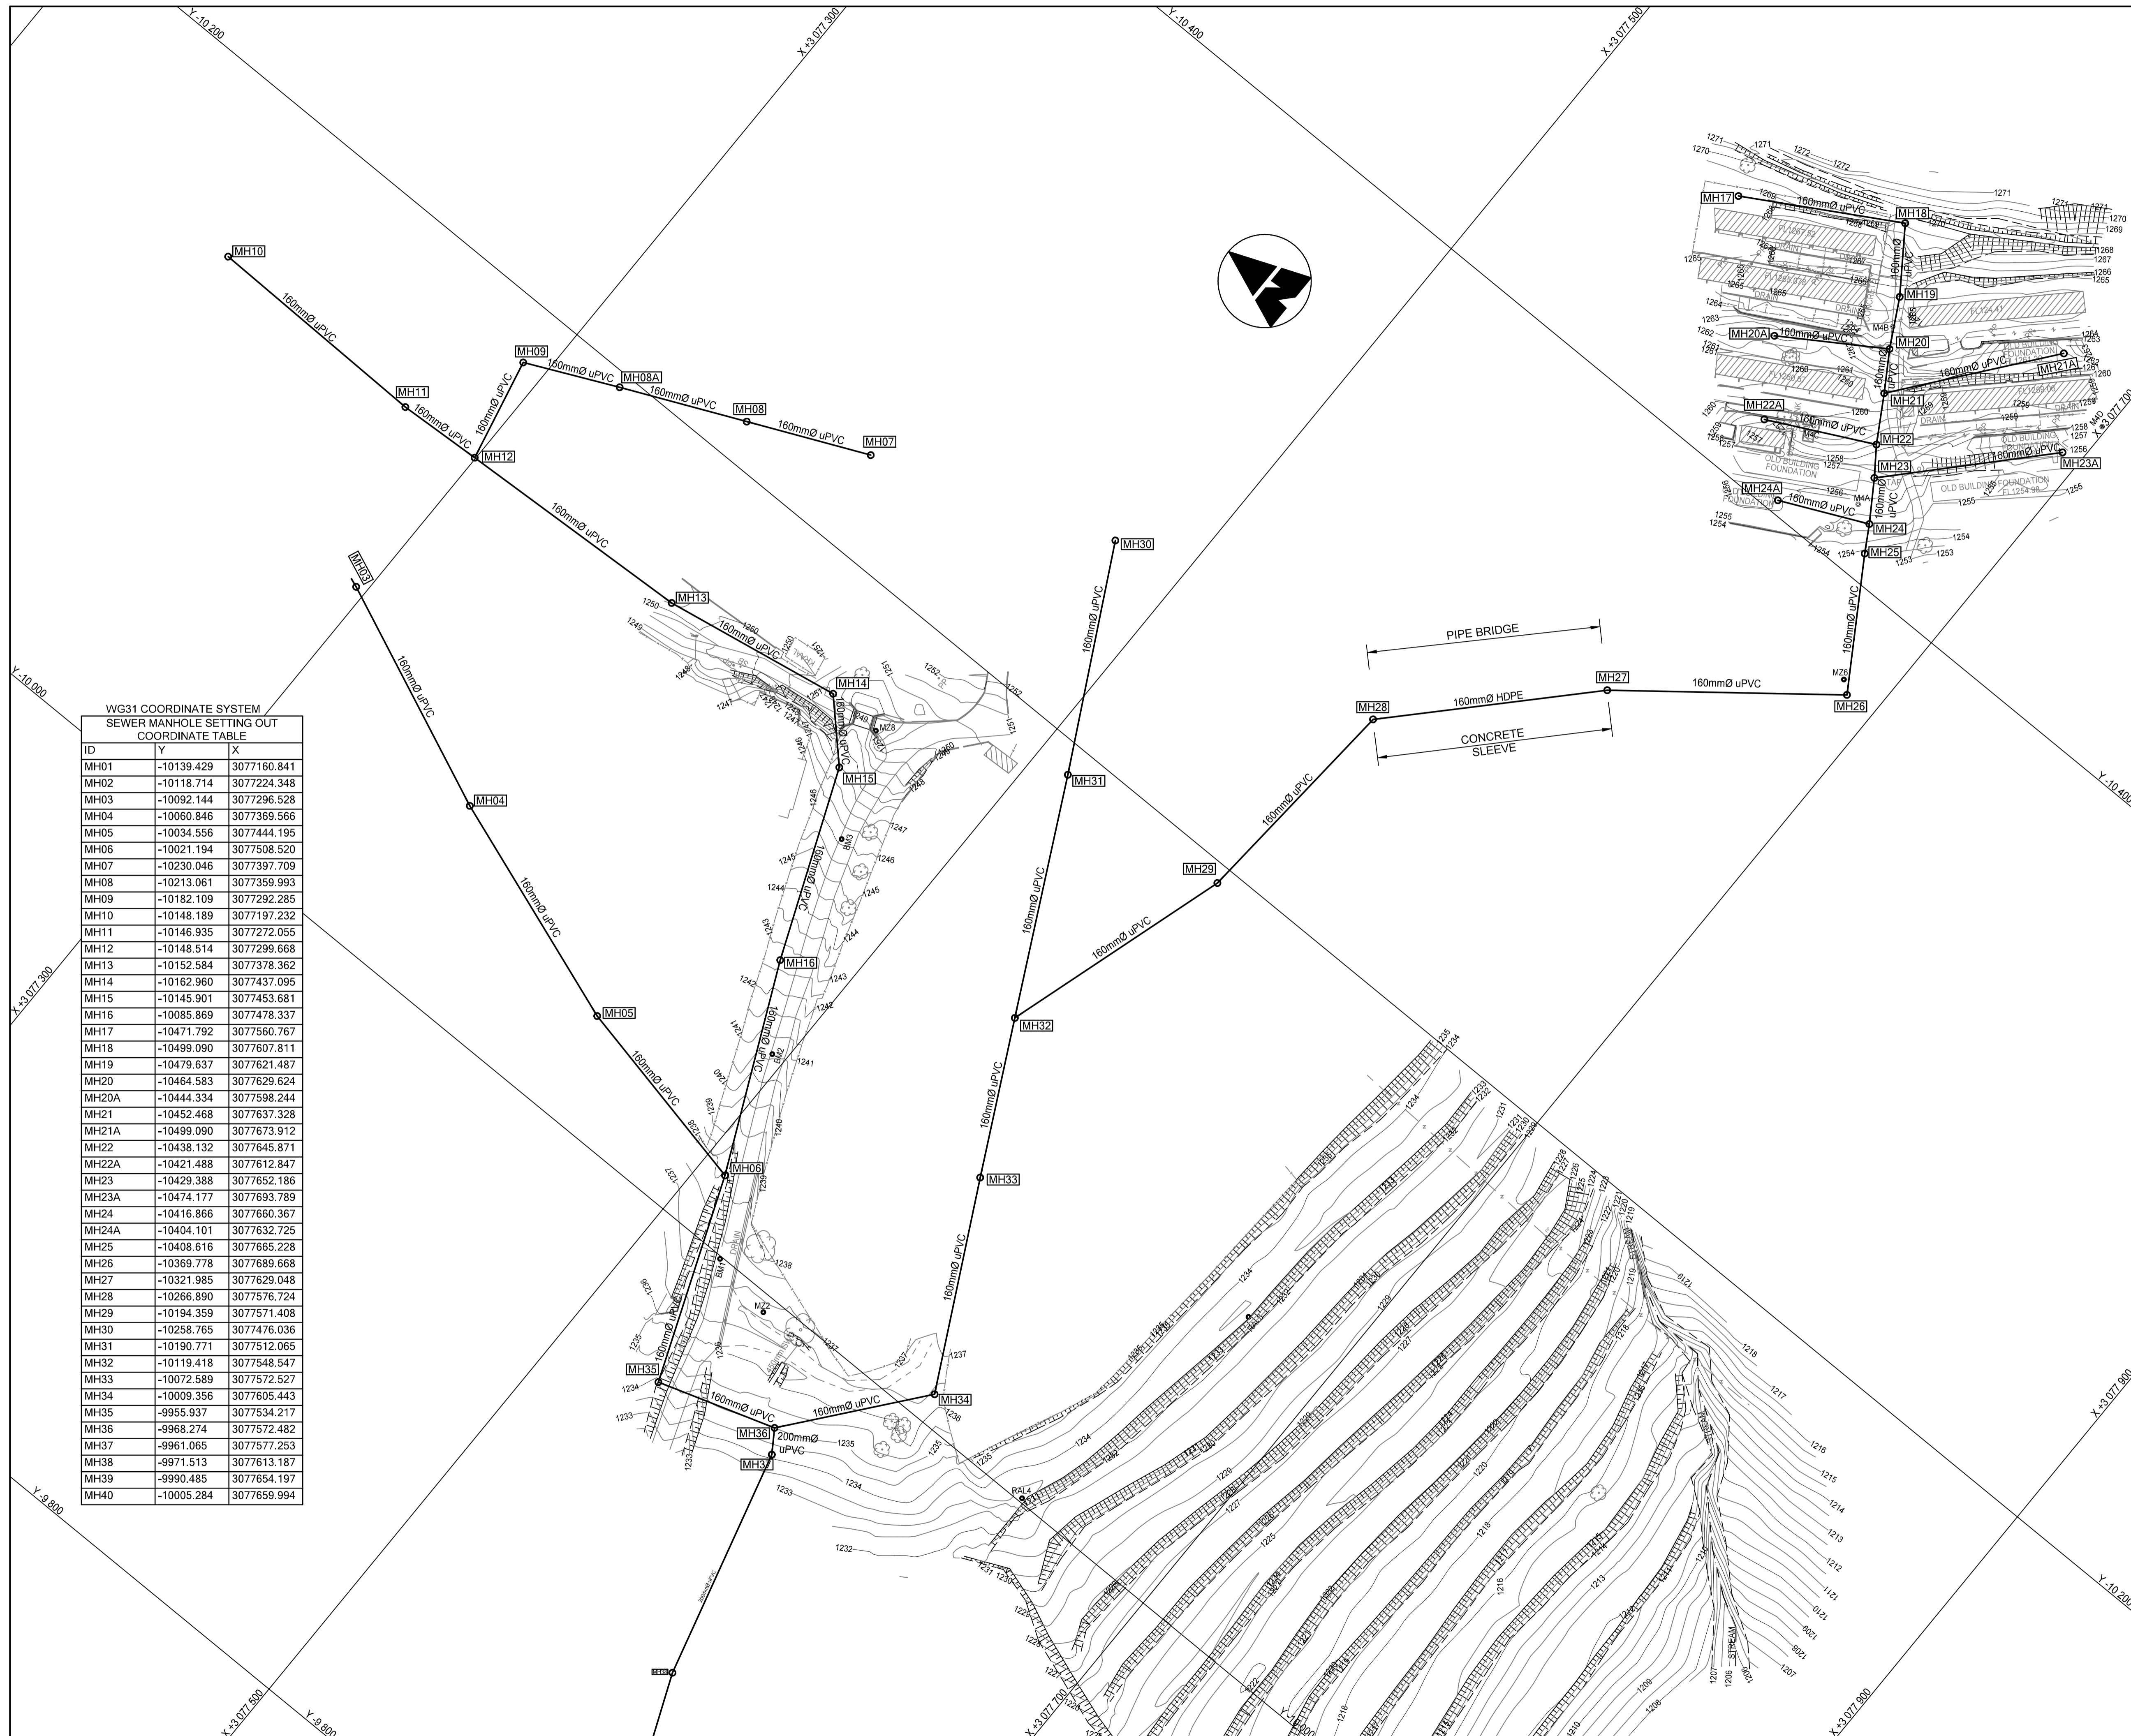
WG31 COORDINATE SYSTEM
SEWER MANHOLE SETTING OUT
COORDINATE TABLE

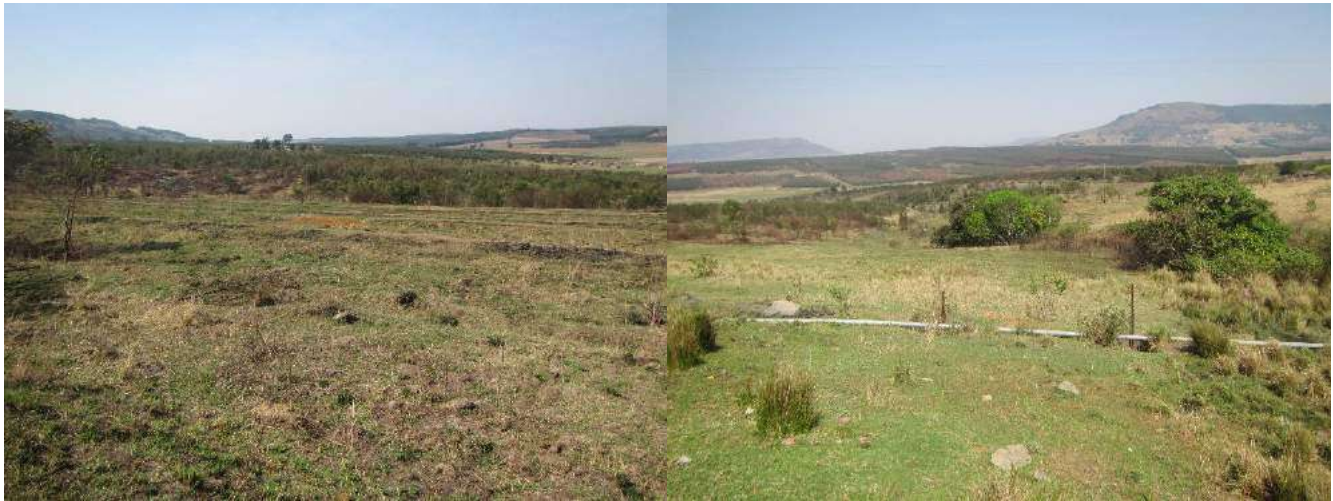
Photograph 1: Disturbed vegetation associated with HGM 1. Note the second picture shows the drainage channel associated with this seep

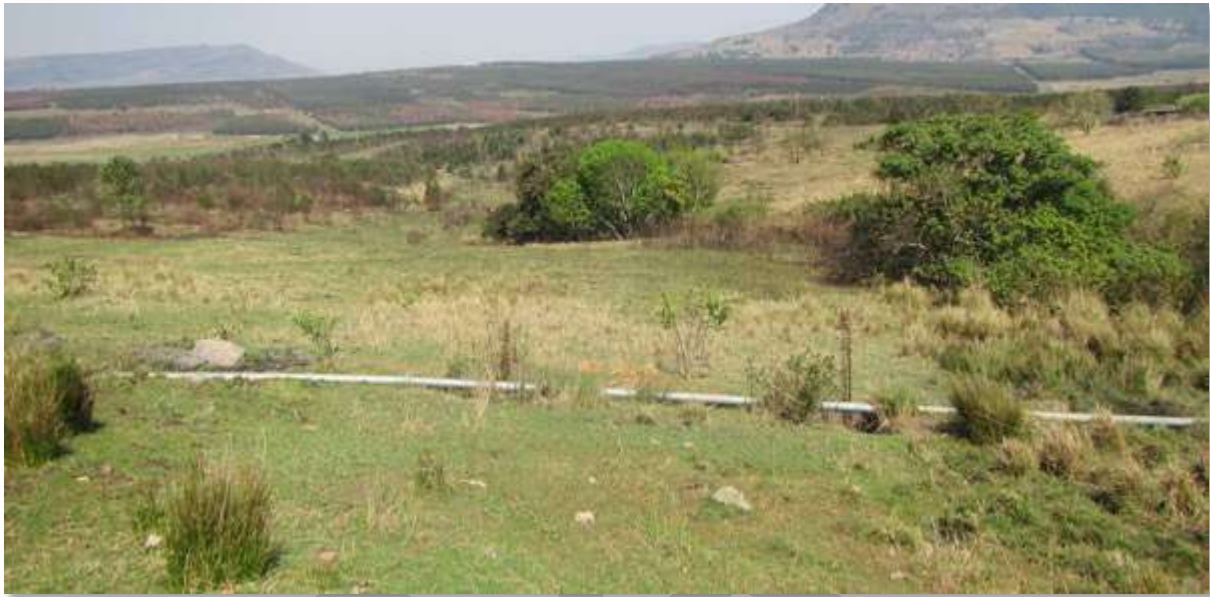
Photograph 3: Drainage channel noted on the north eastern boundary. Note the pipeline already traversing the channel from the previous contractor.

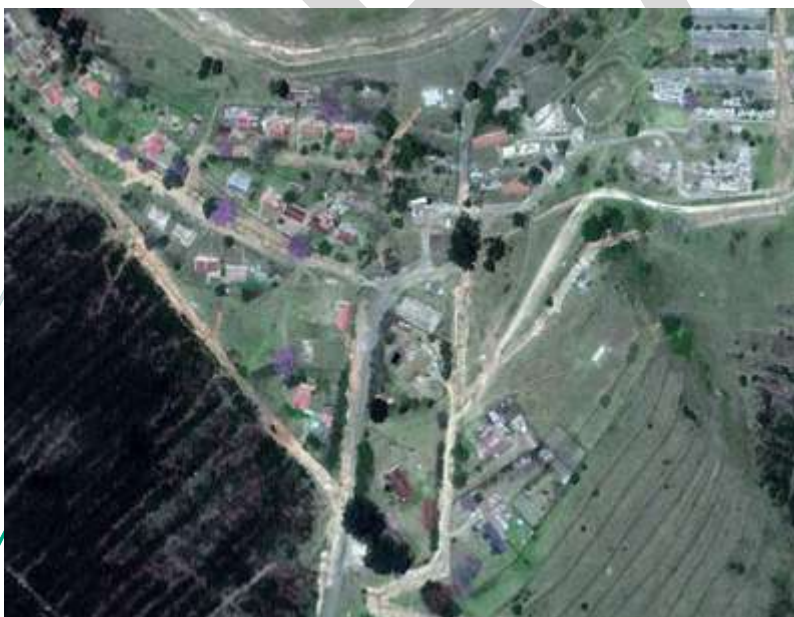
Figure 8: Note the cleared pipeline servitude as at 11/06/2017 aerial imagery.

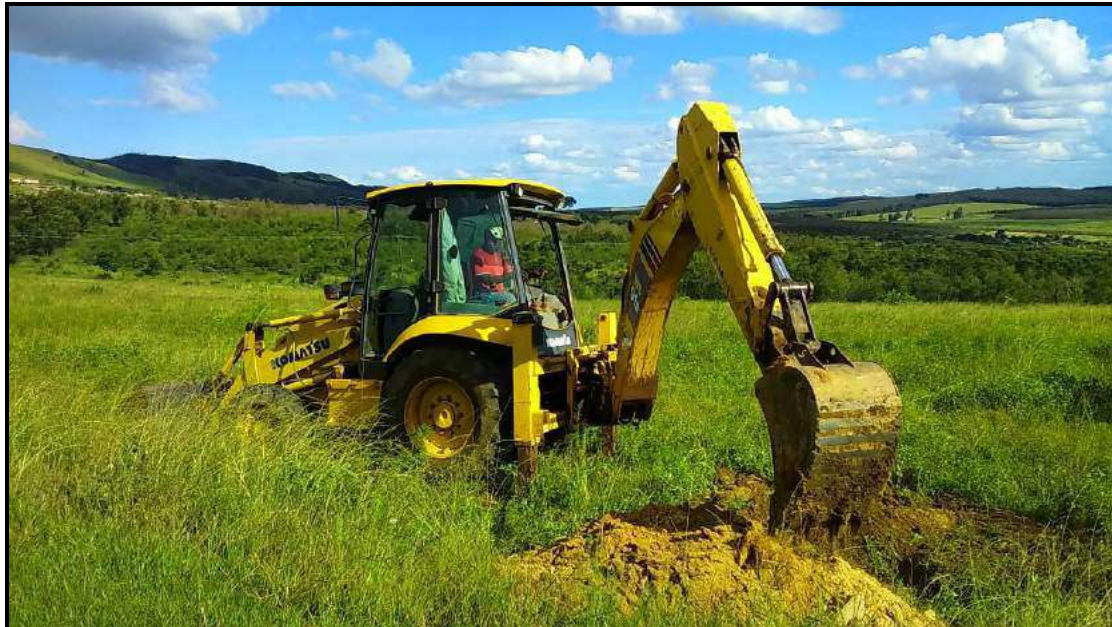
Figure 4 Picture showing trial pit excavation on site

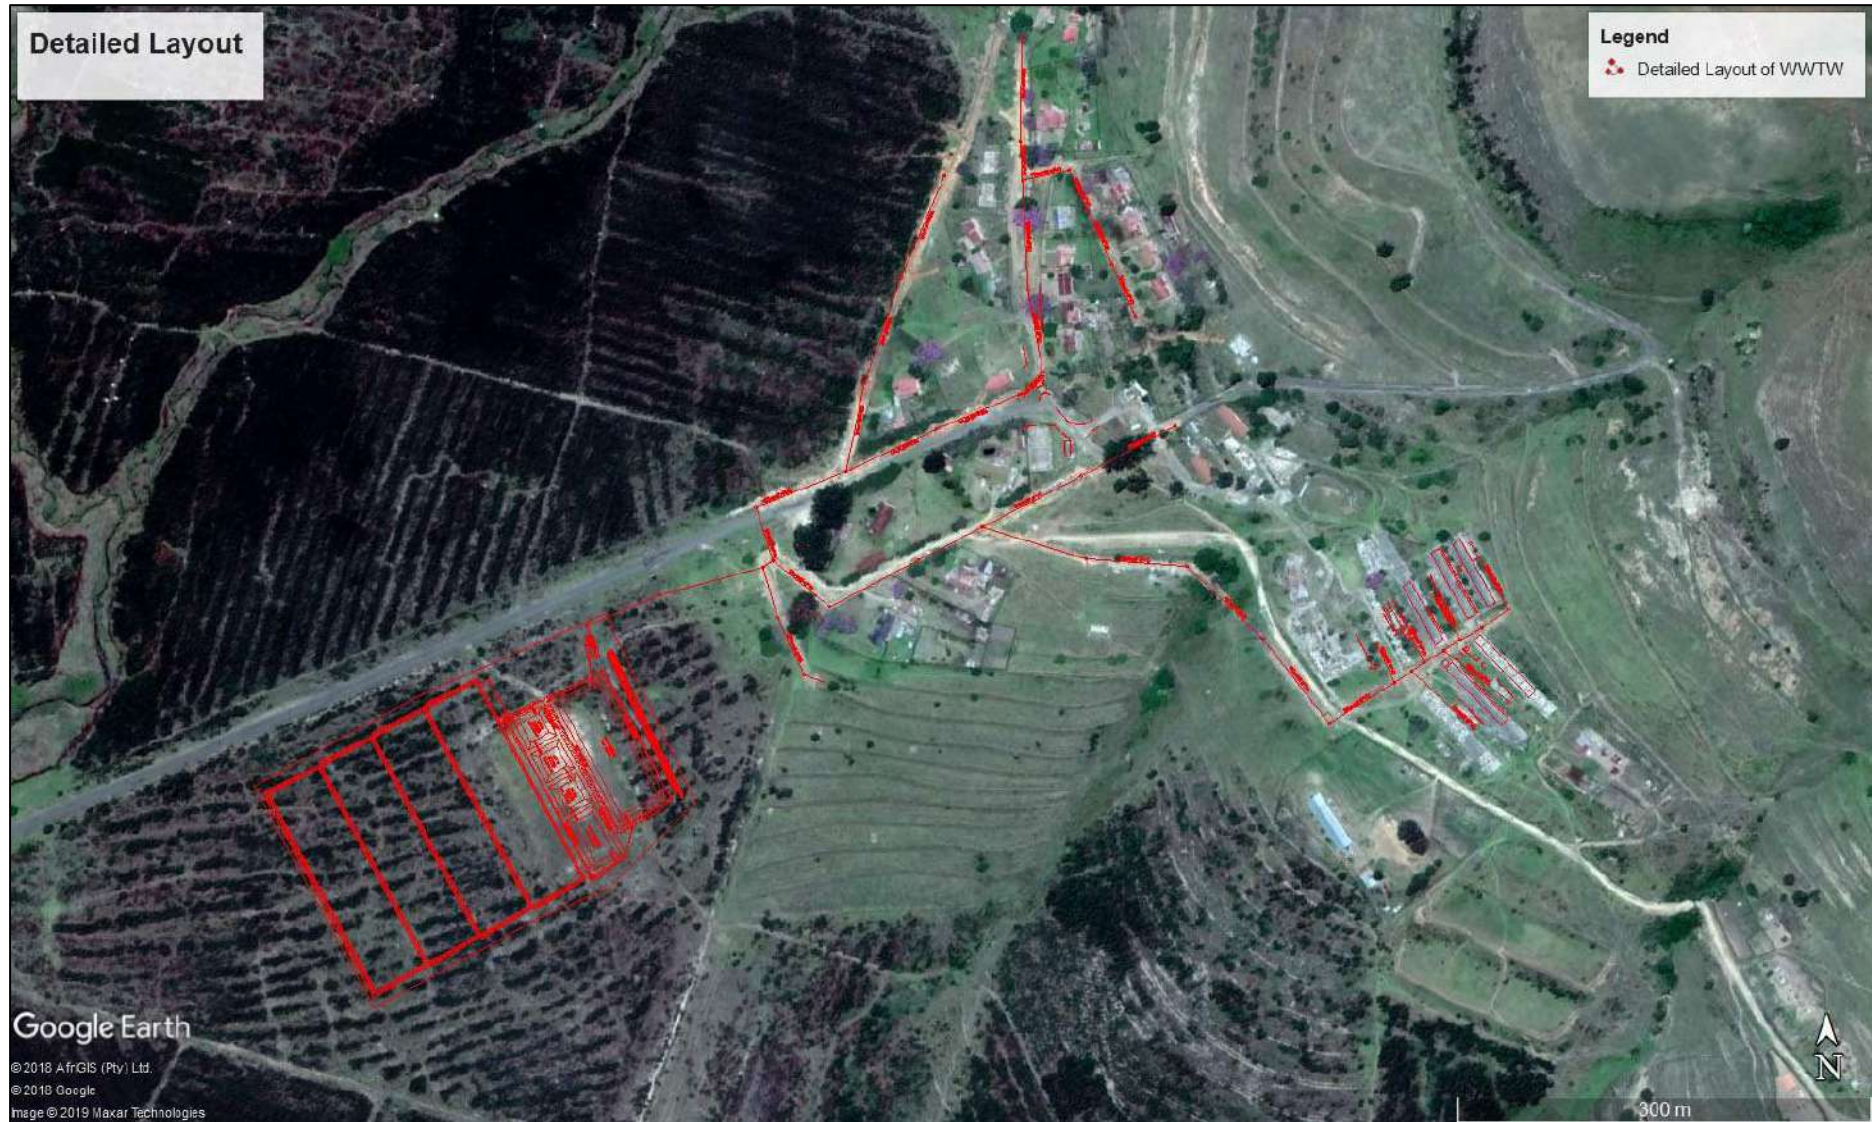
Figure 2: Detailed layout of WWTW

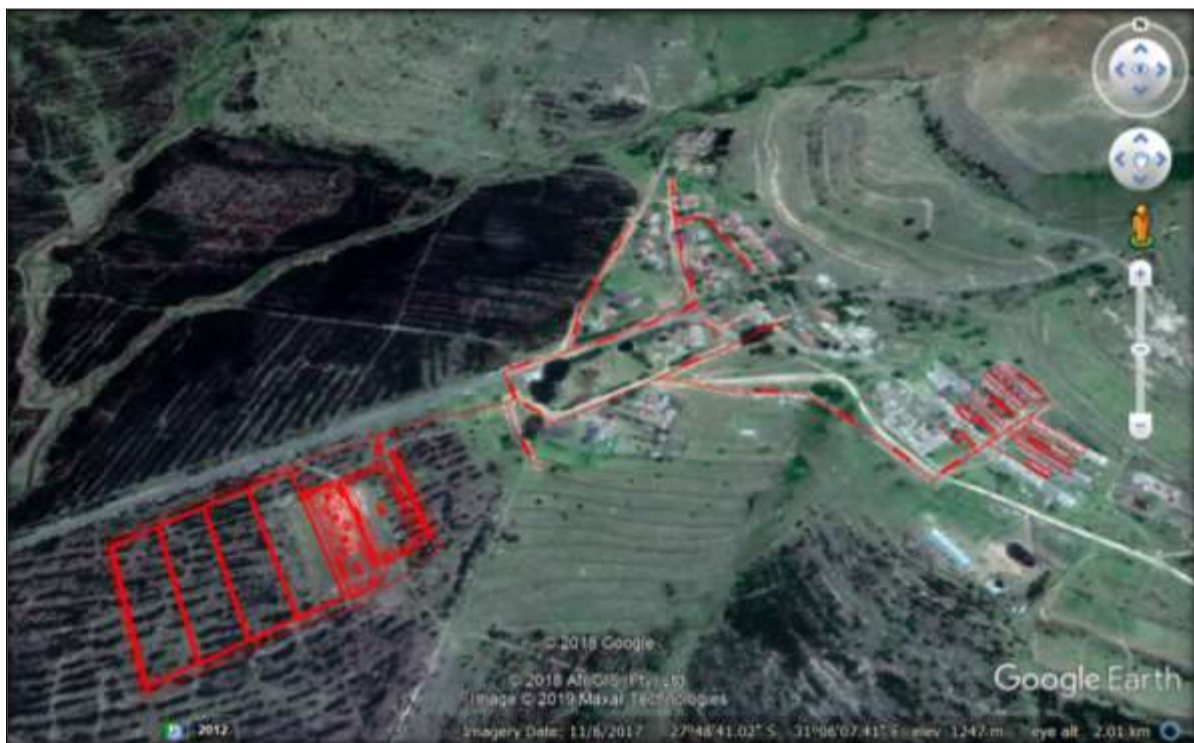
Figure 1. Proposed layout of the Bhokwe Sanitation Project (Source: 1 World Consulting, 2019)
