REHABILITATION PLAN

VENETIA MINE

REPORT NO: RPT00376/F

MARCH 2022

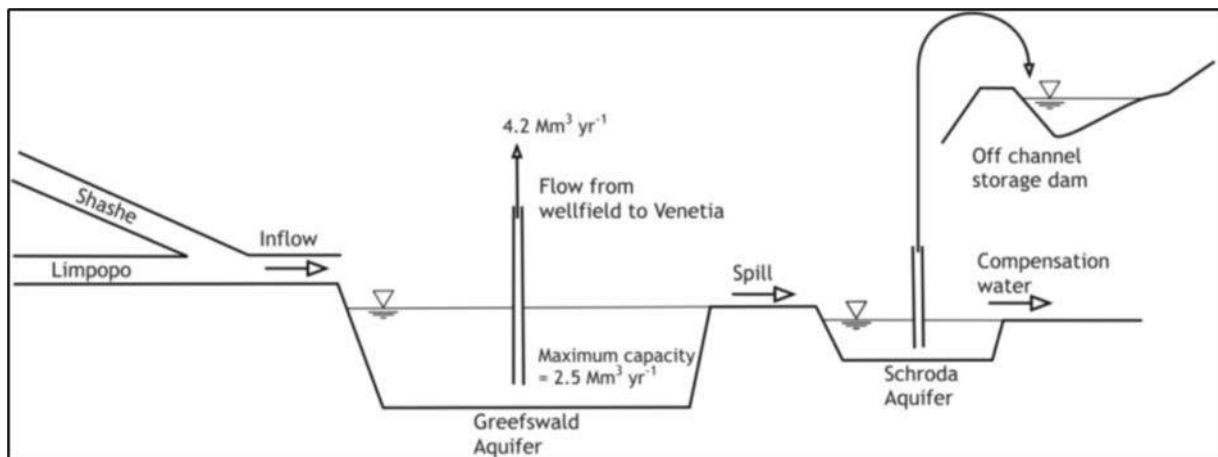
Figure 2: Conceptual model of water abstraction for Venetia Mine (Parke and Richards, 1992).

During flood conditions, water is pumped to the Schroda off-channel storage dam. (OCS dam) This stored water is used to supplement the demand from the mine during dry periods to prevent the Greefswald aquifer from becoming stressed (Figure 2).

A reticulation network connects the wellfields, Schroda OCS dam, Greefswald reservoir/pump station and Venetia on-mine water storage dams (OMWSD). A water pipeline servitude, in favour of De Beers, is aligned from the Greefswald reservoir to the OMWSD.

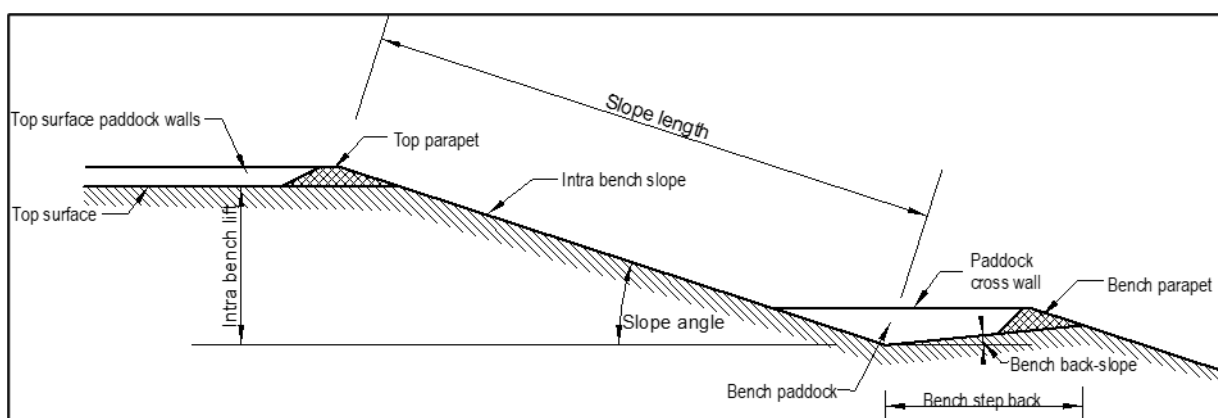
Figure 5: Terminology used to reference a cross-section through profiled WRD slopes.

The 2010 Closure and Rehabilitation plan's closure criteria for WRD rehabilitation were initially implemented (9m intra bench lifts, 18-24-degree slope angle, 10m wide bench step back with a bench paddock capacity enough to contain the surface runoff following a 1:200yr storm event as a minimum).

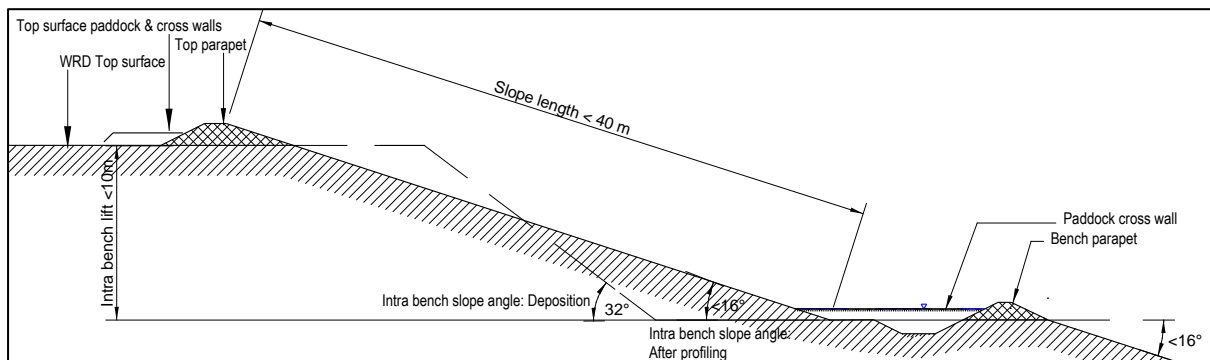
Figure 6: Illustration of ideal dump geometry after reshaping and construction of bench paddocks

During implementation, it became evident that the criteria needed to be adjusted based on site experience gained and safety requirements. The criteria now used, and included in the 2018 closure criteria of the Rehabilitation, Decommissioning and Mine Closure Plan (due to be updated in 2022) summarised is as follows:

- Slope angles: below 16 degrees,
- Intra-bench lifts <10m.
- Minimum bench step-back width of 5m after profiling to allow vehicle access to the dump slopes.
- Bench paddocks: Capacity to contain the surface runoff due to a 1:200yr storm event. (Figure 7)
- Contour paddocks constructed on any slopes which exceed 40m in slope length: 200yr storm event containment capacity (Figure 8)
- **100 ± 50mm Ameliorated topsoil¹** ripped into the waste rock surface profile² to create a functional growth medium. Ripping done on-contour (level – no slope).

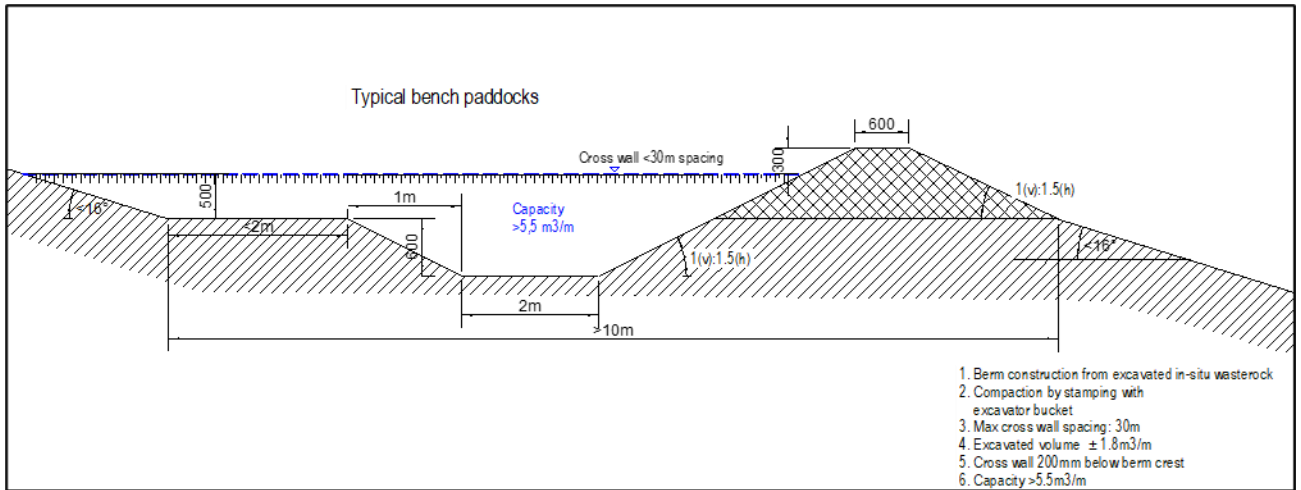
Figure 7: Typical bench-paddock design.

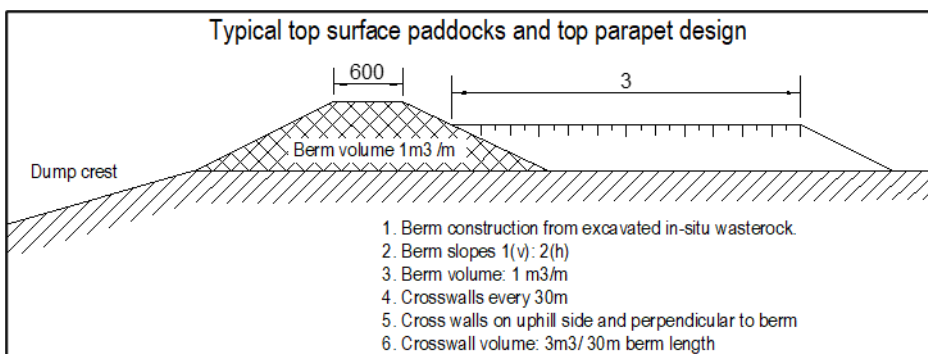
Figure 9: Typical Crest and top surface paddock design

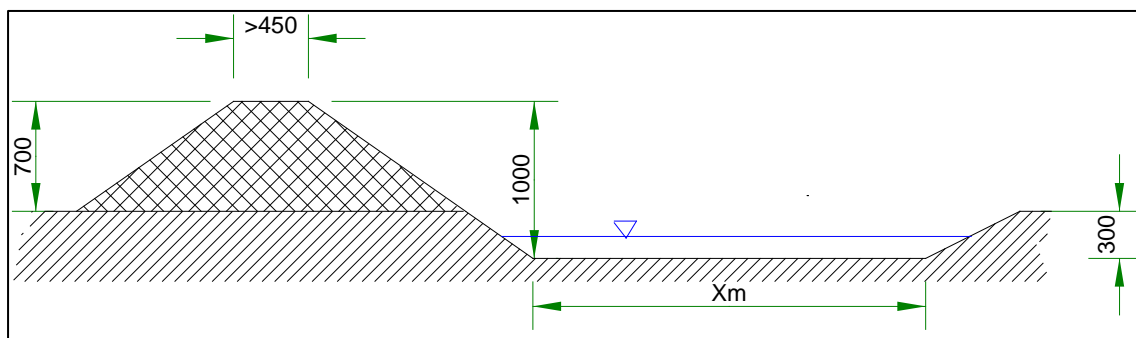
Figure 11: Typical water bearing drain
