Report on the ecological and wetland assessment for the proposed alluvial diamond mining operations on various portions of the farms Vanaswegenshoek 493 and Greylingslyn 355 along the Vaal River near the town of Christiana, Free State Province.

November 2021

Darius van Rensburg

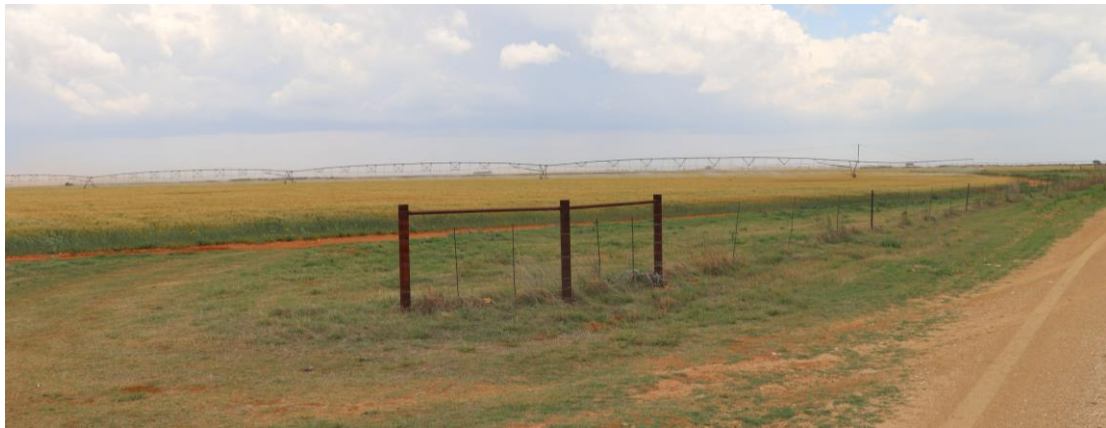
Figure 1: The study area is largely transformed by centre-pivot irrigation.

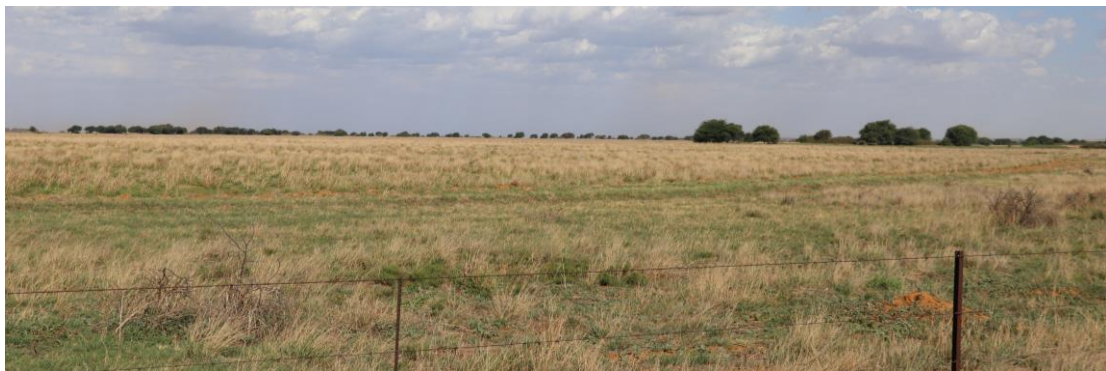
Figure 2: Centre-pivots which are not currently irrigated are either fallow or has been planted with pasture.

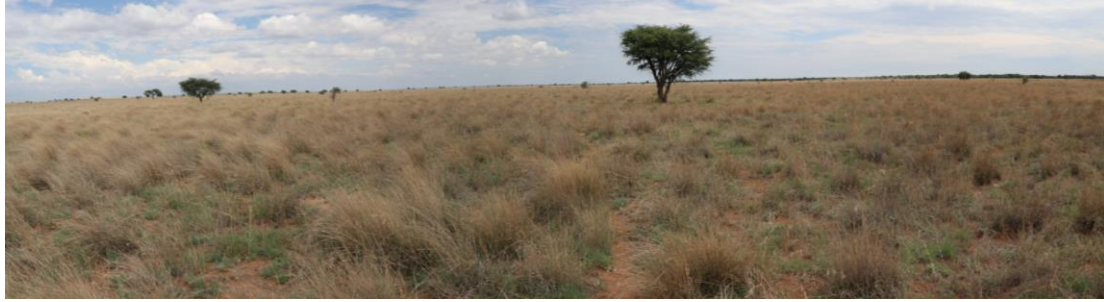
Figure 3: Southern portion of the study area contains a well-developed grass layer with scattered trees.

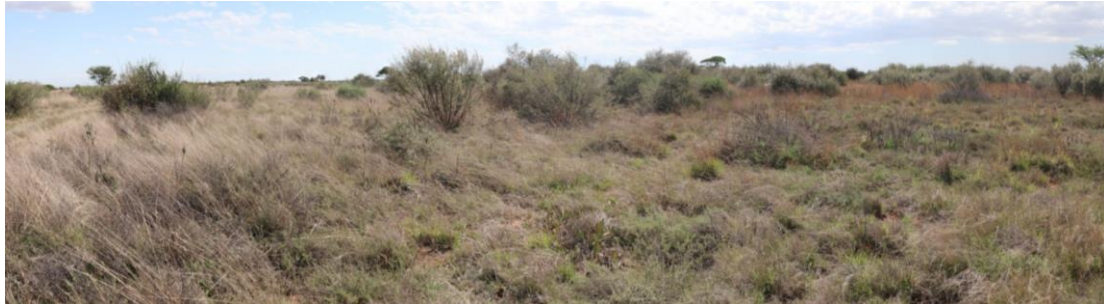
Figure 4: Towards the west of the site, remaining natural vegetation consist of a well-developed grass layer but with a quite dense shrub layer also being present.

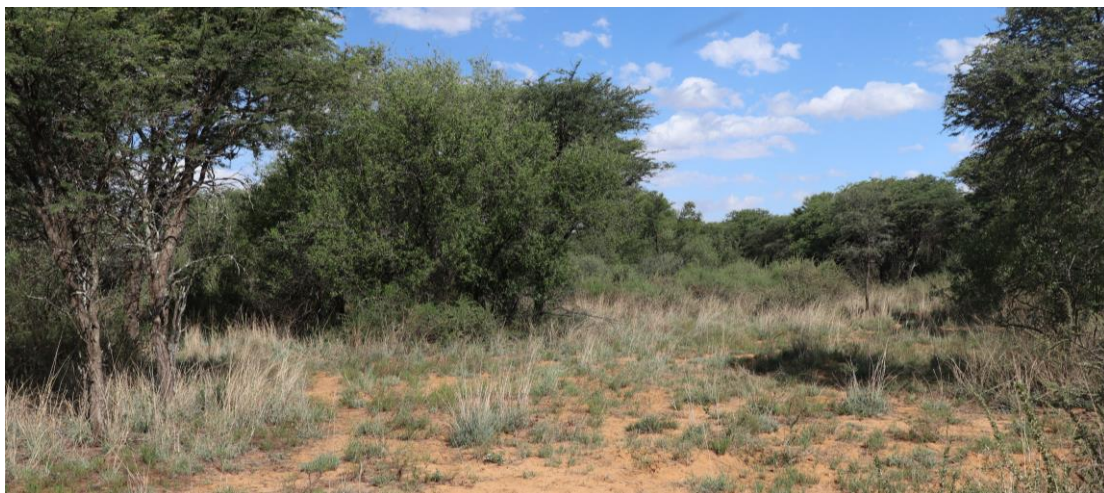
Figure 5: Fragmented central portions of the site is dominated by a well-developed woodland.

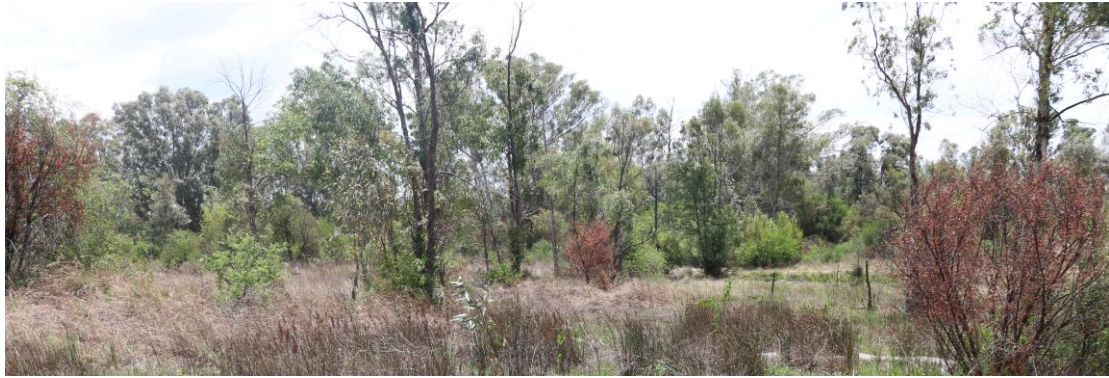
Figure 6: The riparian zone along the Vaal River is dominated in many areas by exotic Bluegum trees (*Eucalyptus camaldulensis*).

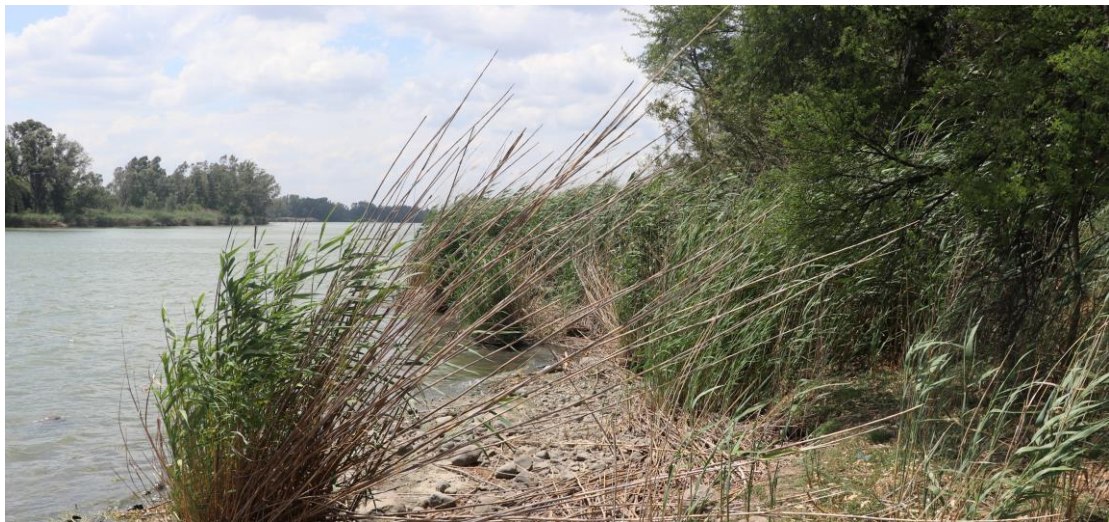
Figure 7: The banks of the Vaal River are largely quite degraded and dominated by reeds (*Phragmites australis*), an indicator of elevated nutrient levels.

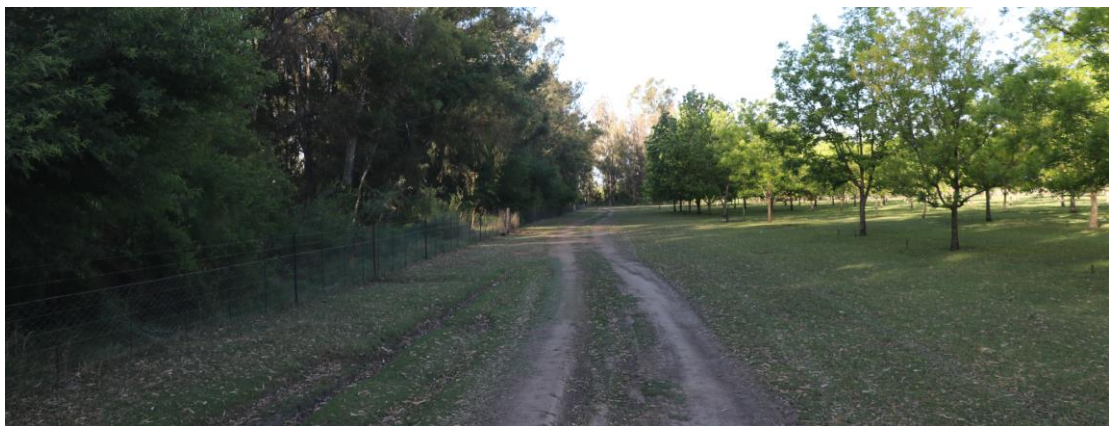
Figure 8: Several pecan nut orchards encroach into the riparian zone and cause transformation of this area.

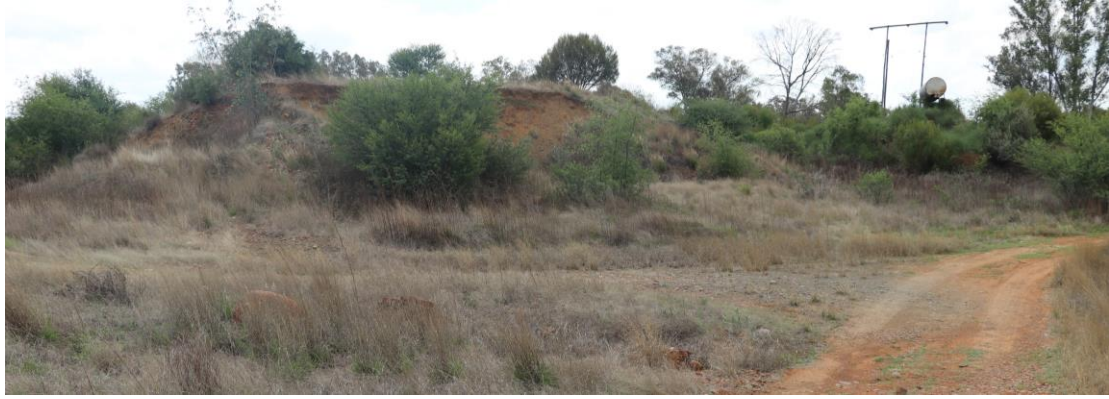
Figure 9: Previous mining operations within the riparian zone has also resulted in significant modification.

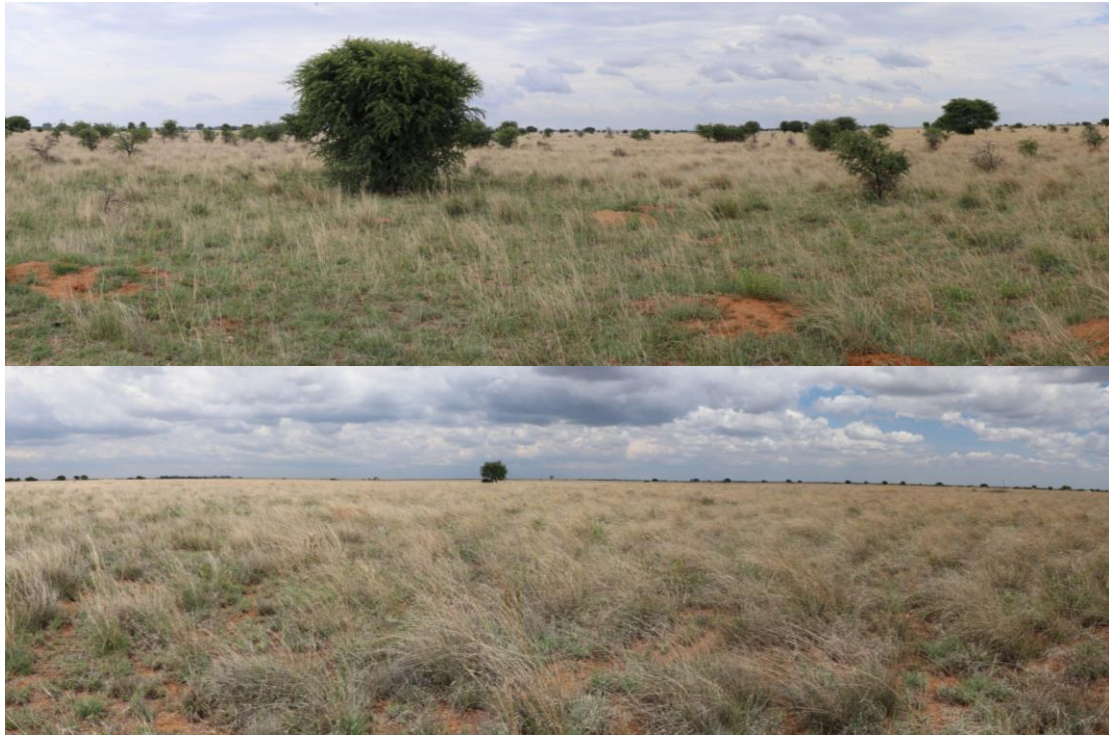
Figure 10: The southern plain has a rather flat topography, dominated by a well-developed grass layer and with trees being scattered.

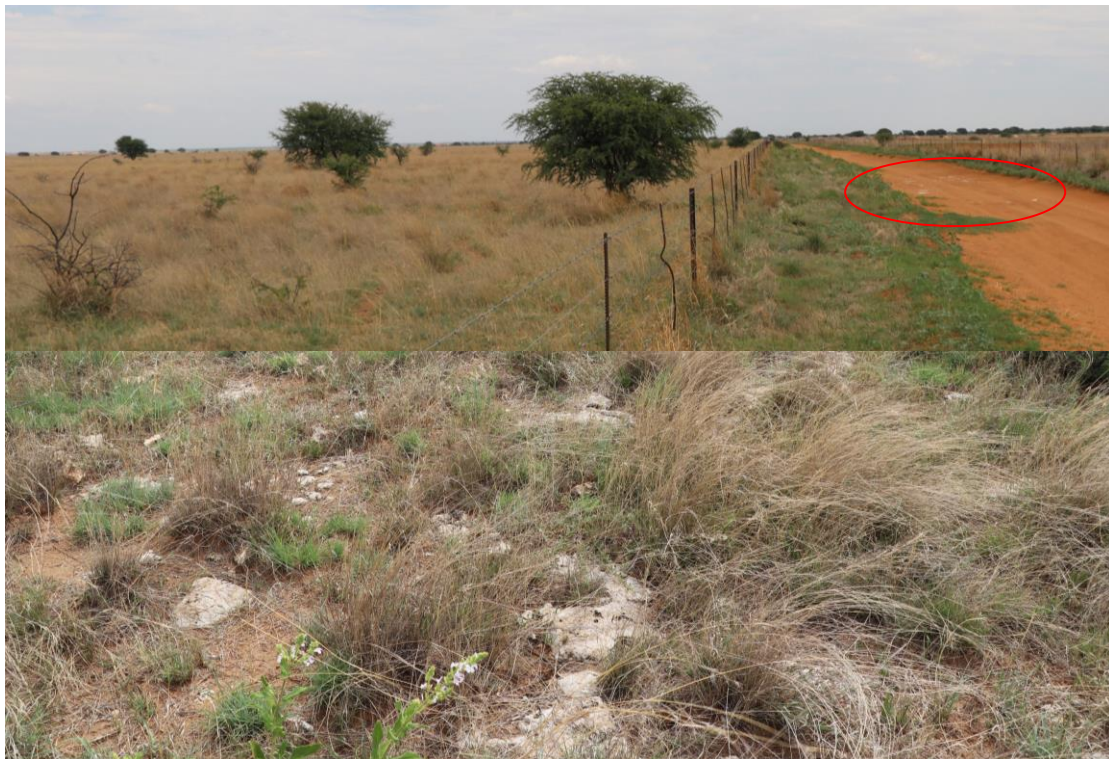
Figure 11: The area is underlain by calcrete which may as shallow as 30 cm and does outcrop in some areas.

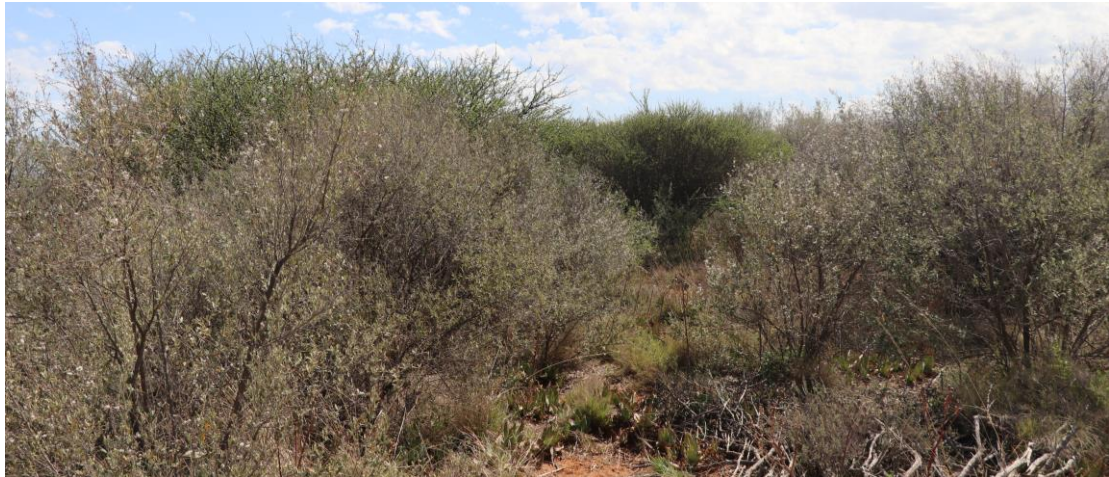
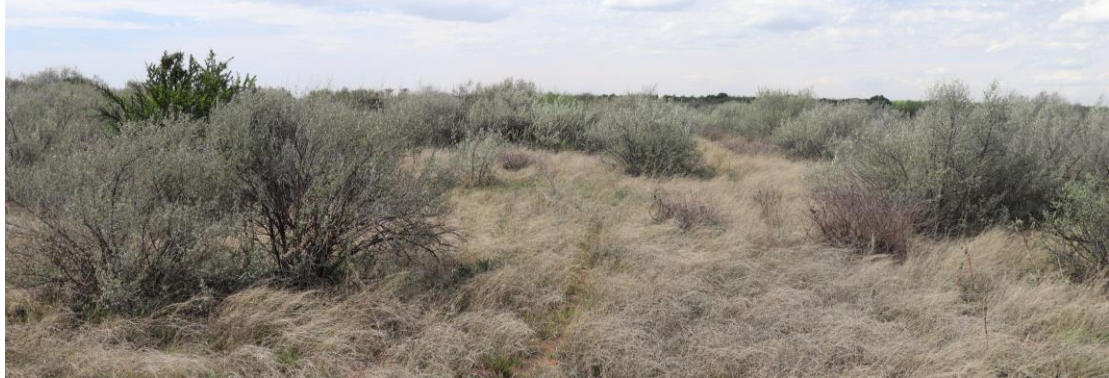
Figure 12: The habitat contains a well-developed shrub layer which can be quite dense in many areas.

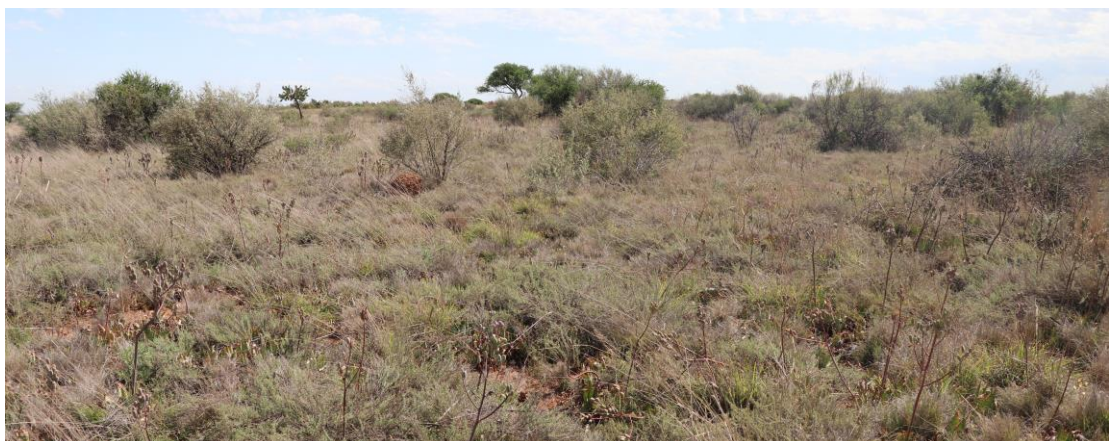
Figure 13: Dwarf karroid shrubs can also be abundant in some areas and is an indicator of disturbance.

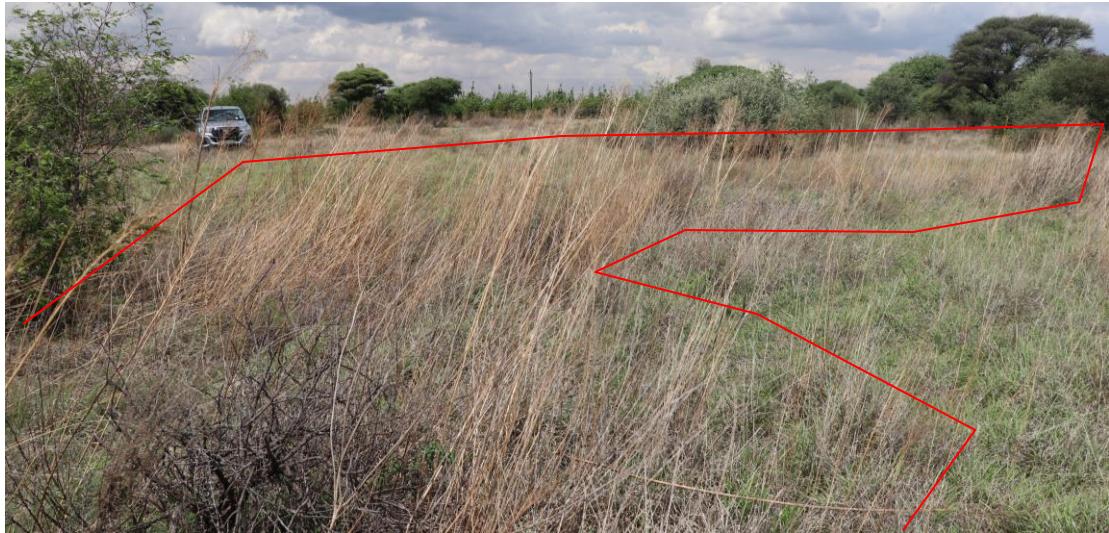
Figure 14: Portions of this habitat contain an abundance of exotic weeds, also an indicator of disturbance.

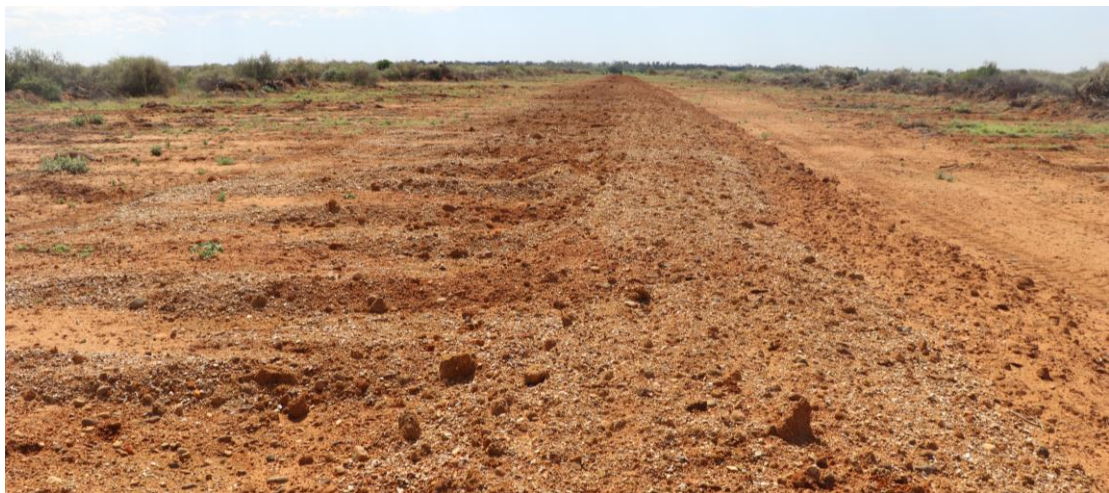
Figure 15: Soils contain a high degree of calcrete and alluvial gravel which is considered the main ecological driver for this habitat.

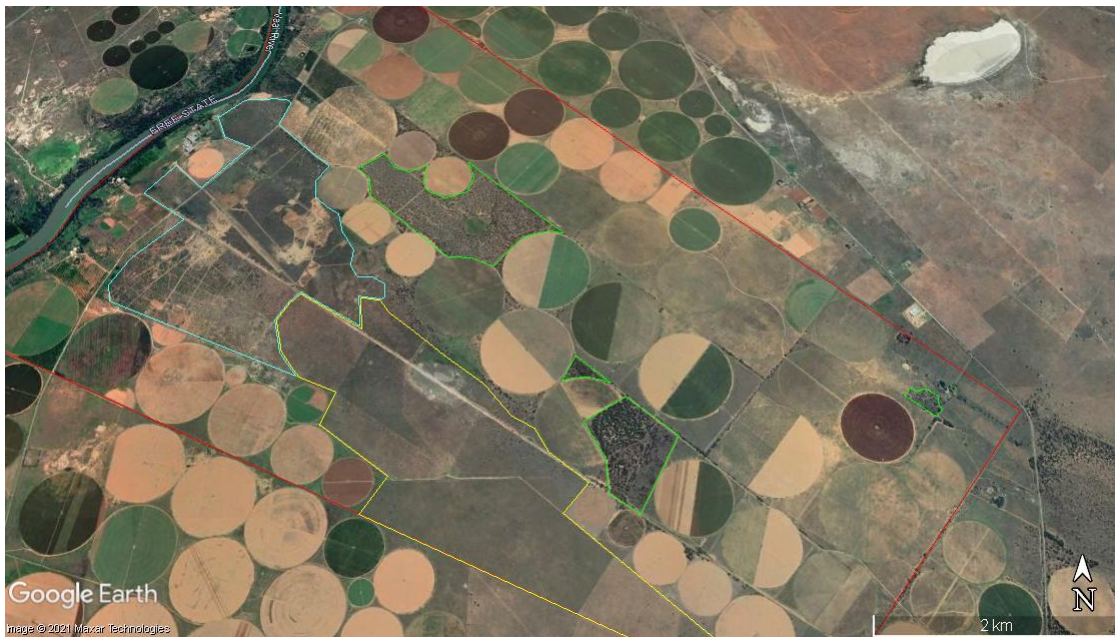
Figure 17: Aerial view of the recent condition of the study area (Google Earth 2021) which clearly indicates the large scale transformation of the area. The approximate extent of natural areas are indicated: Yellow – southern plains, Blue – western rocky areas, Green – central woodland areas.

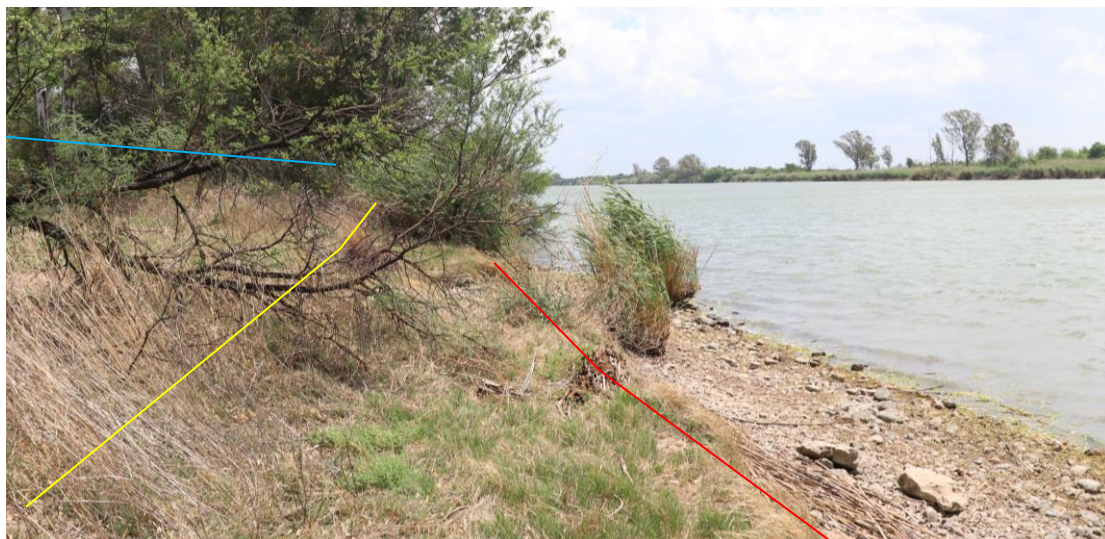
Figure 21: View of the banks of the Vaal River in the study area with the different zonation clearly visible: Marginal (red), Lower (yellow) and Upper Zones (blue).

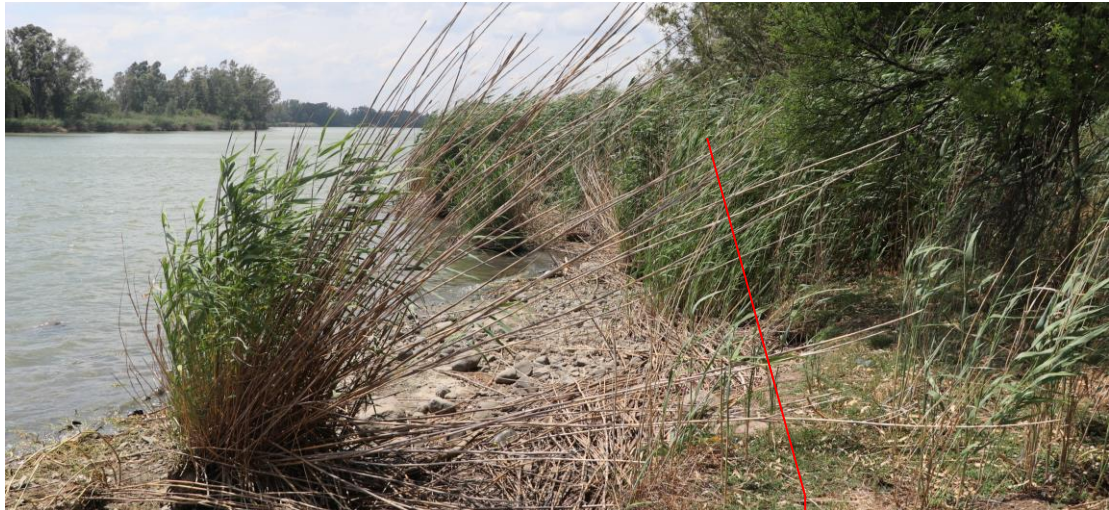
Figure 22: The marginal zone of the river is almost exclusively dominated by reedbeds of the indigenous reed, *Phragmites australis*. This indicates a regulated flow regime and high levels of nutrients.

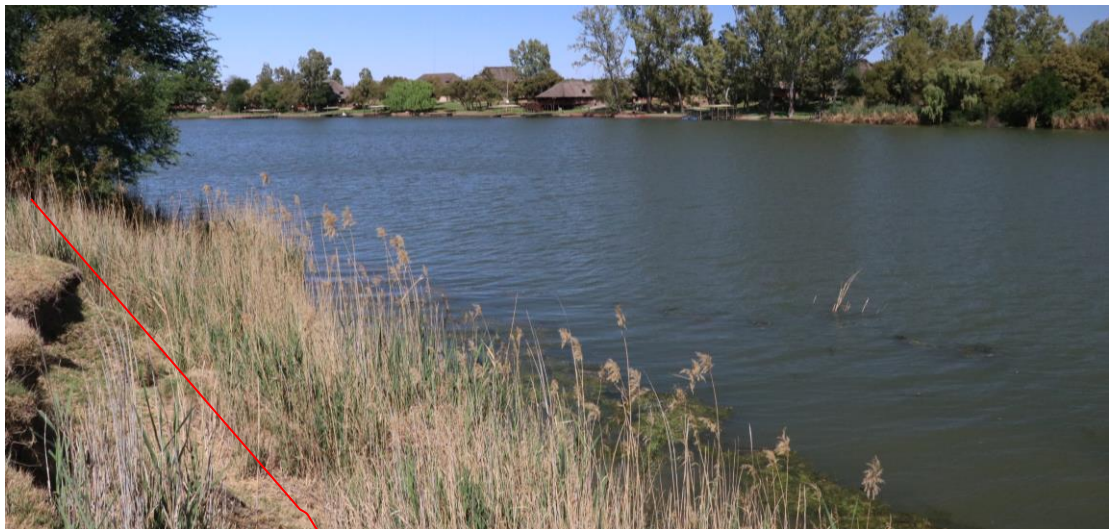
Figure 23: View of the marginal zone (red) in the north eastern portion of the study area. Note dense reedbeds and very narrow marginal zone.

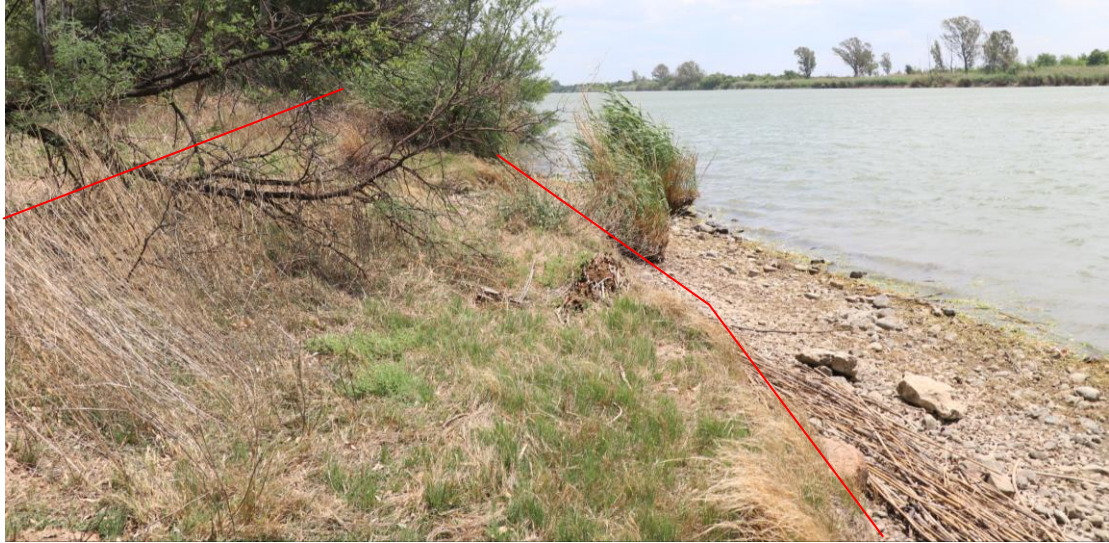
Figure 24: The lower zone is dominated by the pioneer grass, *Cynodon dactylon*.

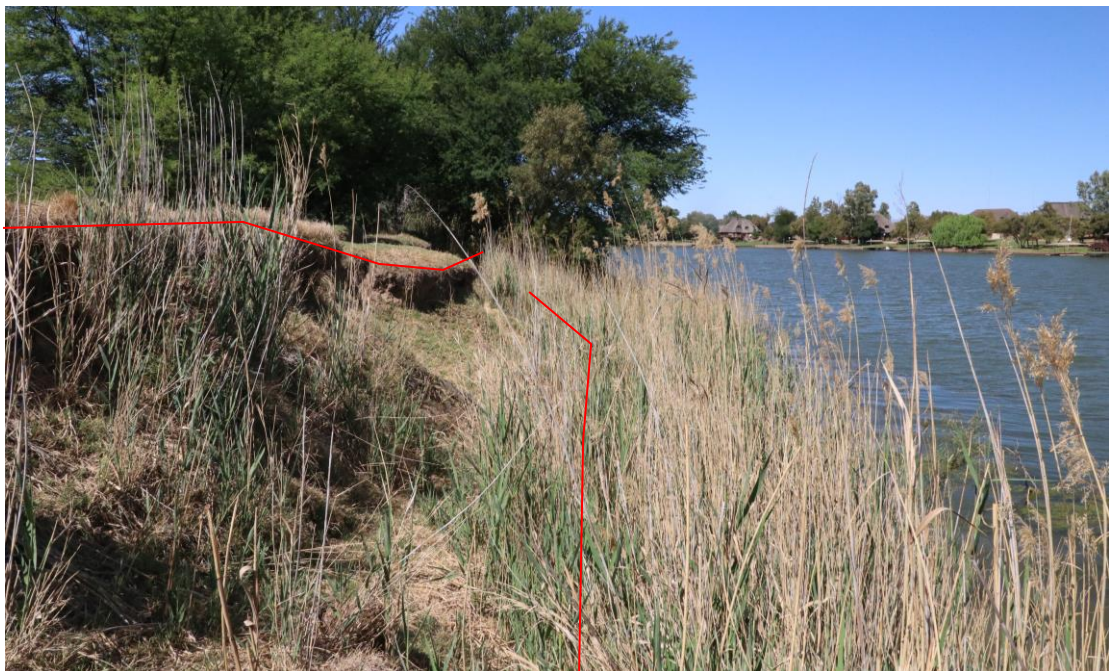
Figure 25: The lower zone (red) is also quite narrow though steep and is dominated in the lower portion by reeds (*Phragmites australis*) and riparian grass (*Cynodon dactylon*). Note also how it clearly levels off into the upper zone.

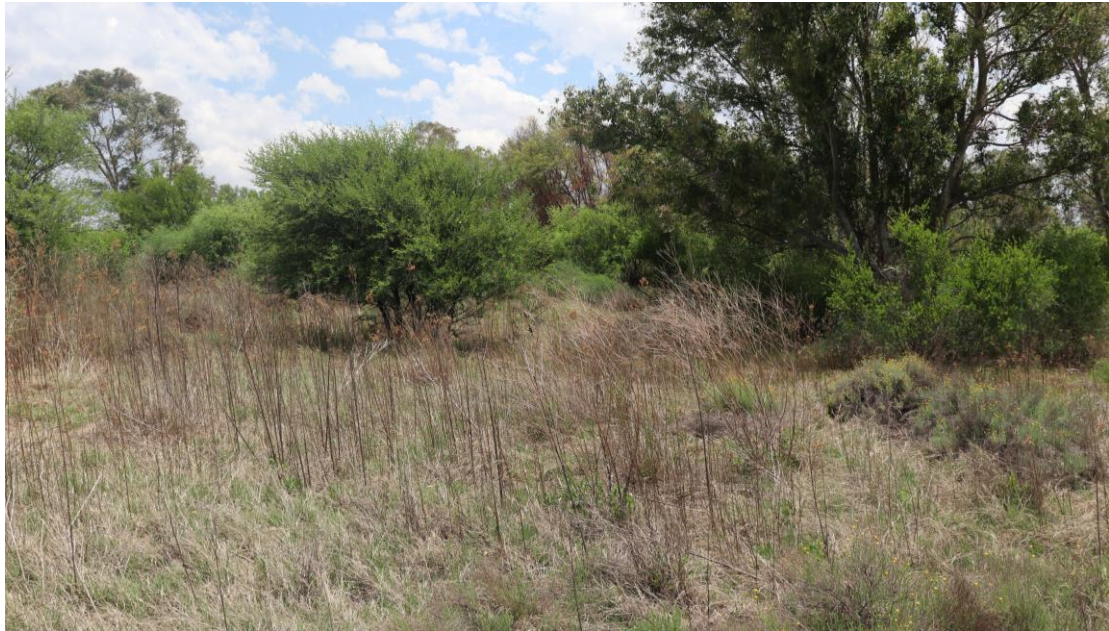
Figure 26: The upper zone is most obviously discernible as a decrease in the slope gradient and a significant increase in the riparian thicket component.

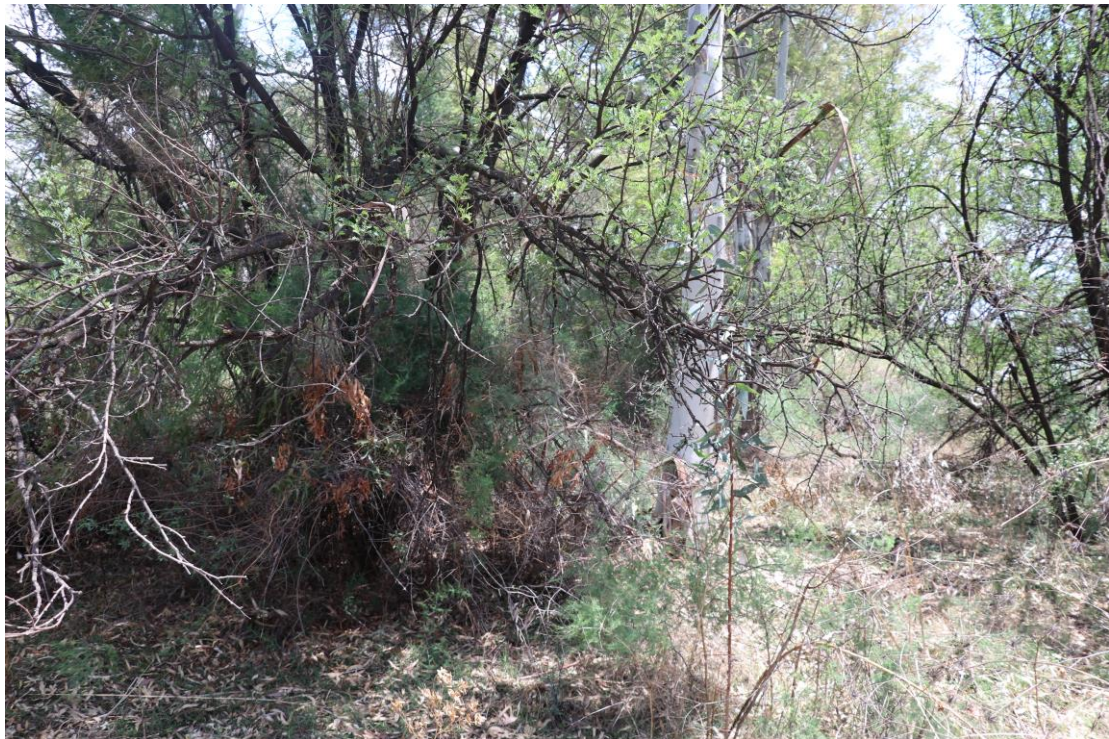
Figure 27: The riparian thicket can also become quite thick in many parts of the upper zone or floodplain.

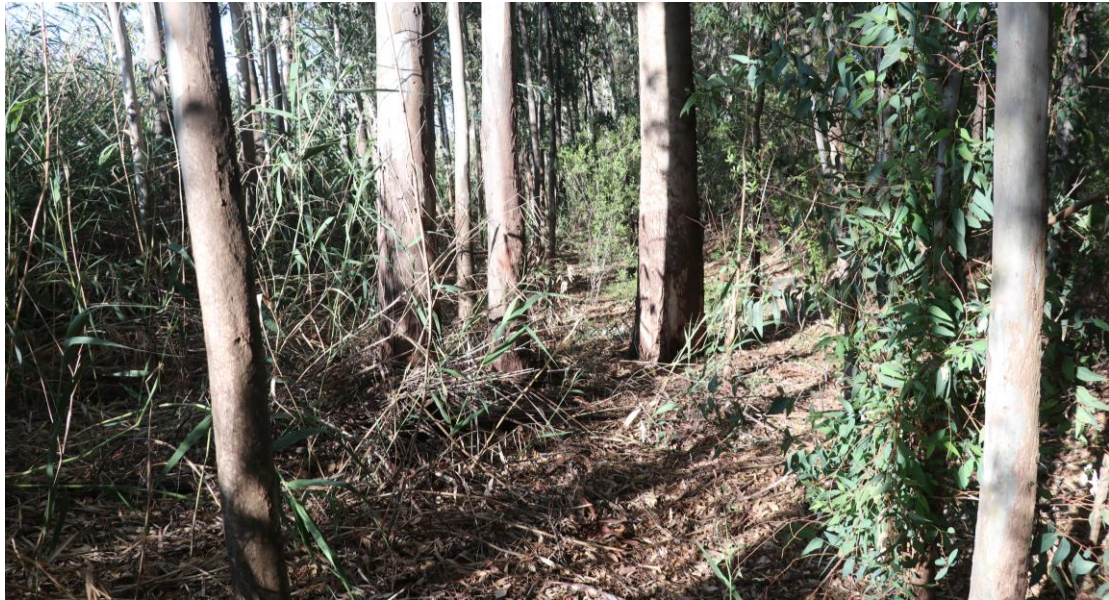
Figure 28: The upper zone along large portions of the site the riparian thicket is dominated by exotic *Eucalyptus camaldulensis* trees.

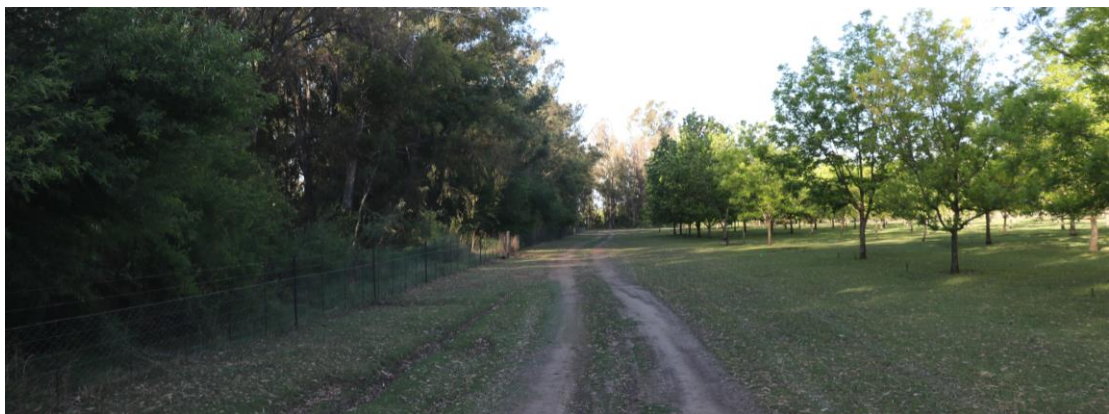
Figure 29: Large portions of the riparian zone or floodplain has also been transformed by orchards of pecan nut trees.

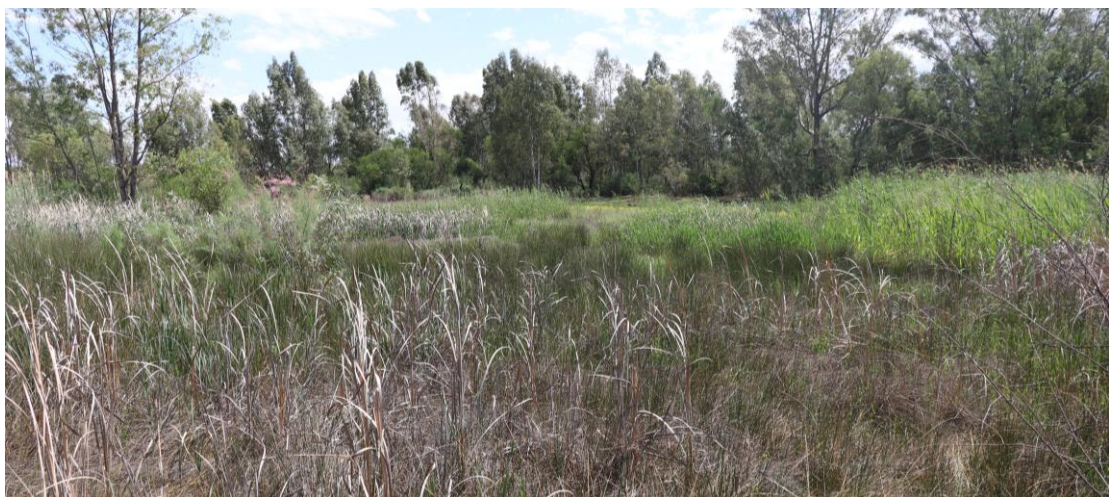
Figure 30: Within the floodplain, especially where lateral drainage lines flow into the Vaal River, prominent wetland areas has formed.

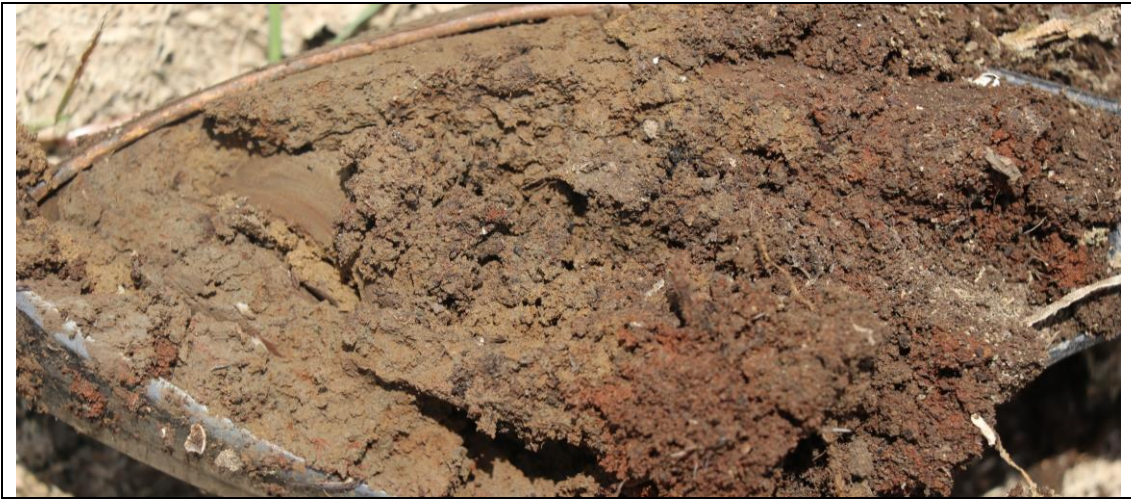
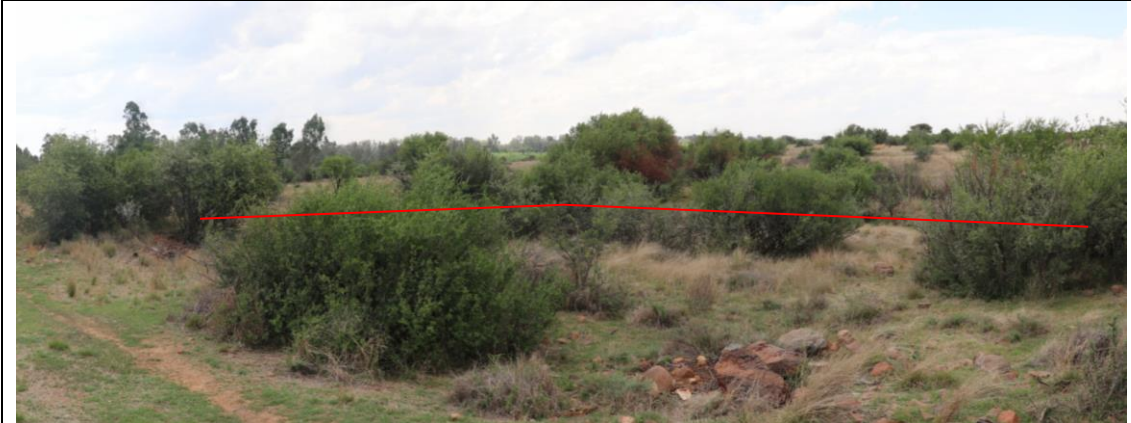
The upper reaches of the drainage line contains a defined main channel although wetland conditions are not prominent.

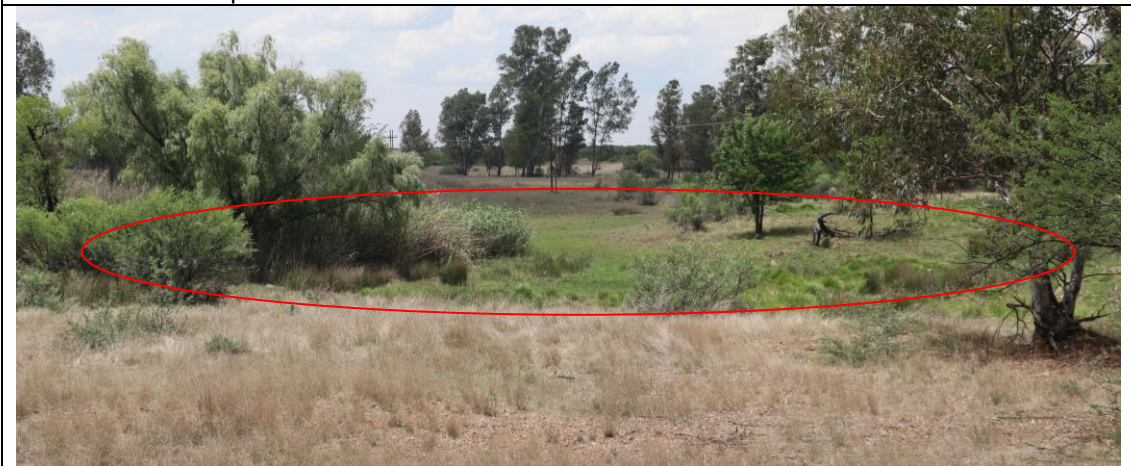
As drainage lines near the riparian zone of the Vaal River, wetland conditions become much more prominent.

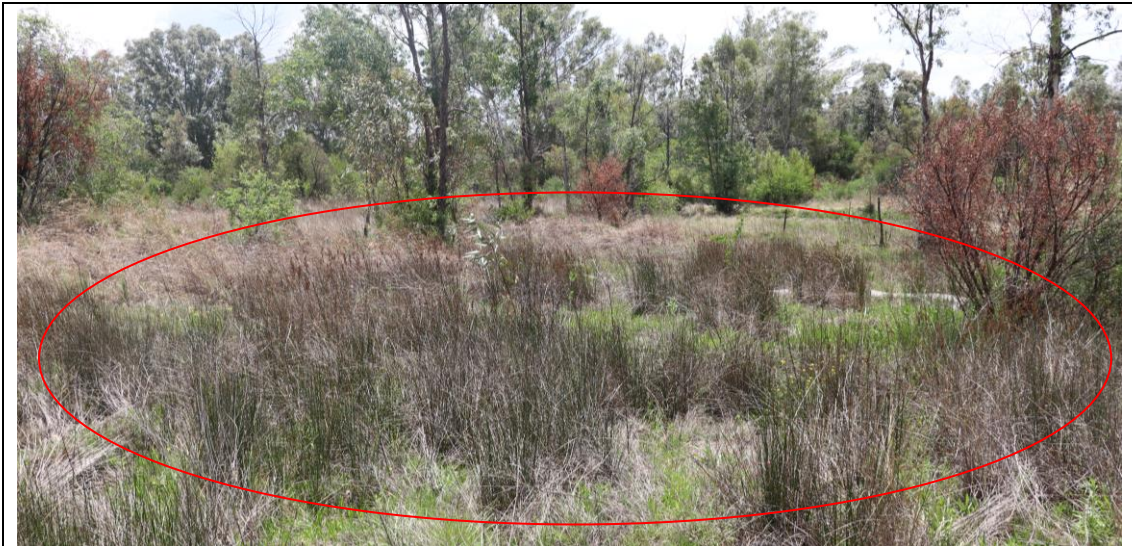
The downstream sections of the drainage lines, occurring in the floodplain of the Vaal River, contain clear wetland conditions though a main channel is shallow and not distinct.

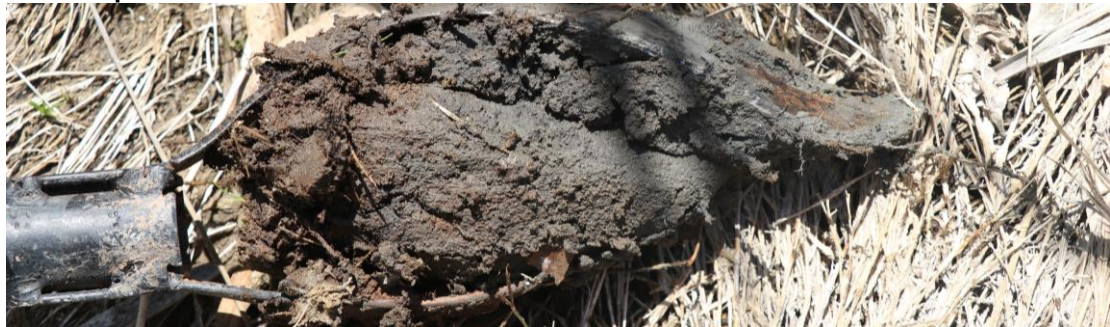
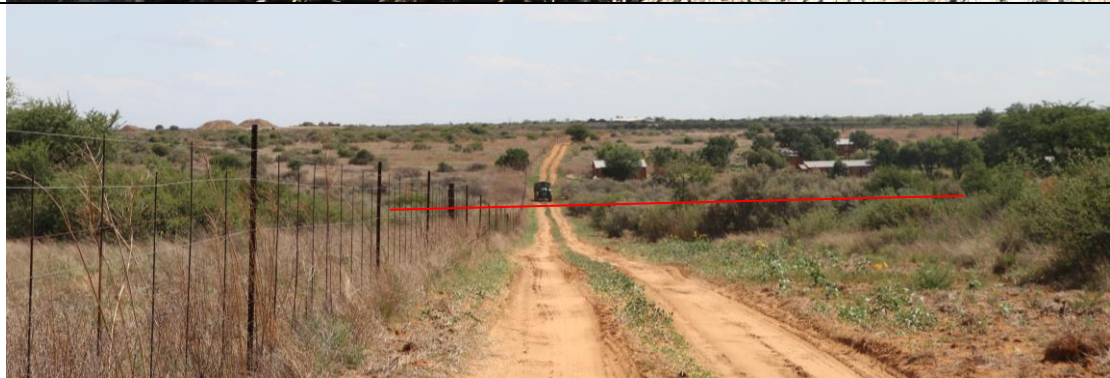
The upstream sections of the drainage lines are not well defined but are visible as low points in the landscape.

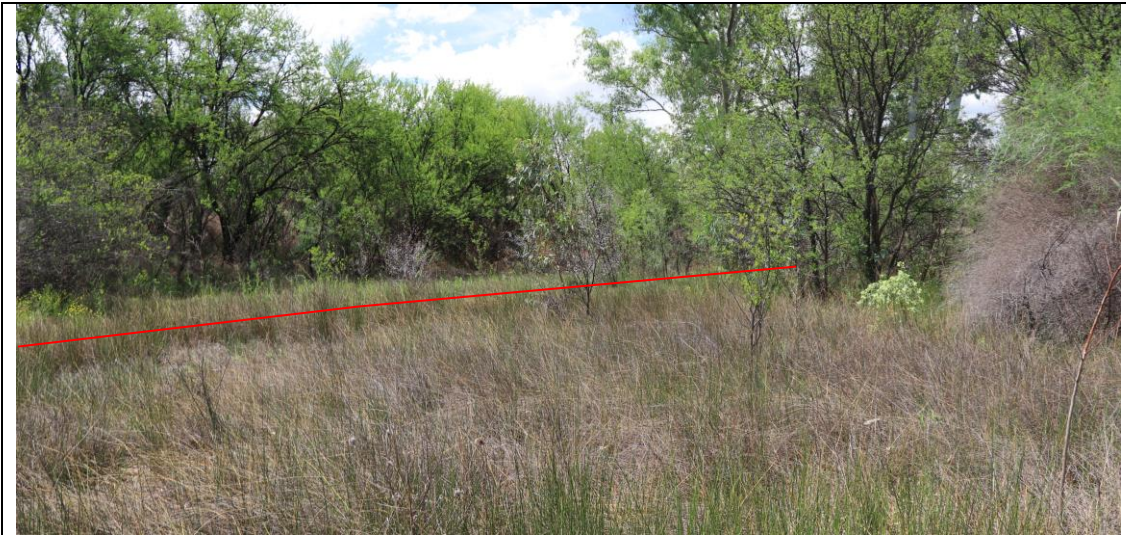
The downstream sections of the drainage lines contain clearer wetland conditions with riparian trees along the banks.

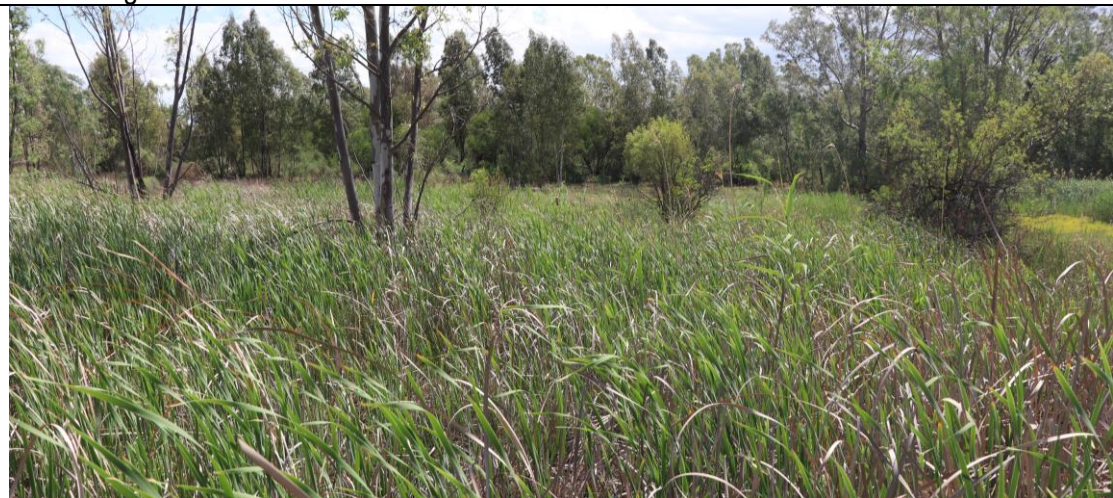
The sections of the drainage lines occurring in the floodplain of the Vaal River contain quite extensive wetland conditions.

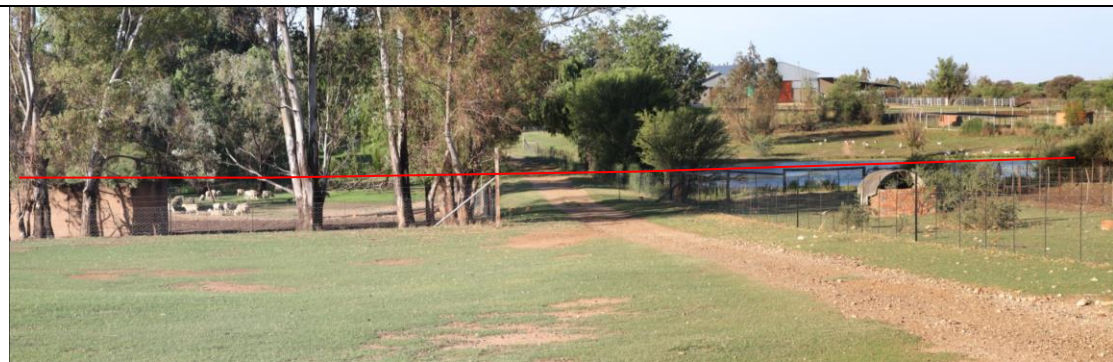
Over the course of the drainage lines they are affected by a range of agricultural operations.

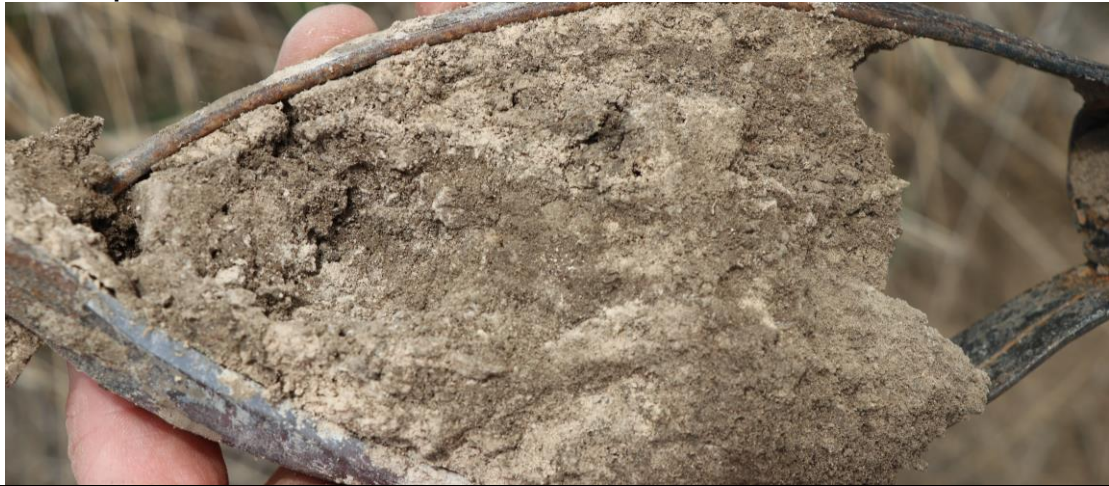
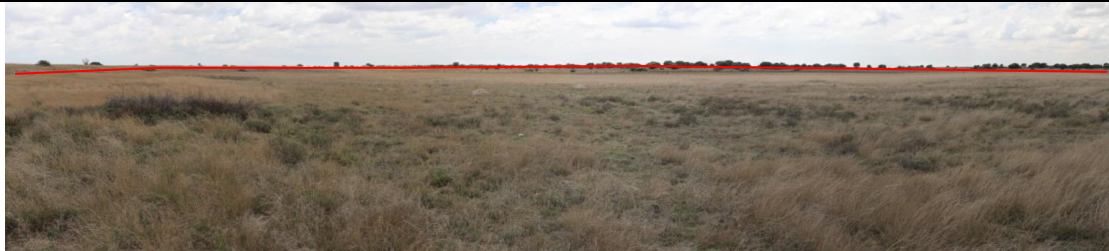
The pan is fairly large and within the interior basin dominated by hygrophilous grasses.

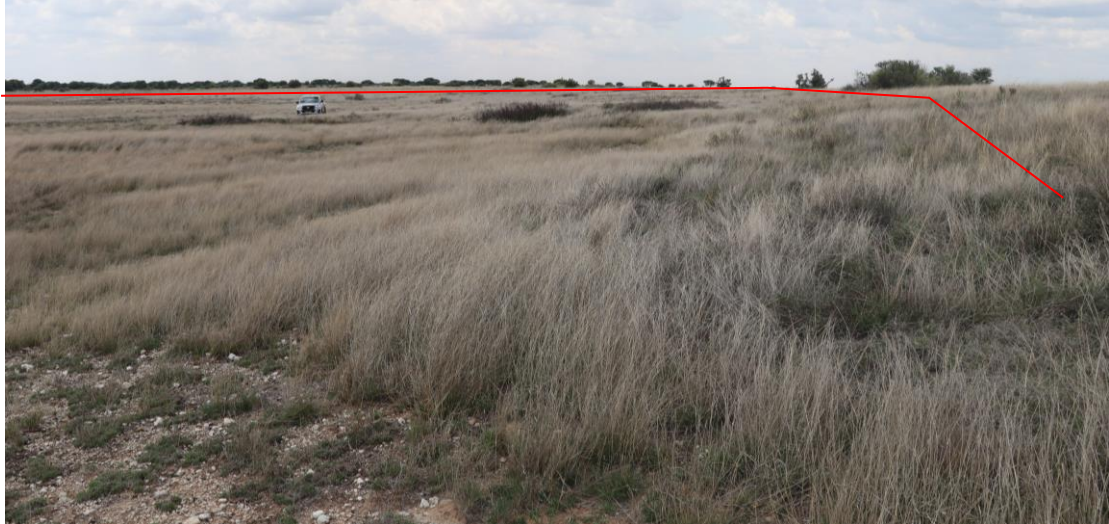
The pan has a well defined edge or shore.

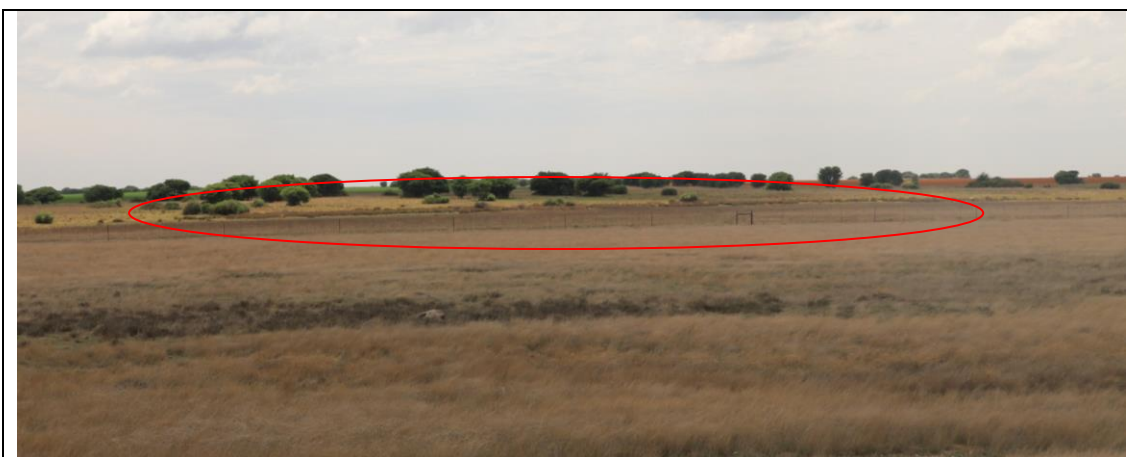
The side of the pan bordering on irrigation areas has a much more defined wetland component, a consequence of runoff and seepage from irrigation areas.
