Report on the ecological and wetland assessment for the proposed alluvial diamond mining operations on various portions of the farms Vanaswegenshoek 493 and Greylingslyn 355 along the Vaal River near the town of Christiana, Free State Province.

November 2021

Darius van Rensburg

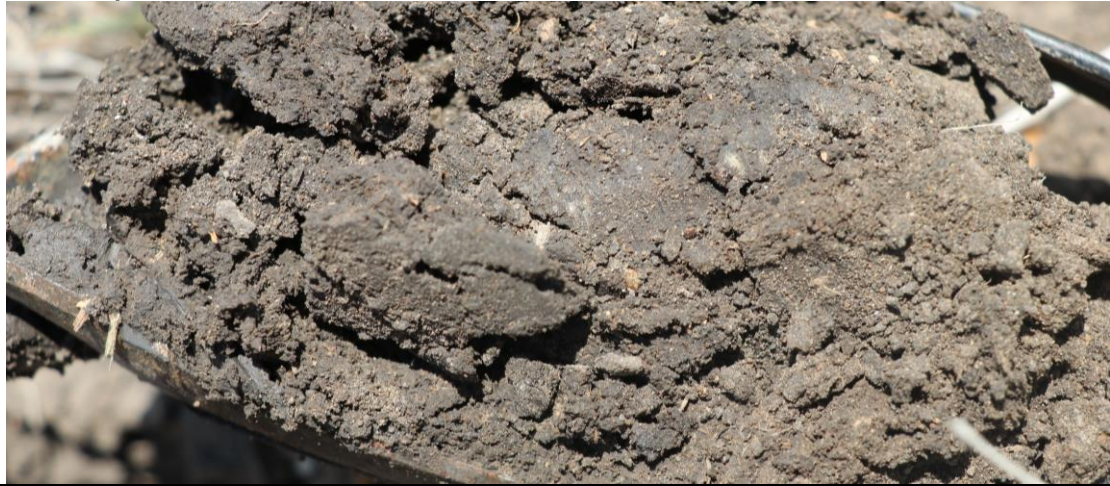
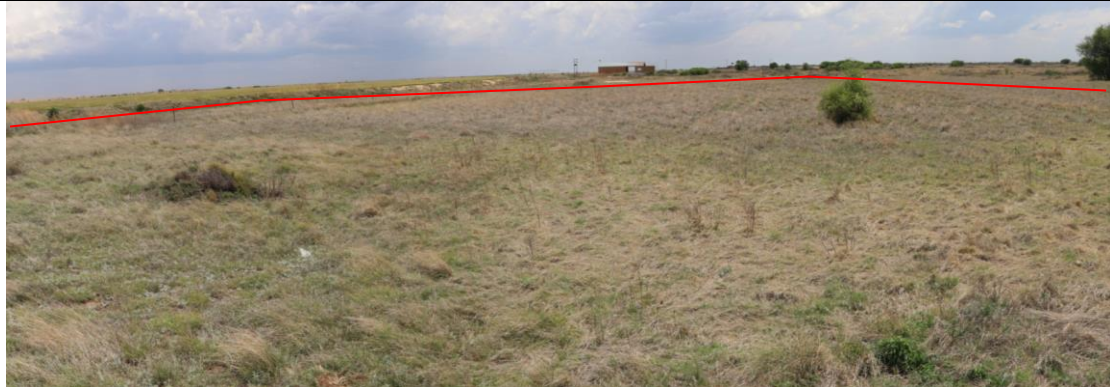
The pan is quite degraded but still easily discernible as a depression wetland.

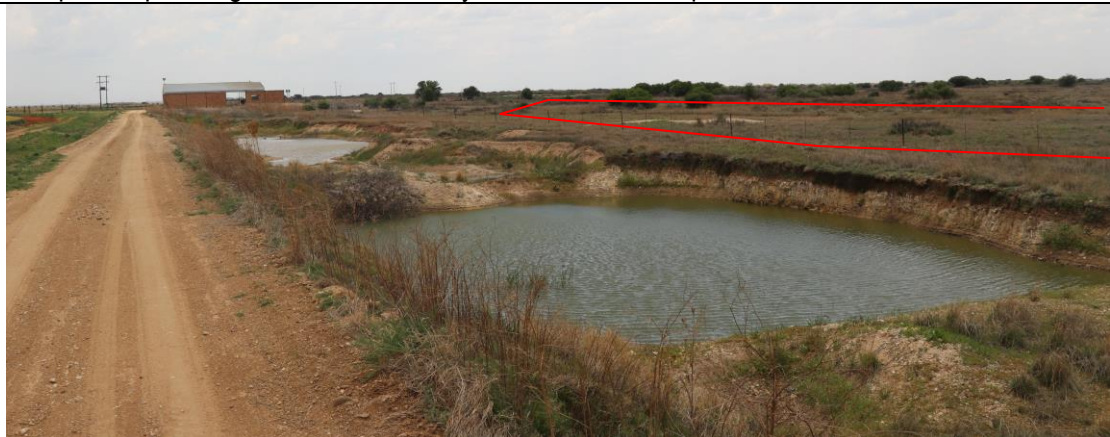
Large excavations adjacent to the pan (red) will result in large impacts, especially in terms of the hydrology of the pan.

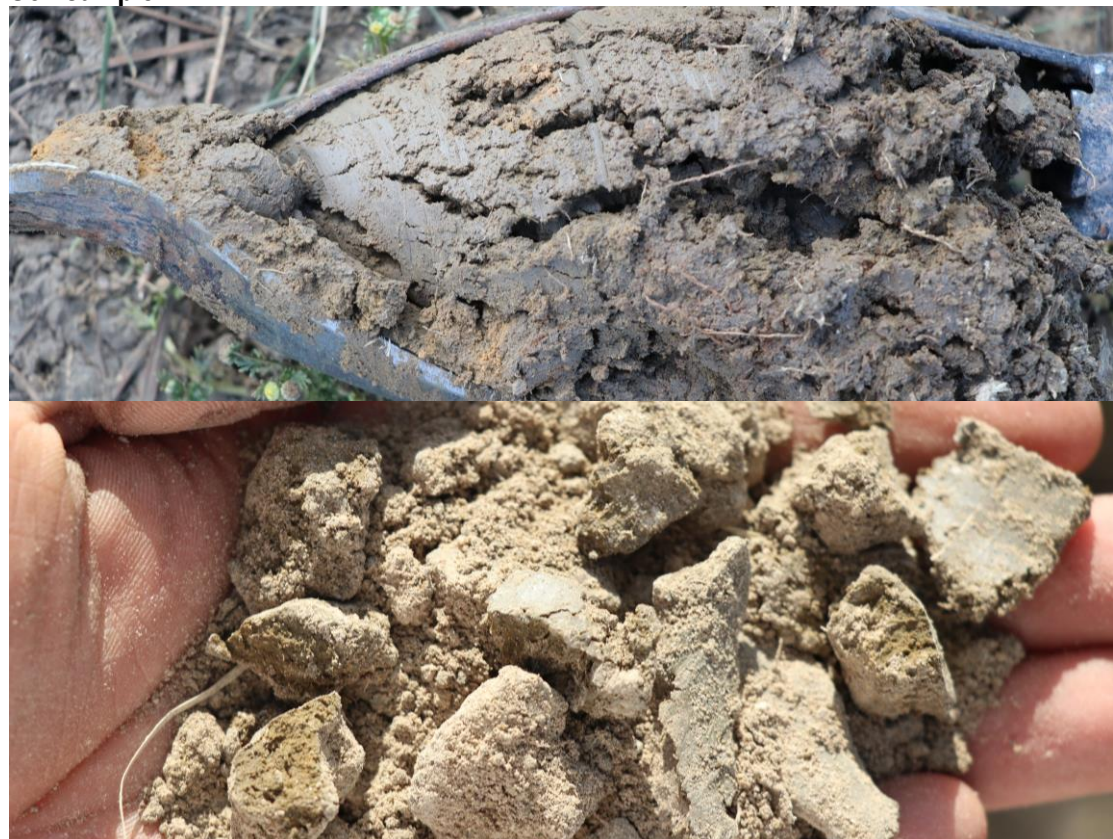
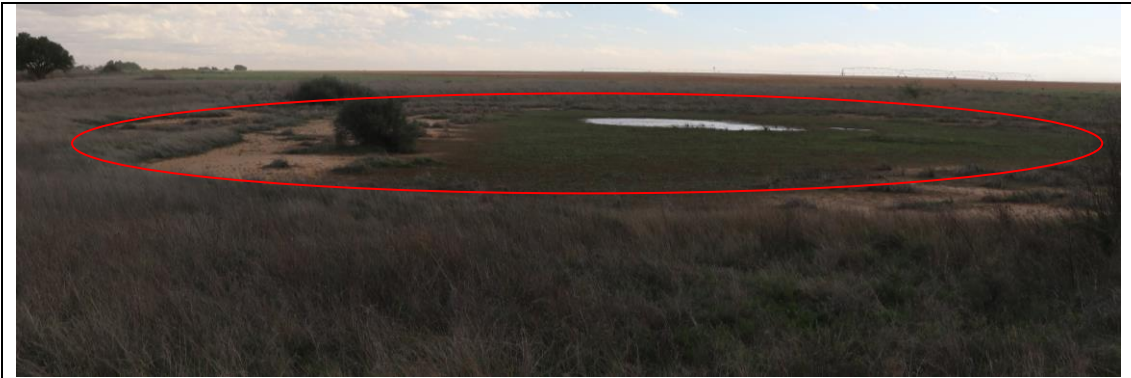
The pan is clearly quite small but forms well-defined depression wetland.

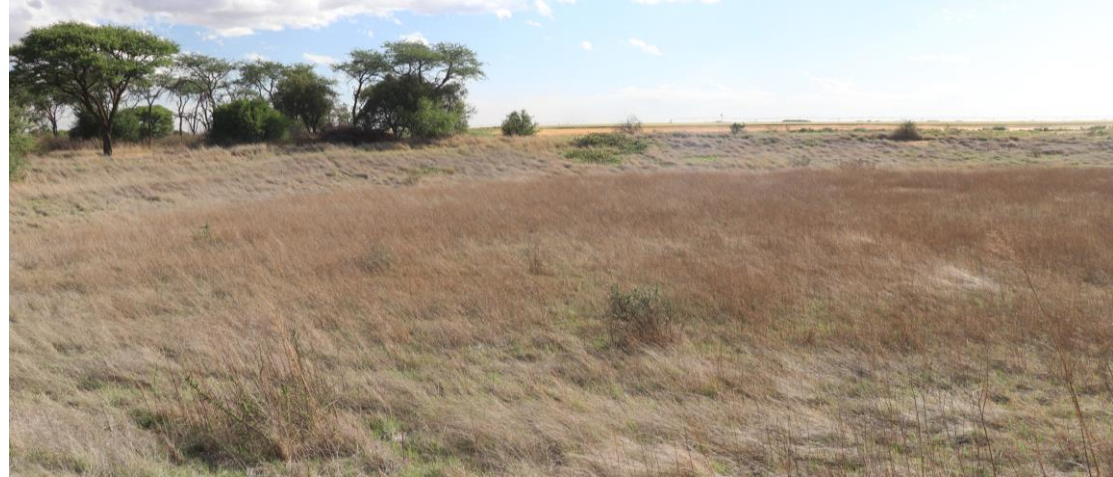
The adjacent pan is also clearly visible though heavily degraded by the artificial building of the surrounding pan edge.

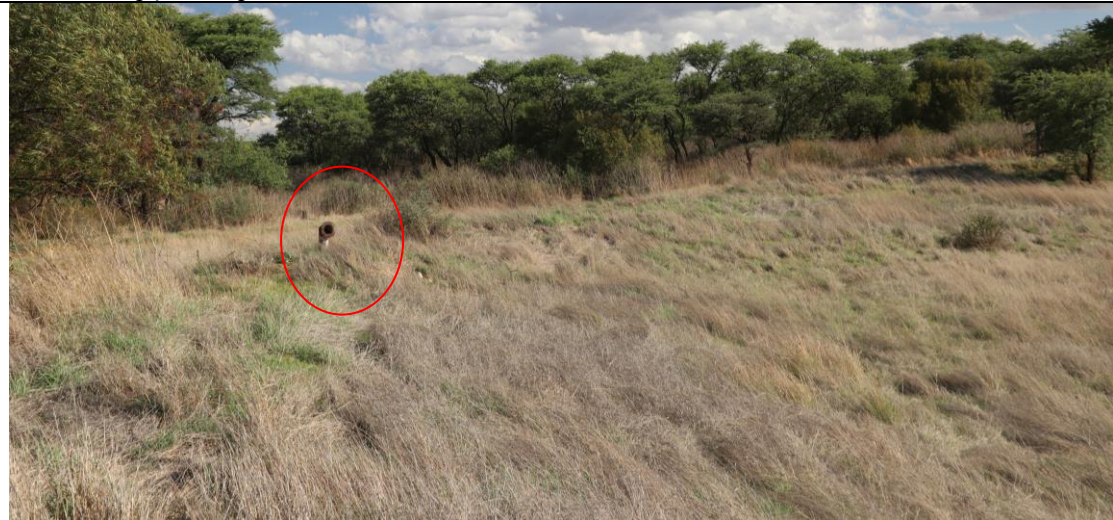
It is highly likely that the more degraded of the two pans was previously used as containment dam.

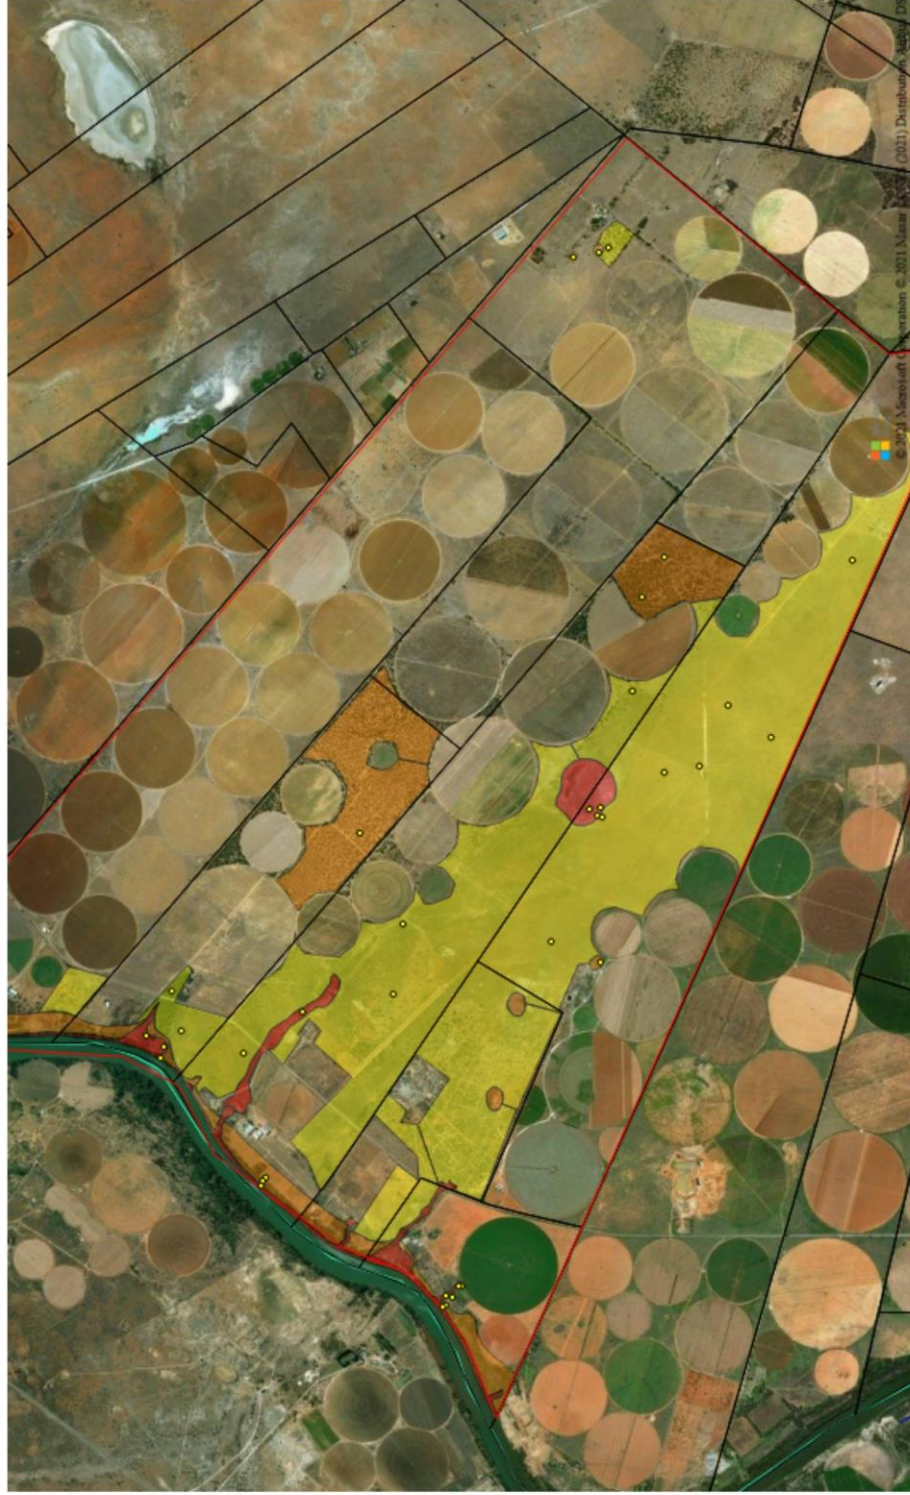
Map 4: Sensitivity map of the proposed mining operations on the Farms Vanaswegenshoek 493 and Greylingslyn 355 near the town of Christiania. Those portions of the site being transformed by agriculture and mining has not been delineated but would be considered to be of Low Sensitivity. Areas of Moderate Sensitivity consist of remaining natural areas but which are fairly uniform and not regarded to be of high conservation value. Areas of High Sensitivity include significant portions of intact woodland, degraded small pan systems and the floodplain or riparian zone of the Vaal River. The banks of the Vaal River, associated wetland areas and all the lateral drainage lines as well as the large pan system in the centre of the site are regarded to be of Very High Sensitivity.

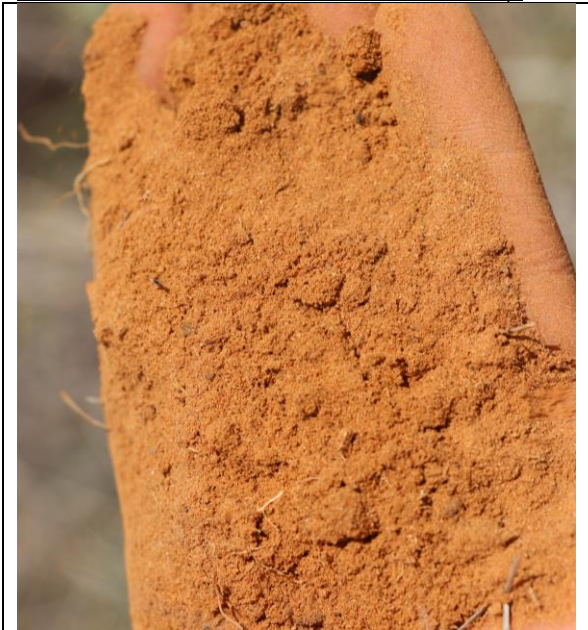
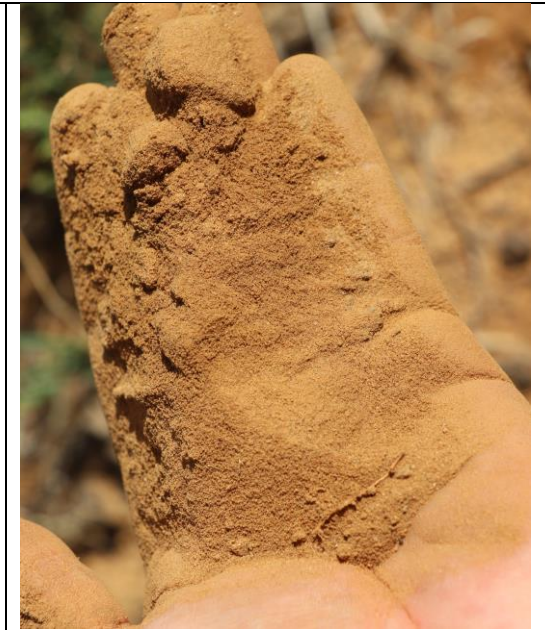
<p>Soil sample taken in the terrestrial area in the western portion of the site Soils are sandy with a reddish brown colouration and unconsolidated without a grey matrix or any mottling and represent soils without any wetland conditions. This soil sample will be used to compare other soil samples against.</p>	<p>Soil sample taken in the terrestrial area in the central portion of the site Soils are sandy with a reddish brown colouration and unconsolidated without a grey matrix or any mottling and represent soils without any wetland conditions. This soil sample will be used to compare other soil samples against.</p>

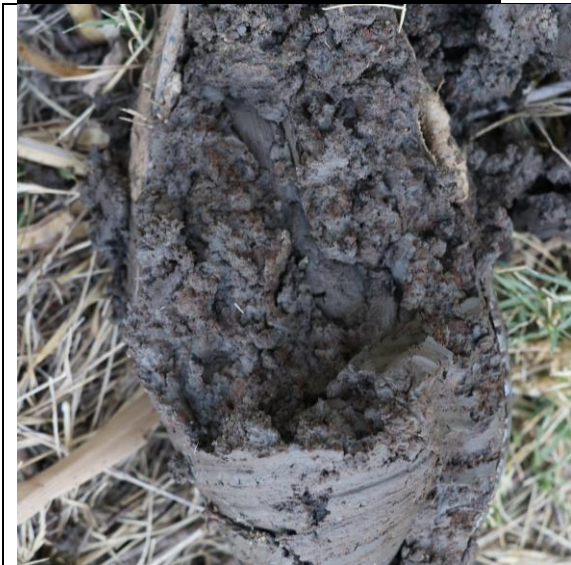
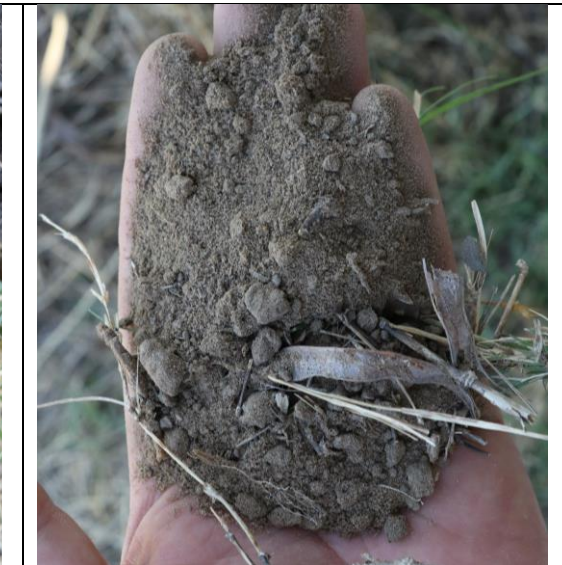
<p>Soil sample taken in the marginal zone of the river. A prominent grey matrix (>10%) is clear and faint mottling is present indicating a permanent zone of wetness. Wetland conditions are therefore clearly present.</p>	<p>Soil sample taken in the lower zone of the river bank. A grey matrix (<10%) is present although mottling is very faint and can only be regarded as a seasonal zone of wetness. Wetland conditions are therefore present though not prominent.</p>

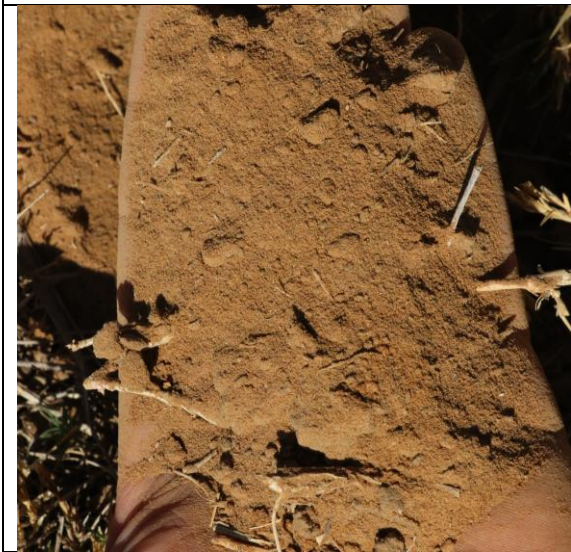
<p>Soil sample taken in the upper zone of the river bank. A grey matrix and mottling is clearly absent and wetland conditions are not present. A high silt content does indicate it still forming part of the floodplain.</p>

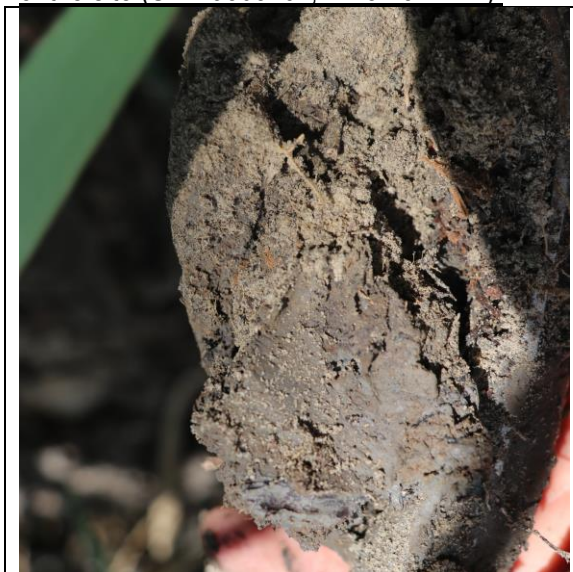
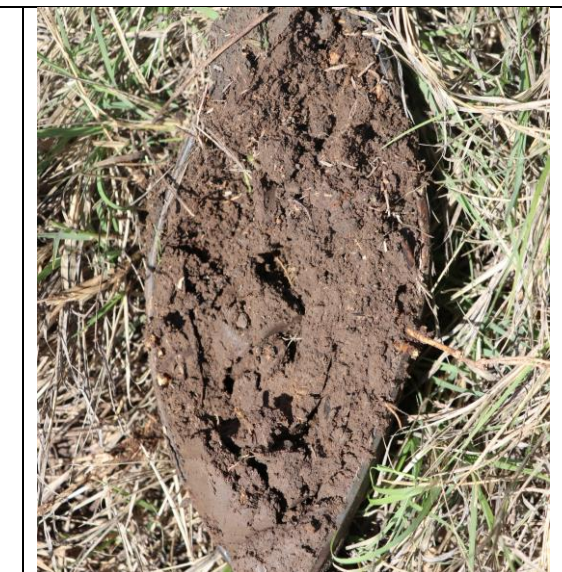
<p>Soil sample taken in the marginal zone of the river. A prominent grey matrix (>10%) is clear and prominent mottling is present indicating a permanent zone of wetness. Wetland conditions are therefore clearly present.</p>	<p>Soil sample taken where a lateral drainage line flows into the Vaal River. A grey matrix (<10%) is present with some mottling also visible and can only be regarded as a seasonal zone of wetness. Wetland conditions are therefore present though not prominent.</p>

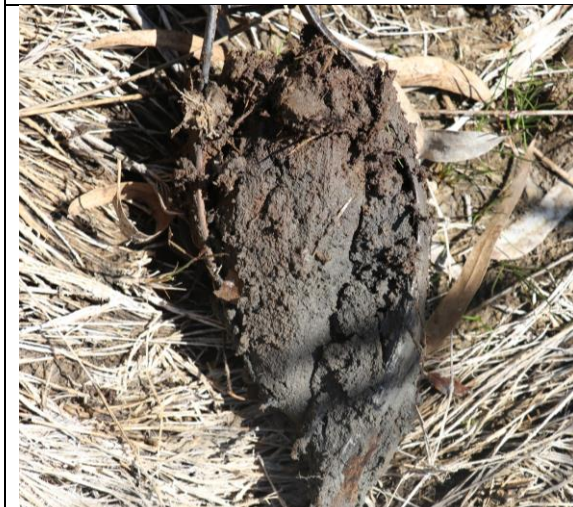
<p>Soil sample taken where a lateral drainage line flows into the Vaal River. A grey matrix (>10%) is prominent with clear mottling and with some mottling also visible indicating a permanent zone of wetness. Wetland conditions are therefore clearly present.</p>

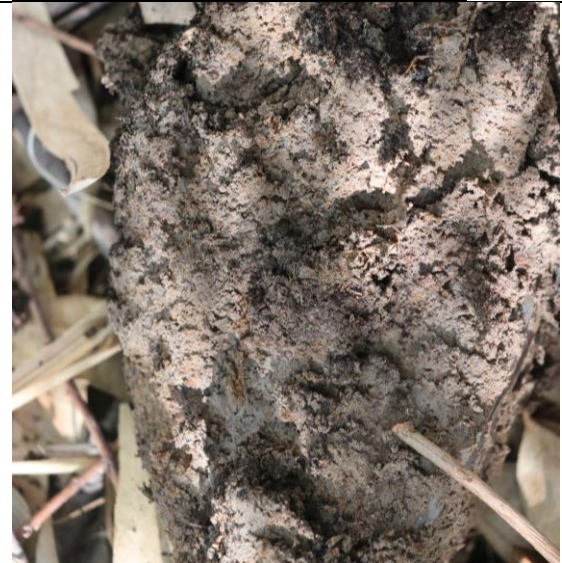
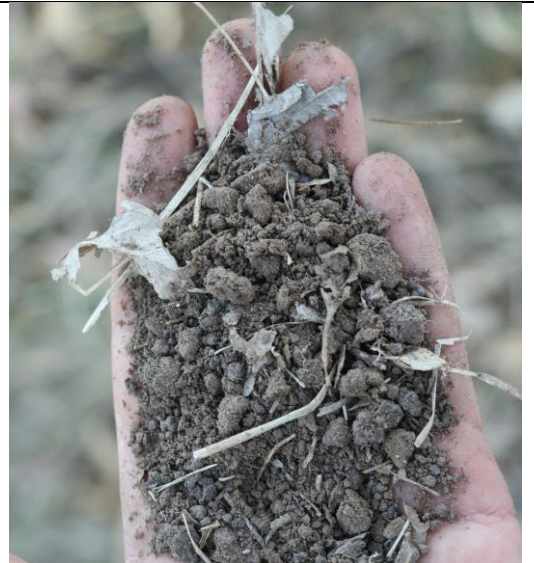
<p>Soil sample taken in the marginal zone of the river. A prominent grey matrix (>10%) is clear and feint mottling is present indicating a permanent zone of wetness. Wetland conditions are therefore clearly present.</p>	<p>Soil sample taken in the upper zone of the river bank. A grey matrix and mottling is clearly absent and wetland conditions are not present. A high silt content does indicate it still forming part of the floodplain. This is also evident when compared to the reference sample (Table 1).</p>

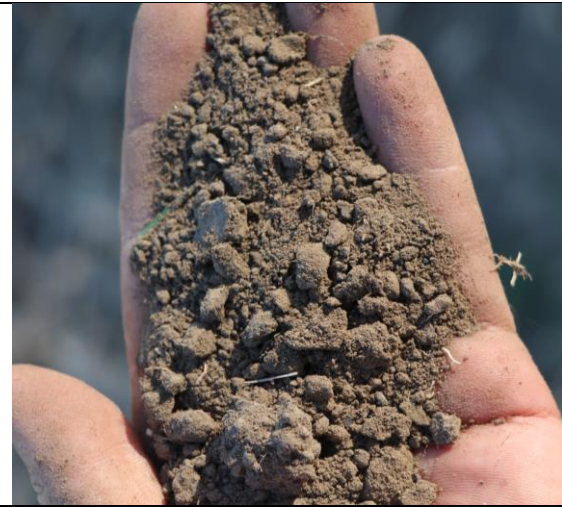
<p>Soil sample taken in the upper zone of the river bank. A grey matrix and mottling is clearly absent and wetland conditions are not present. A high silt content does indicate it still forming part of the floodplain. This is also evident when compared to the reference sample (Table 1).</p>

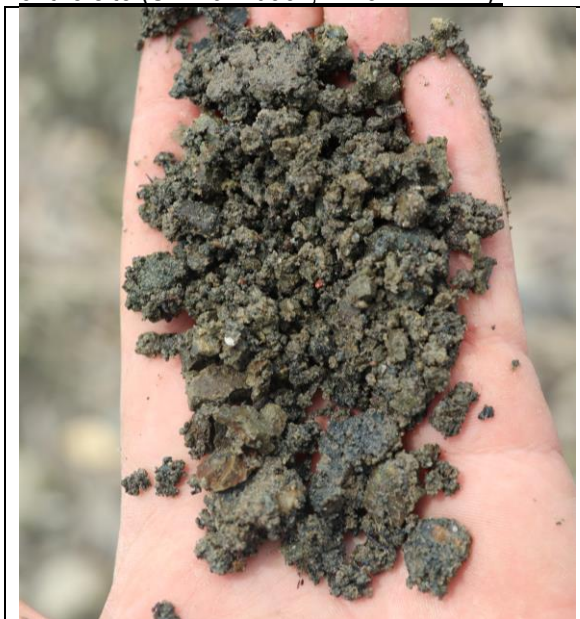
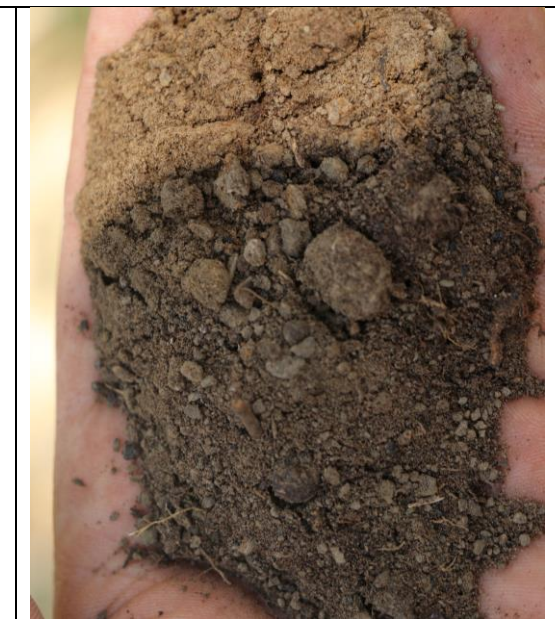
<p>Soil sample taken in the marginal zone of the river. A prominent grey matrix (>10%) is clear and prominent mottling is present indicating a permanent zone of wetness. The soils has a high gravel content. Wetland conditions are clearly present.</p>	<p>Soil sample taken in the lower zone of the river bank. A grey matrix is not clear though a few mottles and oxidised root zones do indicate temporary saturation of soils. Wetland conditions are therefore present but only on a temporary basis.</p>

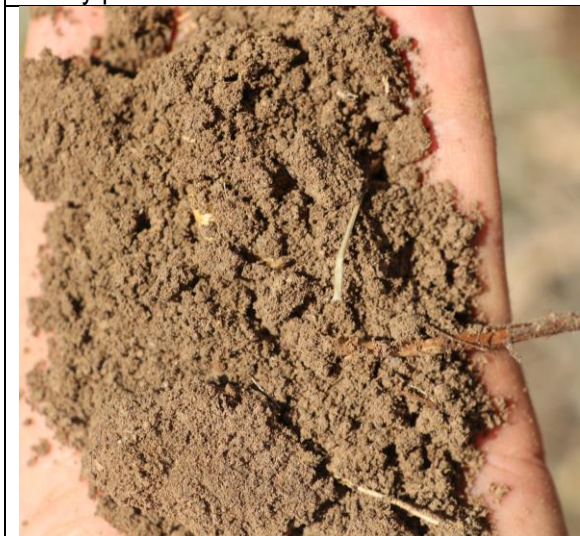
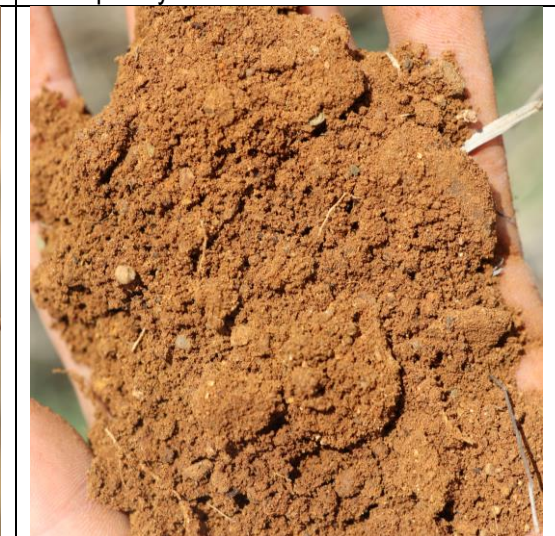
<p>Soil sample taken in the upper zone of the river bank. A grey matrix and mottling is clearly absent and wetland conditions are not present. A high silt content does indicate it still forming part of the floodplain.</p>	<p>Soil sample taken in adjacent terrestrial areas. Note the red colouration of the soil with low organic and silt content and absence of a grey matrix and mottling. This is clearly no longer within the riparian zone of the river.</p>
