ENVIRONMENTAL IMPACT ASSESSMENT FOR THE PROPOSED LETSOAI CSP 1

SOLAR POWER PLANT:

FAUNA & FLORA SPECIALIST ASSESSMENT

January 2017

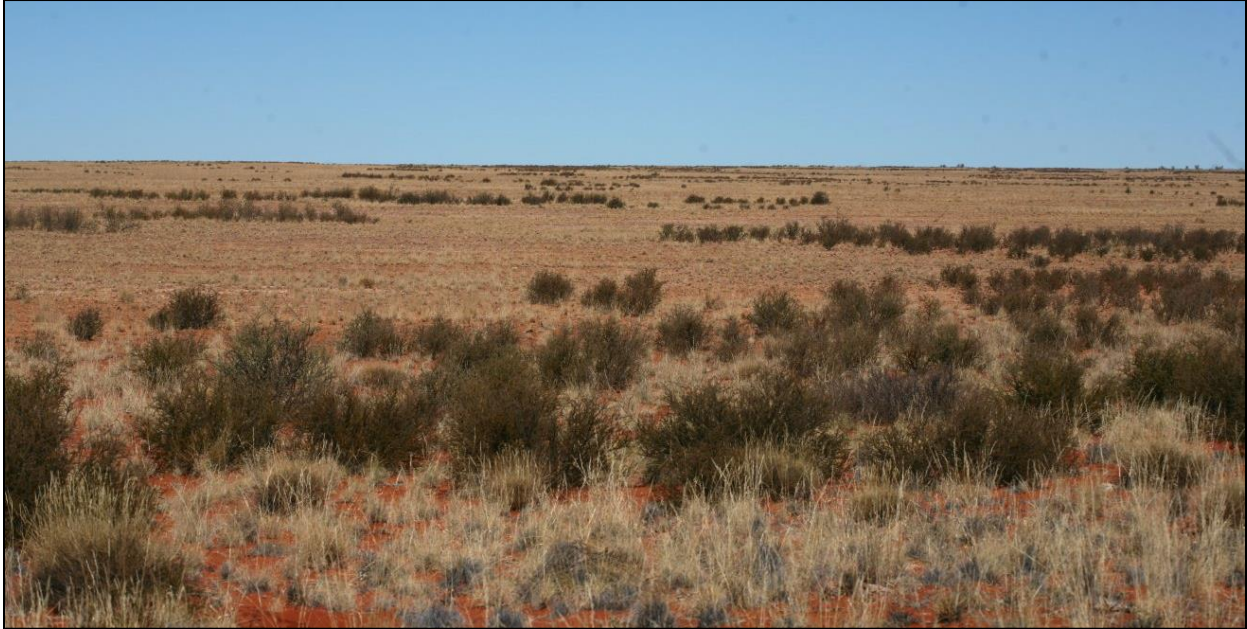
Deeper Aeolian soils within the CSP 1 site are dominated by various *Stipagrostis* grasses with occasional clumps of shrubs, largely *Rhigozum trichotomum*. These occur mostly in the west of the CSP 1 site.

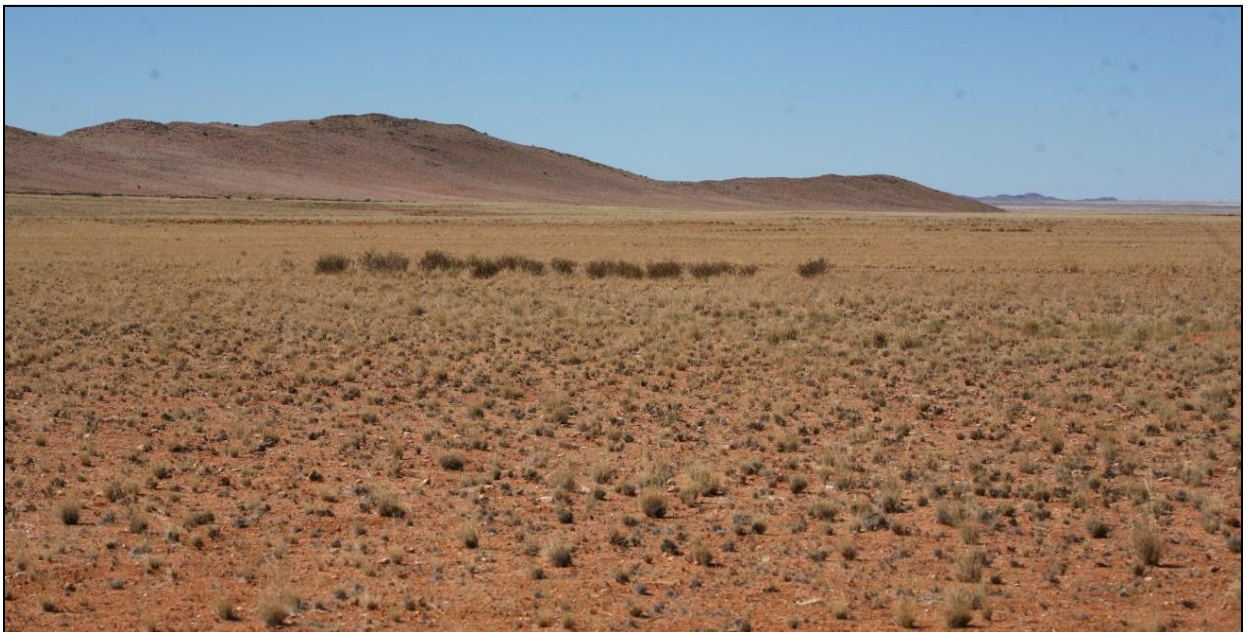
Looking northeast over the CSP 1 site, showing the extensive flat plain the site is located on and the homogenous nature of the vegetation and the lack of features within the development areas. The hill in the distance is outside of the development footprint.

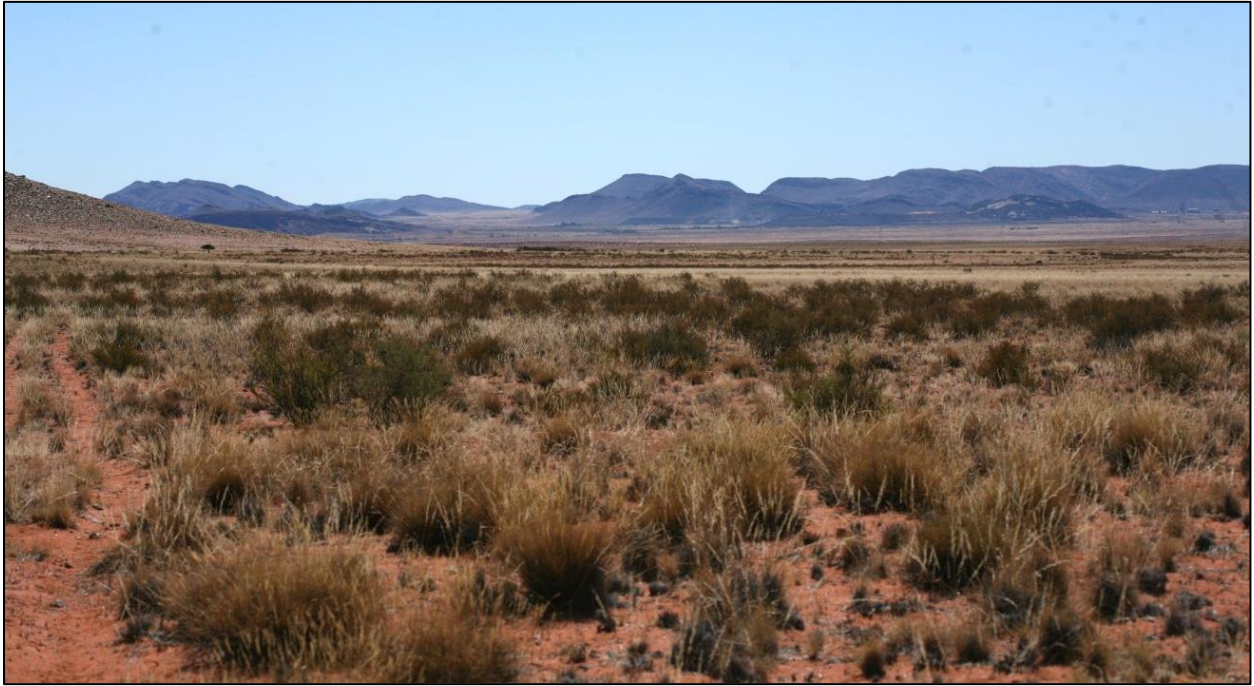
Looking along the alignment of Pipeline 1 and 3 from the site, towards Black Mountain which is visible in the distance. The vegetation is dominated by *Stipagrostis brevifolia* and *S.ciliata* with the shrubs being mostly *Rhigozum trichotomum*. The abundance of species and features of conservation concern in this area is low and it is not considered highly sensitive.

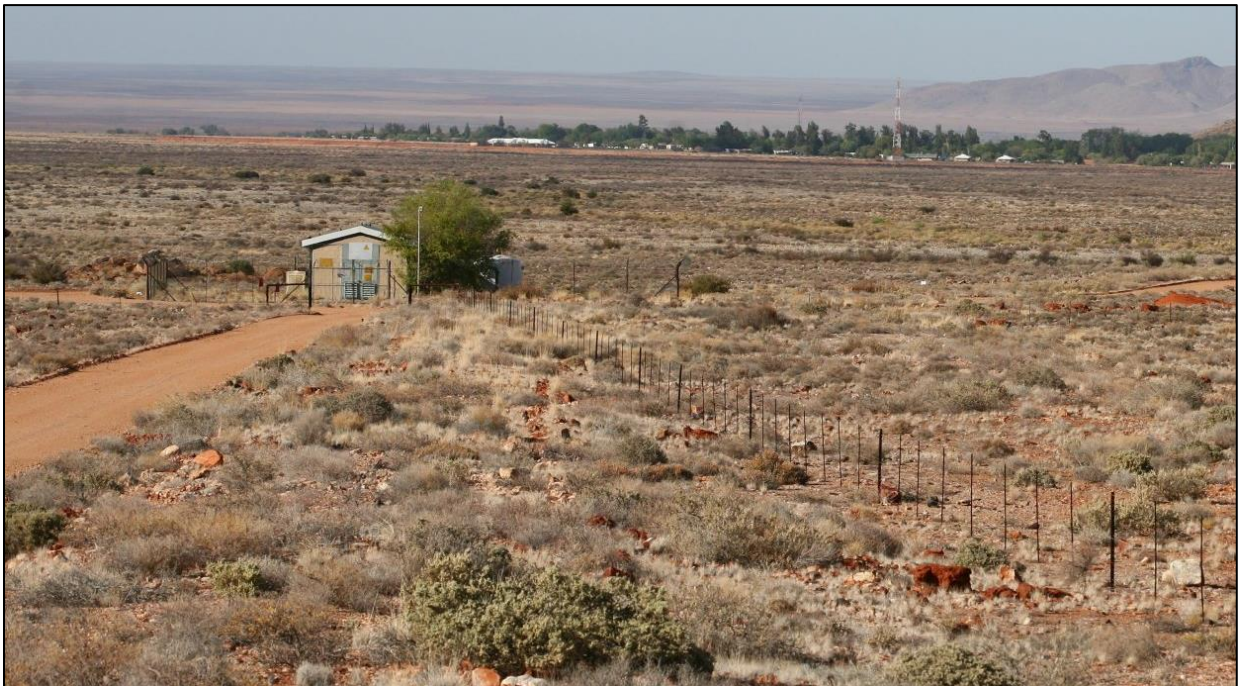
Looking back towards the Letsoai site from the water storage reservoir on Black Mountain Mine, showing the final alignment of Pipeline Option 1 and Option 2. This area is considered moderately sensitive on account of the presence of species and habitats of concern on the plains in this area, where quartz patches are present.

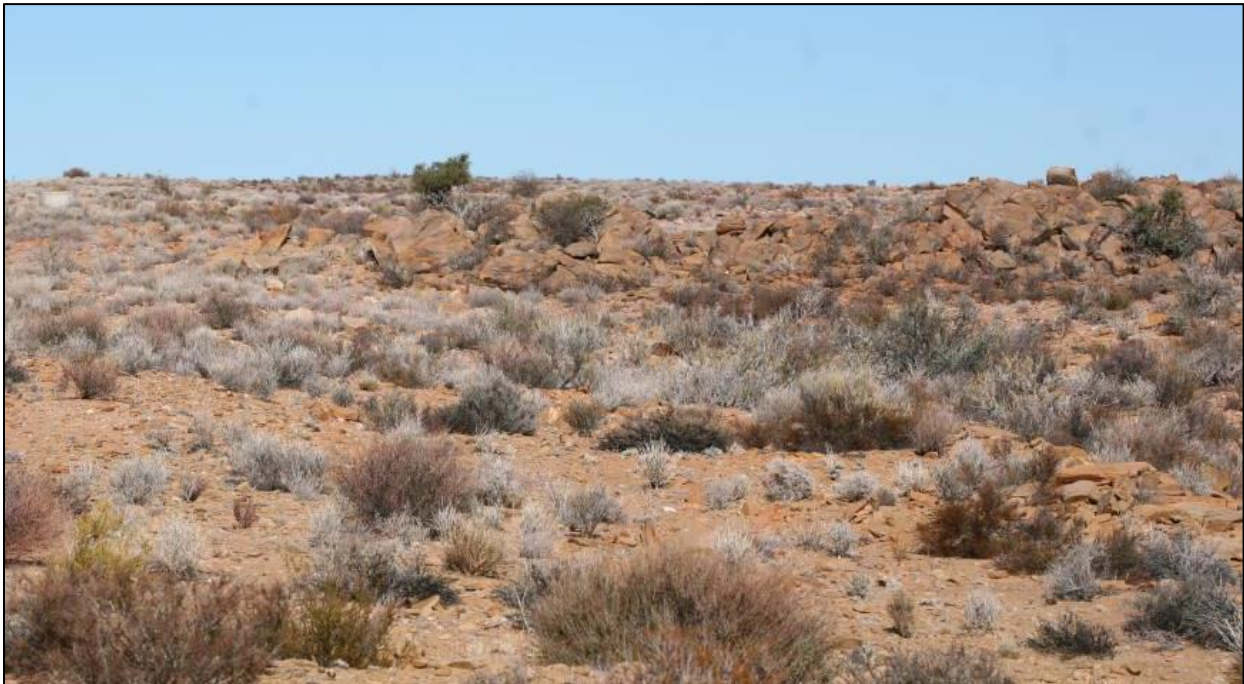
Typical rocky plains habitat along the Pipeline Option 3, between Pella and Aggeneys. The areas of rocky outcrops and shallow gravel soils along this section of the route are typically sensitive with an abundance of listed and endemic species including habitat specialists such as *Titanopsis* and *Lithops*.
