TRAFFIC PROJECTS/102 - Alfred Nzo Borrow Pit EMP's Study/Consultant & Contractor Site Map

Alfred Nzo Borrow Pit EMP's  
 Road: DR08015  
 Site Layout - BP15

D0815 BDM  
BORROW PIT SURVEY  
AND PLATFORM DESIGN

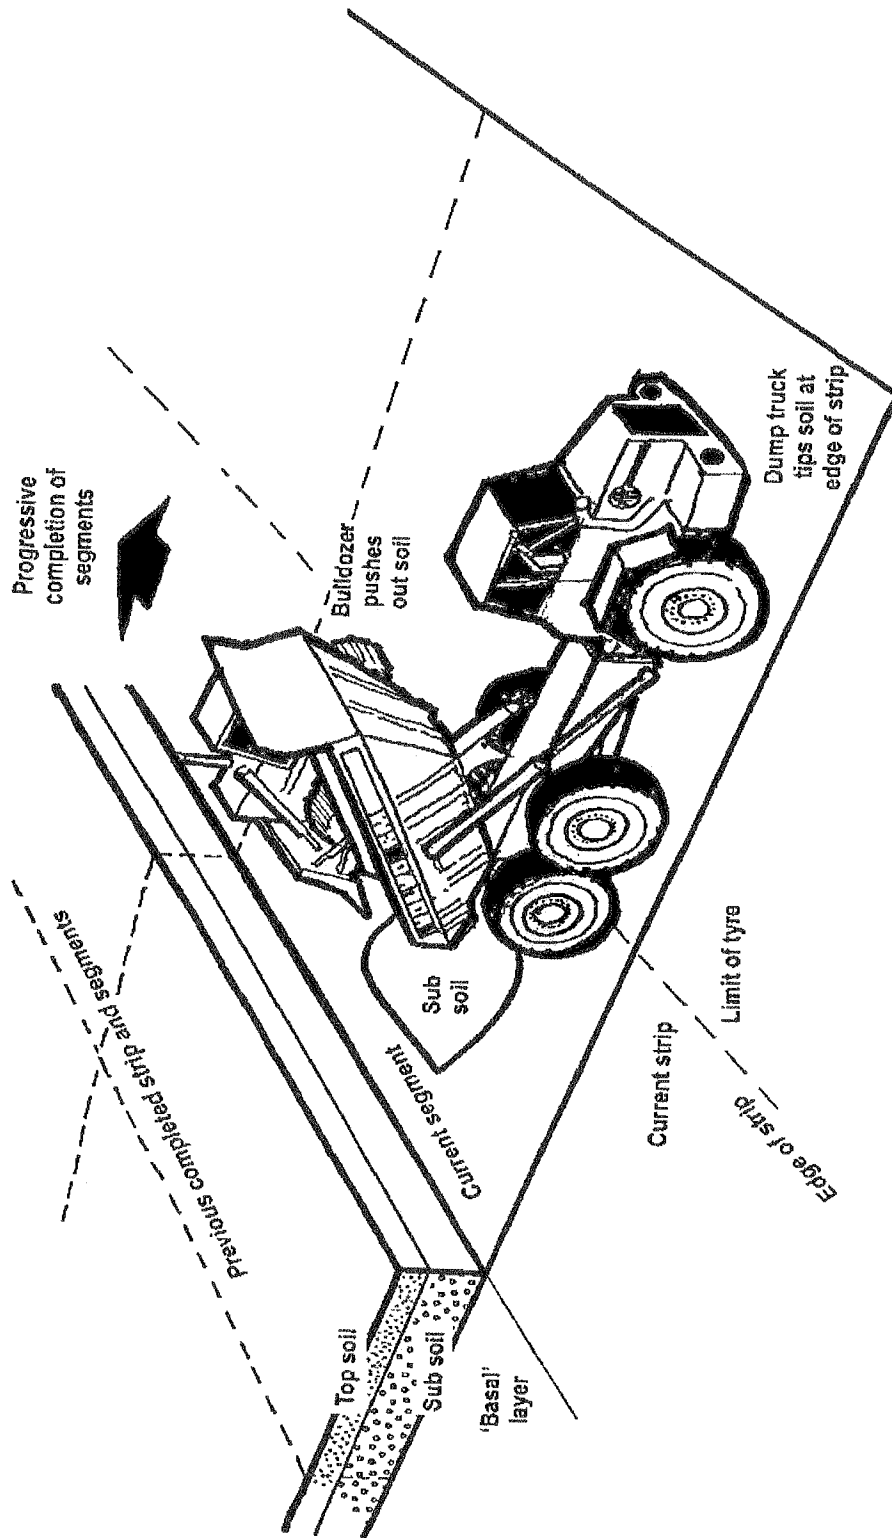
**Figure 15.1 Soil replacement by bulldozers  
 and dump trucks:  
 Sub soil layer**

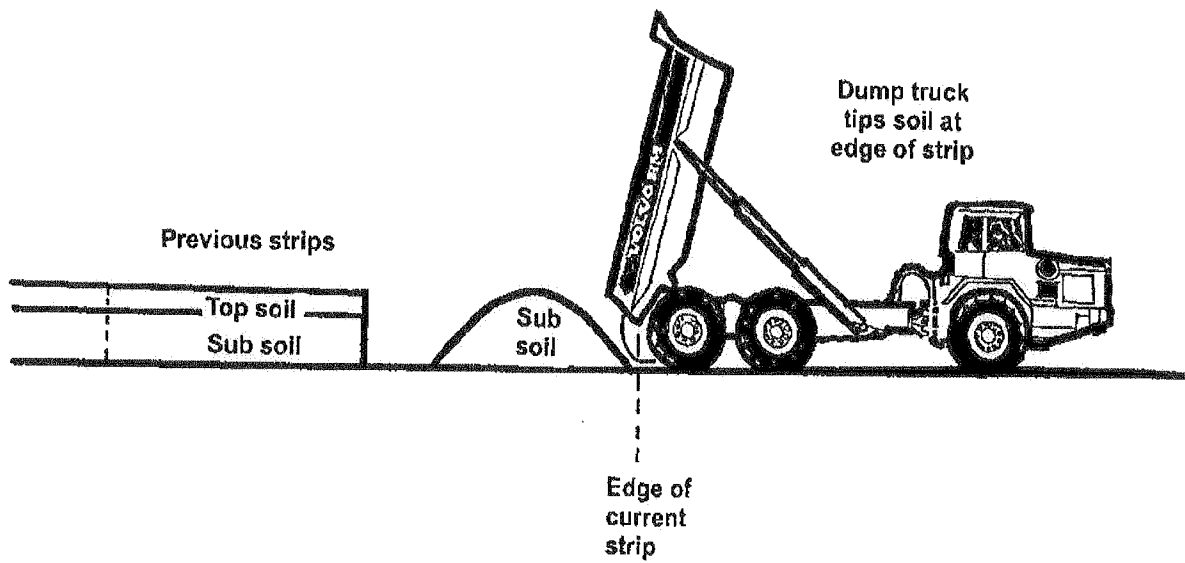
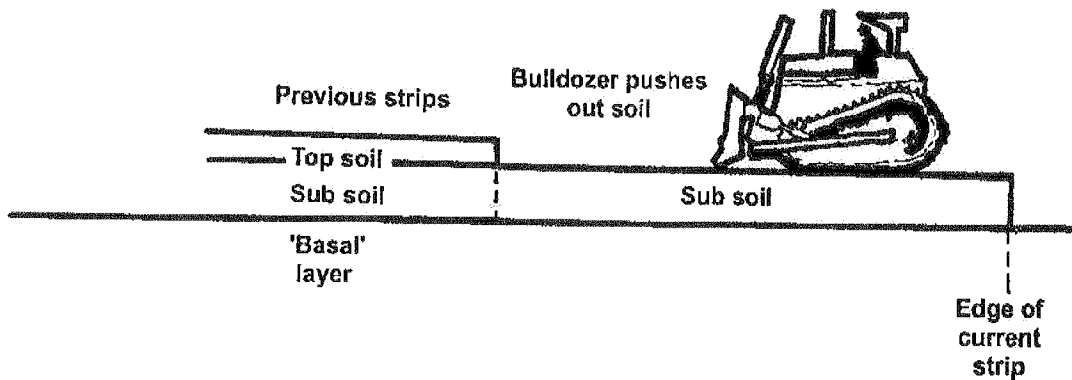
**Figure 15.2 Soil replacement by bulldozers and dump trucks:  
Sub soil layer**

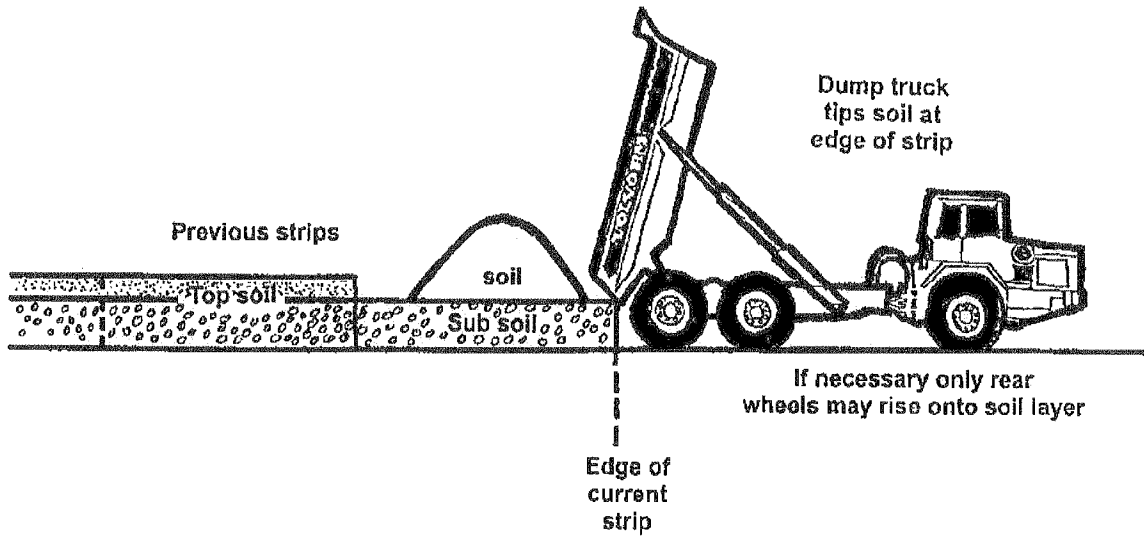
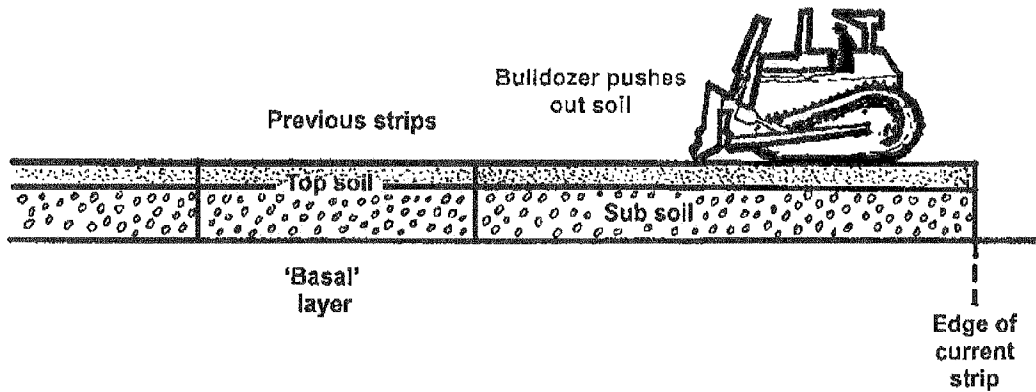
**Figure 15.3 Soil replacement by bulldozers  
 and dump trucks:  
 Top soil layer**
