**CONSULTATION IN TERMS OF SECTION 40 OF THE MPRDA OF 2002: PROPOSED BORROW PITS:
DR08071, ALFRED NZO DISTRICT MUNICIPALITY, EASTERN CAPE: DEPARTMENT OF ROADS AND
PUBLIC WORKS**

**ENVIRONMENTAL MANAGEMENT PLAN FOR THE
PROPOSED BORROW PITS ASSOCIATED WITH
MAINTENANCE OF THE DR08071 GRAVEL ROAD
IN THE ALFRED NZO DISTRICT MUNICIPALITY IN
THE EASTERN CAPE**

Prepared by: Terratest (Pty) Ltd
PO Box 794
Hilton
3245

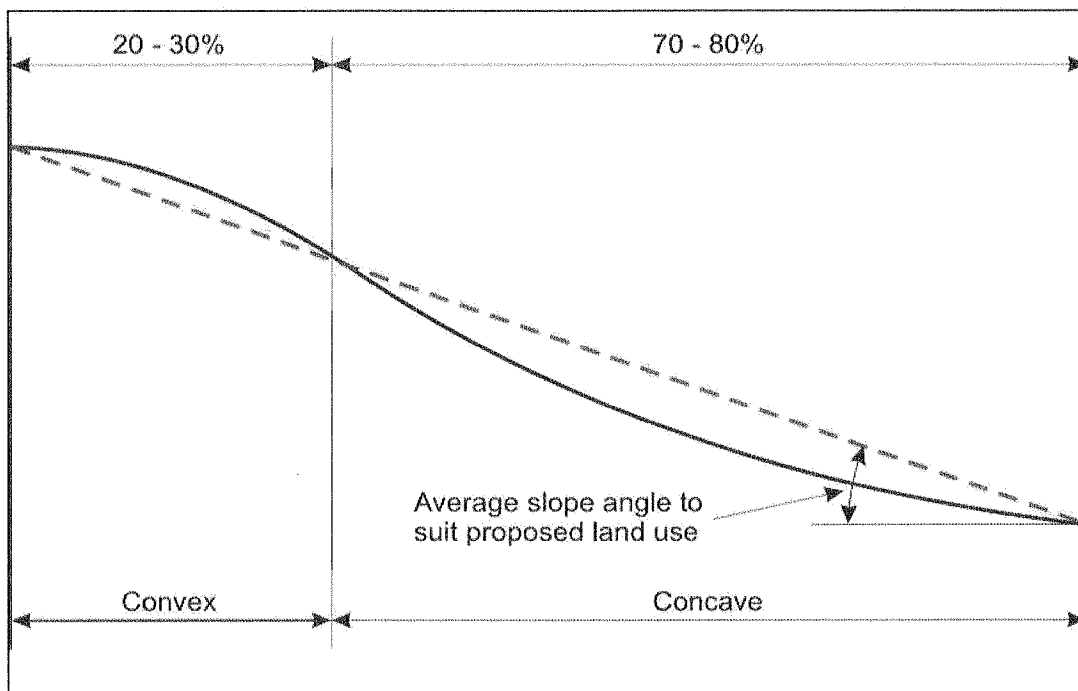
The final borrow pit plan shall leave cut faces sloped at a gradient not steeper than 1:3, not steeper than 3m each and separated by benches (see sketch below). The general direction of the slope of the borrow pit will be in the direction of the existing ground contours, as indicated on the site plans.

DESIGN OF SLOPE PROFILES (HANNAN, 1984) - (a) Preferred Profile

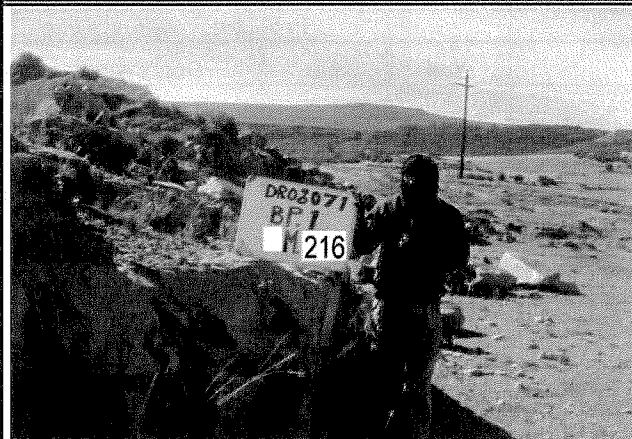
DR08071
BP1 - 216M
S30°14'30.4"
E28°36'43.5"
North East
Part of face - road and power line

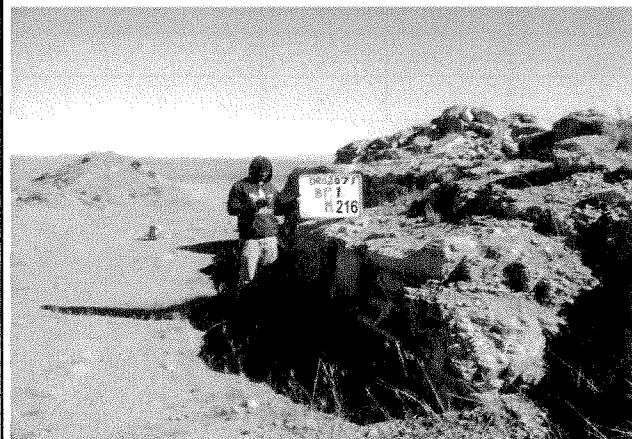
DR08071
BP1 - 216M
S30°14'30.1"
E28°36'44.0"
South West
Part of face - stockpile

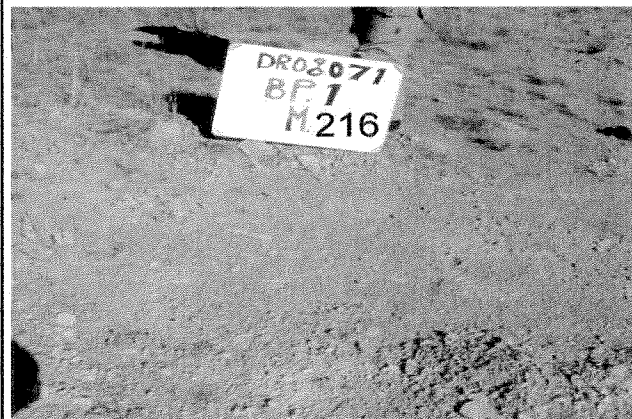
DR08071
BP1 - 216M
S30°14'29.5"
E28°36'44.9"
South West
Floor
