Title: D08129 BP03
BORROW PIT SURVEY
AND PLATFORM DESIGN

DATE: 26 JULY 2011	CLIENT: EASTERN CAPE DEPARTMENT OF ROADS AND TRANSPORT	TITLE: D80129 BORROW PIT 03 SURVEY AND PLATFORM DESIGN								SCALES
DRAWN BY GORDON DRAKE										Horizontal Scale: 400 Vertical Scale: 400
DESIGNED BY SABLE SURVEYS CC										DRAWING No.
SURVEYORS: SABLE SURVEYS CC										
ENGINEERS: TERRATEST

HERITAGE IMPACT ASSESSMENT OF
BORROW PITS IN ALFRED NZO DISTRICT MUNICIPALITY,
EASTERN CAPE PROVINCE, SOUTH AFRICA

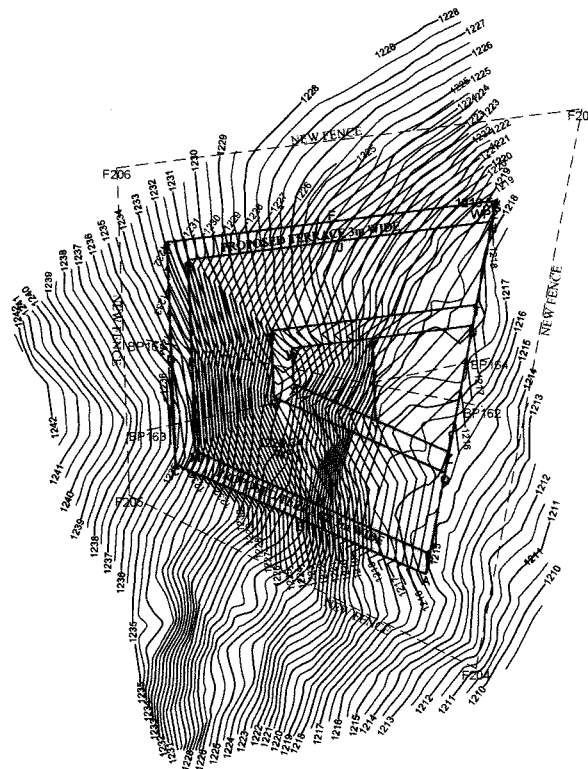
Description : D08129 BP01
Ground Surface : D129 BP01 DTM
Design Surface : D129 BP01 PLATFORM
Ground Hole Distance : 100.000
Design Hole Distance : 200.000
Grid Interval : 0.500
The unadjusted volumes are :-
3822.36 cu.m. total Cut
192.94 cu.m. total Fill
2147.83 sq.m. total area in Cut
321.79 sq.m. total area in Fill

Volumes adjusted for 100.00% compaction and 0.10m Topsoil stripping :-
3607.51 cu.m. Cut available for Fill
225.12 cu.m. of FILL is required giving:-
5382.40 cu.m. of excess Cut and:-
246.96 cu.m. of Topsoil to be stripped

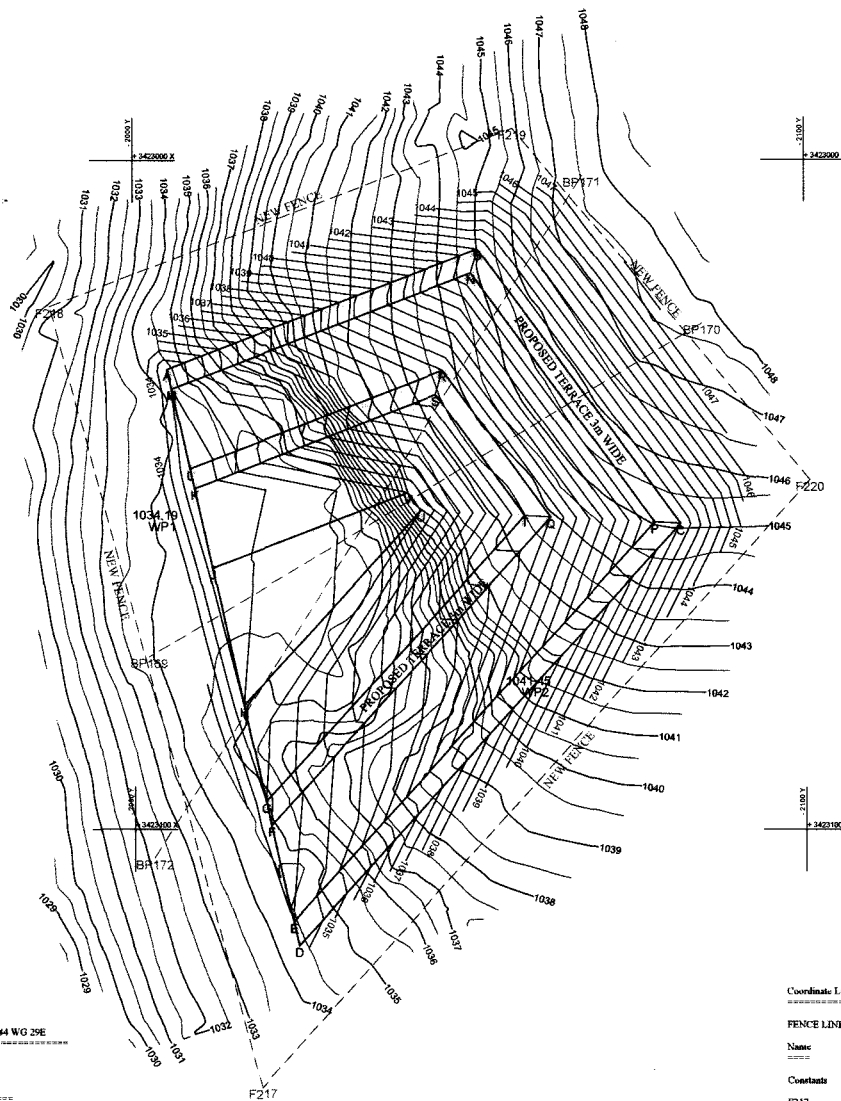
Description : D08129 BP03
Ground Surface : D129 BP03 DTM
Design Surface : D129 BP03 PLATFORM
Ground Hole Distance : 100.000
Design Hole Distance : 200.000
Grid Interval : 0.500
The unadjusted volumes are :-
14966.47 cu.m. total Cut.
3.49 cu.m. total FILL.
6305.63 sq.m. total area in Cut
39.75 sq.m. total area in FILL

Volumes adjusted for 100.00% compaction and 0.10m Topsoil stripping :-
14335.90 cu.m. Cut available for FILL
7.46 cu.m. of FILL is required pricing
14328.44 cu.m. of excess Cut and
634.54 cu.m. of Topsoil to be stripped

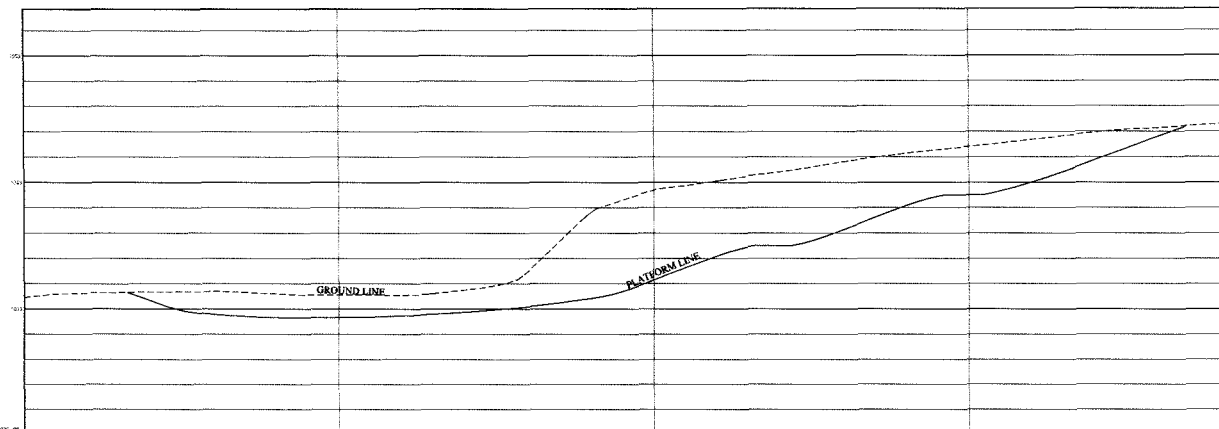
Vertical Alignment		Offset Flag Levels
	Grades	Design Platform Levels
		Left Edge
	Vertical Curves	Centre Line
		Right Edge
Superelevation		
Horizontal Curves		
Chapages

Long Section for 0.00 to 96.35 (BP169 TO BP170)

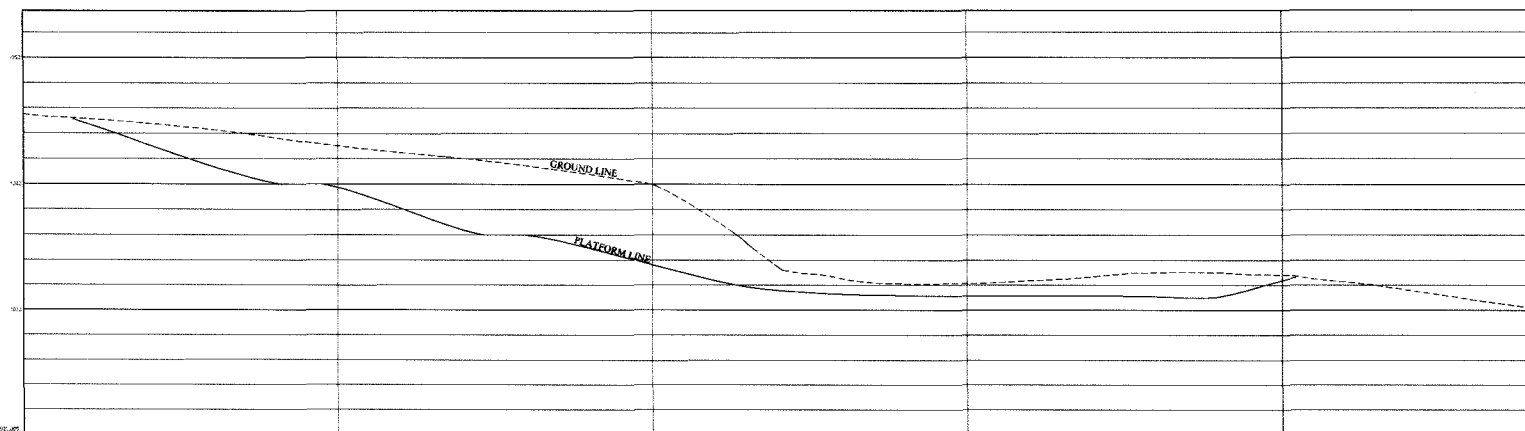
Sheet: 002-09									
Cliff Edge Levels									
Vertical Alignment	Design Platform Levels	Left Edge	180.52	180.52	180.52	180.52	180.52	180.52	180.52
		Center Line	180.52	180.52	180.52	180.52	180.52	180.52	180.52
		Right Edge	180.52	180.52	180.52	180.52	180.52	180.52	180.52
		Grades	180.52	180.52	180.52	180.52	180.52	180.52	180.52
	Vertical Curves		180.52	180.52	180.52	180.52	180.52	180.52	180.52
			180.52	180.52	180.52	180.52	180.52	180.52	180.52
Super-elevation									
Horizontal Curves									
Chamages		0	1.2	2.4	3.6	4.8	6.0	7.2	8.4

Long Section for 0.00 to 120.38 (BP171 TO BP172)

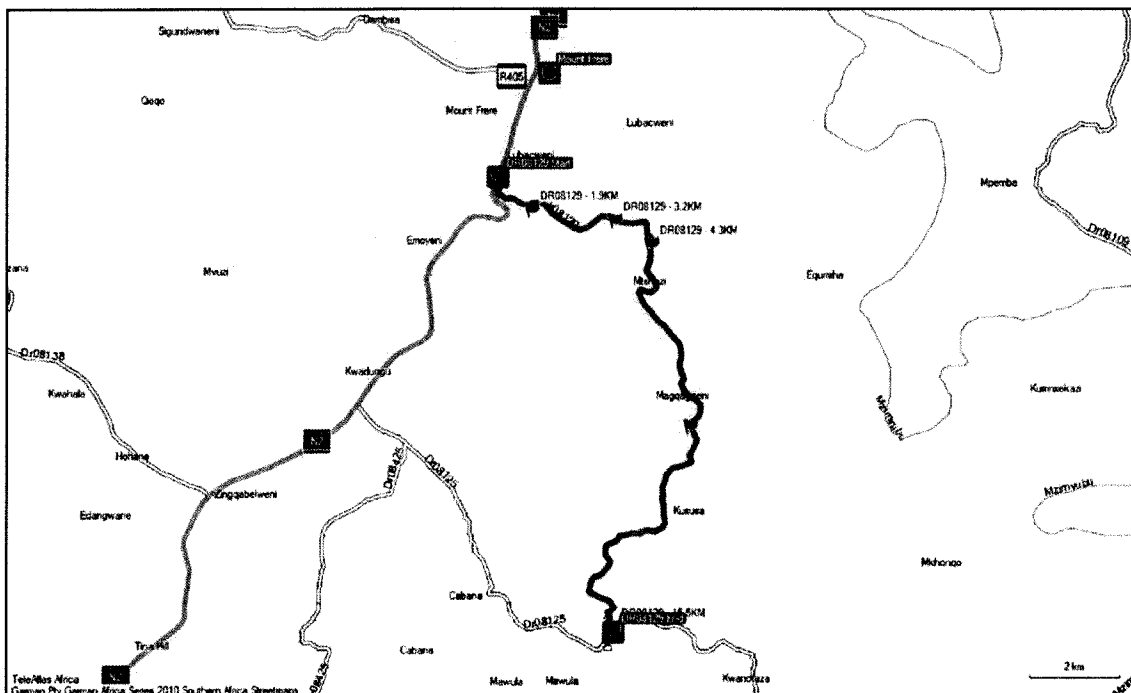
Figure 1. The alignment of the DR08129 (in pink) (Controlab CC).¹

The borrow pits are located on the DR08129, which is a gravel road situated 2 km's south of the town of Mt Frere (See Figure 1 below). The road starts at the intersection with the N2 and runs in an easterly direction to end at the intersection with the DR08125.

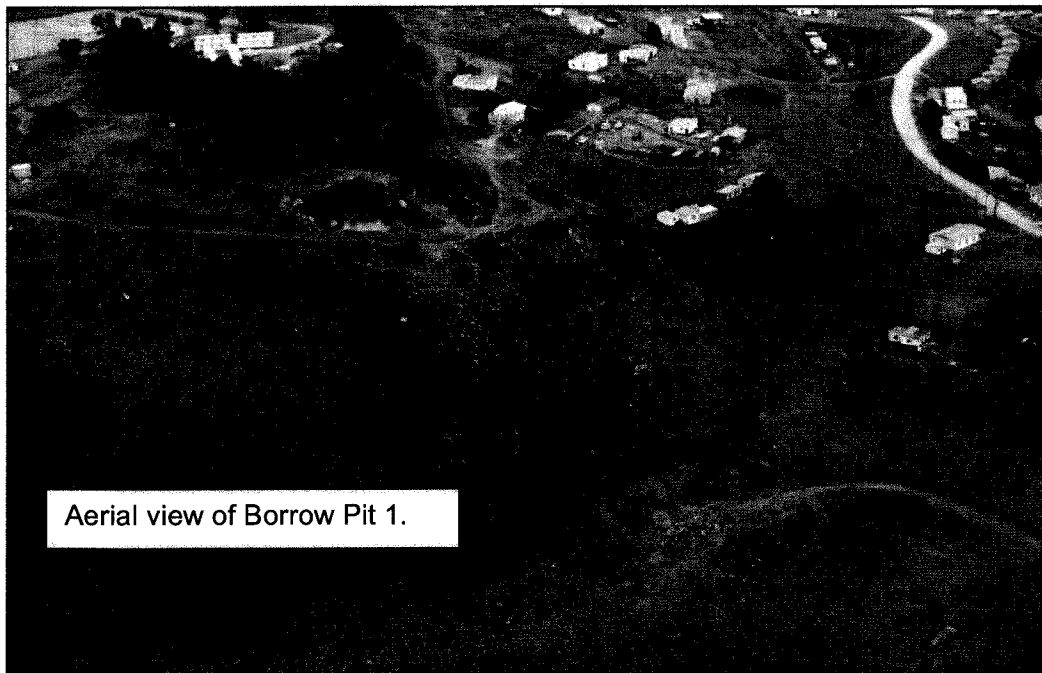
Aerial view of Borrow Pit 1.

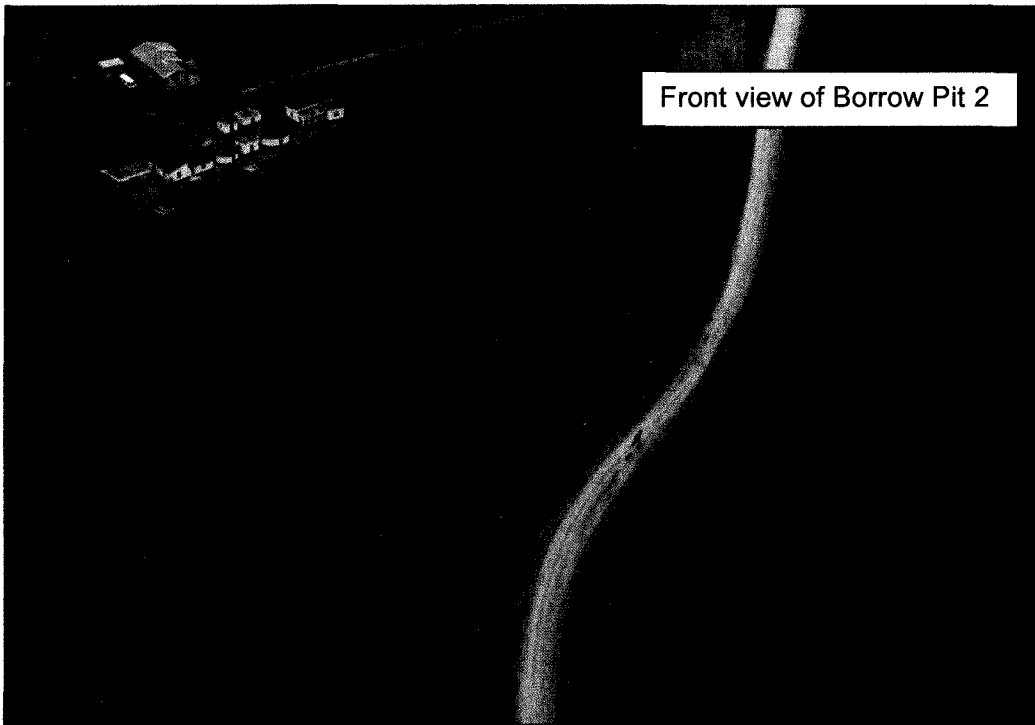
Front view of Borrow Pit 2

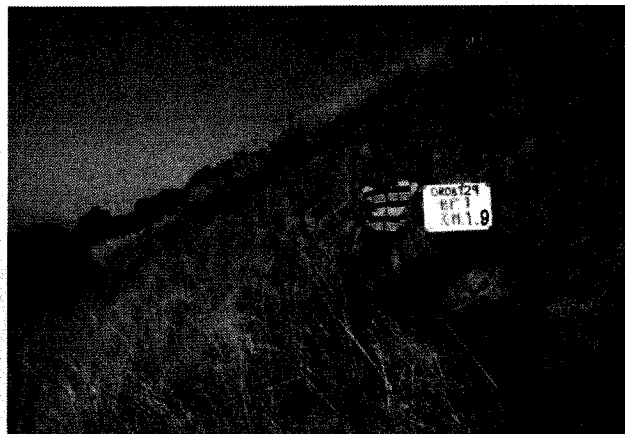
DR08129
BP1 - 1.9KM
S30°55'19.0"
E28°59'45.7"
South East
Part of face - tree

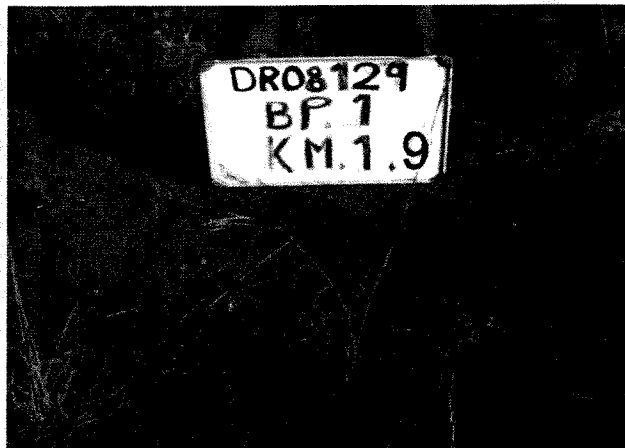
DR08129
BP1 - 1.9KM
S30°55'19.3"
E28°59'45.9"
North West
Floor

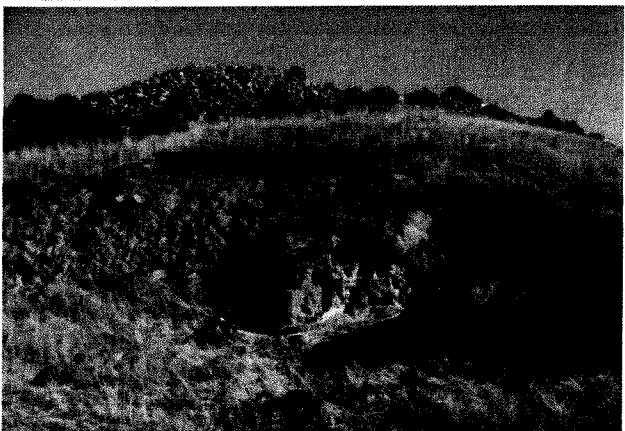
DR08129
BP1 - 1.9KM
S30°55'18.8"
E28°59'46.4"
North West
General view

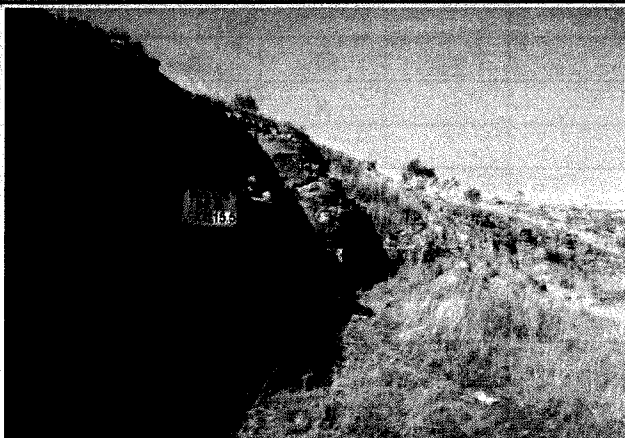
DR08129
BP4 - 15.5KM
S31°00'15.5"
E29°00'48.6"
North West
Part of face

floor and face hard and could require
blasting and crushing to enlarge.

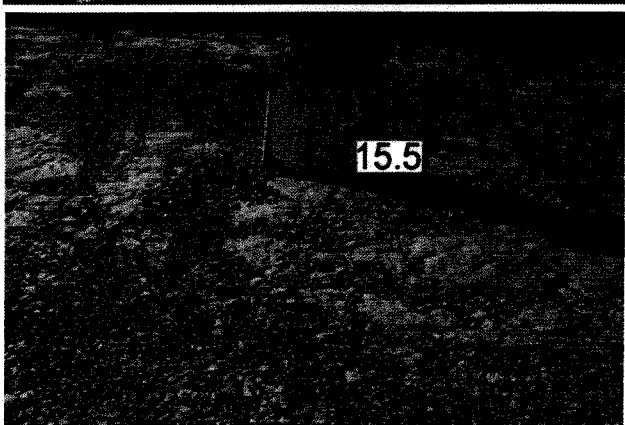
DR08129
BP4 - 15.5KM
S31°00'16.0"
E29°00'48.7"
South East
Floor

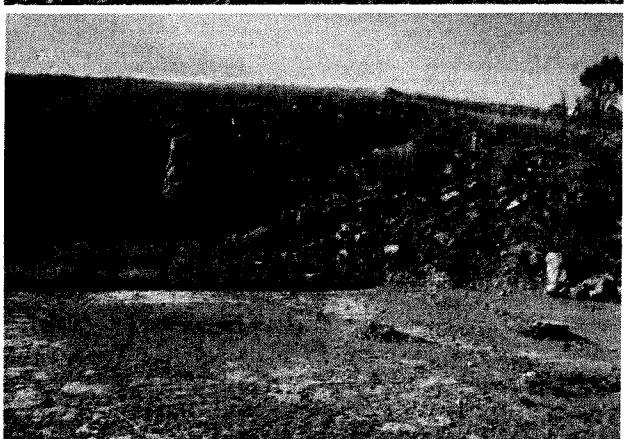
DR08129
BP4 - 15.5KM
S31°00'16.1"
E29°00'48.5"
South East
General view

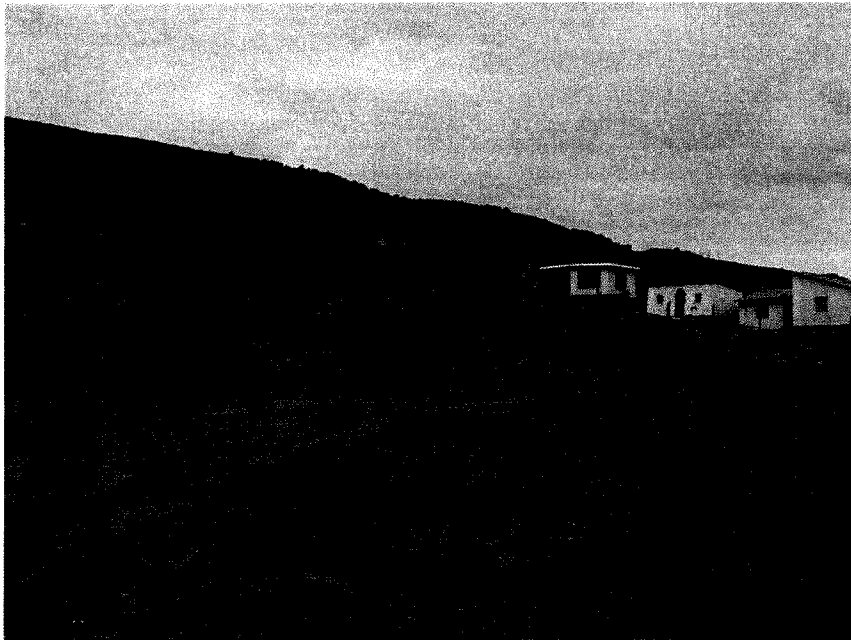
Plate 3 Face of DR8015/BP06 requiring stabilisation to prevent undermining of ancestral graves.

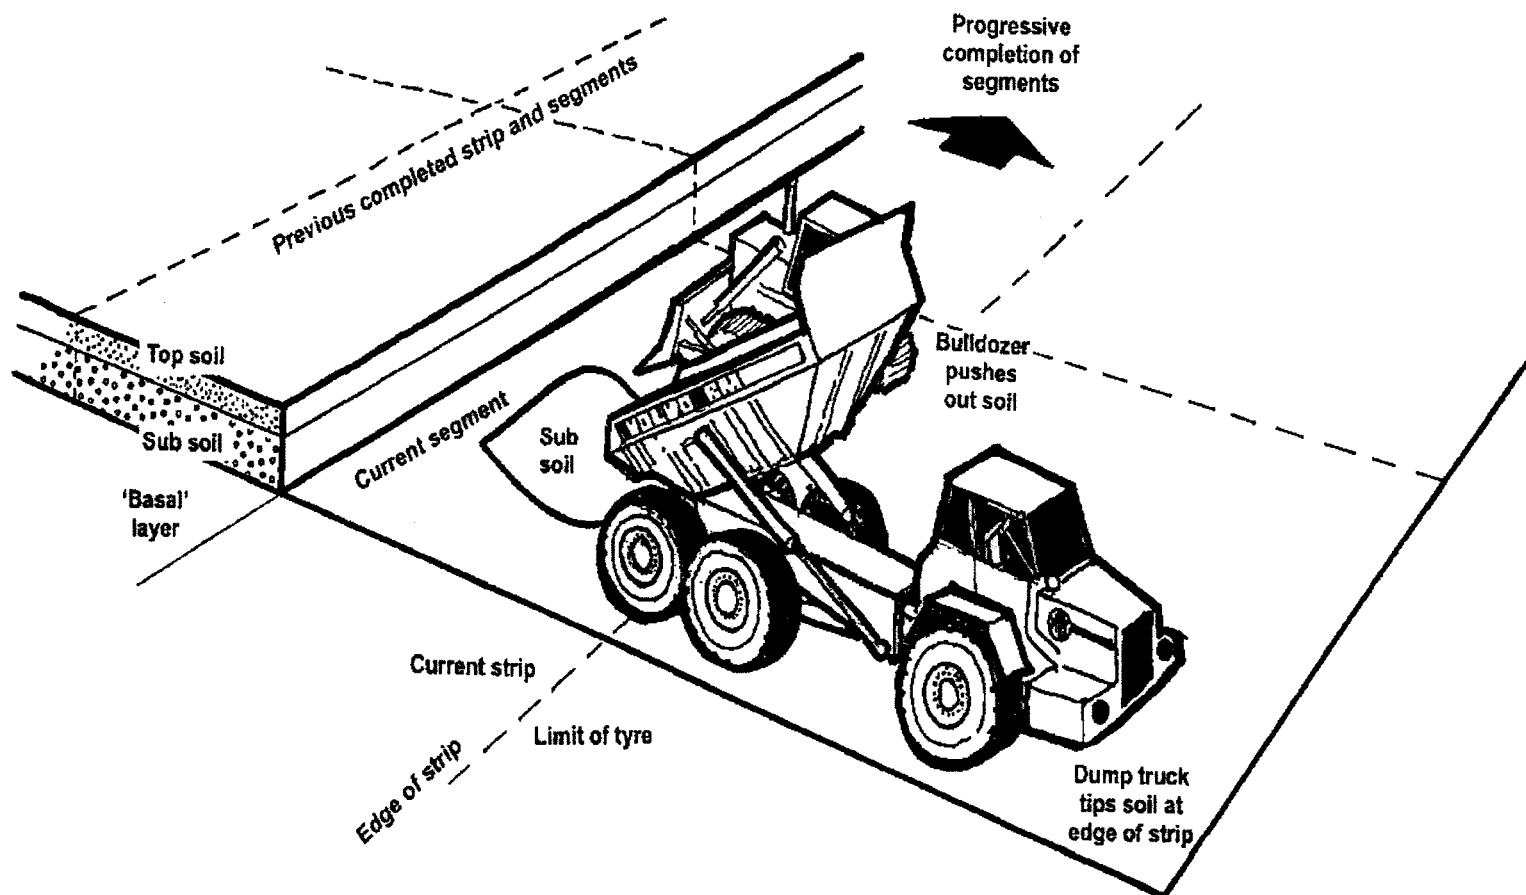
**Figure 15.1 Soil replacement by bulldozers
and dump trucks:
Sub soil layer**

- 15.15 If the basal/formation layer is to be decompacted, before any soil material is placed, each strip is to be firstly decompacted before the subsoil layer is replaced. Decompaction is dealt with in Sheet 19, which covers strategies, equipment and methods of operation. The basal layer must only be decompacted in the strip required for soil replacement, and must be prepared on the day of soil placement. During this process it may be necessary to use Sheet 17 for the removal of stones or damaging materials from the basal layer.

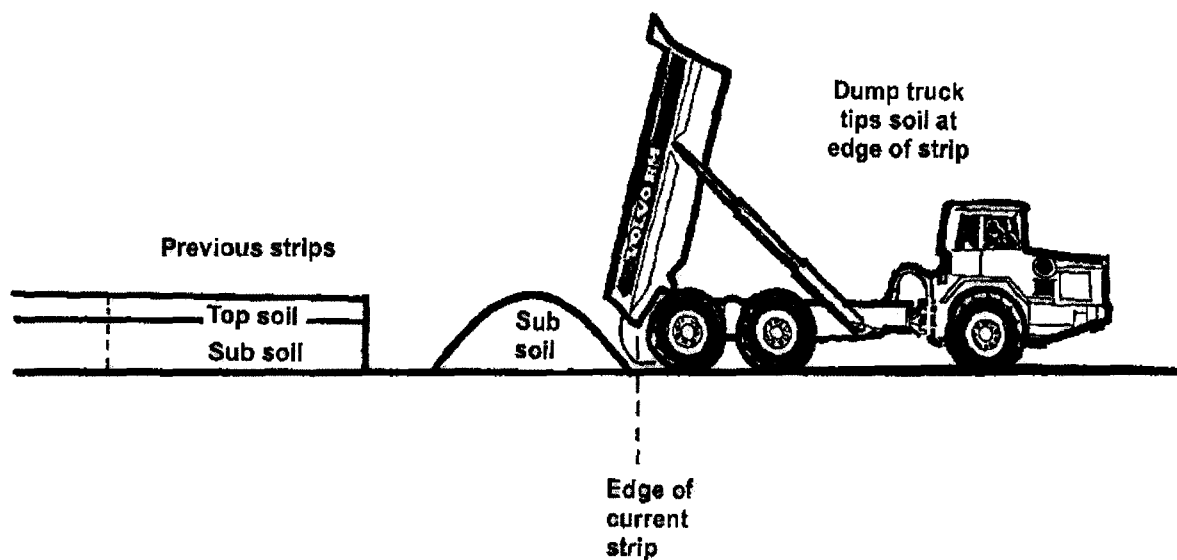
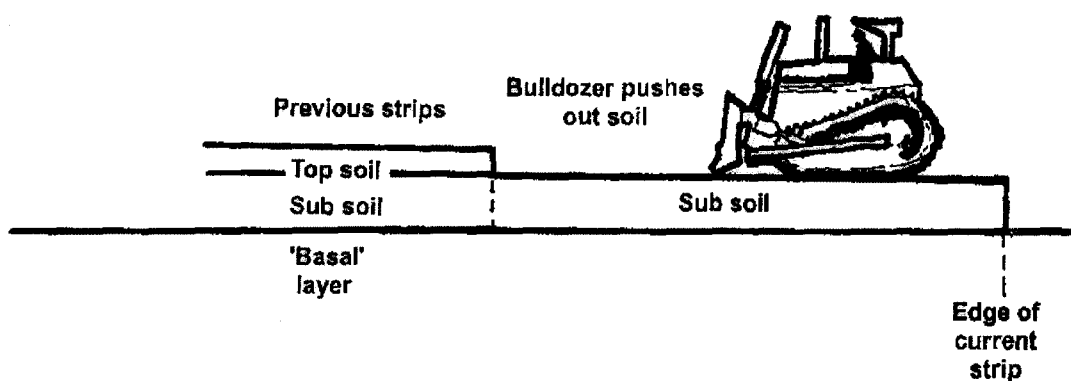
**Figure 15.2 Soil replacement by bulldozers
and dump trucks:
Sub soil layer**

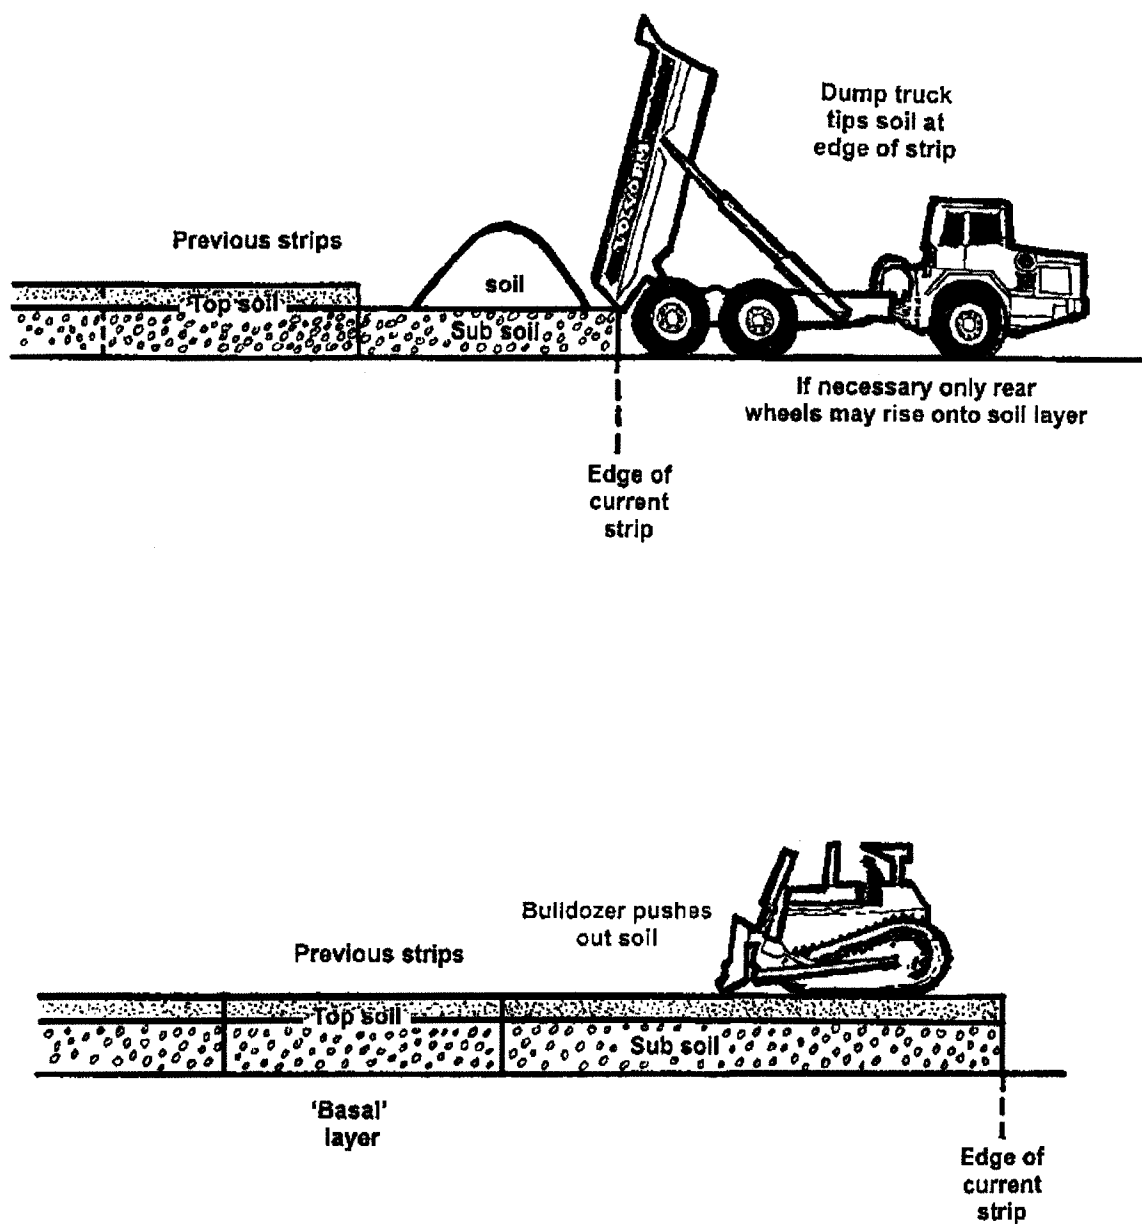
**Figure 15.3 Soil replacement by bulldozers and dump trucks:
Top soil layer**

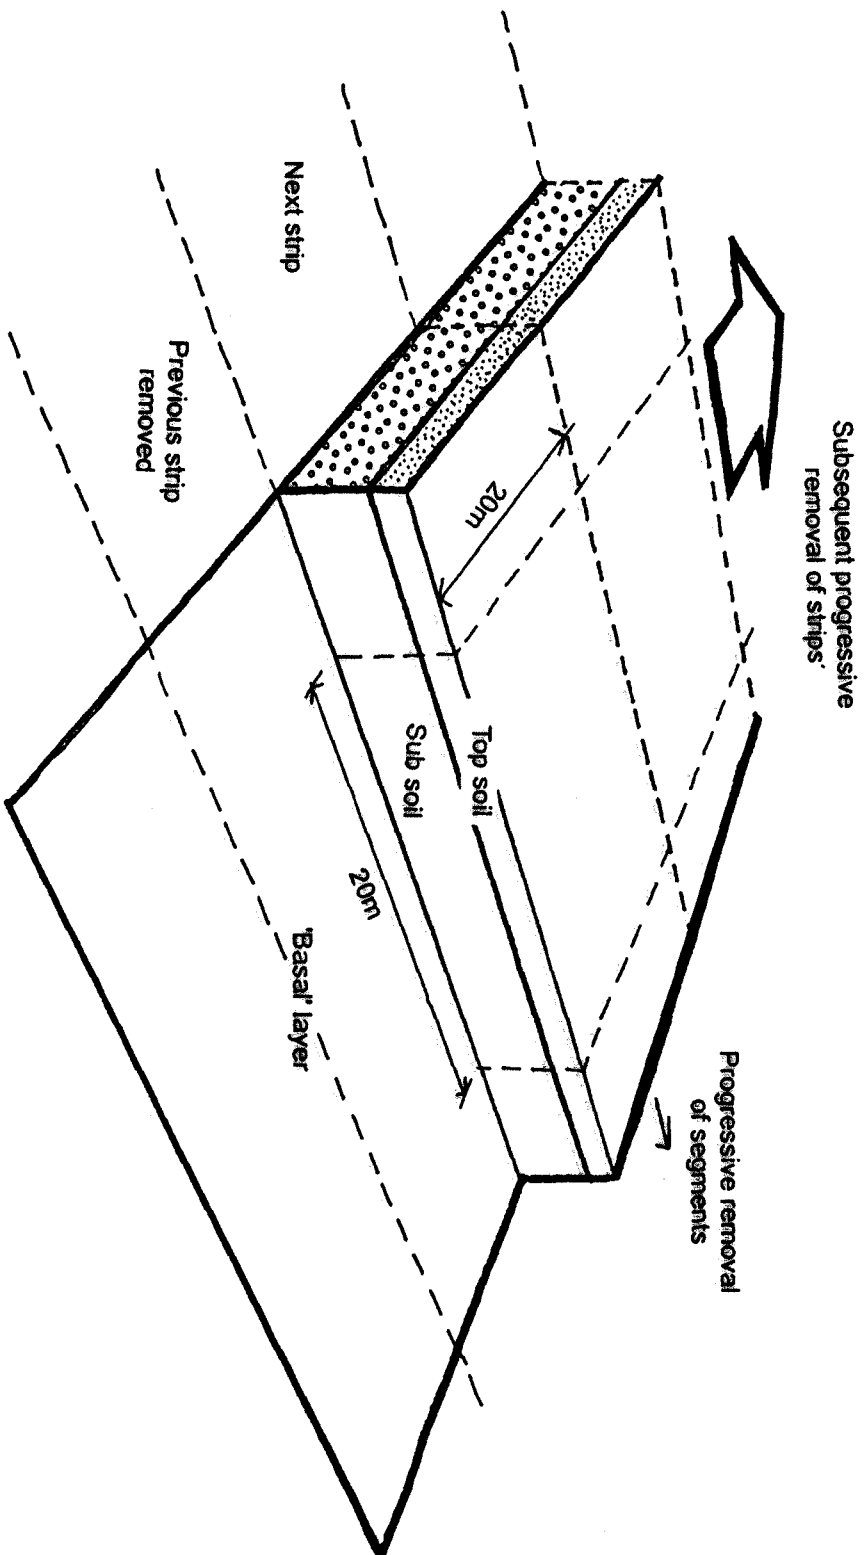
**Figure 13.1 Soil stripping with bulldozers
 and dump trucks:
 The bed and segment system**

- 13.13 On completion of the strip, the procedures are repeated sequentially for each subsequent strip until the area is completely stripped.
- 13.14 Where the soils are to be directly replaced without storage in mounds, the initial strip of the upper horizons will have to be stored temporarily to release the lowest layer and enable the sequential movement of materials. The stored initial soil material would be placed on the lower layer removed from the final strip at the end of the programme or on partially completed profiles if rain was forecast.

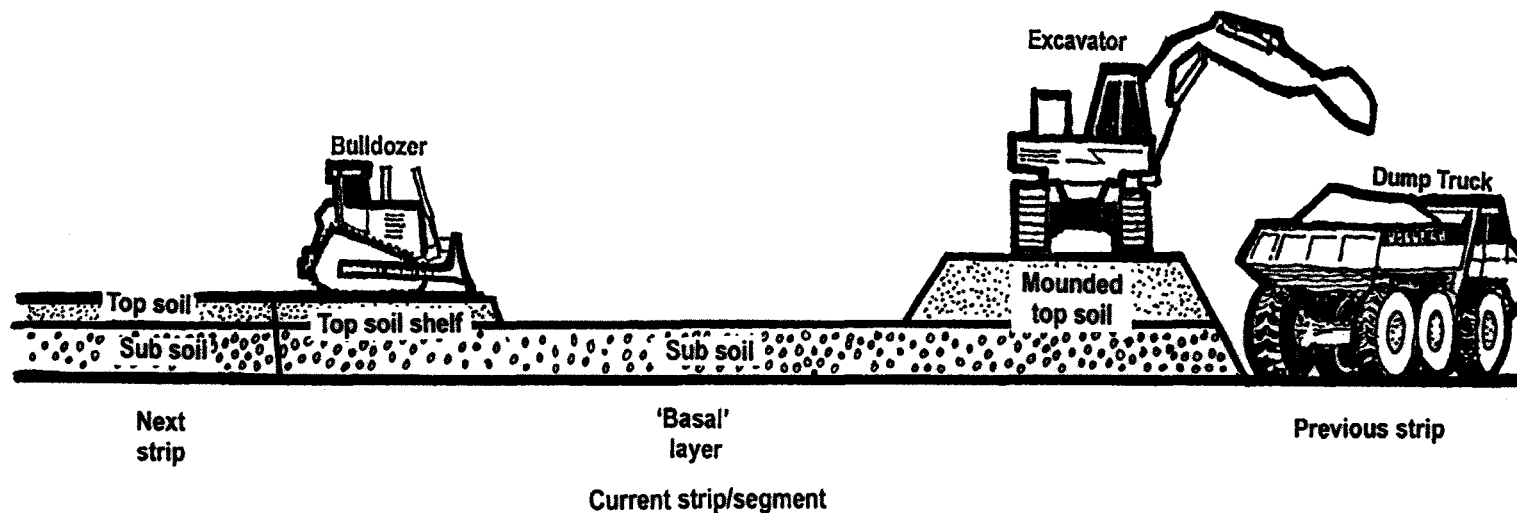
Figure 13.2 Soil stripping with bulldozers
and dump trucks: Top soil

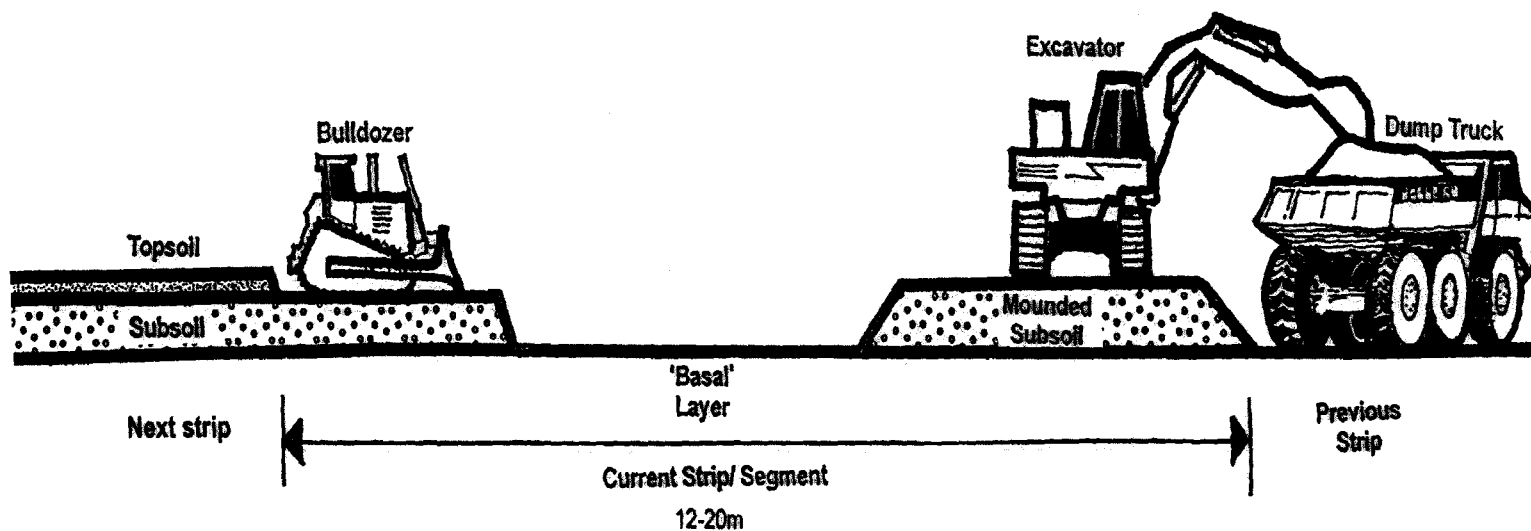
Figure 13.3 Soil stripping with bulldozers-
dump trucks: Subsoil

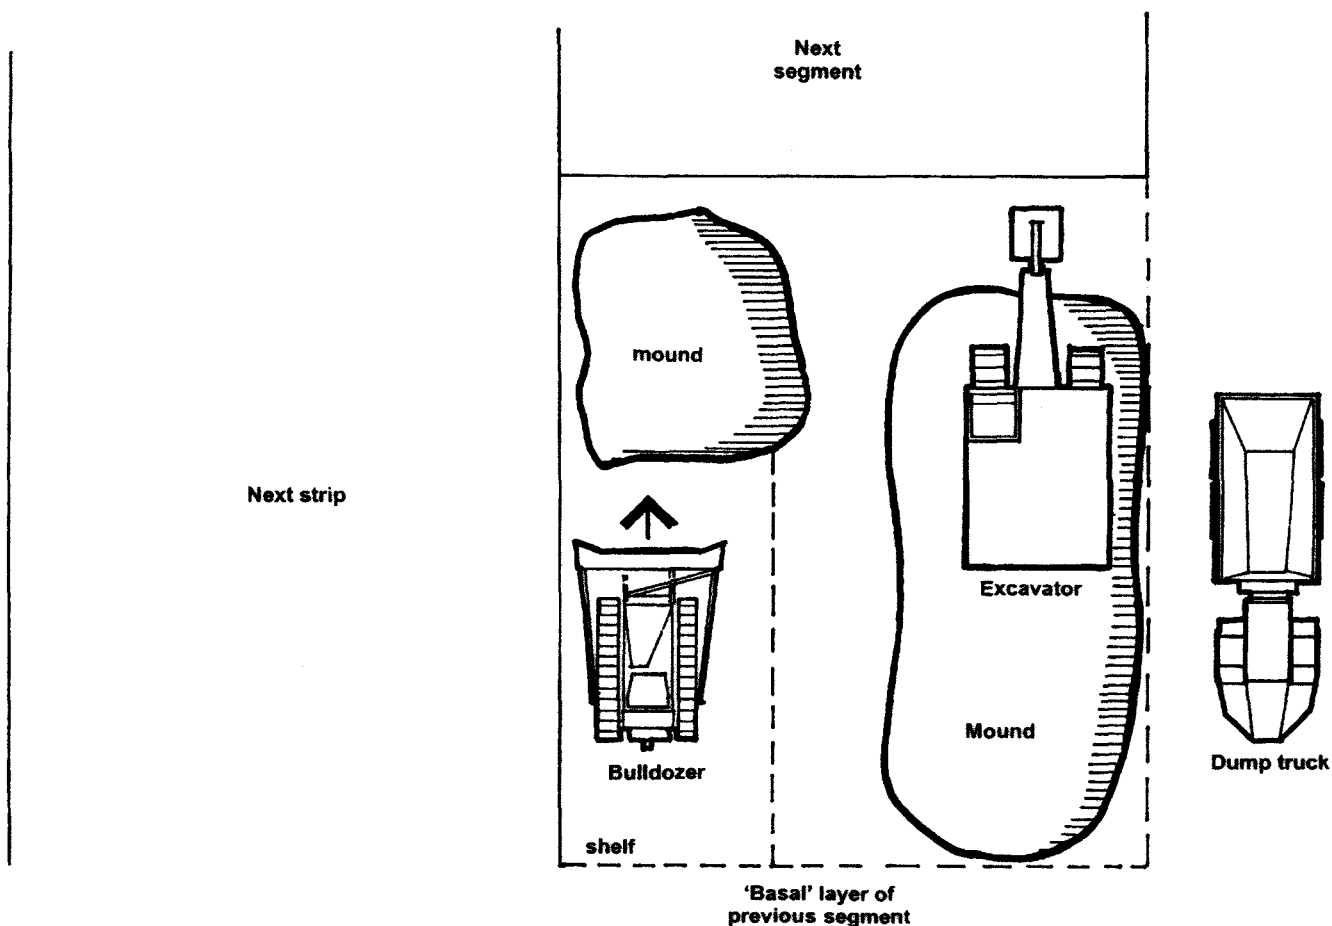
Figure 13.4 Soil stripping with bulldozers and dump trucks:
The removal of soil along top soil and sub soil shelves
