# ENVIRONMENTAL MANAGEMENT PLAN

## The Proposed Utilisation of Borrow Pits Road: DR08348 (Amathole District Municipality)

Department of Roads and Public Works  
Province of the Eastern Cape

Report Number 2011-R502

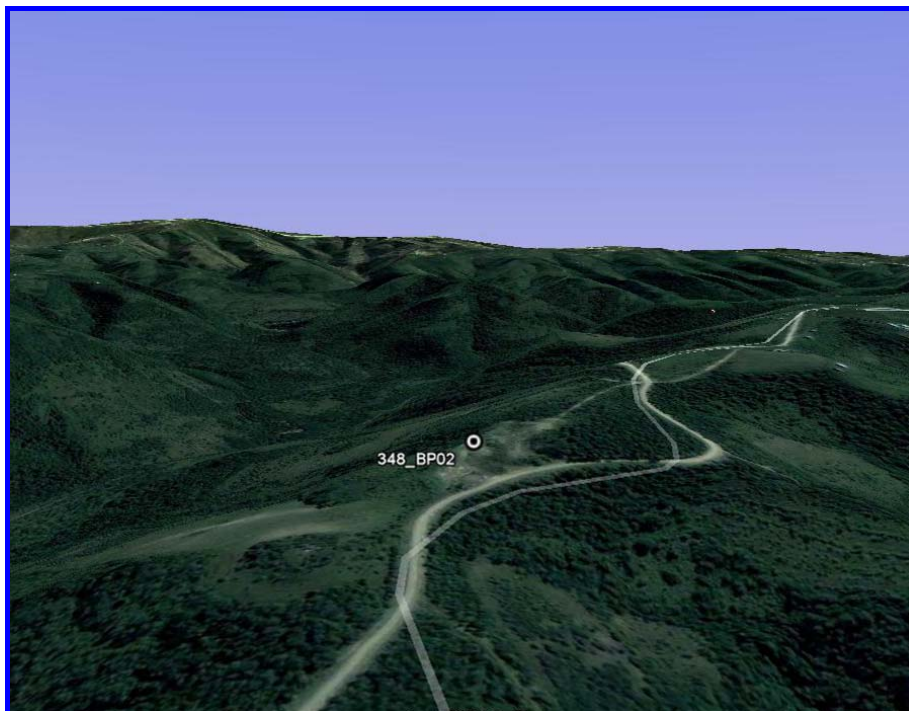
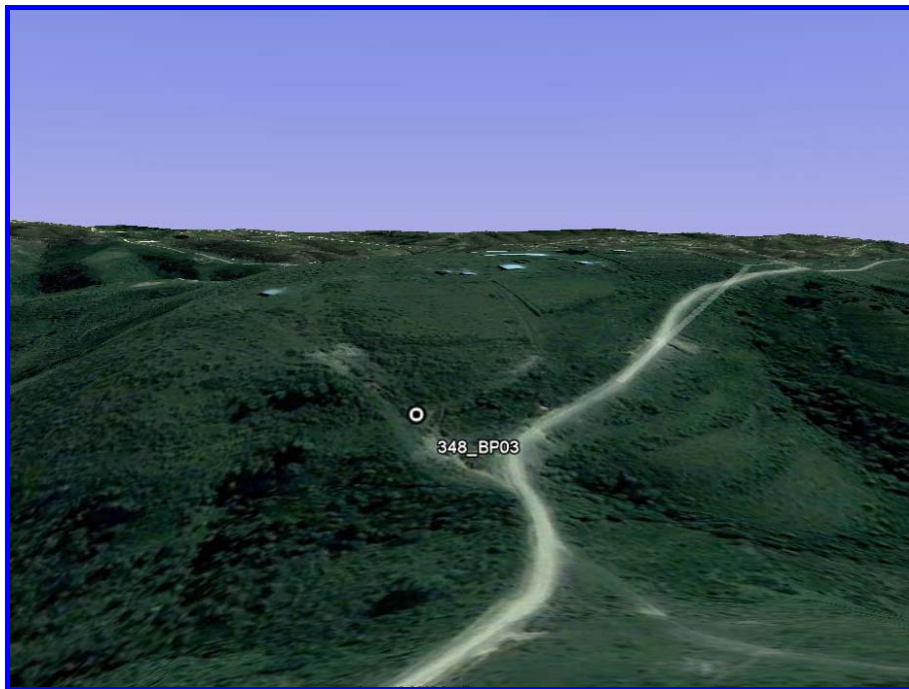
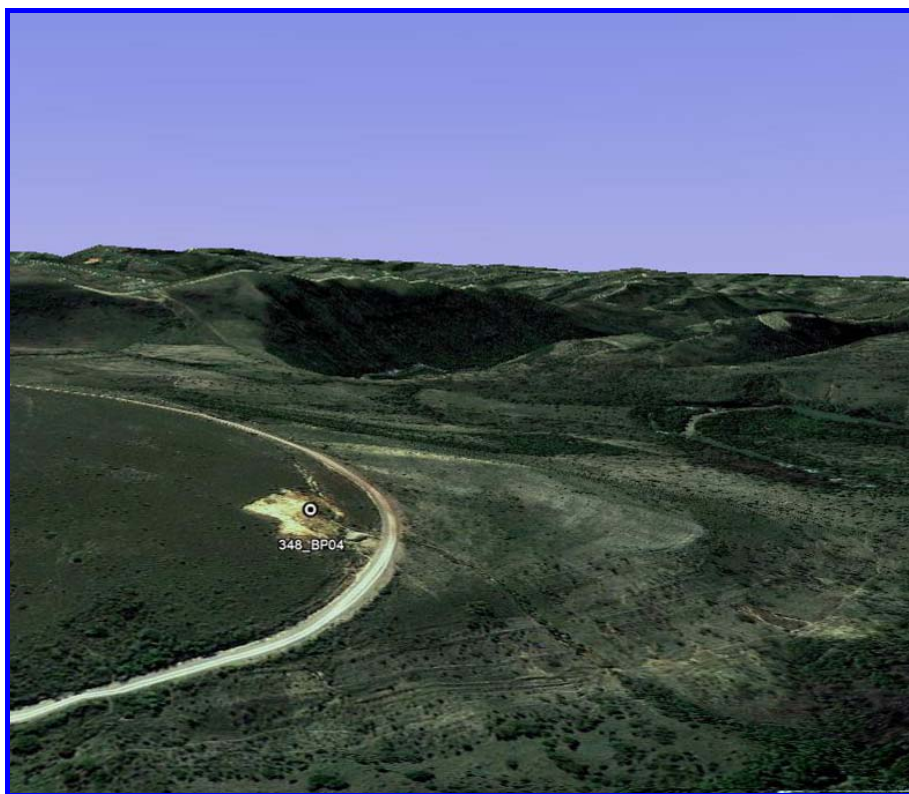
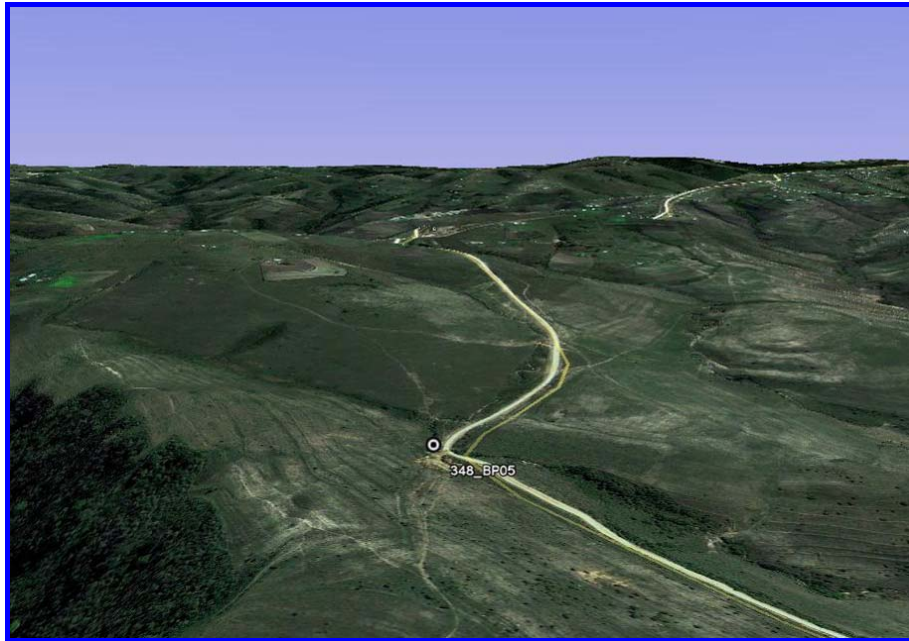
Figure 19: Terrain view indicating the position of the borrow pits in the landscape.

As the borrow pits are existing and have been utilised previously, the topography has been altered by the excavation of material from the hill slopes.
