**CONSULTATION IN TERMS OF SECTION 40 OF THE MPRDA OF 2002: BORROW PIT  
(M - P), DIVISION OF CRADOCK, EASTERN CAPE**

**CHRIS HANI DISTRICT MUNICIPALITY**  
**Environmental Management Plan 2**  
**Borrow Pit Rehabilitation (M – P)**

Project Number: 23034KWE

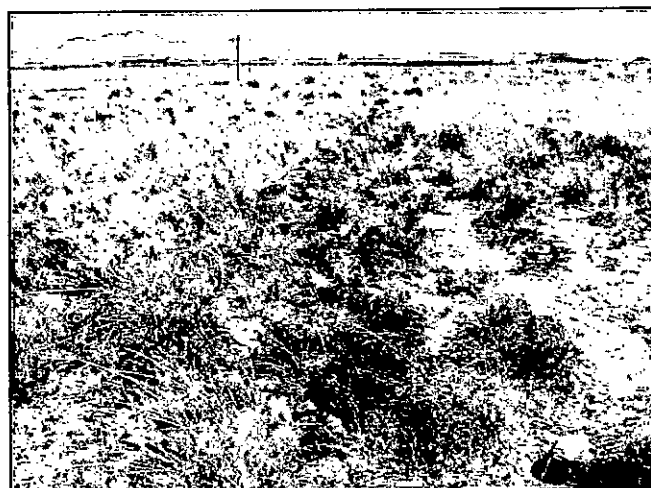
Figure 9: Historical Period stone wall foundations at the general Quarry 1.1 locality

Stone wall foundations dating to the Historical Period was encountered in close proximity to the quarry. Quarrying in the area may well impact on the foundations. Foundations are interpreted as Historical Period farm / camp fence lines and are formally protected under the NHRA 1999.

- **SITE SIGNIFICANCE & RECOMMENDATIONS:** Development at Quarry 1.1 will impact on Stone Age deposits and may well impact on Historical Period stone wall foundations. The low density Stone Age material and the Historical Period stone feature at the site is ascribed a SAHRA *Low Significance* and a *Generally Protected C* Field Rating. It is recommended that the Stone Age deposits be destroyed *in lieu* of the development without the developer having to apply for a SAHRA *Site Destruction Permit*. The Historical Period stone feature may well be conserved by restricting quarrying to the vicinity of the existing quarry / east (E) of the foundations. Should development requirements not allow conservation, it is recommended that the Historical Period foundations be destroyed without the developer having to apply for a SAHRA *Site Destruction Permit*.

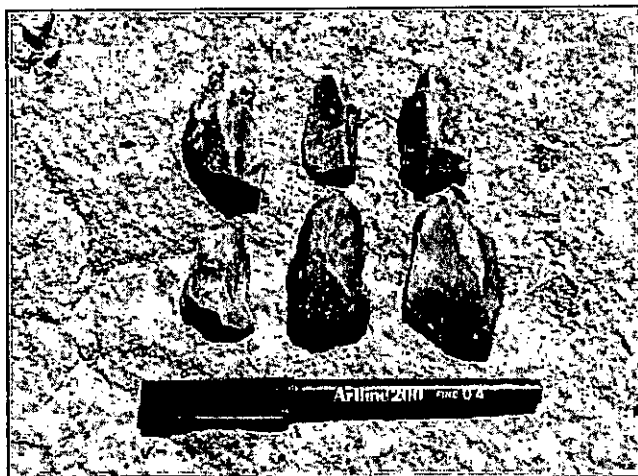
Figure 14: Stone Age artefacts from the Quarry 1.3 area

Quarry 1.3 is located east (E) of the DR2629 on the farm Watervoor / Vleipoort and approximately 150-200m north east (NE) of contemporary farming infrastructure. A low density of Stone Age artefacts were encountered on the surface of the site and primarily within disturbance caused by former quarrying activities. The rolled appearance of the artefacts supports a secondary context. Artefact quantities were very low with recorded artefact ratios (artefacts: m<sup>2</sup>) not exceeding 4:1. The lithics can typologically be ascribed to the later Middle Stone Age, with flake and blade types dominating and a high degree of scraper edges. The cultural member comprises the top approximate 20cm of the more or less 1.5m exposed section of the quarry. Stone Age archaeological deposits are formally protected under the NHRA 1999.

- o **SITE SIGNIFICANCE & RECOMMENDATIONS:** Based on the low quantity of artefacts and their inferred secondary context a SAHRA *Low Significance and Generally Protected C* Field Rating is ascribed to the Quarry 1.3 Stone Age deposits. It is recommended that the deposits be destroyed *in lieu* of the development without the developer having to apply for a SAHRA *Site Destruction Permit*.

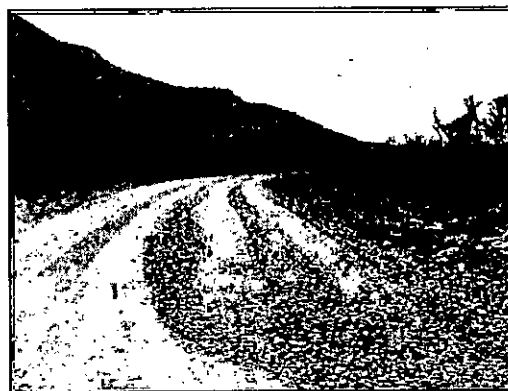
Figure 40: Upgrading of Road nr 654 in progress

The sourcing of gravel at Quarry 2.2 had already stated at the time of the Phase 1 AIA. Upgrading of the road portion in the immediate vicinity of the quarry was in progress.

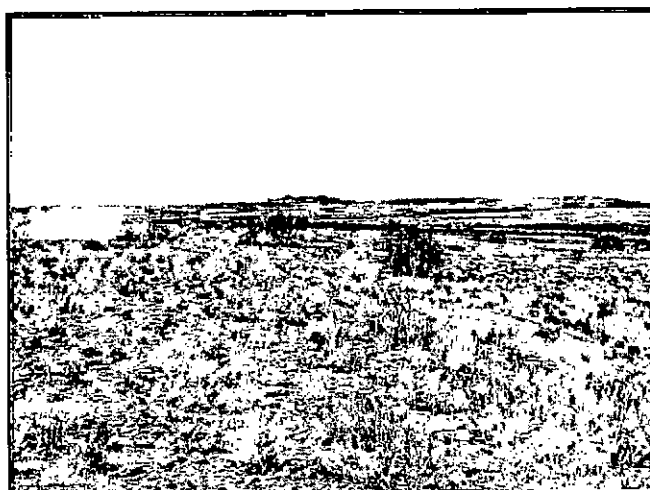
Figure 45: Shallow lying shales may well contain fossils of palaeontological nature

The immediate area is however known to be fossil bearing; palaeontological deposits / sites are formally protected under the NHRA 1999. Recommendations as per the Palaeontological Impact Assessment (PIA) should be complied with.

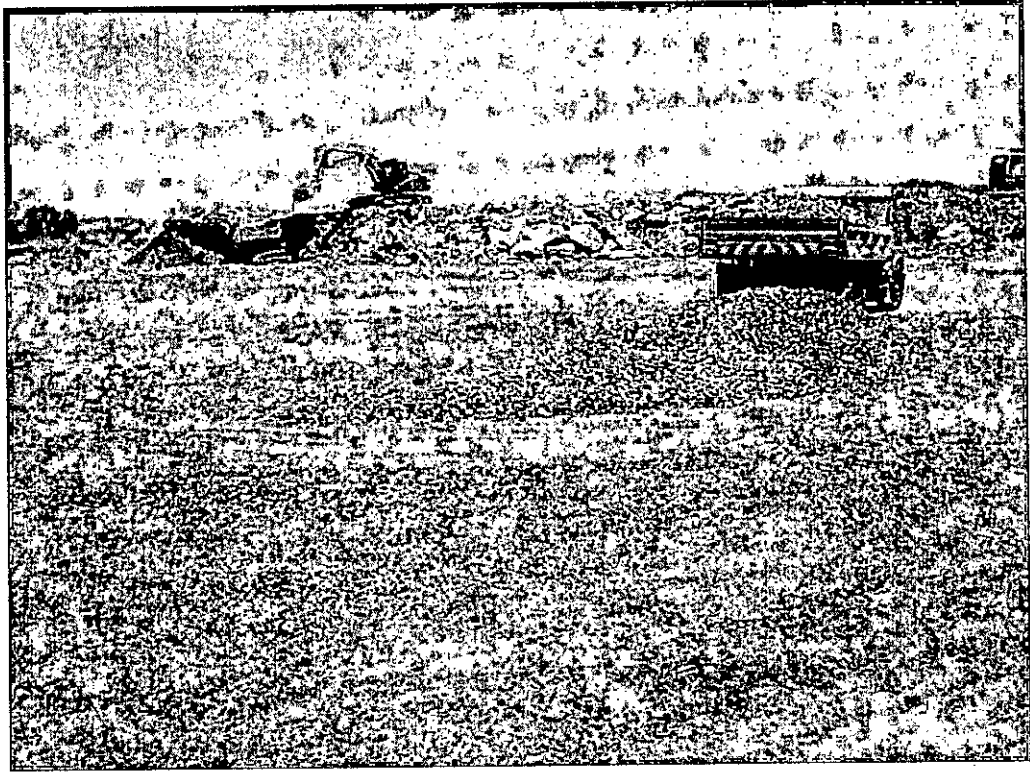
**Figure 4. Burrow Pit no. 11. Excavations are already underway in the mudstone deposits**

Situated in open veld. Approximately 3000m<sup>2</sup>. Weathered maroon mudstones, Red sand and silt capping.
