**CONSULTATION IN TERMS OF SECTION 40 OF THE MPRDA OF 2002: PROPOSED BORROW PITS:
DR604, ALFRED NZO DISTRICT MUNICIPALITY, EASTERN CAPE: DEPARTMENT OF ROADS AND
PUBLIC WORKS**

**ENVIRONMENTAL MANAGEMENT PLAN FOR THE
PROPOSED BORROW PITS ASSOCIATED WITH
MAINTENANCE OF THE P604 GRAVEL ROAD IN
THE ALFRED NZO DISTRICT MUNICIPALITY IN THE
EASTERN CAPE**

ENVIRONMENTAL MANAGEMENT PLAN FOR THE PROPOSED BORROW PITS ASSOCIATED WITH MAINTENANCE OF THE P604 GRAVEL ROAD IN THE ALFRED NZO DISTRICT MUNICIPALITY IN THE EASTERN CAPE

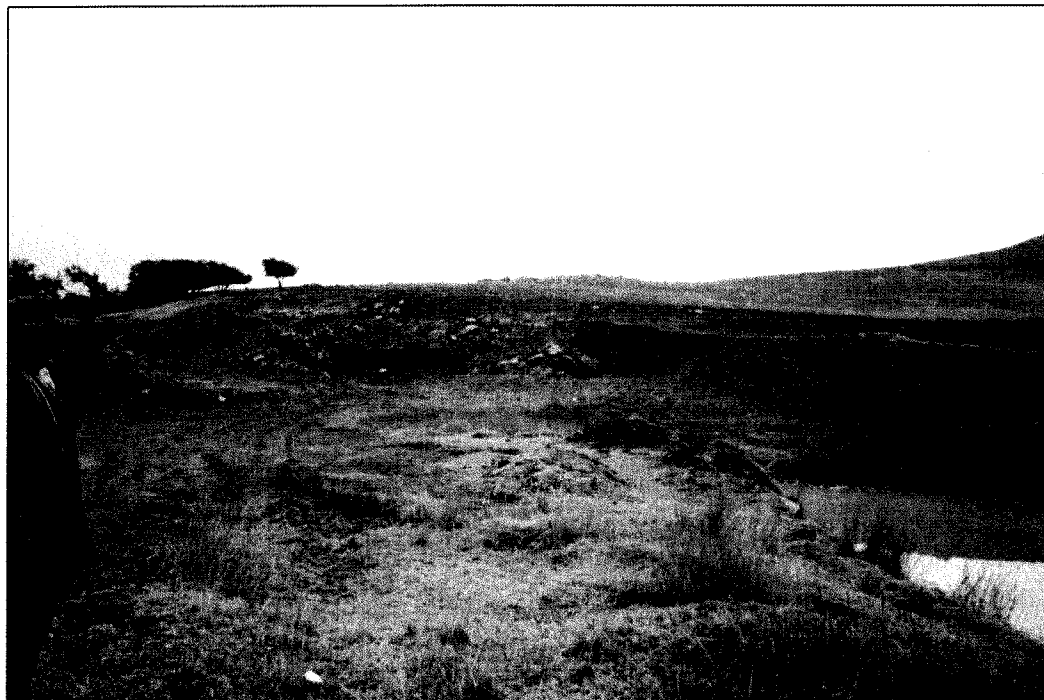
Plate 1: View of the vegetation surrounding the borrow pit

No signs of wildlife were seen during the site visit.

Recommendations: The grass groundcover that is disturbed will be replanted on the re-sloped, topsoiled areas during the rehabilitation phase. It is suggested that the rehabilitated areas be replanted with *Elionurus muticus* (Wire Grass) seed.

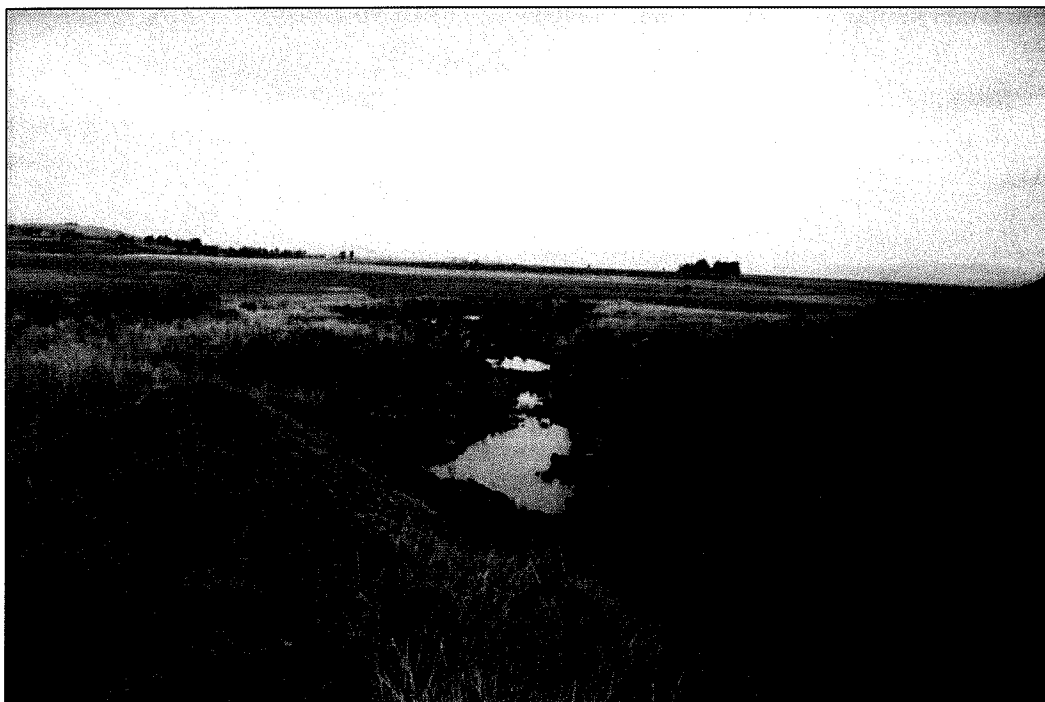
Plate 2: View of the vegetation surrounding the borrow pit

No signs of wildlife were seen during the site visit.

Recommendations: The grass groundcover that is disturbed will be replanted on the re-sloped, topsoiled areas during the rehabilitation phase. It is suggested that the rehabilitated areas be replanted with *Elionurus muticus* (Wire Grass) seed.

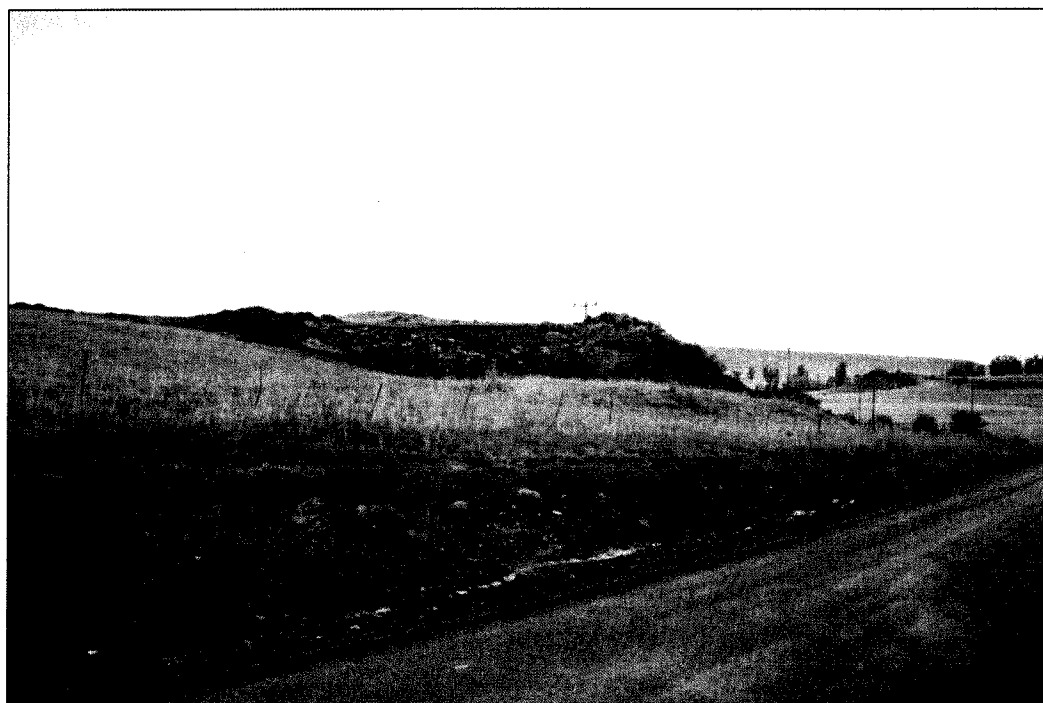
Plate 3: View of the vegetation surrounding the borrow pit

No signs of wildlife were seen during the site visit.

Recommendations: The grass groundcover that is disturbed will be replanted on the re-sloped, topsoiled areas during the rehabilitation phase. It is suggested that the rehabilitated areas be replanted with *Elionurus muticus* (Wire Grass) seed.

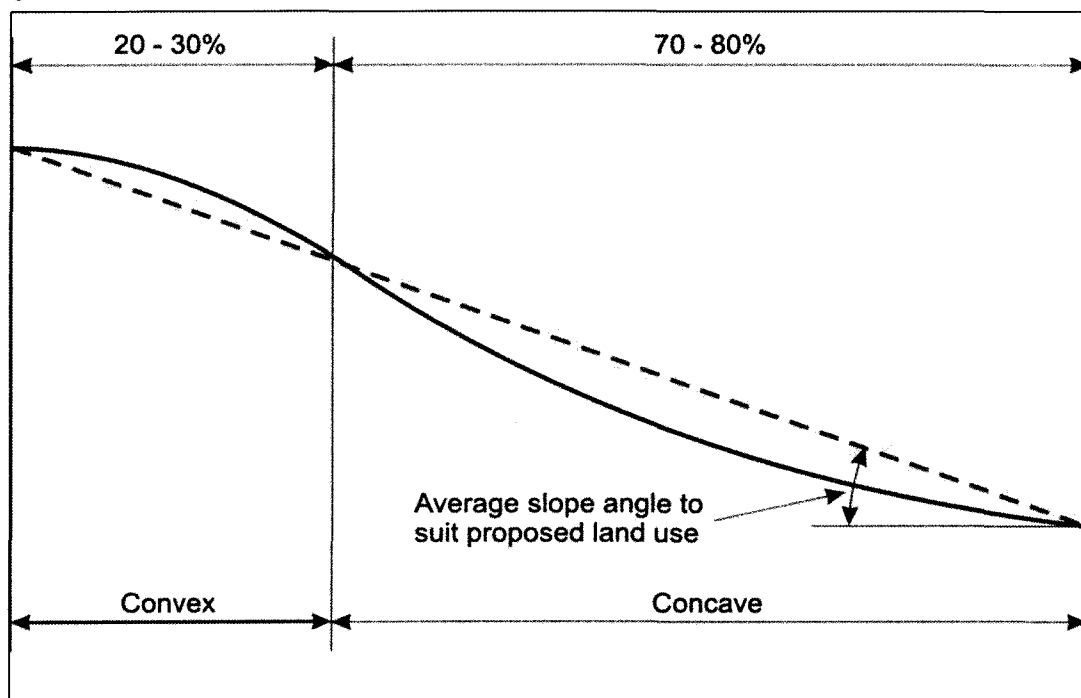
The final borrow pit plan shall leave cut faces sloped at a gradient not steeper than 1:3, not steeper than 3m each and separated by benches (see sketch below). The general direction of the slope of the borrow pit will be in the direction of the existing ground contours, as indicated on the site plans.

Figure 26: DESIGN OF SLOPE PROFILES (HANNAN, 1984) - (a) Preferred Profile

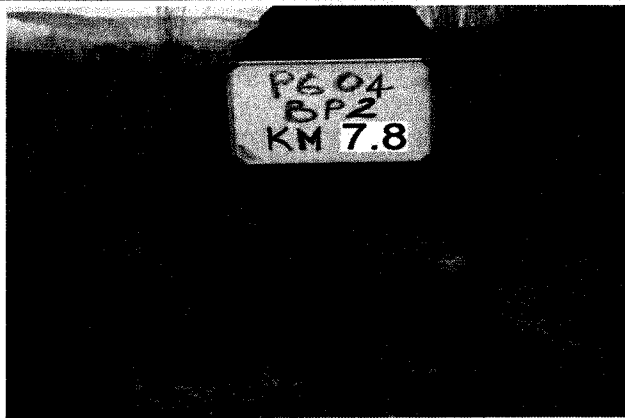
P604
BP2 - 7.8KM
S30°19'6.4"
E28°55'4.4"
Face

h) Other observations : Too close to existing dwelling.

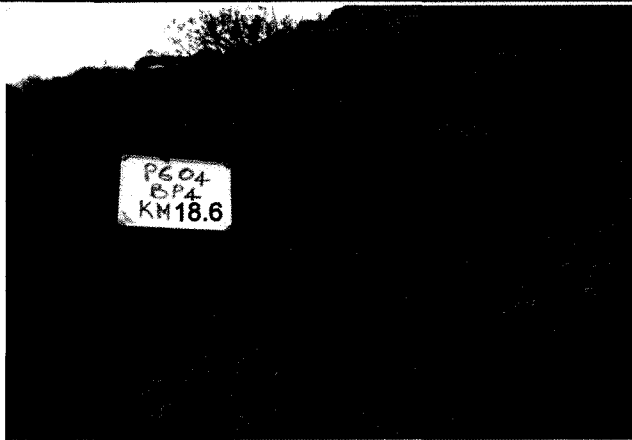
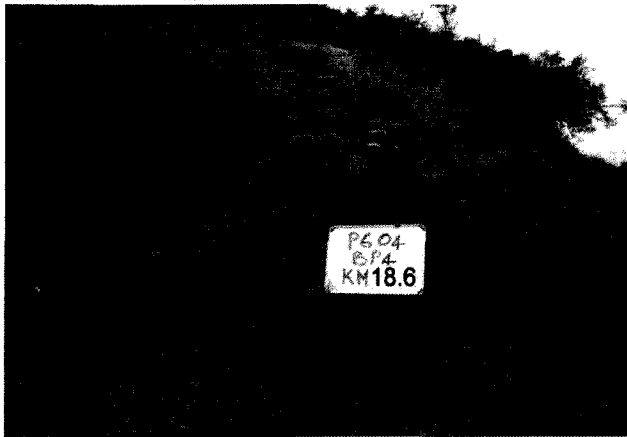
P604
BP4 - 18.6KM
S30°16'36.2"
E29°00'21.0"
Face

h) Other observations : Could be extended away from road.

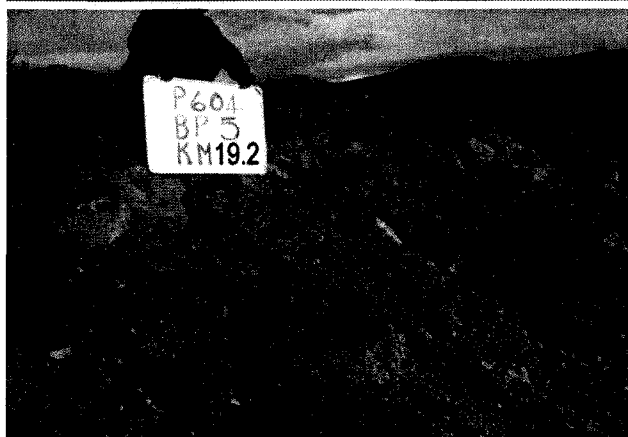
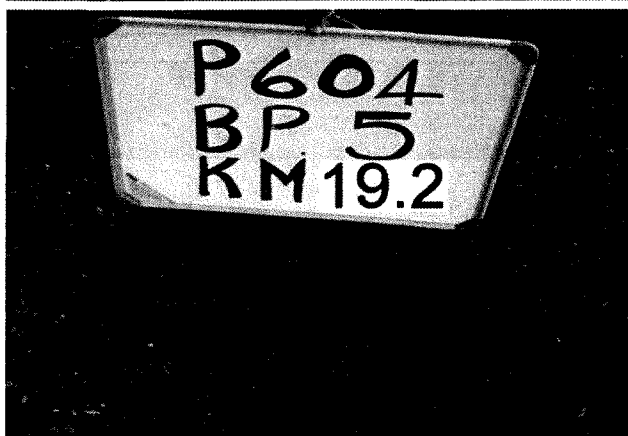
P604
BP5 - 19.2KM
S30°16'23.7"
E29°00'6.2"
Face

P604
BP5 - 19.2KM
S30°16'23.7"
E29°00'6.2"
Floor

P604
BP5 - 19.2KM
S30°16'23.7"
E29°00'6.2"
General view

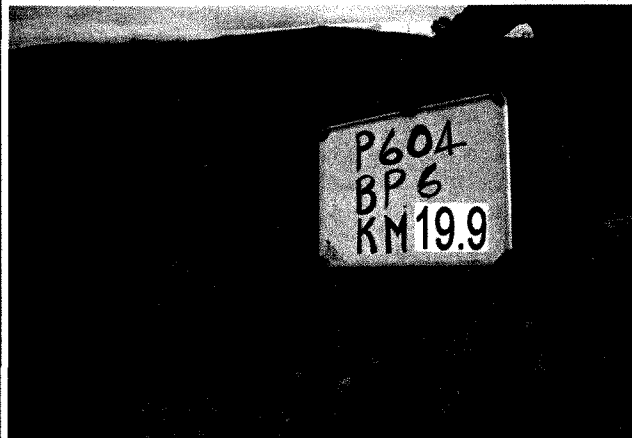
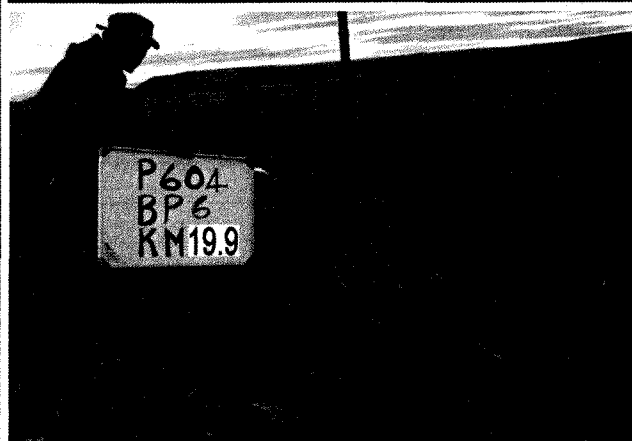
P604
BP6 - 19.9KM
S30°15'56.7"
E29°00'30.7"
Face

h) Other observations : Can be extended parallel to road. Drainage needs attention.

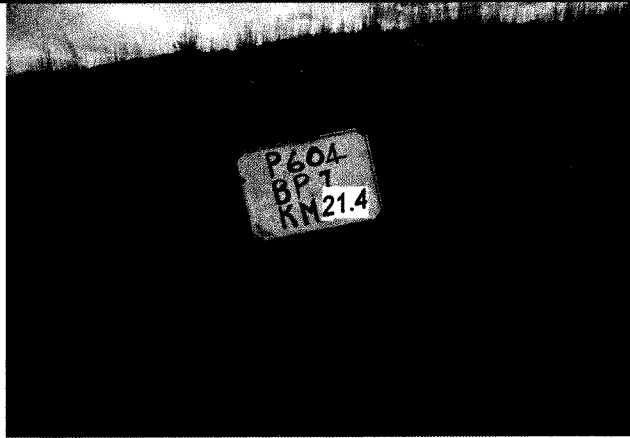
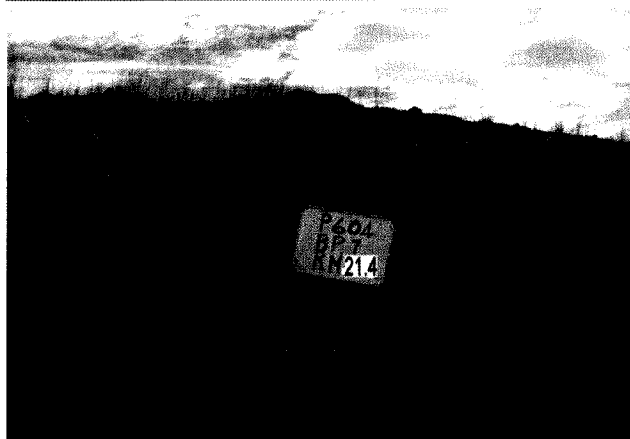
P604
BP7 - 21.4KM
S30°15'13.2"
E29°00'52.4"
Face

Drainage needs attention.

P604
BP7 - 21.4KM
S30°15'13.2"
E29°00'52.4"
General view

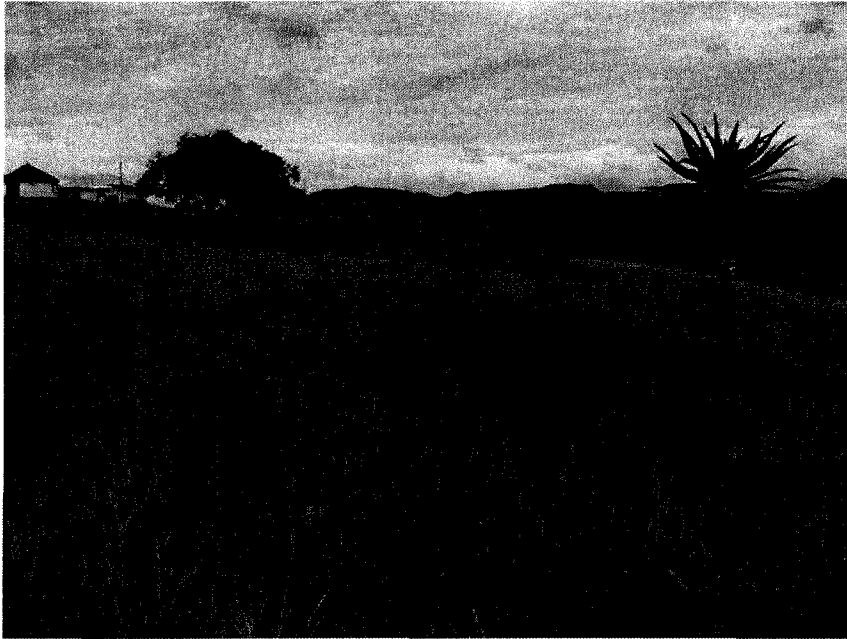
Plate 1 Ancestral graves close to DR8015/BP05.

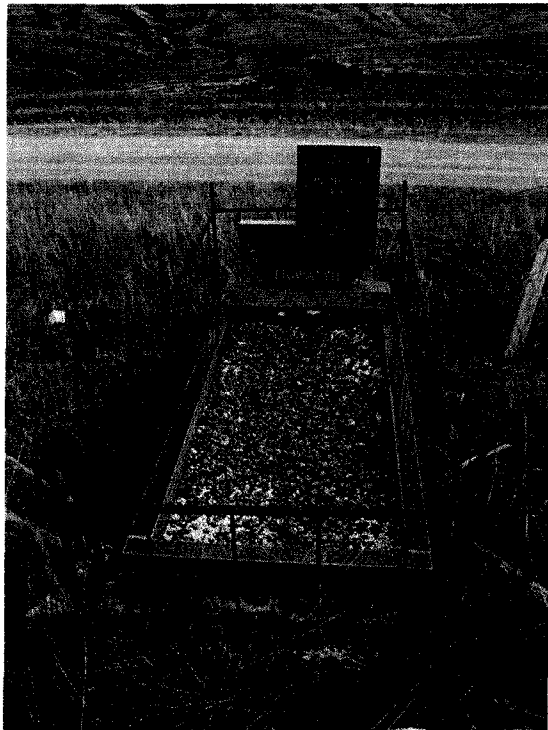
Plate 2 Ancestral grave close to DR8015/BP05.
