**BASIC ASSESSMENT REPORT AND ENVIRONMENTAL MANAGEMENT PROGRAMME
FOR
MINING OF A BORROWPIT NO.1
ON THE REMAINING PORTION OF FARM GREATER GIYANI 891 LT:
MATERIAL SOURCING FOR PROJECT NO. RAL/T825/2018- DESIGN AND
CONSTRUCT 3KM OF ROAD D3810 FROM THOMO TOWARDS KHAKHALA
MOPANI DISTRICT**

MINING OF A BORROWPIT NO.1

ON THE REMAINING PORTION OF FARM GREATER GIYANI 891 LT

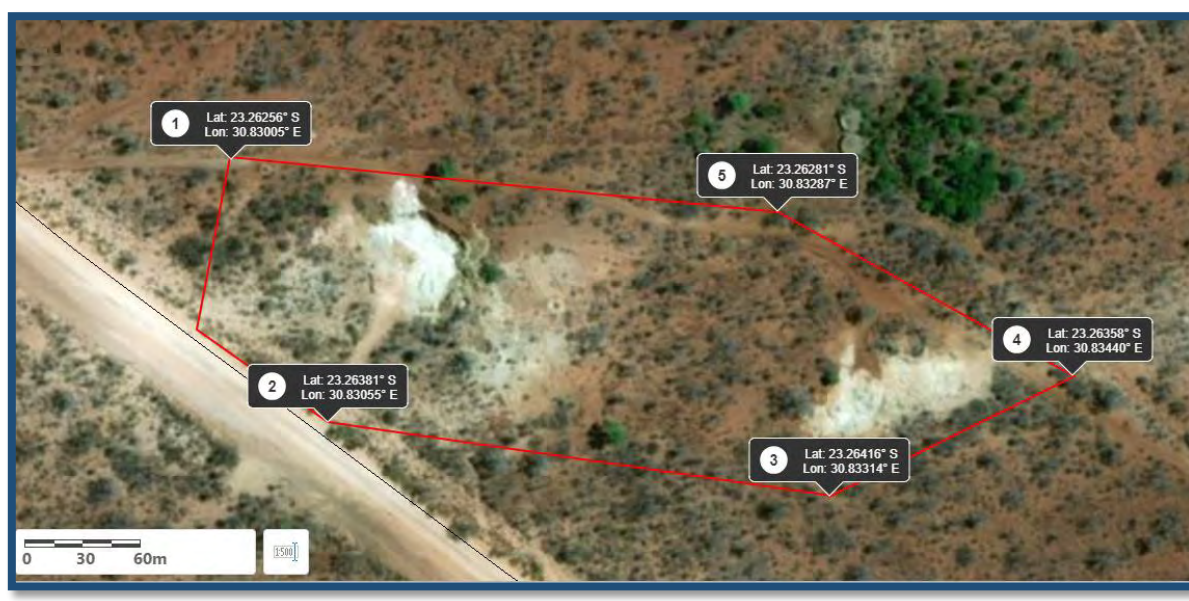
Figure 2: Proposed Layout of Borrowpit and Extract of the mining Plan

Figure 2 shows the proposed layout of the borrow pit and laydown areas within the fenced site. The borrow pit will be established over the following lease area:

1. -23.262551°,30.830054°
2. -23.263807°,30.830556°
3. -23.264151°,30.833151°
4. -23.263619°,30.834333°
5. -23.262810°,30.832881°

- Borrow pit floor to be sloped at 1:100 (V:H) to allow free drainage
- Total topsoil/overburden to be removed: $\pm 1\,720\text{m}^3$
- Total gravel wearing course material to be removed: $\pm 18\,360\text{m}^3$

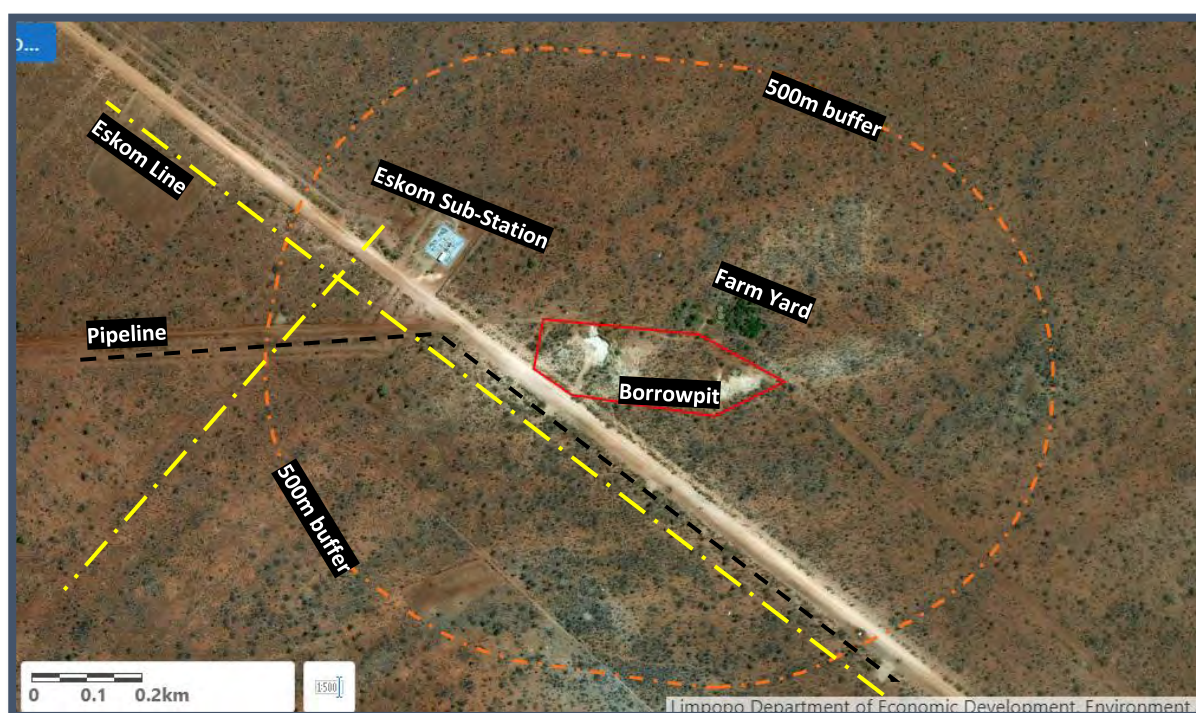
Figure 5: Infrastructure located within 500m of the proposed borrowpit

The proposed borrow pit site is in a natural but degraded condition. Within 500m buffer of the borrowpit, the Road D3810 transverses the southern boundary of the borrowpit and a dilapidated farm Yard is situated on the northern boundary. On the opposite side of the road runs a bulkwater main pipeline parallel to the Eskom-powerlines trans versing to Khakhala village. The powerlines intersect to connect with a sub-station located 300m from the borrowpit.

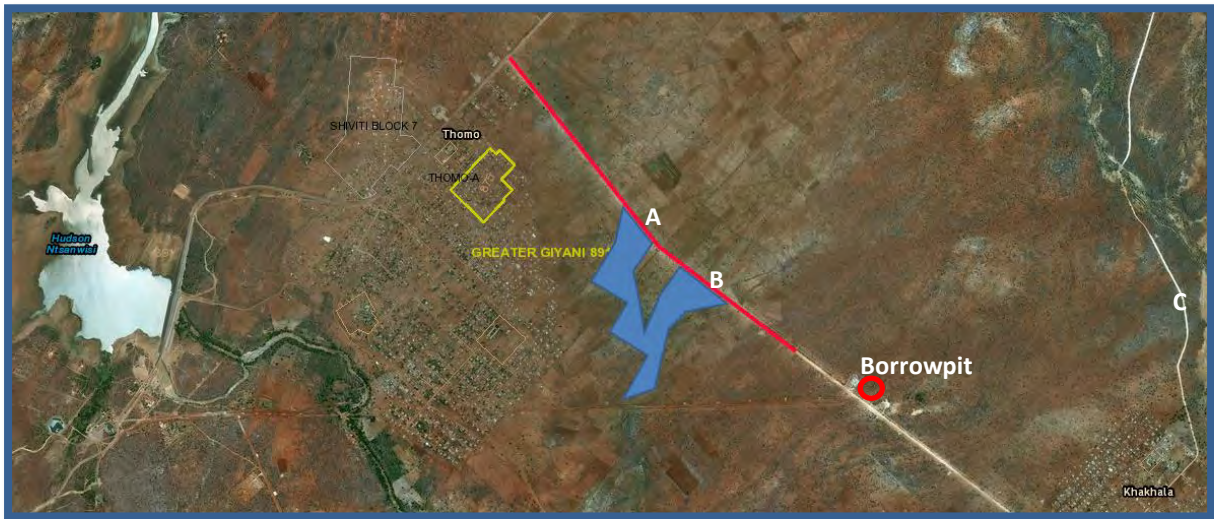
Figure 2-3: land image showing the position of Water Crossings (water courses) at positions A,B

The project occurs on lowlands and at the bottoms of valleys/plateaus of the Letaba catchment and Shingwedzi River and act as areas of natural drainage. The road crosses natural drainage lines (watercourses) at two distinct areas at about 2.5 Km and 3.7Km respectively. An artificial erosion gully has also formed towards the end of the road, as a result of the road interception of natural flow.

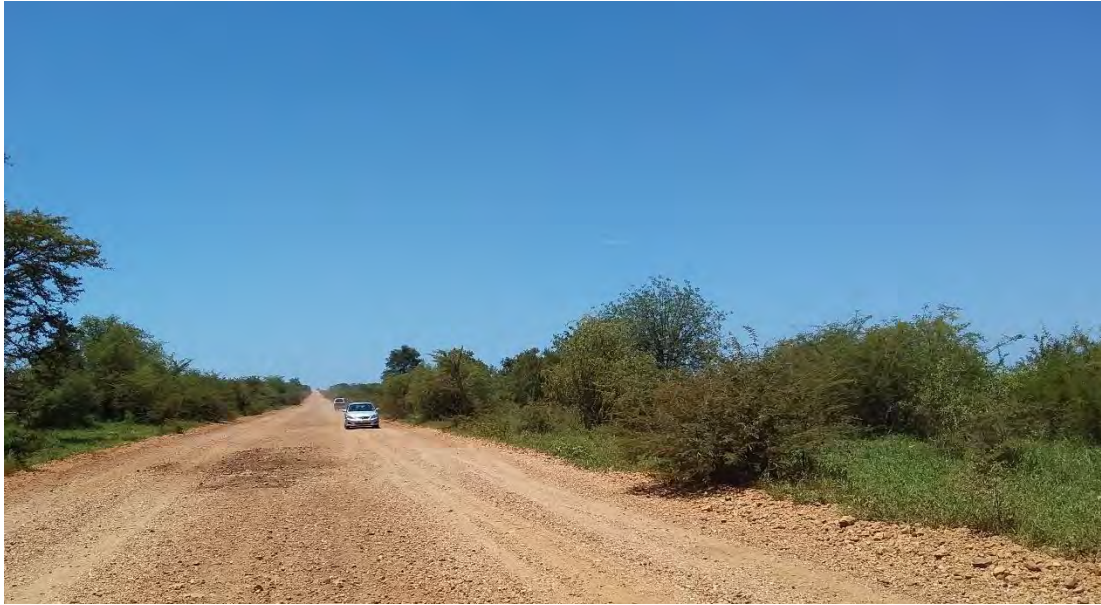
Figure 3-1: Mopani shrubs and *Acacia erioloba* Species to be removed on the path of the road construction

Floral diversity is low, and completely transformed due to extensive utilisation and degradation, with just a grass cover. However, the following protected tree species exist on the footprint of the development:

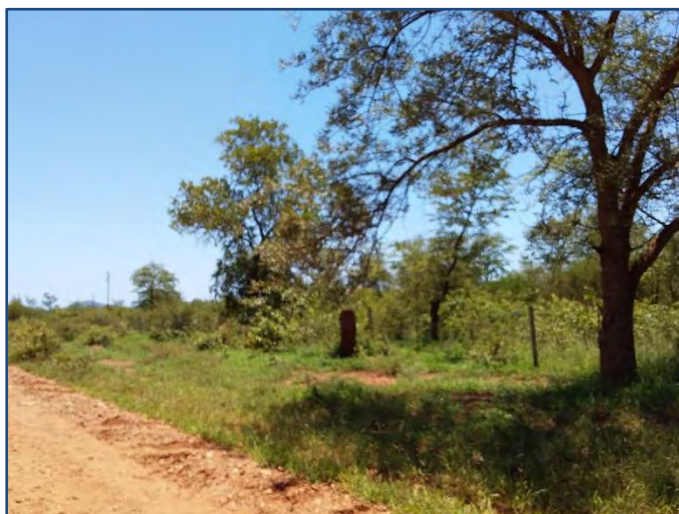
Figure 3-2: Some of the protected tree species of the *Sclerocarya birrea* and *Combretum imberbe* to be removed on the path of the road construction

- No species were recorded or that potentially can occur on site that are protected in terms of the Transvaal Nature Conservation Ordinance (TNCO)
- Tree species, *Sclerocarya birrea subsp. caffra* is protected in terms of the National Forests Act (1998, 2012) was recorded within the site, and will need to be removed on the path of the road alignment
- Tree species, *Combretum imberbe* is protected in terms of the National Forests Act (1998, 2012) was recorded within the site, and will need to be removed on the path of the bypass road alignment
- No Red listed species of concern or local endemics recorded. It should be noted, that their presence is totally dismissed.
- No Problematic or invasive alien flora species were observed during the site visit
