**DRAFT BASIC ASSESSMENT REPORT FOR A PROPOSED CONSTRUCTION
OF A 765KV TRANSMISSION POWER LINE, A NEW SUBSTATION
(MBEWU/THETA SUBSTATION) AND LOOP IN (765kV) AND LOOP OUT
(400KV) POWERLINES IN THE ZULULAND AND KING CETSHWAYO
DISTRICT MUNICIPALITIES, KWAZULU-NATAL PROVINCE,
KWAZULU-NATAL PROVINCE**

MAY 2023

KIM-ENV-2022-023

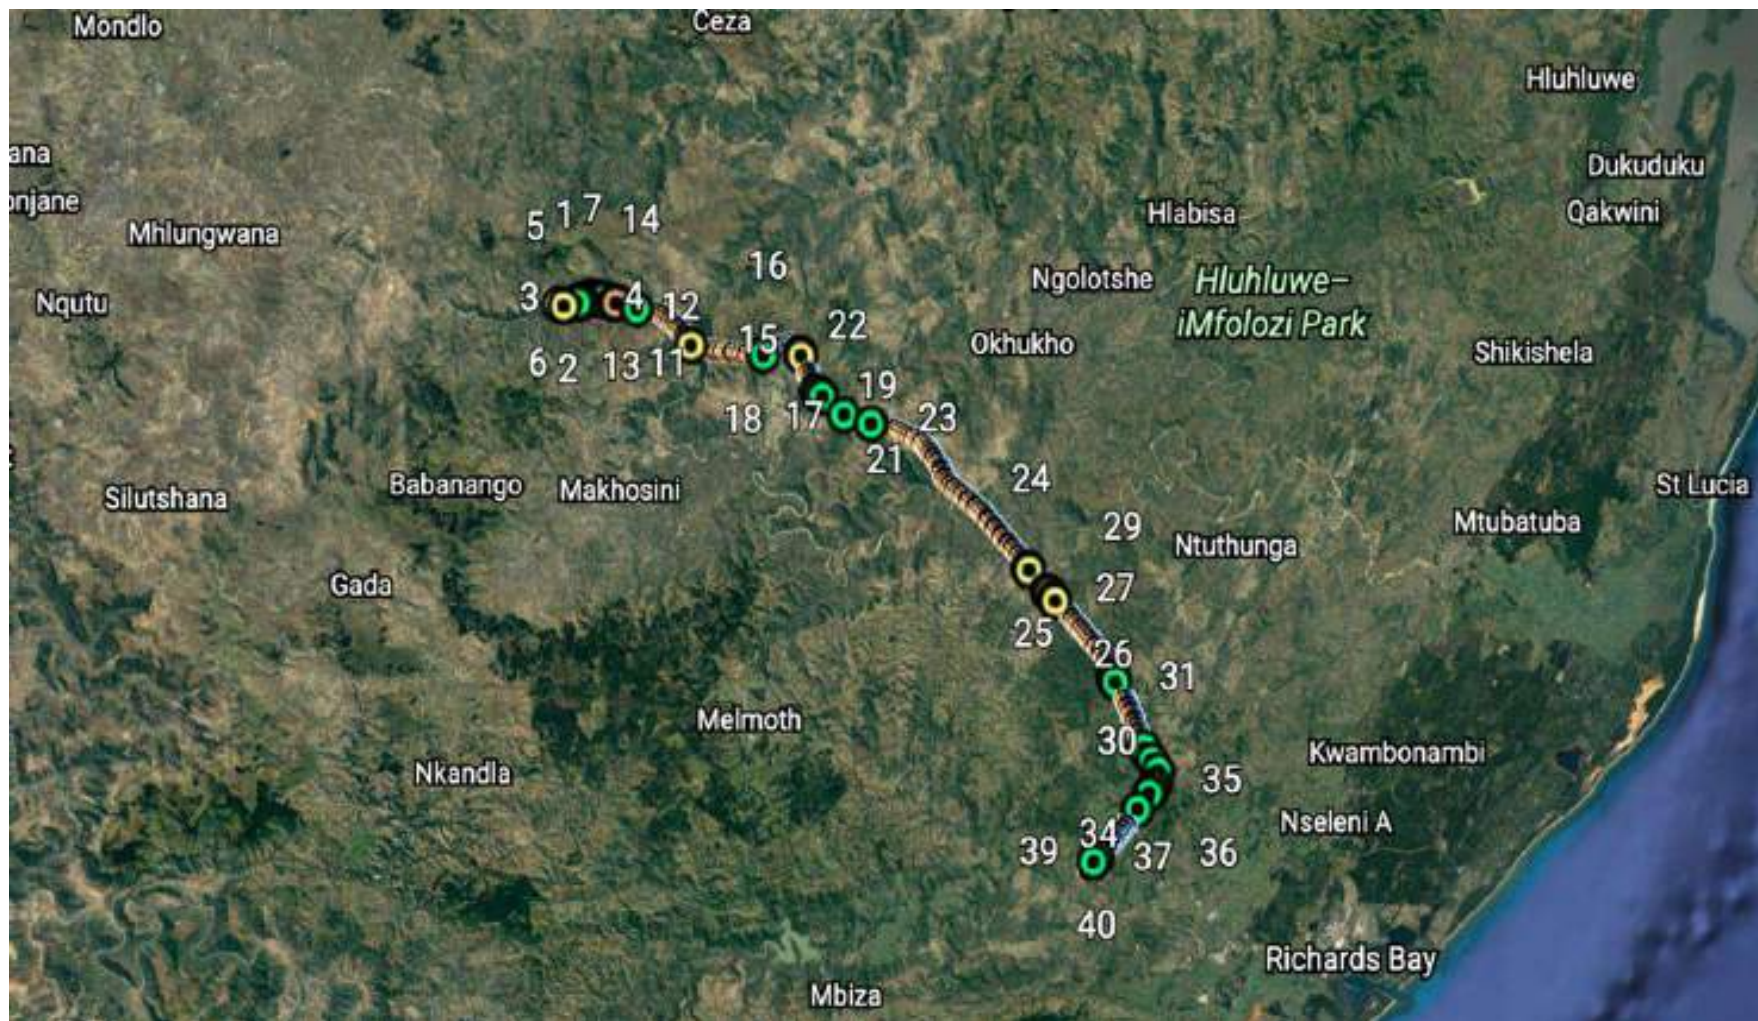
Figure 2: Umfolozi-Mbewu Transmission Line Study Map, Provided by Google Earth, kmz. (97,23km)

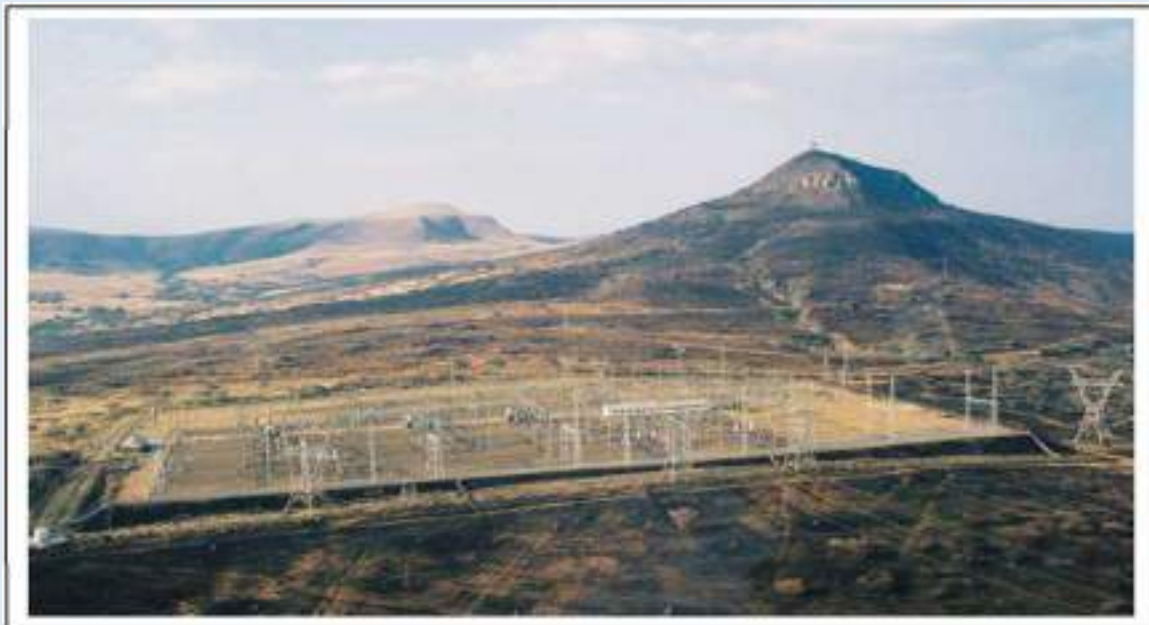
The 400kV Umfolozi Substation is situated just northwest of Ulundi in KwaZulu-Natal (28°12' 52" S, 31°11'13" E). (**Figure 16**). When the line is energised to 400kV, another sub- station closer to Richards Bay will be identified for 400kV integration and will be extended to accommodate the 400kV integration.

Figure 16: Overview of the substation.

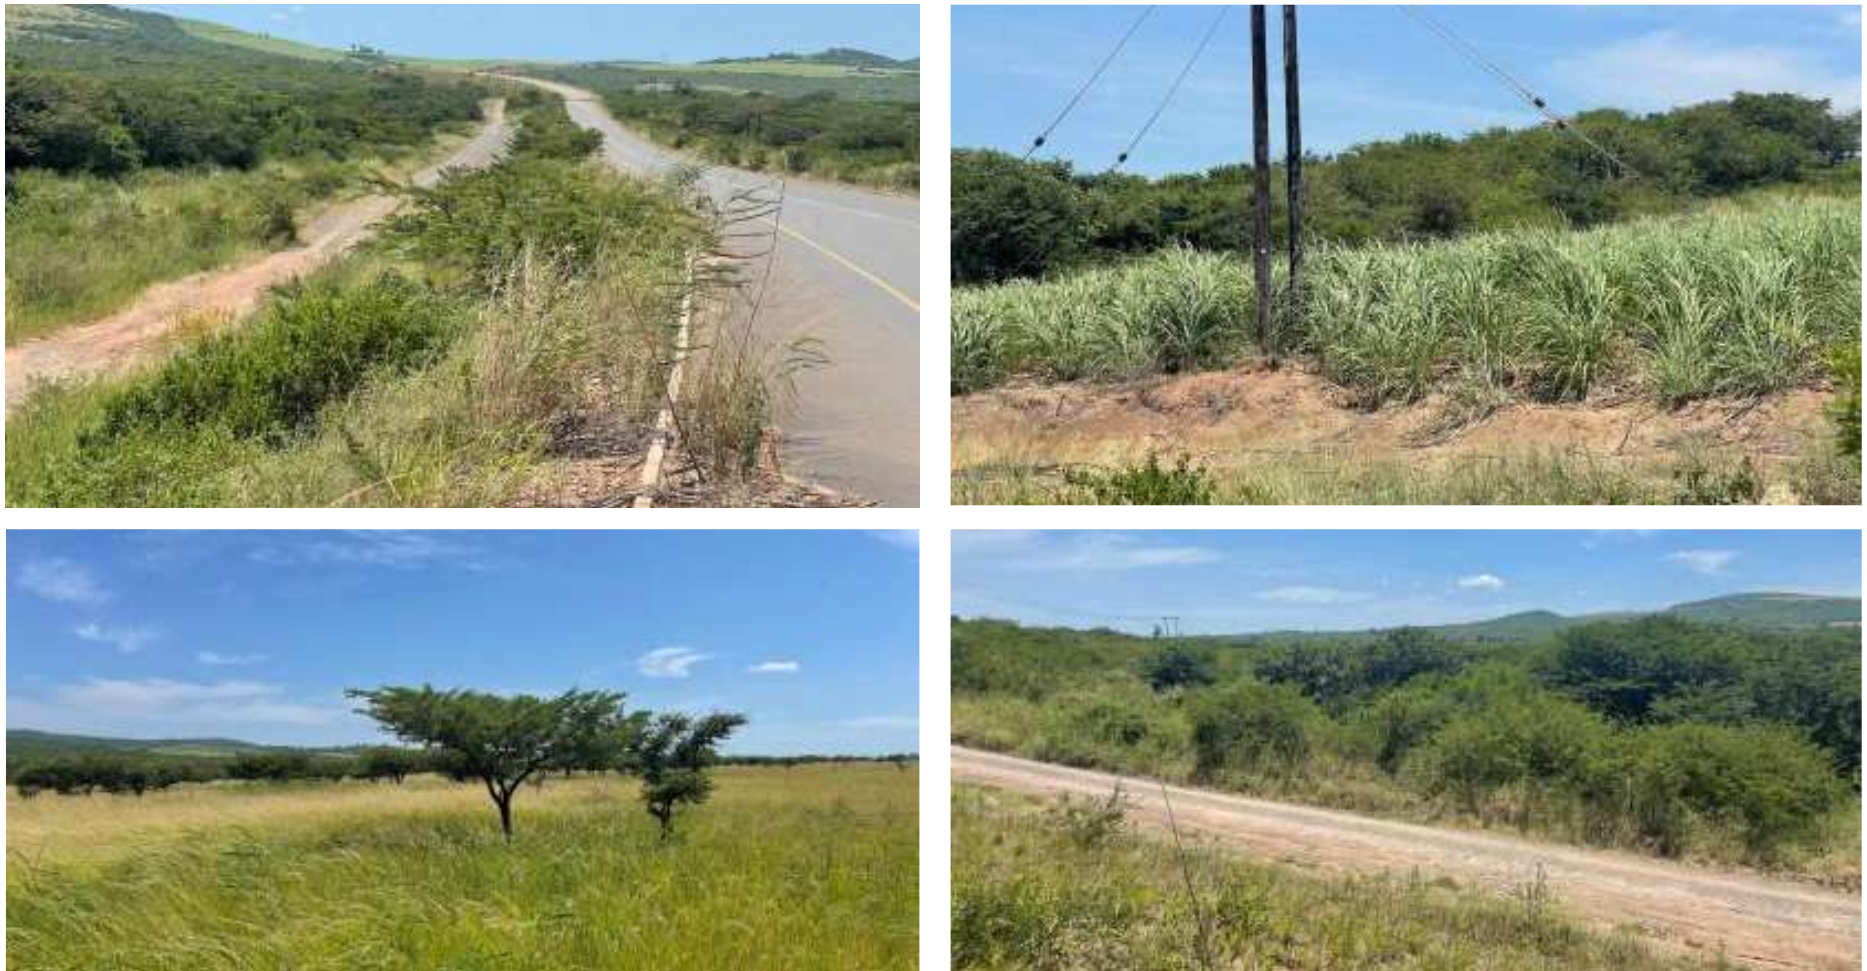
Figure 6:Over of the study site along the proposed servitude (Points 38-40) .

Ithala Quartzite Sourveld and Zululand Coastal Thornveld vegetation units (**Figure 3, above**). However as indicated in the landuse Map (**Figure 2, above**) that land has been transformed by agricultural activities with patches of indigenous vegetation across the proposed servitude (**Figures 6-9**).The transformation/ disturbance onsite has created an suitable habitat for proliferation of invasive alien plant species (**Figure 10**). The area near the substation has a large Lantana camara infestation, and thus any disturbance to the land will exacerbate the infestation. The study site has indigenous vegetation scattered across the broader area, however there are small sections of the servitude that will be located in disturbed land.

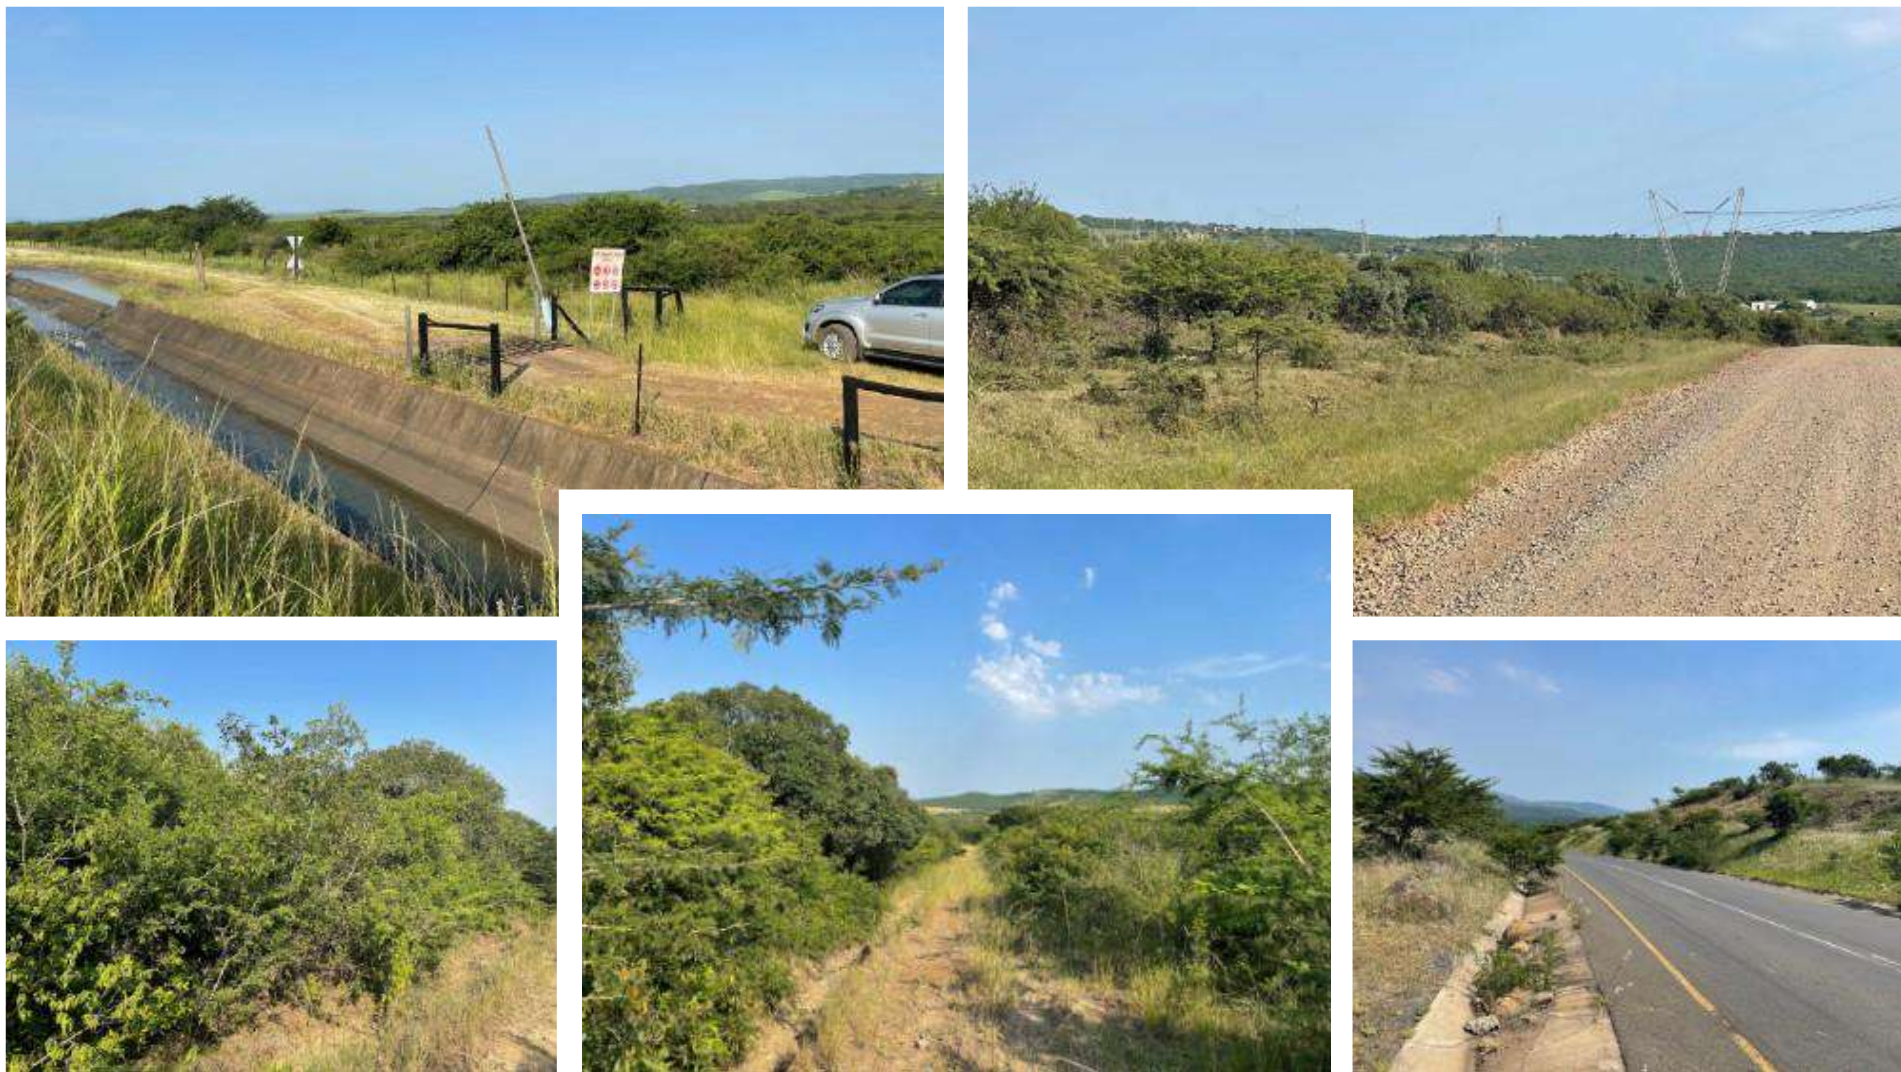
Figure 7: Overview of Point 38-30, the servitude is dominated by indigenous plant species.

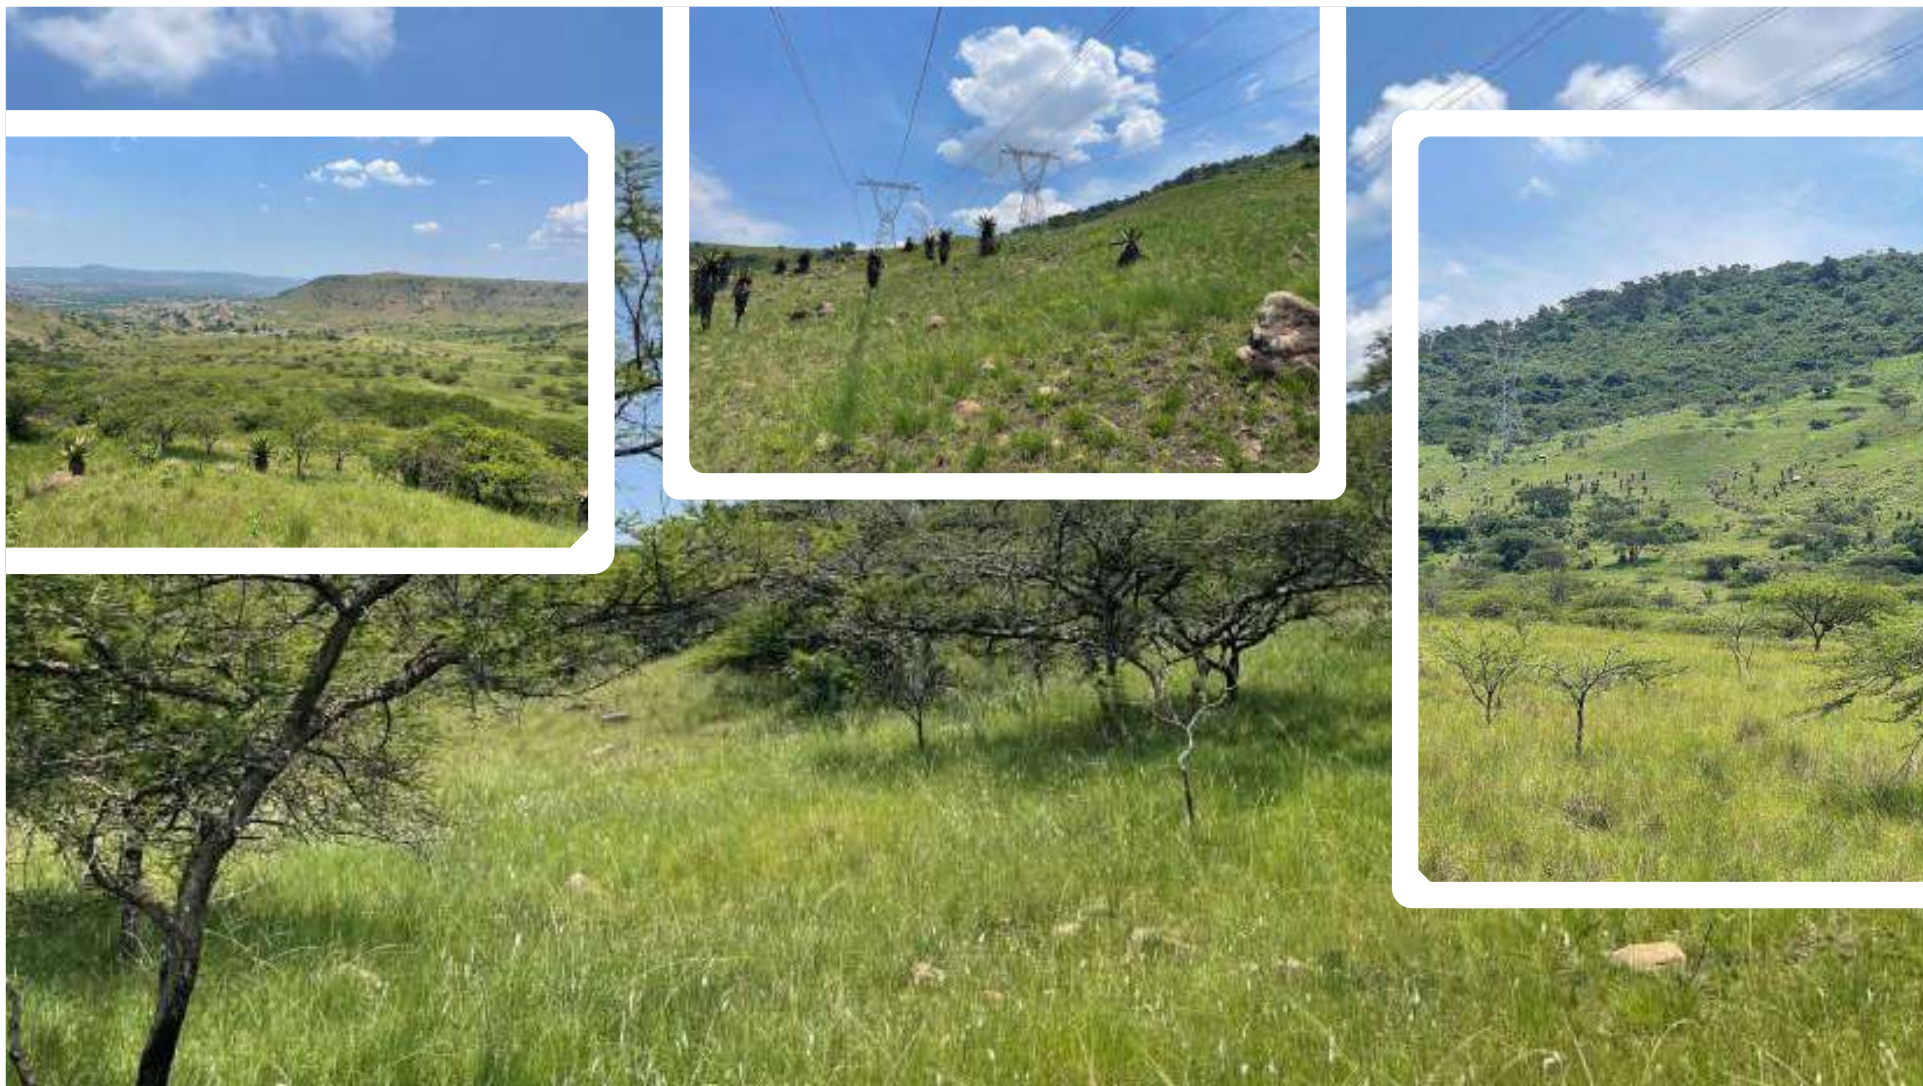
Figure 8: Overview of the servitude near Ulundi (Located between Point 16-15).

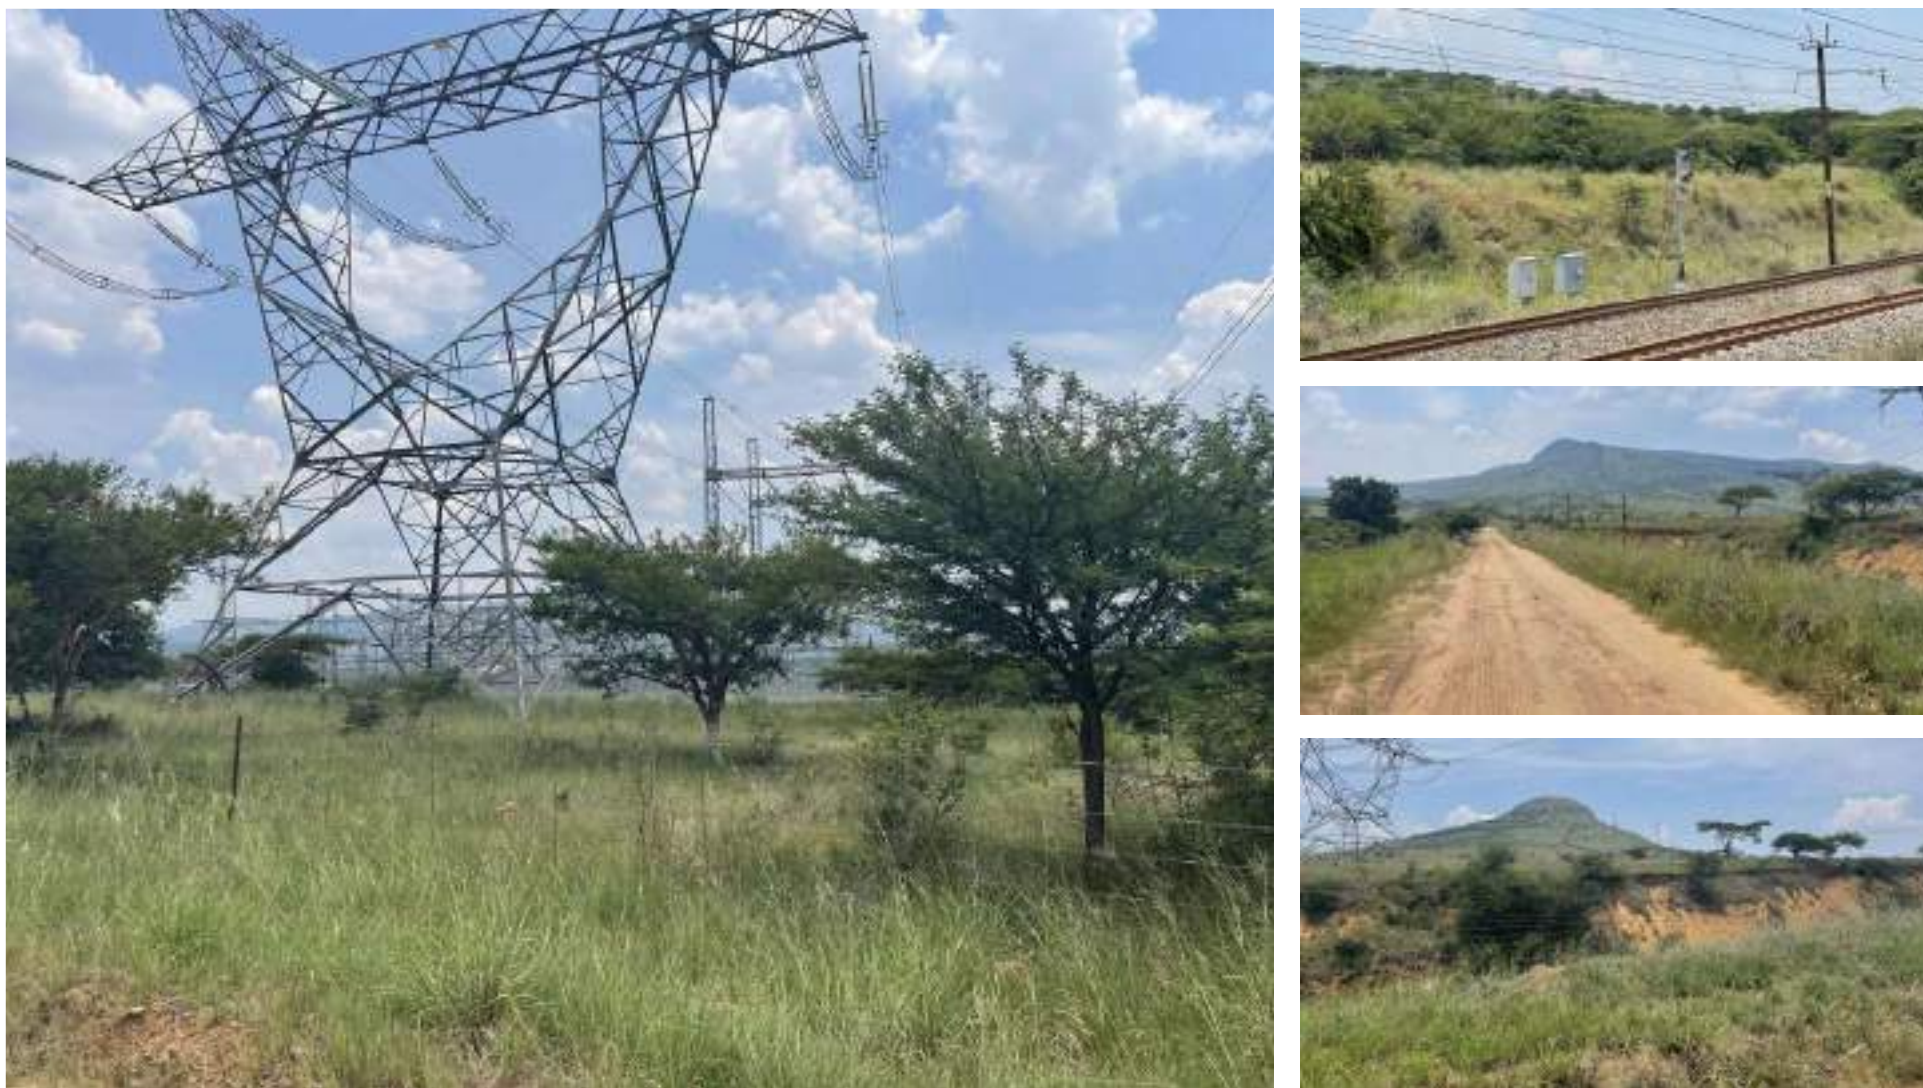
Figure 9: Starting Point of the proposed powerline.

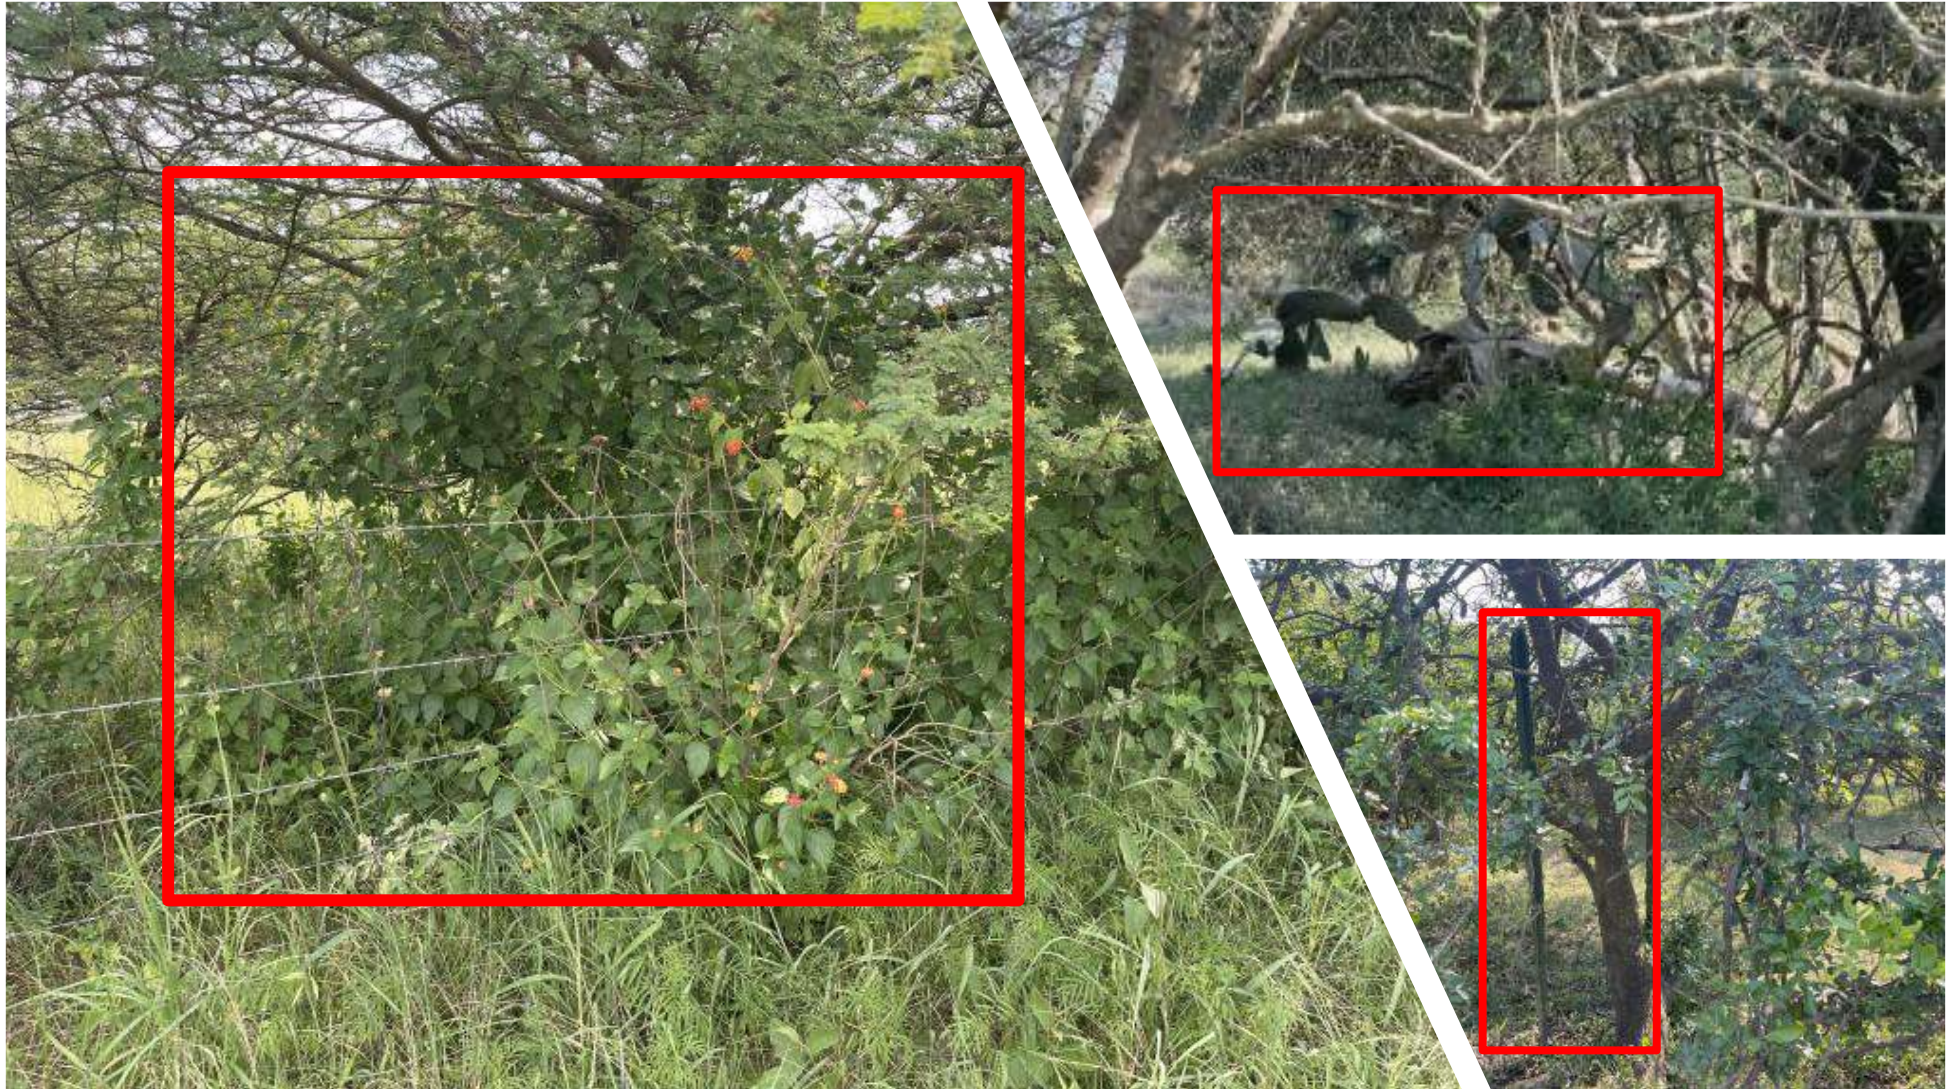
Figure 10: Alien invasive plant species (A -*Lantana camara* , B-*Opuntia* spp, and C-*Cereus jamacaru*)

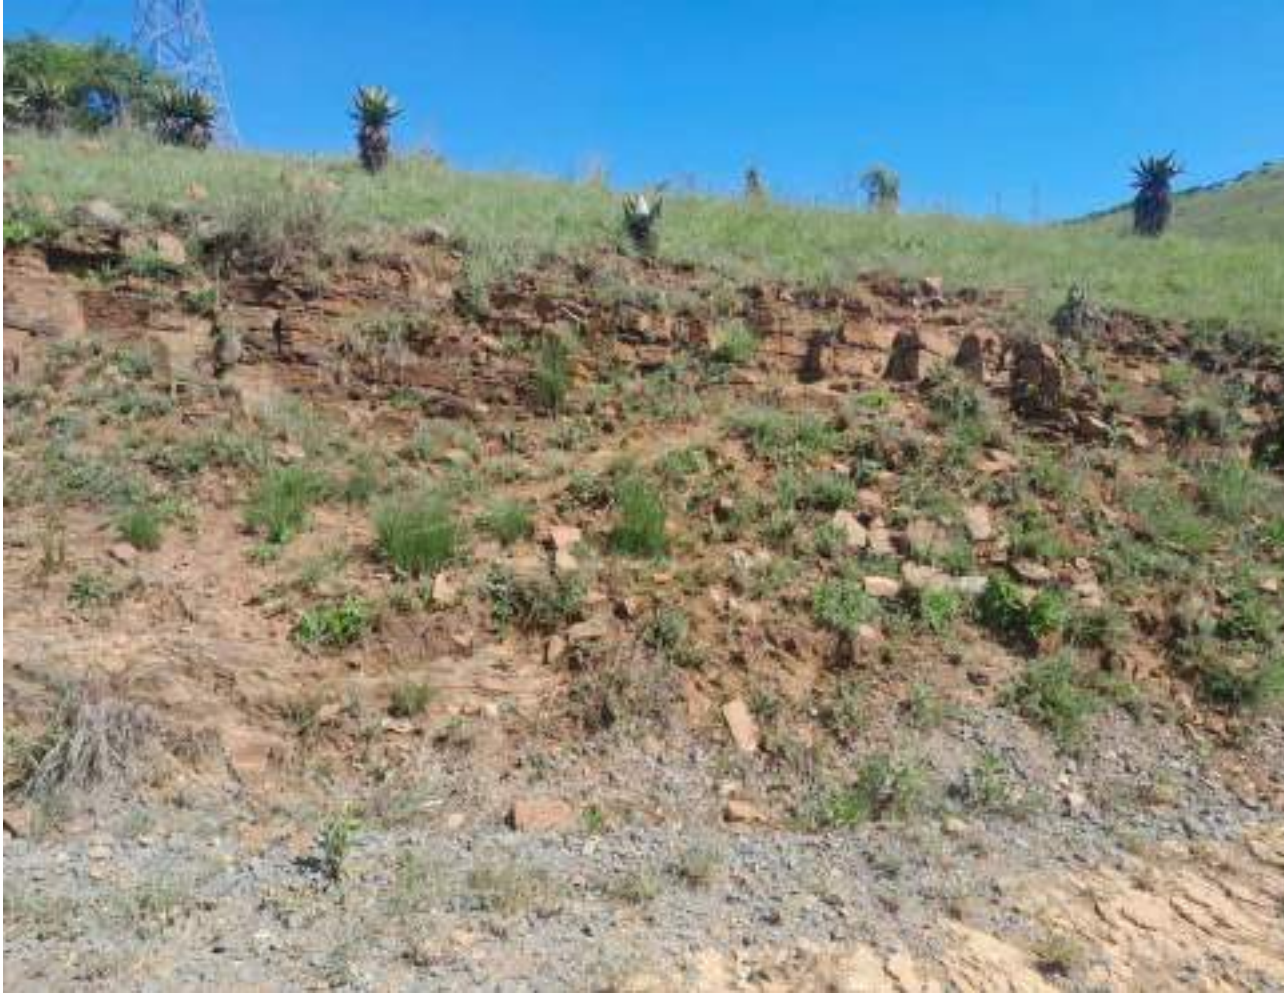
PG.10.1: Glenrosa and Mispah Type Soils

The photograph above illustrates the many shallow soils that were encountered at along the route. They characteristically have shallow soil above solid rock or shale or tongues going into weathering rock. These soils should not be cultivated as they carry a moderate to high erosion hazard depending on surrounding topography and slope.

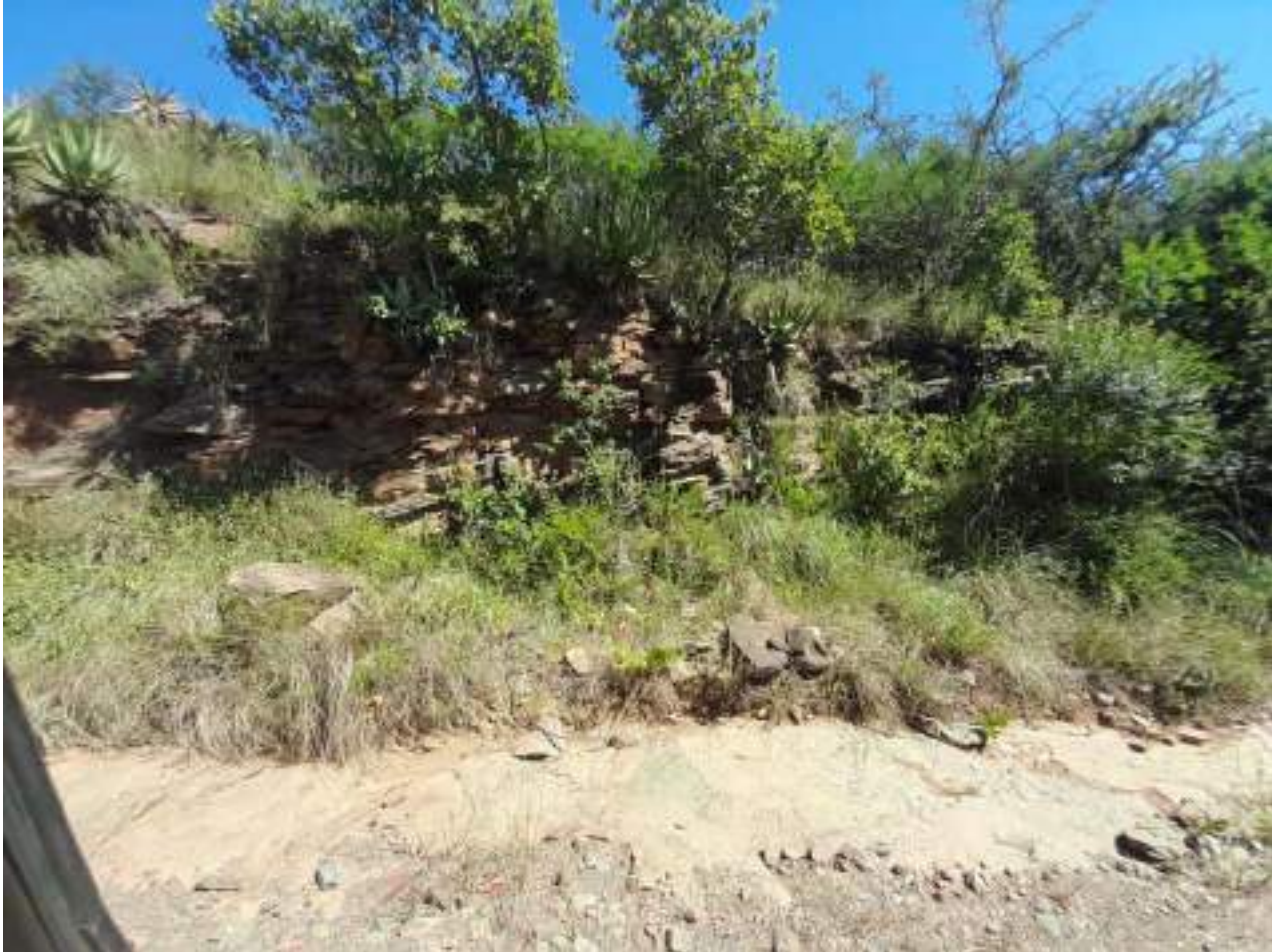
PG .10.3: Typical Roadside Profile

The foreground of this photograph illustrates the solid rock that occurs below the shallow topsoils in many places along this route.

Another typical roadside profile

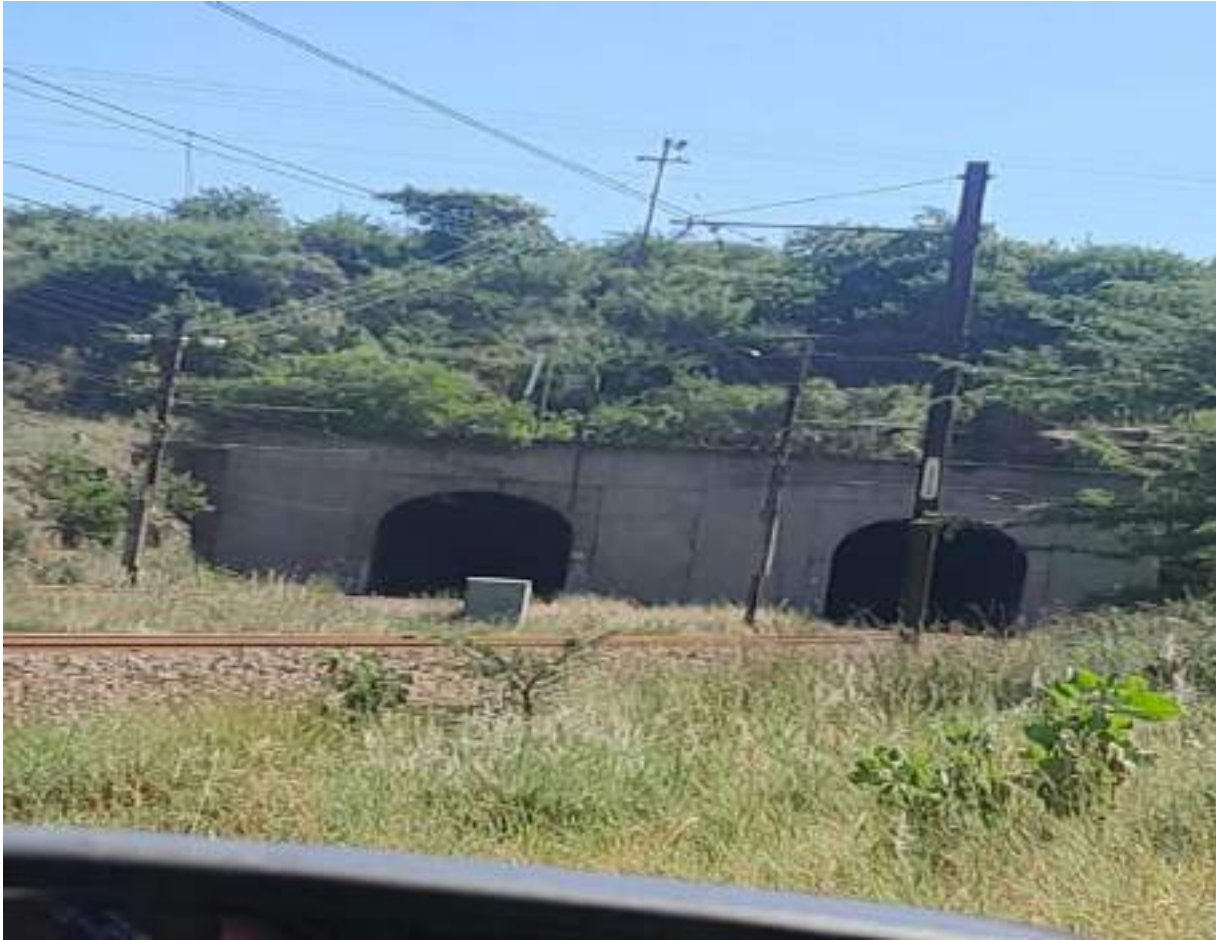
PG. 10.4: Spoornet Tunnels

The numbers of tunnels along the route are a clear indication of how steep and broken the terrain is. The upper half of the photograph illustrates the vigorous and luxuriant of indigenous bushveld along the route. In the foreground is good coverage by Natal Red Grass, a pioneer on disturbed land

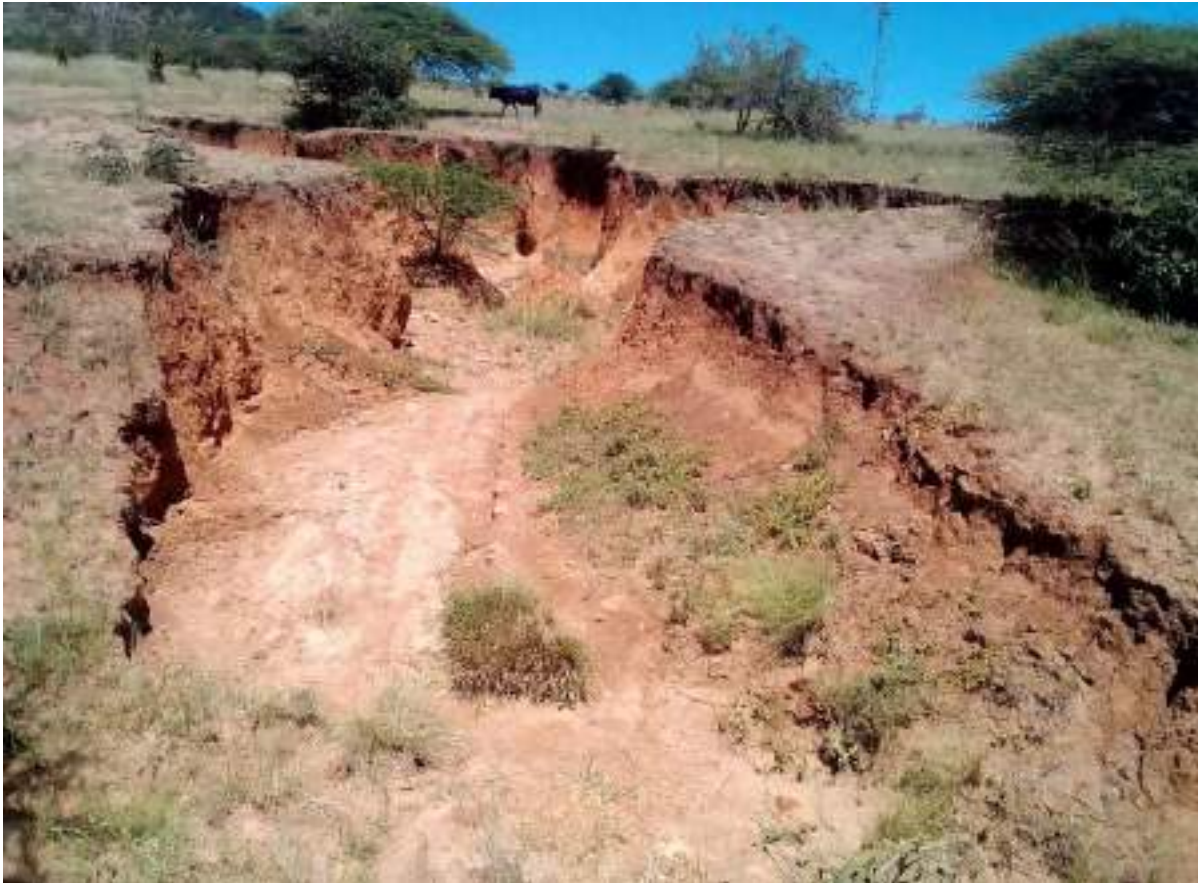
PG 10.5 Valsrivier Soil Form

Because of its parentage and structure this soil can erode even on gently sloping hillsides

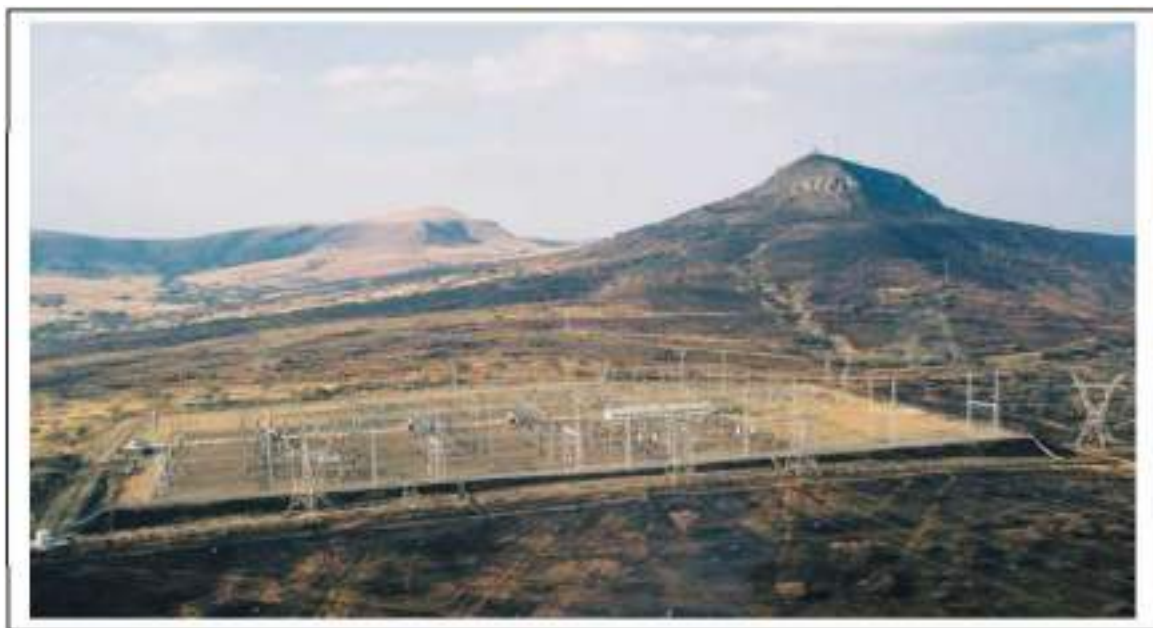
Figure 7: Overview of the substation

The 400kV Umfolozi Substation is situated just northwest of Ulundi in KwaZulu-Natal (28°12' 52" S, 31°11'13"E). No additional land acquisition is anticipated at the Umfolozi substation to receive the proposed line, as there is a vacant bay (Figure 7). When the line is energised to 400kV, another sub-station closer to Richards Bay will be identified for 400kV integration and will be extended to accommodate the 400kV integration.

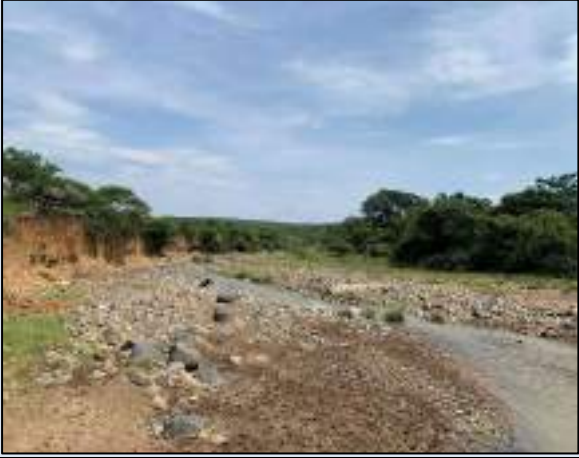
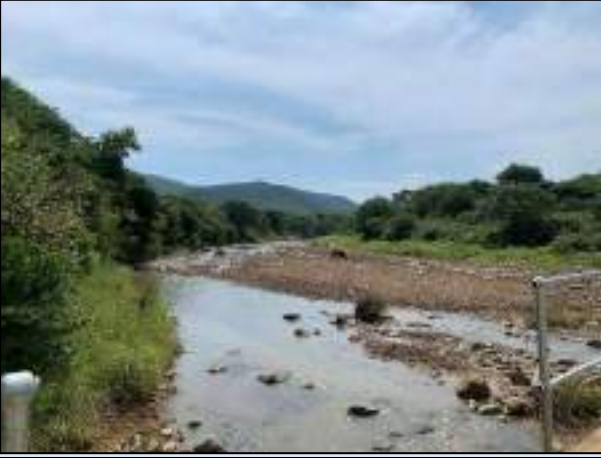
Water Quality			
Ecoregion	North-Eastern Uplands Ecoregion	Quaternary Catchment	W21 H
pH	8.56	Temperature (°C)	29.4
DO (%) / mg/L	72.71% / 5.3 mg/L	Electrical Conductivity (mS/m)	33
Biological Response (Benthic Macro-invertebrates)			
Number of taxa	14	ASPT Score	4.71
SASS5 Score	66	SASS5 classification (Dallas, 2007)	E/F
IHAS Score	44 (Poor)	MIRAI Score	59.9 (C/D)

Table B: Aquatic assessment findings – UMP02 (River) downstream of proposed activities.

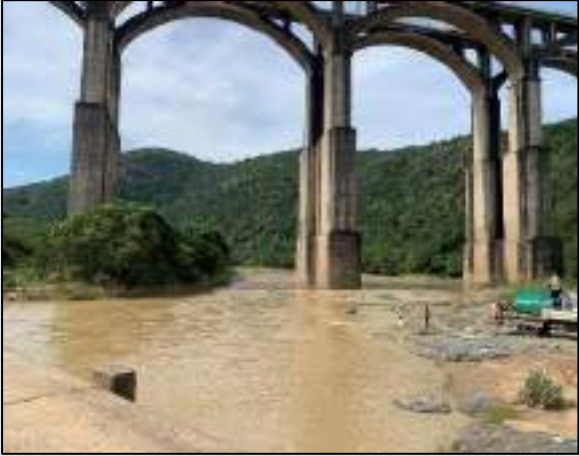
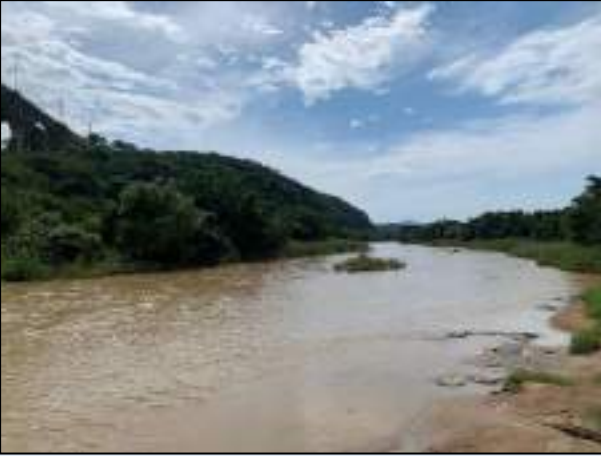
Water Quality			
Ecoregion	North-Eastern Uplands Ecoregion	Quaternary Catchment	W21H
pH	8.01	Temperature (°C)	Moderate
DO (%) / mg/L	64.4 % / 4.33 mg/L	Electrical Conductivity (mS/m)	35.1 mS/m
Biological Response (Benthic Macro-invertebrates)			
Number of taxa	10	ASPT Score	6.4
SASS5 Score	64	SASS5 classification (Dallas, 2007)	E/F
IHAS Score	55 (Fair/Adequate)	MIRAI Score	58.2 (C/D)

Table C: Aquatic assessment findings – UMP03 (White Umfolozi River) downstream of proposed activities.

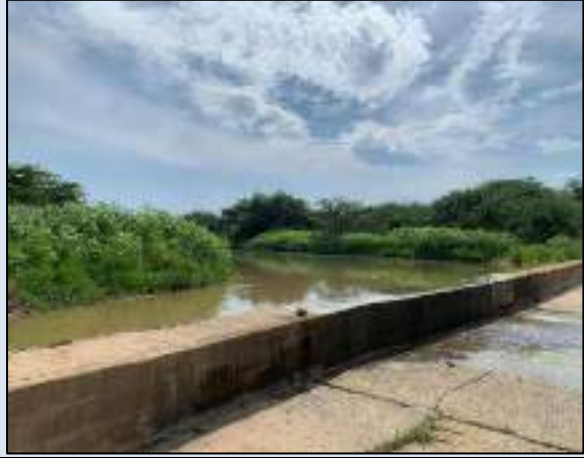
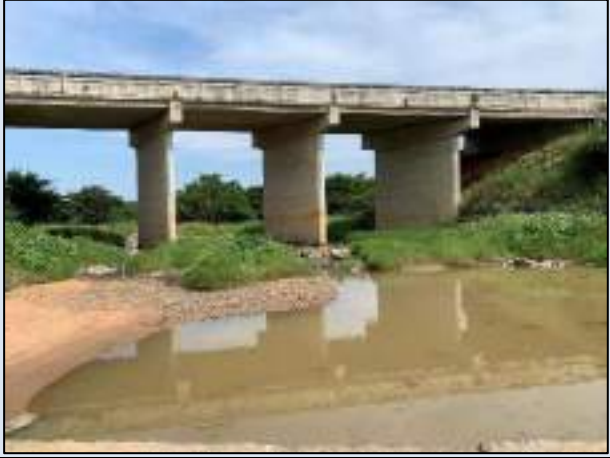
Water Quality			
Ecoregion	Lowveld	Quaternary Catchment	W21K
pH	8.50	Temperature (°C)	29.0
DO (%) / mg/L	75.7% / 5.52 mg/L	Electrical Conductivity (mS/m)	30 mS/m
Biological Response (Benthic Macro-invertebrates)			
Number of taxa	13	ASPT Score	6.08
SASS5 Score	73	SASS5 classification (Dallas, 2007)	E/F
IHAS Score	44 (Poor)	MIRAI Score	58.6 (C/D)

Table D: Aquatic assessment findings – UMP04 (Munywana River) downstream of proposed activities.

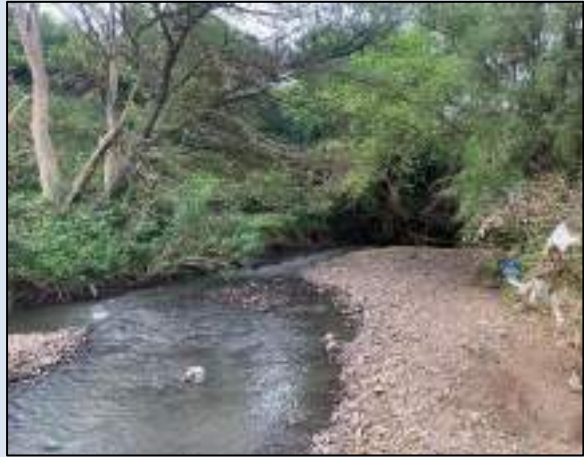
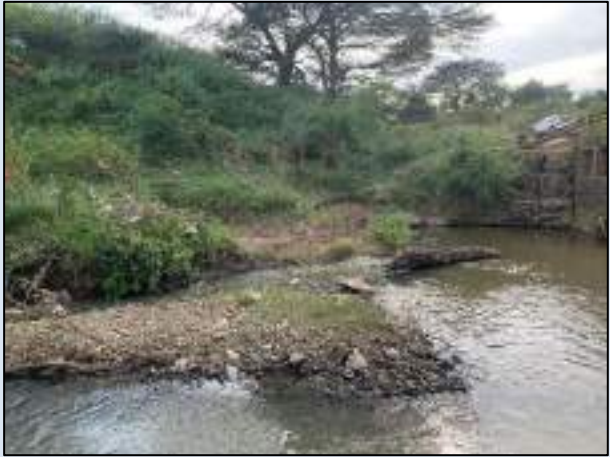
Water Quality			
Ecoregion	North-Eastern Uplands Ecoregion	Quaternary Catchment	W21L
pH	8.75	Temperature (°C)	34.3
DO (%) / mg/L	59.6% / 4.1 mg/L	Electrical Conductivity (mS/m)	139
Biological Response (Benthic Macro-invertebrates)			
Number of taxa	7	ASPT Score	3.71
SASS5 Score	26	SASS5 classification (Dallas, 2007)	E/F
IHAS Score	30 (Poor)	MIRAI Score	52.70 (D)

Table E: Aquatic assessment findings – UMP05 (Nseleni River) downstream of proposed activities.

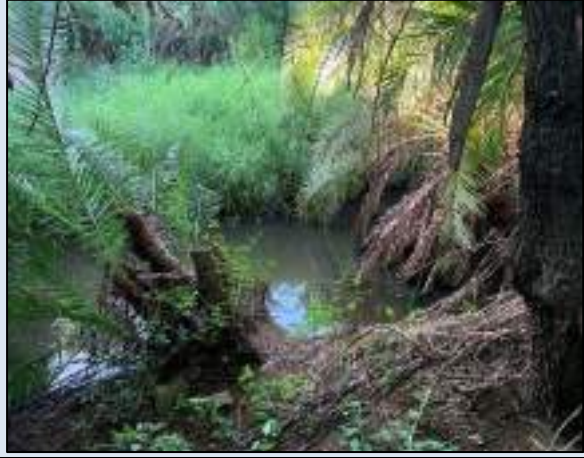
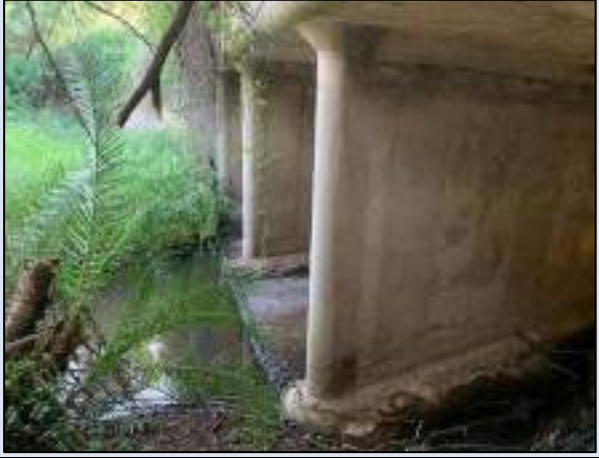
Water Quality			
Ecoregion	North-Eastern Uplands Ecoregion	Quaternary Catchment	W21G
pH	9.3	Temperature (°C)	28.1
DO (%) / mg/L	34.1% / 2.95 mg/L	Electrical Conductivity (mS/m)	78 mS/m
Biological Response (Benthic Macro-invertebrates)			
Number of taxa	9	ASPT Score	4.22
SASS5 Score	38	SASS5 classification (Dallas, 2007)	E/F
IHAS Score	51 (Poor)	MIRAI Score	52.0 (D)

Table E: Aquatic assessment findings – UMP06 (Ntambanana River) downstream of proposed activities.

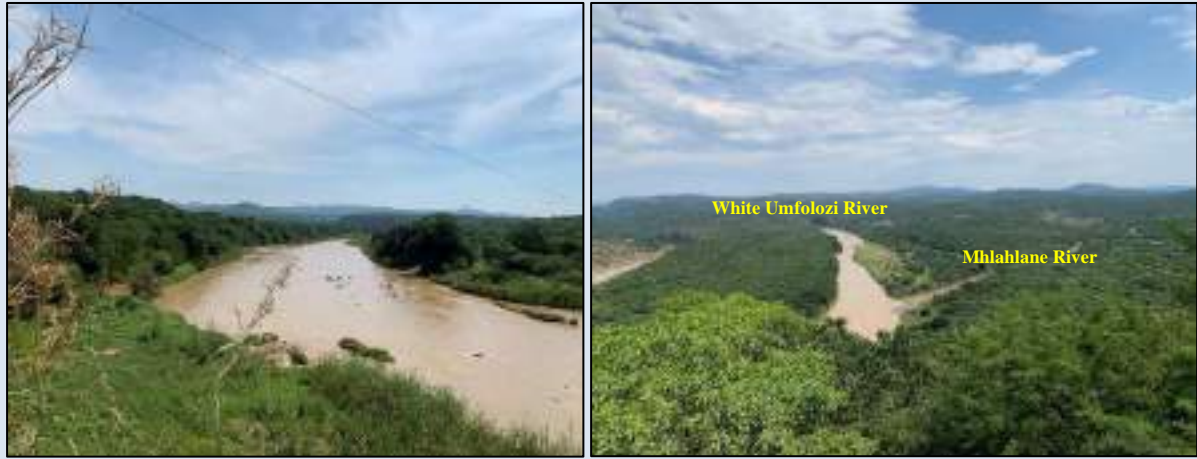
Table 4: UMP01 site - White Umfolozi River on the North-Eastern Uplands Eastern Ecoregion.

Water Quality			
Ecoregion	North-Eastern Uplands Ecoregion	Quaternary Catchment	W21H
pH	8.56	Temperature (°C)	29.4
DO (%) / mg/L	72.71% / 5.3 mg/L	Electrical Conductivity (mS/m)	33
Water Quality Discussion	<p>The water quality conditions at the UMP01 assessment site located on the White Umfolozi River were considered ideal and without major impacts during the current assessment in March 2023. Sufficient dissolved oxygen was measured (72.71%), although this was below the 80 – 120% recommended saturation limit, it is not considered a significant limitation for establishment of sensitive benthic taxa (DWAF, 1996). The electrical conductivity was also considered acceptable (33 mS/m) and not indicate of significant impacts on the system. The turbidity of the White Umfolozi was considered an observable impact likely due to extensive catchment and large volumes with high capacity to carry sediment resulting in reduced water clarity.</p>
