**DRAFT BASIC ASSESSMENT REPORT FOR A PROPOSED CONSTRUCTION
OF A 765KV TRANSMISSION POWER LINE, A NEW SUBSTATION
(MBEWU/THETA SUBSTATION) AND LOOP IN (765kV) AND LOOP OUT
(400KV) POWERLINES IN THE ZULULAND AND KING CETSHWAYO
DISTRICT MUNICIPALITIES, KWAZULU-NATAL PROVINCE,
KWAZULU-NATAL PROVINCE**

MAY 2023

KIM-ENV-2022-023

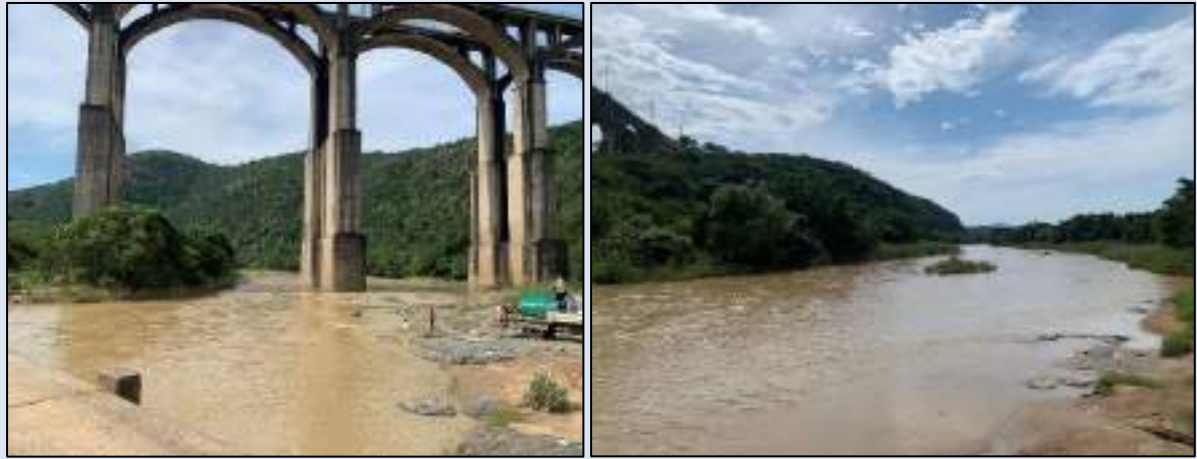
Table 6: UMP03 site - White Umfolozi River

Ecoregion			
Ecoregion	Lowveld Ecoregion	Quaternary Catchment	W21K
pH	8.50	Temperature (°C)	29.0
DO (%) / mg/L	75.7% / 5.52 mg/L	Electrical Conductivity (mS/m)	30 mS/m
Water Quality Discussion	<p>The water quality conditions at the UMP03 assessment site located on the White Umfolozi River were considered ideal and without major impacts during the current assessment in March 2023. Sufficient dissolved oxygen was measured, although this was below the 80 – 120% recommended saturation limit, it is not considered a significant limitation for establishment of sensitive benthic taxa (DWAF, 1996). The electrical conductivity was also considered acceptable and not indicate of significant impacts on the system. The turbidity of the White Umfolozi was considered an observable impact likely due to extensive catchment and large volumes with high capacity to carry sediment resulting in reduced water clarity. Observed impacts include removal of sand on banks and water abstraction.</p>

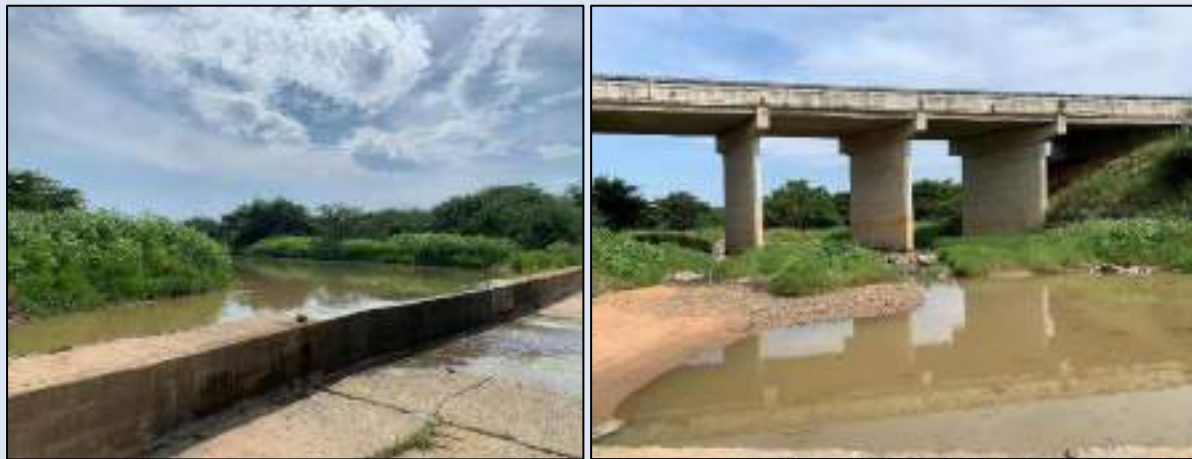
Table 7: UMP 04 - Munywana River, tributary of White Umfolozi River on the North-Eastern Uplands Eastern Ecoregion.

Water Quality			
Ecoregion	North-Eastern Uplands Ecoregion	Quaternary Catchment	W21L
pH	8.75	Temperature (°C)	34.3
DO (%) / mg/L	59.6% / 4.1 mg/L	Electrical Conductivity (mS/m)	139
Water Quality Discussion	<p>The Munywana River is a tributary of the White Umfolozi River and at the time flows were relatively low at the site. At the time of the assessment, the flows were largely disconnected and ponding upstream of the concrete bridge. High electrical conductivity was measured (139 mS/m), this is possibly due to the stagnant flows resulting in concentration of salts at a single point (DWAF, 1996). The absence of significant flows also contributed to reduced dissolved oxygen (59.6%) measured at the site and these conditions are considered likely to be limitations for the establishment of taxa. In addition, increased turbidity was observed at the site, this is considered an impact since turbidity blocks the sunlight that plants need to produce oxygen for benthic macro-invertebrates and other aquatic life.</p>

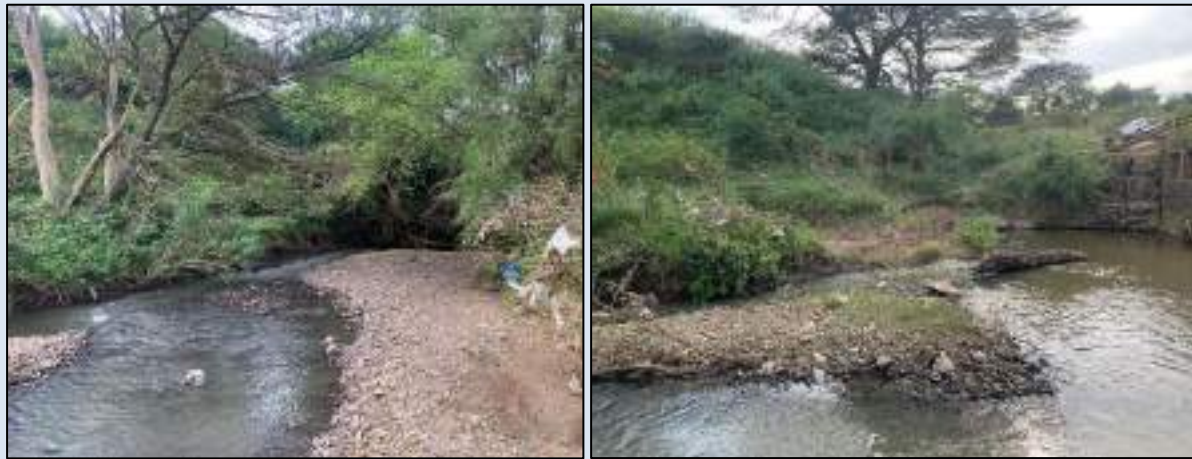
Table 8: UMP05 - Nseleni River, a tributary of the Mhlathuze River on the North-Eastern Uplands Eastern Ecoregion.

Water Quality			
Ecoregion	North-Eastern Uplands Ecoregion	Quaternary Catchment	W21G
pH	9.3	Temperature (°C)	28.1
DO (%) / mg/L	34.1% / 2.95 mg/L	Electrical Conductivity (mS/m)	78 mS/m
Water Quality Discussion	<p>The Nseleni River is located in the vicinity of communities and as a result is subject to various impacts from domestic activities. The Nseleni River is a tributary of the White Mhlathuze River and at the time flows were relatively low at the site. At the time of the assessment, the flow were considered moderate and significant litter/waste was observed at the site. In addition, severe smell of sewage and animal waste was present at the site, and this is likely to result in impacts on water quality. The electrical conductivity was elevated at the time (78 mS/m) and the dissolved oxygen considered low (34.1%) resulting in limitations on the system for establishment of sensitive benthic macroinvertebrates. Disposal of dead animals into the river increases microbial pathogens in water which have a significant impact on aquatic life.</p>

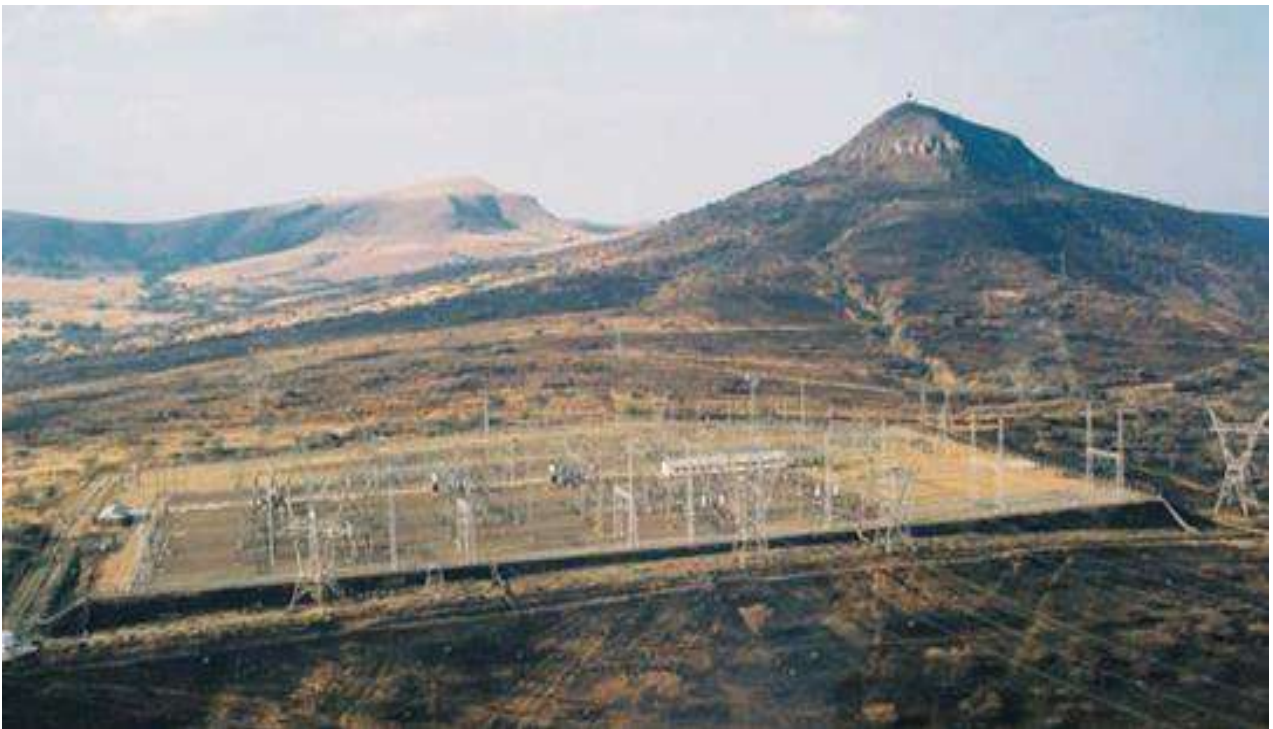
Plate 1: showing Umfolozi Substation where the proposed powerline will connect(Photograph by Menno Klapwijk)

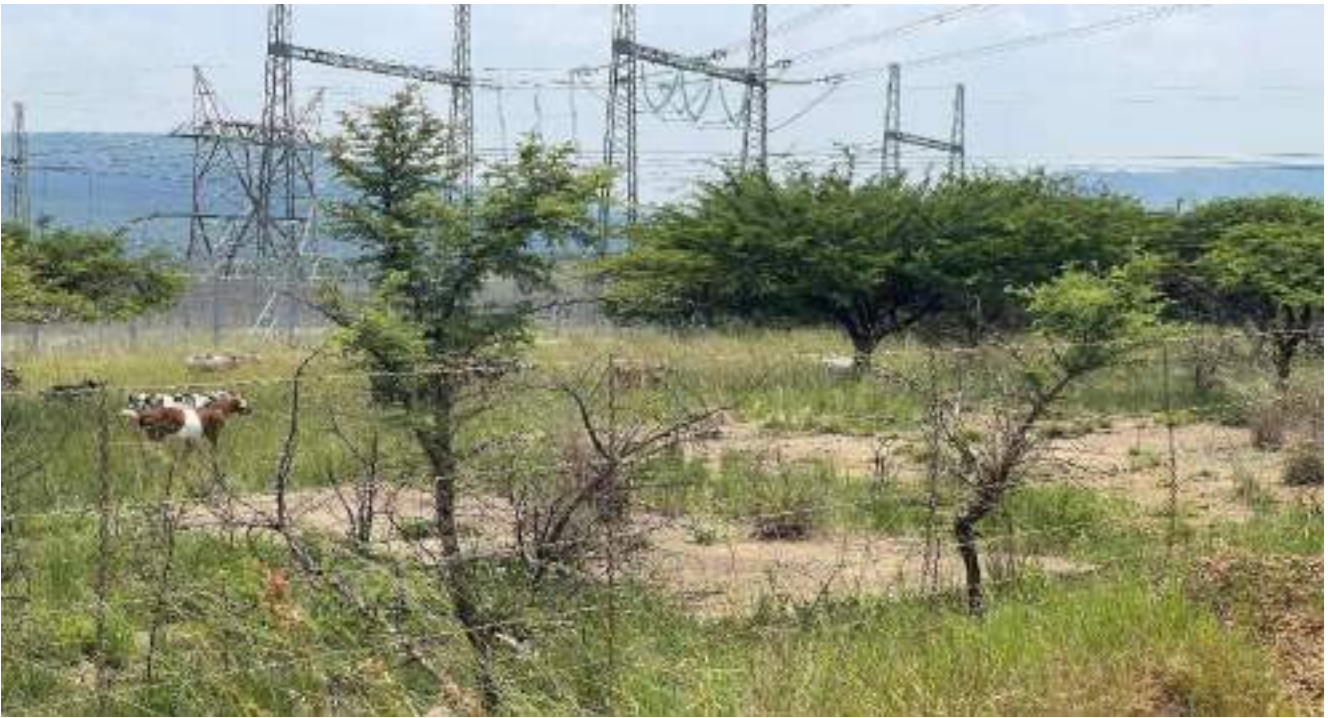
Plate 2: showing the Umfolozi Substation
