APPENDIX 4.4.3.
FISHWAY/LADDER STUDY AND REPORT

**ASSESSMENT OF POTENTIAL MIGRATION BARRIER CAUSED BY
A PROPOSED DAM IN AN UNNAMED (KMAE) TRIBUTARY OF THE
CROCODILE RIVER (MALALENE, MPUMALANGA)**

MAY 2021

Report reference: CSBS/A/2021

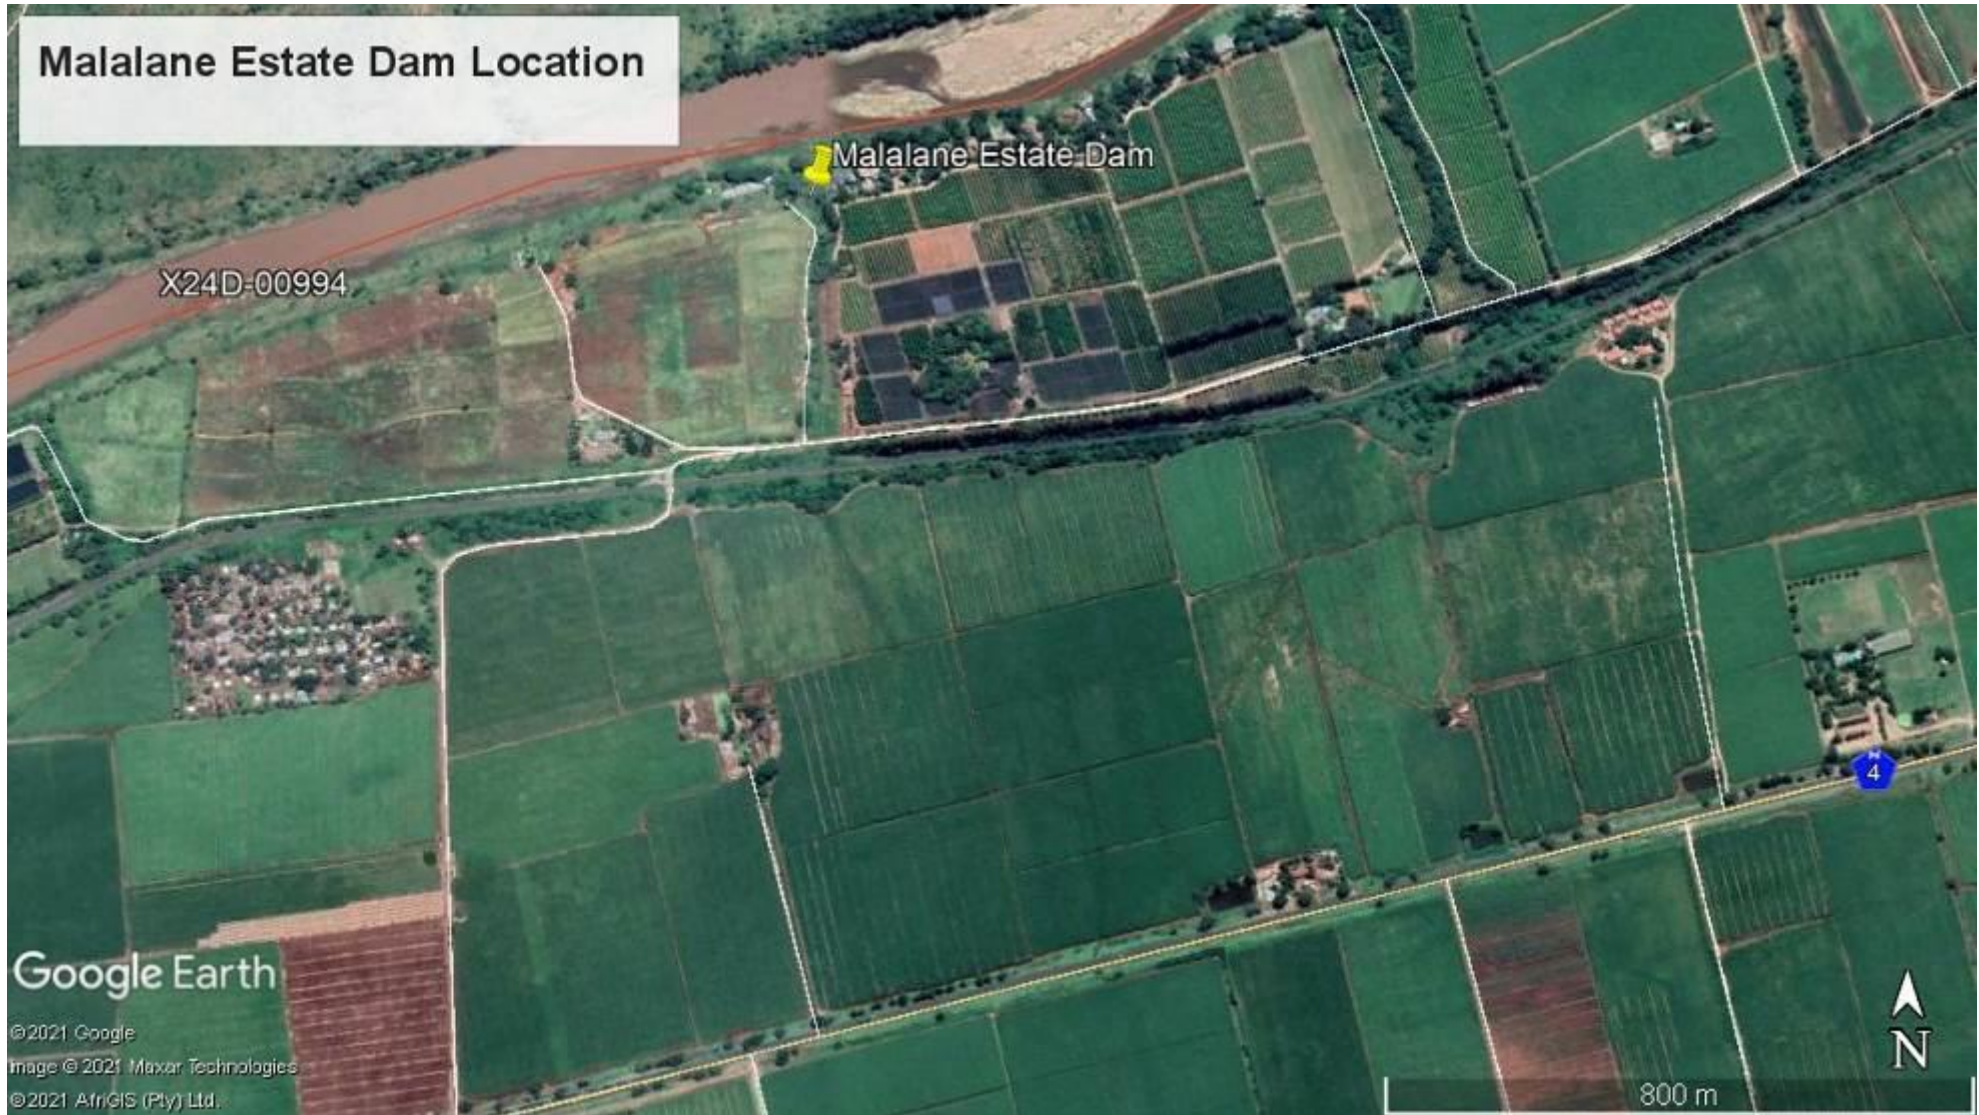
Figure 1: Location and catchment area of proposed barrier

The proposed dam is situated in an unnamed tributary (named KMAE stream for the purpose of this study) of the Crocodile River (East) (Figure 1, Table 1). It is though that this stream may have been a seasonal drainage line under natural conditions and have been altered (made perennial) by irrigation return flows (sugar cane). The present ecological status of this stream is discussed in detail in the aquatic specialist report (compiled by Dr. A. Deacon) that forms part of the EIA process of the proposed development.

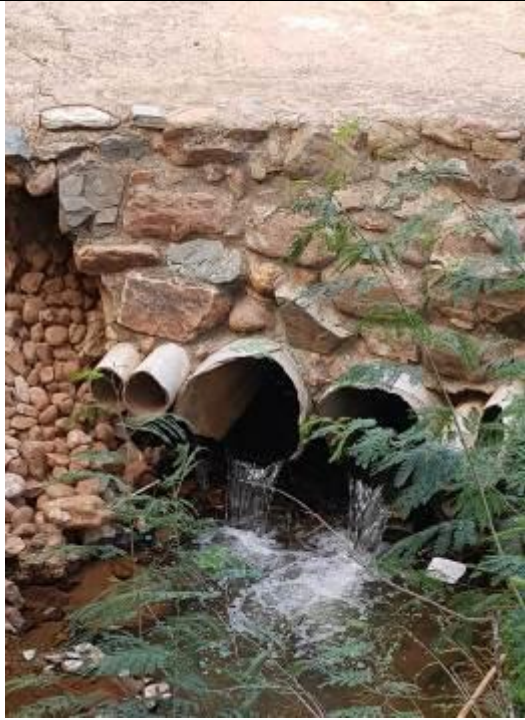
Plate 1: Existing bridge (barrier)

- Ideally the existing barrier (bridge) should be removed and if access is required a bridge should be reconstructed with minimal impact on the riverbed.

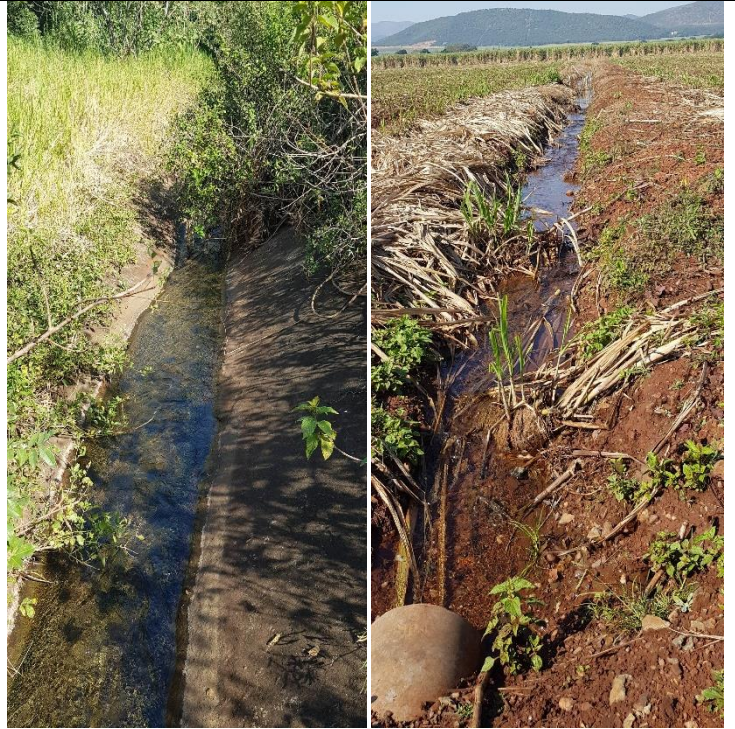
Plate 2: Canal / irrigation return flows (upstream of railway bridge).

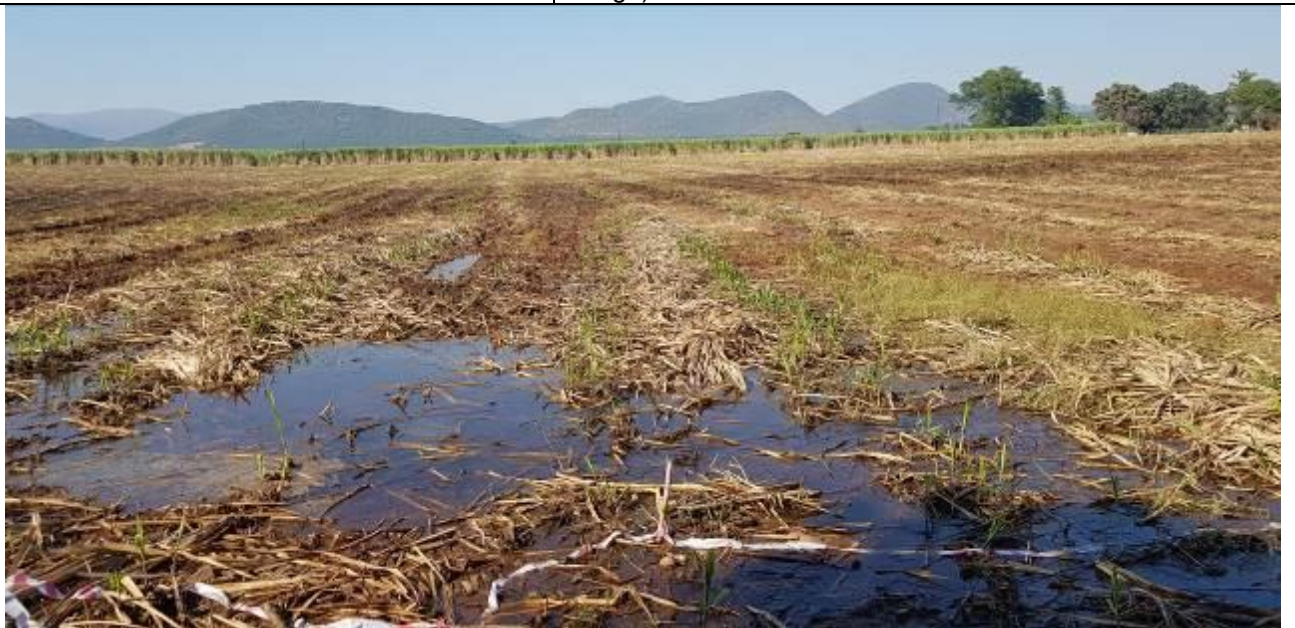
Plate 3: Radically transformed upstream catchment (upstream of railway bridge).

2. The current stream utilizable for fish (aquatic biota) upstream of the current and hence proposed dam is only approximately 650m long (from dam wall/bridge to train bridge) (see aerial imagery in Figure 3). Upstream of the train bridge the catchment has been radically transformed by sugarcane (see aerial imagery in Figure 3 and plate 3). Irrigation return flows are transported in a canal along the railway line that flows into the stream at the railway bridge. The canal is of no habitat value to fish and another migration barrier to movement (due to continuous high velocity over long distance) (Plate 2).

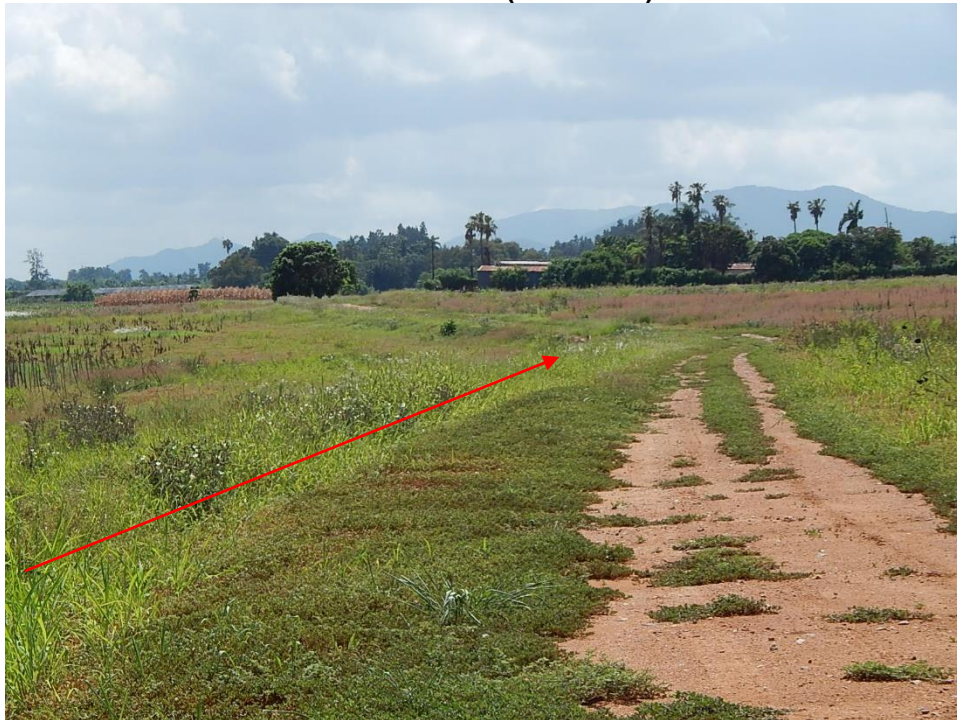
Fig. 6: The middle section in the west, facing east towards the farm residence. The canal follows the road contour and is visible to the left (red line).

The property has a very moderate down slope from the south towards the north and the Crocodile River. An unnamed nonperennial watercourse (drainage line) is situated on the eastern side of the property⁵⁴ and forms the eastern boundary of the study area (fig. 29). A small section in the north-eastern corner of the study area, belongs to the Malelane irrigation board, and is fenced (fig. 30). Several earth canals and weirs form part of the irrigation network on the farm (figs. 6, 11 – 14, 22, 23).

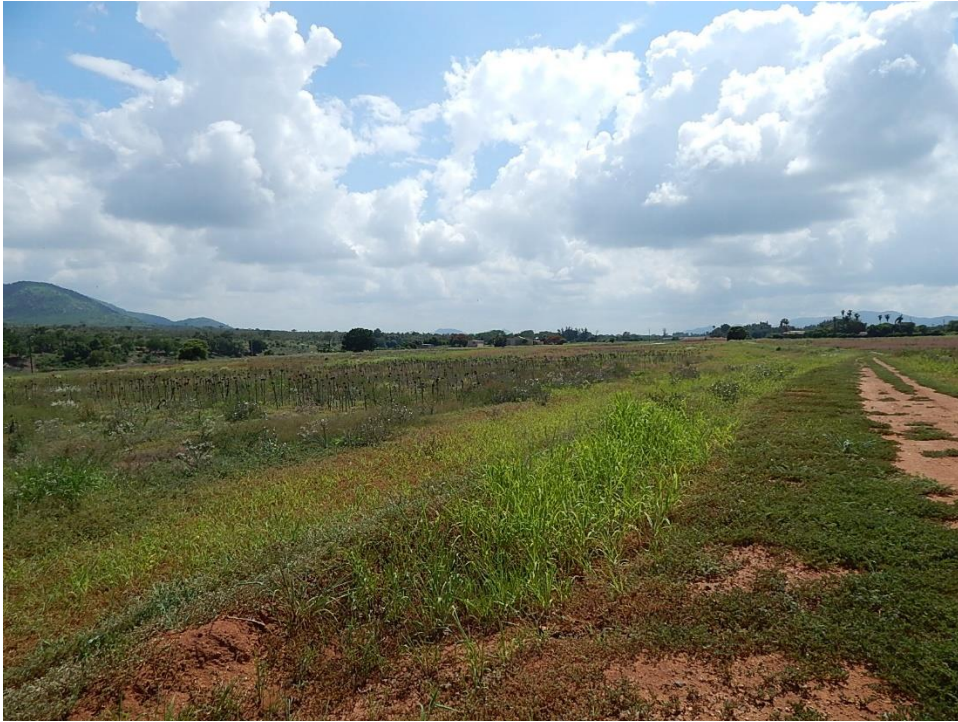
Fig. 11: The middle section, with the earth canal visible next to the road.

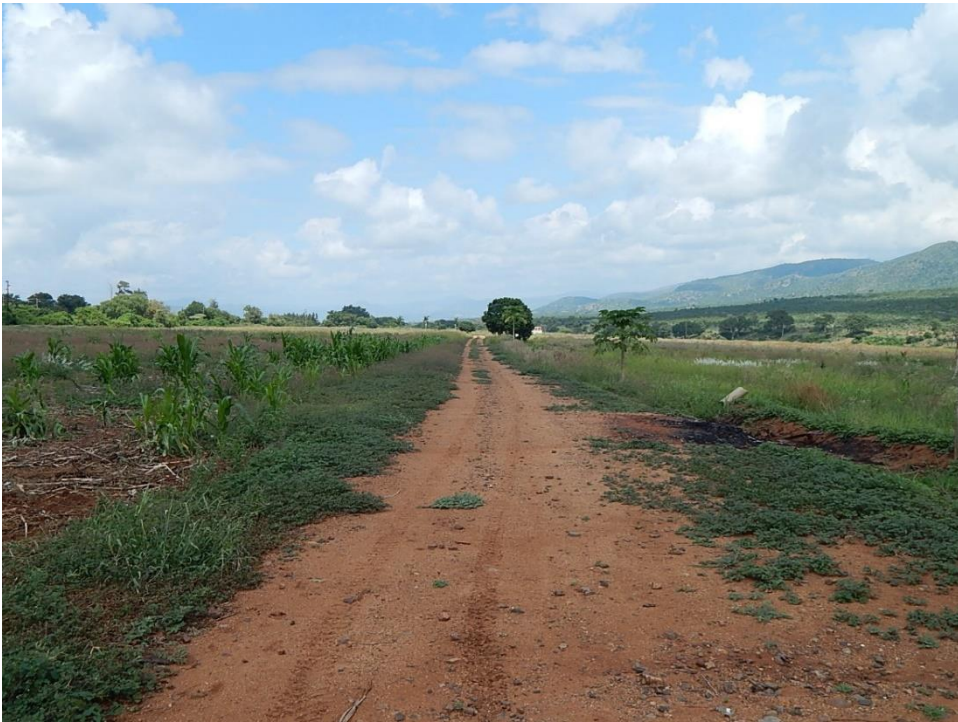
Fig. 12: Another view of the middle section facing west, the earth canal is to the right of the road.

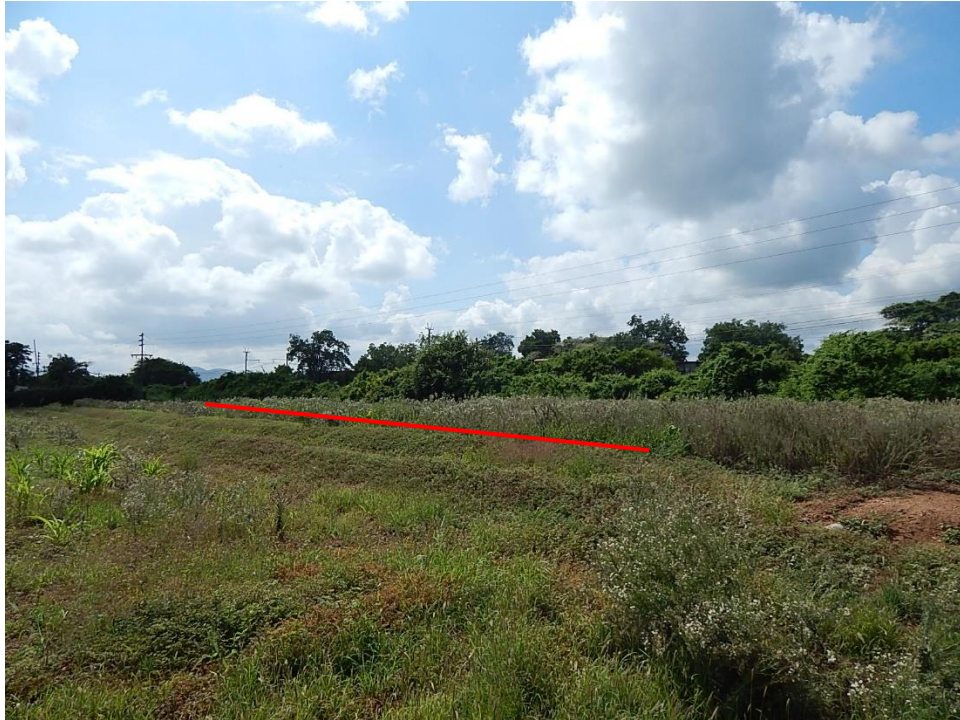
Fig. 13: The middle section facing south towards the railway line. An earth canal is visible (red line).

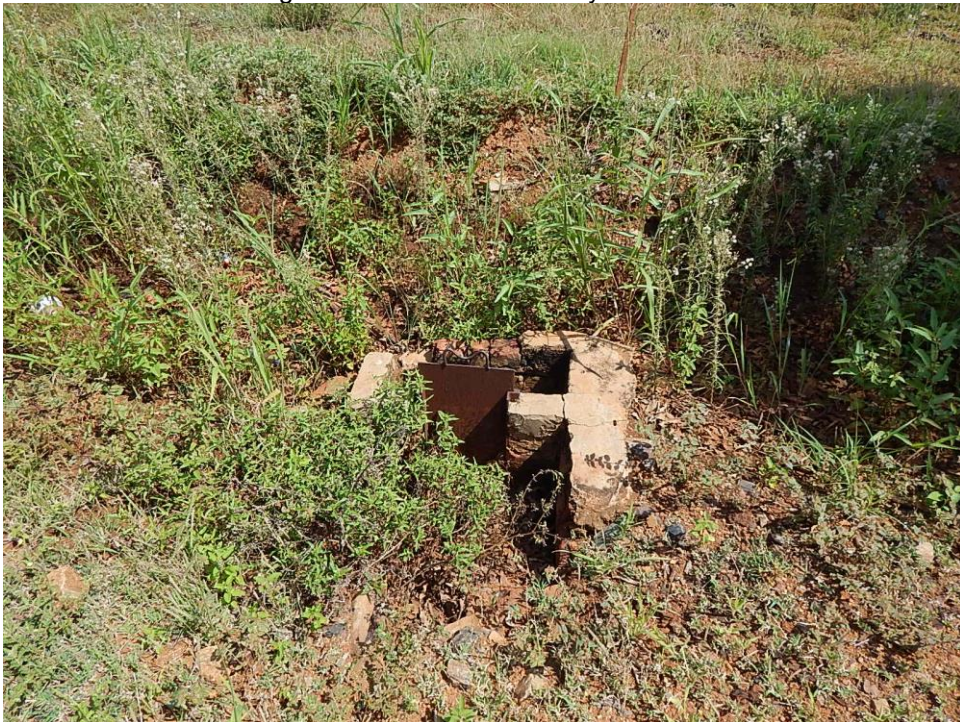
Fig. 14: Several sluices are visible within the earth canal to regulate water, on the study area.

The original pumphouse next to the Crocodile River was replaced in later years with a modern one. A few old pumps are still visible on the farm (figs 20 – 21), and the reservoirs are still in use (fig. 19). Earth canals and concrete sluices used to channel water to the various sections, but these are of no historical significance (figs. 6, 11, 14, 22, 23). The original farmhouse dating from 1955/56, is still visible on the farm (fig. 5), and has never been changed, even after the Gouveia family built a modern house in 1962 (fig. 18).

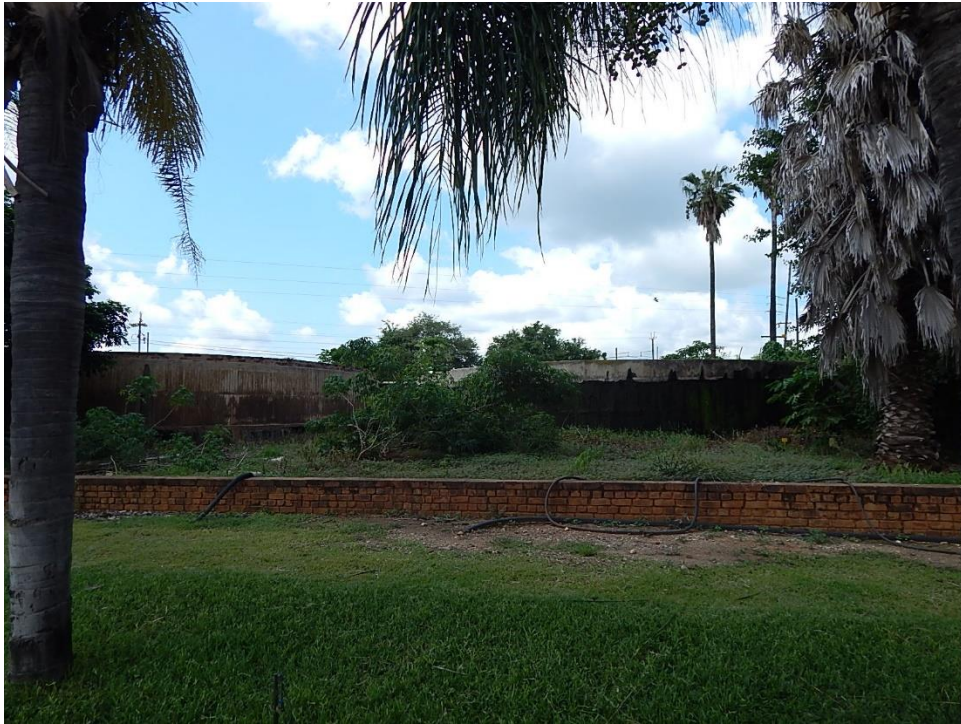
Fig. 19: Large water reservoirs are visible next to the farm residence.

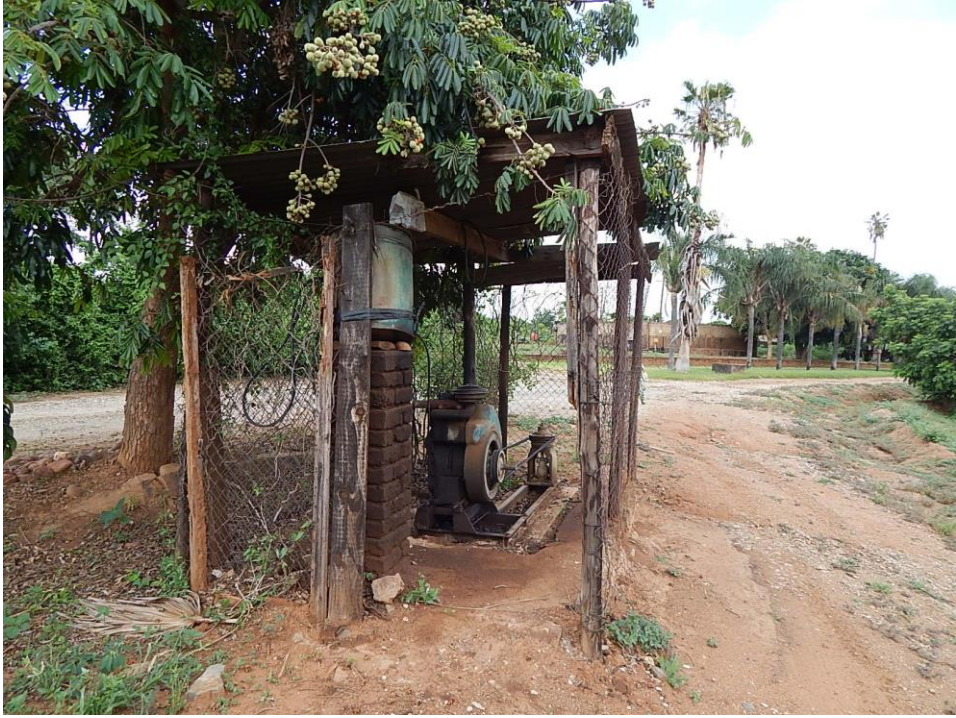
Fig. 21: Another pump for use on the farm.

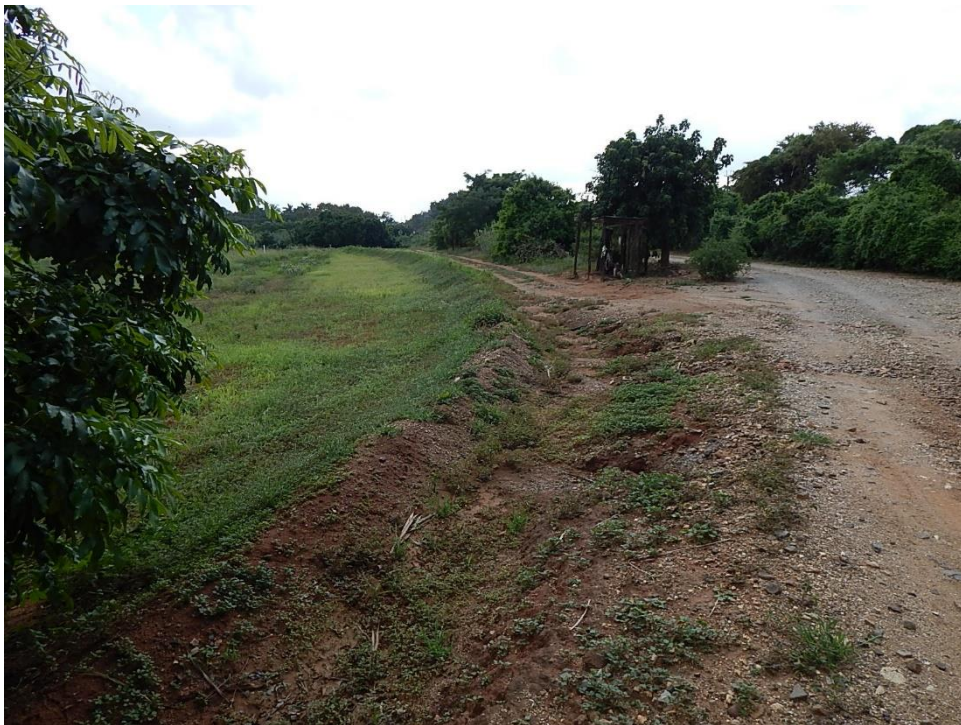
Fig. 22: The earth canal in the eastern section is visible next to the gravel road, facing east.

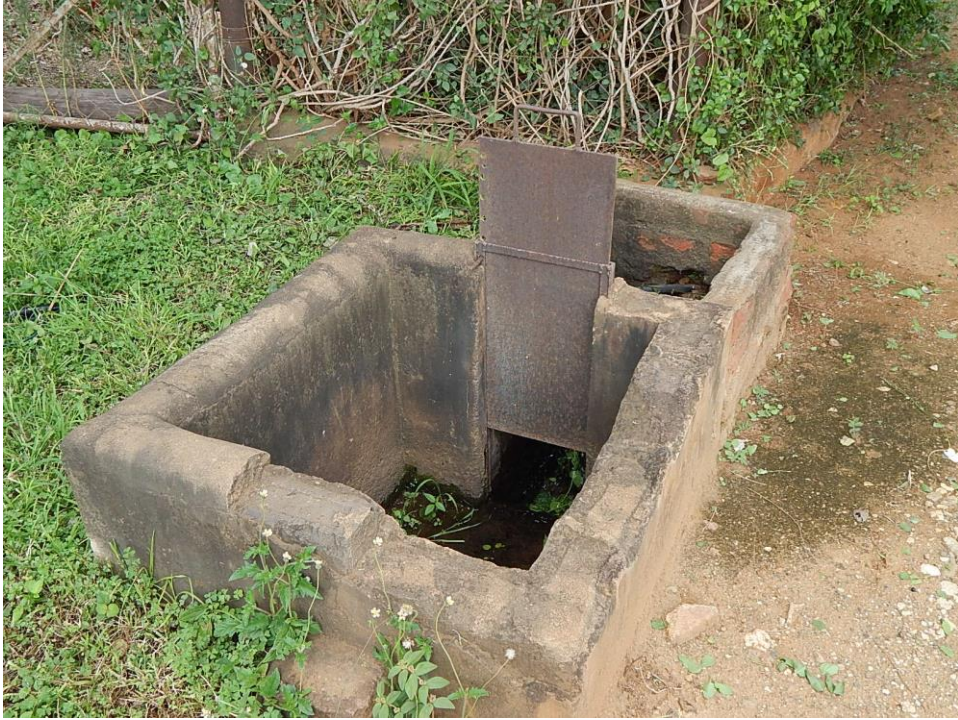
Fig. 23: A few small weirs are visible near the farm residence, to regulate water into the canals.

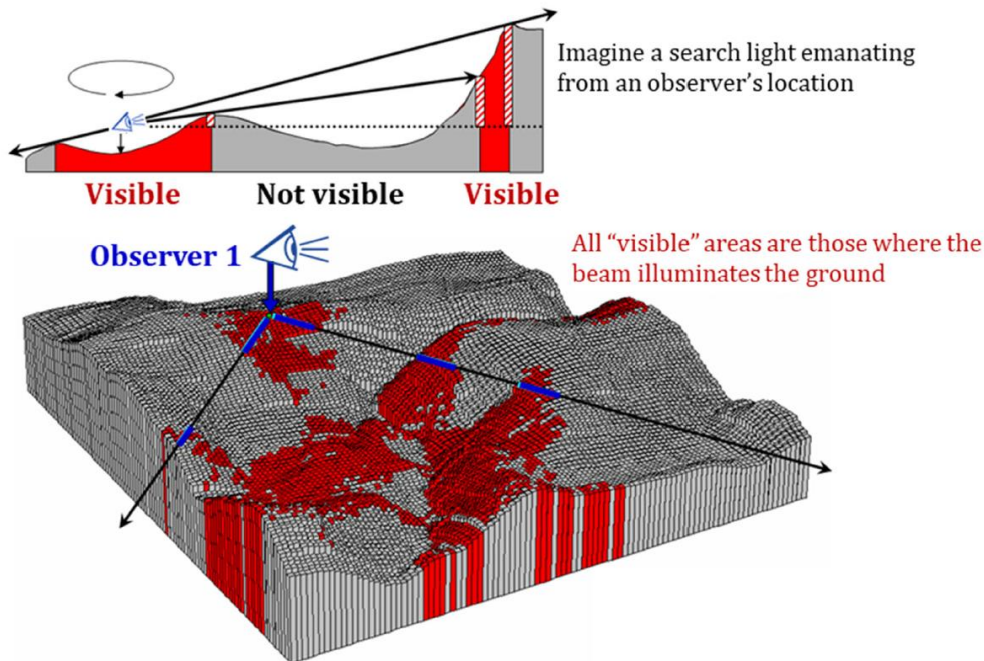
Figure 1: Example of how a viewshed analysis incorporates topographic information with observer locations to identify areas seen (red) and not seen (grey) from different points in the landscape (adapted from Berry 2013).

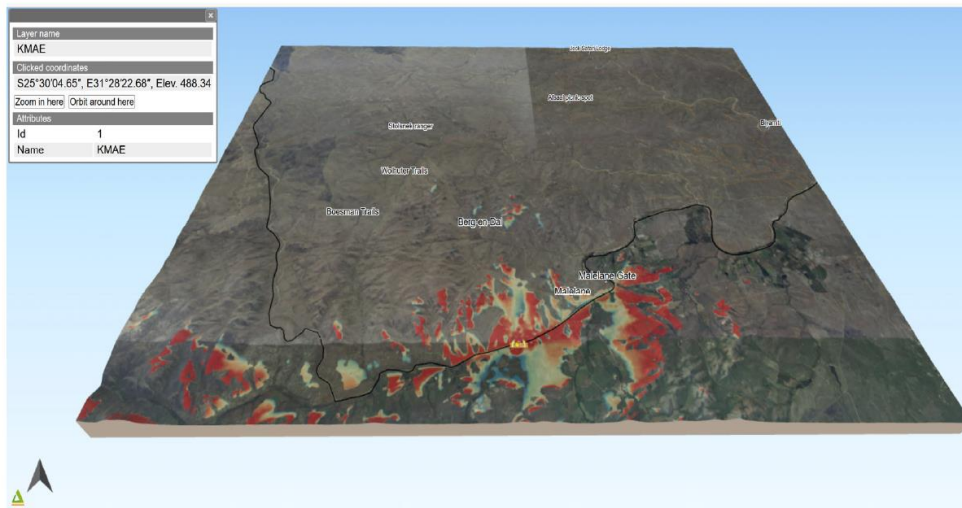
Figure 2: A 3D visualisation of Kruger Malelane Agri Estate's (KMAE) topography and areas identified as potentially sensitive to developing visual impacts to tourists in the Kruger National Park (ranging from pink to dark red in order of risk). Existing tourist infrastructure in Kruger is represented by different icons (camps or picnic spots) and lines (Kruger boundary and roads) on the map. KMAE is visible roughly in the middle of the map (houses icon). To interact with the map: i) use the mouse wheel to zoom in or out; ii) hold down the left mouse button to pivot the map in any direction and ii) hold down the Ctrl key on your keyboard and the left mouse button to pan in any direction. Left mouse click once anywhere on the map to get the clicked coordinates. A yellow circle will be placed on the map where you clicked and a control panel will appear in the top-left corner. Click "Zoom in here" to zoom to the yellow circle or "Orbit around here" to start an orbital animation. Click on any layer (e.g. camps) to get more information about the other features added to the map. See interactive pages for full 3D visualisation.

The viewshed analysis was carried out using Quantum GIS (QGIS 2021) and plugins - *Visibility Analysis* (Čučković 2016) and *Qgis2threejs* (Akagi 2021). First observer points were located within KMAE by creating 121 equally spaced (50m) grid-points within the KMAE development boundary. Viewpoints were then created using these observer points and a Digital Elevation Model (DEM) reflecting ground elevation at 5m intervals (van Niekerk 2012). The maximum distance for visibility testing was set to 40km (radius of analysis) to ensure adequate coverage. Observer and target heights were initially set to 7.5m and 2.0m above ground level respectively. The area's small size negates the need to account for the earth's curvature or light refraction, so no additional parameters were set. Using the resulting viewpoints, a binary viewshed analysis was conducted where visibility (Y/N or 1/0) is calculated for each observer point over the DEM. A visibility map is then produced by combining all visible points (1) into a cumulative viewshed model (Figure 1). Results were overlaid with all tourist infrastructure in Kruger and presented using *Qgis2threejs* (Akagi 2013) to produce a 3D visualization of KMAE's DEM and viewshed (Figure 2). Final results are further summarised by proposed property/subdivision boundaries 1 to 25 (Figure 3).
