## **VOORSPOED MINE OFFICES - ARCHAEOLOGICAL EXCAVATION**

**Archaeological excavation of the ash middens associated with the old  
Voorspoed Mine offices situated on the farm Morgenster 772, Fezile Dabi  
District Municipality, Free State**

### **Proposal Document**

**Date:** 26 July 2013  
**Revision No.:** 1  
**Client:** De Beers (Pty) Ltd

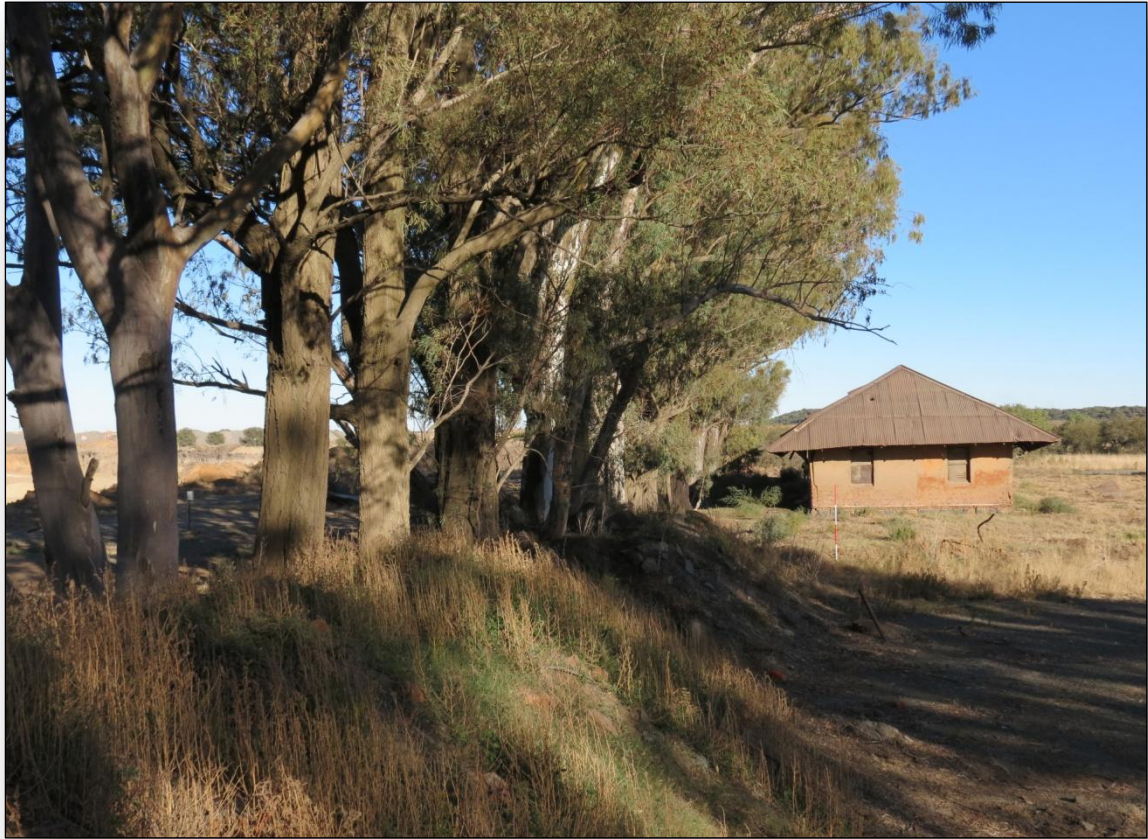
*Figure 2 –General view of the building as seen from the north. Note the avenue of trees on the left. A low ash heap is located directly in front of the building.*

The main feature of the site is the building, which is rectangular in shape, with a central wall dividing it into two sections along the entire length of the structure. All the rooms (offices?) are

arranged along this internal spine with doors opening outwards onto the narrow verandah that runs along all four sides of the building. Each room is relatively small with a single exterior door and window. No doors connect the interior spaces and there is no interface between individual rooms.

One of the exceptional elements of the building is the foundation. This is constructed with neatly dressed bluish granite stone and projects above the surface to form a narrow plinth. Two rows of baked bricks were laid on top of the stone masonry foundation. The most striking structural element of the foundation is the wide galvanized sheet iron that was installed on top of these two layers of brick. It is so wide that the exterior ends could project outwards for approximately 7cms before it was bent downwards to about 45 degrees. One of the questions arising from this structural element and the way it was treated concerns its unusual width as the building has an extensive verandah along all four sides making it unnecessary for such a prominent damp course.

The floors consist of a compacted mixture of ash and fine gravel which were covered with a cement screed about 3cm thick. The floor was not designed to carry heavy loads and over time this screed was destroyed, exposing the compacted gravel fill. The stoep around the building was defined by a neatly constructed row of dressed granite but no evidence of a formal floor screed or concrete could be found.

The building is constructed with baked bricks and may have been plastered with a clay mortar, but this has been replaced, washed away or chipped-off by some of the previous tenants. The exterior has been replastered with a clay plaster along the entire eastern façade while the plaster has been removed along all other walls. The bricks are identified as commercial stock bricks usually used for plastered walls and the degradation of these indicate that they were not intended to be left unplastered and unprotected. They are badly eroded and have become brittle due to exposure to environmental elements.

The building has a hipped corrugated iron roof with wide eaves resulting in the creation of a verandah roof structure along all four sides of the building. The roof structure was constructed with Oregon pine trusses with long tie beams completing the design at the bottom and hanebalke supporting and reinforcing the trusses at the top near the ridging. Diagonal trusses serving as queen posts were installed in the centre preventing any sagging in the centre of the main side rafters of each truss. Some of these have been cut off and removed. The roof had no gutters and down pipes when the building was investigated. No evidence could be found that the wide eaves or verandah roof were supported by timber or cast iron columns along the periphery of the verandah.

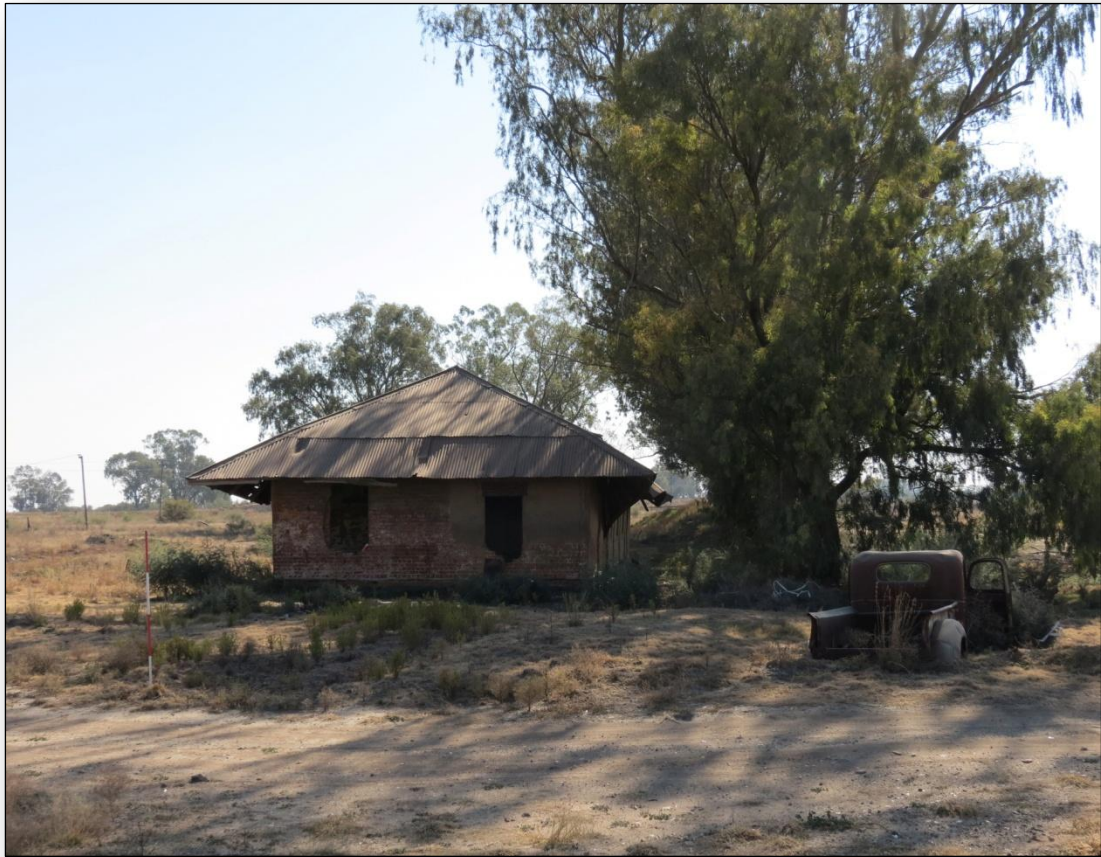
*Figure 3 –General view of the building as seen from the south. The avenue of trees is visible on the right. A low ash heap is located to the left of the vehicle wreck.*

An investigation of the direct surroundings of the building has revealed slightly raised ash heaps to the north and south of the building, with historic waste material exposed by a road a short distance west of the building. This latter material appears to form part of an extensive ash midden located on this side of the site. While sections of the middens are evidently disturbed, significant sections of the ash middens appear to be preserved well enough to warrant archaeological investigation and assessment.

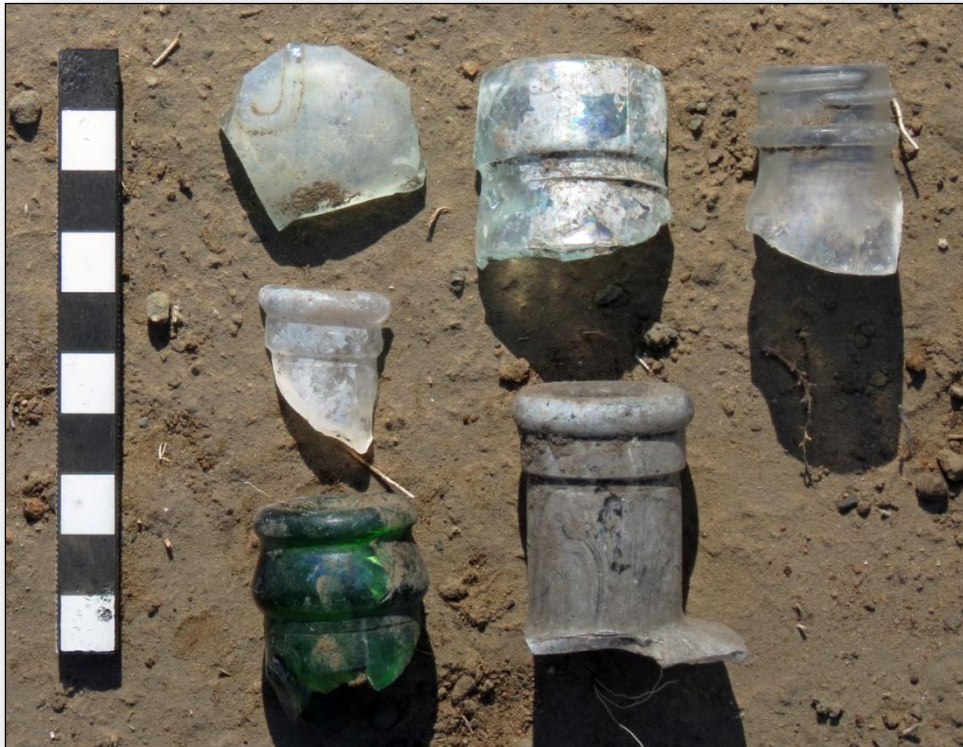
*Figure 5 –Examples of the glass artefacts observed at the site. These artefacts were all found in disturbed contexts.*

Artefacts and ecofacts exposed by disturbances such as the road and burrowing animals include imported ceramics, glass fragments and metal pieces as well as bone. These artefacts were also observed on the surface of undisturbed sections of the ash middens. The ceramics appear to be mainly from plates, although some fragments of cups were also observed. The glass fragments observed on the site appear to be mainly from bottles. One possible mineral water bottle fragment that was embossed with a “J” was identified. Furthermore, a number of different closures were observed on the glass fragments, including screw (external threaded) tops, crown tops and cork closures. The metal artefacts observed at the site include a rail spike (also known as a cut spike or crampon), which was used on railway lines. The rail spikes were used to secure rails and base plates to the railway sleepers. Within the context of the site, this artefact must be associated with the early mining activities at Voorspoed Mine.
