**DE HEUS INDUSTRIAL DEVELOPMENT**  
**Portion 15 of Portion 1 of the Farm Bultfontyn**  
**Middelburg, EC**  
**Geotechnical Investigation Report**

**TITLE:** **PROPOSED INDUSTRIAL DEVELOPMENT FOR DE HEUS  
PORTION 15 OF PORTION 1 OF FARM BULTFONTYN  
MIDDELBURG, EC**  
Geotechnical Investigation Report

**REFERENCE NUMBER:** 2037/01

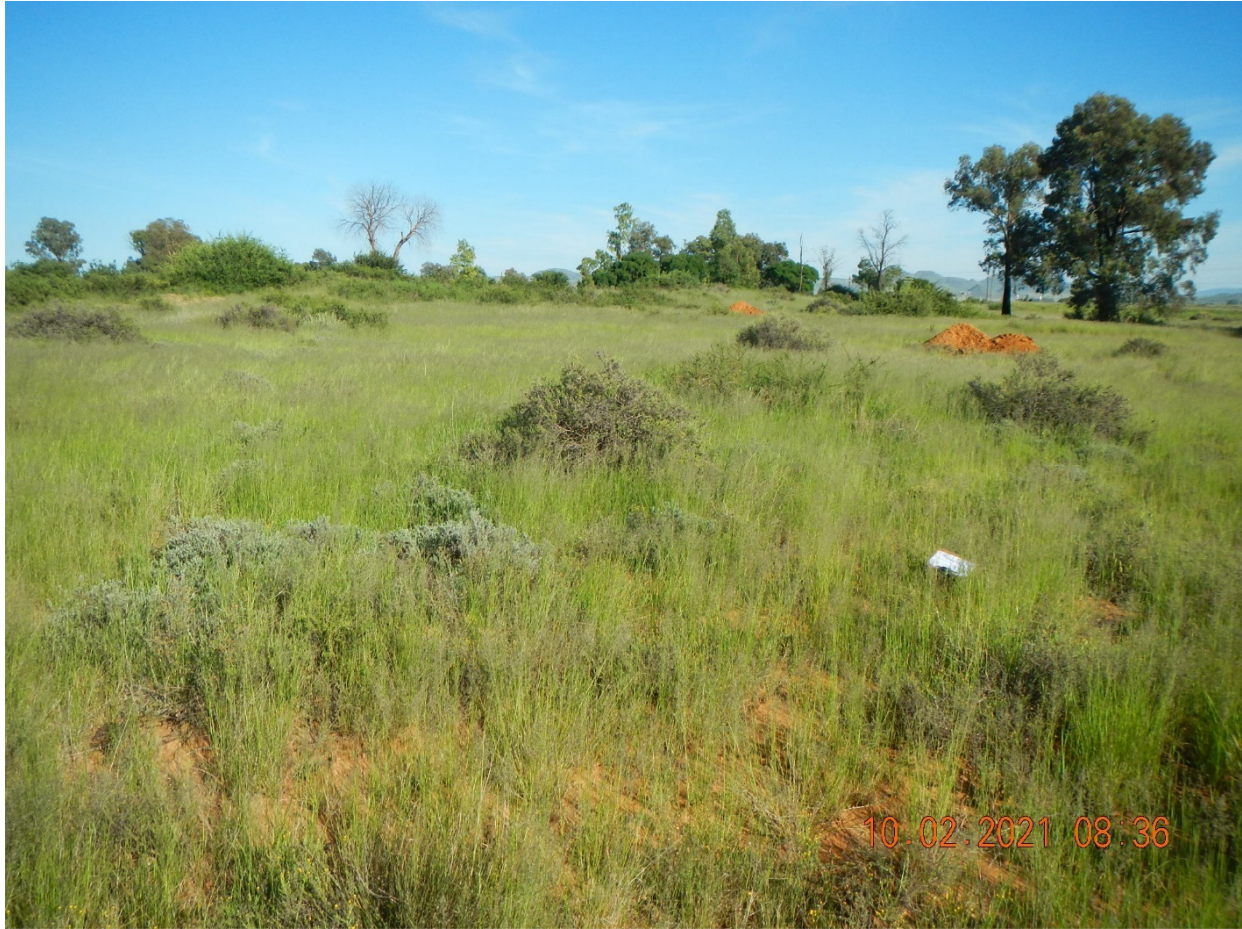
**Photograph 1: General view of site area currently mostly covered by green field grass. Note large trees in background closest to golf course and Road N10.**

The site area is relatively flat and currently covered by a green field grass covering following recent rains (See Photograph 1 below). A prominent linear drainage feature cuts across the site area from north to south (apparently to be backfilled prior to development). A few tall eucalyptus and other trees flank the north eastern (along Road N10), and north western peripheries of the site area. Remnants of a partially completed cricket pitch is situated to the south west of the study area. The remainder of the study area is almost devoid of structural development, apart from a few derelict vehicle ramps, broken up concrete slabs, backfilled excavations, and disturbed surfaces.

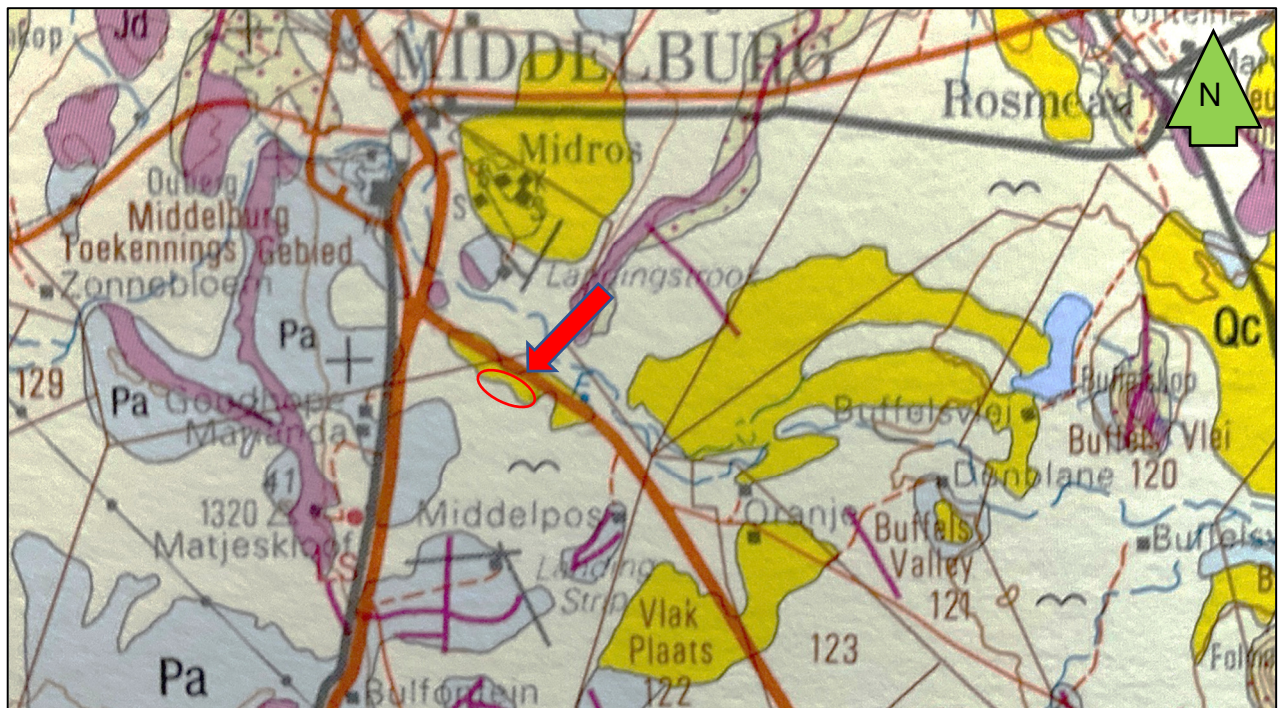
Figure 4: Extract from the 1:25 000 scale geological map 3124 Middelburg.

According to the 1:250 000 scale geological map 3124 Middelburg, the site is underlain by calcrete (symbol **Qc** in dark yellow), and alluvium and colluvium (symbol  $\sim$  in light yellow). Other geological formations around the site but not shown to directly underly the site include **Jd** in purple (intrusive dolerite formations), and **Pa** in light blue (red, purple and grey mudstone with subordinate sandstone).

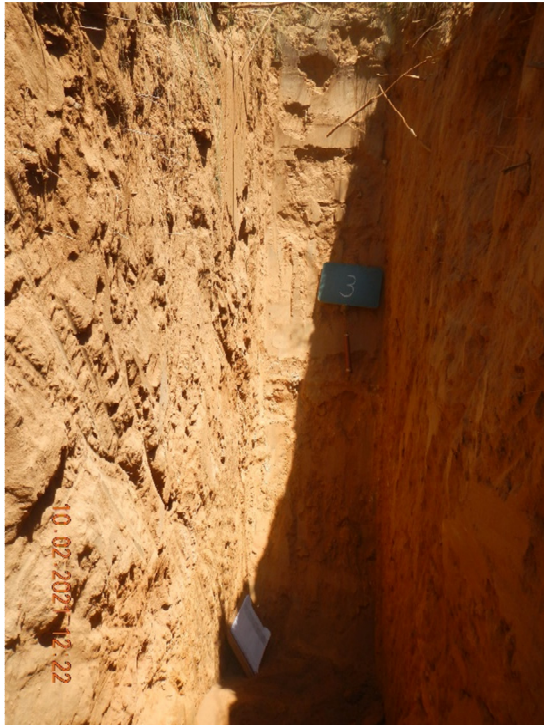
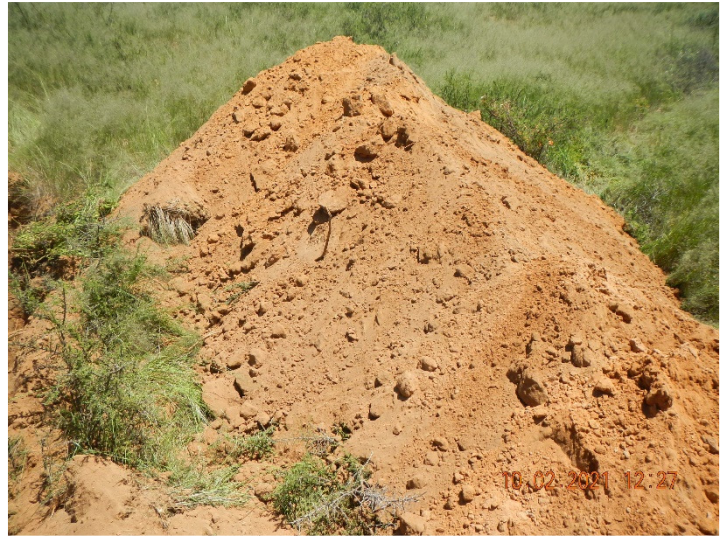
**Photographs 4 and 5: Example of colluvium soils.**

Typically described as: *Dry to slightly moist, pale light orange to pinkish brown slightly blotched off white, loose, voided, fine, slightly silty fine sand with occasional soft calcareous nodules and gravels.*

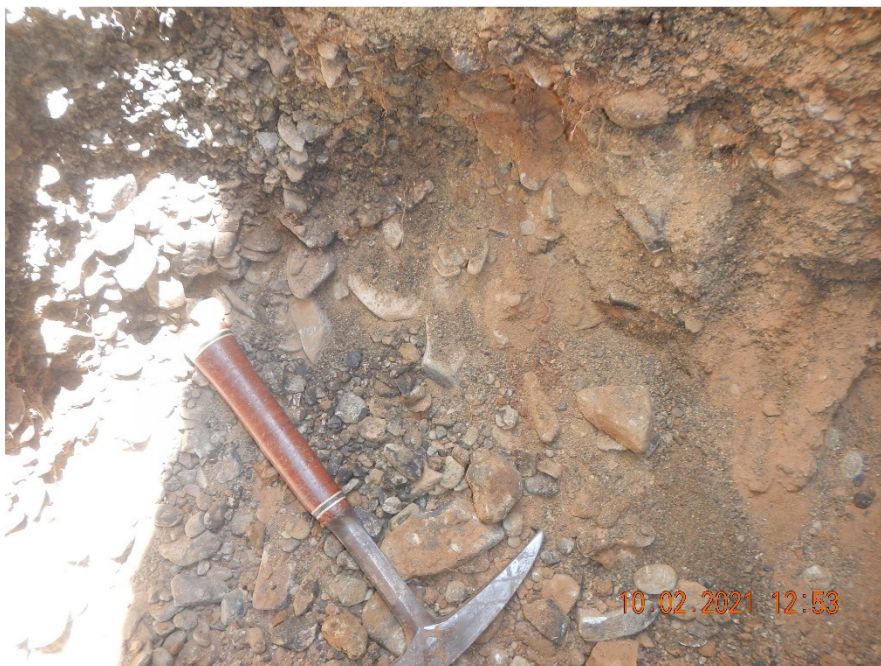
**Photographs 6: Example of alluvium encountered at some test pits at depth.**

Typically encountered as either loosely packed rounded pebbles and cobbles in a coarse, clean sandy matrix (DH02 and DH06), or a clean sand (DH 09).

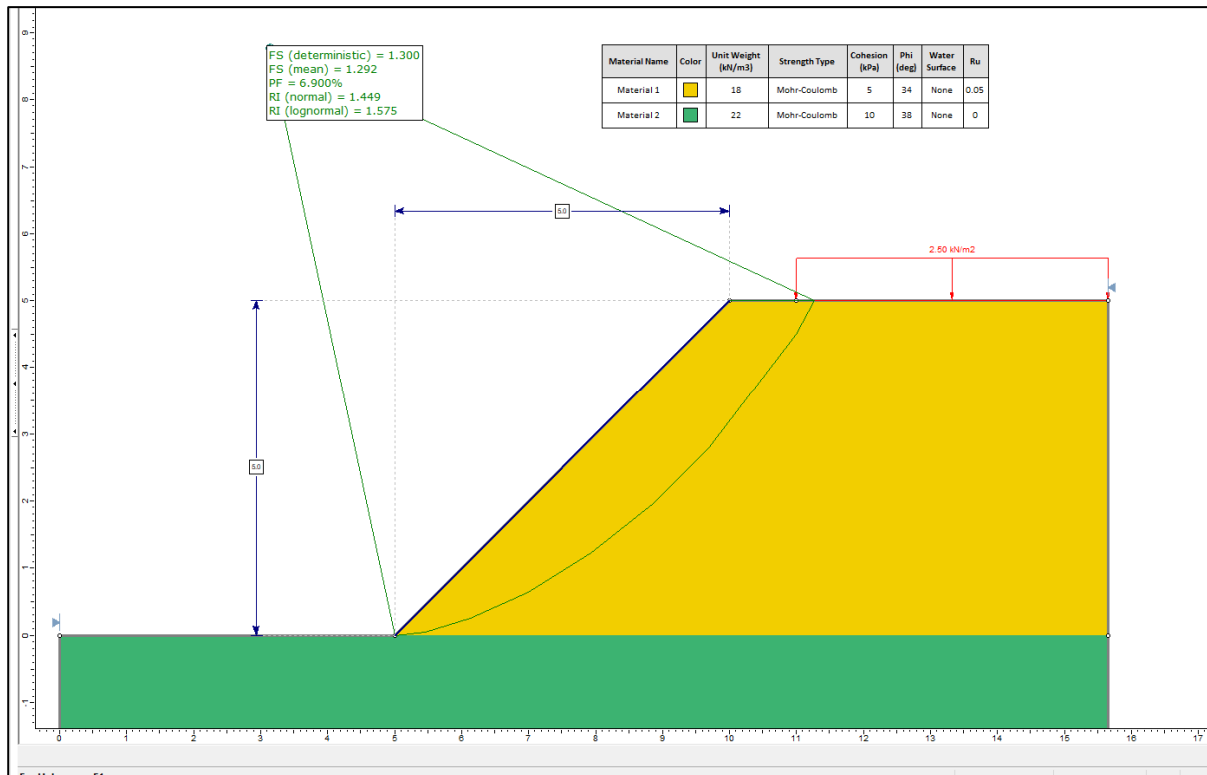
**Figure 5: Illustrative stability of a 5m deep excavation cut at a 1:1 batter.**

The vertical walls of the test pit excavations were stable for the short period that it stood open and unsupported. However, during the construction phase, only very shallow excavations of say less than 1.0m deep can be cut vertically and left unsupported for some time. Deeper excavations must be battered sufficiently to retain long term stability to complete construction activities. The illustrative 5m deep excavation cut at a slope of 1:1 (as can be seen in Figure 5 below), realises a factor of safety of 1.3 and a probability of failure around 7%.

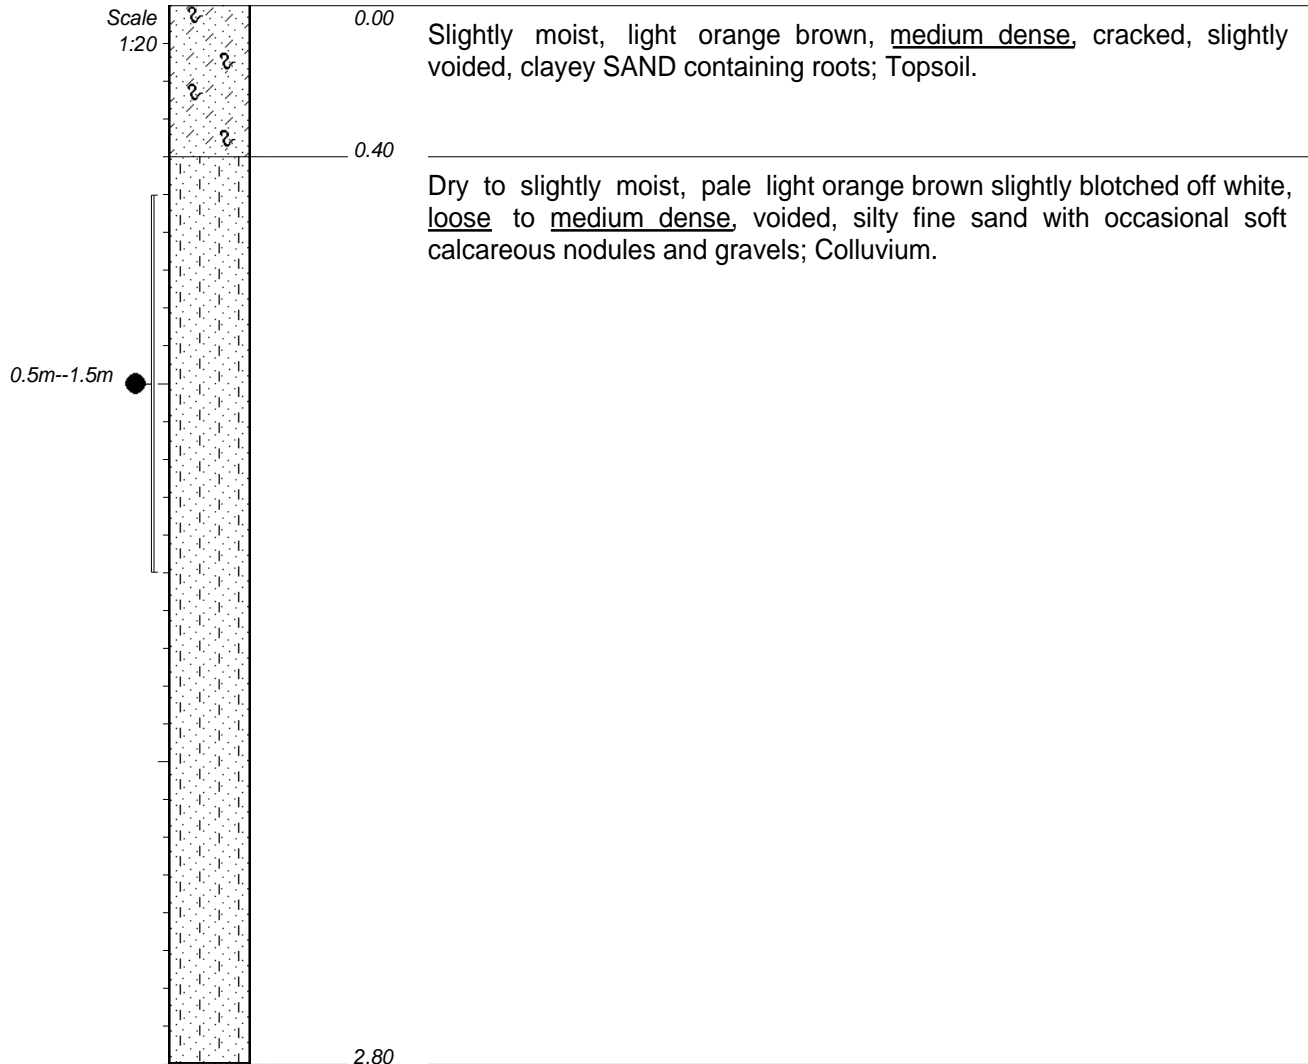
HOLE No: DH 08

- 1) Stopped at 2.8m deep; Near maximum depth reach. Not yet refusal.
- 2) No water seepage encountered.
- 3) Disturbed foundation indicator sample taken from 0,5m--1,5m.

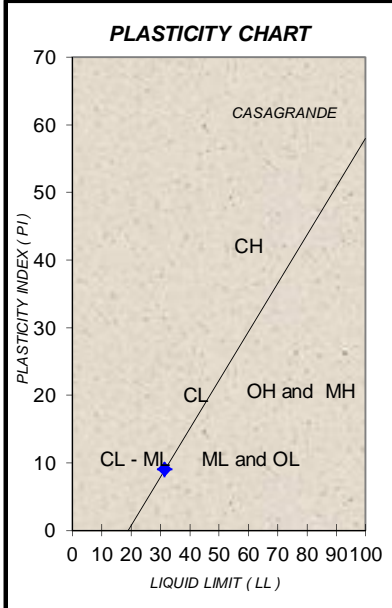
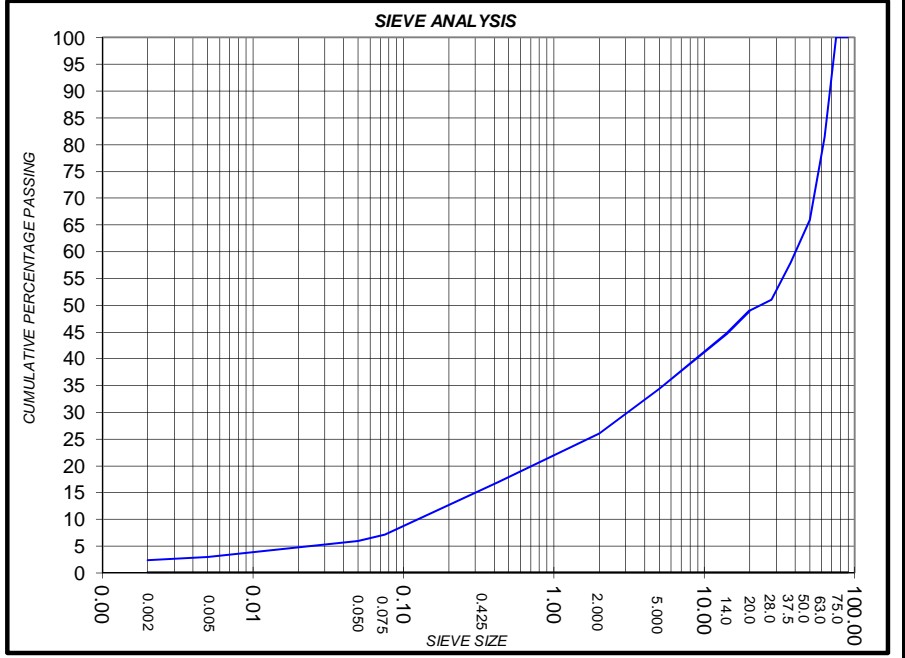
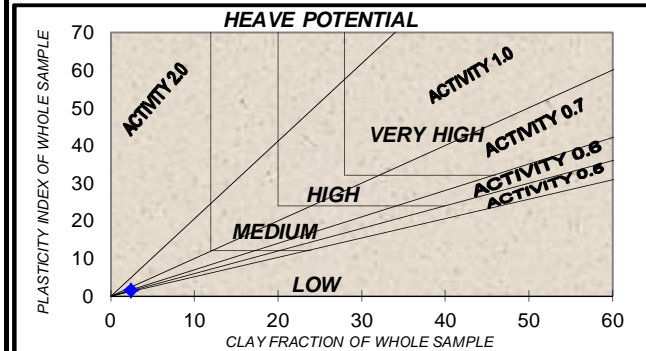
<b>Your Reference :</b> DH 01	<b>Environmental Conditions :</b> Sunny / Hot	<b>Sample No. :</b> 21/116
<b>Sampled By :</b> Client		<b>Sampling Method :</b> Not Specified

Description	MDD / OMC SANS 3001-GR20 & GR30		Sieve Analysis SANS 3001-GR1 Cumulative percentage passing														Grading Modulus SANS 3001-PR5	Soil Mortar Analysis % of mat. <2,00 mm				Atterberg Limits SANS 3001-GR10			Classification				
	Maximum Dry Density kg/m <sup>3</sup>	Optimum Moisture Content %	100.0mm	75.0mm	63.0mm	50.0mm	37.5mm	28.0mm	20.0mm	14.0mm	5.00mm	2.00mm	0.425mm	0.075mm	0.05 mm	0.005 mm		0.002 mm	Coarse - sand <2,0 >0,425mm	Fine - sand <0,425 >0,05mm	Silt <0,05 >0,005mm	Clay <0,005 mm	Liquid Limit %	Plasticity Index	Linear Shrinkage %	Unified Soil	Colto	US. Highway	Group Index
Dark Brown Orange Well Graded Clayey Gravel	1862	10.2	-	100	81	66	58	51	49	45	34	26	17	7	6.0	3.0	2.4	2.5	35.1	42.0	11.3	11.6	31	9	4.1	GW/GC	G6	A-2-4	0

GENERAL :		CBR RESULTS :	
Effective size :	0.124	SANS 3001-GR40	
Uniformity co-eff. :	325.7	@ 100% comp. :	56
Curvature co-eff. :	1.9	@ 98% comp. :	46
Oversize Index :	1082	@ 97% comp. :	41
Shrinkage Product :	70	@ 95% comp. :	34
Grading co-eff. :	8.6	@ 93% comp. :	25
Swell @ 100% :	0.24	@ 90% comp. :	16

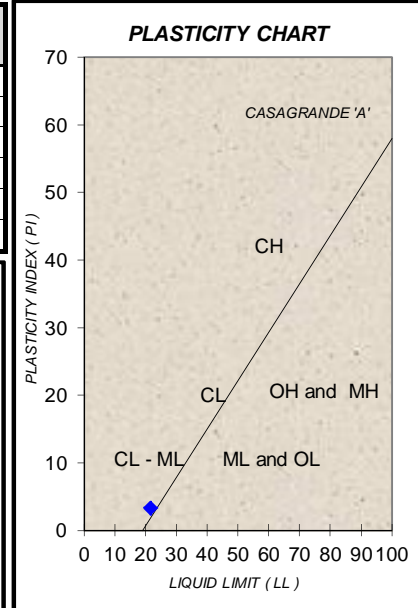
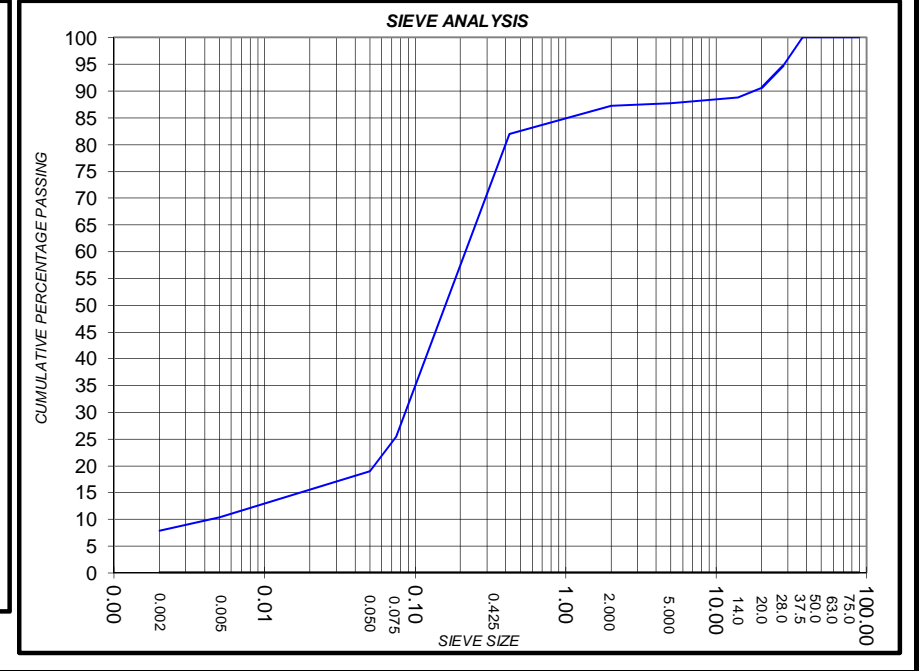
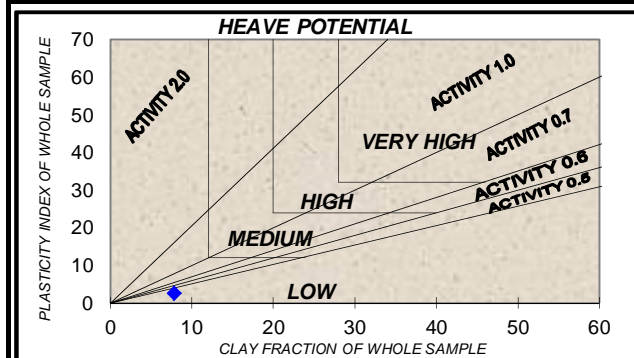
<b>Your Reference :</b>	DH 03	<b>Environmental Conditions :</b>	Sunny / Hot	<b>Sample No. :</b>	21/117
<b>Sampled By :</b>	Client			<b>Sampling Method :</b>	Not Specified

Description	MDD / OMC SANS 3001-GR20 & GR30		Sieve Analysis SANS 3001-GR1 Cumulative percentage passing													Grading Modulus SANS 3001-PR5	Soil Mortar Analysis % of mat. <2,00 mm				Atterberg Limits SANS 3001-GR10			Classification					
	Maximum Dry Density kg/m <sup>3</sup>	Optimum Moisture Content %	100.0mm	75.0mm	63.0mm	50.0mm	37.5mm	28.0mm	20.0mm	14.0mm	5.00mm	2.00mm	0.425mm	0.075mm	0.05 mm		0.005 mm	0.002 mm	Coarse - sand <2,0 >0,425mm	Fine - sand <0,425 >0,05mm	Silt <0,05 >0,005mm	Clay <0,005 mm	Liquid Limit %	Plasticity Index	Linear Shrinkage %	Unified Soil	Colto	US. Highway	Group Index
Dark Reddish Brown Silty Sand	1978	11.6	-	-	-	-	100	95	91	89	88	87	82	25	19.0	10.4	7.8	1.1	6.0	72.3	9.9	11.9	22	3	1.4	SM (d)	G7	A-2-4	0

<b>GENERAL :</b>	<b>CBR RESULTS :</b>
Effective size : 0.004	SANS 3001-GR40
Uniformity co-eff. : 49.7	@ 100% comp. : 41
Curvature co-eff. : 7.9	@ 98% comp. : 36
Oversize Index : 0	@ 97% comp. : 33
Shrinkage Product : 115	@ 95% comp. : 29
Grading co-eff. : 6.6	@ 93% comp. : 22
Swell @ 100% : 0.02	@ 90% comp. : 14

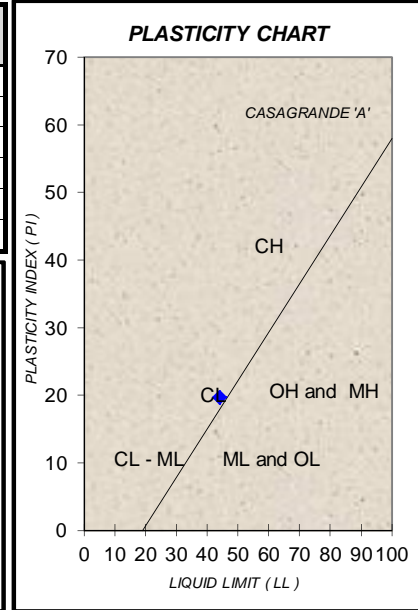
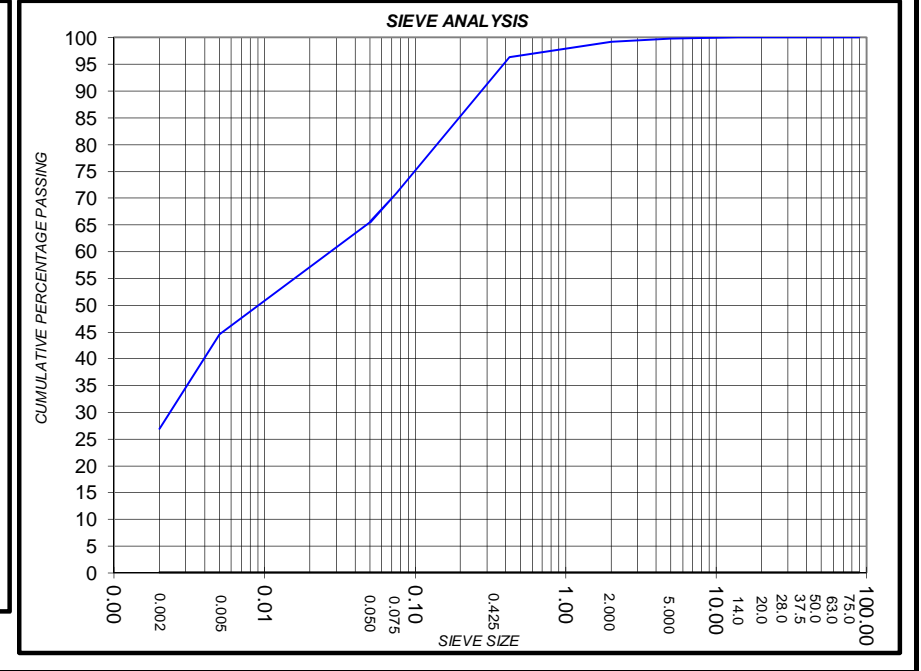
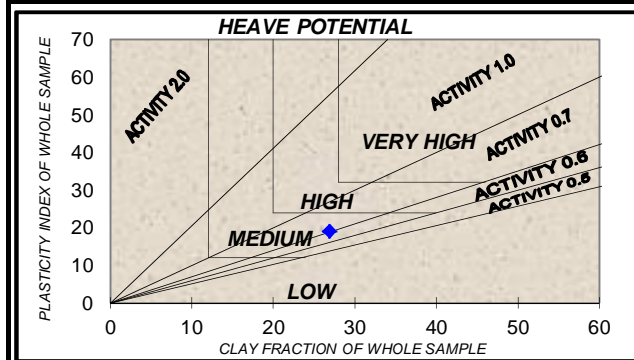
<b>Your Reference :</b>	DH 05	<b>Environmental Conditions :</b>	Sunny / Hot	<b>Sample No. :</b>	21/118
<b>Sampled By :</b>	Client			<b>Sampling Method :</b>	Not Specified

Description	MDD / OMC SANS 3001-GR20 & GR30		Sieve Analysis SANS 3001-GR1 Cumulative percentage passing													Grading Modulus SANS 3001-PR5	Soil Mortar Analysis % of mat. <2,00 mm				Atterberg Limits SANS 3001-GR10			Classification					
	Maximum Dry Density kg/m <sup>3</sup>	Optimum Moisture Content %	100.0mm	75.0mm	63.0mm	50.0mm	37.5mm	28.0mm	20.0mm	14.0mm	5.00mm	2.00mm	0.425mm	0.075mm	0.05 mm		0.005 mm	0.002 mm	Coarse - sand <2,0 >0,425mm	Fine - sand <0,425 >0,05mm	Silt <0,05 >0,005mm	Clay <0,005 mm	Liquid Limit %	Plasticity Index	Linear Shrinkage %	Unified Soil	Colto	US. Highway	Group Index
Dark Yellow Orange Inorganic Clay	1728	11.9	-	-	-	-	-	-	-	-	100	99	96	71	65.6	44.6	26.8	0.3	2.9	31.1	21.1	45.0	44	20	9.7	CL	<G9	A-7-6	12

<b>GENERAL :</b>	<b>CBR RESULTS :</b>
Effective size : <0.002	SANS 3001-GR40
Uniformity co-eff. : 27.2	@ 100% comp. : 5
Curvature co-eff. : 0.2	@ 98% comp. : 4
Oversize Index : 0	@ 97% comp. : 4
Shrinkage Product : 936	@ 95% comp. : 3
Grading co-eff. : 0.8	@ 93% comp. : 2
Swell @ 100% : 4.01	@ 90% comp. : 2

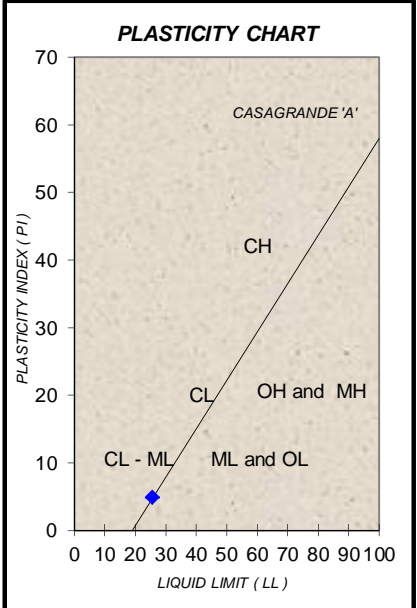
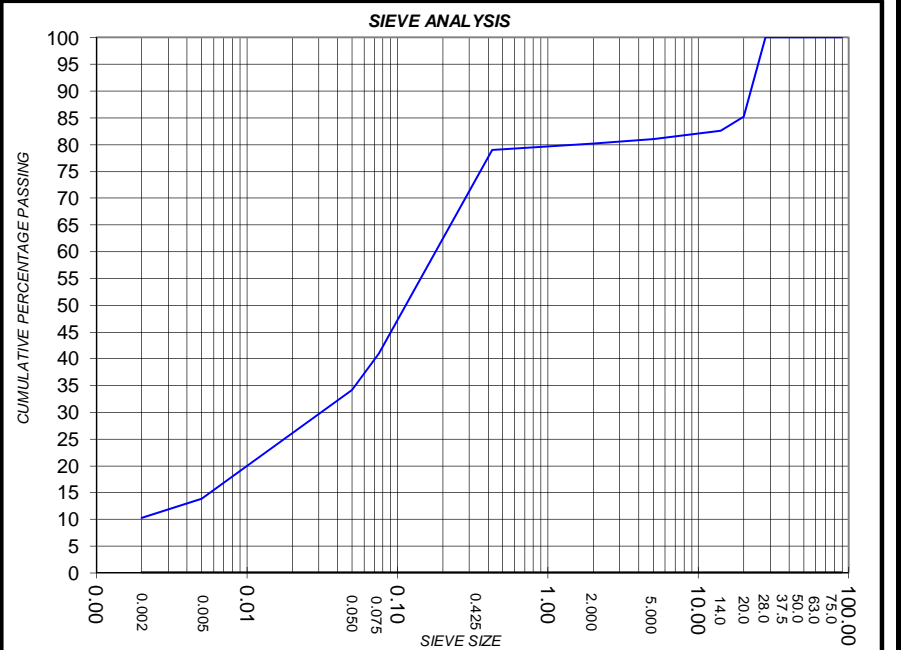
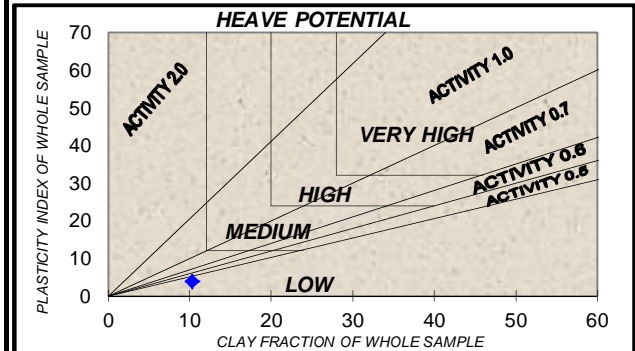
<b>Your Reference :</b> DH 08	<b>Environmental Conditions :</b> Sunny / Hot	<b>Sample No. :</b> 21/119
<b>Sampled By :</b> Client		<b>Sampling Method :</b> Not Specified

Description	MDD / OMC SANS 3001-GR20 & GR30		Sieve Analysis SANS 3001-GR1 Cumulative percentage passing													Grading Modulus SANS 3001-PR5	Soil Mortar Analysis % of mat. <2,00 mm				Atterberg Limits SANS 3001-GR10			Classification					
	Maximum Dry Density kg/m <sup>3</sup>	Optimum Moisture Content %	100.0mm	75.0mm	63.0mm	50.0mm	37.5mm	28.0mm	20.0mm	14.0mm	5.00mm	2.00mm	0.425mm	0.075mm	0.05 mm		0.005 mm	0.002 mm	Coarse - sand <2,0	Fine - sand >0,425mm <0,075mm	Silt >0,005mm <0,005mm	Clay <0,005 mm	Liquid Limit %	Plasticity Index	Linear Shrinkage %	Unified Soil	Colto	US. Highway	Group Index
Dark Yellow Orange Silty/Clayey Sand	-	-	-	-	-	-	-	100	85	83	81	80	79	41	34.2	13.8	10.3	1.0	1.4	55.9	25.4	17.2	26	5	2.3	SM/SC	-	A-4	1

<b>GENERAL :</b>	<b>CBR RESULTS :</b>
Effective size : <0.002	SANS 3001-GR40
Uniformity co-eff. : 178.6	@ 100% comp. : -
Curvature co-eff. : 5.4	@ 98% comp. : -
Oversize Index : 0	@ 97% comp. : -
Shrinkage Product : 185	@ 95% comp. : -
Grading co-eff. : 16.0	@ 93% comp. : -
Swell @ 100% : -	@ 90% comp. : -

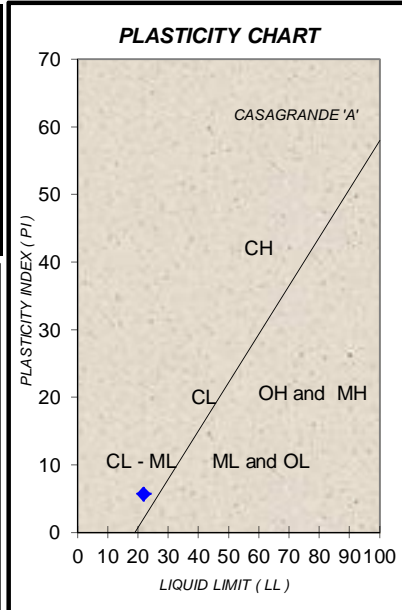
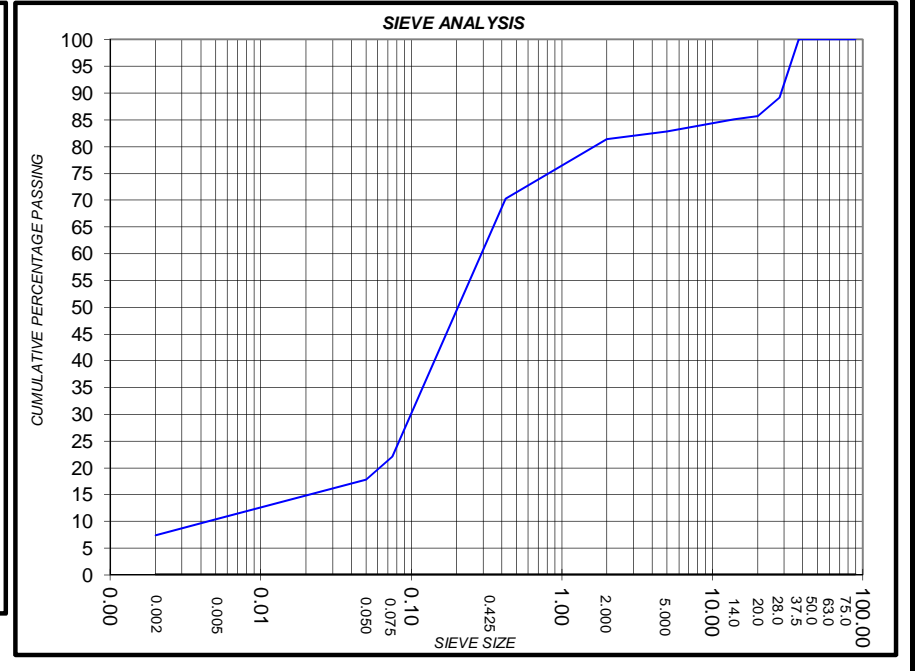
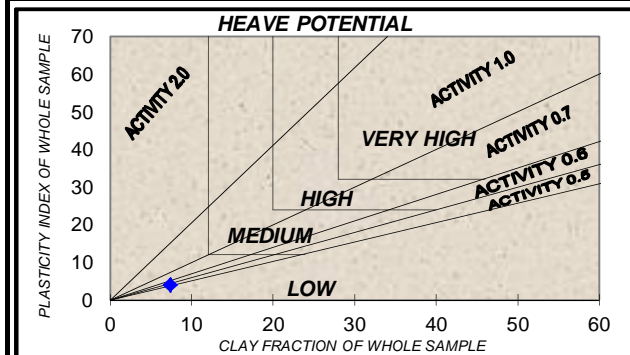
<b>Your Reference :</b> DH 09	<b>Environmental Conditions :</b> Sunny / Hot	<b>Sample No. :</b> 21/120
<b>Sampled By :</b> Client		<b>Sampling Method :</b> Not Specified

Description	MDD / OMC SANS 3001-GR20 & GR30		Sieve Analysis SANS 3001-GR1 Cumulative percentage passing														Grading Modulus SANS 3001-PR5	Soil Mortar Analysis % of mat. <2,00 mm				Atterberg Limits SANS 3001-GR10			Classification				
	Maximum Dry Density kg/m <sup>3</sup>	Optimum Moisture Content %	100.0mm	75.0mm	63.0mm	50.0mm	37.5mm	28.0mm	20.0mm	14.0mm	5.00mm	2.00mm	0.425mm	0.075mm	0.05 mm	0.005 mm		0.002 mm	Coarse - sand <2,0	Fine - sand >0,425mm	Silt <0,05	Clay >0,005mm	Liquid Limit %	Plasticity Index	Linear Shrinkage %	Unified Soil	Colto	US. Highway	Group Index
Dark Brown Silty/Clayey Sand	1971	7.9	-	-	-	-	100	89	86	85	83	81	70	22	17.8	10.4	7.3	1.3	13.7	64.4	9.2	12.7	22	6	2.2	SM/SC	G8	A-2-4	0

<b>GENERAL :</b>	<b>CBR RESULTS :</b>
Effective size : 0.004	SANS 3001-GR40
Uniformity co-eff. : 65.3	@ 100% comp. : 31
Curvature co-eff. : 7.5	@ 98% comp. : 25
Oversize Index : 0	@ 97% comp. : 22
Shrinkage Product : 157	@ 95% comp. : 18
Grading co-eff. : 6.4	@ 93% comp. : 13
Swell @ 100% : 0.49	@ 90% comp. : 8

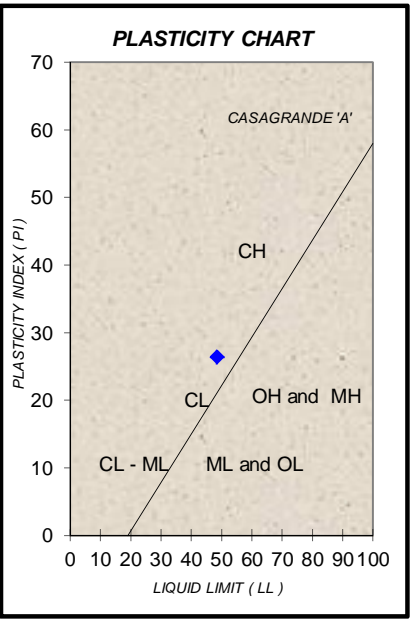
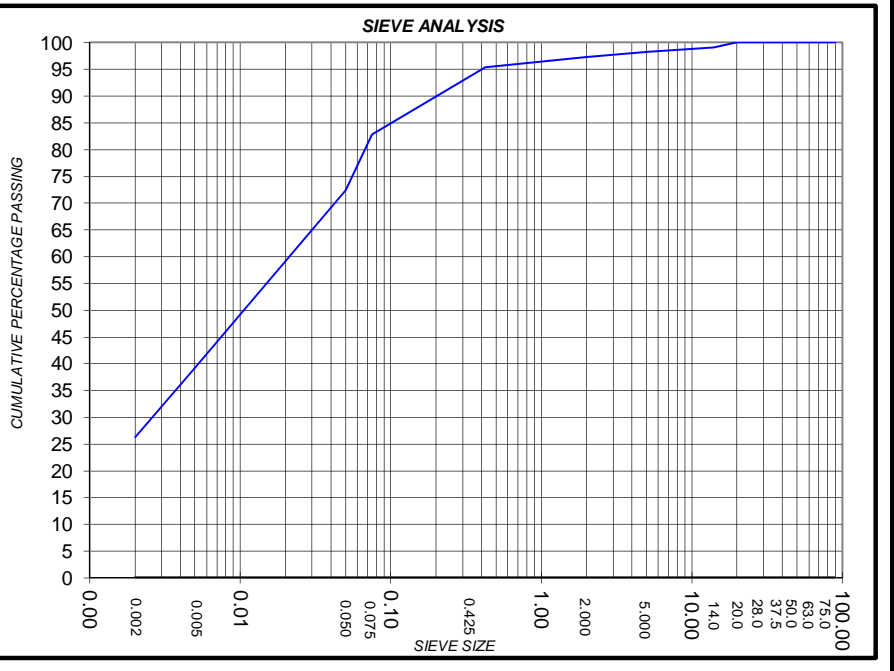
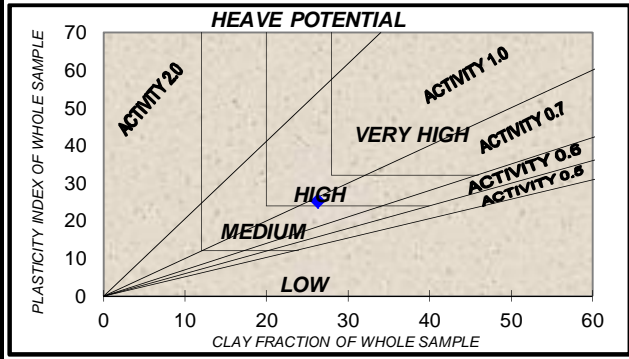
**Your Reference :** DH 11 **Environmental Conditions :** Sunny / Hot **Sample No. :** 21/121  
**Sampled By :** Client **Sampling Method :** Not Specified

Description	MDD / OMC SANS 3001-GR20 & GR30		Sieve Analysis SANS 3001-GR1 Cumulative percentage passing													Grading Modulus SANS 3001-PR5	Soil Mortar Analysis % of mat. <2,00 mm				Atterberg Limits SANS 3001-GR10			Classification					
	Maximum Dry Density kg/m <sup>3</sup>	Optimum Moisture Content %	100.0mm	75.0mm	63.0mm	50.0mm	37.5mm	28.0mm	20.0mm	14.0mm	5.00mm	2.00mm	0.425mm	0.075mm	0.05 mm		0.005 mm	0.002 mm	Coarse - sand <2,0 >0,425mm	Fine - sand <0,425 >0,05mm	Silt <0,05 >0,005mm	Clay <0,005 mm	Liquid Limit %	Plasticity Index	Linear Shrinkage %	Unified Soil	Colto	US. Highway	Group Index
Dark Yellow Orange Inorganic Clay	-	-	-	-	-	-	-	-	100	99	98	97	95	83	72.5	39.2	26.3	0.2	2.0	23.6	34.1	40.3	48	26	12.5	CL	-	A-7-6	16

GENERAL :	CBR RESULTS :
Effective size : <0.002	SANS 3001-GR40
Uniformity co-eff. : 21.1	@ 100% comp. : -
Curvature co-eff. : 0.3	@ 98% comp. : -
Oversize Index : 0	@ 97% comp. : -
Shrinkage Product : 1197	@ 95% comp. : -
Grading co-eff. : 2.6	@ 93% comp. : -
Swell @ 100% : -	@ 90% comp. : -

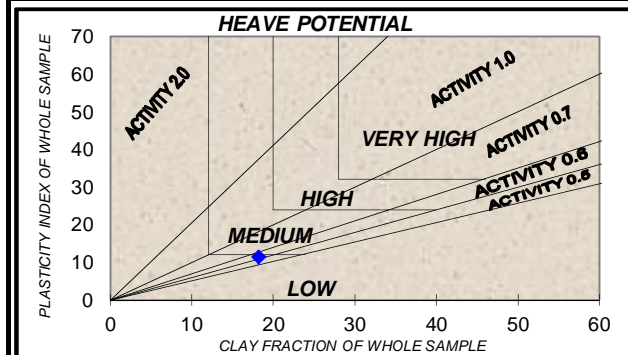
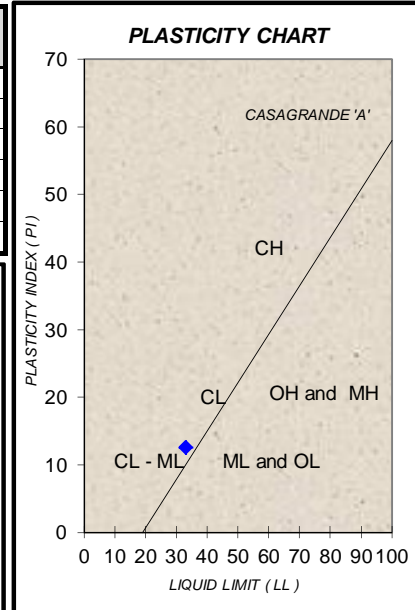
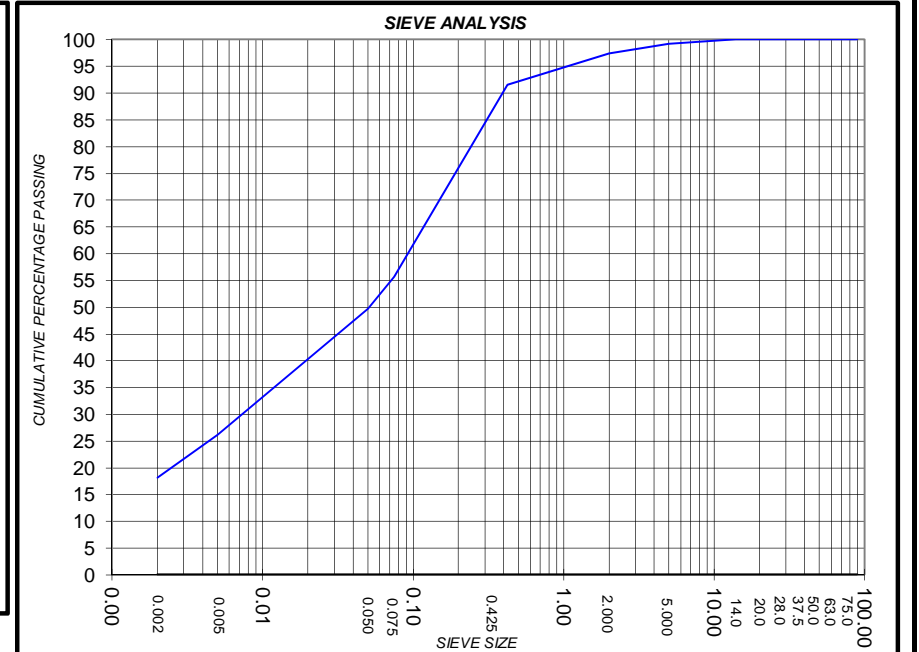
<b>Your Reference :</b>	DH 12	<b>Environmental Conditions :</b>	Sunny / Hot	<b>Sample No. :</b>	21/122
<b>Sampled By :</b>	Client			<b>Sampling Method :</b>	Not Specified

Description	MDD / OMC SANS 3001-GR20 & GR30		Sieve Analysis SANS 3001-GR1 Cumulative percentage passing														Grading Modulus SANS 3001-PR5	Soil Mortar Analysis % of mat. <2,00 mm				Atterberg Limits SANS 3001-GR10			Classification				
	Maximum Dry Density kg/m <sup>3</sup>	Optimum Moisture Content %	100.0mm	75.0mm	63.0mm	50.0mm	37.5mm	28.0mm	20.0mm	14.0mm	5.00mm	2.00mm	0.425mm	0.075mm	0.05 mm	0.005 mm		0.002 mm	Coarse - sand <2,0 >0,425mm	Fine - sand <0,425 >0,05mm	Silt <0,05 >0,005mm	Clay <0,005 mm	Liquid Limit %	Plasticity Index	Linear Shrinkage %	Unified Soil	Colto	US. Highway	Group Index
Dark Yellow Orange Inorganic Clay	1889	13.6	-	-	-	-	-	-	-	100	99	97	92	56	49.7	26.1	18.2	0.6	6.0	43.0	24.2	26.8	33	13	6.5	CL	<G9	A-6	5

<b>GENERAL :</b>	<b>CBR RESULTS :</b>
Effective size : <0.002	SANS 3001-GR40
Uniformity co-eff. : 92.5	@ 100% comp. : 8
Curvature co-eff. : 0.6	@ 98% comp. : 6
Oversize Index : 0	@ 97% comp. : 6
Shrinkage Product : 595	@ 95% comp. : 4
Grading co-eff. : 2.6	@ 93% comp. : 4
Swell @ 100% : 1.82	@ 90% comp. : 3
