**LETTER OF EXEMPTION FROM FURTHER HERITAGE STUDIES:  
PROPOSED PIGGERY AND CHICKEN BROILER FACILITY NEAR DELMAS, MPUMALANGA  
SAHRA Case ID: 9674**

Based on a field inspection and basic background research it is believed that the proposed development does not require any further assessment of impacts to any heritage resources. No significant impacts are expected at the site. The following text and images provide the basis for this recommendation.

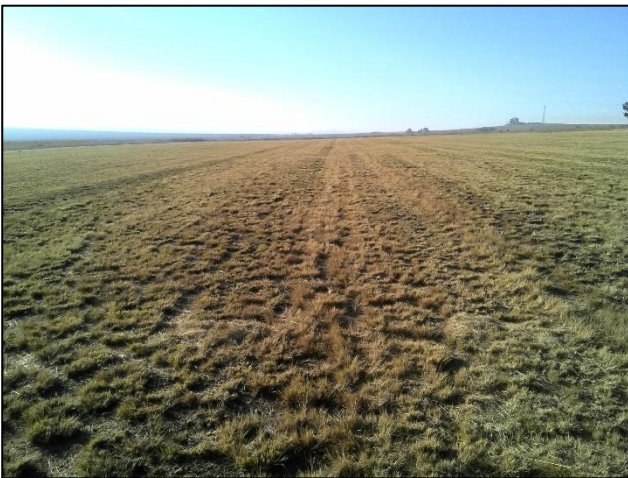
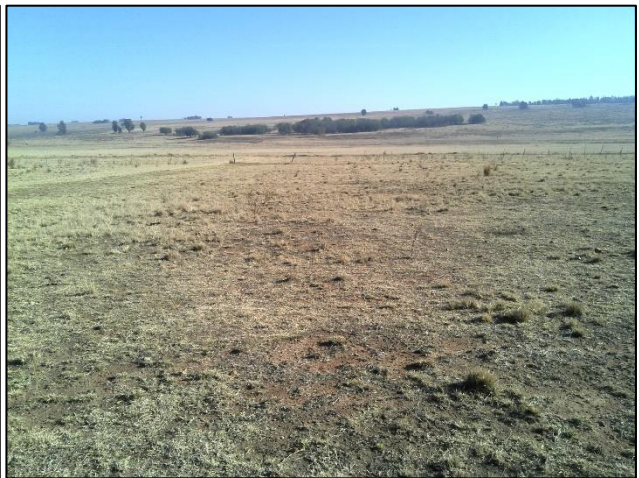
Figures 3 and 4 show typical views of the fields in which the proposed development would be constructed. The only archaeological material encountered was four stone artefacts that are likely to be part of the broader background scatter and, because of their very low density, are considered to be of very low significance (Figures 5 & 6). Four long stone mounds of between 5 m and 10 m long were found in one area but these are certain to represent stones removed from the ploughed agricultural lands (Figure 7).

**Figure 3:** View across the fields in the south-eastern Part of the study area.

**Figure 4:** View across the fields in the north-western part of the study area.

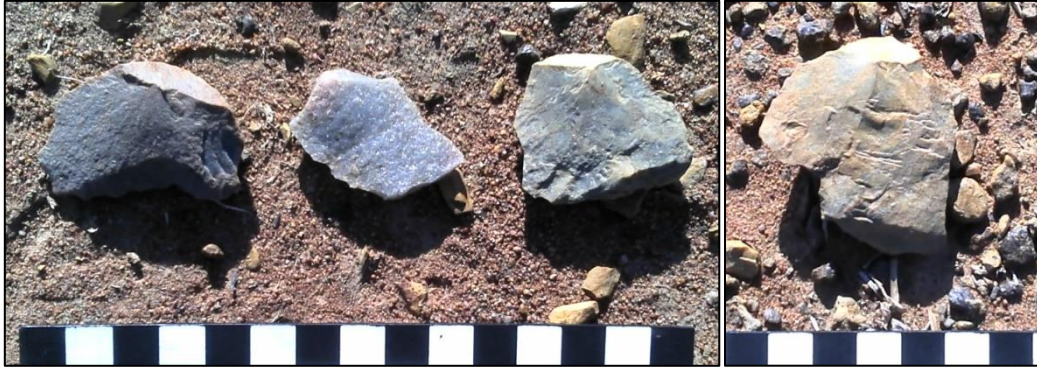
**Figures 5 & 6:** Stone artefacts found on site. Scale bars in cm.

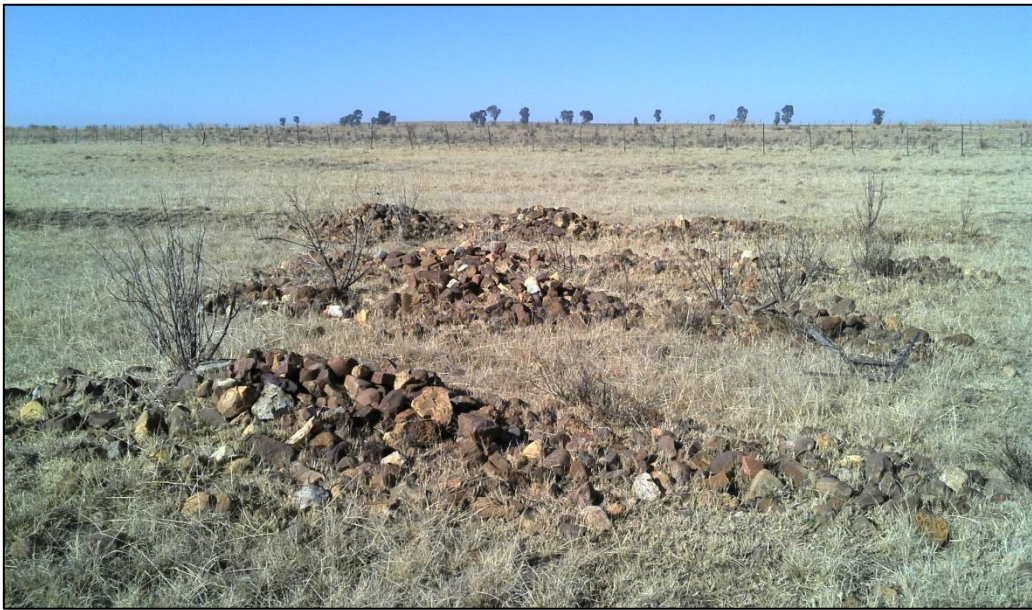
**Figure 7:** Collections of stone removed from agricultural lands during ploughing.

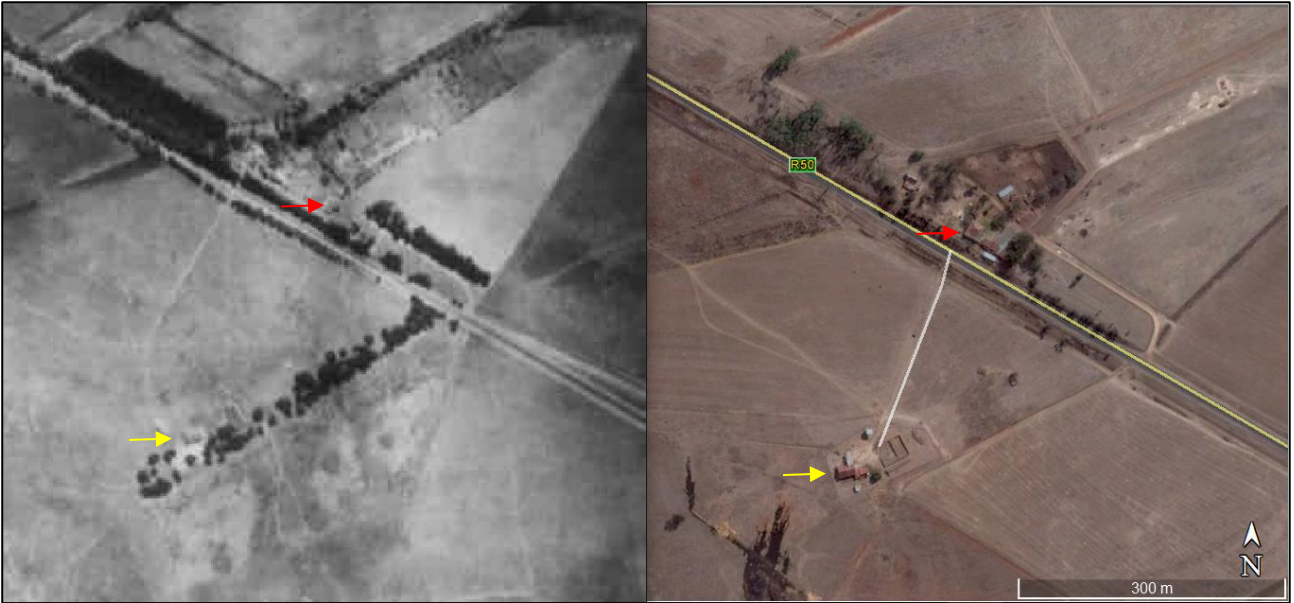
A number of buildings are present on the farm. They are located in two clusters, one to the north and one to the south of the R50 road. Examination of a 1945 aerial photograph shows that at least some were present already at that time (Figure 8). Figures 9 to 12 show the cluster located some 250 m to the southwest of the road. Only one was present in 1945 but is now in very poor condition. It has minimal heritage value. Another small brick ruin located between this complex and the road is modern. The cluster to the north of the road is the main farm complex. The main house, at least, was present in 1945 and appears to be the only structure that retains some heritage value, albeit relatively little (Figure 13). Another modern house also exists in this area (Figure 14). None of these buildings is proposed to be altered as part of the present project.

**Figure 8:** Aerial views of the study area from 1945 (left; Strip 5, no. 328) and 2016 (right; Google Earth). At least some of the current structures were present in 1945 (arrowed).

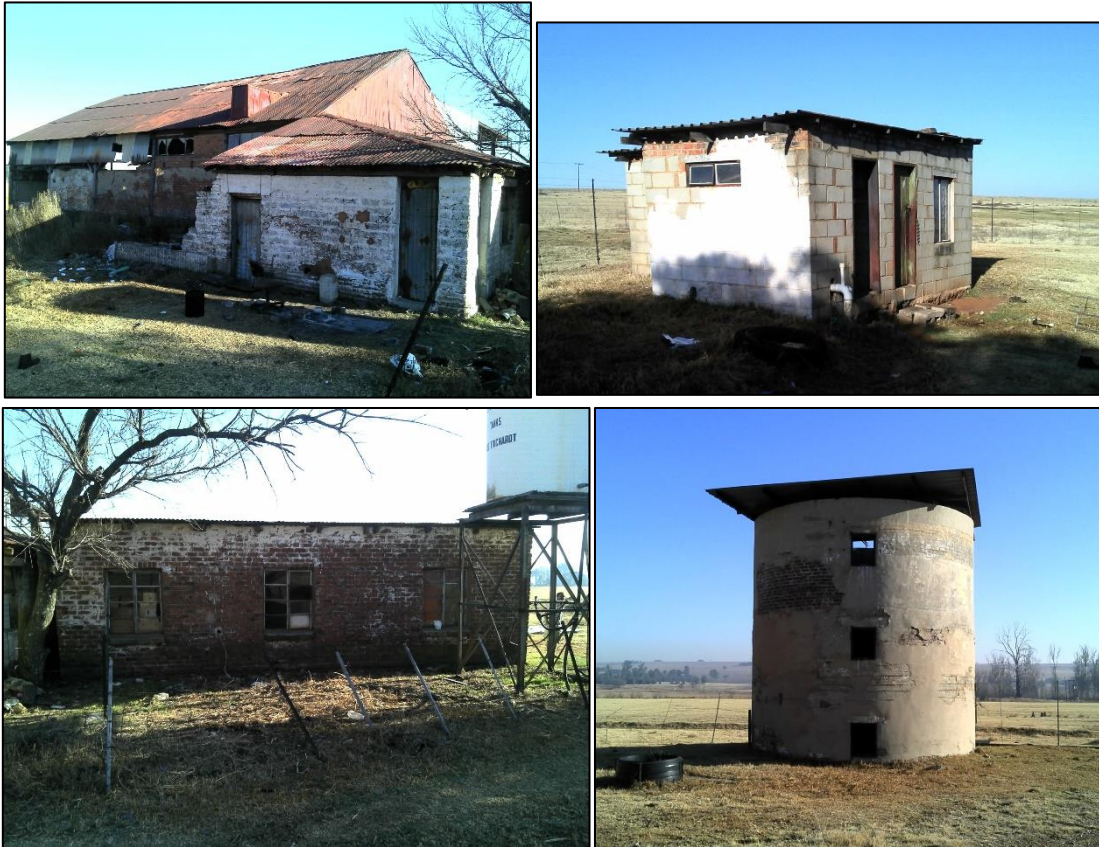
**Figures 9 to 12:** Buildings to the south of the R50 road. Only the large shed at upper left seems to have been present in 1945.

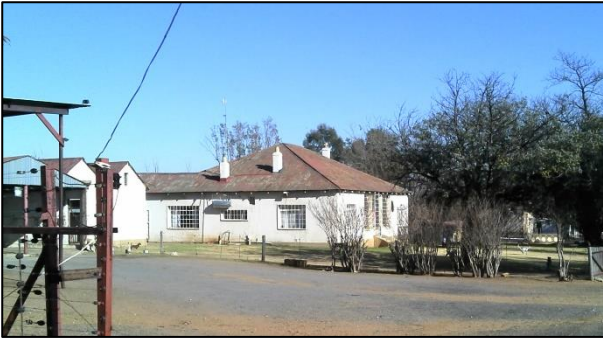
**Figure 13:** The main house that predates 1945.

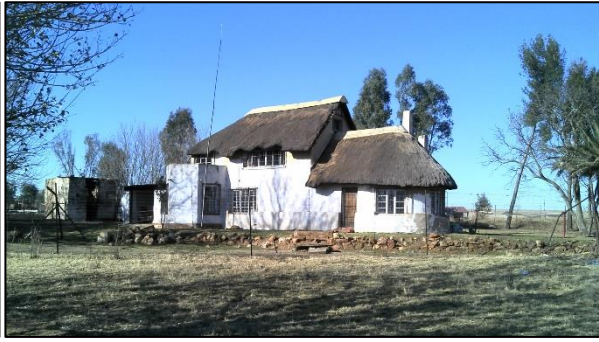
**Figure 14:** A modern house.
