NDC EVAPORATION POND EIA - TERRESTRIAL ECOLOGY

Aquatic Ecology and Wetland Assessment for the New Denmark Colliery Evaporation Pond

**New Denmark Colliery
Evaporation Pond EIA**

VISUAL IMPACT STATEMENT

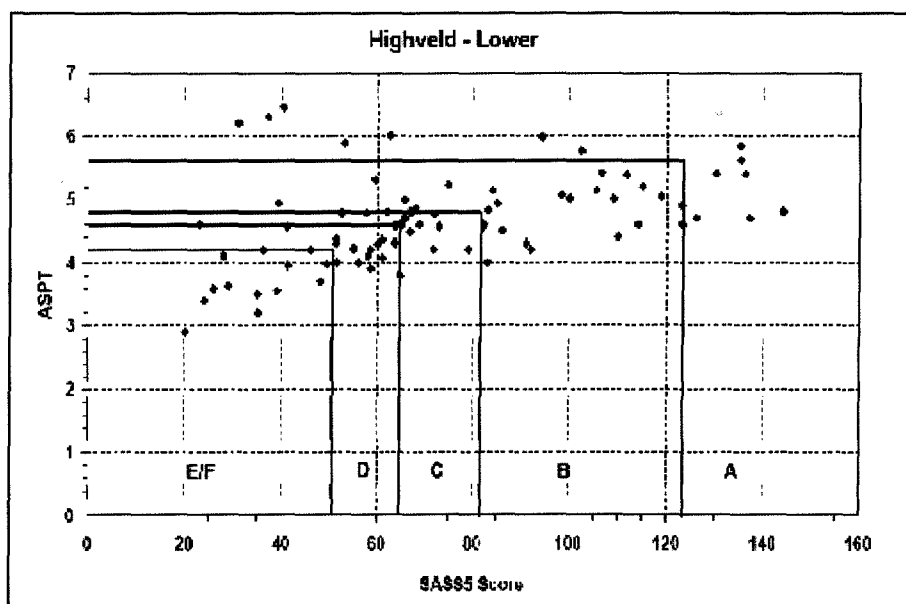
SASS scores are plotted against the ASPT values and give an indication as to the integrity of the aquatic macroinvertebrate integrity at a site. Plotted results are then divided into bands that represent different Ecological Categories associated with the Highveld Ecoregion - lower zones.

Figure 2: Biological bands associated with the Highveld Ecoregion for lower longitudinal zone rivers (Dallas 2007)

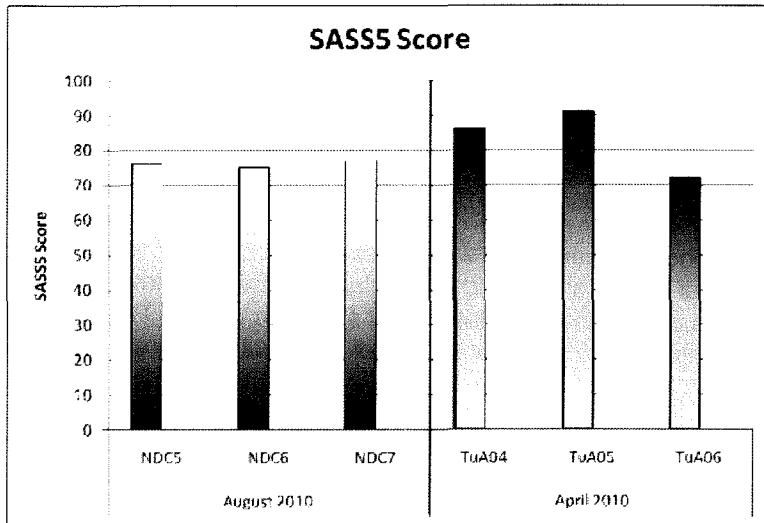
Figure 3: Comparative SASS5 scores at the aquatic ecosystem sites

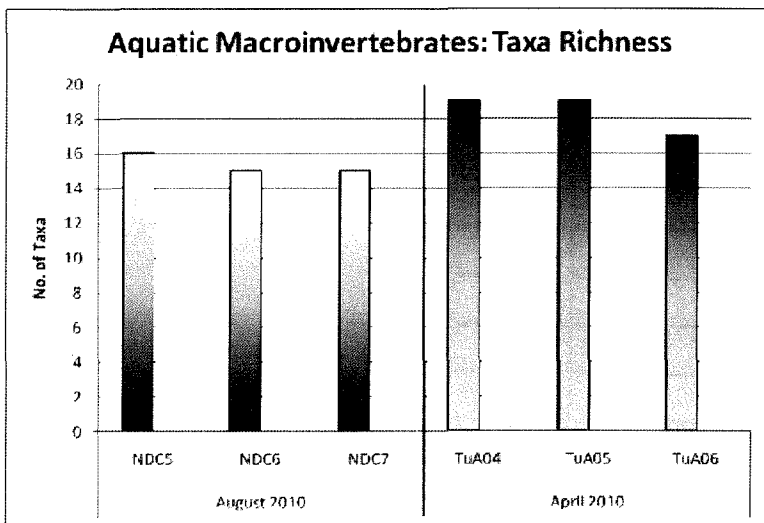
Figure 4: Comparative number of aquatic macroinvertebrate taxa at the aquatic ecosystem sites

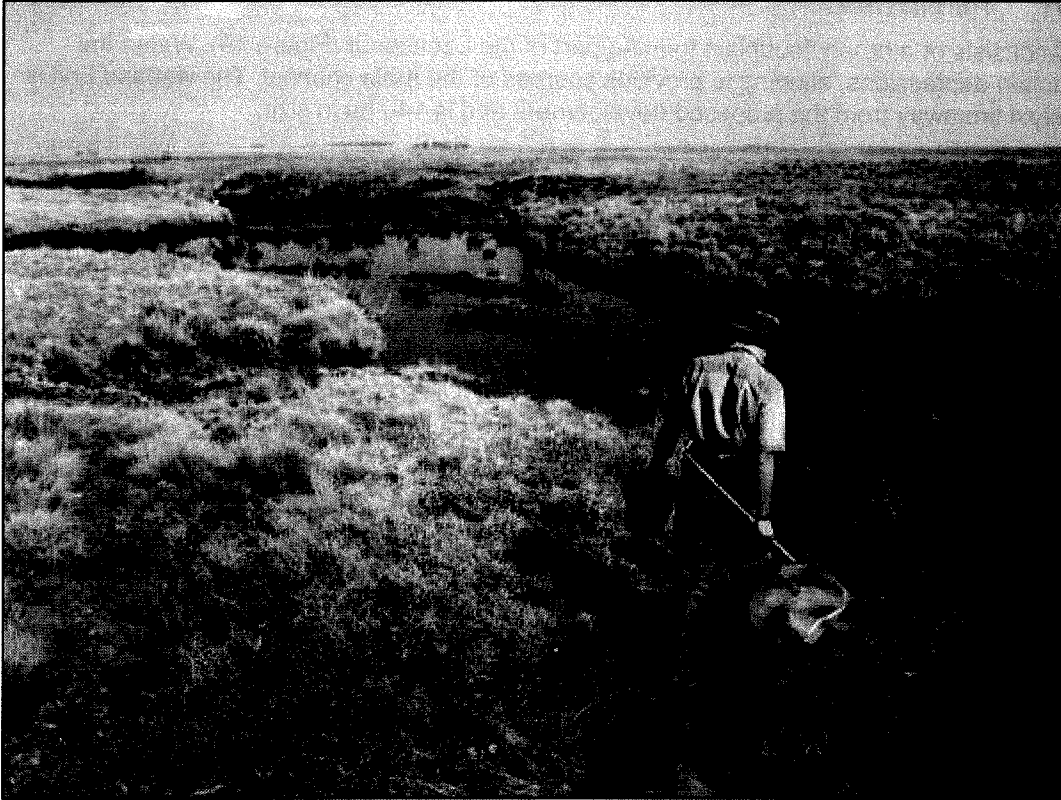
Existing impacts on the wetlands in this unit are largely due to agricultural activities (cropping and grazing) (Figure 13). An impoundment in the form of a low stone bridge has caused damming upstream. Bank erosion was noted upstream of the stone bridge.

The site was assessed to have an PES class of A/B and moderate EIS. The wetland unit provides moderate natural services and low human services.

Figure 17: Photograph of the floodplain within wetland unit NDC05

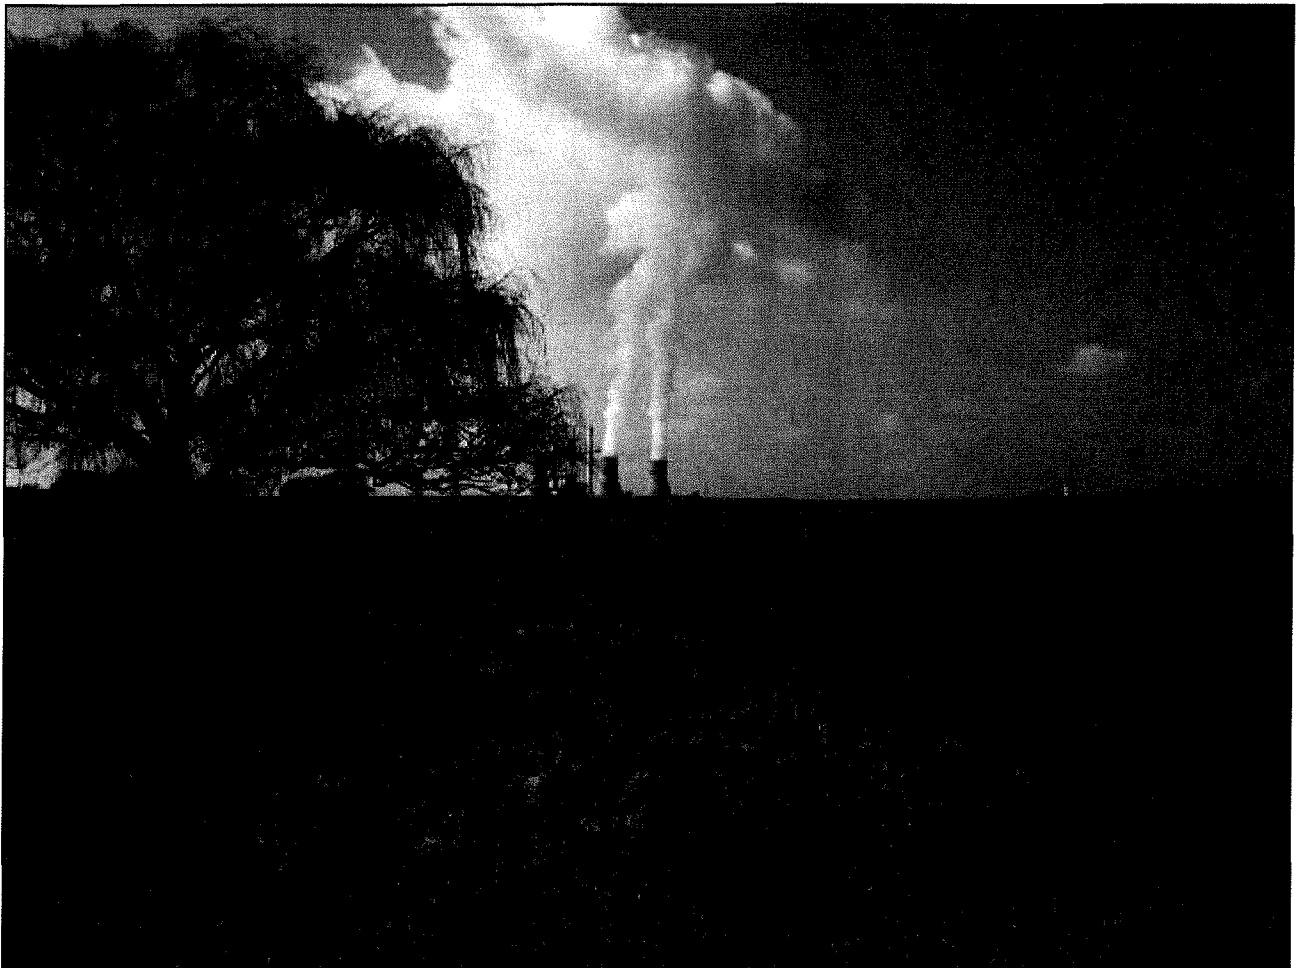
Existing impacts on the wetlands in this unit are largely due to agricultural activities (cropping and grazing) and impoundments such as dams and roads. The site was assessed to have a PES class of B and moderate EIS. The wetland unit provides moderate to low natural services and low human services.

Figure 20: Photograph of the channelled valley bottom within wetland unit NDC06

The wetland vegetation was moderately diverse with mostly hardy grass species such as *Hyparrhenia hirta* and *Themeda trindra* recorded. Also noted were *Eragrostis curvula*, *Sporobolus africanus*, *Panicum maximum*, and *Setraria sphaecelata* var. *torta*. Hydrophitic plants like *Cyperus longus* and *Typha capensis* were recorded in the more permanent zones and along the banks of the channel. Some exotic and / or weedy species were observed such as *Cirsium vulgare*, *Verbena bonariensis*, and *Tagetes minuta*. The invasive woody species *Salix babylonica* and *Populus xcanesense* (Weeping willow and Poplar tree) were noted along the channel banks (Figure 20).

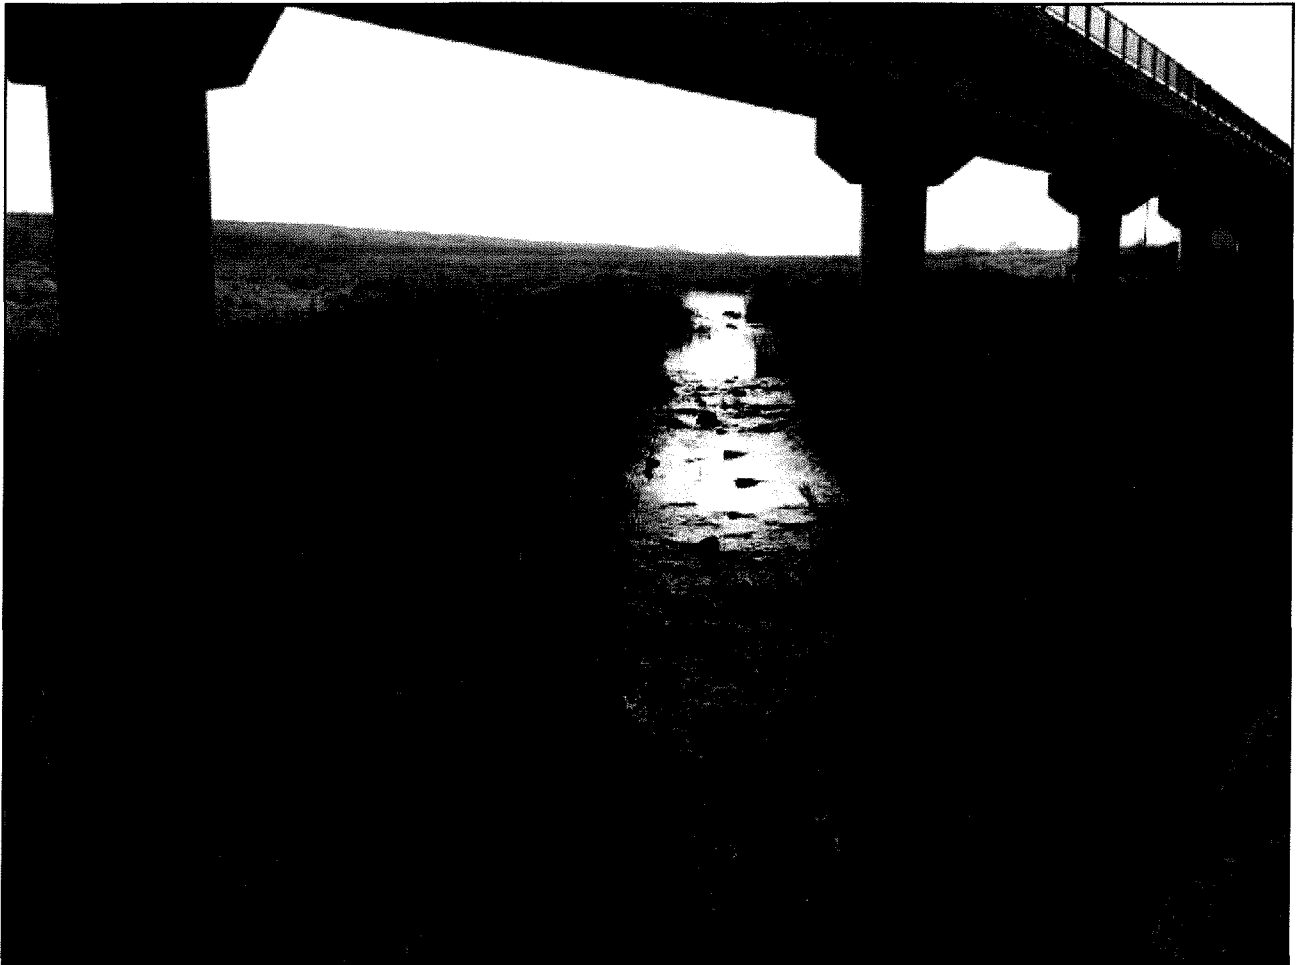
Existing impacts on the wetlands in this unit are largely due to agricultural activities (cropping and grazing) and impoundments such as dams and roads. The site was assessed to have an PES class of A/B and moderate EIS. The wetland unit provides moderate to low natural services and low human services.

Figure 22: Photograph of the floodplain within wetland unit NDC07

The wetland vegetation was found to have good, dense plant growth mostly in the form of grasses such as *Digitaria eriatha*, *Imperata cylindrical*, *Cynodon dactylon*, *Eragrostis tef*, and *E. curvula* (Figure 22). Also in abundance were the hardy species like *Themeda triandra* and *Hyparrhenia hirta*. Wetland indicator species such as *Cyperus longus* and *Schoenoplectus brachyceras* were noted in the permanent zones.

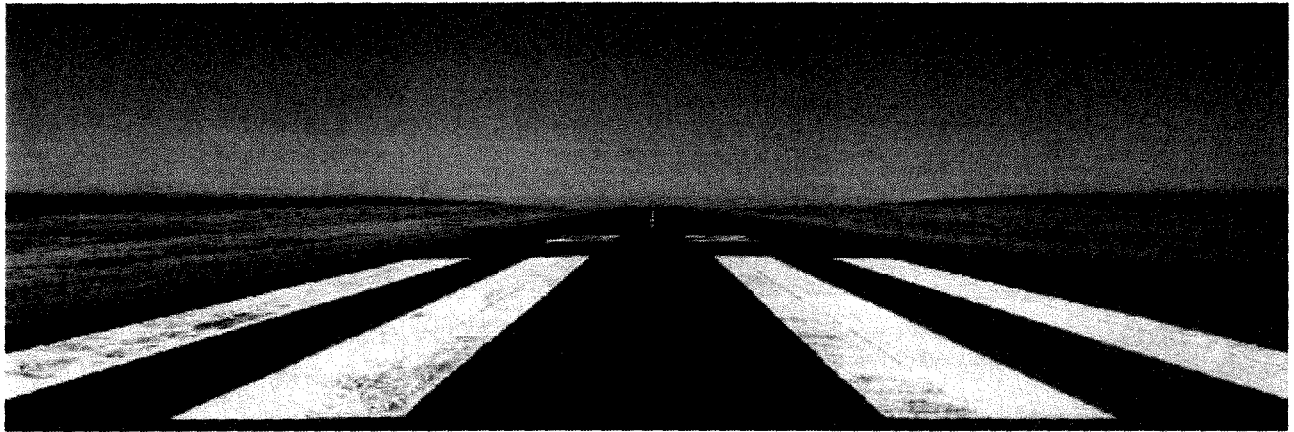
Figure 3: The topography of the study area is very gently undulating to flat with no prominent features. The runway situated along the eastern border of the site is also visible in this view.

The area surrounding the Tutuka power station is located at some 1 640 metres above mean sea level with the slope very gradually falling to the south towards the Grootdraai Dam. The power station precinct and ash dump are located at the highest point in the immediate surrounds. The study area is characterised by gently undulating topography with no prominent topographical features present and although drainage lines form localised low-lying areas, these are not visually distinct. Furthermore the study area for the propose project is representative of the topography in the greater area (Figure 3).

Due to the gently rolling and largely featureless nature of the landscape the topography is not visually distinct and as such is not considered to be a significant visual resource.
