DRAFT BASIC ASSESSMENT REPORT

Casteel Dam Safety Rehabilitation Project (DSRP),
Remaining Extent of the Farm Kasteel 231-JU,
Bushbuckridge Local Municipality, Ehlanzeni District,
Mpumalanga Province, South Africa

REPORT DATE: 20 June 2023

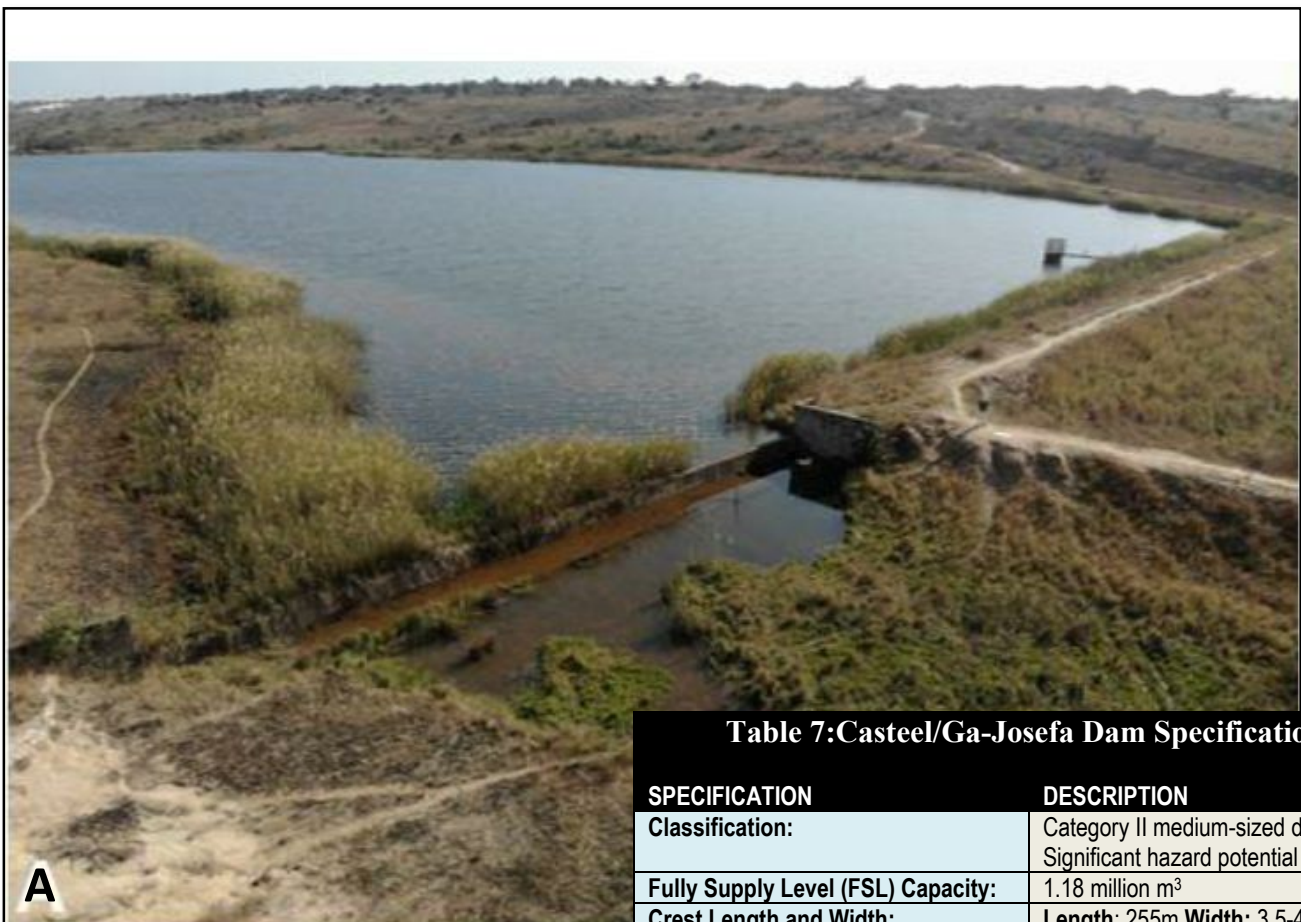
Plate 1: Casteel Dam with a spillway on the western bank (right flank). Image courtesy of Nepid, 2022

As mentioned in section 1, Casteel Dam is a Class II medium-sized earth-filled embankment dam (L-shaped) with a surface area of approximately 16-hectares and capacity of 1.18 million m³. The dam has a sharp crested weir spillway on its western bank (right flank) (**Plate 1, Table 7**). (*DWS, Proposed Rehabilitation Works of Casteel Dam Design Report, 2014*).

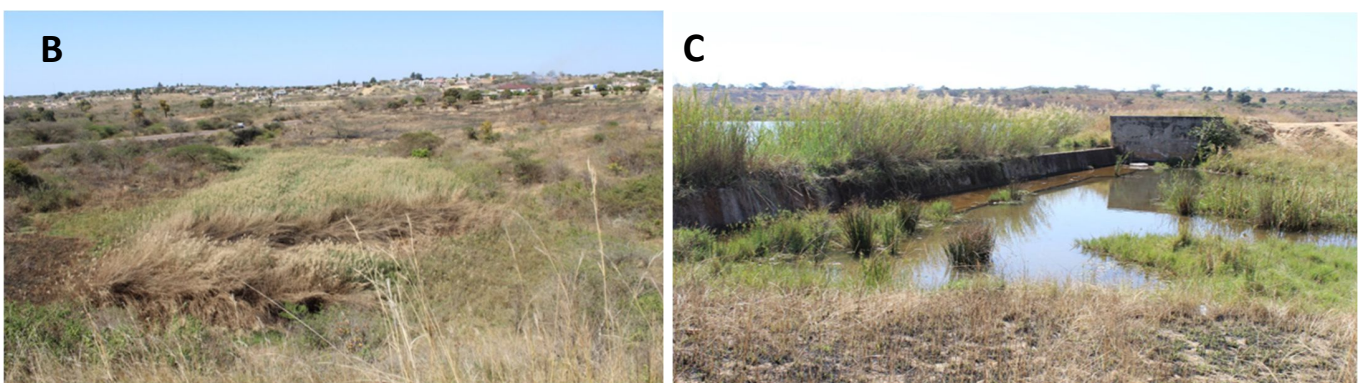
Plate 2: (B) Seepage below dam embankment (C) Spillway apron

- The slope on the downstream dam embankment is steep therefore unstable with a for potential slip failure.
- The downstream toe of the dam is saturated from seepage through the dam wall embankment.

- The outlet work (emergency siphon) is defective. A temporary pipeline has been installed to release water to downstream water users.
- The dam is freely discharging from the spillway to the river which resulted in a deep erosion gully downstream in the spillway channel on the right (western) flank of the dam.

- The spillway capacity is inadequate and has eroded to rock level. It cannot handle the 430m³ Regional Maximum Flood to and requires the dam embankment to be raised. If not rehabilitated it may overtop the embankment during RMF flood events.

Refer to **Plate 2 - 3** below.

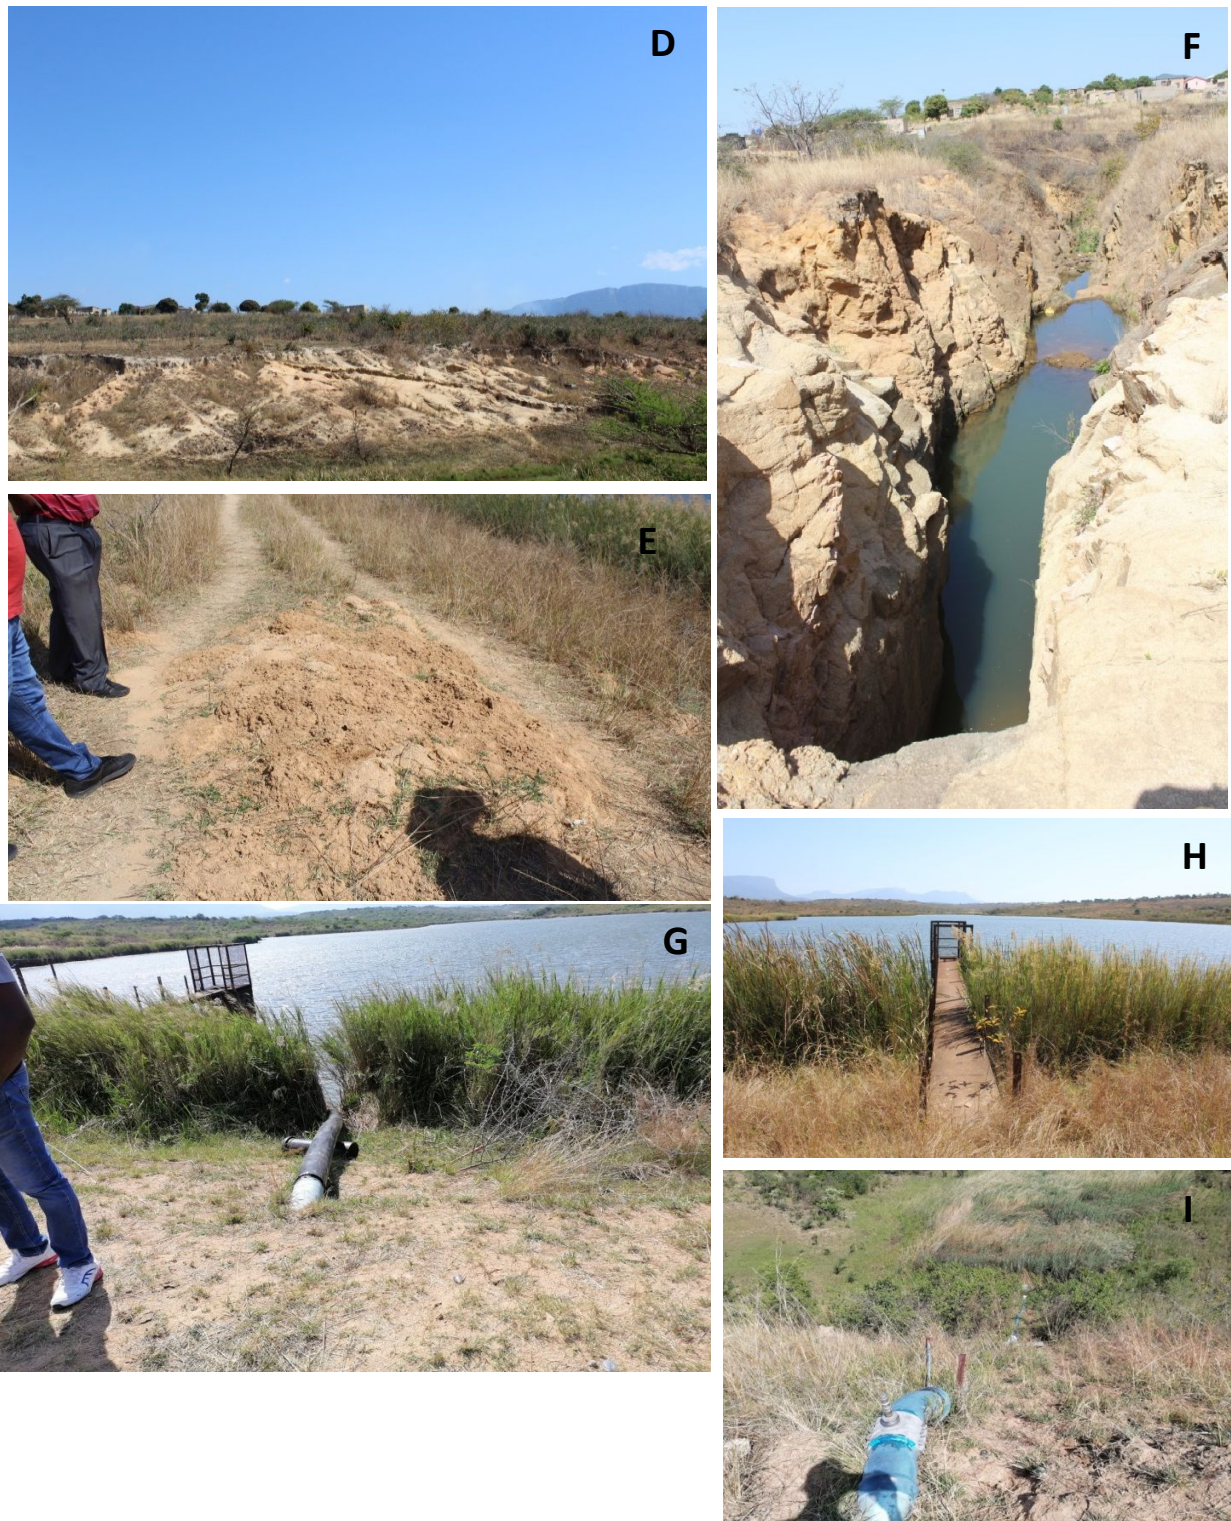
Plate 3: (D) Erosion along the right flank of Casteel Dam; **(E)** Termites colonising the dam wall/crest, **(F)** Large donga in the spillway channel; **(G)** Intake tower (metal/iron parts removed overtime making it unsafe **(H)** & **(I)** Temporary pipeline over the dam embankment releasing water to downstream water users.

- Termite infestation is present on the dam embankment/wall. The termite burrows could result in tunnels through the dam wall and may cause piping through the structure.

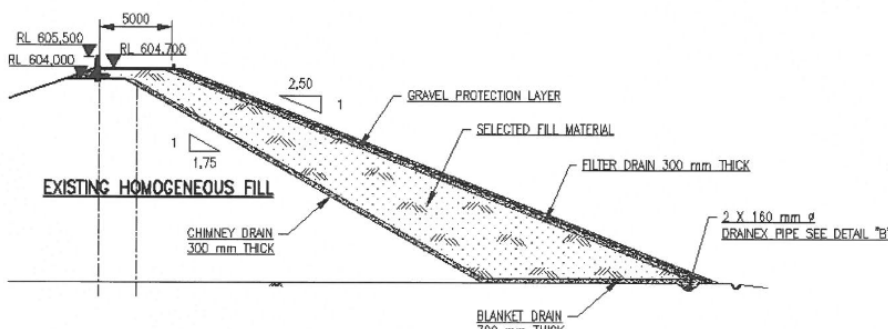
Figure 7-1: Raising using a Parapet Wall

- Option 1 – Raising using Parapet Wall (Estimated cost – R 6 670 500.00) (Figure 7-1)
- Option 2 – Raise using a 4m berm (Estimated cost – R 12 350 000) (Figure 7-2)

Option 1 is the most preferred as it is a more cost-effective design method to rehabilitate the dam. Therefore, the dam will be raised using a parapet wall.

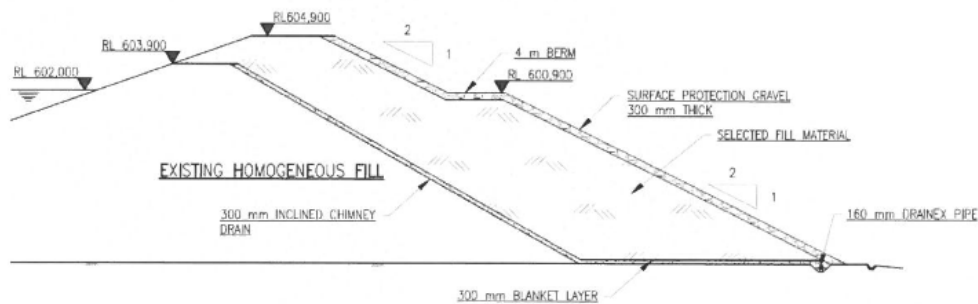
Figure 7-2: Raise using a 4m berm.

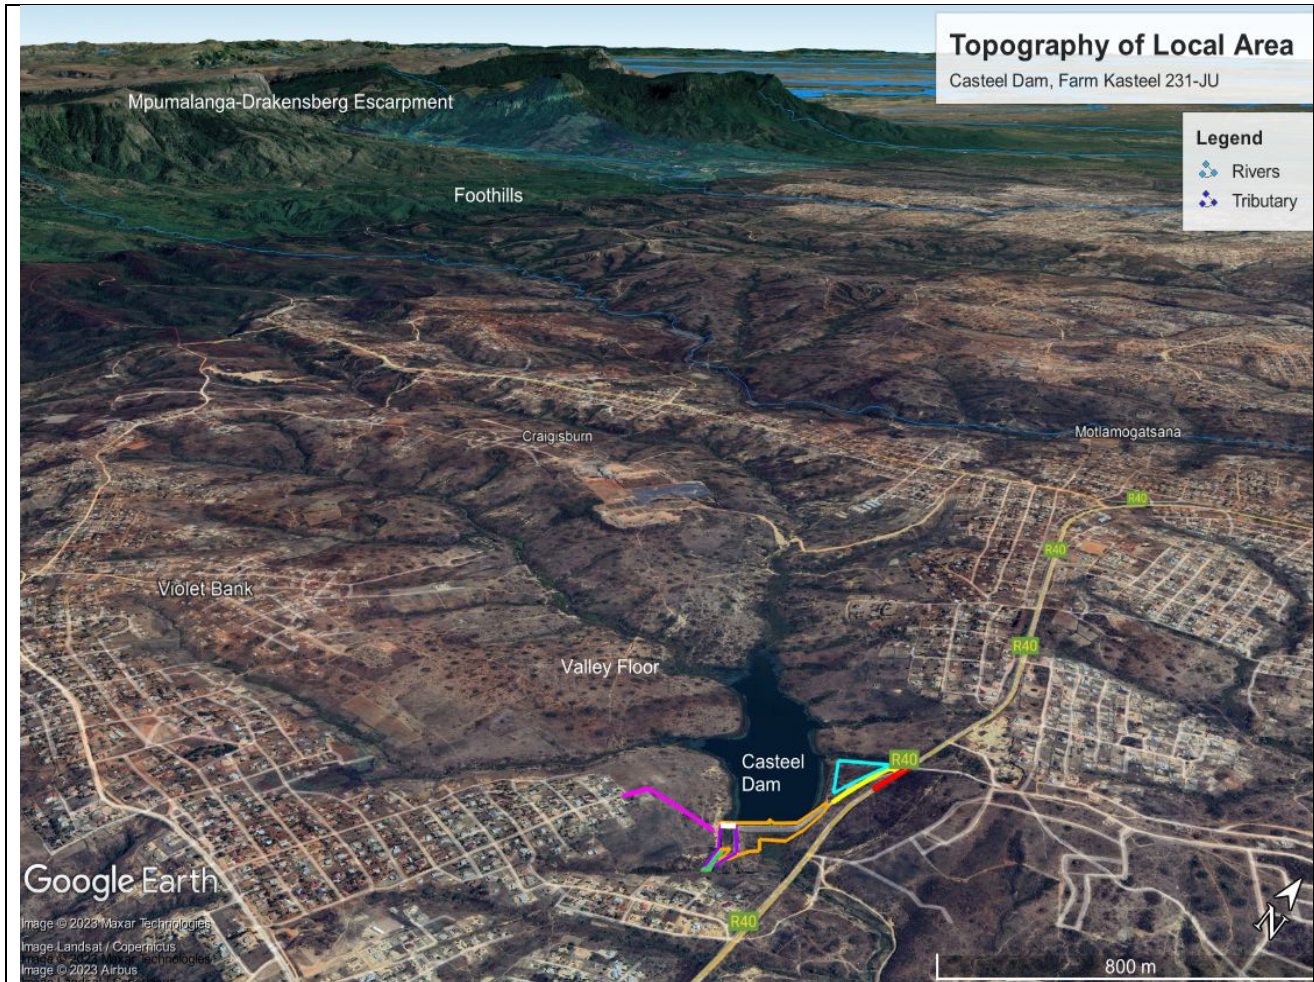
Figure 9-1: Tilted Google Earth imagery showing the location of Casteel Dam on the valley floor with shallow to deeply eroded drainage lines below the Mpumalanga-Drakensberg Escarpment.

Casteel Dam is situated on the valley floor below and east of the Mpumalanga-Drakensberg escarpment at an elevation of 600 meters above sea level. The topography of the general area is gentle to moderately undulating (hilly) with shallow to deeply eroded drainage lines. The proposed repair works are located on the valley floor of the landscape and along the steep embankment of the dam (1:7.5 embankment slope). Refer to **Figure 9-1, 9-2 and 9-3** below and overleaf.

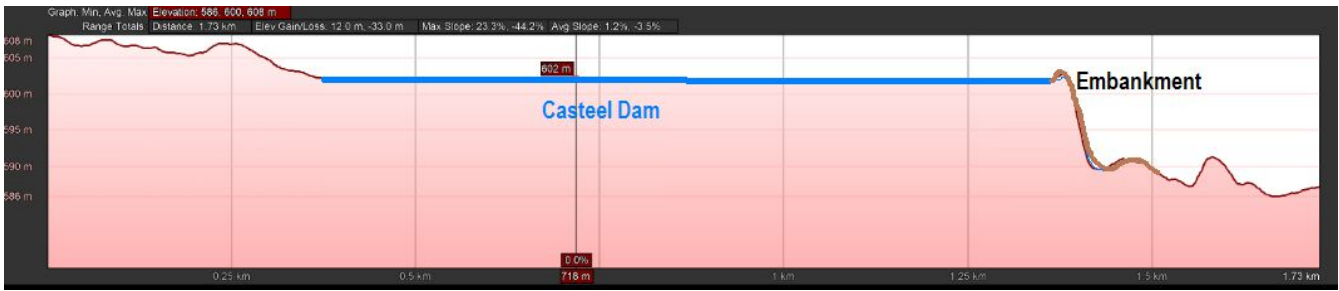
Figure 9-2: Elevation profile of the location of Casteel Dam from North to South.

As part of the proposed rehabilitation works the unstable dam downstream slope (i.e., steep) at 1: 1,75 (**Figure 9-2**) and will be flattened to 1: 2,5 as part of the proposed rehabilitation works to avoid embankment failure (**Figure 9-4**).

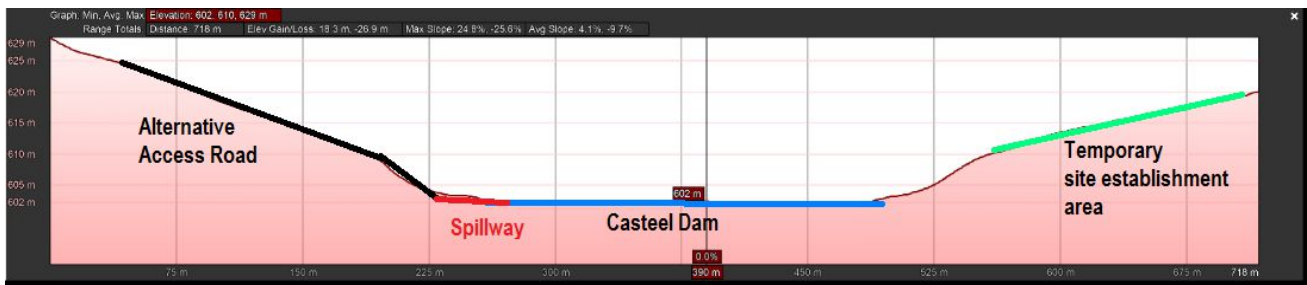
Figure 9-3: Elevation profile of Casteel Dam and its flanks from West to East

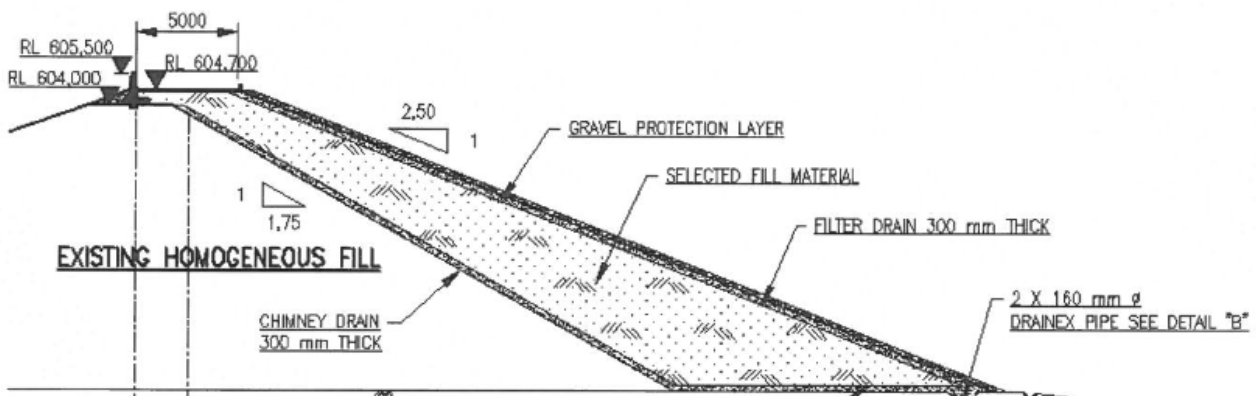
Figure 9-4: Downstream slope design where the existing 1:7.5 slope is flattened to 1: 2.5.

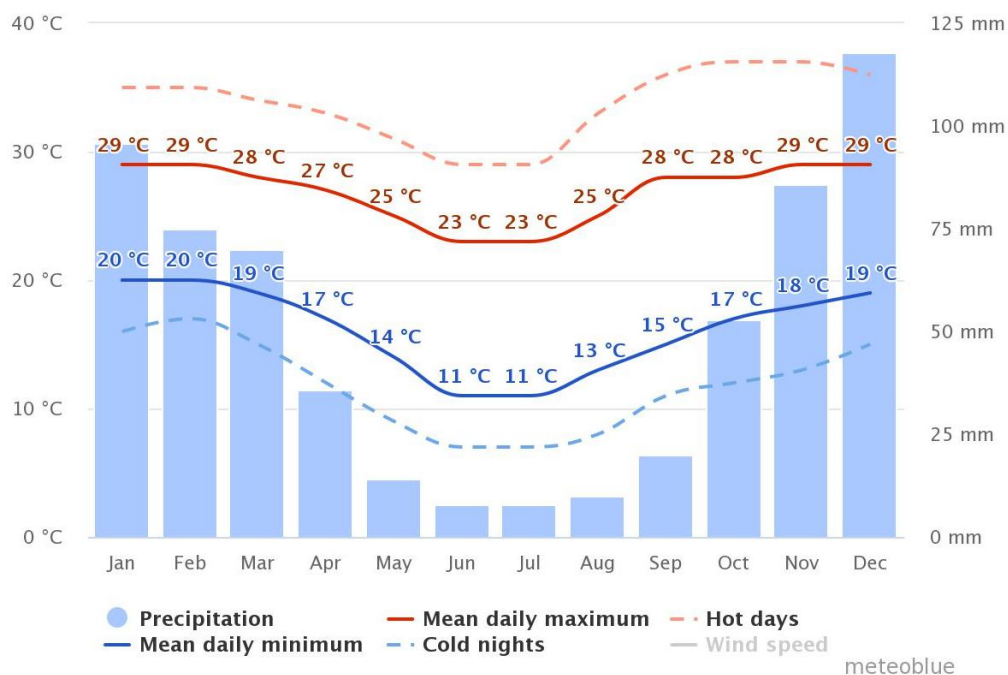
Figure 9-6: Average temperature and precipitation graph for Acornhoek (historical simulated data from Meteoblue)

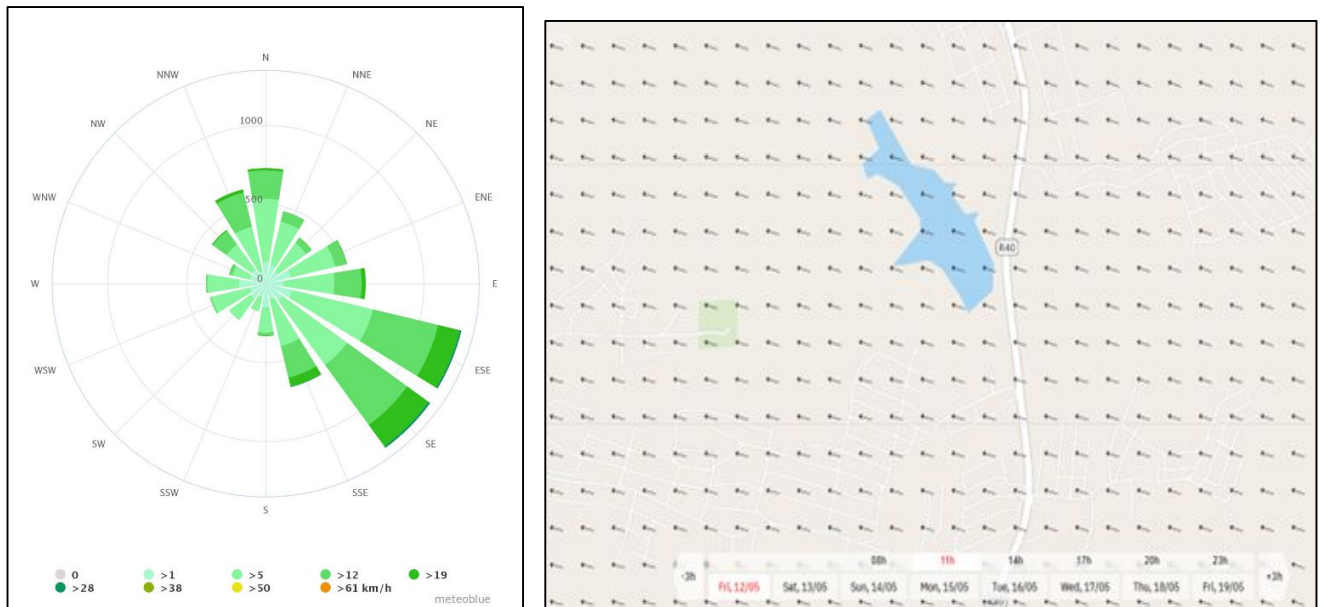
Figure 9-7 Acornhoek Windrose and wind direction map

The hourly wind speed and direction data for the project area (I.e., Acornhoek) are presented in the annual wind rose in **Figure 9-7**. The wind directions predominantly blow from south-east (SE) to northwest (NW) and east-southeast (ESE) blowing west-northwest (WNW).

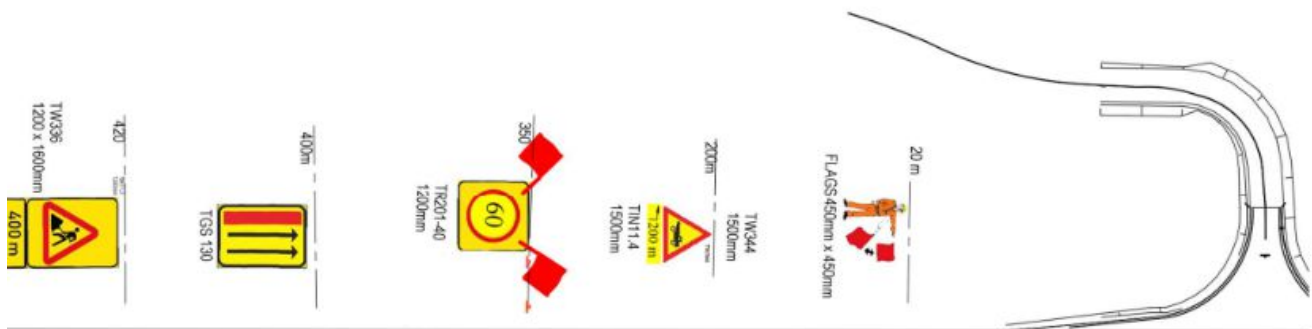
Figure 9-17: Typical construction signs to be implemented on both sides of the R40/Casteel Dam access intersection.

- Recommended temporary construction signage to be provided on the R40/Casteel Dam access intersection in accordance with the SA Road Traffic Signs Manual to the north of the dam and ‘Reduce Speed’ signage to calm traffic in this specific section from 100km/hr to 60km/hr.
