PROPOSED REHABILITATION OF THE KALKSPRUIT BRIDGE, EMALAHLENI LOCAL MUNICIPALITY, MPUMALANGA PROVINCE

DEDET Reference No: 17/2/3/N-190

DRAFT BASIC ASSESSMENT REPORT

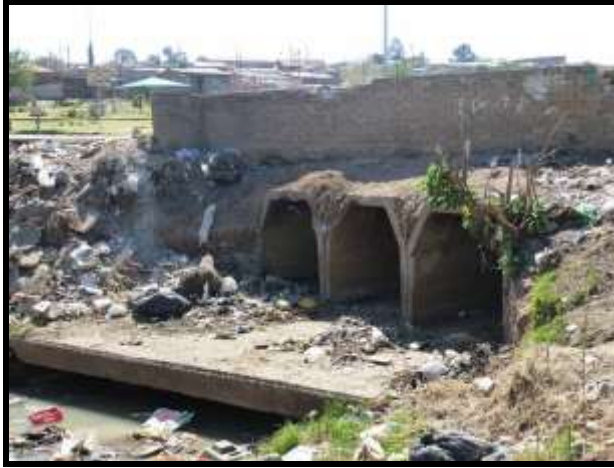
Figure 1: Existing undermined bridge structure

Plates 1 and 2 below indicate the existing status of the Kalkspruit Bridge.

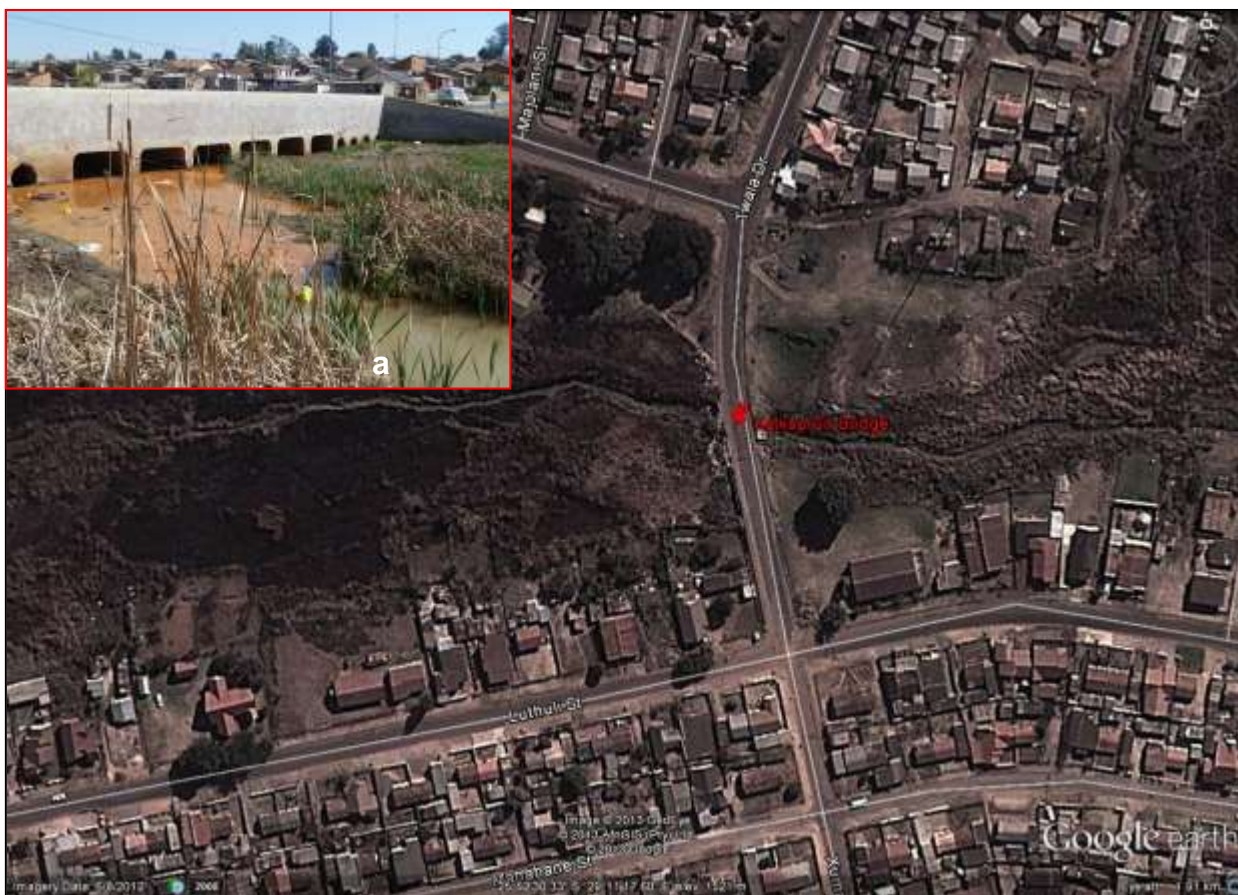
Figure 4: Aerial map showing the location of the Kalkspruit bridge, (a) picture of the existing structure

Kalkspruit Bridge is located within the Emalahleni Local Municipality and Nkangala District Municipality, Mpumalanga Province (See appendix 1 for Topographical Maps). The bridge is located on Farm Kwaguqa 313 JS (T0JS00000000031300011 and T0JS00000000031300000).

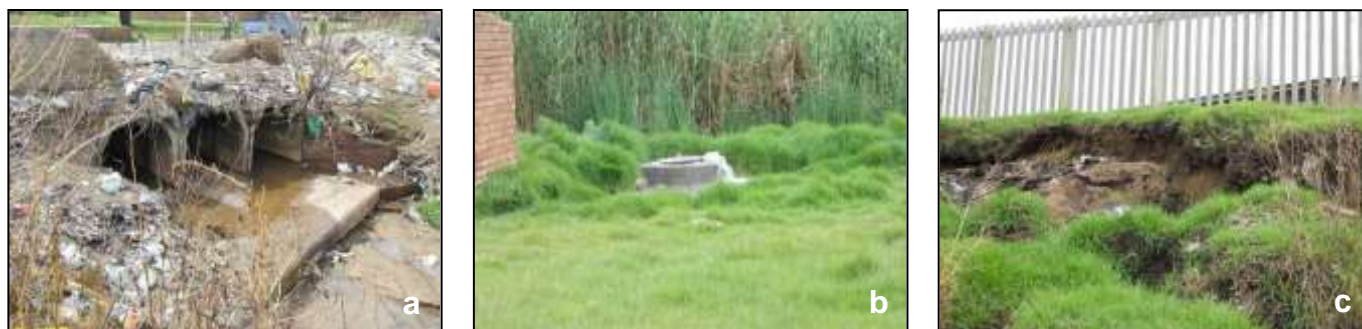
Figure 8: (a) litter and illegal dumping in the stream, (b) blocked sewerage drain overflowing into wetland and (c) erosion of stream banks

- Alien vegetation dominating the stream channel of the wetland feature;
- Illegal dumping of litter and building rubble within the wetland unit ;
- Erosion, incision and siltation (Scientific Aquatic Services, 2012).

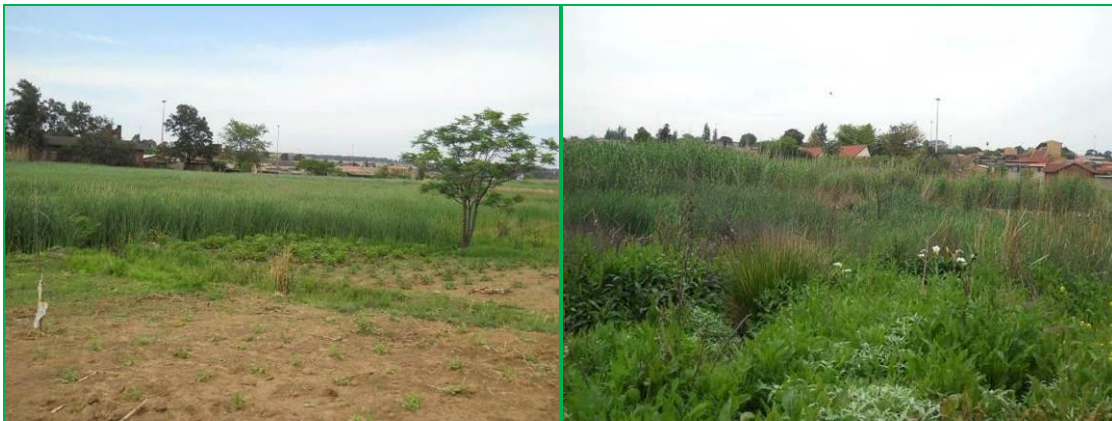
Figure 10: Abundant *Typha capensis* vegetation found within the wetland system.

The wetland and active channel area was dominated by *Typha capensis* which has congested much of the channel. This can be attributed to the fact that the wetland has been severely impacted on by erosion and siltation which has formed leading to alteration of the wetlands ecological status. The siltation of the wetland area forms suitable habitat for *Typha capensis* to occur in abundance (Figure 10). This has led to alteration in the vegetation within the channel, and is now dominated by *Typha capensis*. Although *Typha capensis* is an indigenous perennial plant, it can prevent access to streams and channels and become a hindrance to water flowing through the stream channel.

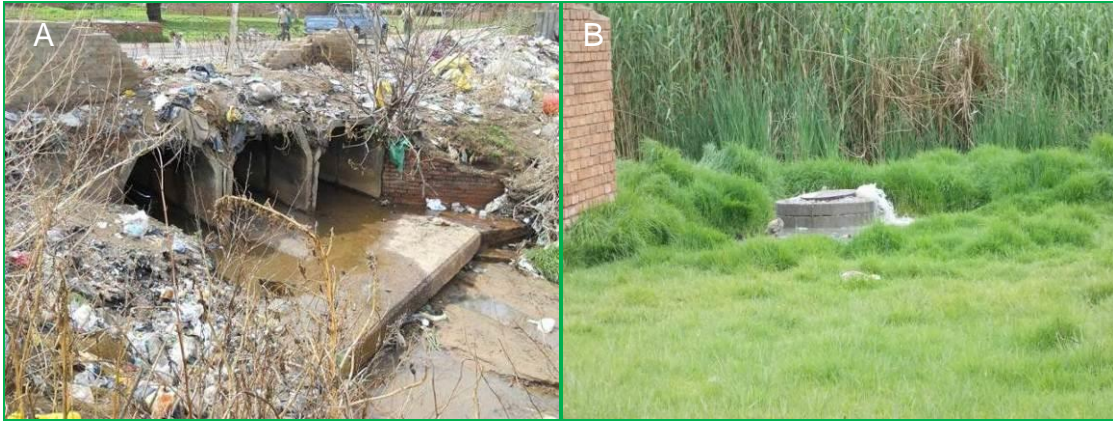
Figure 11: A) Illegal dumping of waste material by the local community and B) the blocked sewerage drain overflowing into the wetland system.

A blocked sewerage drain system was seen flowing from Luthuli Street into the wetland area. This also contributed to the decrease in water quality and aquatic species found within the wetland system (Figure 11b).

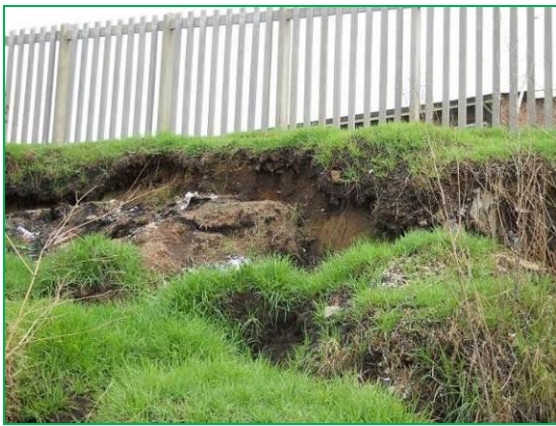
Figure 12: Erosion and bank failure noted within the wetland system.

Severe erosion and siltation of the wetland unit area was noted (Figure 12). This has led to several topographic changes within the wetland unit and has resulted in creating a habitat for *Typha capensis* which now dominates most of the wetland unit.
