Draft Basic Assessment Report for the Proposed Piet Retief X22, Mpumalanga Province

A Portion of Portion 100 of the farm Piet Retief Town and
Townlands 149-HT

MDEDET Reference No: 17/2/3/GS-239

March 2015

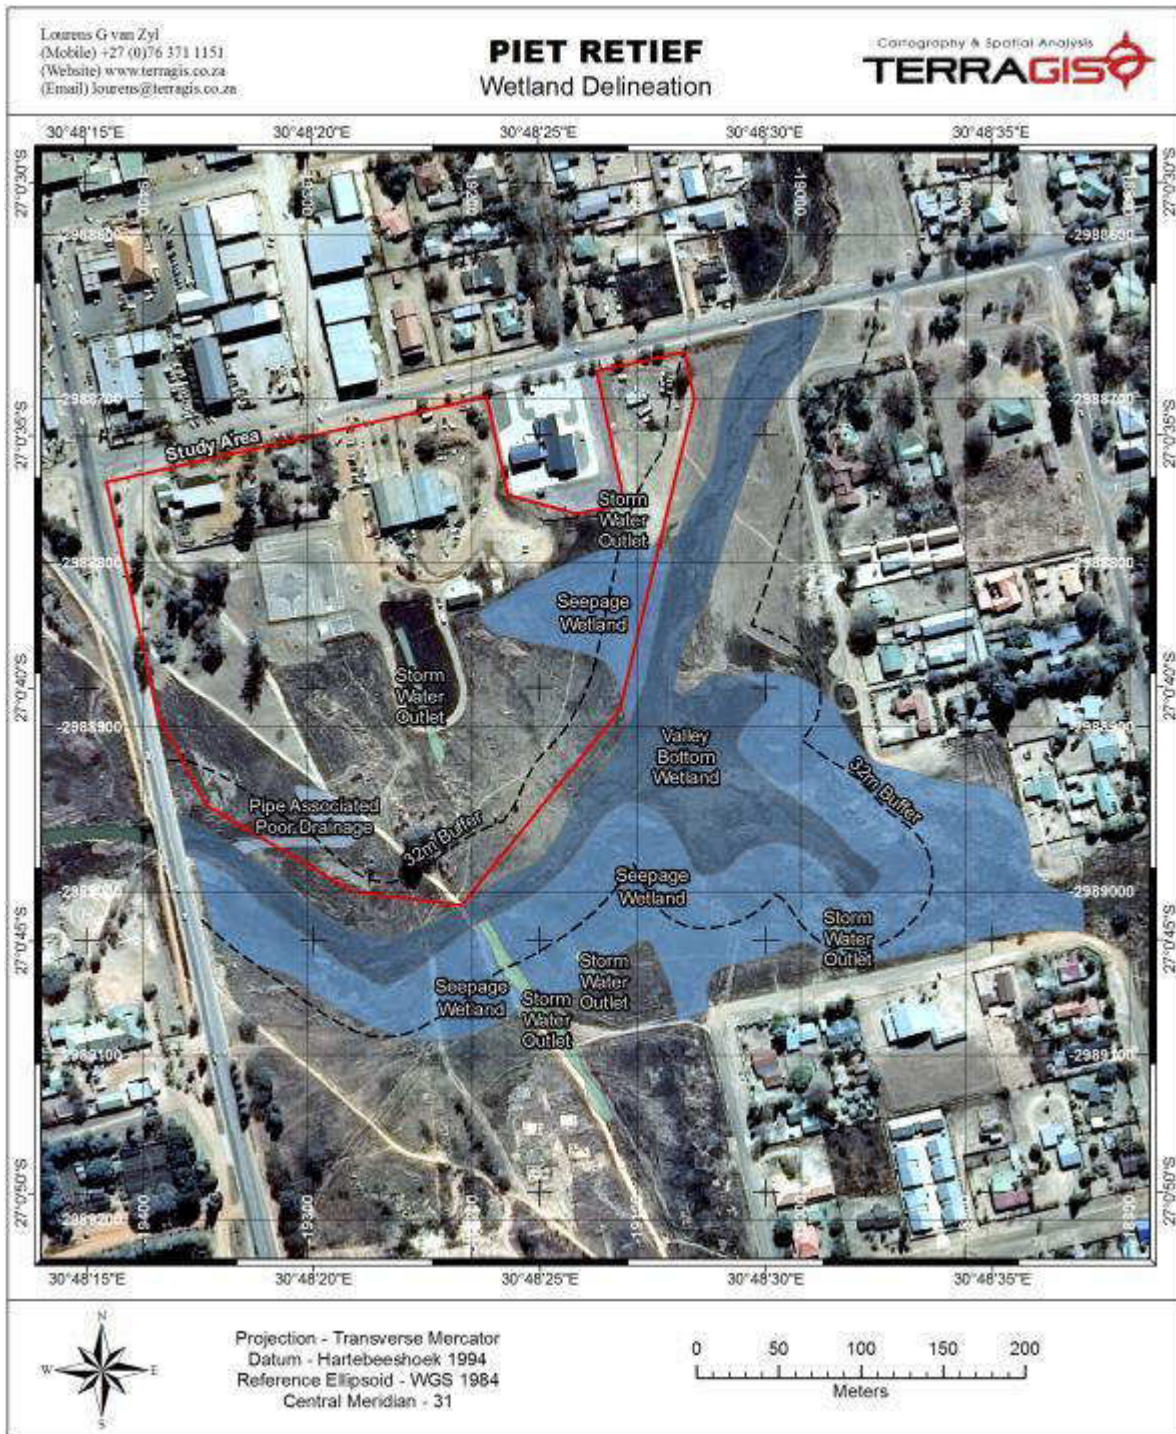
Figure 7: Wetland Delineation Map

32m. No buffer is proposed around the man-made seepage wetland in the north-eastern section of the study area, which is associated with a storm water discharge point. Furthermore, the poor drainage area associated with a pipe in the south-western section of the study area is not regarded as a man-made wetland or watercourse and therefore no watercourse delineations or buffers were identified for this poor drainage area. **Refer to Figure 7 for Wetland Delineation Map**

Wetland consultant, Terrasoil Science, was appointed to conduct a wetland delineation and management report for the study area. Seepage wetland areas have been identified on the site and have been modified by human activities. Since 2003 changes occurred on the site in the form of additional paving and storm water runoff. The valley bottom wetland is greatly impacted upon through erosion and excavation, there is also significant amounts of litter and invasive plants throughout the channel. Figure 5 illustrates the delineated wetland with the proposed/ recommended buffer zone. The specialist recommends that the construction activities should be limited to a distance of 30m from the water course except if adequate storm water management and containments structures are constructed to minimise high energy flows into the stream channel. The seepage wetland has no recommended buffer zone due to it being situated immediately downslope of paved up areas.

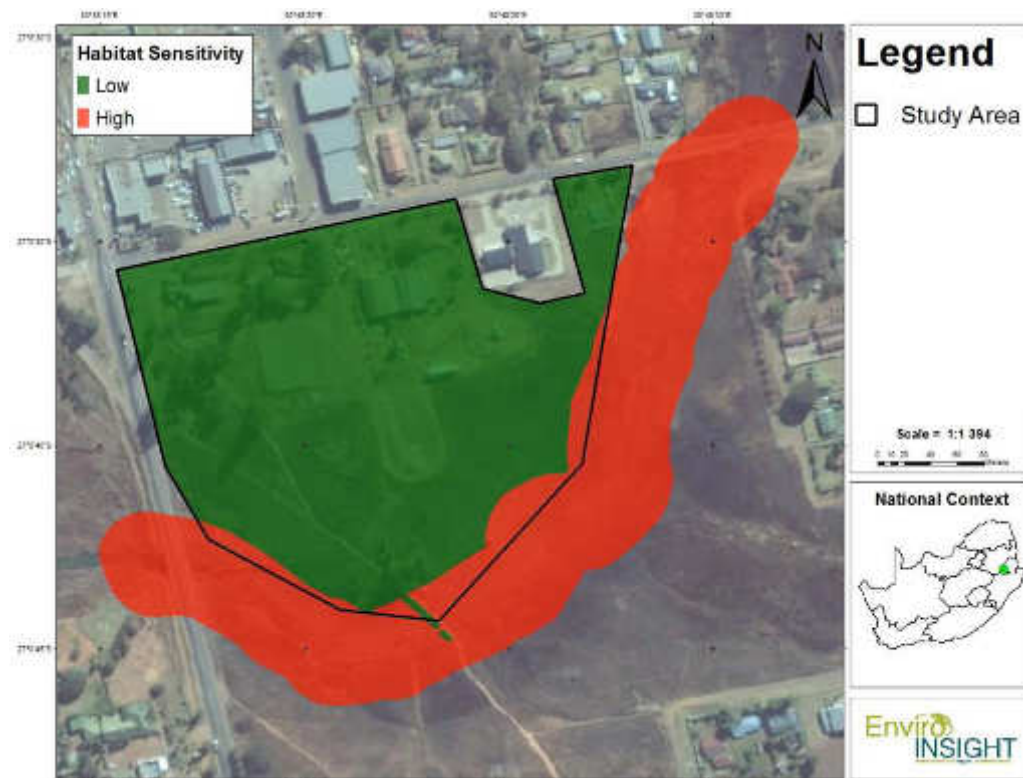
Figure 9: Sensitivity Map

Sections of the site was found to have been disturbed or transformed. A stream and stream buffer area is located adjacent to the site.

The site is classified as being non-sensitive and it's not expected that any Red-Listed species will occur. It was recommended that the stream/ stream buffer habitat areas should be buffered in order to maintain corridor movement of birds and aquatic faunal species. Any alien or invasive plants should also be removed from the site.

- It is recommended that only indigenous flora be used for landscaping;
- An alien invasive eradication and monitoring programme should be implemented;
- Sediment barriers should be placed above and below the construction site in pairs of three to reduce sediment entering the system lower down in the catchment area; and
- The stormwater leaving the site downstream must be clean and of the same quality as in situ before it enters the construction site (upstream). Pre-construction measures must be in place to ensure that sedimentation is trapped.

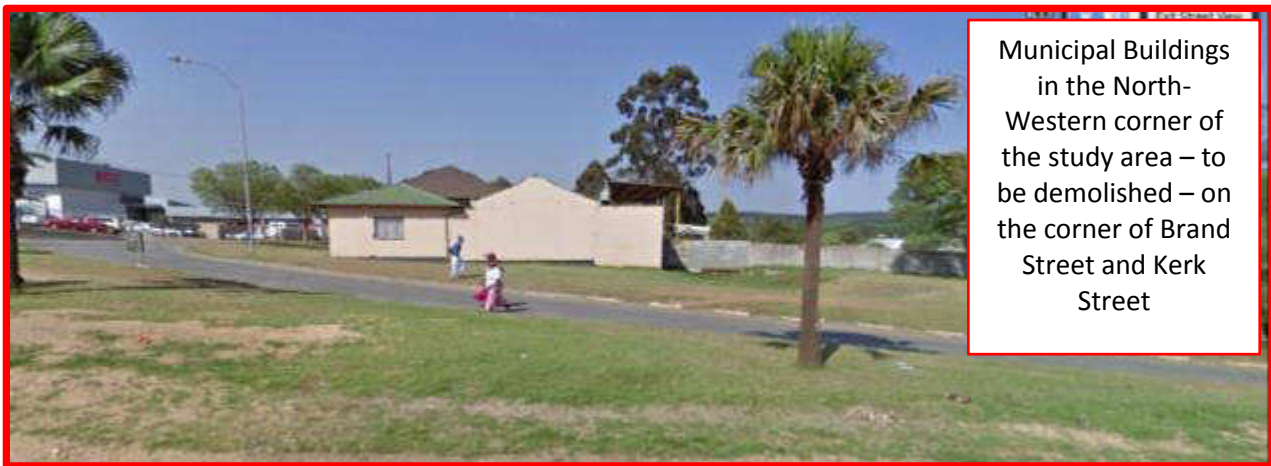
Figure 11: Municipal Buildings on Corner of Brand Street and Kerk Street

Municipal Buildings in the North-Western corner of the study area – to be demolished – on the corner of Brand Street and Kerk Street

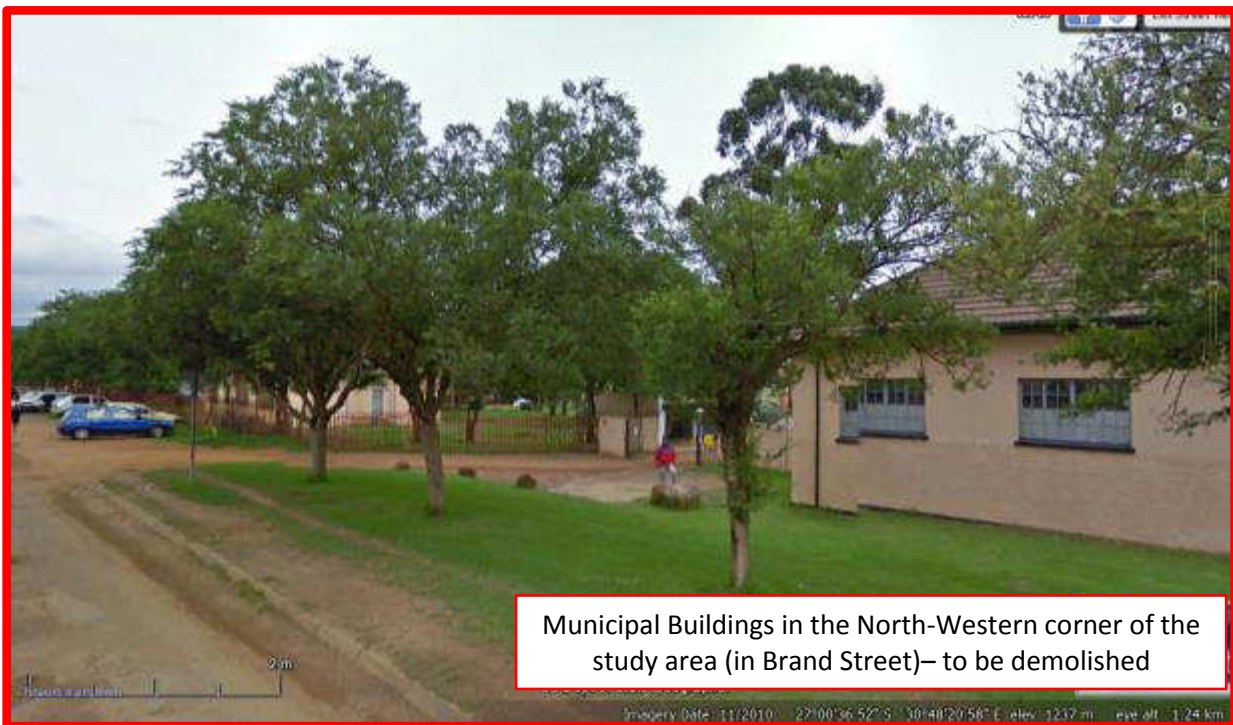
Figure 12: Municipal Buildings Brand Street

Municipal Buildings in the North-Western corner of the study area (in Brand Street)– to be demolished

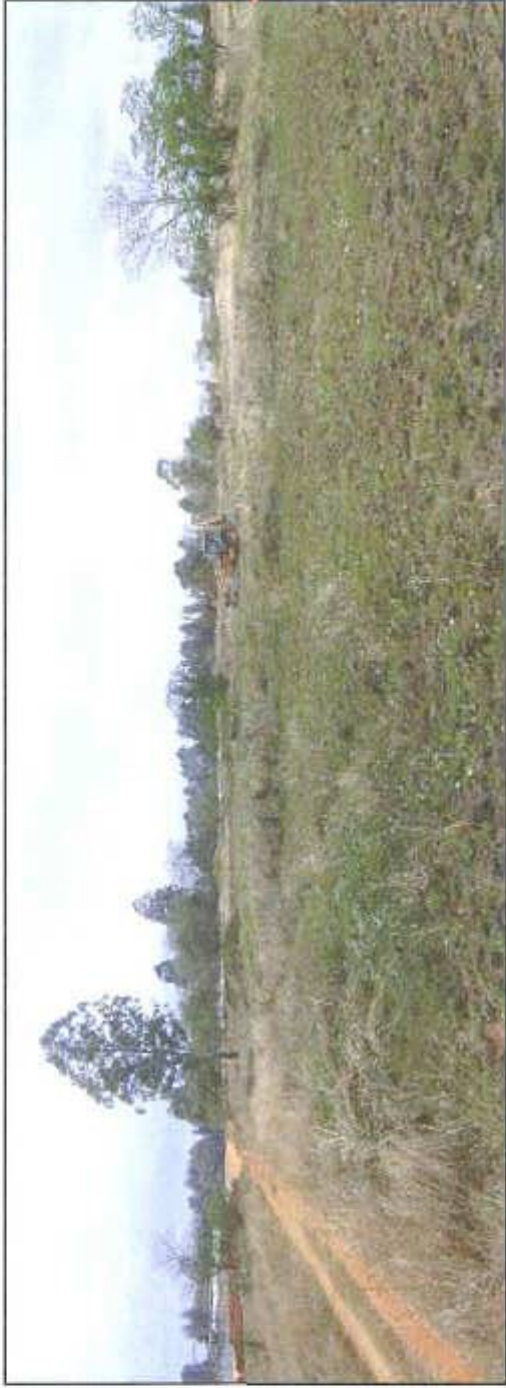
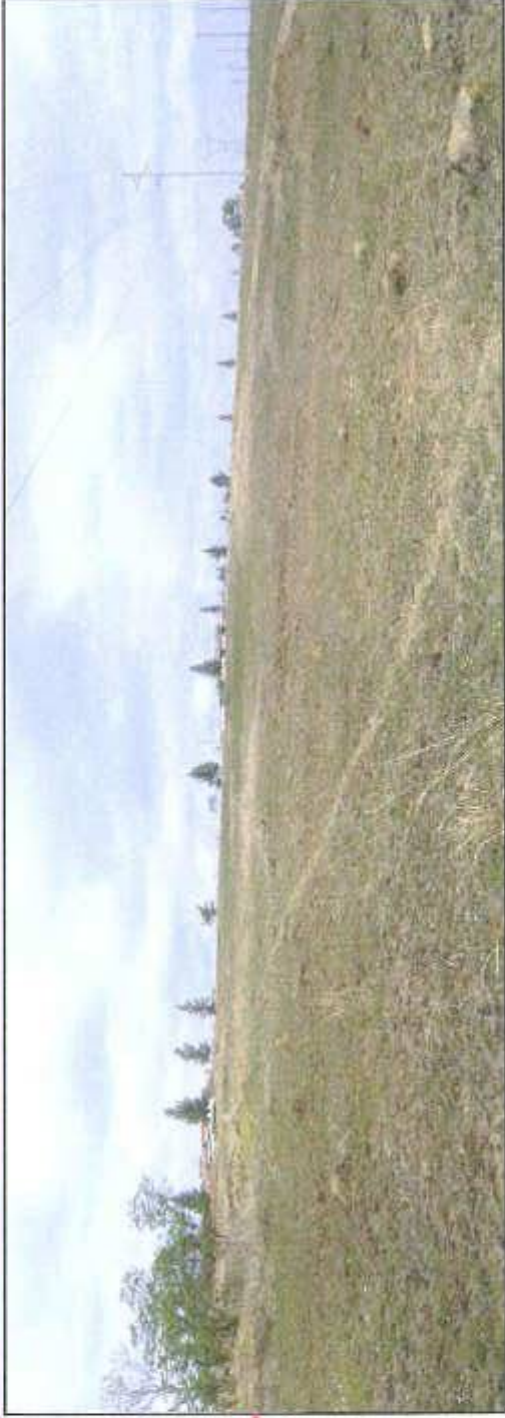
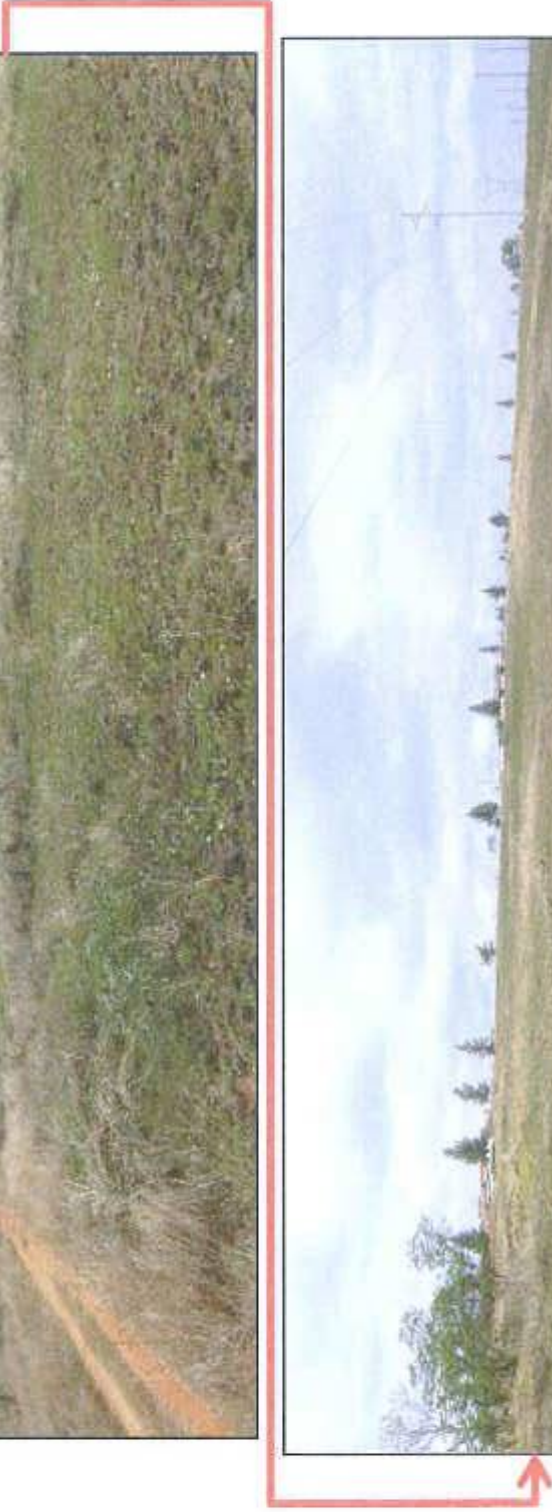
PHOTO 1

From initial reconnaissance of the site it appeared as though the south eastern corner of the land had been exploited for gravel procurement (i.e. borrow pit) at some point in past decades. Considering the growth of trees in the borrow area, it is estimated that the borrow pit is at least twenty years old.

SITE CONDITIONS

Site conditions are illustrated on the attached Photo 1 - Site Conditions.

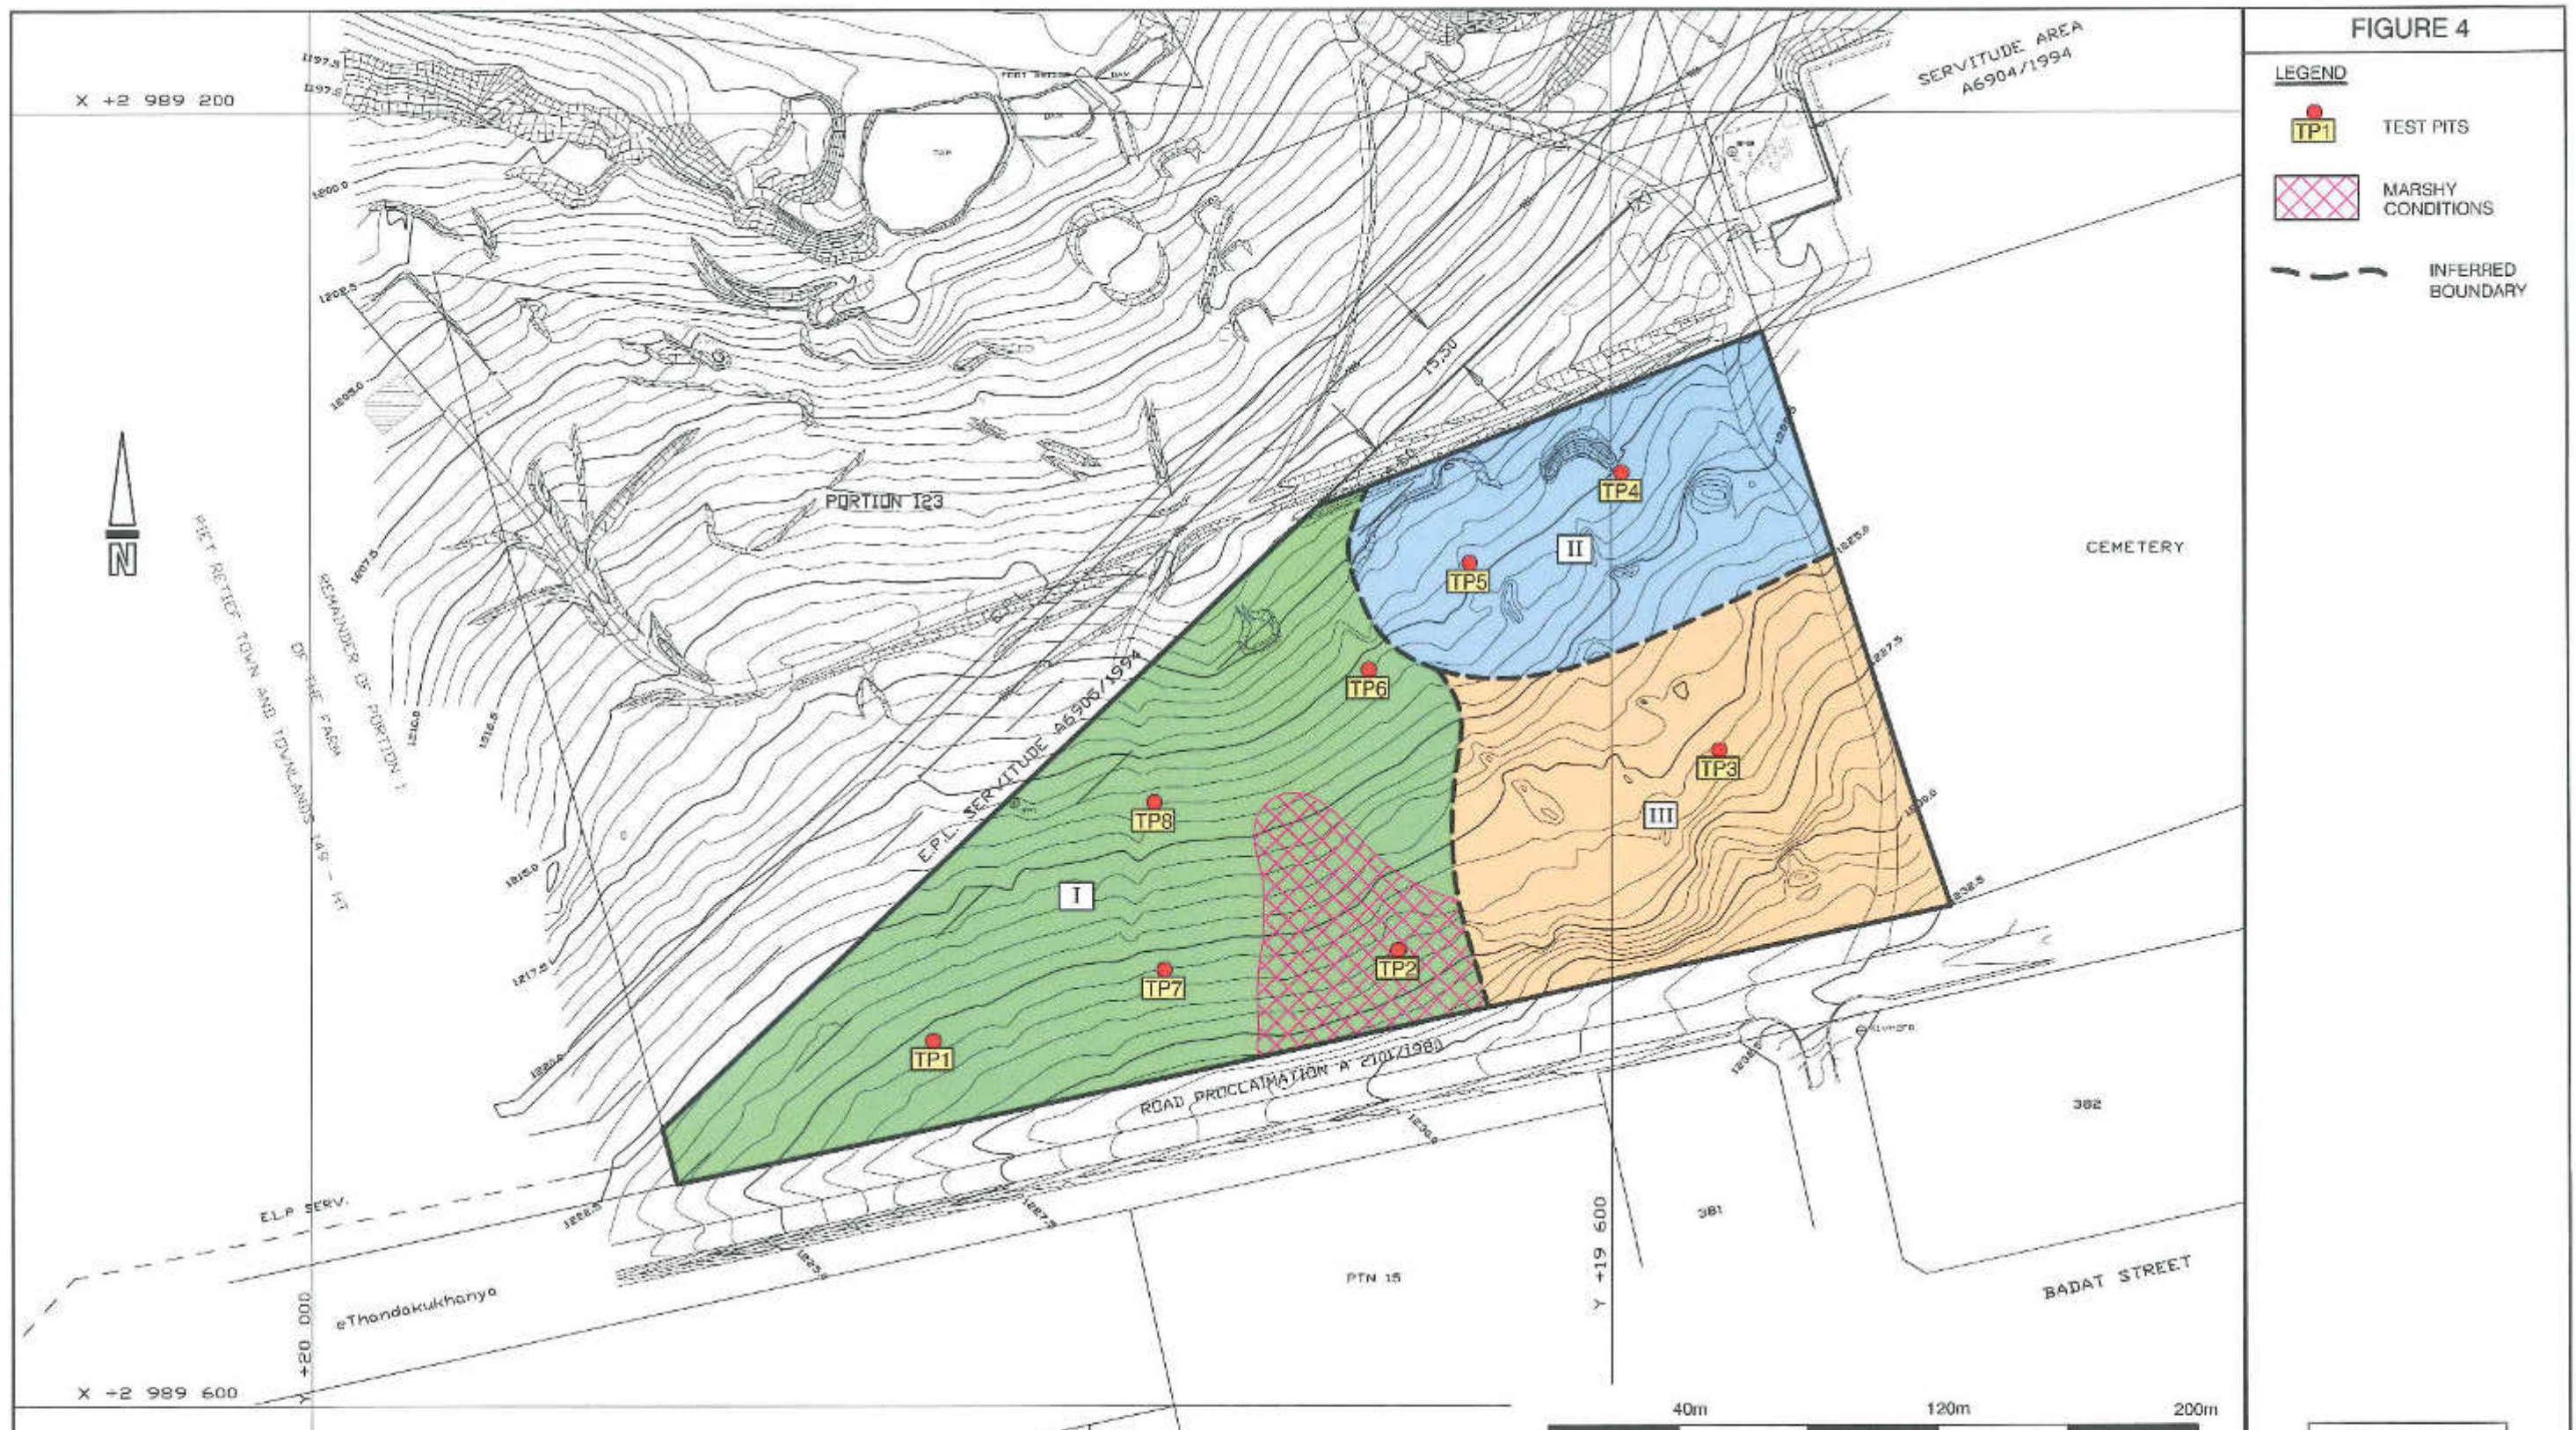
FIGURE 4
LEGEND
 TEST PITS
 MARSHY CONDITIONS
 INFERRED BOUNDARY

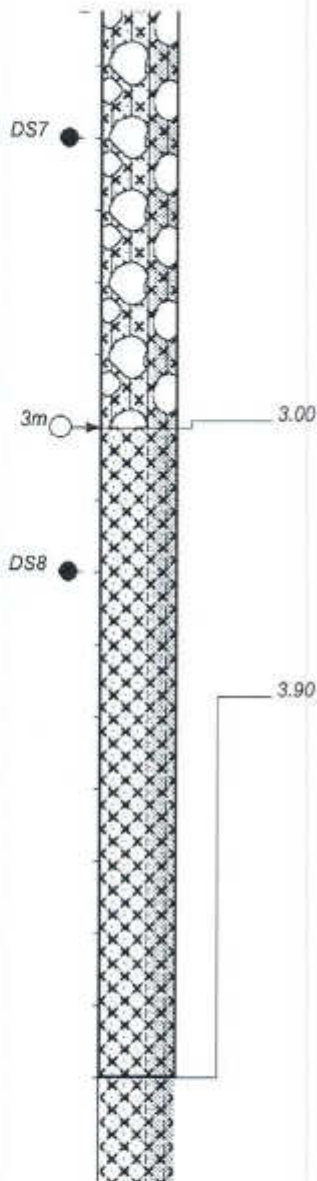
Very moist to wet, dark olive and yellow-orange, very soft, relic jointed, sandy SILT, with abundant scattered, unweathered very hard rock cobbles and boulders (up to 1,5m in diameter) in profile. Residual diabase.
