DRAFT NEMA BAR AND EMPr:

IN SUPPORT OF A MINING PERMIT AND ENVIRONMENTAL AUTHORISATION APPLICATION FOR THE ESTABLISHMENT OF A QUARRY ON REMAINDER OF FARM DE HOOP 320, BLOEMFONTEIN, FREE STATE

Report on the ecological assessment for the proposed quarry on the Remainder of the Farm De Hoop 320, Bloemfontein, Free State Province.

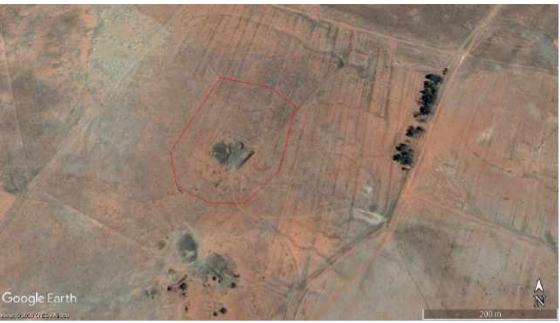
Figure 1: Aerial view of the proposed site (Google Earth 2019). Note the historical borrow pit on the site is clearly visible as well as plough furrows in the surrounding grassland which clearly indicates previous clearing of the natural vegetation.

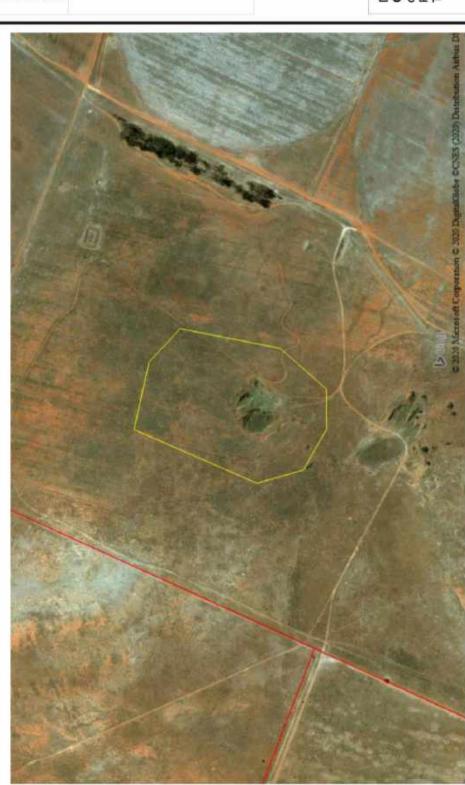
Map 1: Layout map of the proposed quarry on the Farm De Hoop 320 near Bloemfontein. The existing historical borrow pit is visible on the site. Note also feint plough furrows still visible on the site and surroundings.

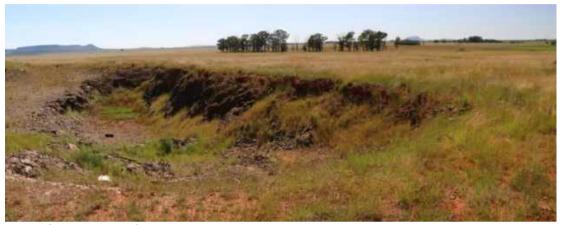
Figure 2: Panorama of the site showing the existing borrow pit excavation. Note that it remains free draining.

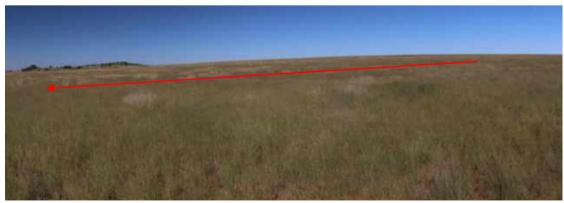
Figure 4: Panorama of the site showing the surrounding grassland. Again, note the dominance of pioneer grasses. The gentle slope of the site is also clearly visible (red arrow).

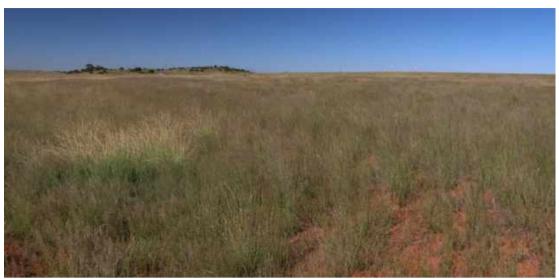
Figure 5: Another panorama of the site illustrating the pioneer grass layer dominating the area.

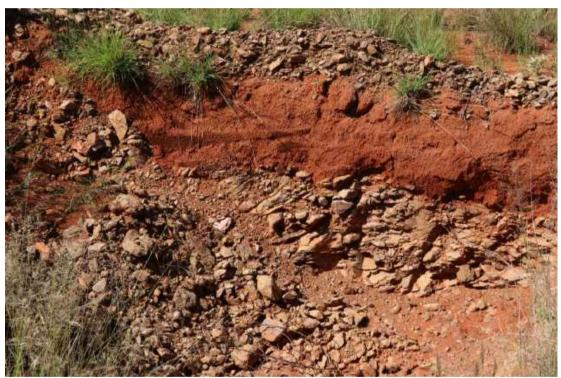
Figure 6: View of the soil profile at the site indicates a shallow topsoil layer, dominated by sandy-loam soils overlying weathered dolerite.
