DRAFT BASIC ASSESSMENT REPORT FOR:

**PROPOSED UPGRADE OF NOSITHA ROAD IN WARD 27 WITHIN RAY NKONYENI LOCAL MUNICIPALITY
(FORMERLY HIBISCUS COAST LOCAL MUNICIPALITY), UGU DISTRICT MUNICIPALITY, KWAZULU NATAL**

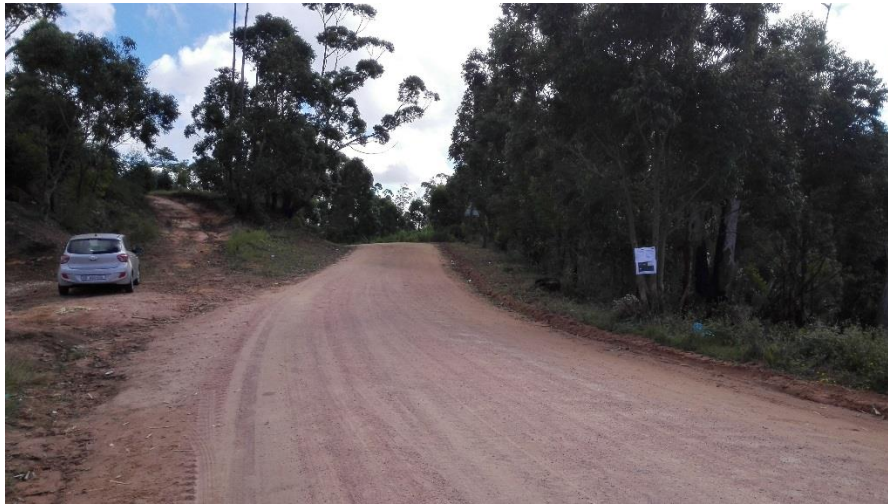
Photograph 1: Shows the existing condition of the start of the Nositha Road.

Stormwater culverts were observed at seven (7) locations along the proposed road alignment which assist in draining surface runoff from the one side of the road to the other where the water is discharged into natural drainage channels. The existing culverts observed on site were found to have 450.0mm diameter concrete drainage pipes which pass under the road into lower lying areas. Some culverts were noted to have formal brickwork housings around their entry and exit points, whereas others have merely been placed beneath the existing roadway. The performance of the culverts appears to have been hindered by blockages through sedimentation. Refer to the **photos 1 to 8** below showing existing conditions of the road.

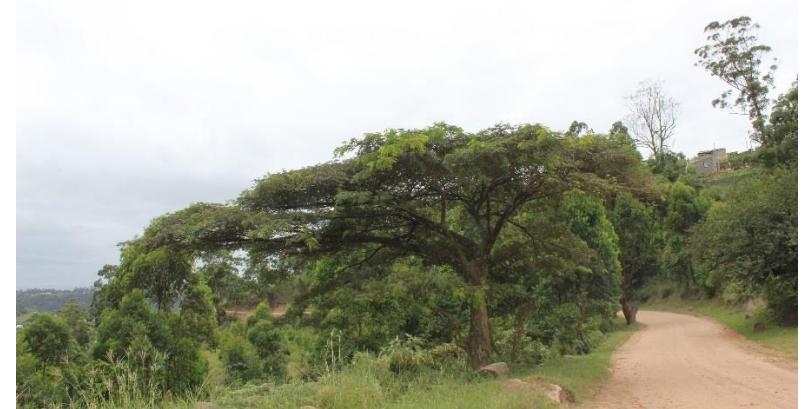
Photograph 2: Shows the existing condition of Nositha Road with dense vegetation along the edges, particularly in the beginning of the road.

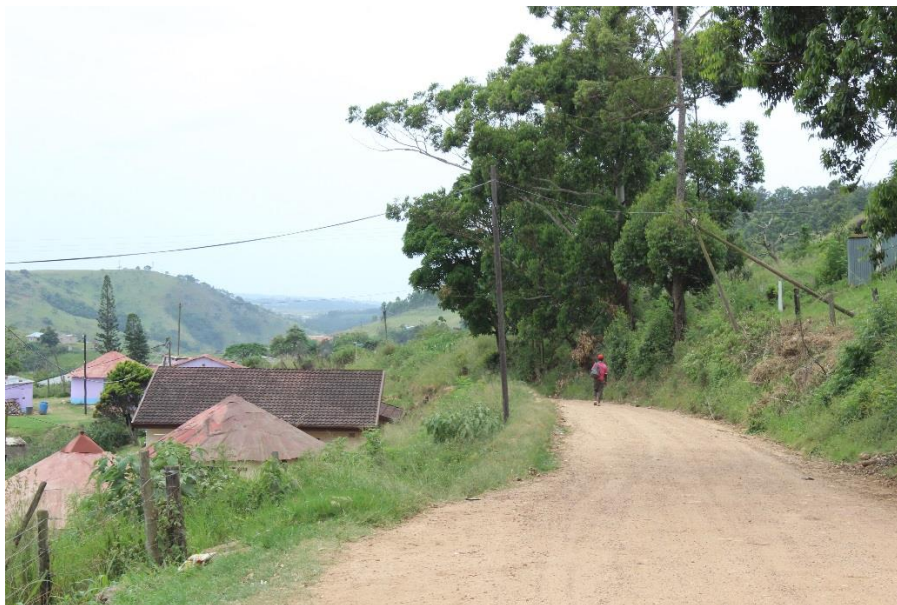
Photograph 3: Shows the existing condition of Nositha Road. Note, no storm water management system has been provided.

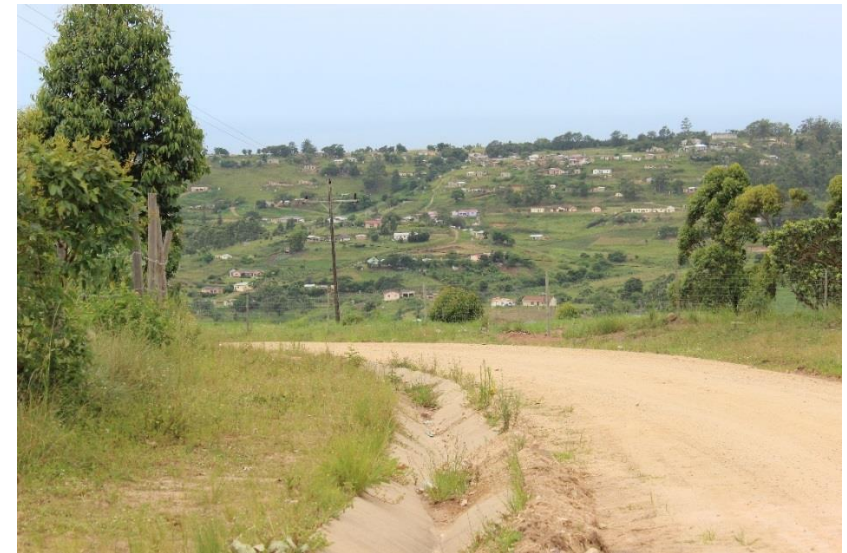
Photograph 4: Shows the existing condition of Nositha Road with storm water drains for 561m along the inner edge.

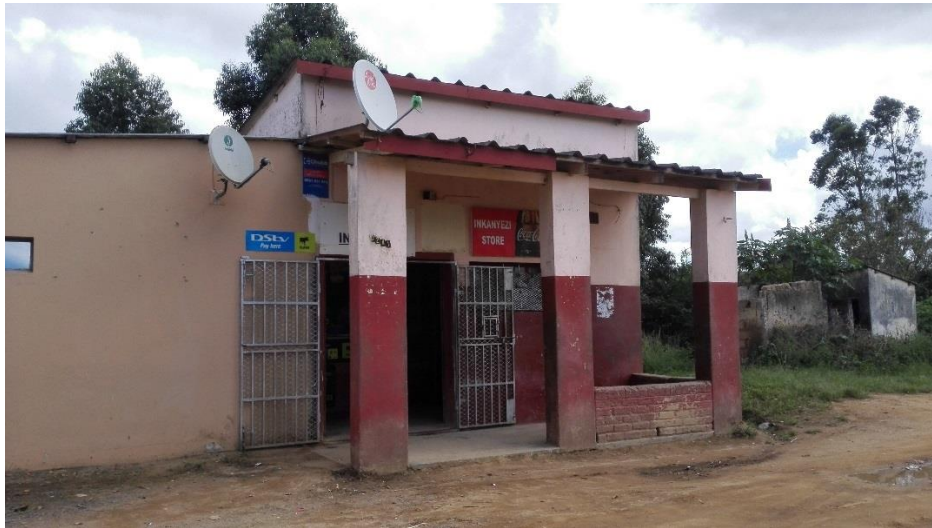
Photograph 5: Shows the close proximity of a “spaza” shop along the road.

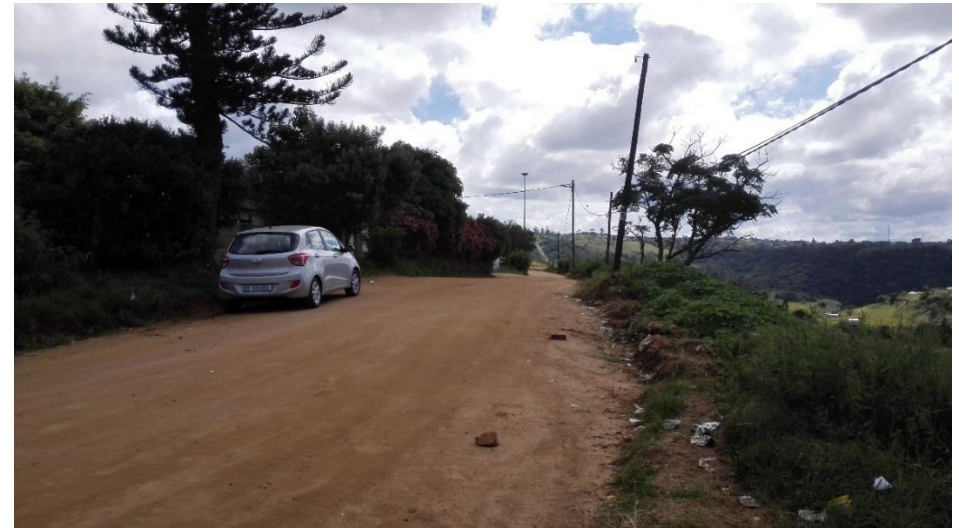
Photograph 6: Shows the existing condition of Nositha Road. Note, alien vegetation lines the road, and Eskom powerlines are in close proximity to the road reserve.

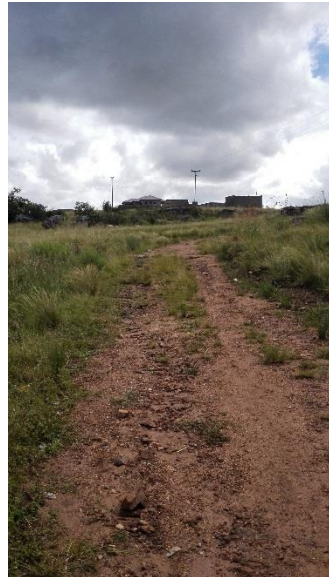
Photograph 7: Shows the erosion at the end of Nositha Road.

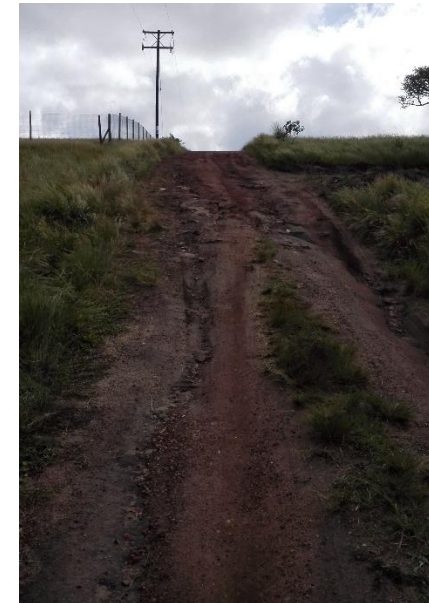
Photograph 8: Shows the erosion at the end of Nositha Road.

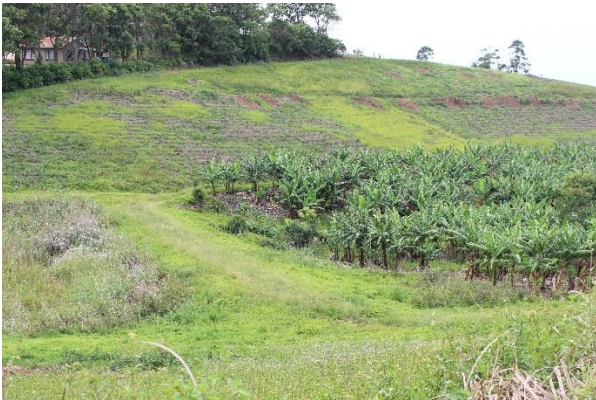
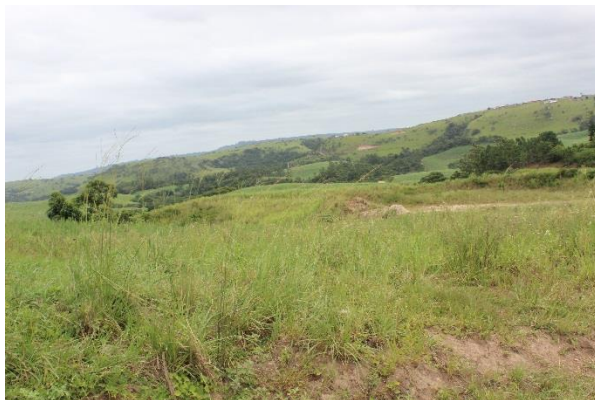
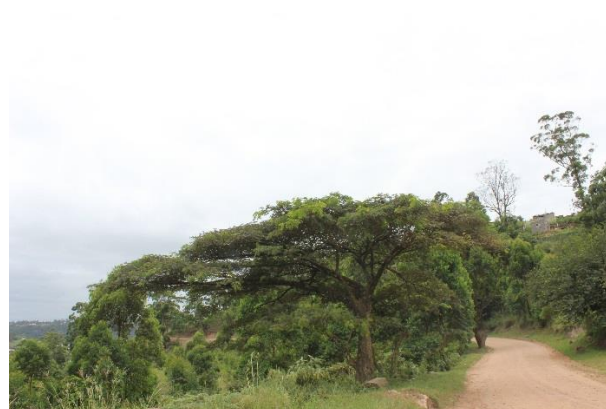
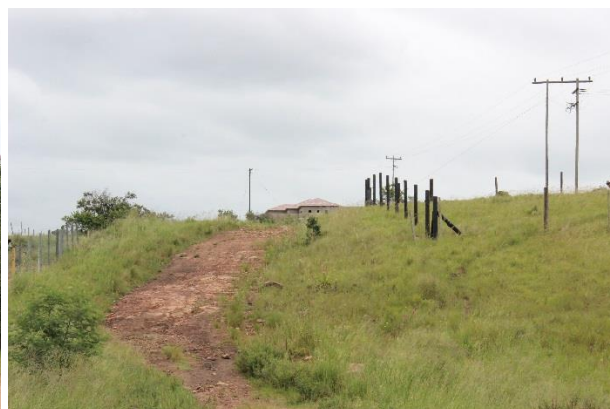
The topography and landforms of the surrounding area comprise of generally steep hilly terrain, side slope of hill or mountain, open valley, undulating plain and low hills, plateau and ridgelines with a number of inter-leading river courses. The general gradient of the site varies approximately 1:5 – 1:2 to steeper than 1:5. Refer to **photographs 1-4** below:

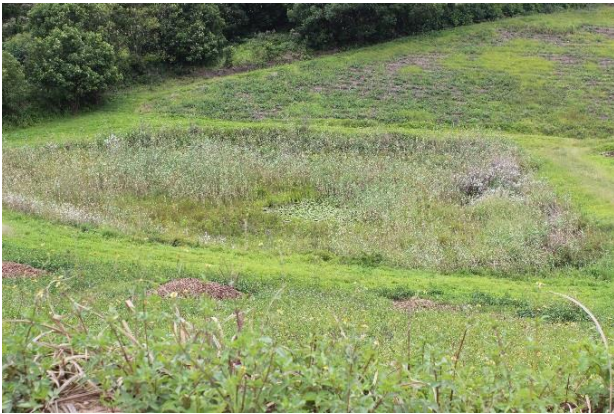
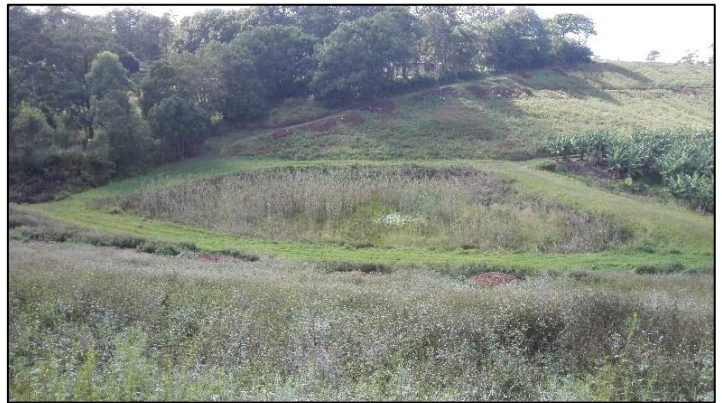
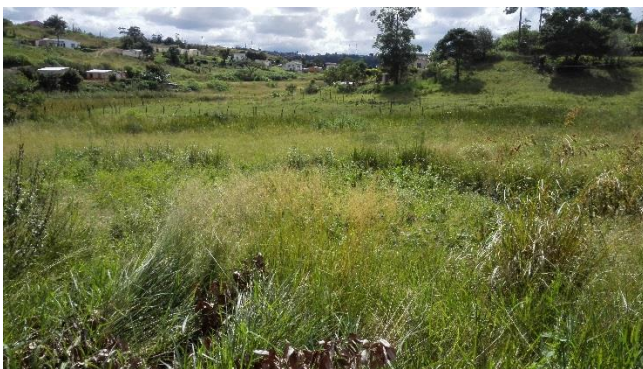
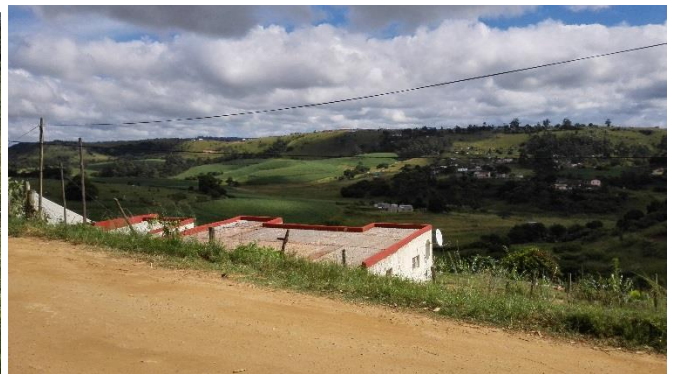
The wetland survey conducted by Earth Water Environmental has identified six (6) HGM units within a 500m buffer of the proposed Nositha road upgrade. Some of the wetlands occur within an 80m buffer from the proposed Nositha road upgrade. Please refer to **photographs 1-4** below and **Figure 6 Wetland Delineation Map within 500m and 80m buffer**. Section 3

findings of the specialist under point 3.5.1 Present Wetland Health of this DBAR provides a detailed information on the general condition of these wetlands. The road will have a direct impact on the water sources (the stream- HGM 5)

There is a potential threat or risk that the road upgrade will pose to the wetlands in the area as a result proposed change from the unpaved road to paved road, resulting in increased hardened surface.
