SECTION 5: DESCRIPTION OF THE ENVIRONMENT

5. DESCRIPTION OF THE ENVIRONMENT

5.1 BIO-PHYSICAL ENVIRONMENT

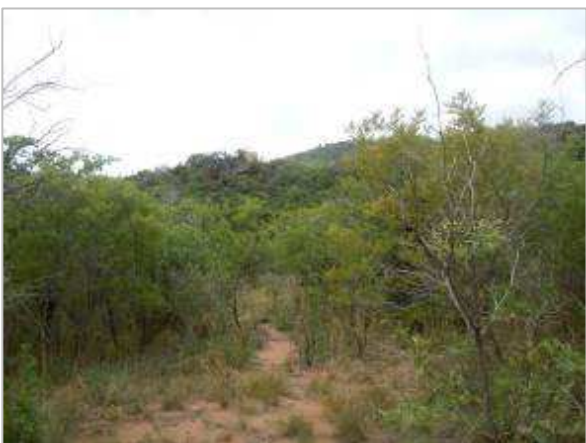
Figure 33: The dense bush at the site proposed for new residential development at A: Training Camp

This area is situated directly east of the Existing Training Camp A, across the spruit at approximately 24° 33' 01"S; 27° 44' 58"E. The area is already developed and the natural vegetation has partly been cleared and altered, for the construction of housing. The site is adjacent to the spruit, though the newly proposed extension are located east of the existing houses, away from the spruit into bushveld. The steep slopes of the mountain are situated directly north of the proposed development. The vegetation is dense bush, about 5-6 m tall, covering 60% and dominated by *Dichrostachys cinerea*.

The species richness of this area is high, with no protected tree species and no red data species present. The area is partly already developed and the dense bush is degraded and encroached by *Dichrostachys cinerea*.

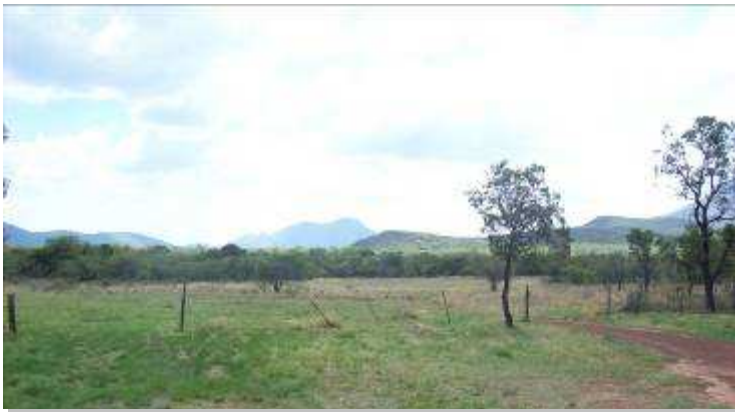
Figure 24: Disturbed vegetation at the proposed new E Camp

This area is situated at approximately 24° 33' 47"S; 27° 46' 24"E, on Groenfontein, at the current cross-roads leading to the D Training Camp. The vegetation is dense bush, similar to that of Site 2, about 5-6 m tall, covering 60-70% and dominated by *Dichrostachys cinerea*. A power / telephone line transects the site, where the vegetation has been cleared. The general impression is that the vegetation is degraded and encroached by *Dichrostachys cinerea*

The species richness of this area is high, with no protected tree species and no red data species present. The dense bush is degraded and encroached by *Dichrostachys cinerea*.

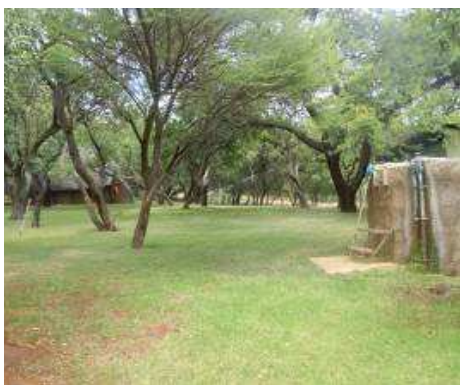
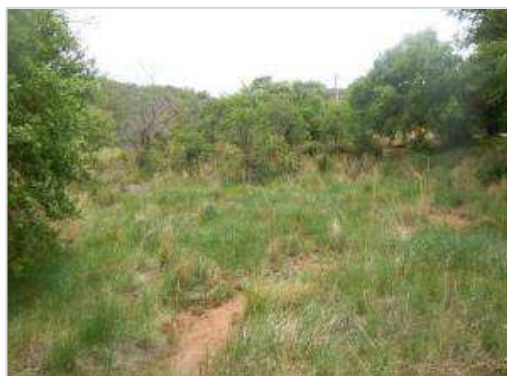
Figure 25 & 26: The existing D Training Camp – developed area& natural area

There is an existing Training Camp (D), situated towards the north on Groenfontein, at approximately 24° 31' 20"S; 27° 43' 43"E. This Camp is located in a small kloof into the mountain. A small spruit drains down the kloof. The area in general would be regarded as sensitive, though the existing facilities are already in use for a long time. Fortunately the existing development covers a very small area. The camp area is for training of senior police officers; the camp terrain is well developed, neat and well kept. The existing buildings have thatched roofs. It is planned to upgrade the existing facilities at D Camp.

The site is located between the tributaries of two small spruits, within the mountains, which causes the site to be ecologically sensitive. The natural vegetation has partly been cleared and altered, for the construction of the existing camp. Within the area of the camp the vegetation has partly been cleared, lawn grass established with mainly large indigenous trees remaining. Some exotic (alien) trees and other garden plants have been planted in the gardens. These are not all recorded for the survey. Little grass and forb species remained due to the maintenance of the gardens.

In spite of the bush clearing and the well kept garden, the species richness of indigenous species is high, particularly for the tree species, but no protected tree species and no red data species were recorded.

The area is already partly developed and the area is well maintained. It is strongly recommended that the new developments must not go closer to the spruits, remaining outside the riparian zone with a buffer zone. It is further suggested to avoid developing on to the mountain hillsides, try to avoid clearing large areas of natural bush. Furthermore, try to keep as many as possible of the large trees, to maintain the bush atmosphere.

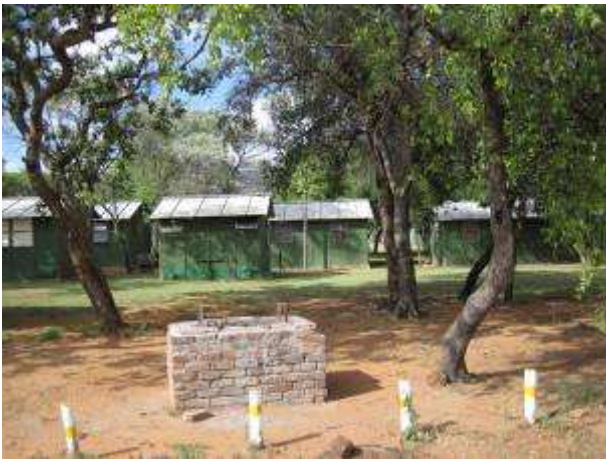
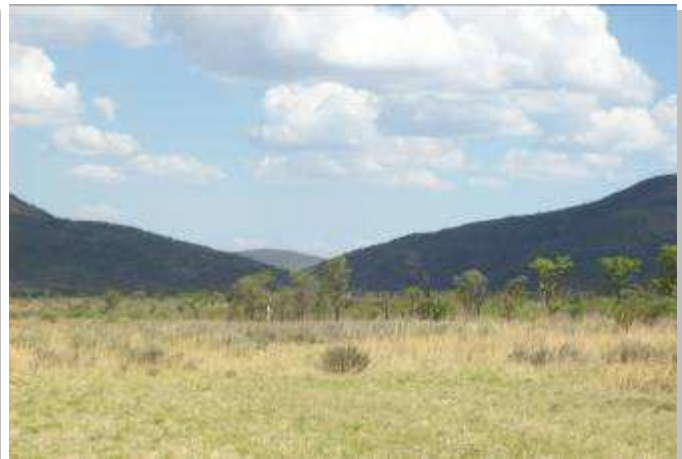
Figure 27 & 28: The existing B Training Camp and surrounding natural bush areas

The area is already developed and the natural vegetation has partly been cleared and altered, for the construction of housing and other facilities. All these facilities are temporary, though some alien plants have been planted in the gardens. The existing camp is surrounded by natural, though somewhat disturbed, bushveld. This camp will be demolished and replaced by a new facility. Currently the facility closest to the Rookpoort dam edge is about 200 m. The new facility will not be closer to the dam than the current facility. The vegetation has partly been cleared for the existing facility, though the new camp will extent into natural bush.

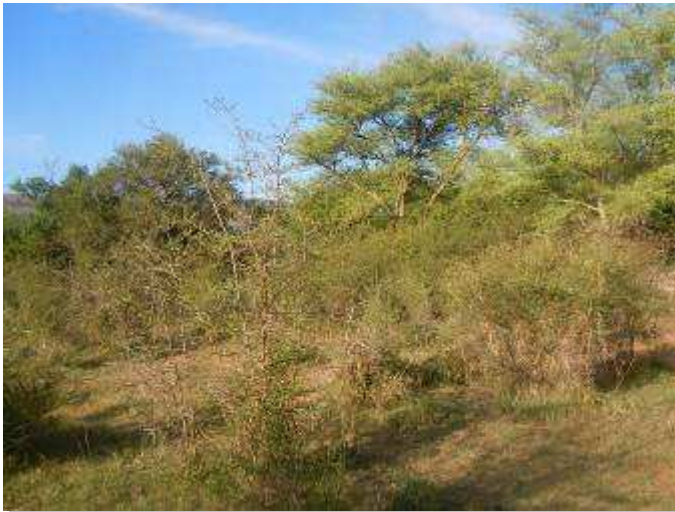
Figure 29 & 30: Vegetation on the foot slope at the site of the proposed new Shooting Range

This area is situated at approximately 24° 34' 59"S; 27° 45' 36"E, on Buffelspoort, at the foot of the north-facing slopes of the mountain. The mountain forms a safe background for the shooting. The vegetation is dense bush, about 3-5 m tall, the taller trees cover about 5% while the denser shrub layer covers about 30%. *Combretum apiculatum* and *Acacia caffra* are prominent trees. The protected trees *Sclerocarya birrea* (marula) and *Philenoptera violacea* (apple-leaf) are present on this site.

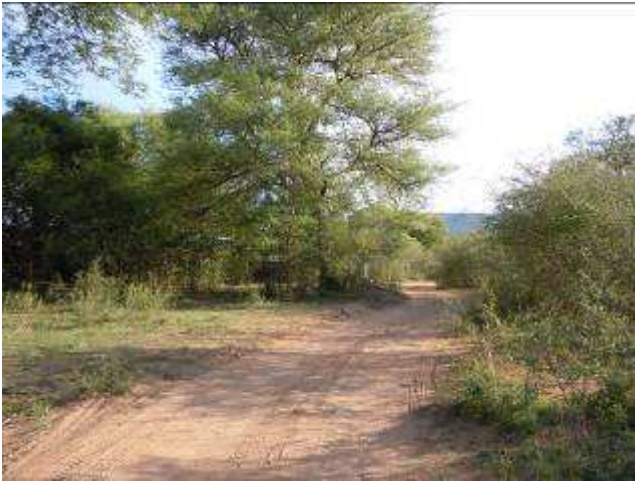
Figure 31: A view of the area proposed for establishment of the New A Training Camp

This new camp is situated on an existing tented camp, south of the Thabazimbi-Alma road, on Buffelskloof, at approximately 24° 33' 48"S; 27° 45' 36"E.. The temporary tented camp was built in an area with clumps of large Tamboti trees and an unique plant species composition. Typical bushveld vegetation surrounds the tall tree clumps. The vegetation has partly been cleared for the existing tented facility, though the new camp is proposed to extend into natural bush.

It is suggested to move the position of the new camp slightly into the surrounding bushveld in order to protect the tall tree bush clumps of Tamboti trees. The development can be supported.

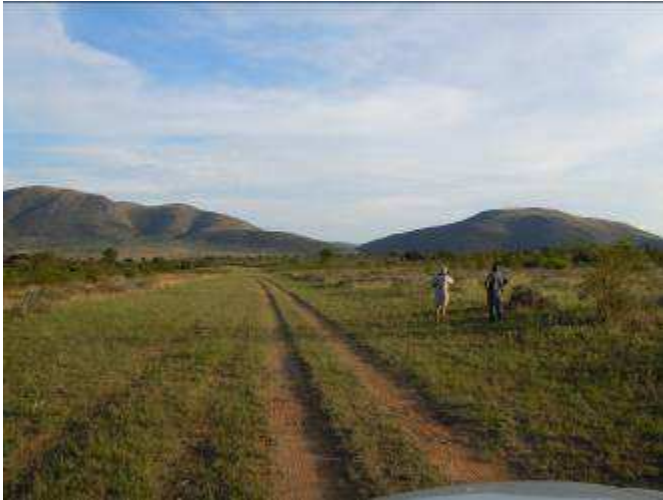
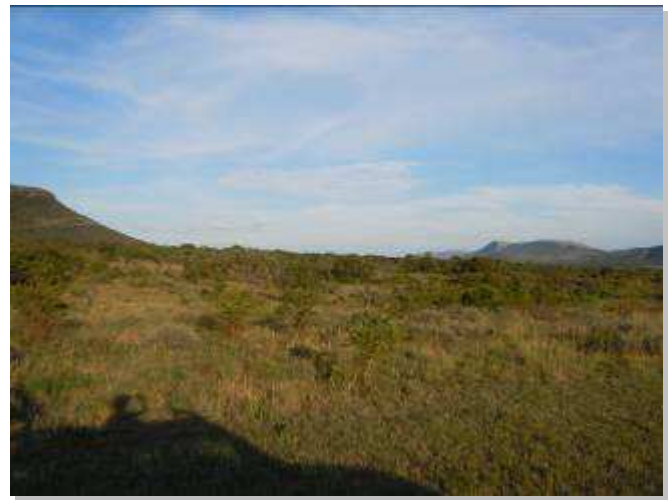
Figure 32 & 33: The area of the existing & newly proposed Landing Strip

The existing landing strip is situated south of the Thabazimbi-Alma road, between the existing C Training Camp and the proposed new A Training Camp, on Buffelskloof, at approximately 24° 33' 20"S; 27° 47' 00"E. This landing strip stretches north-west to south-east. The new proposed extension will stretch north-east to south-west, at a right angle to the existing strip. The proposed administration building is close to the junction of the two landing strips. The natural vegetation is fairly open shrubby bushveld, more suitable for landing aircraft than the surrounding taller bushveld.

The species richness of this area is medium, with no protected tree species and no red data species present. The development can be supported.

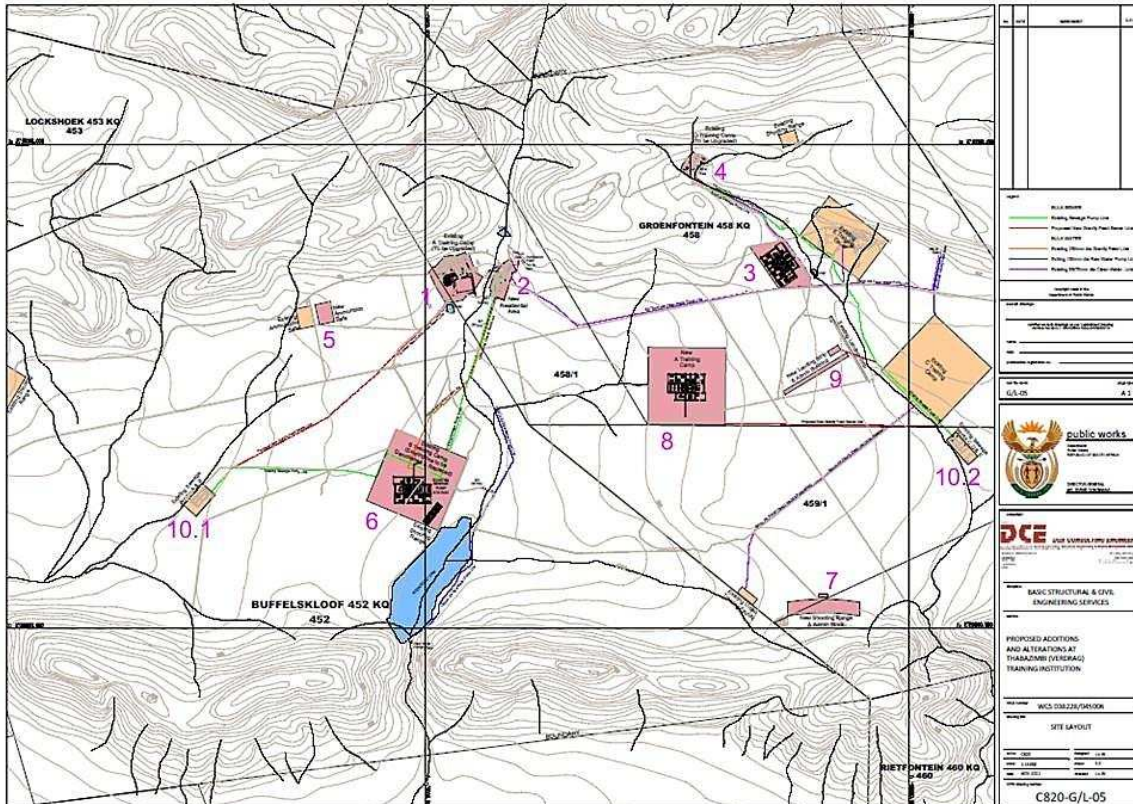
Figure 34: Location of the sites and numerical reference included in the specialist report

1a) Taller and denser woodland, Sites 1, 2, 4, 7. This habitat was found mostly along the base of the hills and especially along the banks of the drainage lines, including up into the valleys and gorges of the mountains. Some of the larger trees included *Acacia*, *Burkea*, *Celtis*, *Euphorbia*, *Faurea*, *Ficus*, *Lannea*, *Peltophorum* and *Zizyphus*. Ground cover is generally shaded and sparse, but taller and coarser on the more exposed rocky slopes. Several species that occur on the rocks and cliffs among the tall trees are actually more dependent on this substrate than on the wooded cover. Some open marshy patches with tall dense grasses and sedges occurred alongside the seasonal drainage lines and seeps, with open grassy areas under or between the trees retained on the development sites, but sometimes encroached by *Dicrostachys* shrubs (Photos 1-3).

1b) Sites 5, 6, 10.1.1, 10.1.2. Smaller, more densely-packed trees with coarse grass cover wherever sunlight penetrates in less dense area, mainly on degraded patches in the western half of the valley. Obvious tree species include *Burkea*, *Combretum*, *Dombeya*, *Terminalia* and *Searsia*, with various shrubs including *Grewia* and, especially in previously disturbed areas, *Terminalia sericea* and/or *Dicrostachys cinerea* encroachment. Most openings are formed by eroded sheet washes alongside drainage lines, except for old fields or gravel pits near the D926 gravel road

1c) Sites 3, 8, 9, 10.2. Generally smaller trees with more open areas, some of this apparently due to shallower, more-gravelly soils (as revealed by bare areas at washes and/or erosion areas), but also due to past effects of unsuitable veld management and transformation on the farm Buffelspoort 459 KQ. Some stands of larger trees along watercourses, notably *Spirostachys*, but the rest mostly *Acacia*, *Dombeya*, *Euclea*, *Lannea*, *Mundulea* and *Searsia* species, with *Dicrostachys cinerea* shrubs encroaching in degraded areas and small

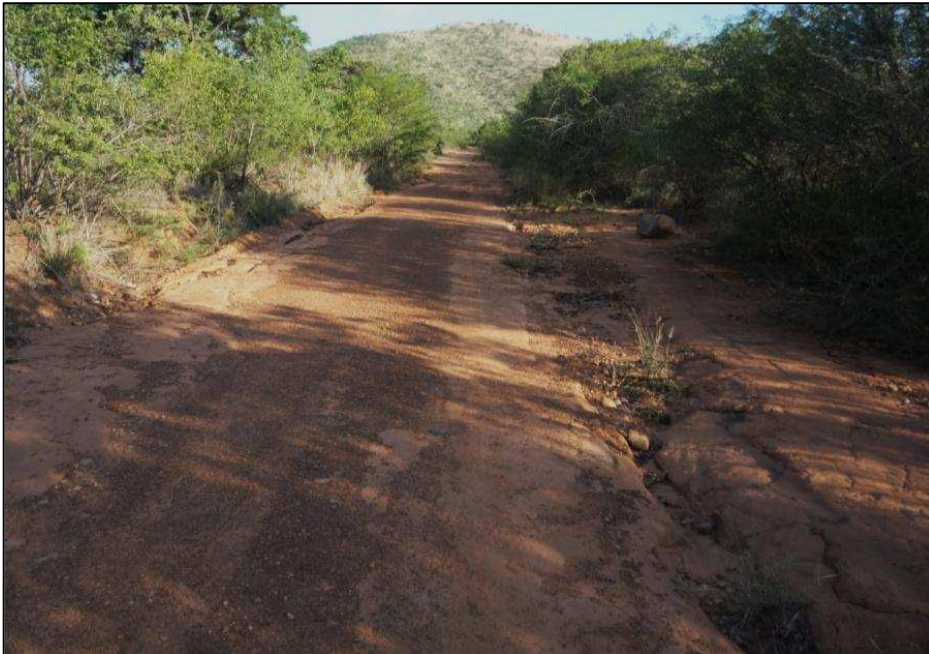
Figure 35: View south along the road leading to Site 7, just past the urban training facility, showing the eroded road from lack of drainage to reduce velocity of rainwater runoff, even though the road has been surfaced

3) Sites 11 and others. This is not really a separate or important avian habitat, but is one of the site-categories requested for assessment. Degraded bare and eroded areas are included with the roads as all are prone to the same problems of erosion and management requirements

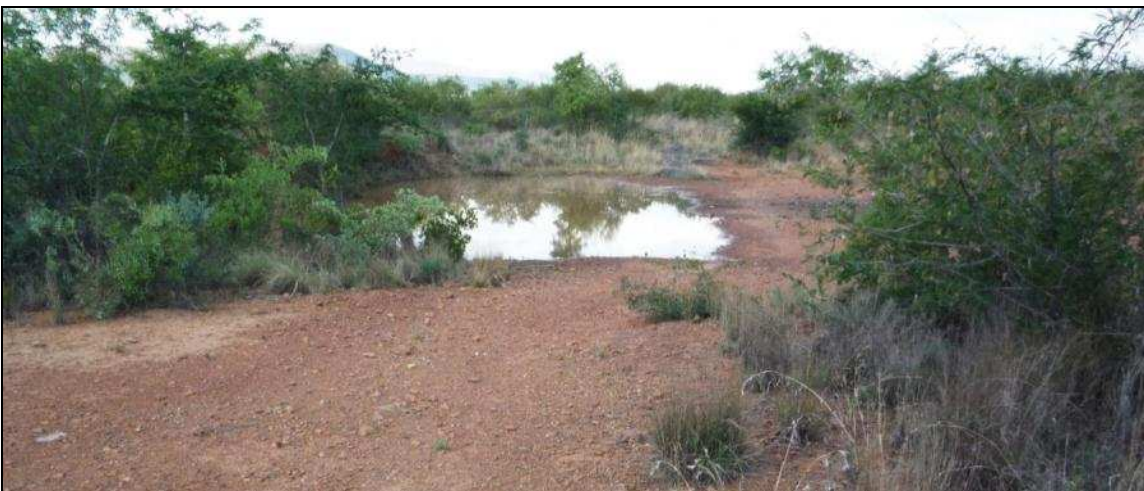
Figure 36: Gravel borrow pit near the urban training facility, showing the bare surface exposed to erosion, but the positive

benefit of the water that has gathered as a temporary source for wild animals is also relevant, and may be enhanced by adding a clay lining during rehabilitation.

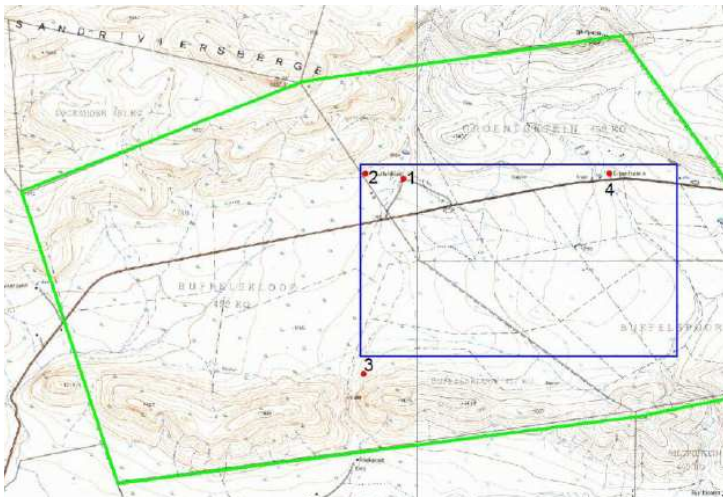
Figure 42: Study area showing location of identified sites

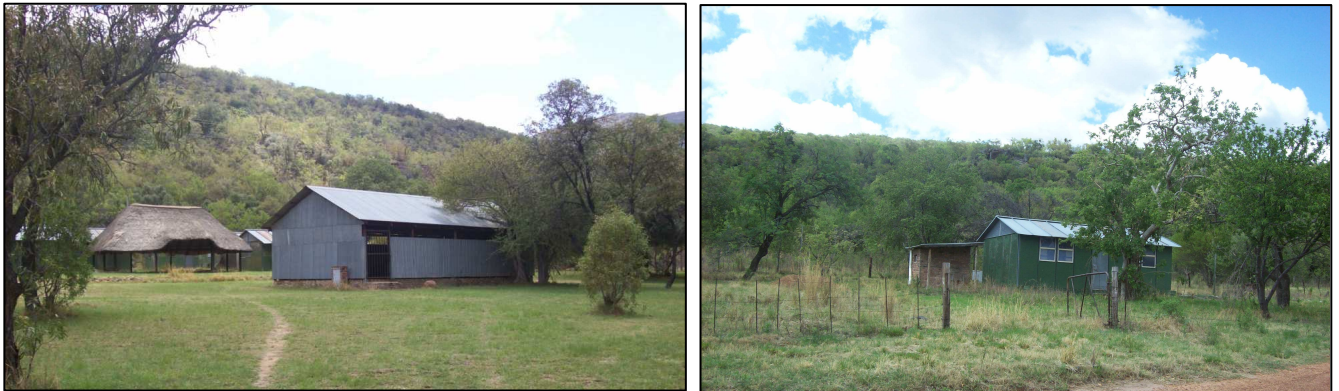
Figure 47: Structures are small and little vegetation is removed at Camps which provides screening capacity

It is important to establish whether the proposed development is compatible with surrounding land uses and activities and ultimately the landscape character. Farming activities and low key eco tourism land uses are mainly functioning in the immediate surrounding area. The site characteristics provide the required setting for the training. The location of the subject property in a remote rural area with very limited development makes it ideal for the purposes of the SAPS Training Institute, which requires a secluded and private setting. The nature of the training facilities for the SAPS furthermore requires that the respective camps on the site must be situated well apart and in dense vegetation, in order to prevent visual contact between the camp areas. This is also the aim in terms of visibility from surrounding properties. It is evident from the existing development little vegetation is removed at Camp areas as it provides the privacy required.

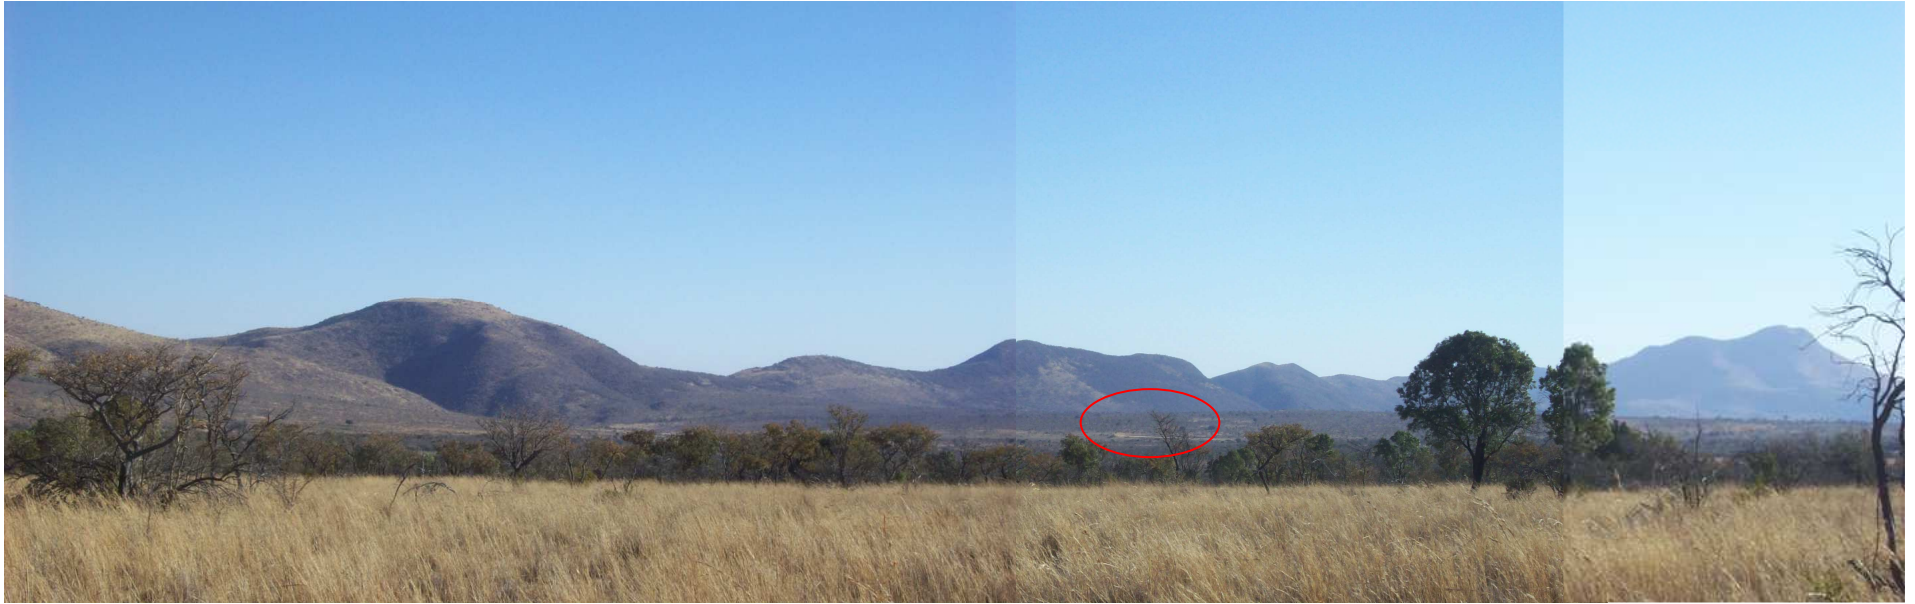
Figure 49: A view toward the existing shooting range from the point indicate in Figure 48

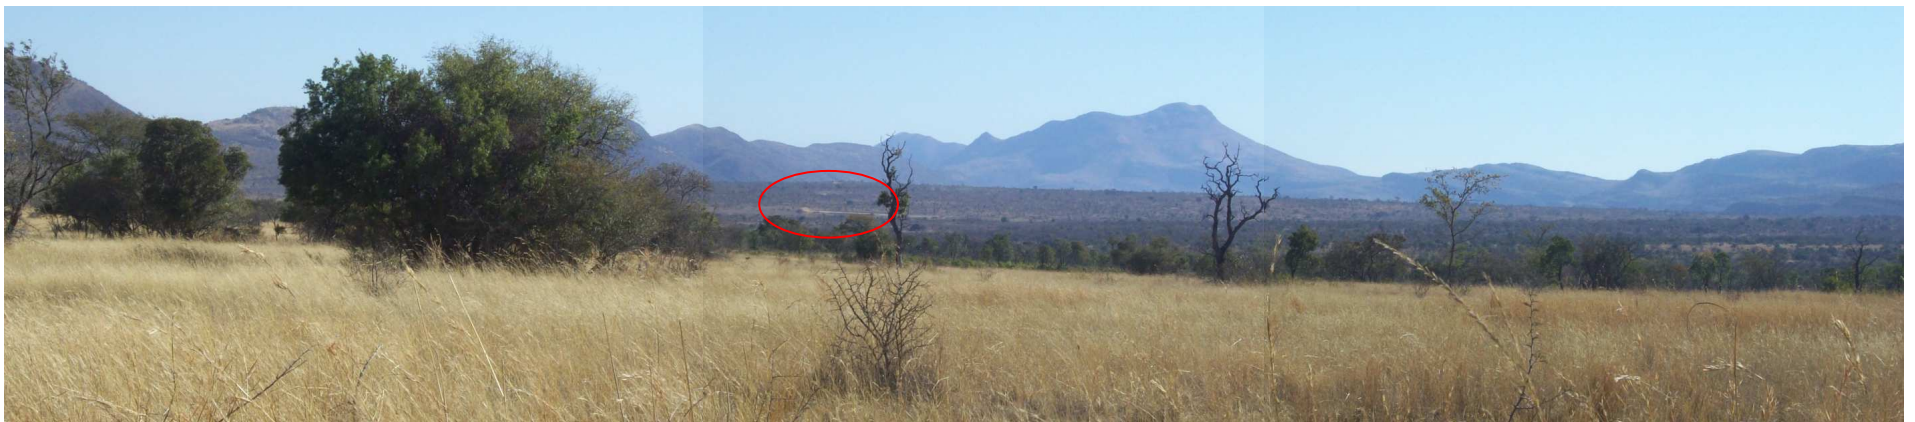
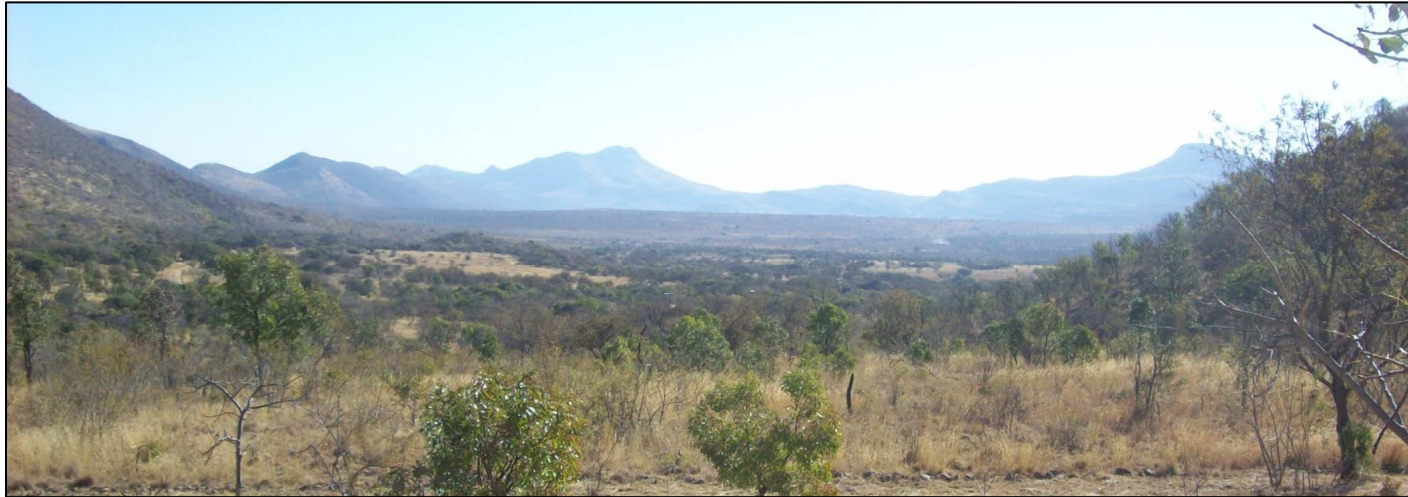
Figures 50 & 51: These photos were taken from higher ground within the Reserve looking toward the eastern boundary of the application property toward the shooting range [encircled]. Note the rise in topography further eastward from where it slopes eastward. The landscape is characterised by a diversity of colour in vegetation which adds to screening capability of a site

Due to the nature of the proposed land use and the type of buildings to be erected including the screening capacity of the property in terms of vegetation and topography it is anticipated that visibility of structures during the day will be minimal. However dust from vehicles travelling along dirt roads within the application property will be visible. It is therefore recommended that the road nearest the eastern boundary of the application property not be utilised for any training activity. The purpose of the road should be purely for management and maintenance of the property. Construction vehicles should not be permitted to use the roads near the boundary. Furthermore it is evident from the photos that due to the clearance of vegetation for the shooting range the exposed soil makes the area visible. Through limiting the area of surface disturbance during the construction phase, the extent and significance of the visual impact can be notably reduced. Measures for mitigation during the construction phase have been included in the EMPr.
