SABIE GORGE NR 4 CC

DRAFT ENVIRONMENTAL IMPACT REPORT FOR THE PROPOSED TOWNSHIP ESTABLISHMENT AND ASSOCIATED INFRASTRUCTURE ON PORTION 2 OF THE FARM COOYONG 1100-LS, HAENERTSBURG, LIMPOPO PROVINCE

REF: 16/1/7/1p-M2

SEPTEMBER 2012

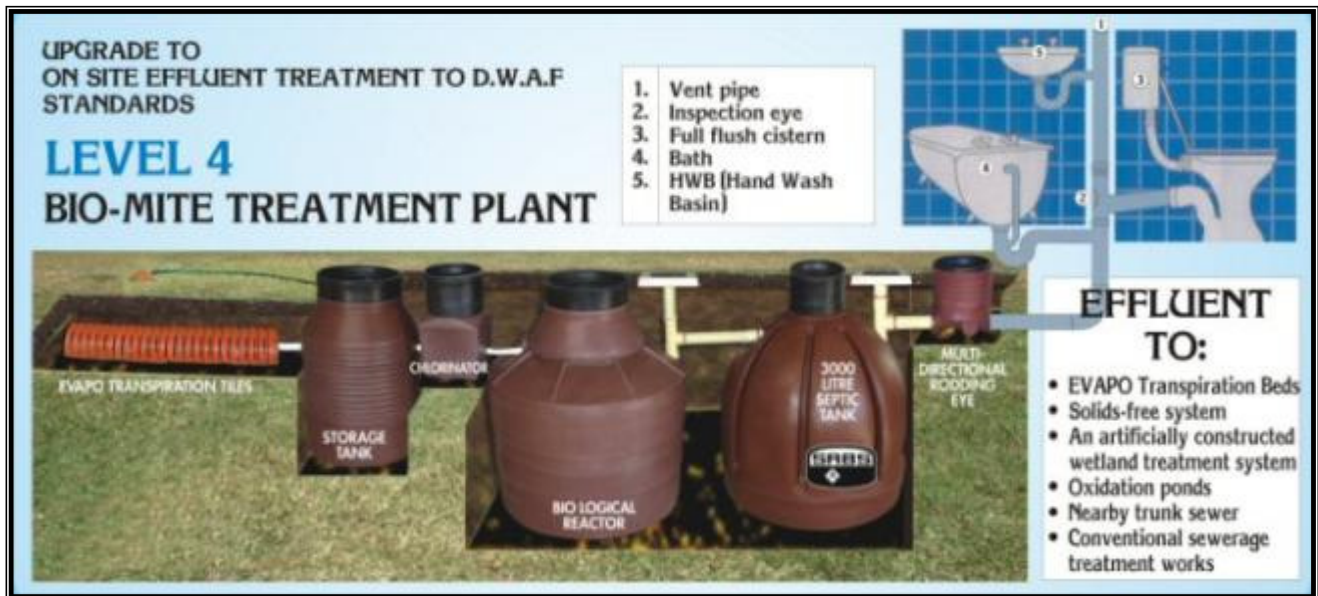
Figure 2.5: Calcamite System at Single Housing Unit (Level 4)

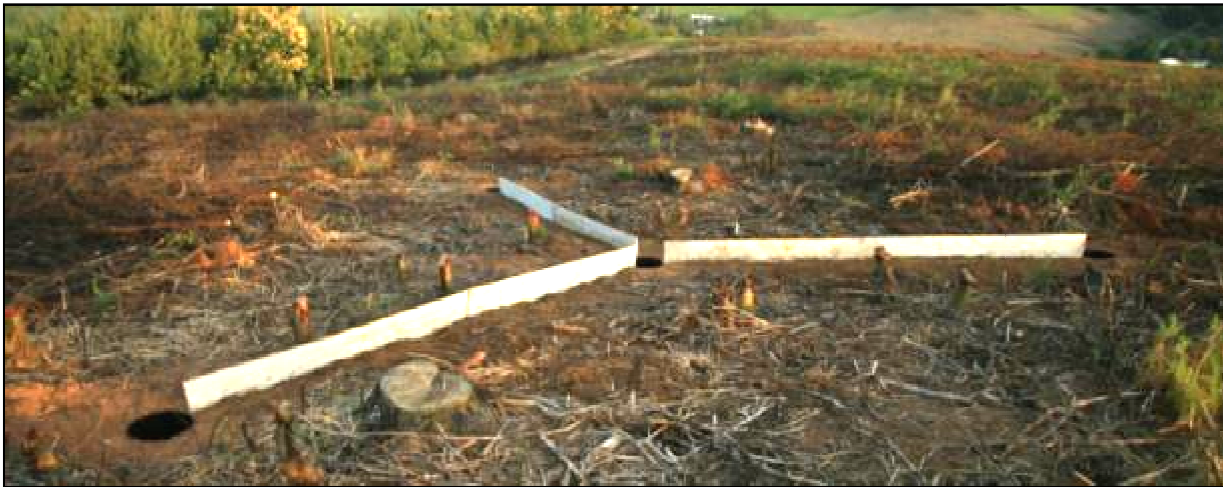
Figure 5.11: View of array A1 (drift fences and pitfall traps), facing SE.

in height. These dimensions are adequate for the primary target species, *B. sylvestris*, as well as toads and various smaller frog species but not for larger, more agile species such as *Amietia angolensis*.

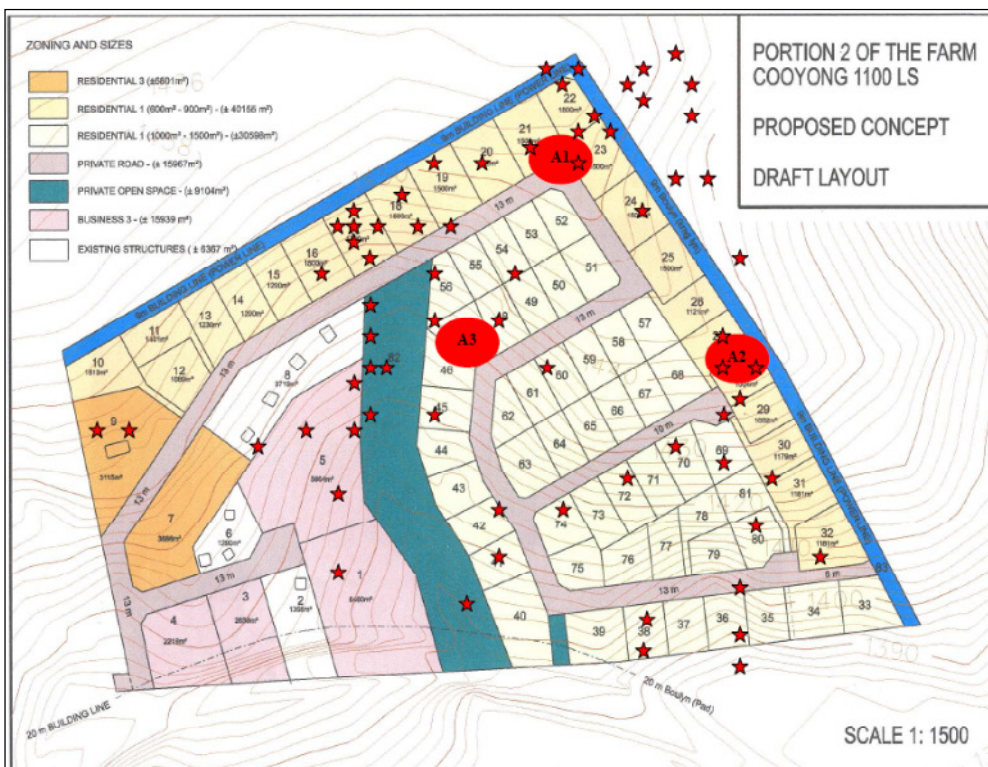
Figure 5.17: Plan of the proposed development showing the positions of the pitfall trap arrays and calling male *Breviceps sylvestris* located during this survey (***please note that the layout has since changed***).

Figure 8. Plan of the proposed Cooyong Portion 2 development showing the positions of the pitfall trap arrays **A1-3** and calling male *Breviceps sylvestris* ★ located during this survey.
