**SHONGWENI**  
Report 2 of 2012

# RAPID ASSESSMENT OF THE VEGETATION ASSOCIATED WITH A PROPOSED 500 MM BULK WATER LINE

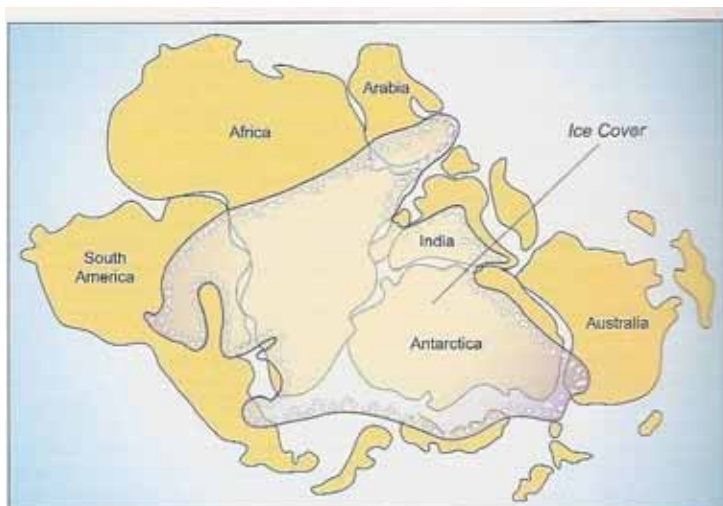
**Figure 1** The extent of the ice cover over Gondwana during the Great Ice Age

Around 400 million years ago, a glacial event in the Great Ice Age that lasted 50 million years, got underway. Across Gondwana, which then sprawled over the southern polar region, vast ice sheets ground over India, nearly all Africa south of the Equator, south eastern South America, Antarctica and Southern Australia, leaving as evidence a thick layer of glacial sediments, known in South Africa as Dwyka Tillite, as they melted?

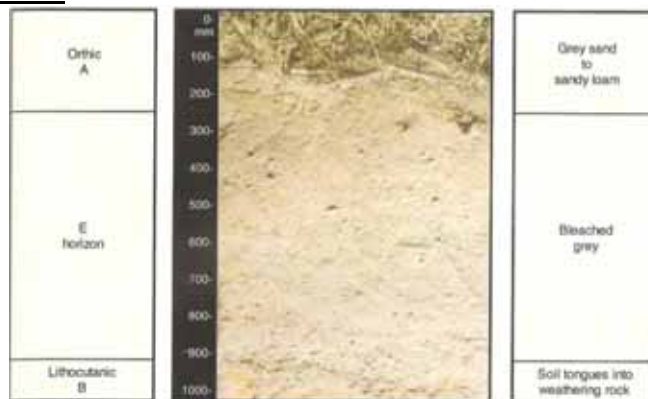
**3.1.1 Cartref Soil Form**

This soil is derived from Natal Group Sandstone and/or Dwyka Tillite. Both types occur on the Estate. These soils have a high erosion hazard, moderate to poor drainage, medium infiltration rate and, an available soil water content of 80 to 140mm m<sup>-1</sup>. Their make-up is as presented in the diagram above.

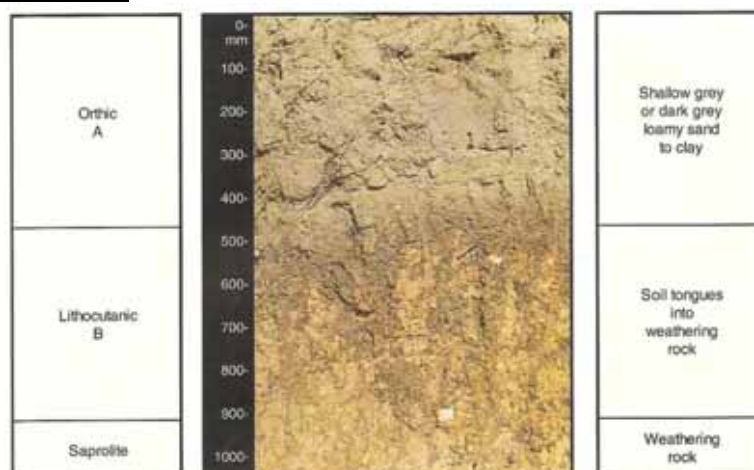
### 3.1.2 Glenrosa Soil Form

These soils are derived from numerous parent materials all occurring in this region, namely Natal Group Sandstone, Granite and Dwyka Tillite. They have a high to moderate erosion hazard, good to moderate drainage, good to medium infiltration rate and an available soil water content of 80 to 140mm m<sup>-1</sup>. Their make-up is as presented in the diagram above.

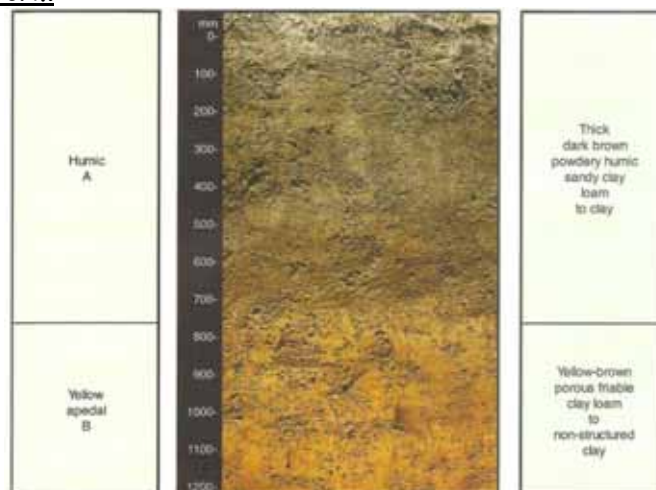
### 3.1.4 Magwa Soil Form

These soils are derived from Natal Group Sandstone. They have a low erosion hazard, good drainage, good infiltration rate and an available water content of 140 to 180 mm m<sup>-1</sup>. Their make-up is as presented in the diagram above.

As with any good farming practice it is advisable to ensure good soil conservation structures are in place albeit that these soils have good physical properties and do not erode easily. They do exhibit aluminium toxicity and need lime and/or gypsum to correct this toxicity and deficiencies of calcium and magnesium. They are normally low in potassium and zinc and moderate in phosphorus.

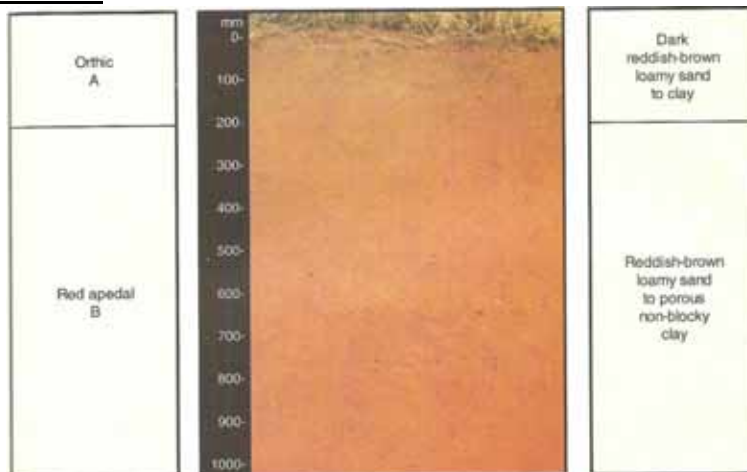
### 3.1.5 Hutton Soil Form

These soils are derived from Natal Group Sandstone and Dolerite. They have a low to very low erosion hazard, good drainage, good infiltration rate and an available soil water content of more than 180 mm m<sup>-1</sup>. Their make-up is as presented in the diagram above.

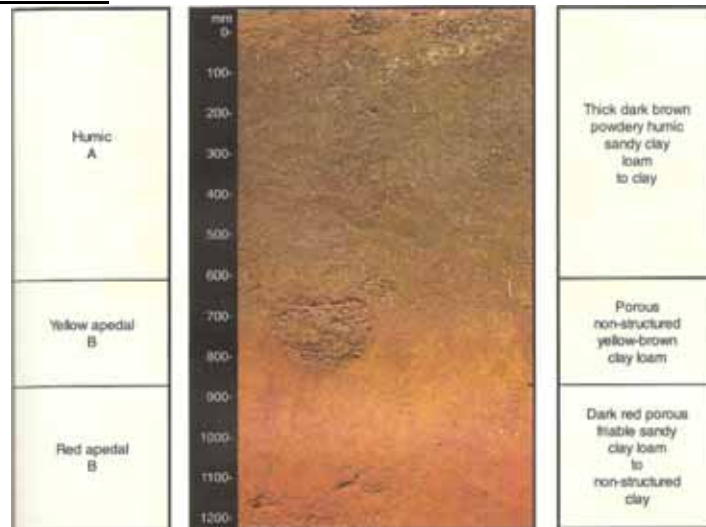
### 3.1.8 Kranskop Soil Form

These soils are derived from Natal Group Sandstone, Dwyka Tillite and Dolerite. They have low erosion hazard, good drainage, good infiltration rate and an available water content of 140 to 180 mm m<sup>-1</sup>. Their make-up is as presented in the diagram above.

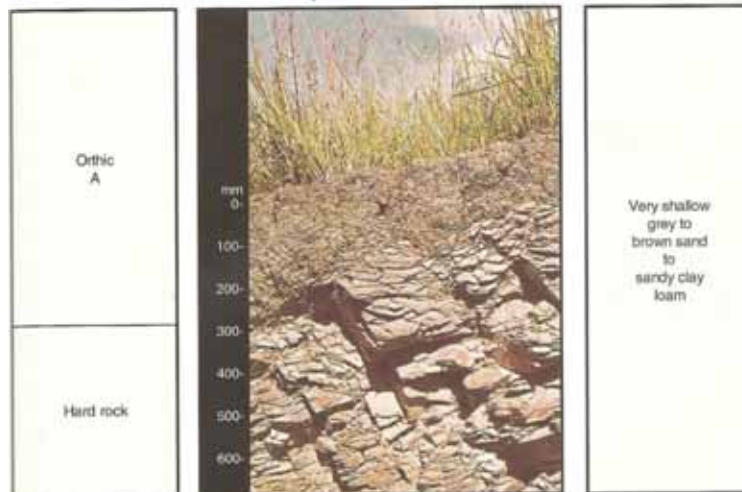
### 3.1.9 Mispah Soil Form

These soils are derived from Cave Sandstone and Vryheid Sediments. They have a moderate to high erosion hazard, moderate drainage, medium infiltration rate and an available soil water content of < 80mm m<sup>-1</sup>. Their make-up is as presented in the diagram above.

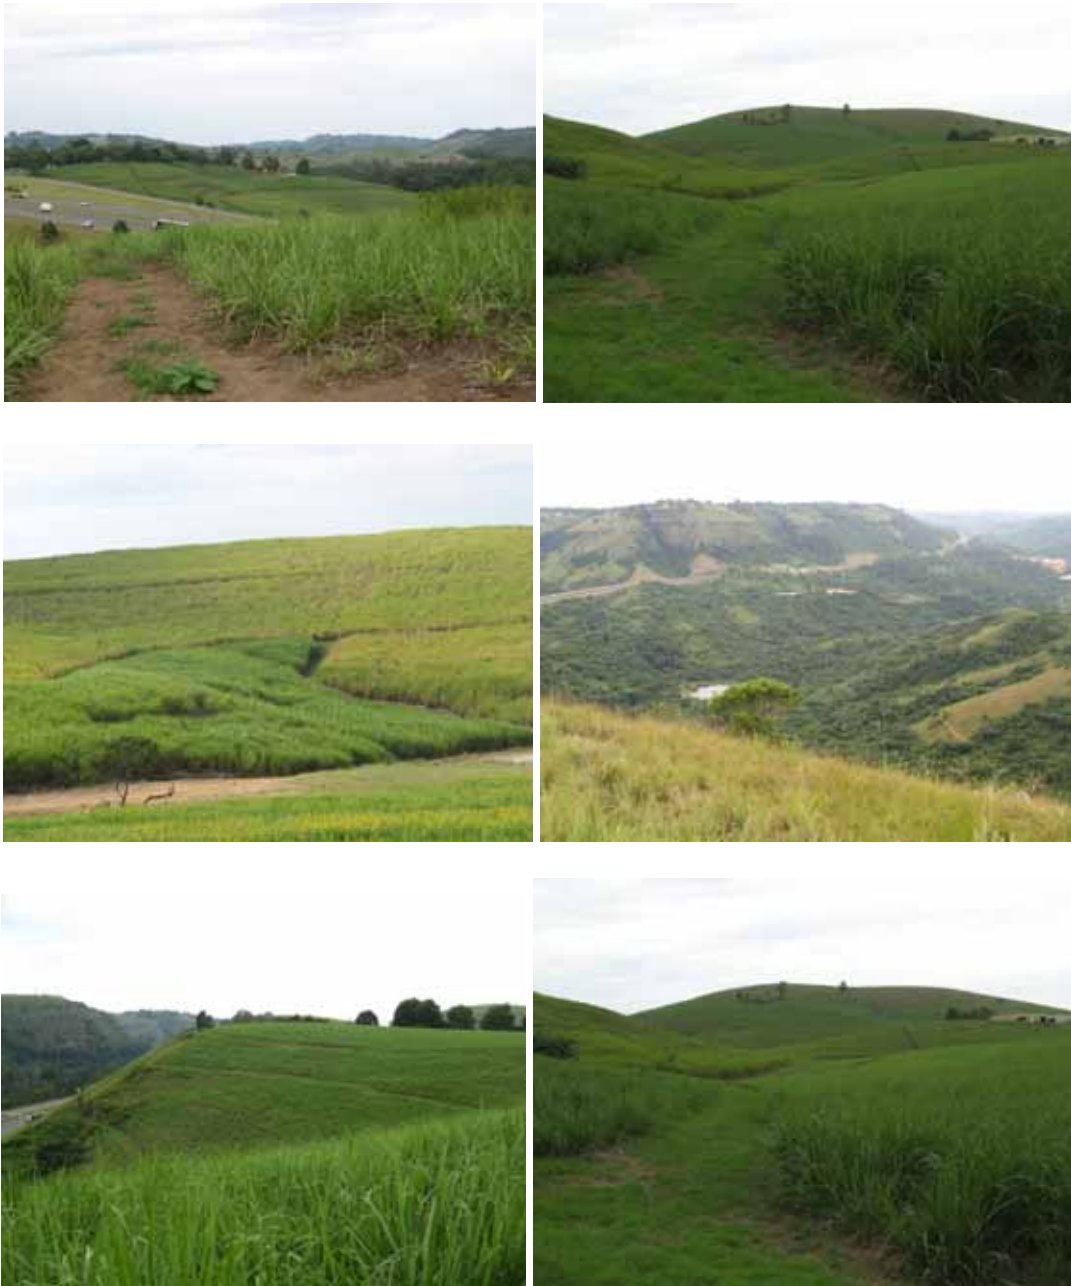
**Photograph 4 Varying Terrain on the Shongweni Estate**

The Estate comprises of flat, gentle and steep slopes as can be seen in Map 2 above and Photograph 4 below.

Drainage lines on the Estate run in a various directions, being predominantly south and south-east. There is a need for contours on these fields and minimum tillage practices are carried out when possible.

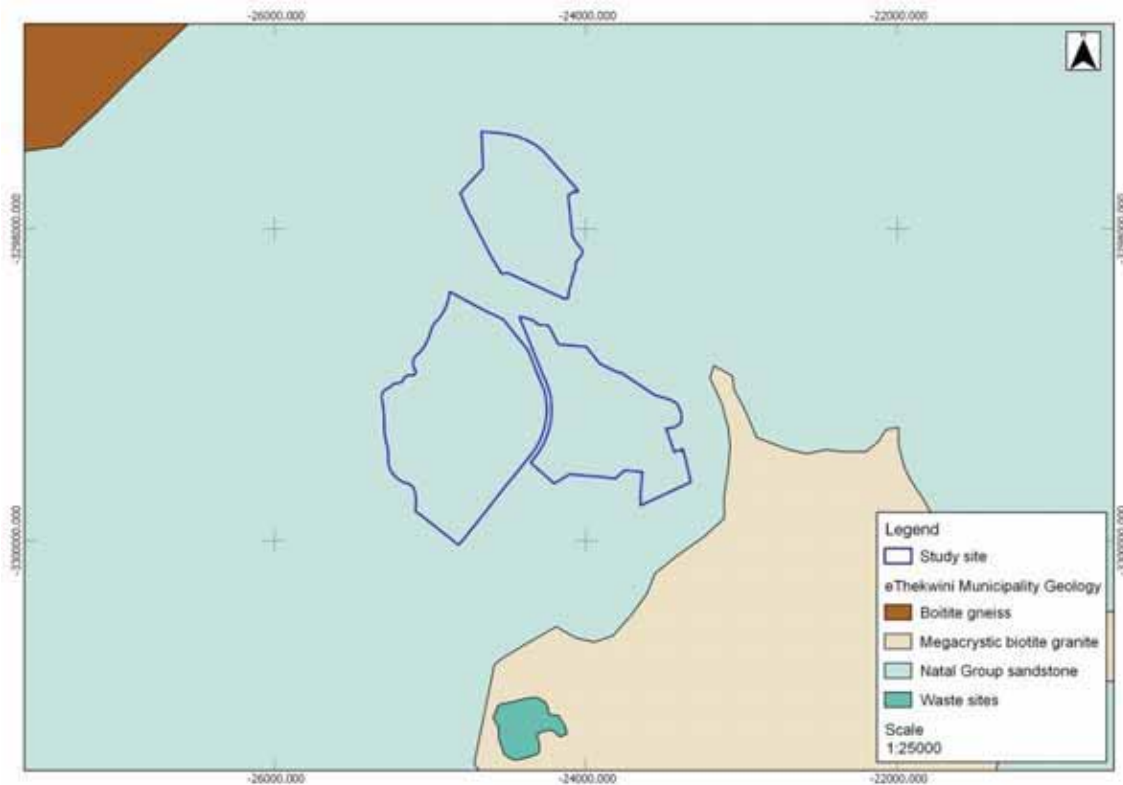
**Figure 2-1 The geology of the study site**  
(eThekweni Municipality, n.d.)

Mucina and Rutherford (2006) describe the geology for the greater region to be underlain by Ordovician Natal Group sandstone, which is dominated by shallow, nutrient-poor sandy soils (Mucina & Rutherford, 2006). The geology of the study site as classified by eThekweni Municipality’s geological spatial coverage is shown in **Figure 2-1**. It is evident that the Natal Group sandstone dominates the study site.

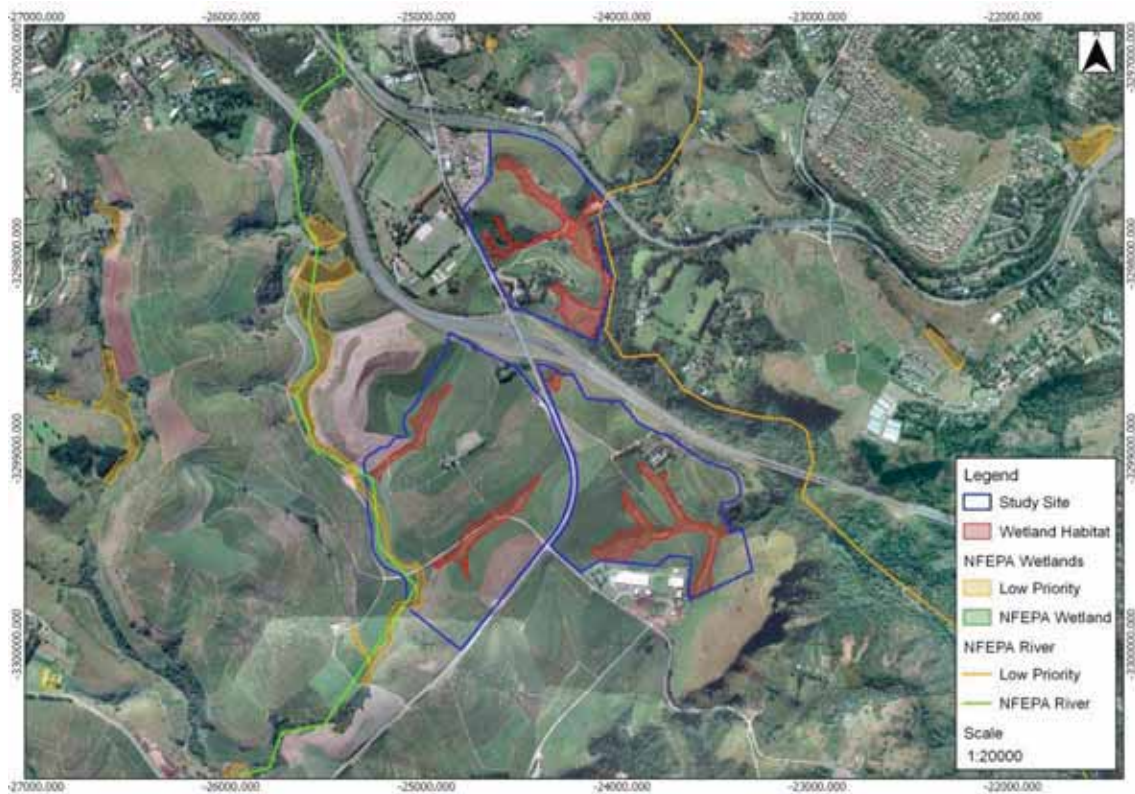
Figure 2-2 View of NFEPA systems and their classification

According to the available NFEPA wetlands coverage, none of the wetland HGM units onsite were classified as NFEPA wetlands, most likely due to their altered nature. However; the HGM unit within Site 2 drains into a NFEPA river, the Wekeweke Stream (**Figure 2-2**). The condition of this system is considered to be ‘AB’, and therefore should be maintained at this

level. The natural vegetation recorded within portions of the river system is most likely the reason for this classification. To provide more detailed information on the Wekeweke Stream, a riparian assessment has been undertaken on the system (GroundTruth, 2013) assessing the present ecological state of the system and the ecological importance and sensitivity. The results of the assessment informed the recommendations relating to the potential development of Site 2 and its associated buffers, stormwater management and site specific rehabilitation.

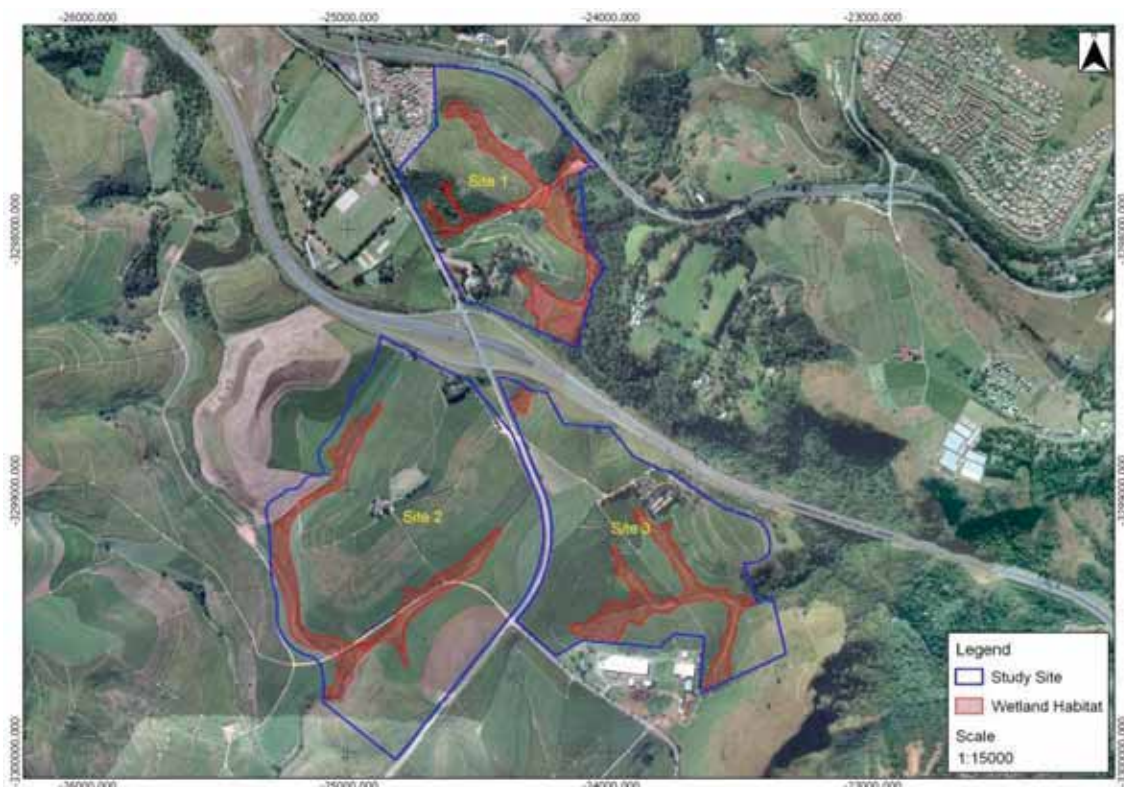
**Figure 6-1 View of the study sites and the wetland habitat identified by LRI**

The freshwater ecosystems associated with the study area, comprise unchannelled valley-bottom wetlands. The wetlands within Sites 1 and 3 drain into the uMhlatuzana River, whilst Site 2 drains into the Wekeweke Stream (**Figure 6-1**).

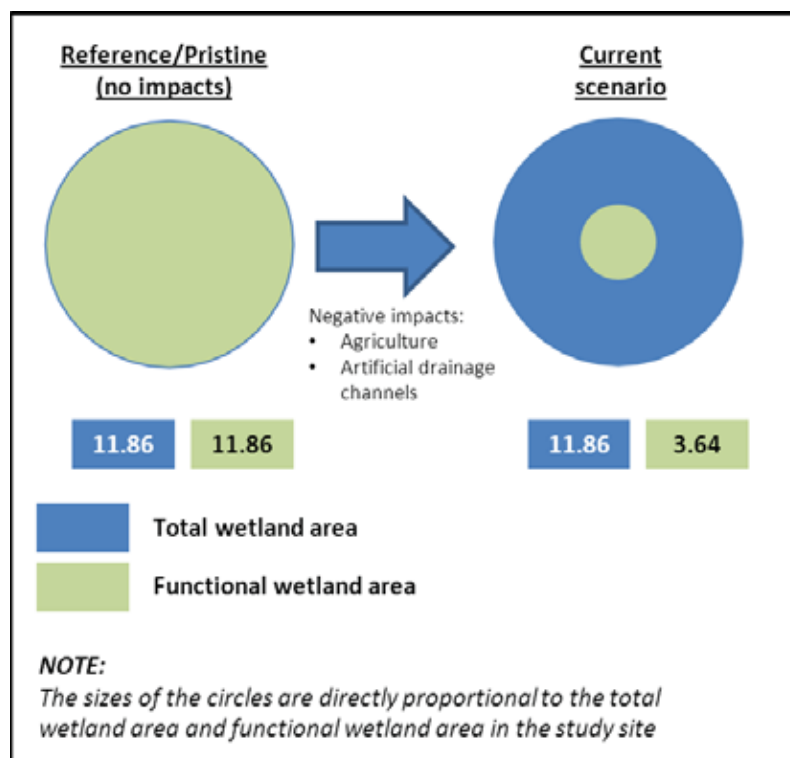
**Figure 6-3** A graphic representation of the wetland habitat within Site 1, in terms of both spatial extent and functional area, comparing the reference conditions to the current scenario.

Site 1			
	Hydrology	Geomorphology	Vegetation
Area weighted impact scores	7.5	3.4	9.6
PES Categories	E	C	F
Overall Impact Score	6.93		
Overall PES Category	E		
Hectares of Wetland	11.86		
Hectare Equivalents	3.64

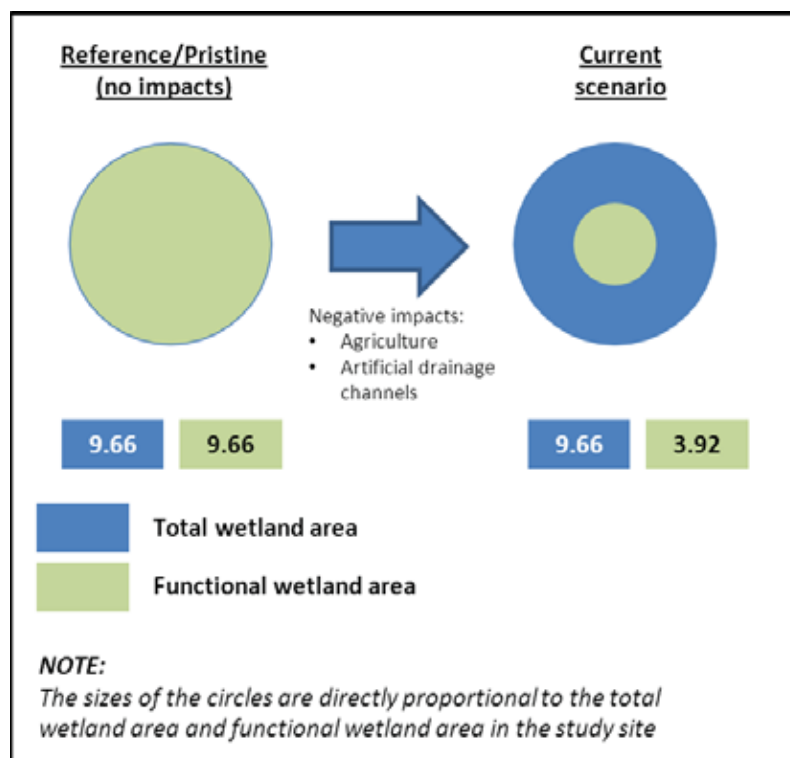
Figure 6-5 A graphic representation of the wetland habitat within Site 3, in terms of both spatial extent and functional area, comparing the reference conditions to current scenario.

Site 3			
	Hydrology	Geomorphology	Vegetation
Area weighted impact scores	6.4	2.2	9.0
PES Categories	E	C	F
Overall Impact Score	5.94		
Overall PES Category	D		
Hectares of Wetland	9.67		
Hectare Equivalents	3.92

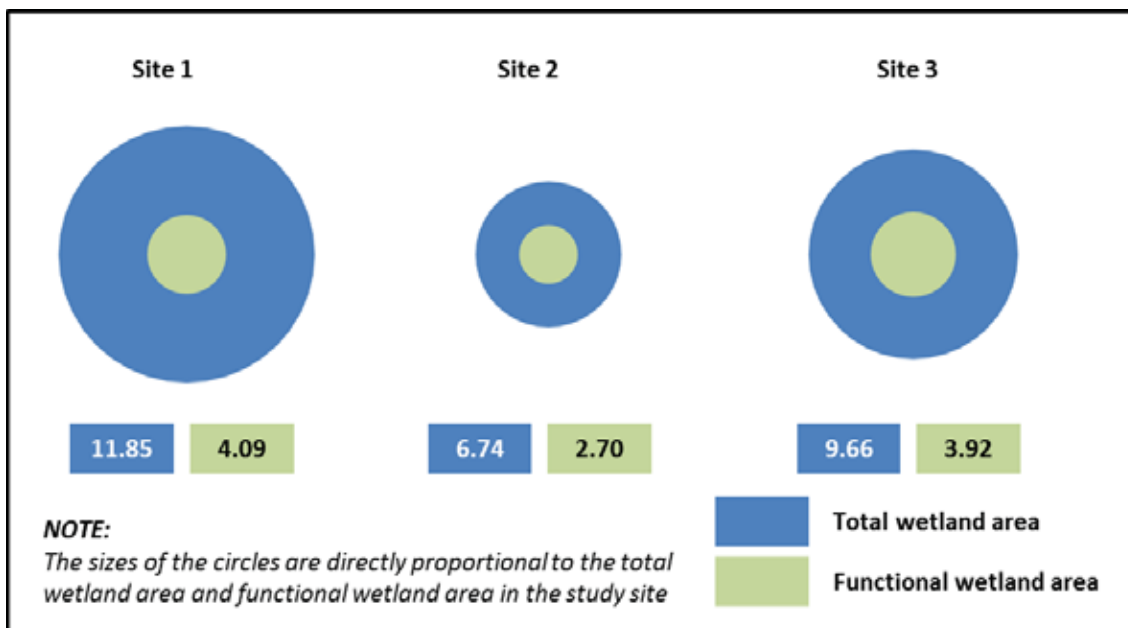
**Figure 7-2 A graphic representation of the wetland habitats per site, in terms of both spatial extent and functional area for the current scenario**

Site 1	Site 2	Site 3
Actual wetland area (ha)	11.85	6.74	9.66
Functional area (ha)	3.64	2.70	3.92
Functional area (%)	31%	40%	41%

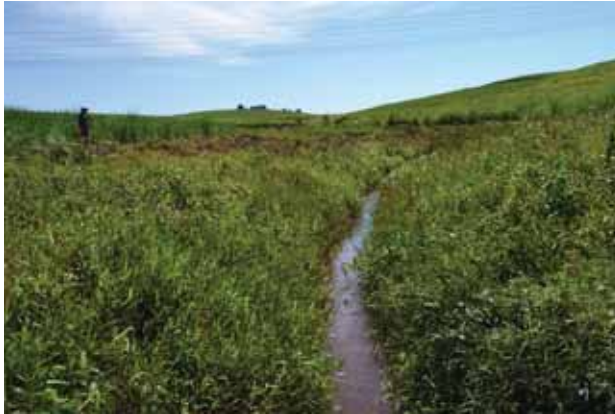
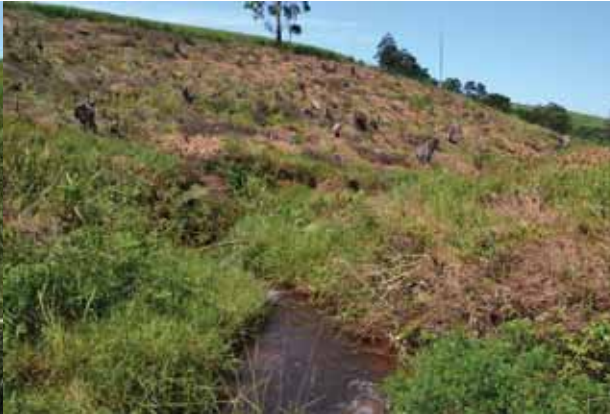
**Table 3-1: Description of the riparian vegetation along the Wekeweke River, downstream of the proposed Shongweni Regional Retail/Commercial Development Site**

<b>River:</b>	<b>Wekeweke</b>		
<b>Latitude:</b>	29.820249°S	<b>Date:</b>	6 March 2013
<b>Longitude:</b>	30.738160°E	<b>Time:</b>	12:00
	<b>Upstream</b>		<b>Downstream</b>

<b>VEGRAI Ecological Condition</b>		<b>Moderately modified</b>
<b>Reference:</b>	<p>The marginal zone would have been a grass-dominated system with a high proportion of sedges and reeds with the occasional presence of Tree Ferns.</p> <p>The non-marginal zone would have been characterised by a variety of herbaceous plant species. There would have been a significant contribution of lateral flow from a natural catchment maintaining the high proportion of herbaceous species and exclusion of woody components.</p>		
<b>Drivers:</b>	<ul style="list-style-type: none"> <li>• Alien plant infestation</li> <li>• Removal of vegetation</li> <li>• Road crossing</li> <li>• Sugarcane cultivation</li> <li>• Dumping</li> </ul>		
<b>Present:</b>	<p>The marginal zone is characterised by a dominance of herbaceous plant species with dense cover of <i>Ischaemum fasciculatum</i>. A relatively deep channel incision defines the upstream edge of the marginal zone resulting in reduced cover in parts. Localised removal of vegetation along the marginal</p>

zone and river channel incision due to construction of a road crossing.

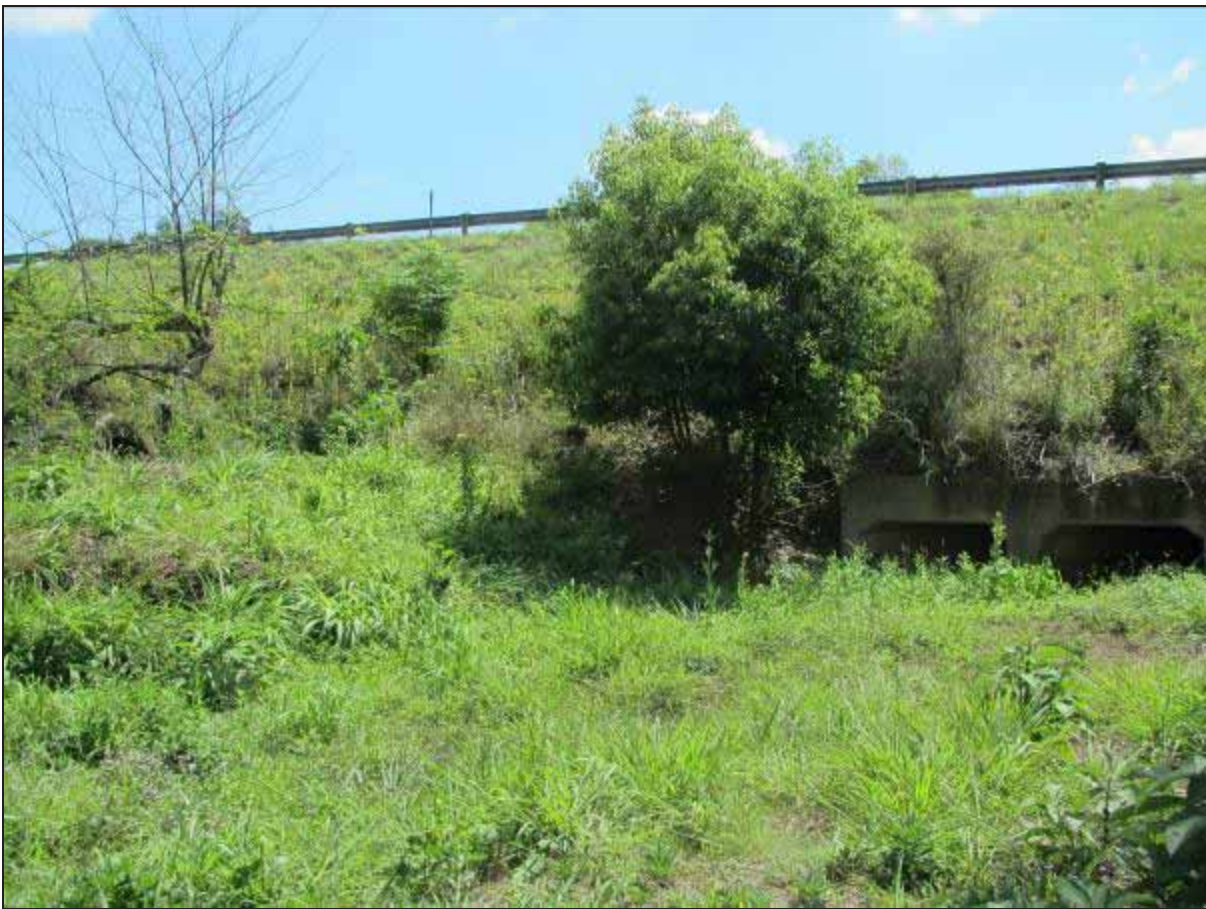
Plate 3. Culvert under N3, silted up and infested with alien invasive species and pioneer indigenous species.

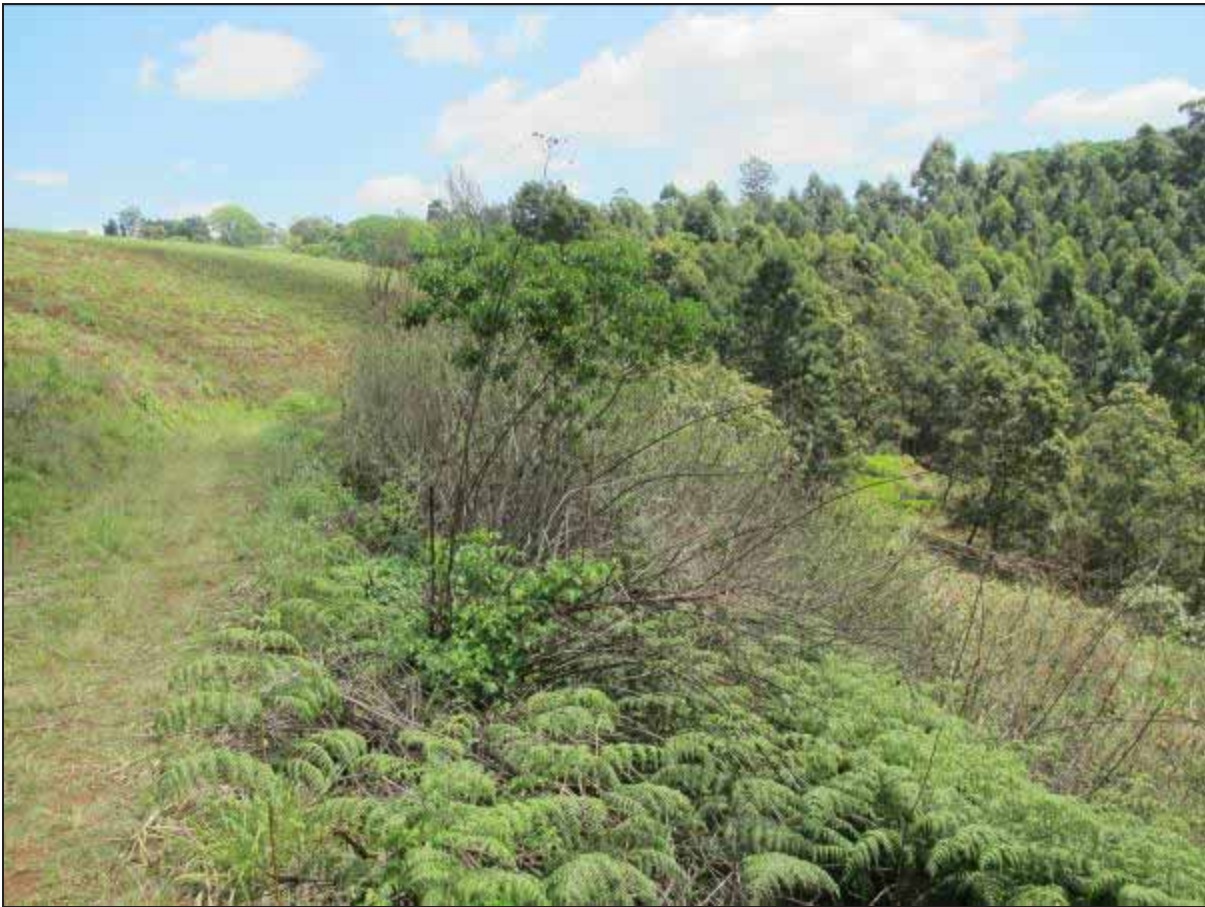
Plate 9. Area to the left of road is where we would recommend that the pipe line is aligned. Foreground is remnant Sandstone Sourveld infested with aliens, note the *Pteridium aquilinum*.

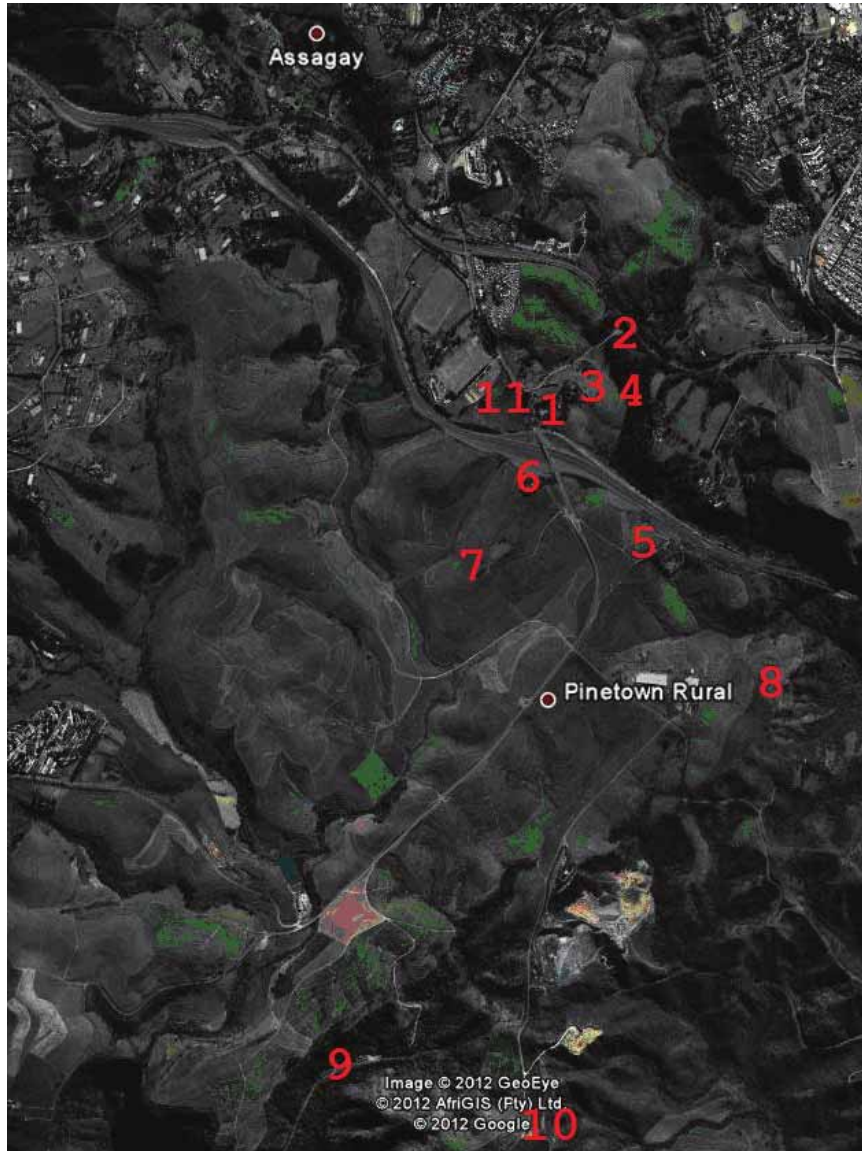
**Fig 1: Sites identified for discussion**

- 1: Waterfall Farmhouse- currently Tongaat Hulett Headquarters**
- 2: Site of ruin by Umhlatuzana River**
- 3: Estate Management House 1**
- 4: 2 Labour Cottages**
- 5: Full time labour cottages**
- 6: Estate Management House 2**
- 7: Seasonal Labour compound**
- 8: Fire Lookout tower**
- 9: Delville Wood Station**
- 10: Signal Tower**
- 11: Estate Management House 3**

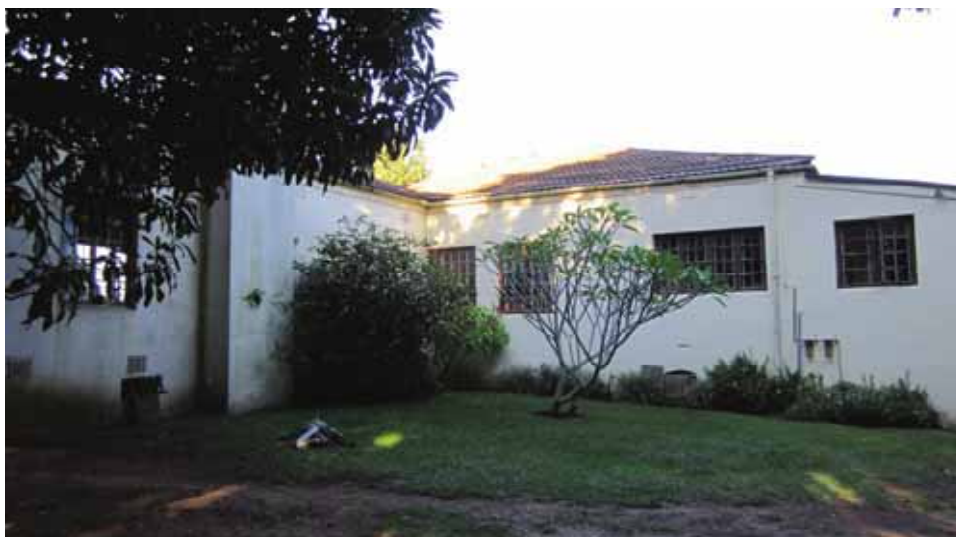
**Fig 5: Entrance aspect to Waterfall Farmhouse**

From the driveway the entrance is nondescript, possibly given the realignment of the Hillcrest Shongweni Road, removing the approach from the old road directly to the house. One is greeted with plastered walls containing meranti cottage pane windows.

*Even though the house has lost much of its architectural appeal, there is little left in the Hillcrest area which fully represents buildings of this period. There is thus an opportunity for reuse of the farmhouse. This would be better served removing the accretions, namely the enclosed portico to the south west, the extended veranda and the addition to the south, in order to arrive at a more compact, architecturally pleasing structure. More research needs to be carried out on the house in this regard. Furthermore, given the topophilic quality of the garden, it is recommended that this be retained in any new development. It is recommended that the outbuildings associated directly with the farmhouse be demolished should this route be pursued.*

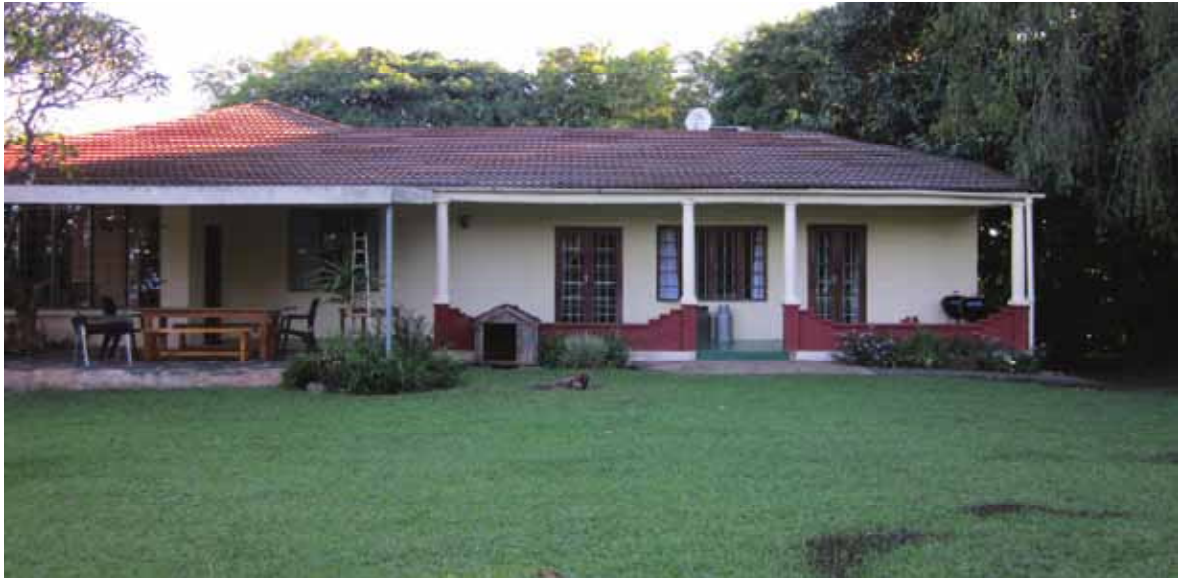
**Fig 6: North East Facade of Waterfall Farmhouse**

The north-east façade has a long veranda facing onto the garden, with a section consisting of four Tuscan columns on top of two low slung brick walls that flank an entrance onto the veranda- oddly aligned with a window rather than a door. The veranda has been further extended, and enclosed with *louvres*, distorting the proportions and the integrity of the façade (See Fig 6).

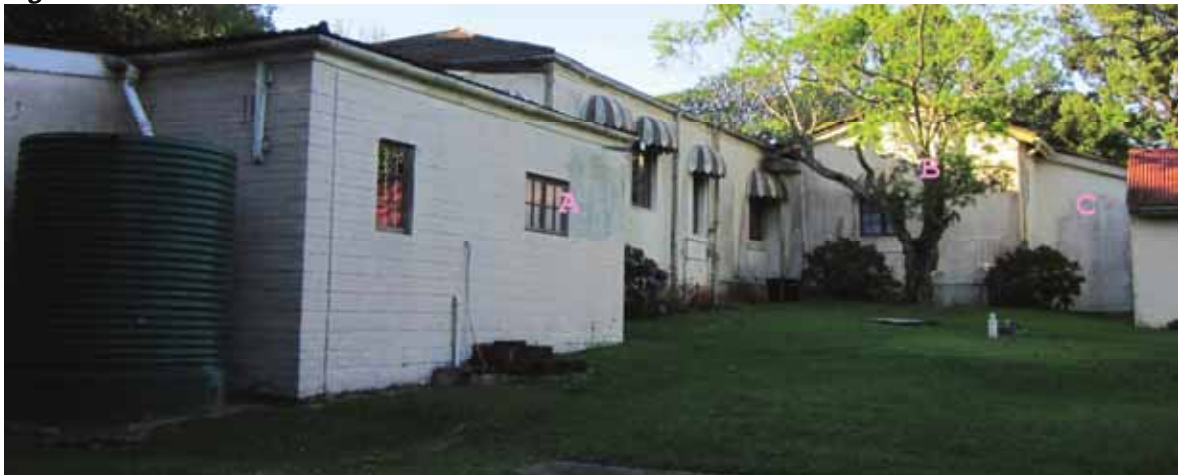
**Fig 7: South East Elevation showing accretions: A, B and C.**

The South East façade is equally discombobulated. The addition marked A is in raked pointing and bagwashed with meranti windows. Addition B is a double pitched accretion onto the edge of the veranda and C is a little portico with stone columns which has been enclosed (See Fig 8).

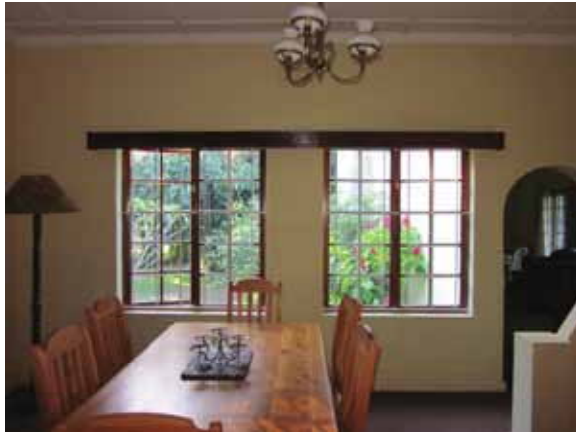
**Fig 9. Room currently used as a dining room**

Internally, the core of the house retains some of the elegance which it must have had. Panelled doors with fanlights, timber floors (under carpet) and timber ceilings exist in those parts of the house that have not been added to or modernized (see figs 9, 10 and 11).

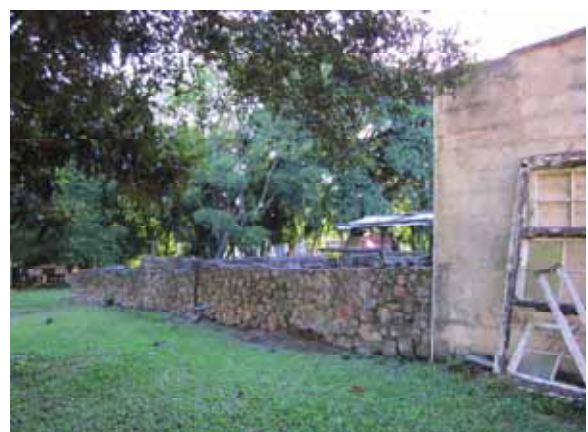
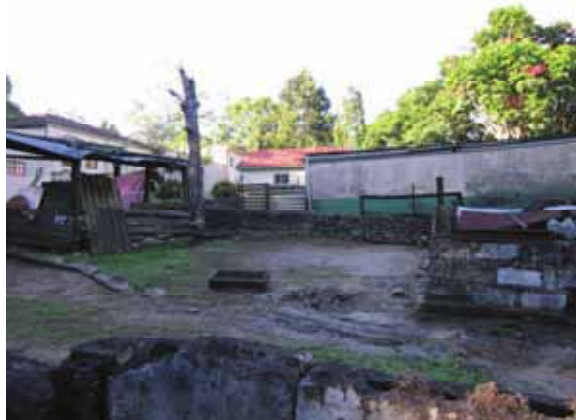
**Fig 13: Stock pen looking towards the house**

The 'stock pen' is of random rubble and roughly cemented at a fall close to the house (see Fig 13). It is adjacent to a bagwashed structure of block (see fig 12). It is not certain exactly what function this structure played, given its proximity to the house. Certainly the family is known to have kept ponies, and, one would assume fowls and the like (Camp 1999:29).

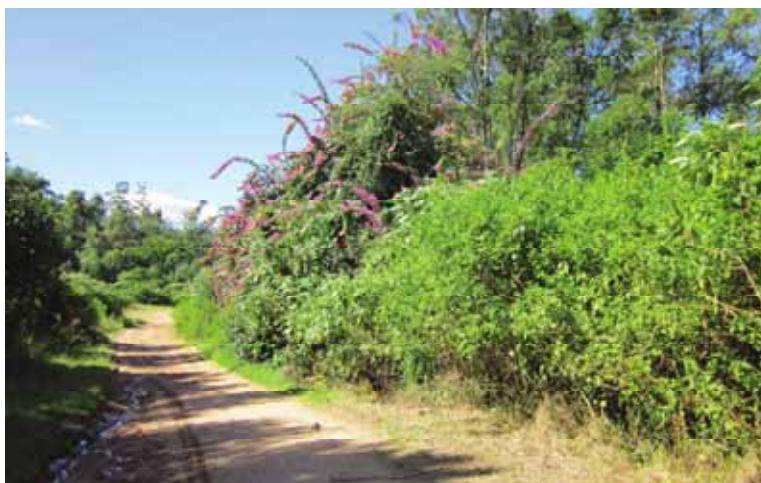
Fig 18: Site of demolished building

Identified by large and established *Bougainvillea sp.* the building that stood in its place was allegedly demolished about 15 years ago (Stroud pers.comm). Given that this was positioned on the old road to Hillcrest, this could have had some value. Nothing further is known about it at this point. It is recommended that during any bush clearing and excavation, an archaeologist is present in a monitoring capacity.

Demolished building Age: unknown	Local	Regional	National	International
Architectural	low	low	low	low
Historical	low	low	low	low
Social	low	low	low	low
Technical	low	low	low	low
Scientific	low	low	low	low

**Mitigation:** It is recommended that during any bush clearing and excavation, an archaeologist is present in a monitoring capacity.

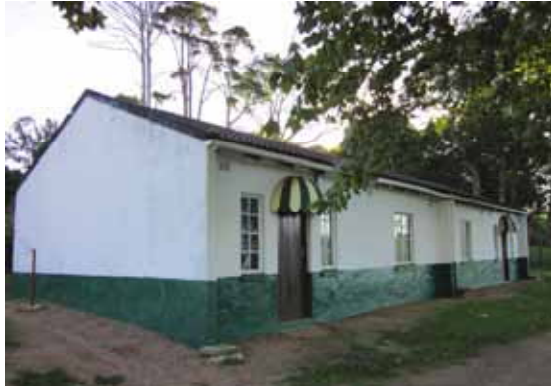
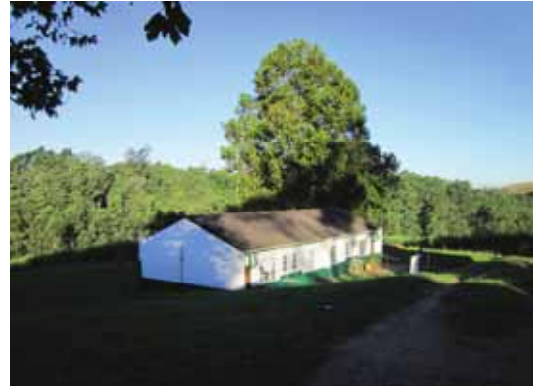
Fig 19 and 20: Labour cottages

These two cottages are located close to the main farmhouse beyond the Estate Management House number 1. They are in a similar architectural mould as the Full-time labour cottages in section 5.5, and are situated on an upper and a lower terrace. They have Marseilles tiled roofs, are bagged and painted, and have standard steel section windows. Half-moon awnings have been positioned over the entrance ways.

The buildings are modest and well considered, well maintained, and are good examples of a labour village idiom. It is suspected that they were constructed in the 1960s, after the consolidation of Kirkfalls.

Pair of labour cottages Age: circa 1960s	Local	Regional	National	International
Architectural	low	low	low	low
Historical	low	low	low	low
Social	low	low	low	low
Technical	low	low	low	low
Scientific	low	low	low	low

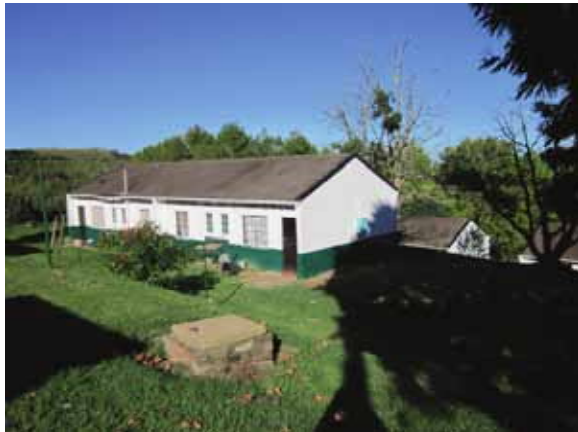
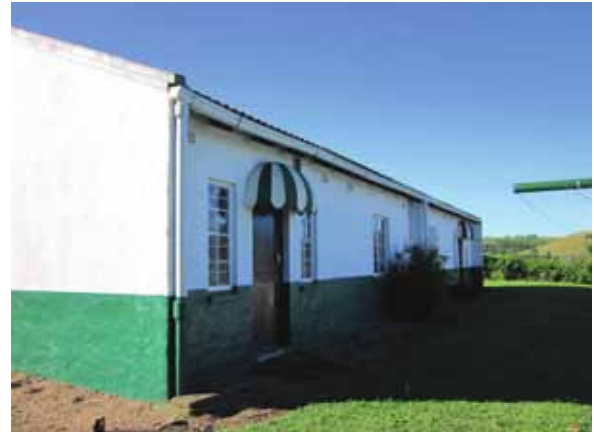
**Fig 21 & 22: Labour cottages on upper terrace**

The structures on the lower terraces are smaller flatlets, most likely constructed at a later date. They are of face brick, with end gables under Marseilles tiles. There is a small patio at the entrance to each complex unit with a decorative low *stoep* wall defining space. As before, these structures are well designed and very good examples of a labour village.

Labour villages are an important part of the history of KwaZulu-Natal and it is important that there is some record as to their contribution in the labour history of the province. It is suggested that even though these structures do not fall within the ambit of the KwaZulu-Natal Provincial Heritage Act No 4 of 2008, there is opportunity for reuse of what are, at face value, solid and well designed buildings.

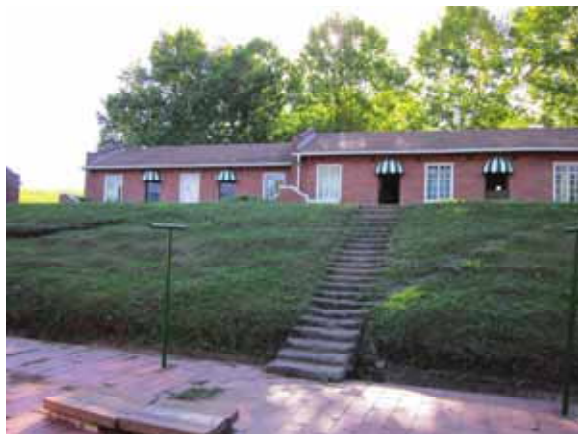
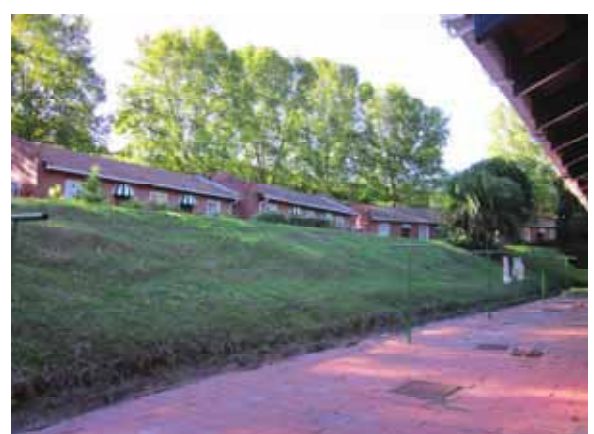
**Fig 25 & 26: Cottages on lower terrace**

Full time labour cottages Age: 1960's-1970's	Local	Regional	National	International
Architectural	medium	low	low	low
Historical	low	low	low	low
Social	medium	medium	low	low
Technical	low	low	low	low
Scientific	low	low	low	low

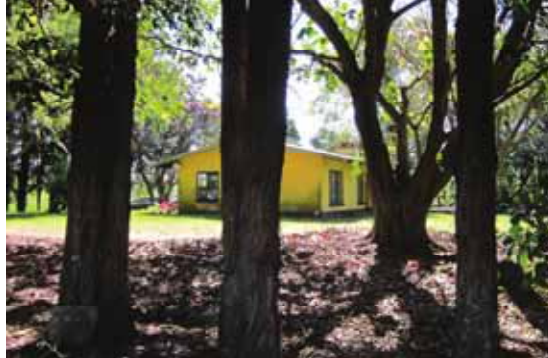
**Fig 27: Estate management house 2**

This is a ranch style suburban building of conventional construction and materials. It is of recent construction, possibly late 1960's to early 1970's. It has no architectural merit and is of similar ilk to the house described in section 5.3. Note, however, that this house is situated in a well-established garden.

Estate management house 2 Age: 1960's-1970's	Local	Regional	National	International
Architectural	low	low	low	low
Historical	low	low	low	low
Social	low	low	low	low
Technical	low	low	low	low
Scientific	low	low	low	low

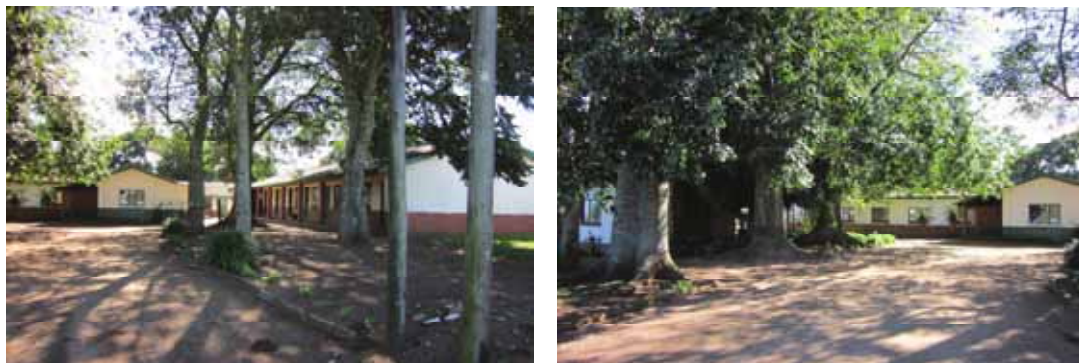
**Fig 28 & 29: Courtyard in seasonal labour compound**

As with the Labour compound in 5.5 above, this compound is also well appointed and slightly elevated, and situated in the middle of the cane fields. It consists of a number of buildings, arranged around a series of courtyard spaces, with established trees in and around these courtyards. There is a football field to the north east of it.

The buildings themselves are utilitarian, constructed out of stretcher bond brickwork, bagged and rule jointed with steel section standard windows, and 'Big Six' asbestos sheeting. Flippant elements of Modernism such as *brise soleil* and screens add privacy. Rooms lead onto the courtyards which assist in constructing a strong sense of place. As with the Full-time labour compound, this complex provides an opportunity for reuse.

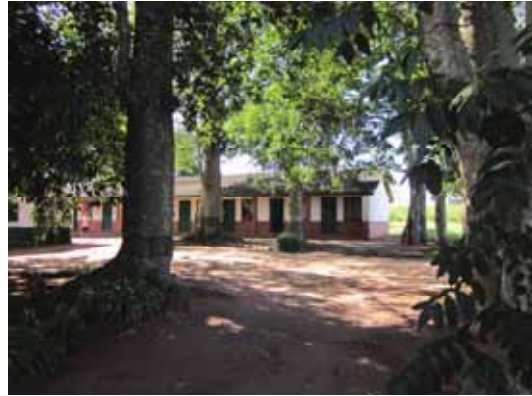
**Fig 31: Courtyard**

Seasonal labour compound Age: 1960s?	Local	Regional	National	International
Architectural	low	low	low	low
Historical	low	low	low	low
Social	medium	medium	low	low
Technical	low	low	low	low
Scientific	low	low	low	low

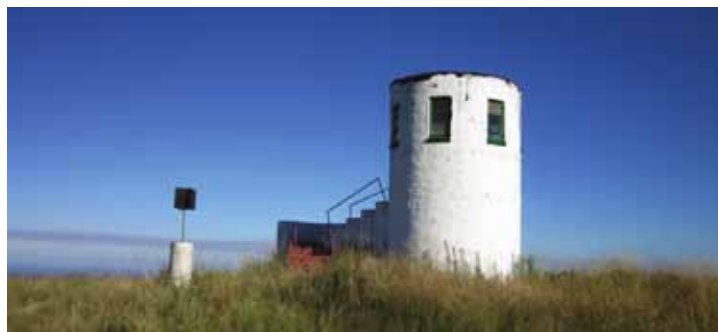
**Fig 32: Fire Lookout tower**

This is a circular tower of mixed construction visible from the N3 and situated adjacent to the Ntabankulu trigonometric beacon on top of the hill. It is apparently an old structure, which has been much altered in the past (Stroud: pers.comm). It is suspected that given its inaccessible position, it is generally safe from development, thus retaining its landmark quality.

Fire Lookout tower Age: unknown	Local	Regional	National	International
Architectural	low	low	low	low
Historical	low	low	low	low
Social	medium	low	low	low
Technical	low	low	low	low
Scientific	low	low	low	low

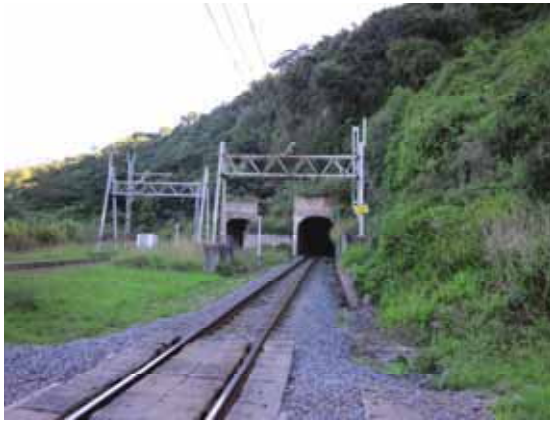
**Fig 33: Tunnels dated to 1974**

The railway tracks came through this area in the early 1920s. Significantly the blasting and tunneling made an impression on local residents, as noted by Camp in her work on the area (Camp 1999:29). However, little of any import remains as the current tunnel is dated to 1974 and the station is reduced to an electrical substation. A single element of its history exists in the square concrete structure in Fig 34 below, possibly used as a reservoir in the past.

**Mitigation: None**

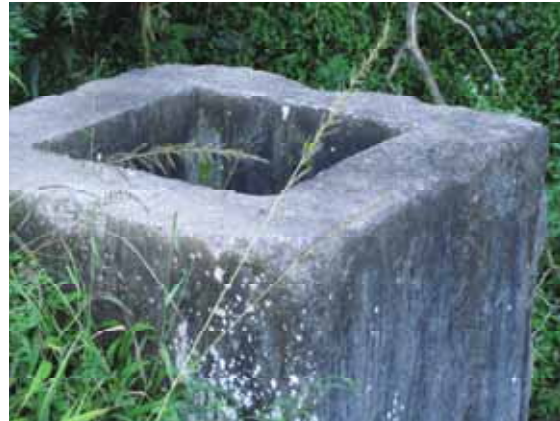
**Fig 34: Possible reservoir**

Delville station and surrounds Age: 1960's-1970's	Local	Regional	National	International
Architectural	low	low	low	low
Historical	low	low	low	low
Social	low	low	low	low
Technical	low	low	low	low
Scientific	low	low	low	low

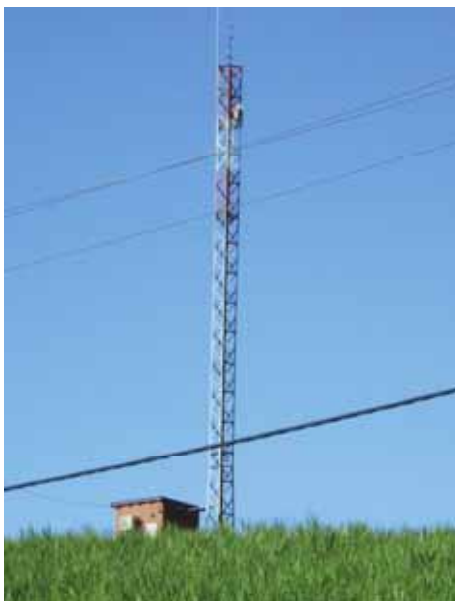
**Fig 35: Microwave tower**

This is a steel framed tower of recent construction and function in the middle of canelands on the descent to Shongweni. At its base is a small, nondescript and utilitarian plant room constructed of stretcher bond brickwork. This has no architectural nor heritage value.
