**SHONGWENI**  
Report 2 of 2012

# RAPID ASSESSMENT OF THE VEGETATION ASSOCIATED WITH A PROPOSED 500 MM BULK WATER LINE

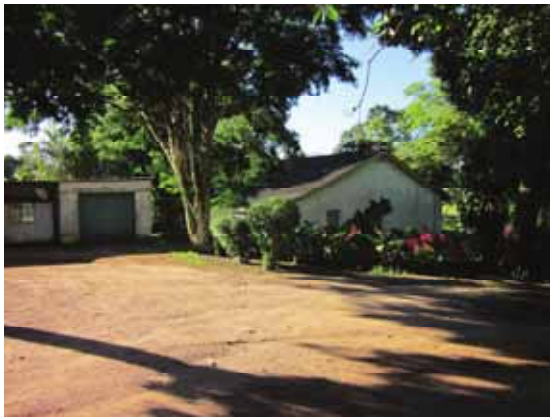
*Fig 36: House 3 from drive*

This is a ranch style suburban building of conventional construction and materials. It is of recent construction, possibly late 1960's to early 1970's. It has no architectural merit and is of similar ilk and period to the houses described in section 5.3 and 5.6. It is, however, set in a well- established and maintained garden.

<b>Estate management house 3 Age: 1960's-1970's</b>	<b>Local</b>	<b>Regional</b>	<b>National</b>	<b>International</b>
<b>Architectural</b>	low	low	low	low
<b>Historical</b>	low	low	low	low
<b>Social</b>	low	low	low	low
<b>Technical</b>	low	low	low	low
<b>Scientific</b>	low	low	low	low

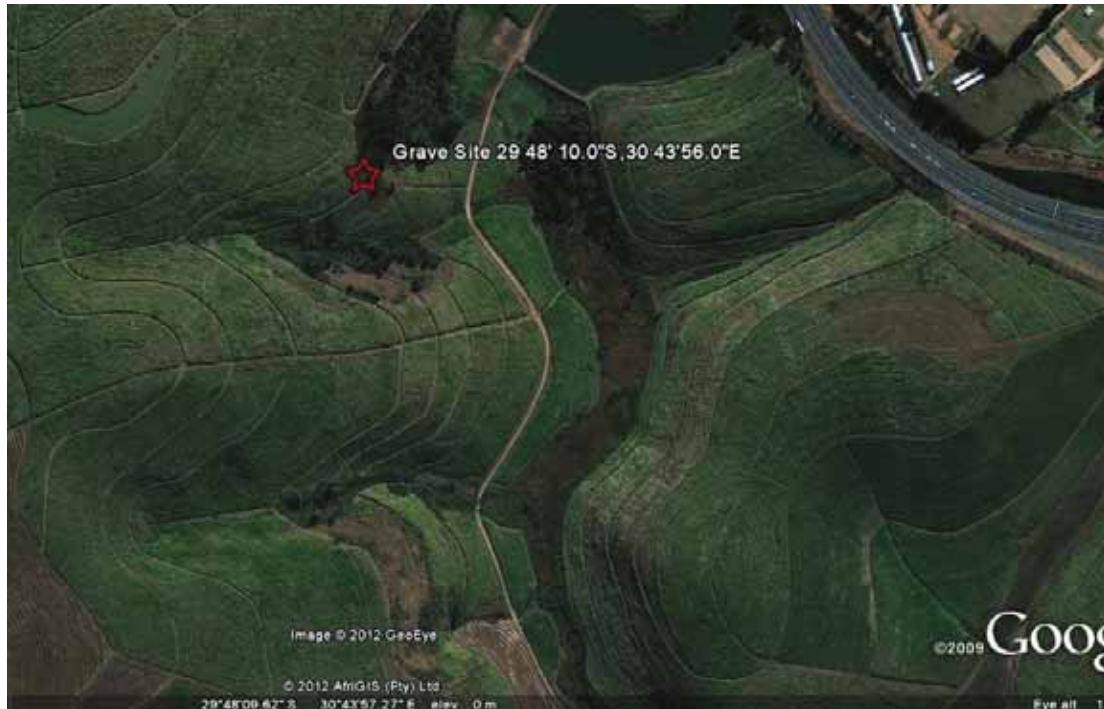
**Fig 1: Showing grave sites superimposed on Google Earth**

A grave site with three burials is recorded on the property at S29° 48.166'; E30° 43.930'. The location of the graves was provided to eThembeni from the Tongaat Hulett Graves and Cemeteries Data Base. Field inspection places these on the edge a thicket of uncultivated land above the dam adjacent to the N3. The graves are those of Nkunzi Mgwaba (died 1959), Anelia Mgwaba (died 1971) and a child that died 1965.

All graves have high heritage significance and are protected in terms of legislation. In the process of ongoing development of the property it is possible that further human remains may be exposed. The following legal guidelines are appended (see Appendix C1).

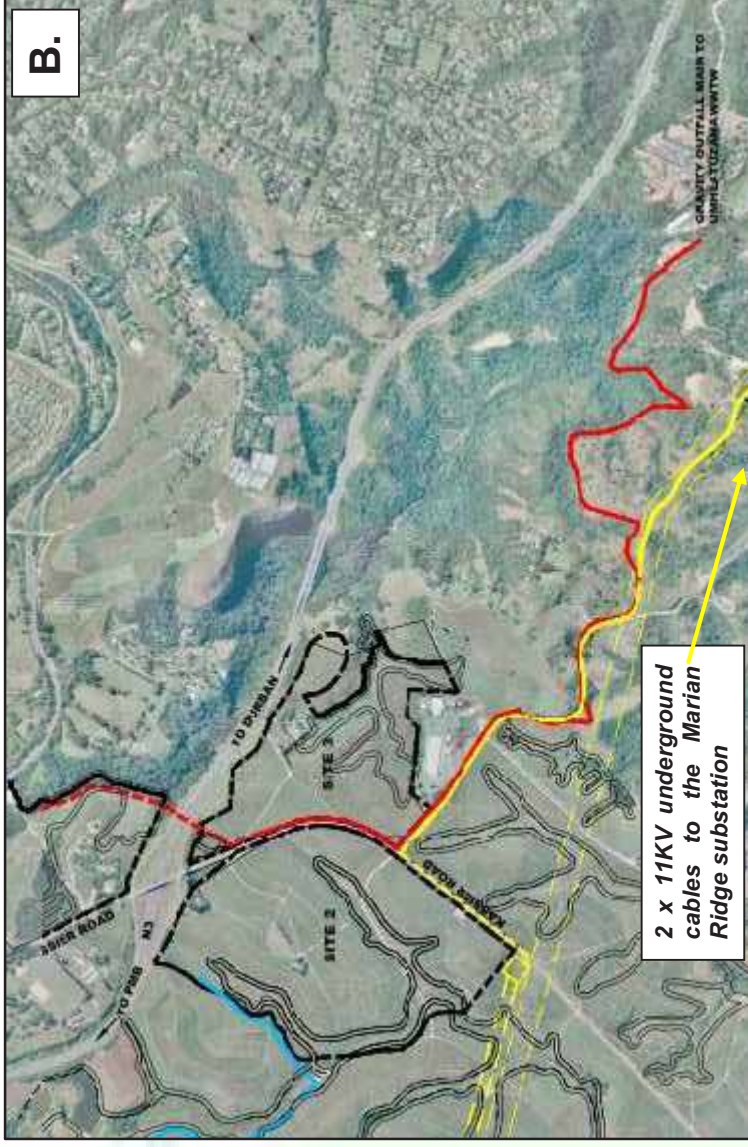
Figure 3: Proposed bulk service provisions

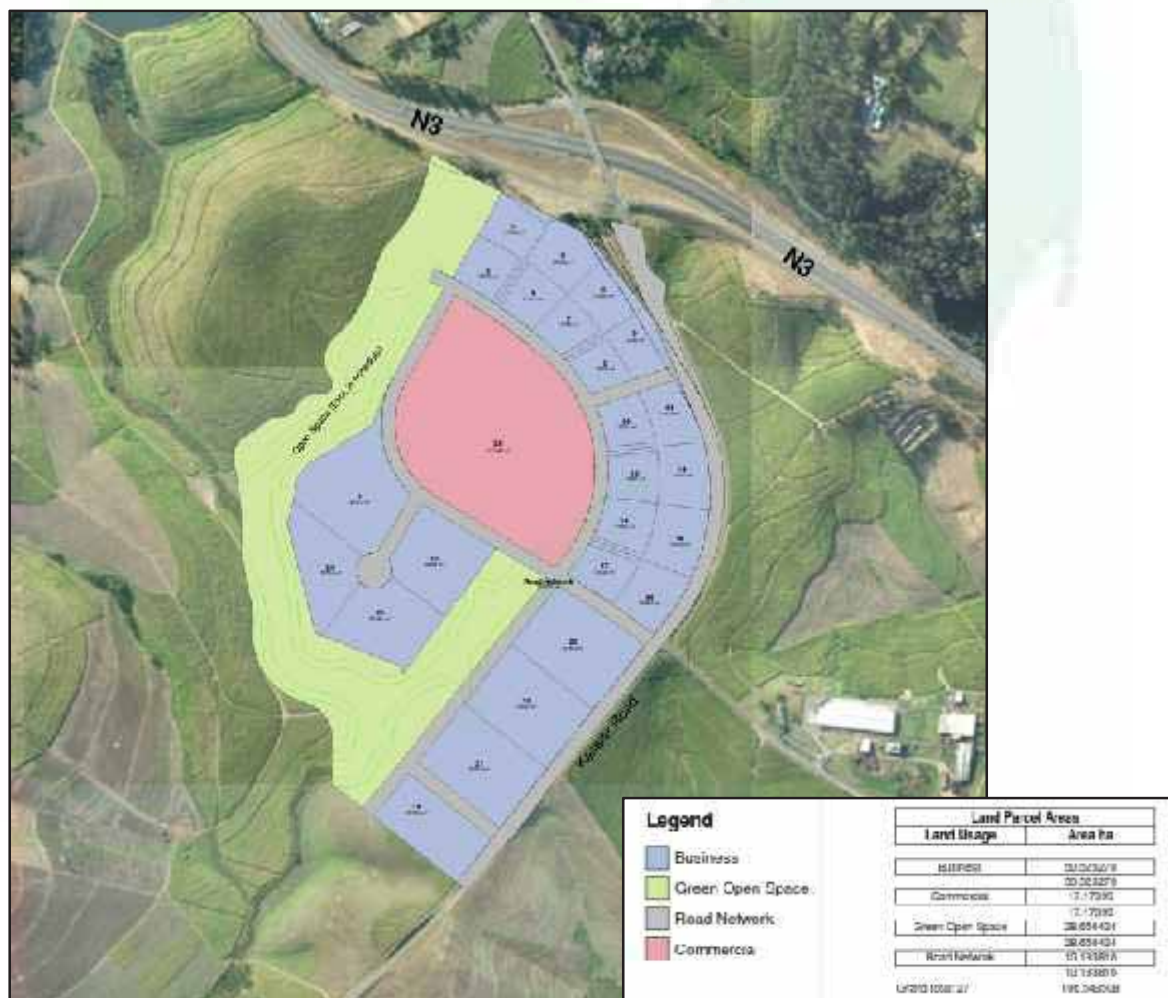
Figure 4: Proposed development layout for the Shongweni Retail / Mixed Use Centre (source: GAPP Architects/Urban Designers, 2013).

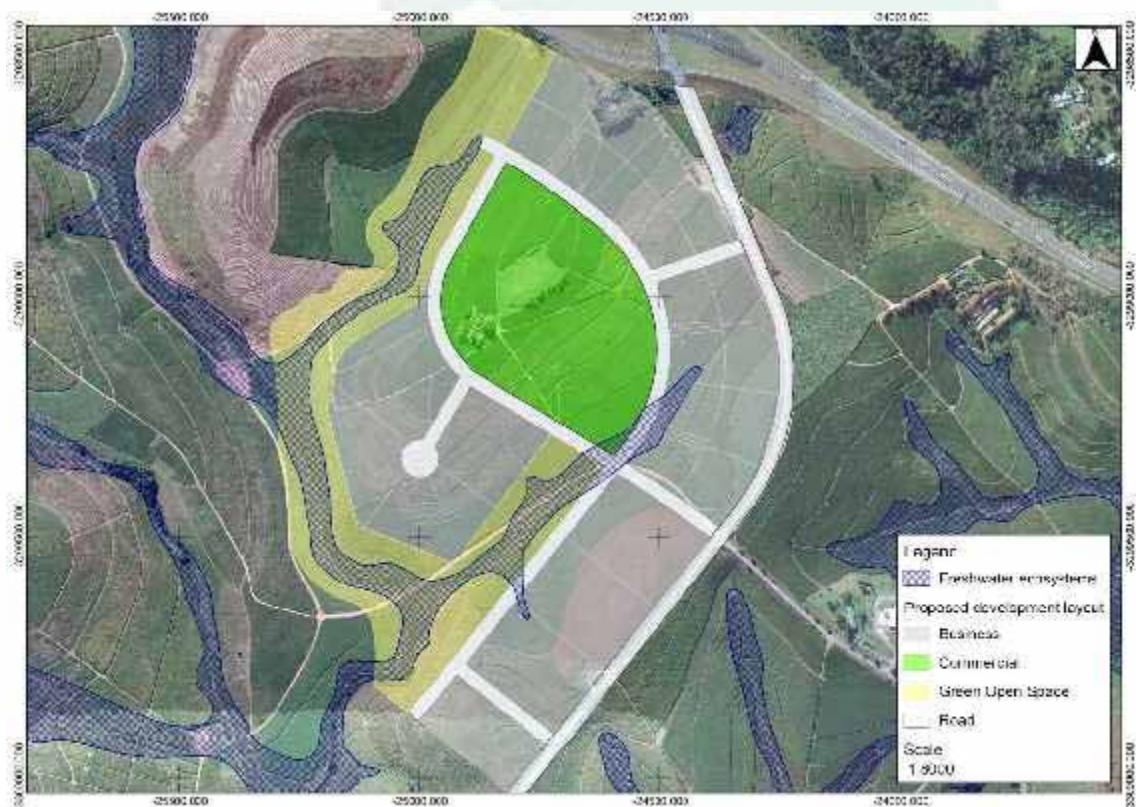
**Figure 6: Map showing the drainage lines within and adjacent to the site in blue. The waste management area, stockpiles and chemical toilets must not be placed within or adjacent to these areas (source: GroundTruth, Riparian Assessment, 2013).**
