**DRAFT ENVIRONMENTAL IMPACT REPORT
Carisbrooke Quarry on Portion 3 of Lot 9 Incalu
5000**

**uBuhlebezwe Local Municipality
Matzogystix (Pty) Ltd
KZN 30/5/1/1/2/10463MP**

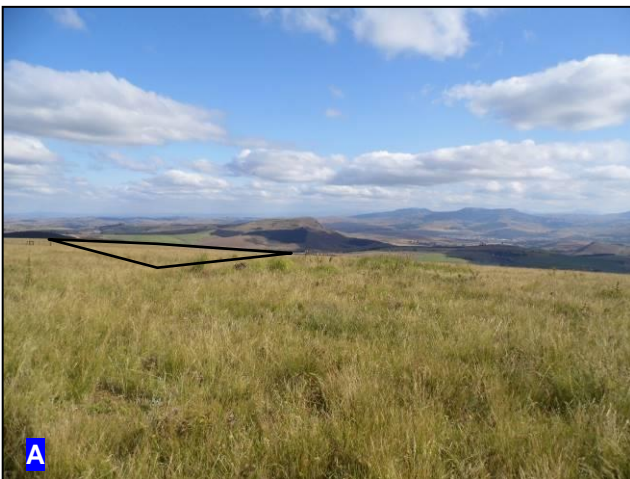
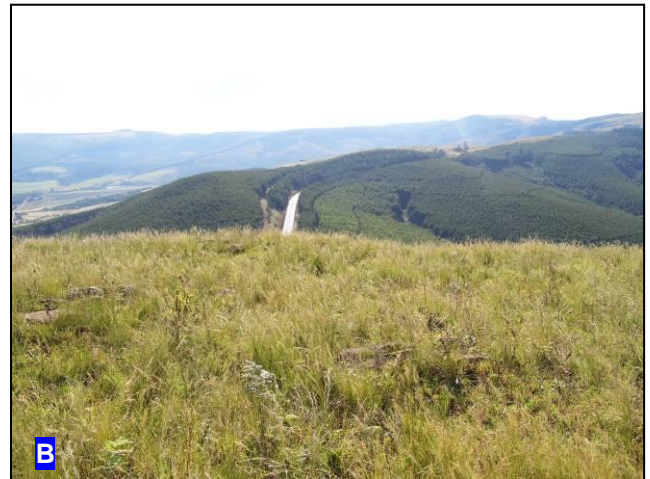
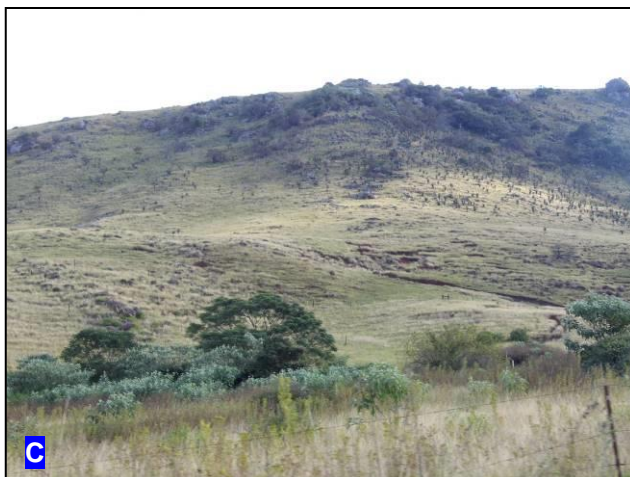
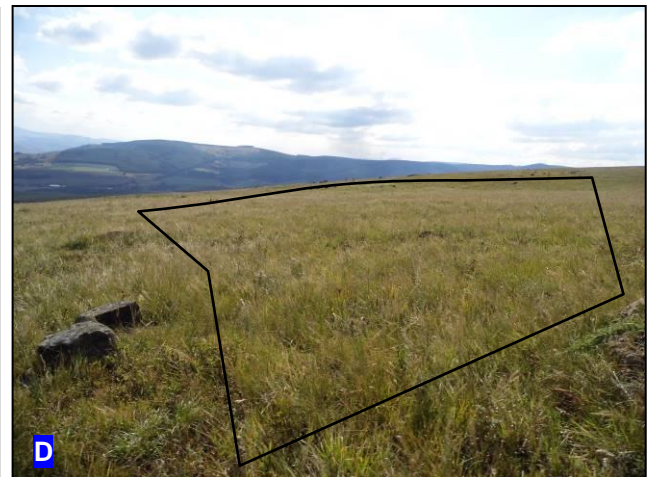
Figure 4: Photographs of the proposed Carisbrooke Quarry area, outlined in black (a) Photograph taken in a southerly direction towards the mine area; (b) Photograph showing crest of hill and steep gradient associated with the northern portion of the property looking down towards the R56; (c) View from the Inyezi Community looking up the steep easterly bank; and (d) Photograph showing the general condition of the grassland associated with the proposed quarry area.

The different variations to the quarry site that were considered are shown in black in Figure 3 below. The vegetation does not differ greatly between the alternatives as all alternatives fall within the Midlands Mistbelt Grassland ecosystem. The property is currently used for grazing by the surrounding community. Vegetation is discussed further in section 3.0 of the EIR. Similar to the vegetation, potential fauna species associated with the mine area is unlikely to differ significantly between the layout alternatives due to their close proximity. Since the layout variations do not significantly differ from the proposed preferred layout (red in Figure 3), apart from the distance to the drainage lines, no feasible alternative layout have been discussed. Photographs of the preferred Carisbrooke Quarry site are provided in Figure 4.

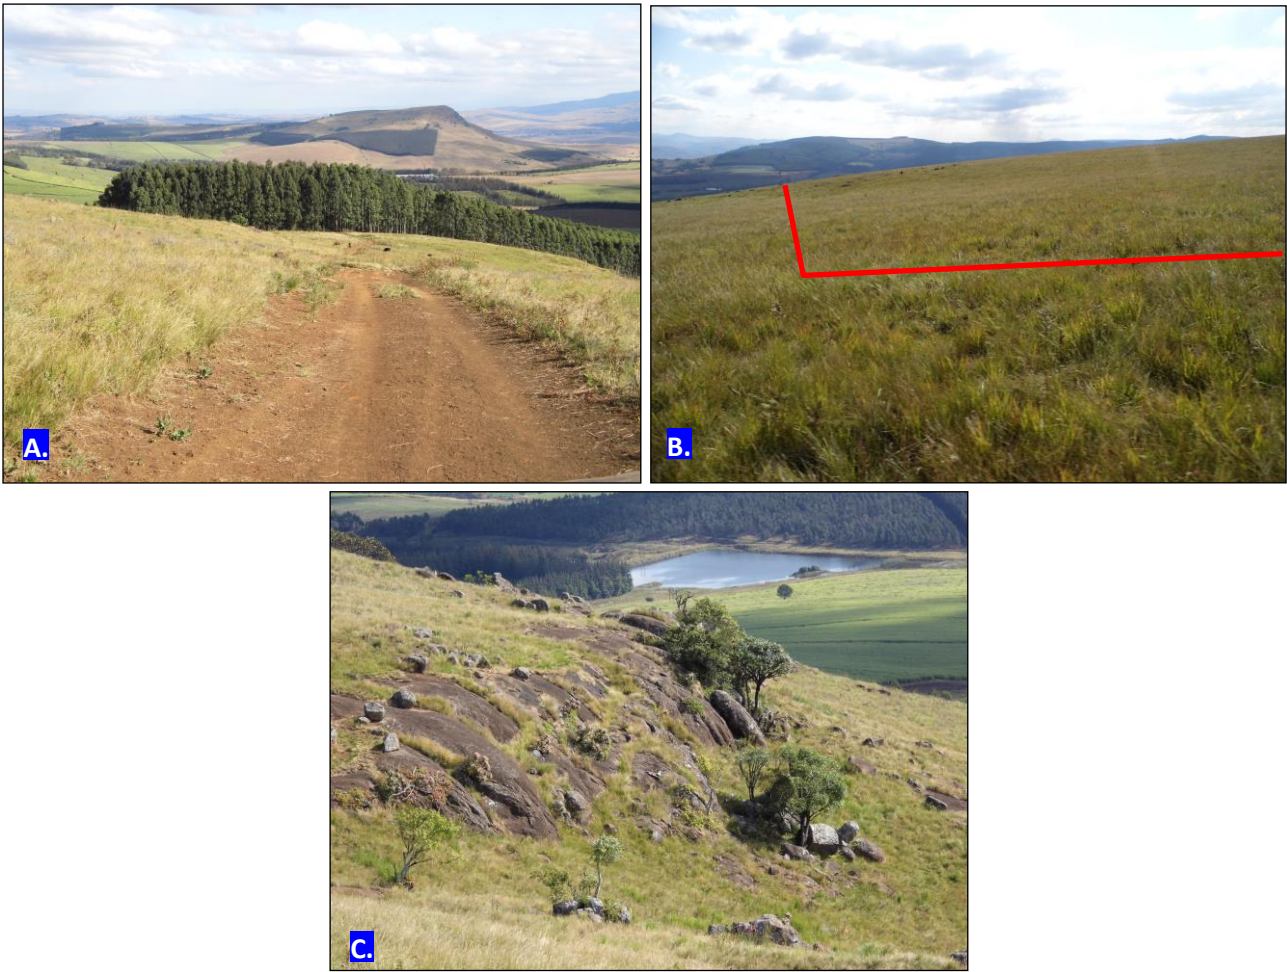
Figure 7: Photographs showing the topography and characteristics of the Carisbrooke Quarry site (a) Photograph taken facing south showing the existing dirt access road onto the property, (b) Photograph taken facing north over the proposed mining area, indicated in red; and (c) Exposed dolerite outcroppings in the northern section of the property.

Photographs taken of the proposed Carisbrooke Quarry showing the surrounding topography and dolerite outcroppings are included in Figure 7. The R56 is located to the west of the property with timber farming being a typical land use surrounding the site. The Inyezi Community is located to the north-east. Surrounding land uses are illustrated in Figure 8 below.

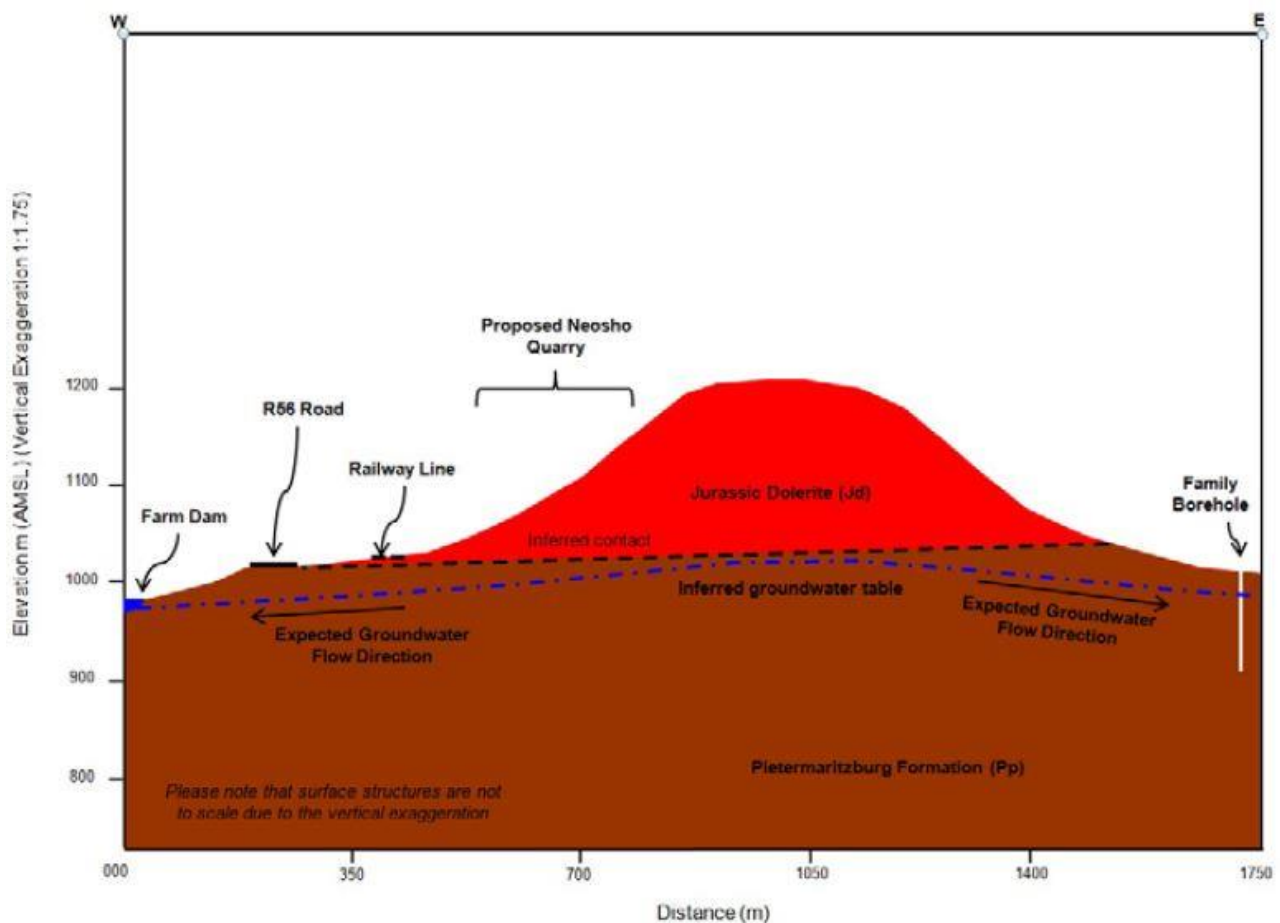
Figure 12: Conceptual site model (source: Geohydrological Investigation, 2015).

A basic conceptual site model of the geohydrology associated with the hill was prepared by the Geomeasure Group and presented in Figure 12. The model shows the farm dam to the west of the quarry and borehole to the east (main receptors). After contour analysis, the groundwater beneath the quarry is likely to flow towards the west. If the mining operations are not managed correctly or if there are any uncontrolled spills of hydrocarbons / leaking vehicles etc. operating on site, this has the potential to impact the groundwater and, in turn, the downstream farm dam. Mitigation measures to ensure the correct storage of hydrocarbons and management of mining structures/vehicles have been included in the EMP. Further to these measures, the geohydrologist recommends that the spring to the north of the quarry, borehole to the east and the farm dam to the west be sampled twice a year to ensure there is no change in the current water quality (Appendix C of the Geohydrological Investigation). Alternatively, monitoring wells up- and down-gradient of the quarry are to be installed to allow for long-term sampling of the groundwater. Water quality tests attached to the Geohydrological Investigation are to be used as the baseline quality, to compare future samples against. The potential for the quarry operations to impact the groundwater quality has been included in Table 3 under section 7.0 of the EIR.

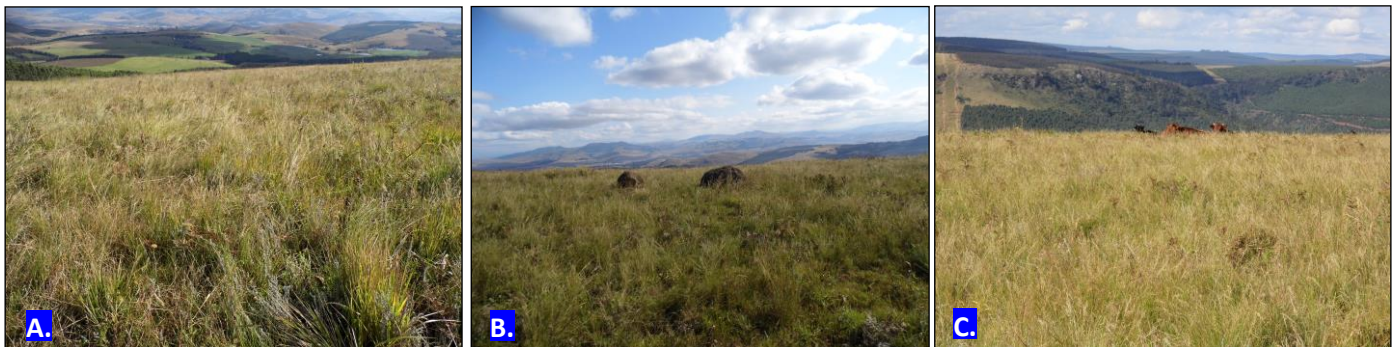
Figure 14: Photographs showing the general condition of the vegetation on the preferred Carisbrooke Quarry site (a) Photograph of the centre of the proposed preferred mining area facing west; (b) Grassland with dolerite outcrop near the northern boundary; and (c) Cattle grazing in the grassland near the preferred quarry site.

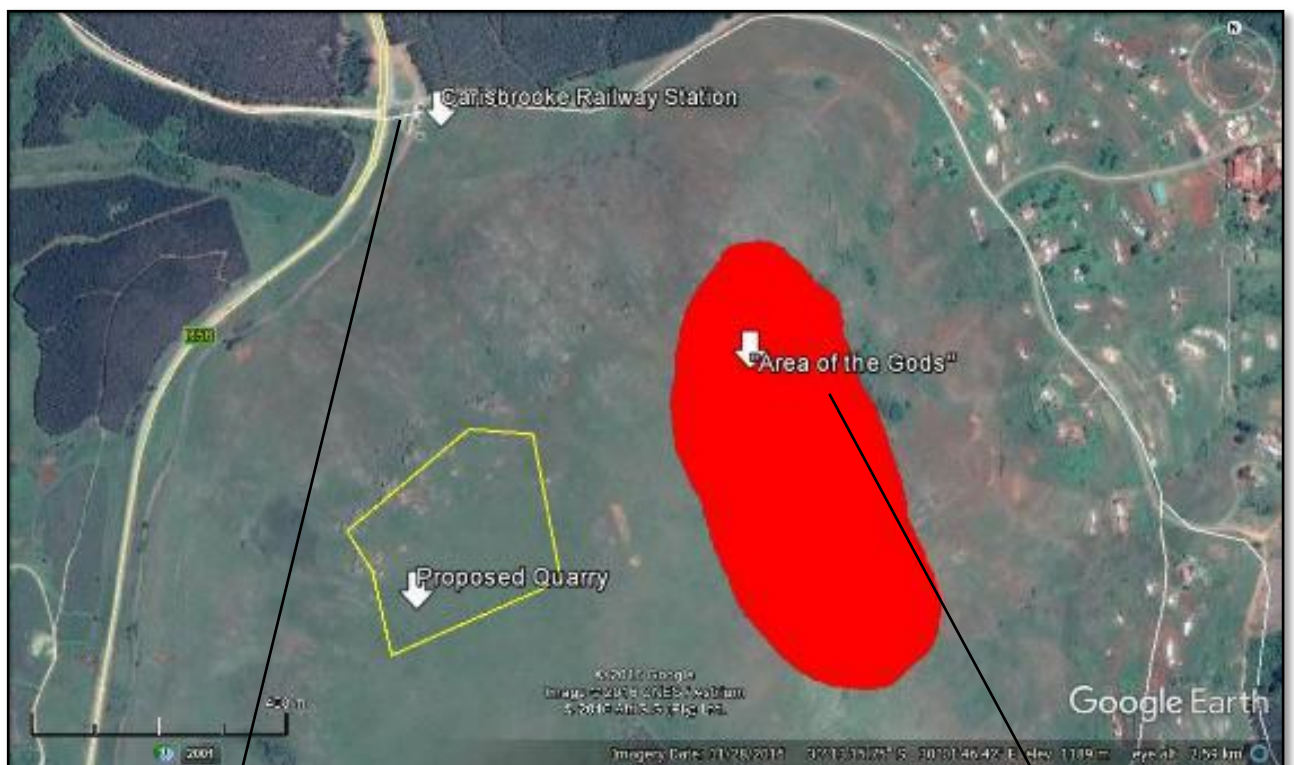
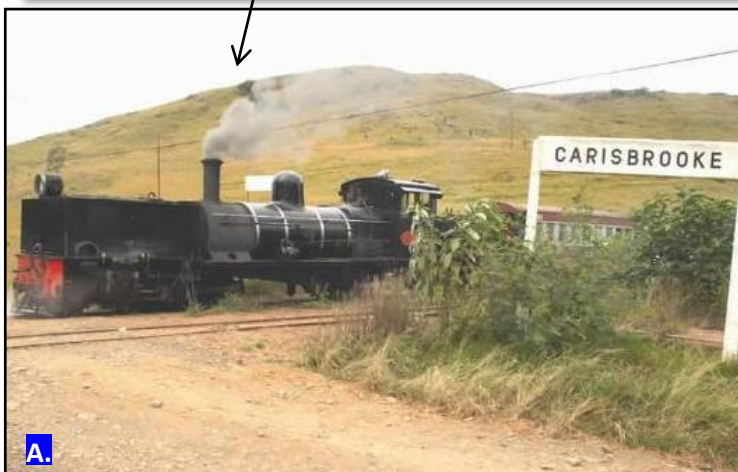
Figure 16: Google aerial photograph showing the location of identified heritage sites or areas in the near vicinity of the proposed quarry site. Photographs of the (a) Carisbrooke Station and (b) Elephant rock formation are included underneath the figure (source: Heritage Impact Assessment, 2017).

The desktop survey identified no archaeological sites within 2km of the proposed quarry. The Carisbrooke Railway Station was identified as a historical site 450m north-west of the quarry (older than 60 years; Figure 16). The station is mentioned in Alan Paton's book "Cry the Beloved Country" with one of the books central themes being the social protest against the structures of the society which gave rise to apartheid. The station therefore falls within the genre of "struggle-era literature and politics" and is rated as locally significant. Due to the distance from the quarry, the heritage specialist concluded that there will be no direct impact on this historical site.

The “Area of the Gods”, where the rocky outcrops occur along the eastern portion of the hill and associated shelter-like formations mentioned in section 5.2.2 of the HIA, is shaded in red in Figure 16. It is located approximately 230m east of the quarry site, which is on the opposite side of the hill. During the consultation process with the Inyezi community, no concerns have been raised around the cultural / heritage value of the hill. A lease agreement is currently being drafted by the applicant, which the community will sign, indicating their willingness for the operation to go ahead. It is anticipated that the lease agreement will be ready for inclusion in the Final EIR for submission to DMR. The EAP is currently obtaining further feedback regarding the community’s view on the subject.

24. Excavations and blasting impacting on potential heritage resources (Heritage Impact Assessment, 2016).	11 (high)	<p>The HIA concluded that there were no archaeological sites within 2km from the project area. The Carisbrooke Railway Station is 450m north-west to the nearest quarry boundary and will therefore not be directly impacted by the mining activity. The heritage specialist concluded that it was difficult to give an objective evaluation of the impact of the mining on the intangible heritage value¹⁵ of the hill since the entire hill has been regarded as a "living-heritage site" by a member of the local Hindu community. The "Area of the Gods", shaded in red in Figure 16 correlates to the</p>	10 (med)
