**June  
2017**

**DRAFT ENVIRONMENTAL IMPACT REPORT  
Thornridge Farm Quarry on Portion 55 of Farm  
Uitkomst & Doornrug No. 852  
eThekweni Municipality  
Cato Ridge Quarry (Pty) Ltd  
KZN 30/5/1/3/2/10497MP**

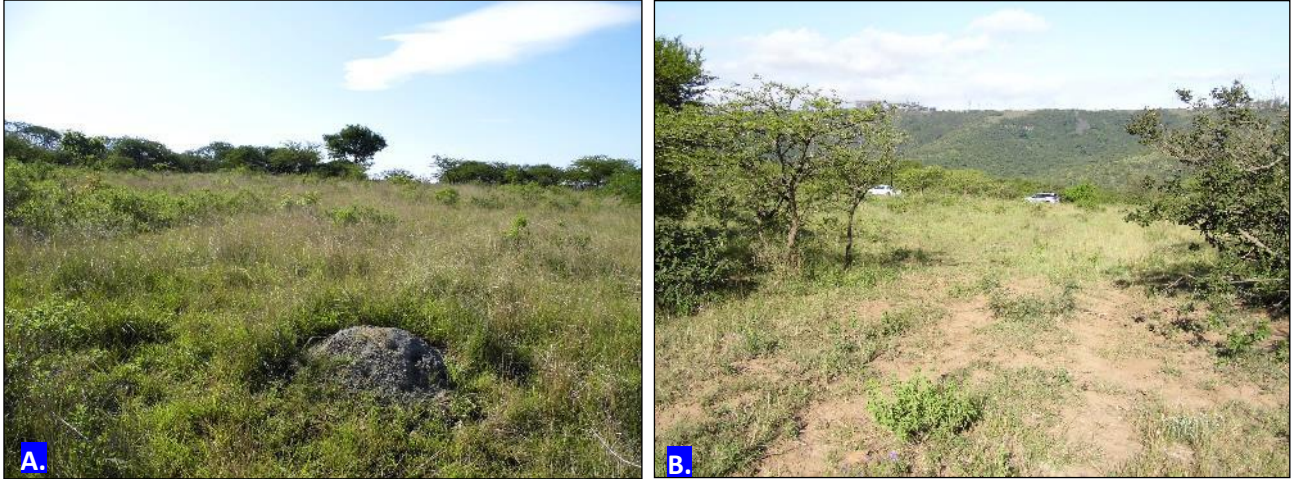
**Figure 6: Photographs showing the topography and characteristics of the Thornridge Quarry site (a) Photograph taken facing north up the slope of the proposed quarry site, and (b) Photograph taken from the centre of the site facing south-east towards the existing access road across the property.**

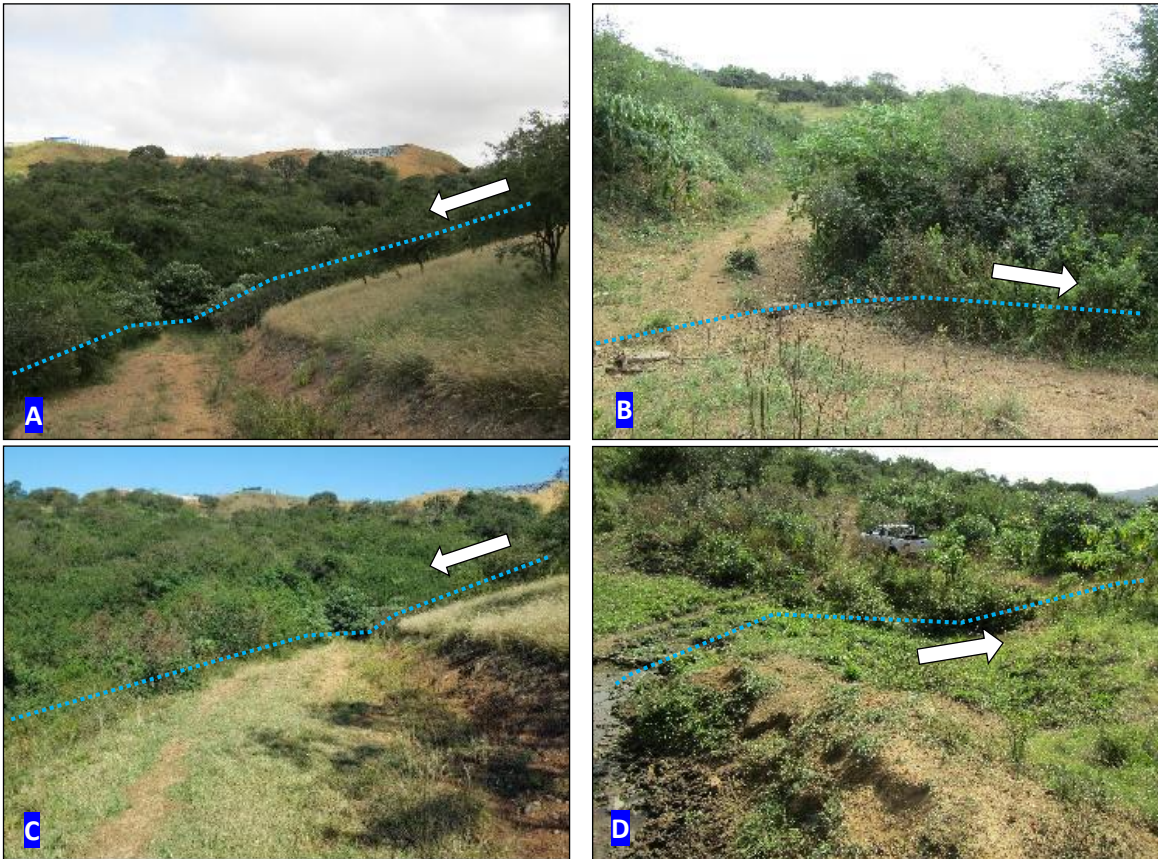
Figure 9: Photographs of where the access road crosses (a) Drainage line 1; (b) Drainage line 2; (c) Drainage Line 3; and (d) Drainage line 4.

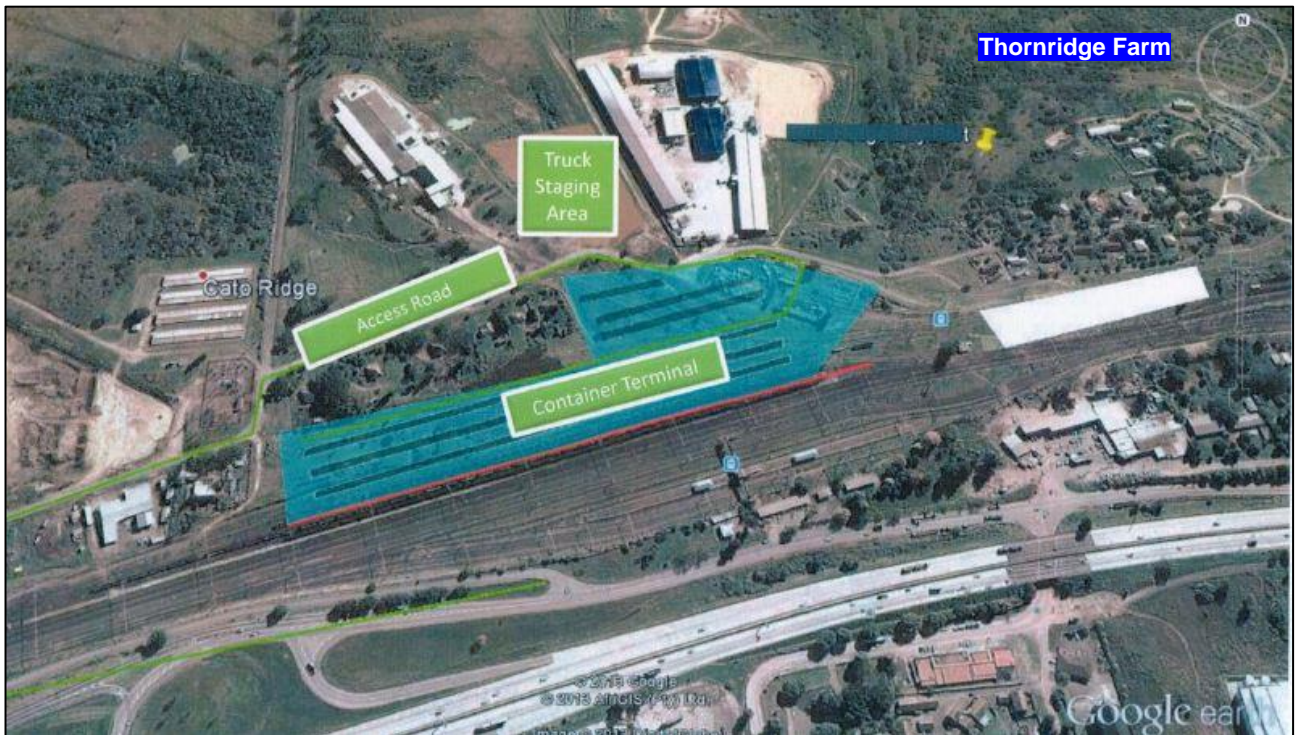
**Figure 14: Proposed Layout of Transnet's Container Terminal in Cato Ridge (source: Transnet Inputs to the Cato Ridge Development Indaba, August 2014).**

Another large development opportunity in close proximity to the proposed Thornridge Farm Quarry is Transnet’s Container Terminal and truck staging area. The location is shown in Figure 14 and is located directly south-west of Thornridge Farm.
