**PHASE 1 NEAR SURFACE GEOTECHNICAL INVESTIGATION FOR  
THE PROPOSED TOWNSHIP ESTABLISHMENT TO BE SITUATED  
ON THE REMAINDER OF THE FARM DWARSLOOP 248 KU,  
MPUMALANGA PROVINCE OF SOUTH AFRICA**

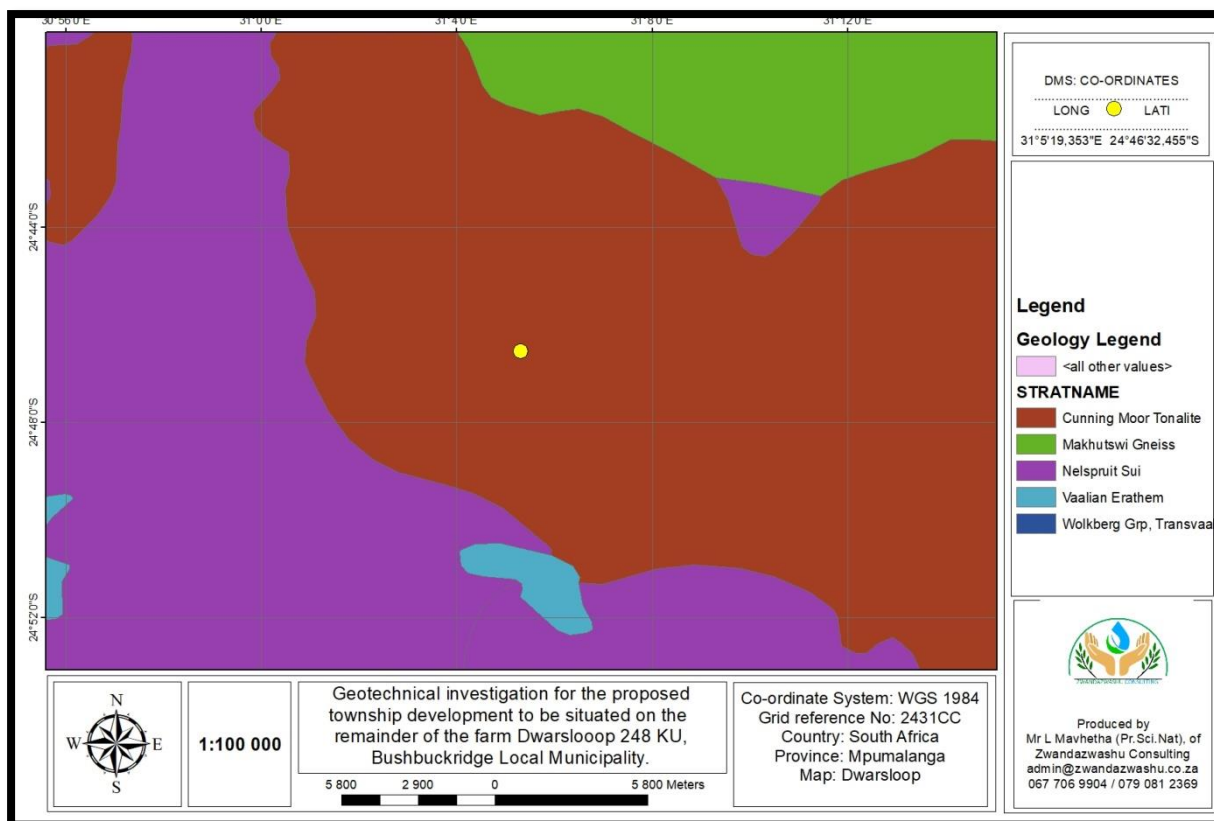
**Figure 3: Geological setting of the site**

The site under investigation falls under the cunning moor tonalite of the archaean granitic basement which is situated adjacent to the Mpuluzi Granite and Barberton greenstone belt. It must be noted that outcrops which were observed during site geological examination reveal the phaneritic texture granatoid rocks which are predominately composed of felsic minerals such as quartz, plagioclase feldspars and mafic (amphiboles and pyroxene) accessory minerals. Based on the physical properties of the rock samples and geological maps review of the site; the lithology of the site is medium to coarse grained sphene bearing tonalite. In areas where outcrops were overburden by soil; medium to coarse gravel were observed at the northern and central portion of the site while the fine sand dominant the southern lower portion of the site along Nwarhele River.

The geological map in figure 3 indicates the geological setting of the site and its surrounding.

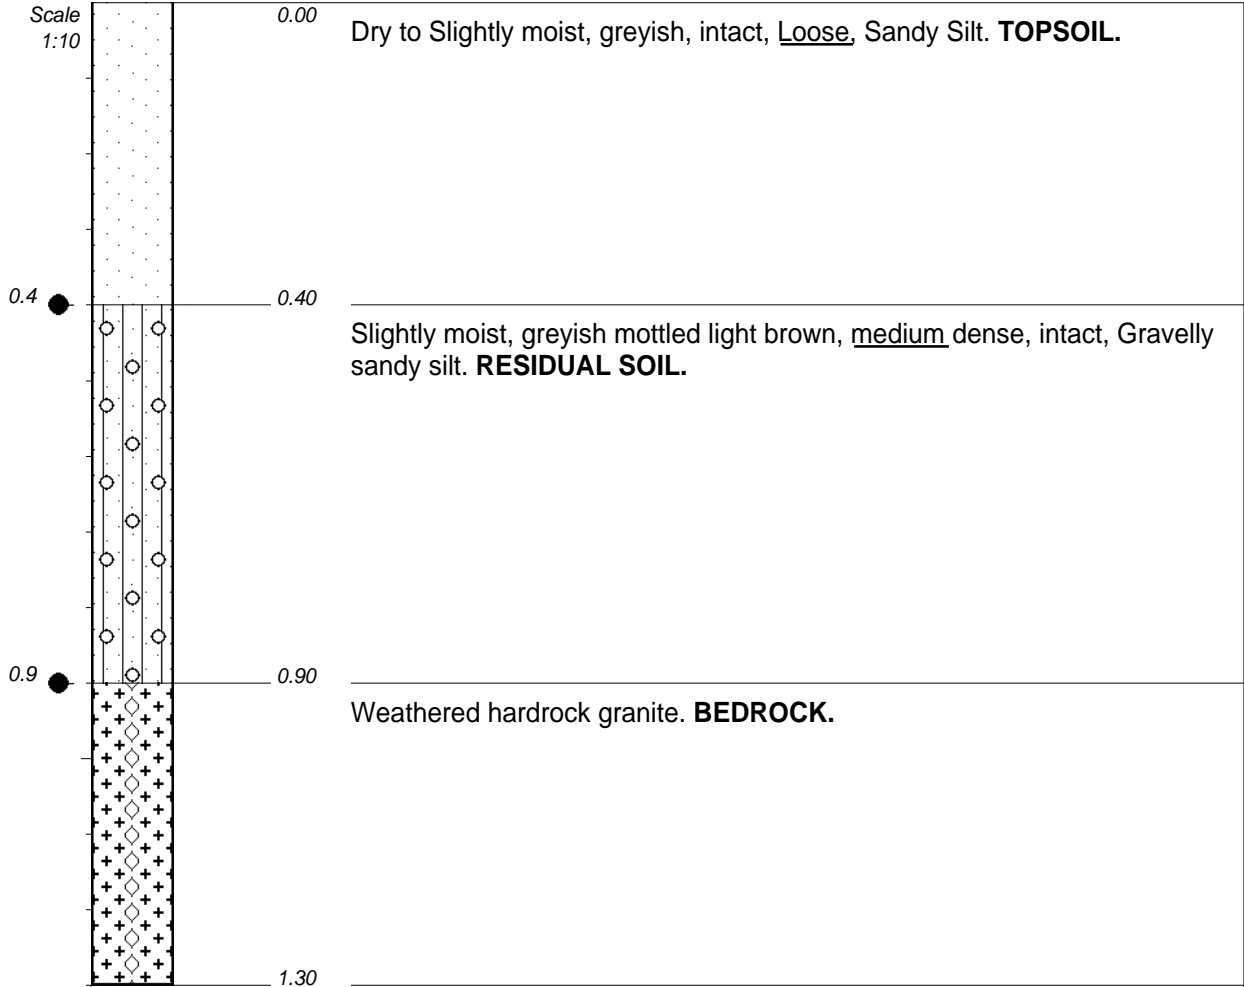
- 1) Roots inclusion from a depth of 0 - 0.6m
- 2) Stable side walls
- 3) No water seepage encountered
- 4) Refusal encountered at 1.3 m
- 5) Disturbed sample taken at 0.4 - 0.9 m
- 6) No Undisturbed sample taken

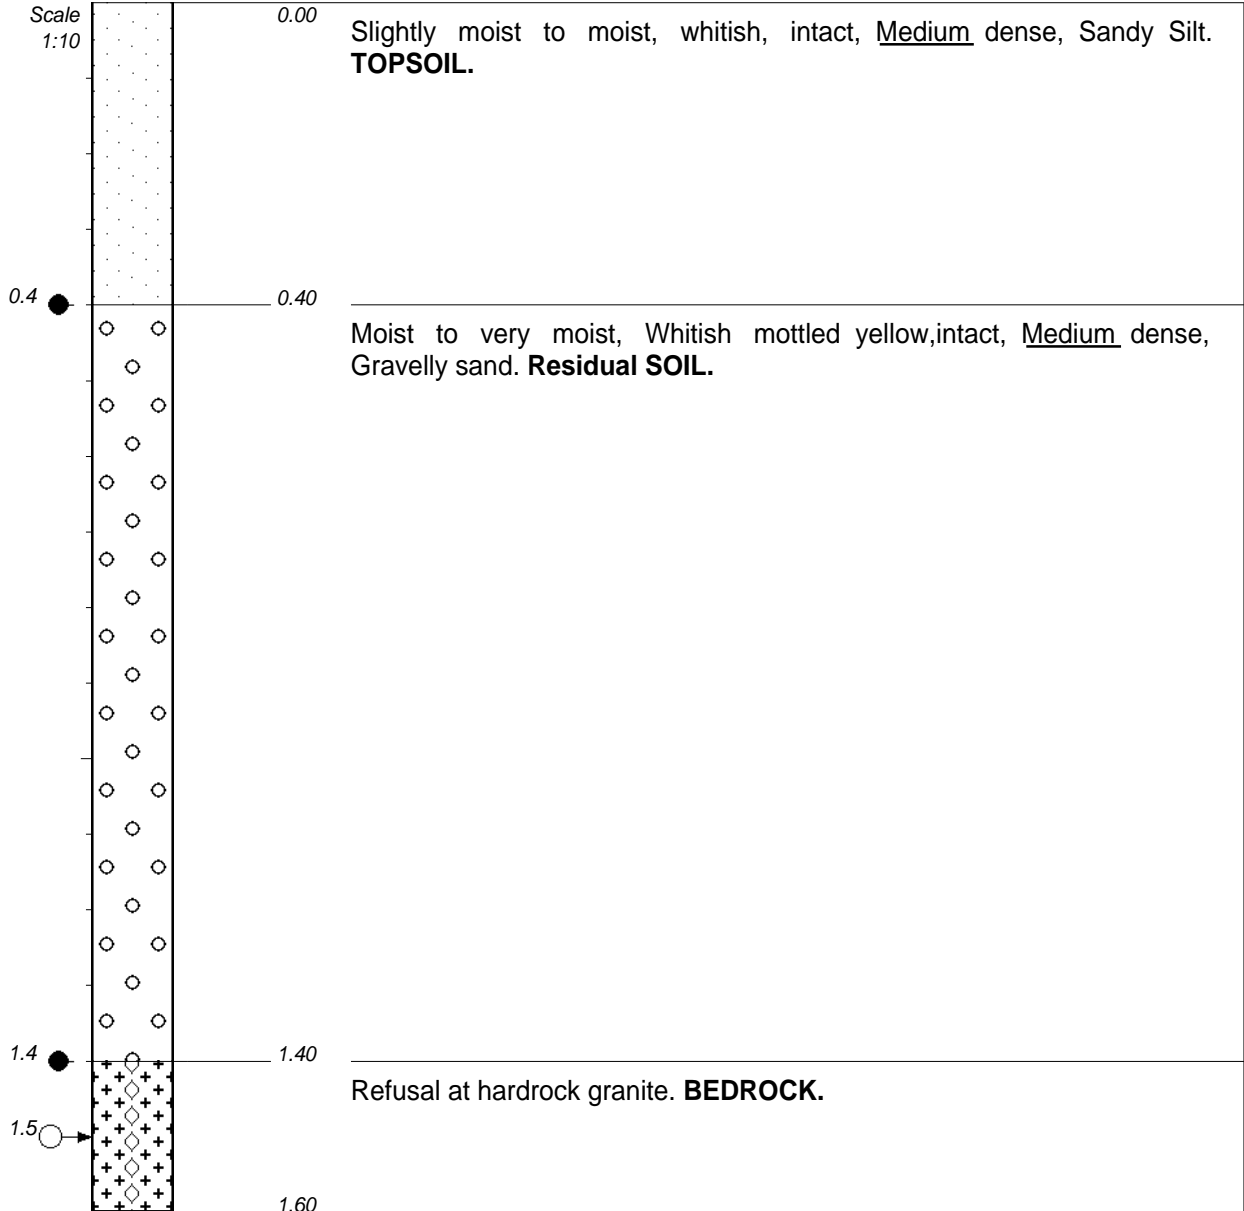
- NOTES**
- 1) Roots inclusion from a depth of 0 - 0.5m
  - 2) Stable side walls
  - 3) Water seepage encountered at 1.5 m
  - 4) Refusal encountered at 1.6 m
  - 5) Disturbed sample taken 0.4 - 1.4 m
  - 6) No Undisturbed sample taken
