**REPORT ON A PHASE 1 HIA FOR A PROPOSED TOWNSHIP DEVELOPMENT
ON PORTION 1 OF THE FARM WATERVAL 51R, NEAR MIDRAND
GAUTENG PROVINCE**

**SPECIALIST FAUNAL SURVEY FOR
PROPOSED DEVELOPMENT ON PART OF
THE REMAINDER OF PORTION 1 OF THE
FARM WATERVAL 5-IR;
GAUTENG PROVINCE**

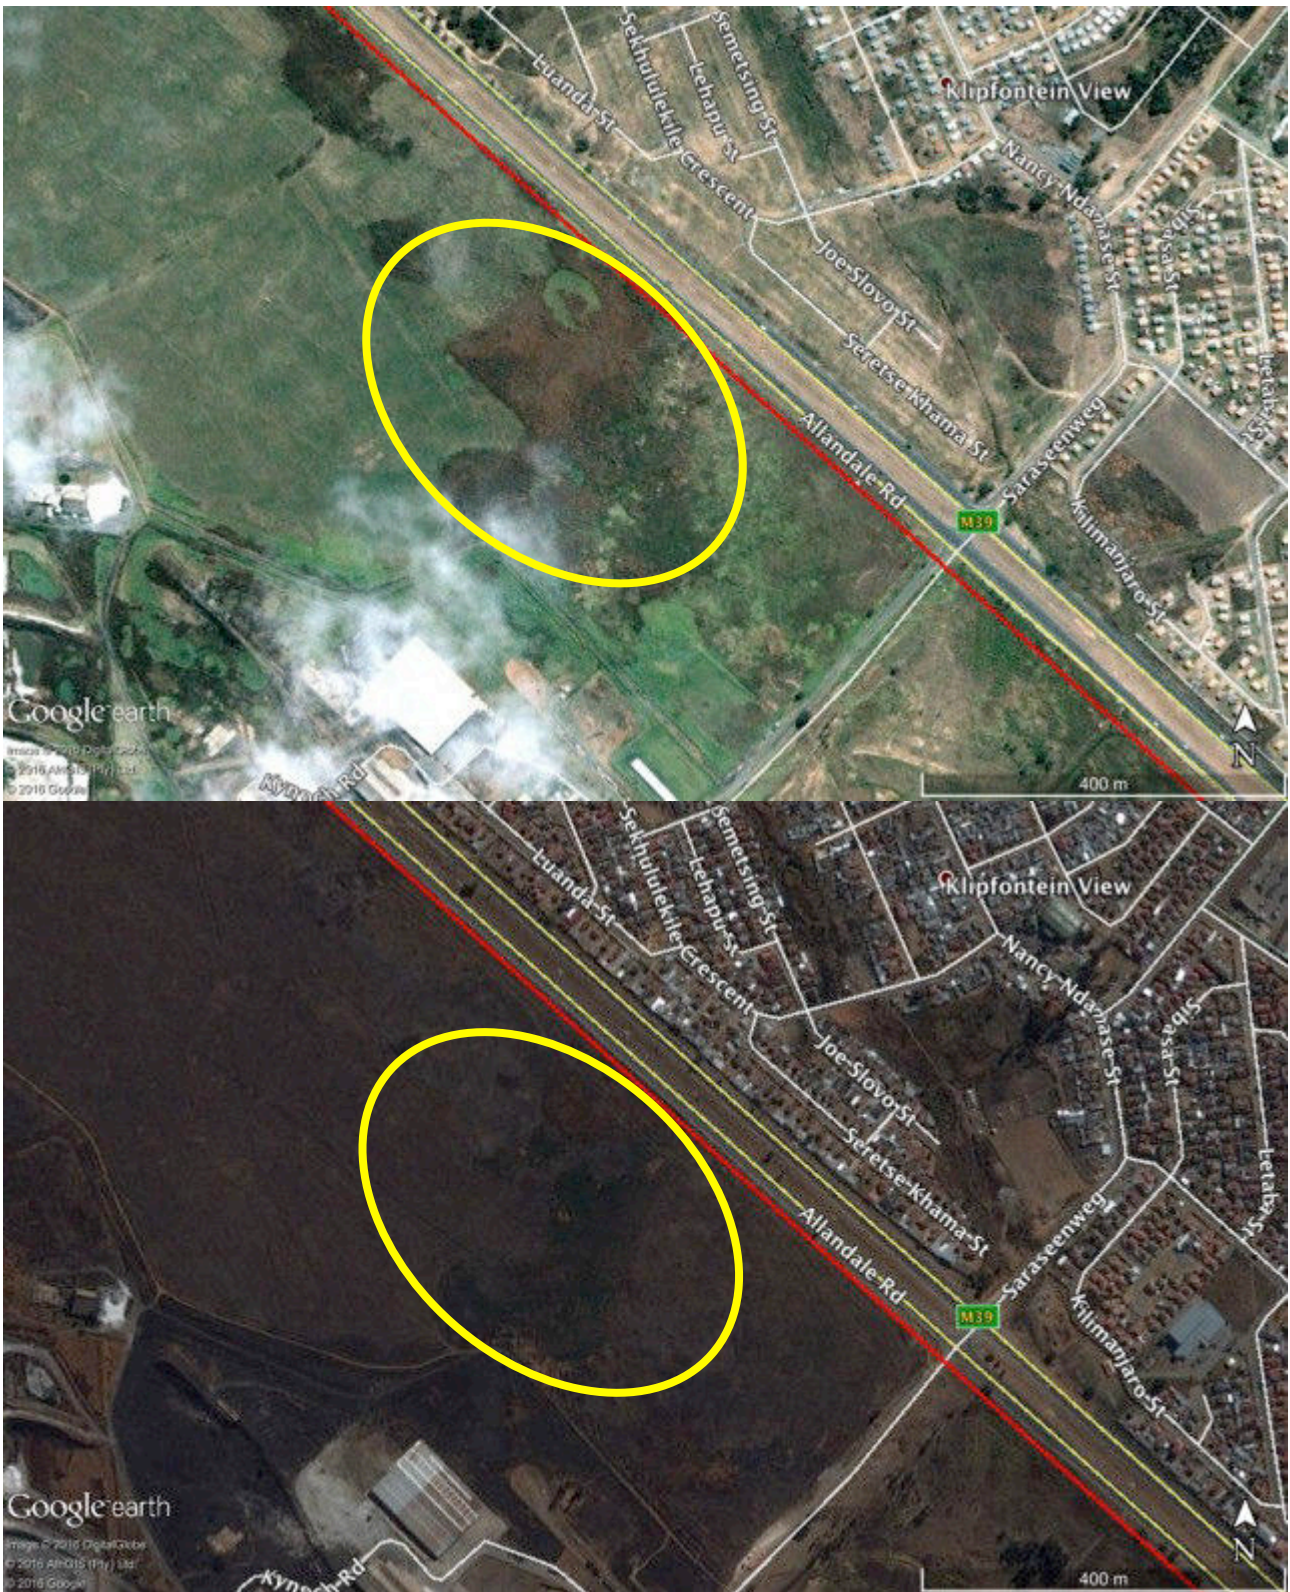
An apparent drainage depression was observed immediately north of the Kynoch site (**Figure 22**) and this feature has undergone the same alteration as the one to the south in the form of Allandale Road and its associated storm water infrastructure.

Figure 22 Google Earth images from 2003 (top) and 2015 (bottom) indicating the drainage feature

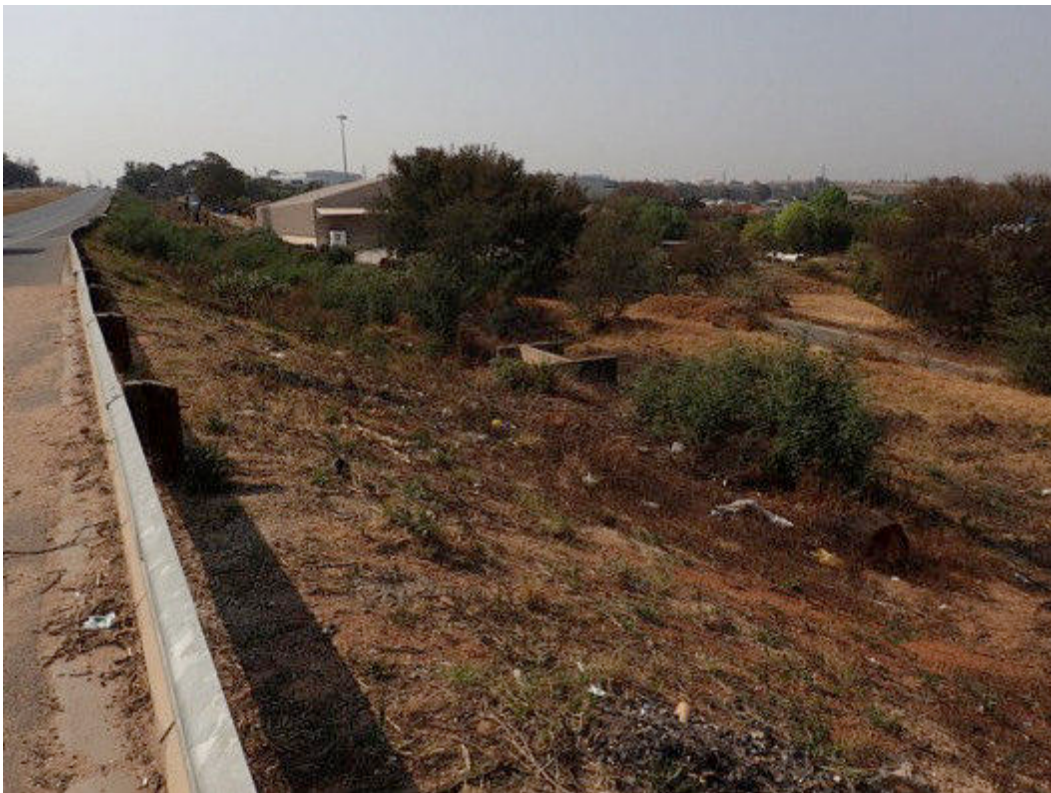
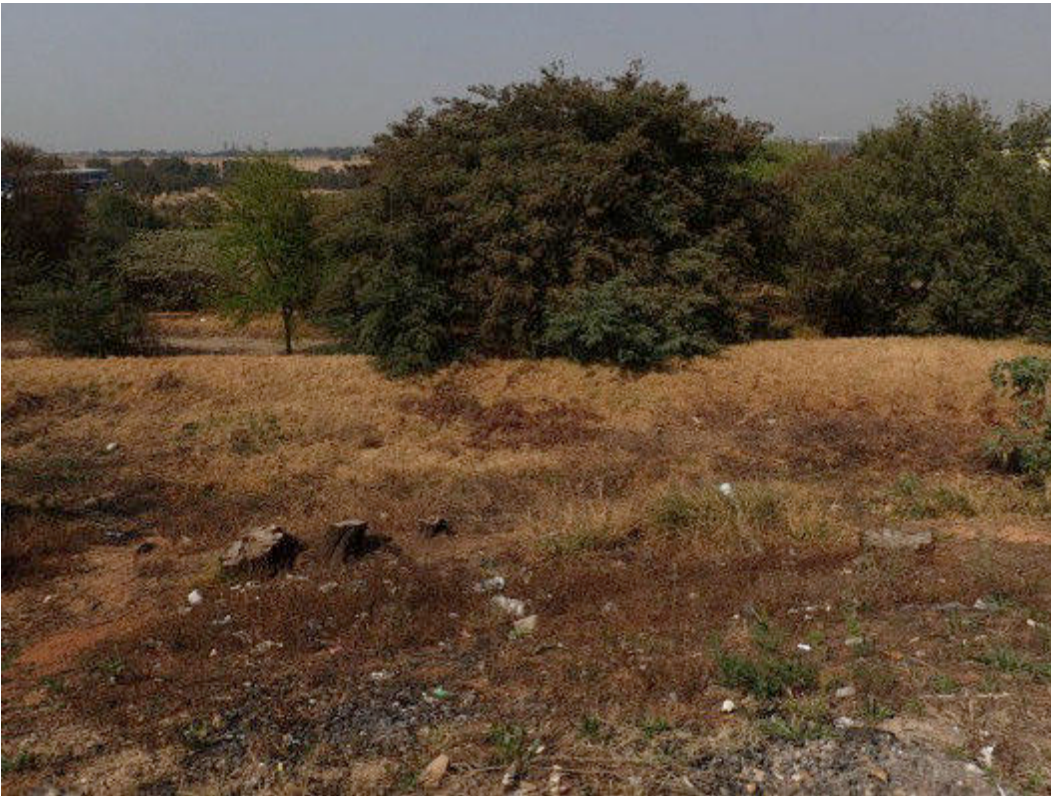
This site has been impacted significantly and no intact soil profiles were observed (**Figures 25 to 27**). The roadbed is wide and grades into an area downslope that has been subjected to the construction of a road, excavation and construction of storm water trenches and the impoundment of water further downslope.

Figure 25 View of Site 1 towards the east

Figure 26 View of Site 1 towards the south

Figure 27 View of Site 1 towards the west

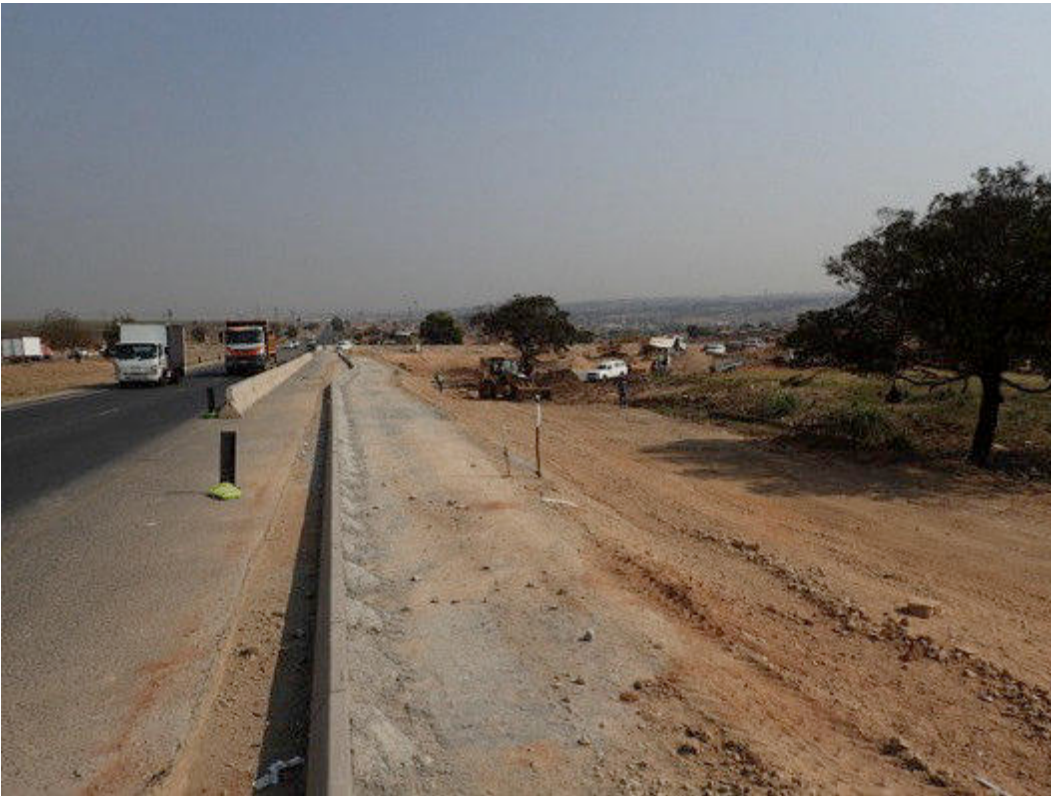
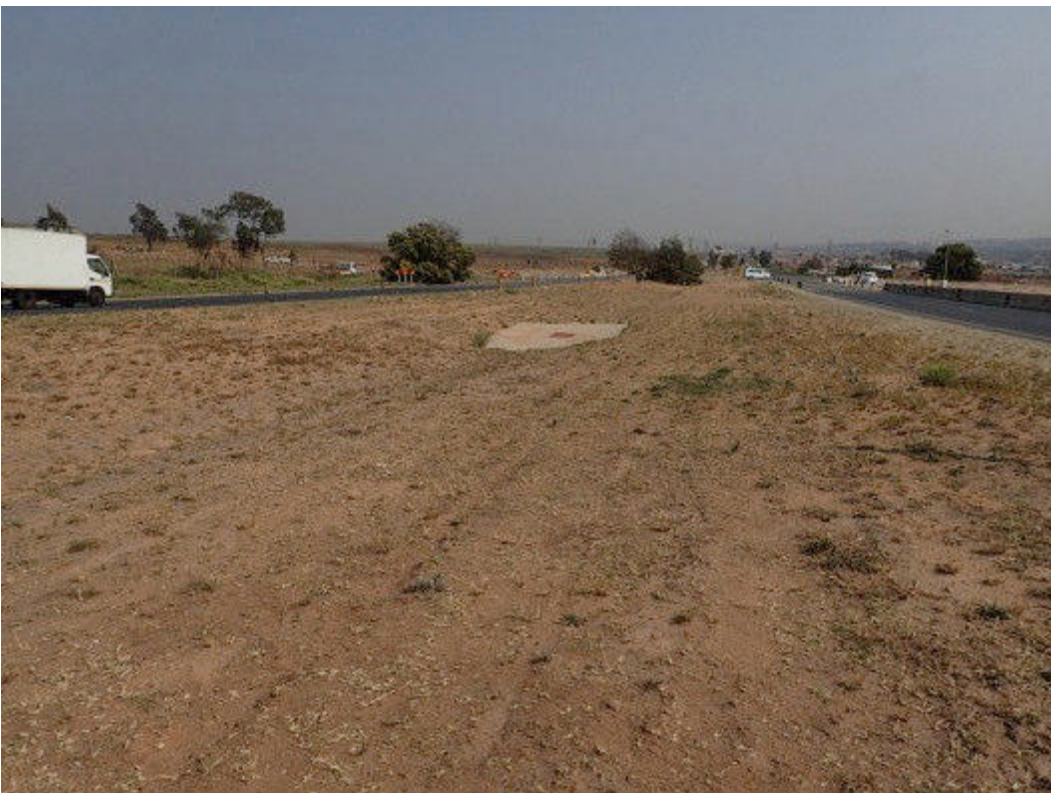
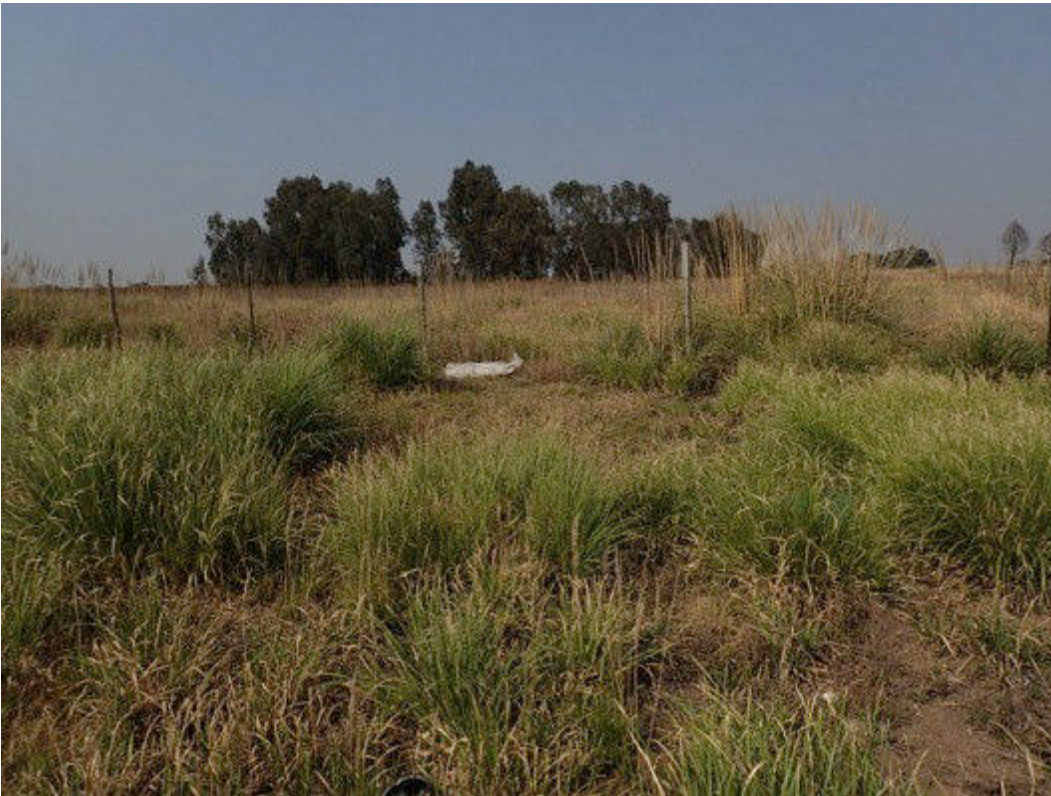
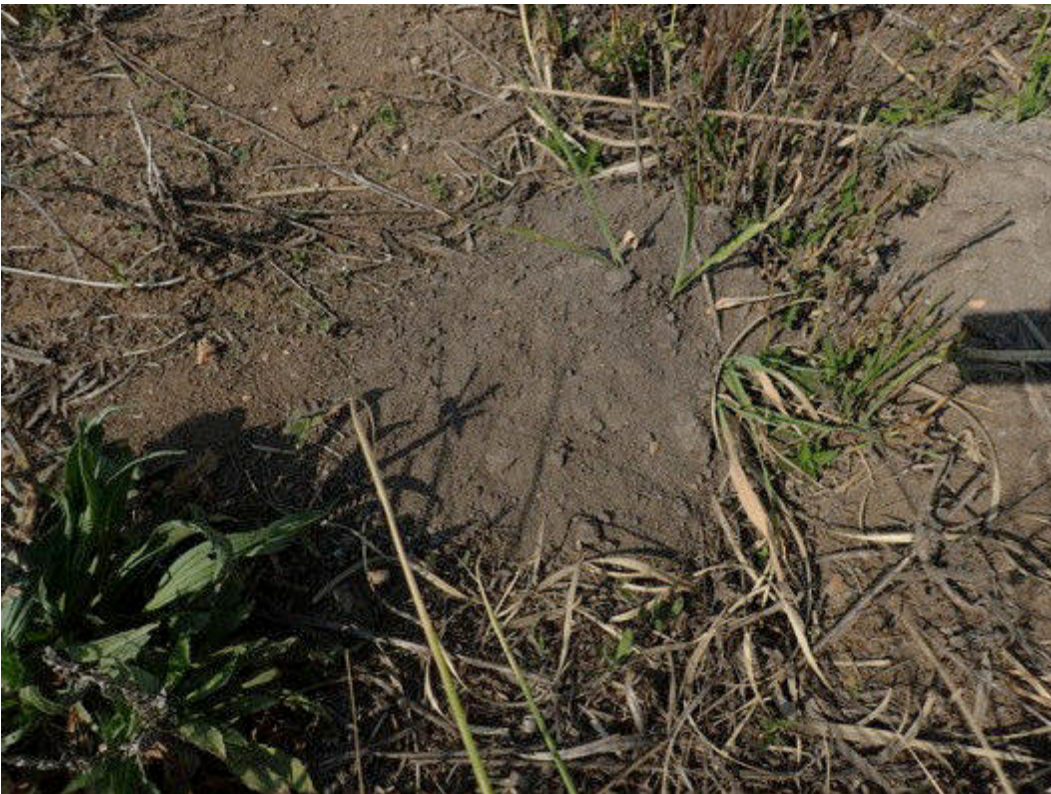
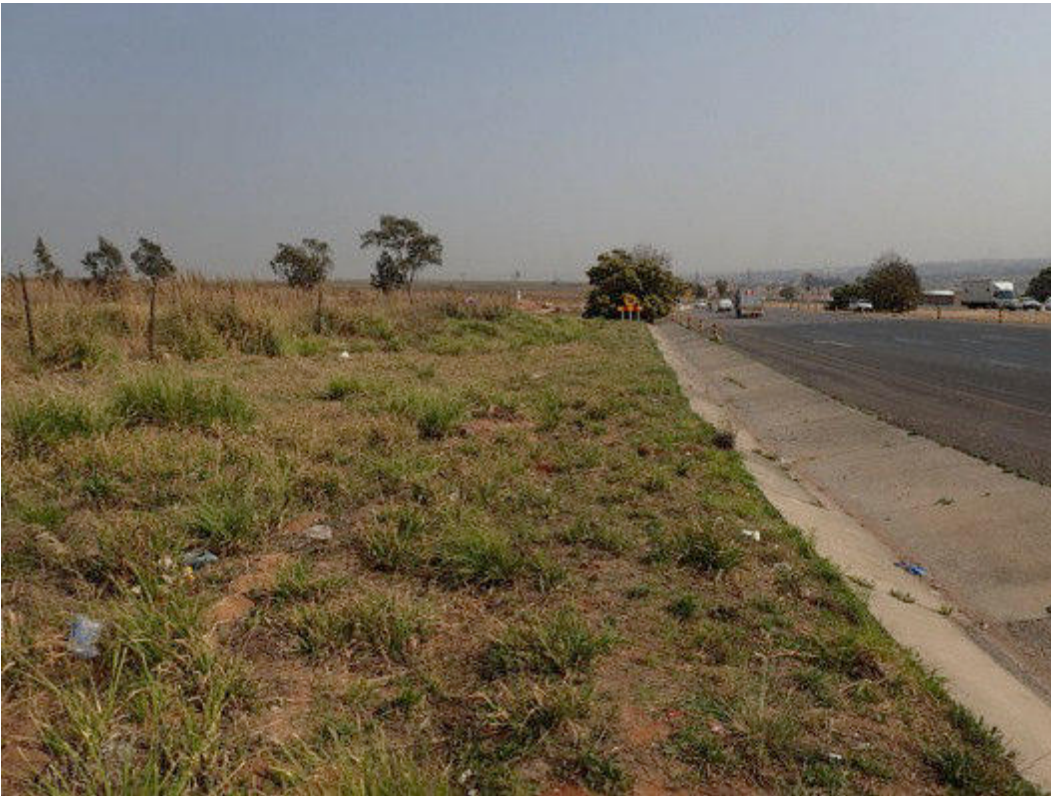
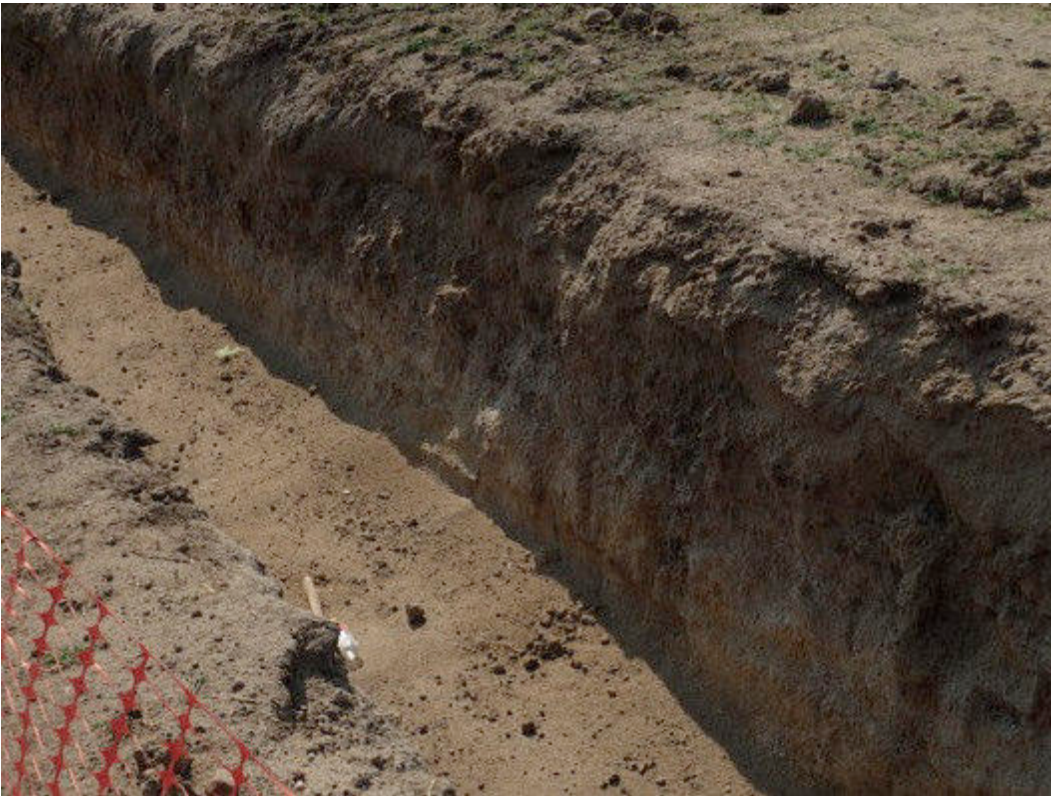
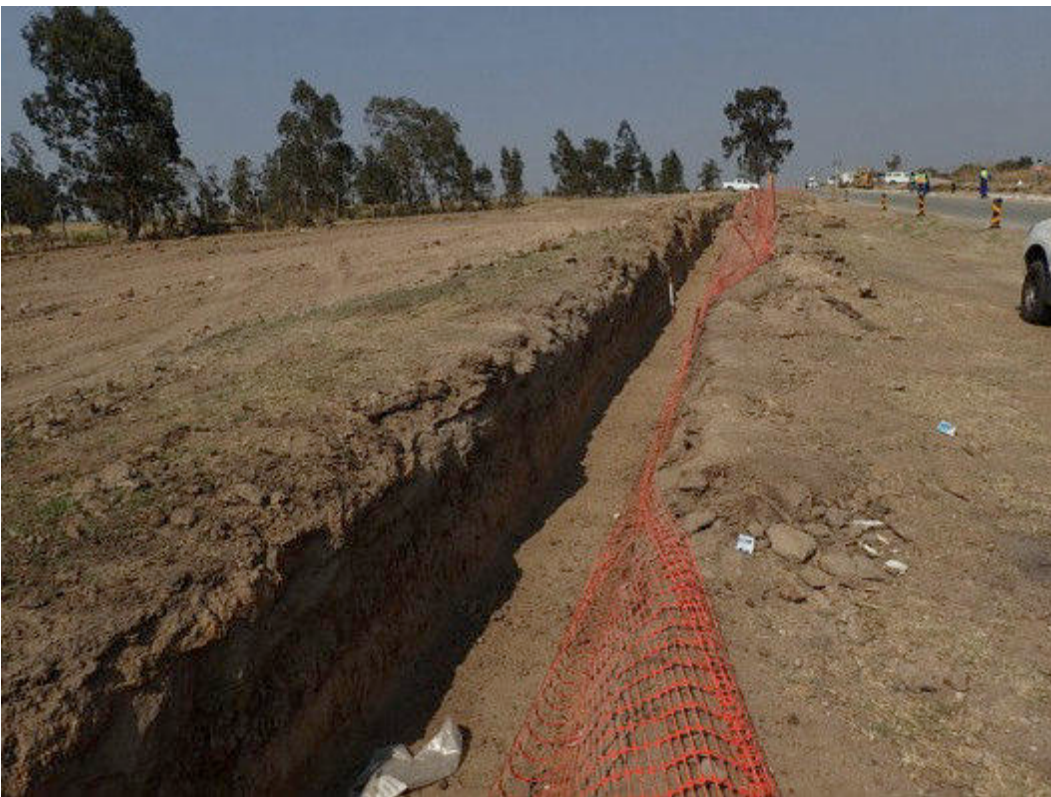
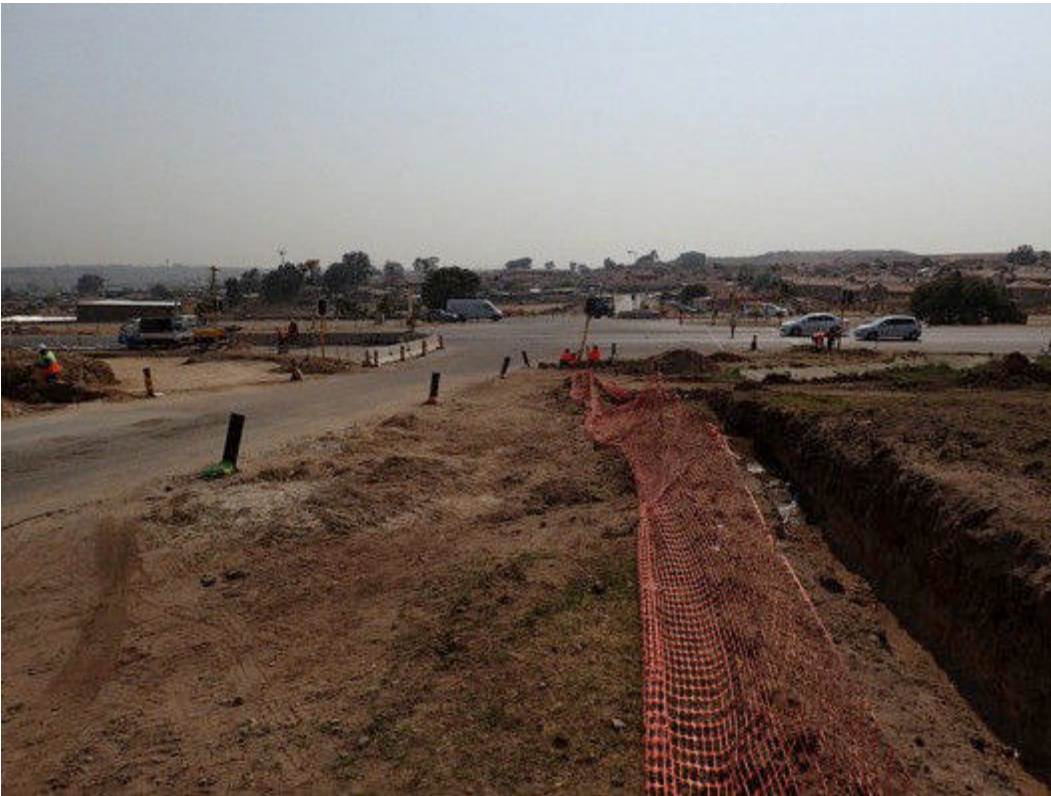
Site 2 is characterised by a large concave area that constitutes a typical headwater area with associated seepage zone of the HHGD. The soils associated with this type of area have been elucidated in sections 5.7 and 5.8. Allandale Road forms a distinct interception of the wetland and watercourse associated with the feature as does the access road to the old Kynoch facilities. The road interception and continual construction activities associated with this feature are indicated in **Figures 28 to 36**.

Figure 28 View of Site 2 towards the northwest with additional road infrastructure and storm water structures under construction

Figure 29 View of Site 2 towards the northwest with a storm water inlet between the two lanes

Figure 30 View of Site 2 towards the south upslope from Allandale Road with exotic vegetation indicative of a wetter part of the landscape

Figure 31 Darkened A horizon soil material on Site 2 that indicates an original seepage wetland zone

Figure 32 View of Site 2 towards the north west with Allandale Road and its storm water infrastructure evident

Figure 33 View of Site 2 towards the south with a seepage zone immediately above Allandale Road that has been intercepted and cut off by the associated storm water infrastructure

Figure 34 Current road works and trenching on Site 2

Figure 35 Current road works and trenching on Site 2

Figure 36 Current road works and trenching on Site 2

The soils of the site have been impacted in the infrastructure development area and the hydrological pathways have been intercepted. Within the road reserve as well as immediately on the edge of the roadways the soils have been altered to that of the Witbank soil form and extensive areas have been compacted. It is also evident on the upslope side of Allandale Road (**Figures 30 to 33**) that the lateral seepage of water has been intercepted by storm water infrastructure and that this water is forced to the surface with a subsequent flow into the storm water channel.

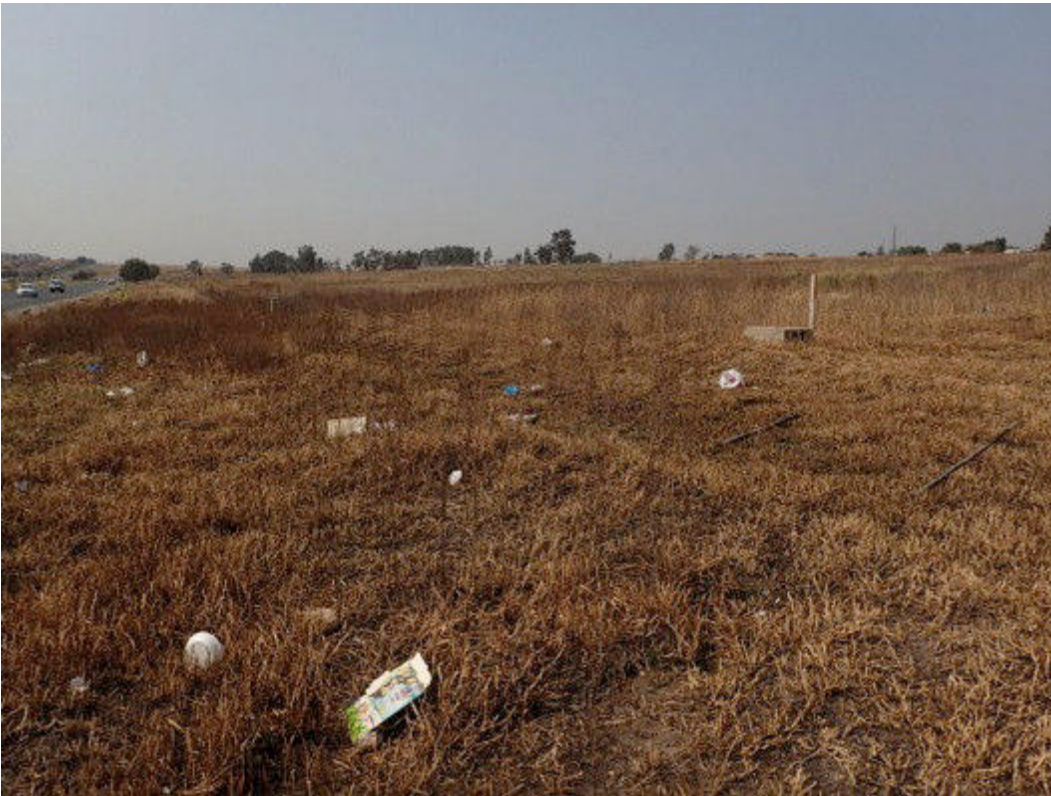
Figure 37 Kikuyu grass on Site 2 above Allandale Road (view to the southeast)

The drainage feature further to the north west on Allandale Road on Site 2 exhibits a similar pattern in terms of the severing of the lateral flow paths from the upslope areas. The vegetation is dominated extensive kikuyu grass growth and it appears that there are swales or surface soil disturbances evident immediately upslope of the road (**Figure 37 to 40**). This area on the road is characterised by a storm water inlet upslope from Allandale Road that appears blocked (**Figure 41**), a storm water inlet between the two roadways (**Figure 42**) and a storm water outlet between houses towards the drainage feature to the north (**Figure 43**).

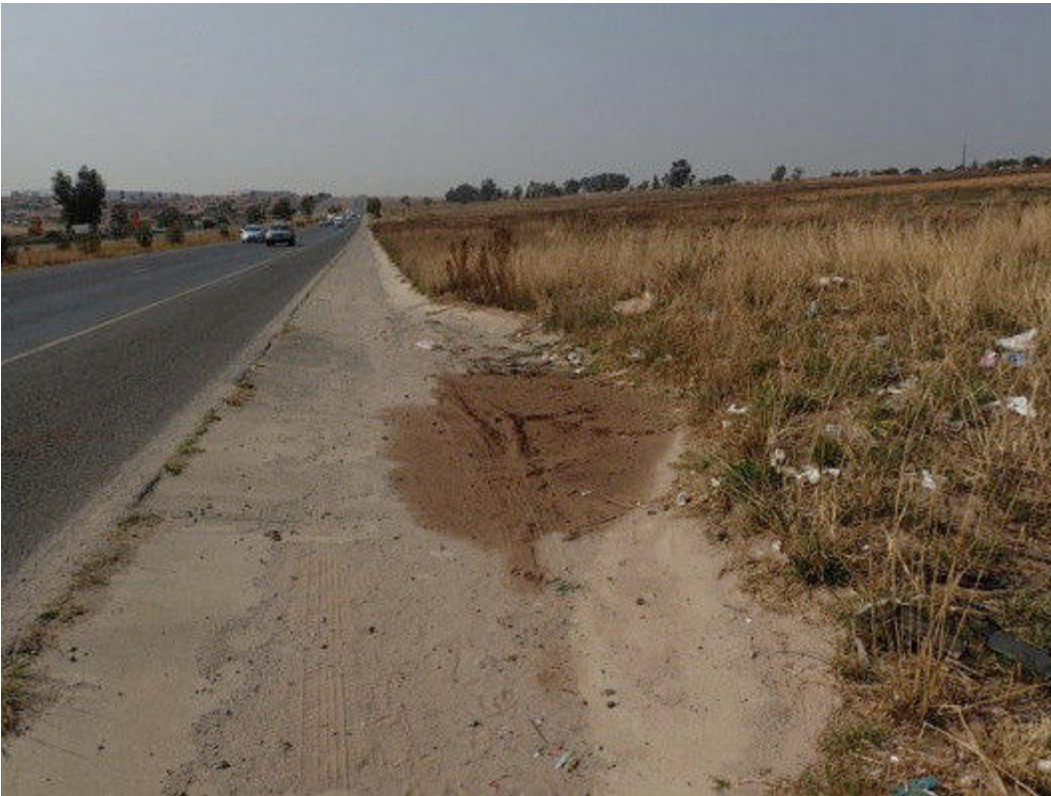
Figure 41 Blocked storm water inlet on Allandale Road on Site 2

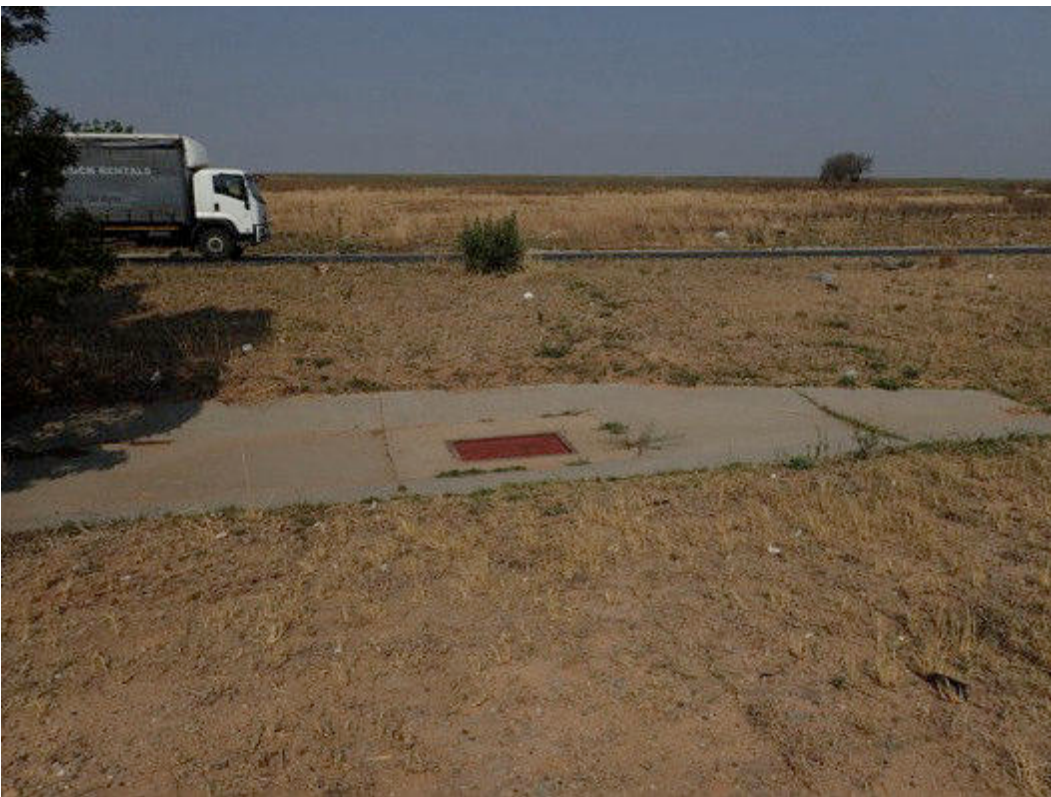
Figure 42 Storm water inlet on Allandale Road on Site 2 between the roadways

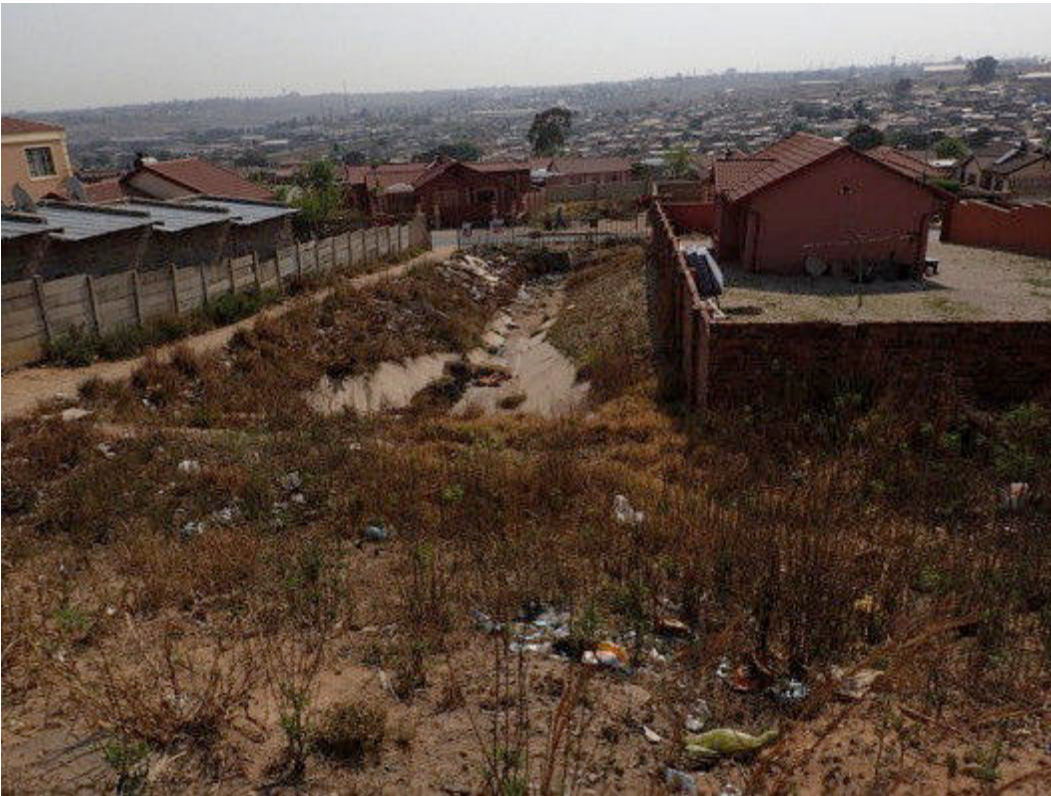
Figure 43 Storm water outlet on Site 2 towards the north of Allandale Road

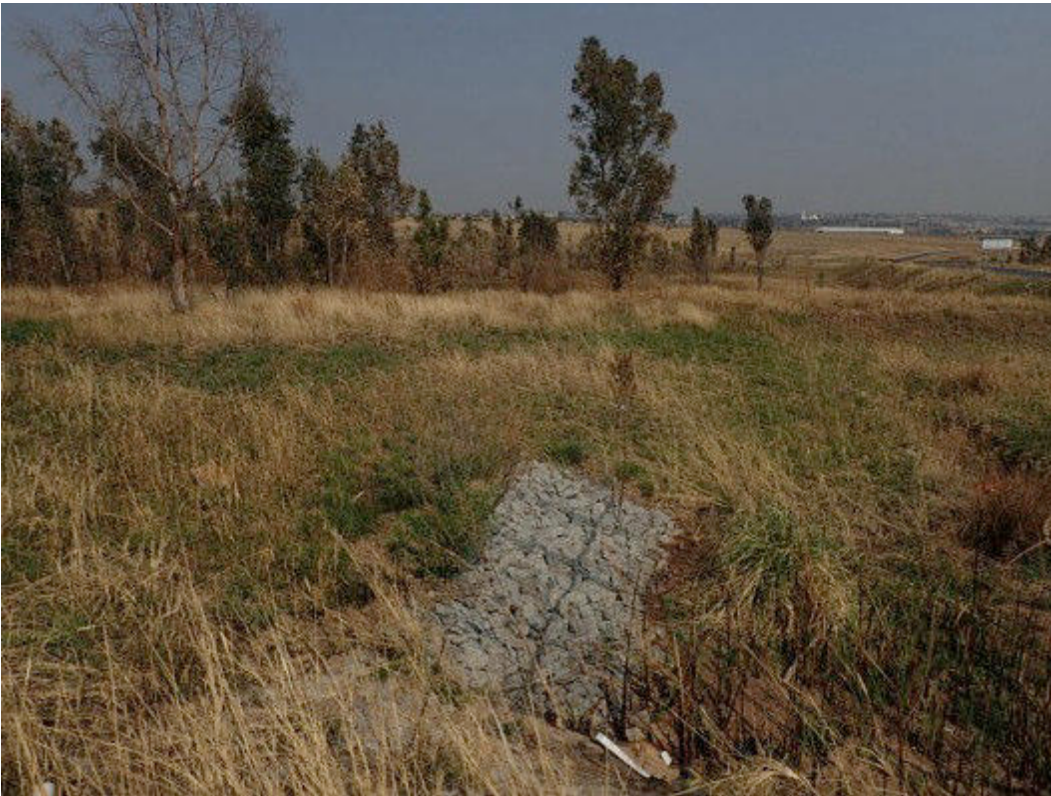
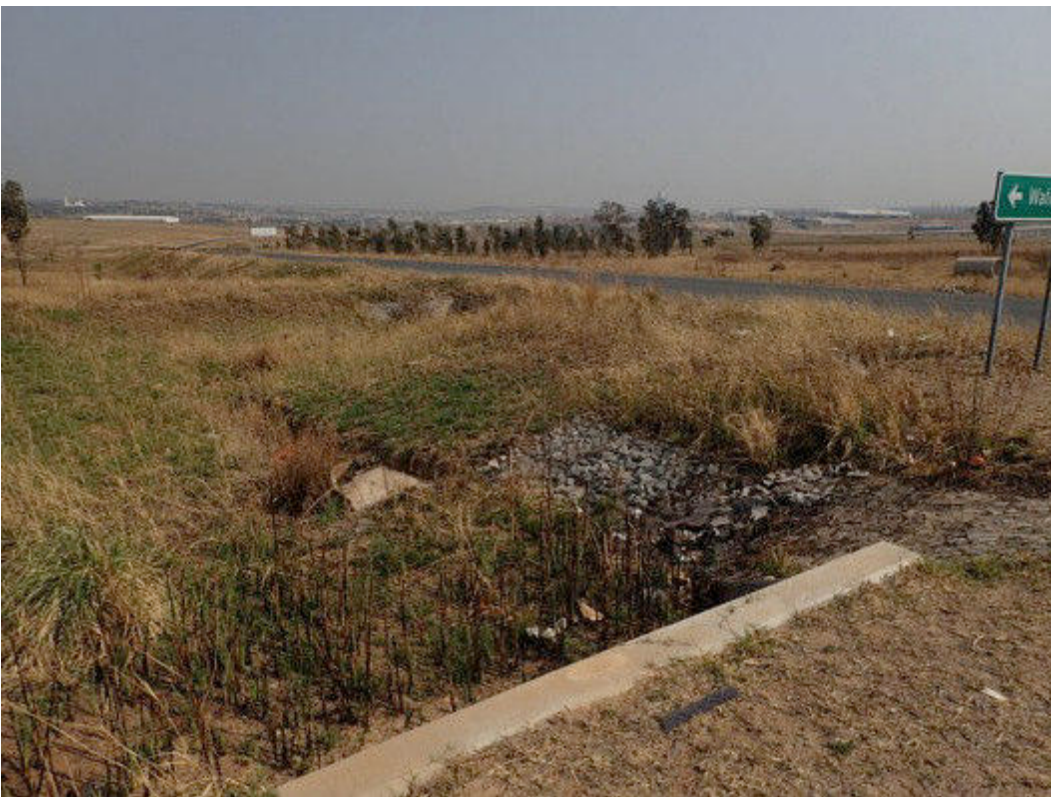
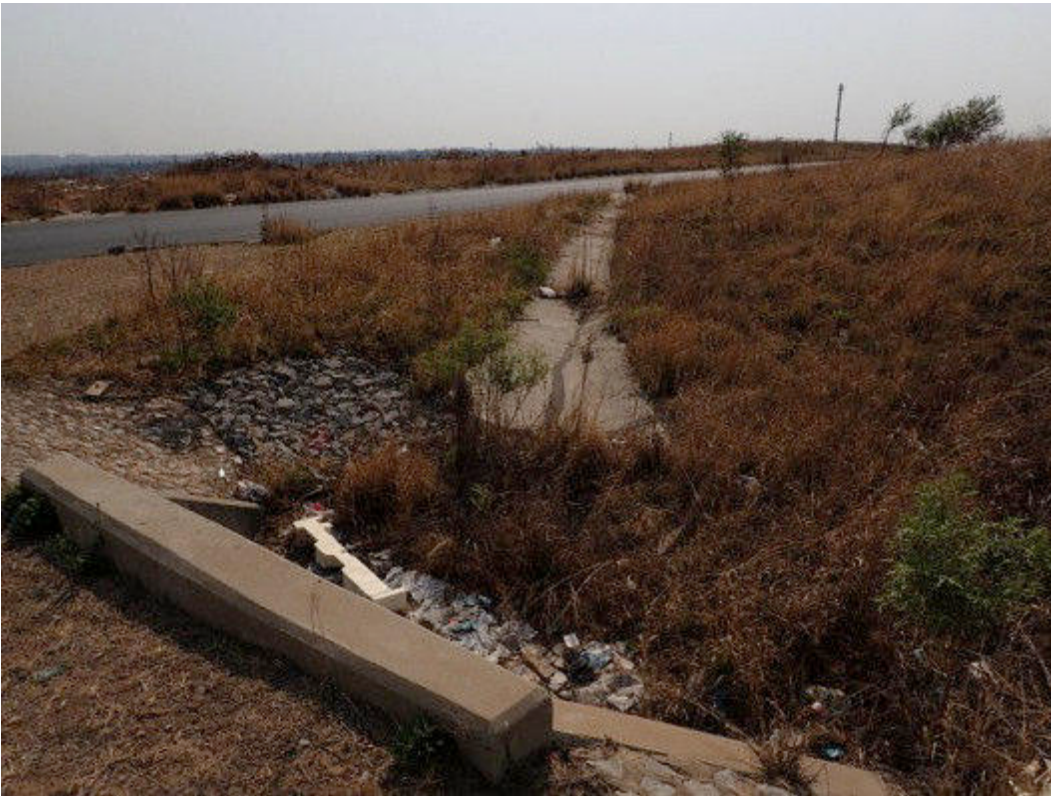
The access road to the Waterfall Cemetery has storm water infrastructure associated with it (**Figures 44 to 46**) and there is a distinct storm water channel that runs down the upslope side of Alsation Road (**Figure 47**). The area for the proposed extension of the access road and pipeline alignment is characterised by soils of the Wasbank and Dresden forms and as such have no wetland characteristics.

Figure 44 Storm water outlet under the access road to the Waterfall Cemetery

Figure 45 Storm water outlet under the access road to the Waterfall Cemetery

Figure 46 Storm water inlet under the access road to the Waterfall Cemetery

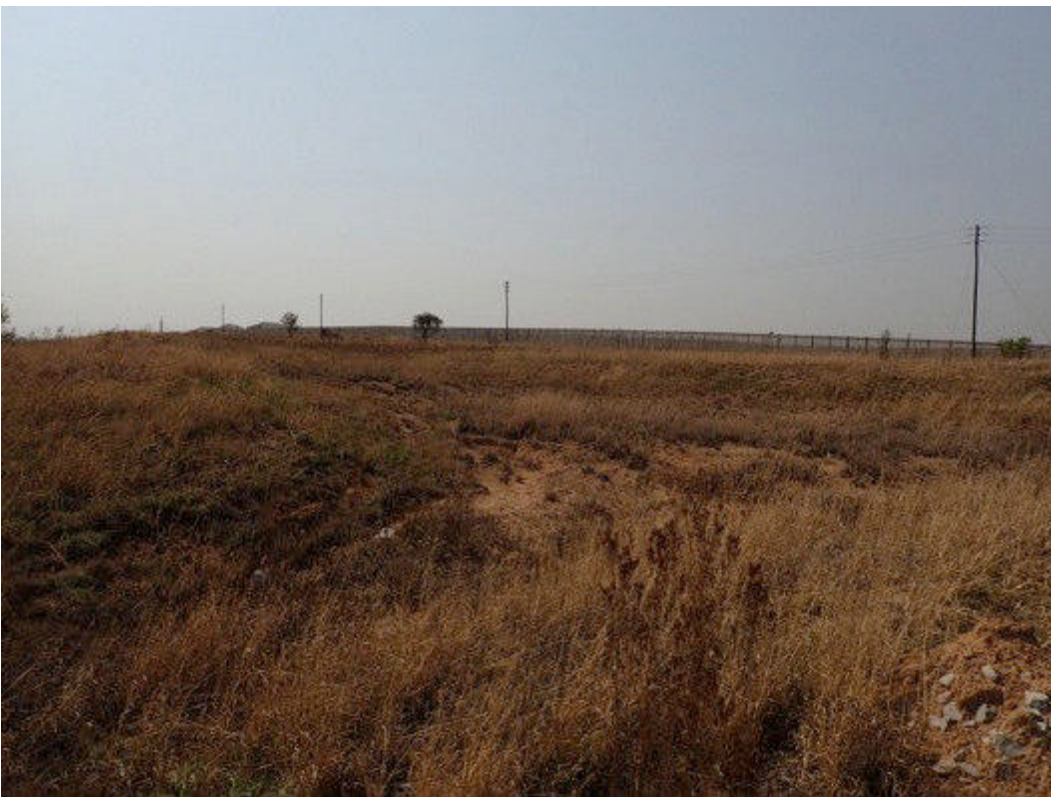
Figure 47 Storm water channel (unlined) running parallel to Alsatian Road above the access road to the Waterfall Cemetery

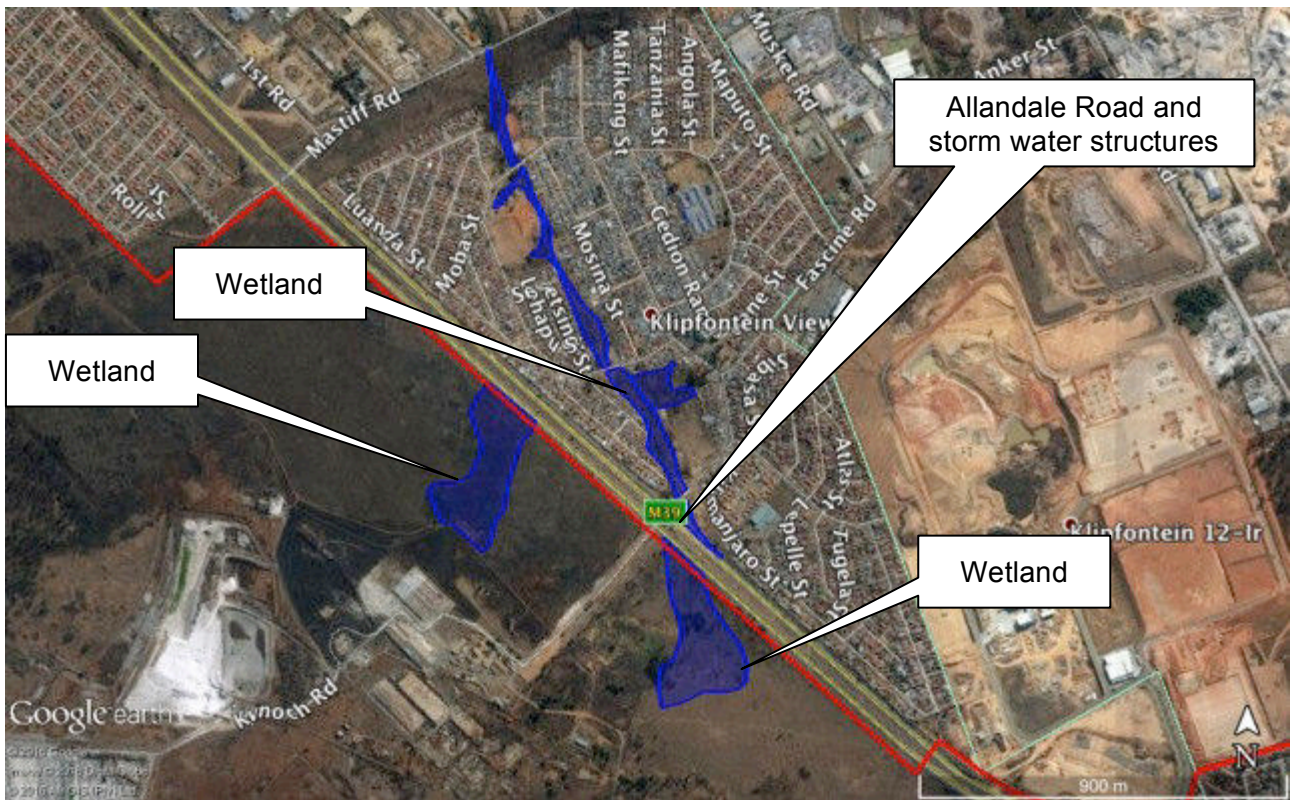
The high-level delineation of the wetlands on Site 2 is provided in **Figures 49 to 51**. The delineation was conducted on the historical images available for the site and excludes the areas that have been impacted by road construction and associated storm water structures.

Figure 49 Proposed high-level delineation and identification of urban impacts on Site 2

Figure 50 Proposed delineation and identification of urban impacts on Site 2

Figure 51 Proposed delineation and identification of urban impacts on Site 2

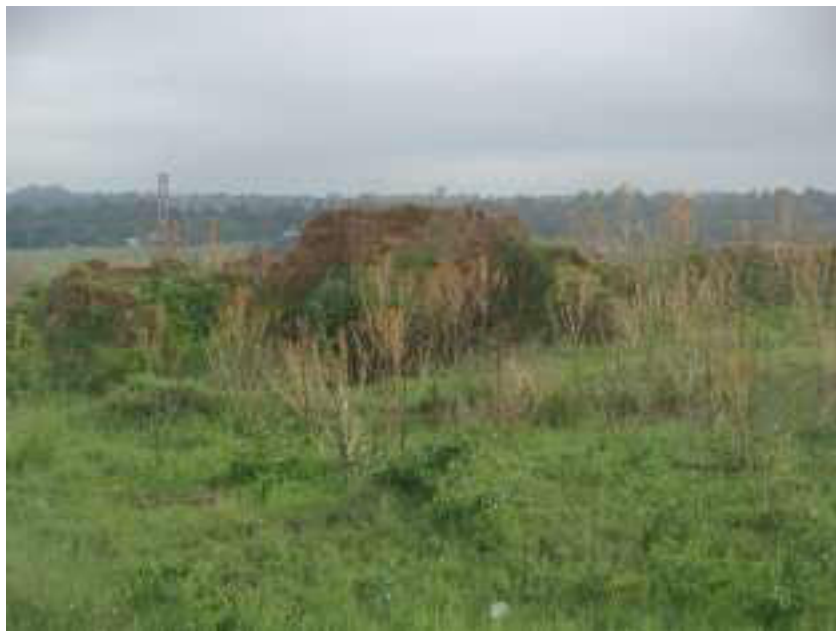
Figure 7: General view of the remains of a clay-built structure on Site 1.

Only two sites were identified and recorded during the assessment and both consist of the remains of what could possibly be farm labour homesteads constructed of clay and plaster. No other sites or features were found. The age of these sites could not be determined. No graves or cemeteries were located in the larger study area, although these could be present in close proximity to the homesteads. None were however noticed in these areas. The possible significance of these features are further diminished by the nearly total destruction and natural degradation of both.

Field Ratings: General protection C (IV C): phase 1 is seen as sufficient recording and it may be demolished (low significance)

Mitigation: None required. Should any low stone packed or unmarked graves be found in close proximity these should be mitigated. Social consultation should be undertaken.

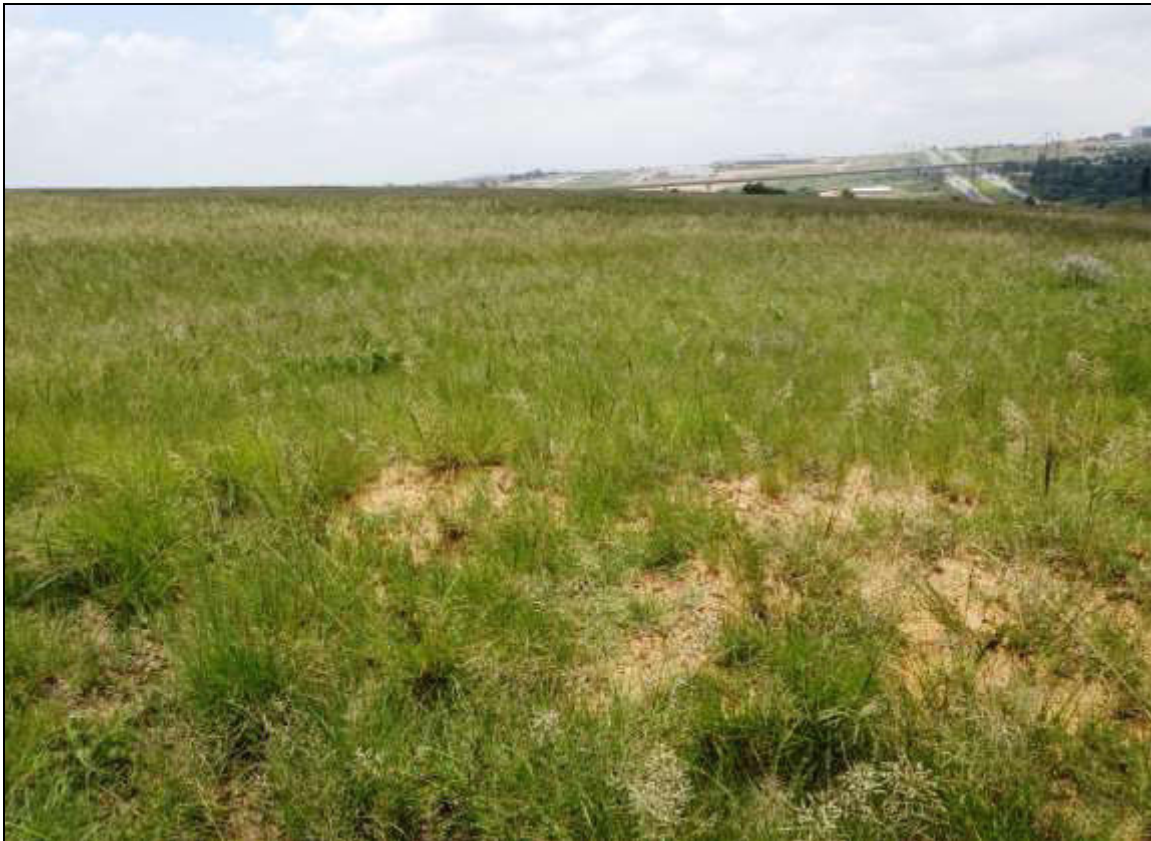
Figure 3: Secondary grassland on site.

The two natural vegetation types occurring on site are grassland and wetlands. Both have been heavily impacted and there is little remaining in good condition. The grasslands on site (Figure 3) are intact in places, but degraded in others. Degradation is due primarily to historical disturbance, as described in the section above (“Landuse and landcover”).

Secondary grassland on site has a uniform species composition dominated overwhelmingly by weeping lovegrass, *Eragrostis curvula*. Local species richness is low, approximately 5 species per 100m², as is expected in a secondary grassland. Overall diversity is also relatively low, with only 41 species recorded throughout the entire site within secondary grasslands, of which 14 species are exotic weeds and/or declared invader species. Vegetation cover is good and there is limited recent disturbance.

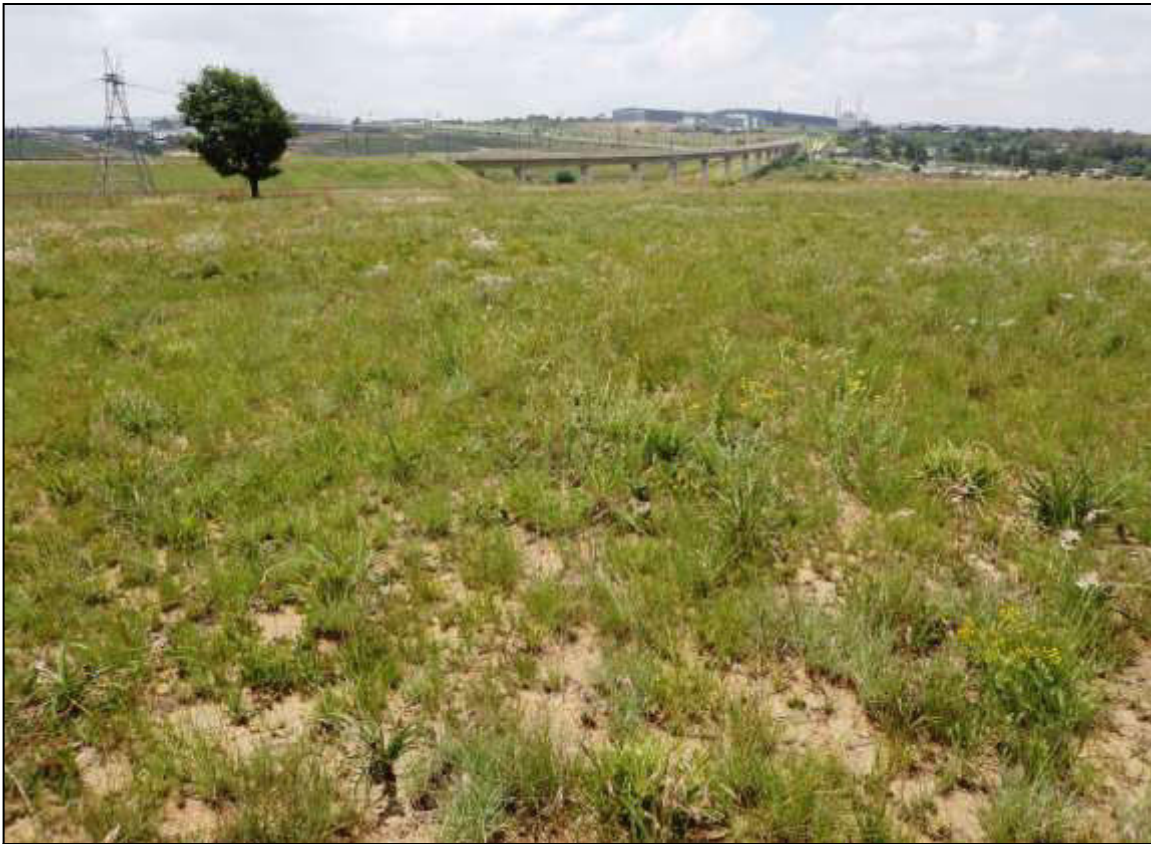
Figure 4: Natural grassland on site with mixed species composition.

has a relatively good species composition (Figure 4). A total of 70 plant species were recorded on site within these natural grassland areas, with local species richness being approximately 40 species per 100m². Most of these are indigenous species expected within natural grasslands with very few weeds. There is no dominance by any single species.
