**REPORT ON A PHASE 1 HIA FOR A PROPOSED TOWNSHIP DEVELOPMENT
ON PORTION 1 OF THE FARM WATERVAL 51R, NEAR MIDRAND
GAUTENG PROVINCE**

**SPECIALIST FAUNAL SURVEY FOR
PROPOSED DEVELOPMENT ON PART OF
THE REMAINDER OF PORTION 1 OF THE
FARM WATERVAL 5-IR;
GAUTENG PROVINCE**

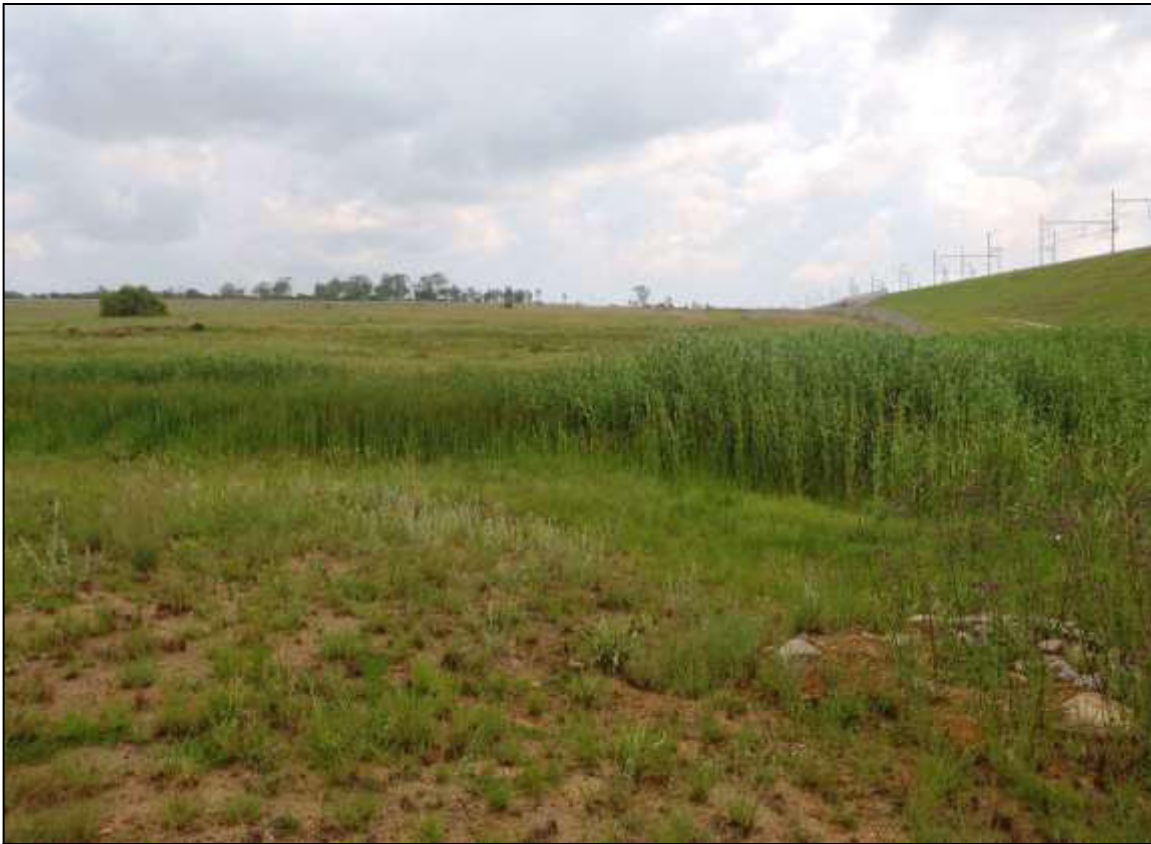
Figure 5: Wetland vegetation on the lower end of the site.

The wetlands on site are in moderate condition and, in the permanently wet areas, dominated by *Phragmites australis* and *Typha capensis* (Figure 5). It has been invaded in places along its margins by *Eucalyptus* trees and there are paths crossing it in various places as well as a road cutting through the top end of the one wetland system. From a vegetation point of view, the wetland is considered to be ecologically functional.

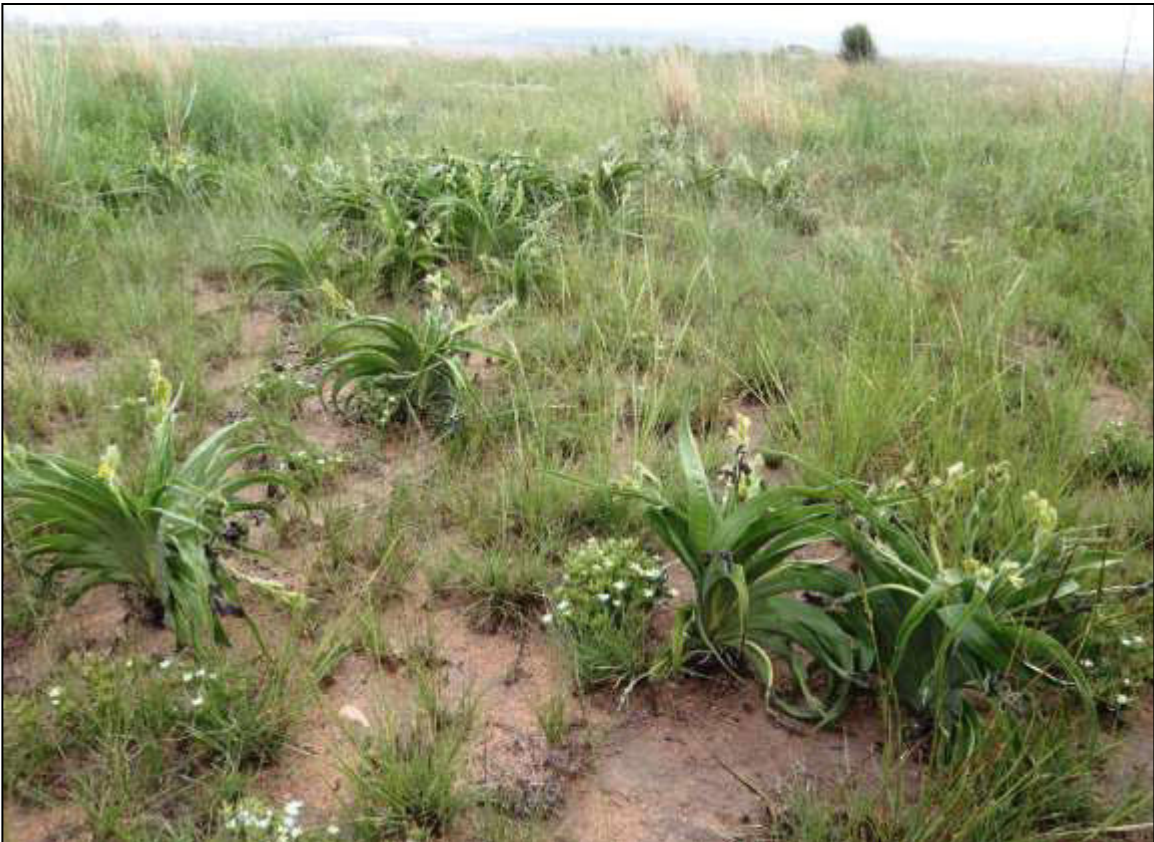
Figure 5: Plants of the Declining plant species, *Hypoxis hemerocallidea*, found on site.

A Declining plant species was recorded on site. This species (*Hypoxis hemerocallidea*) was recorded as a relatively large population scattered throughout the site within grasslands (Figure 5). It is estimated that a few hundred individuals occur on site. The species is not listed as a priority species in Gauteng for conservation purposes and the GDACE Red List Policy provides no guidelines for the retention or management of populations of Declining plant species. This is a relatively widespread species in South Africa, often found in moist grasslands on slopes overlooking drainage lines. It is declining due to harvesting for medicinal purposes. It is proposed that, should development of the site proceed, all individuals of this population are rescued by an approved organisation and housed at an appropriate nursery.

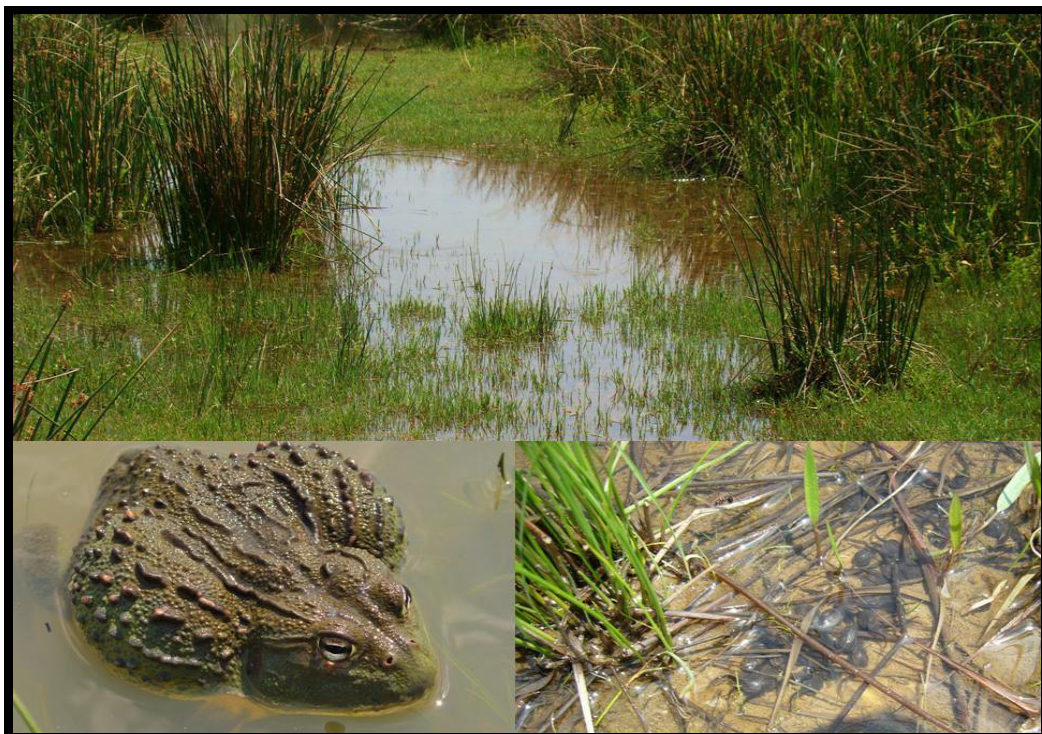
Figure5. Giant Bullfrog breeding was previously recorded within seasonally inundated pools within the central valley bottom wetland. A single clutch and adult male was observed. High levels of predation resulted in a small school of tadpoles (<100).

Bullfrog populations have declined dramatically over the past twenty years especially in the Midrand and Fourways area. Continual destruction and deterioration of suitable breeding and foraging areas have resulted in the disappearance of several smaller Giant Bullfrog populations. The majority of records (post 2000) of Giant bullfrogs from the Glen Austin Agricultural Holdings area are of migrating adult males usually found dead on the roads as well as a large breeding populations to the north-east of the site (Glen Austin population). Giant Bullfrogs have been previously recorded (1994 and 2004) by the consultant breeding within seasonally inundated hygrophilous sedge and grass dominated pools within the central valley bottom wetland.

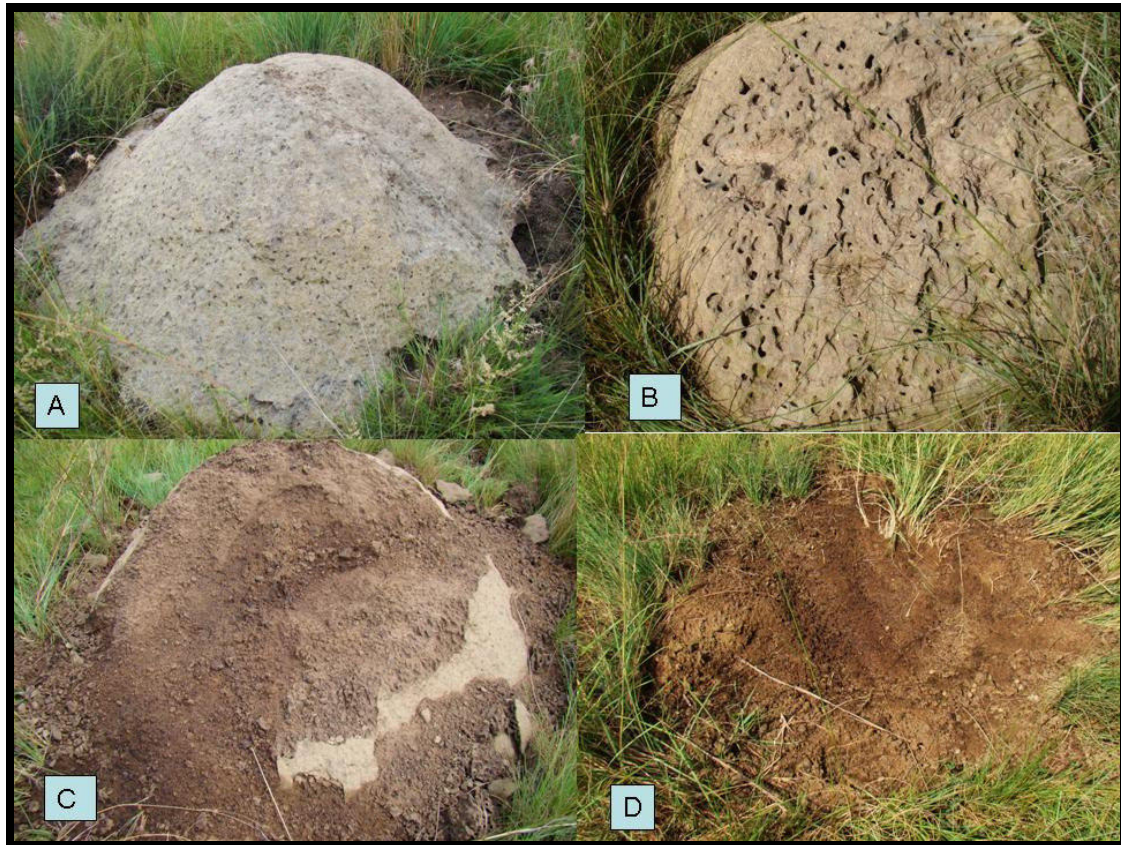
Figure 6. Several large termite mounds *Trinervitermes spp.* were observed within the moist grassland adjacent to the tributary of the Jukskei River on the northern portions of the site. A: Large termite mounds (1m²) were observed along the grasslands above the southern banks of the Jukskei Tributary. **B:** Moribund (old abandoned or dead mounds) termite mounds offer important refuges for numerous frog, lizard and snake species (Striped Harlequin Snake). Large number of species of mammal, birds, reptiles and amphibians feed on the emerging alates (winged termites). These mass emergences coincide with the first heavy summer rains and the emergence of the majority of herpetofauna. Termite mounds also provide nesting site for numerous snakes, lizards (varanids) and frogs. **C & D:** Several large termite mounds have recently been destroyed. Termite mounds are destroyed during illegal reptile collecting as well as for feeding aviary birds as well as exotic reptiles.
