## 5. SENSITIVE ENVIRONMENTS/HABITATS ON THE WATERVAL SITE:

# Waterval Bulkwater Supply

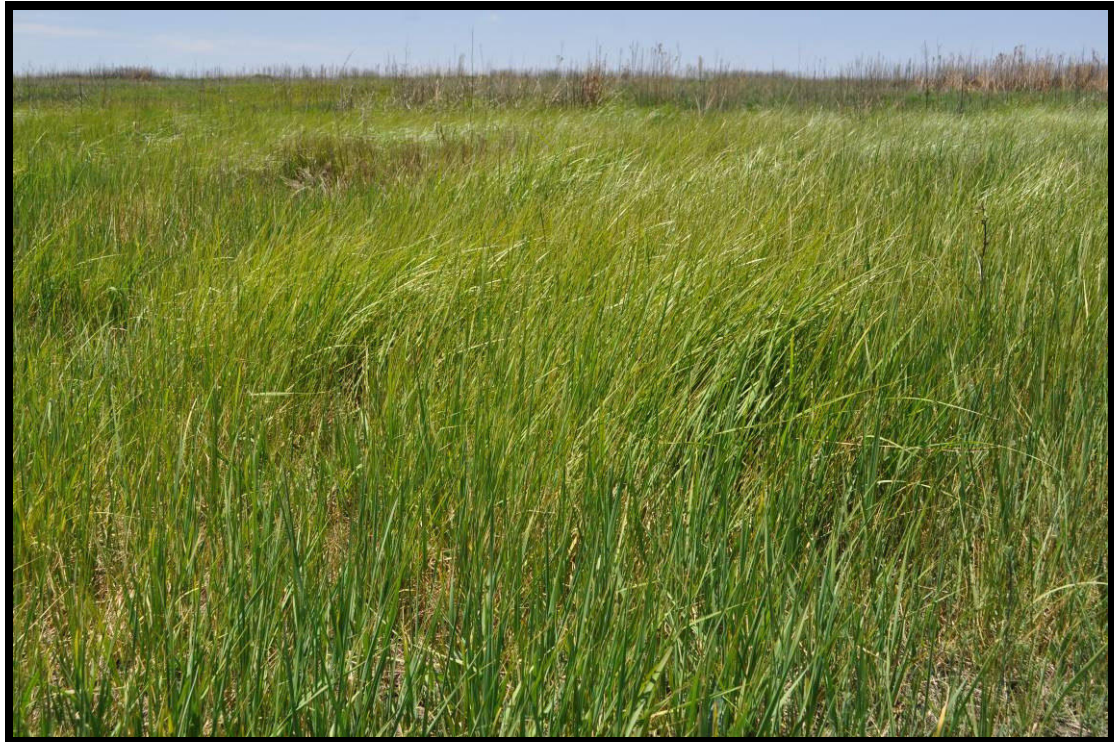
**Figure8.** The limited rank hydrophilic sedge and grass patches within the central valley bottom wetland provide suitable roosting and foraging habitat for African Grass Owls. The high levels of human disturbances on the site including hunting with dogs; severely restricts the likelihood of any nests and limits potential roosting suitability. The annual burning of the site restricts the vegetative cover along the valley bottom wetland. Off-road bikes, quads and vehicle tracks transverse the entire site as well as helicopter training and landing on the site and open areas to the south of the site adjacent to the Waterval cemetery.

Limited suitable roosting and foraging habitat exists within the small patches of rank hygrophilous and hydrophilic sedges and grasses within the central valley bottom wetland.. Due to current high levels of human disturbances (frequent cutting and harvesting of thatch, illegal hunting activities) on the site and surrounding areas limit the likelihood of successful nesting activities. It does not seem to adapt to transformation of its preferred rank grassland habitat into short grasslands, crop or grazing land. Its habit of nesting on the ground may make it susceptible to disturbances by people and livestock as well as dogs. No African Grass Owls or Marsh Owls were flushed during the current field survey. African Grass Owls have been flushed from the central valley bottom and seepage areas to the north of the site along the Jukskei River in 2006.

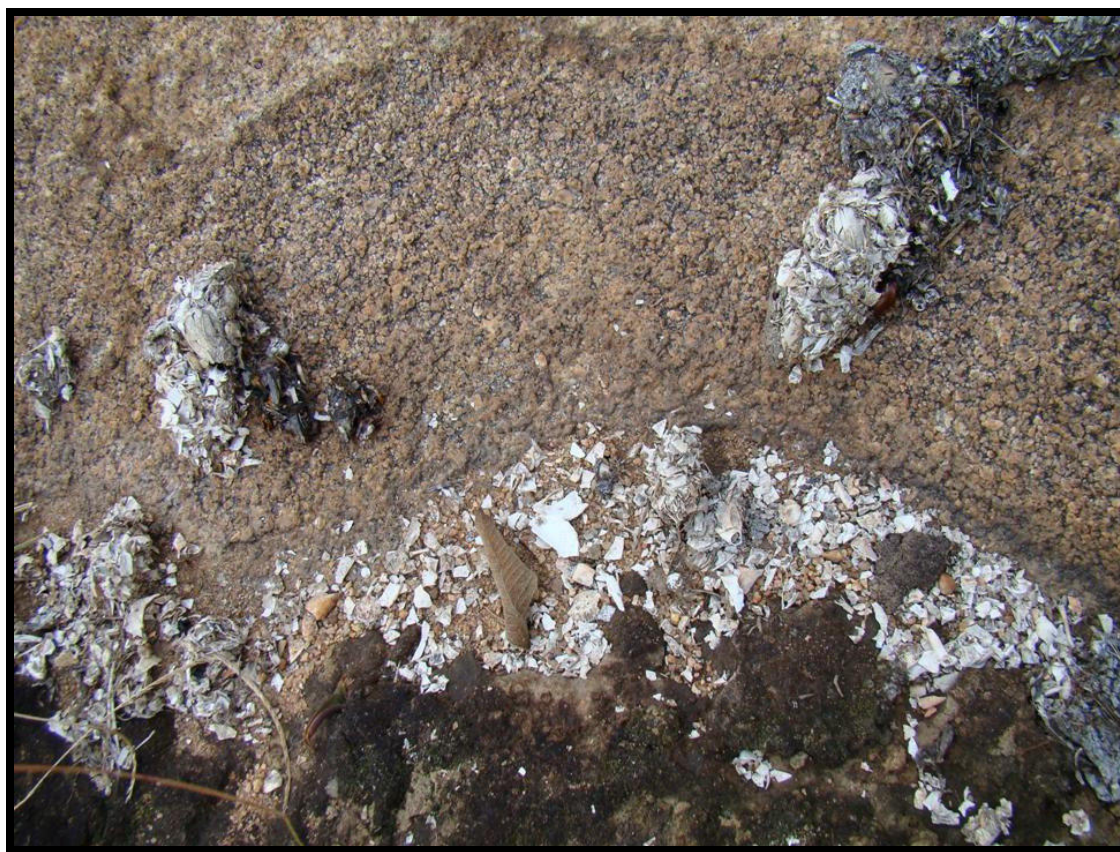
**Figure10.** The latrine of a Cape Clawless Otter was observed on the northern banks of the Modderfonteinspruit to the southeast of the site as well as along the Jukskei River during previous surveys.

The latrine of a Cape Clawless Otter was observed on the northern banks of the Modderfontein Spruit. The permanent dams with dense reed invaded margins offers suitable refuge habitat for remaining Cape Clawless Otters. Suitable foraging areas occur along the dams on the Modderfonteinspruit as well as Jukskei River. The wetland habitats on the site are isolated from surrounding suitable habitat to the north-east by large areas of transformed old agricultural lands as well as the Gautrain alignment and Allandale and Alsation roads or “high risk” areas for Otters. The surrounding dams contain suitable prey items including crabs, frogs, fish and other aquatic life. The presence of several hunting dogs and wire snares on and around the site and neighbouring properties is an immediate threat to remaining Cape Clawless Otters.

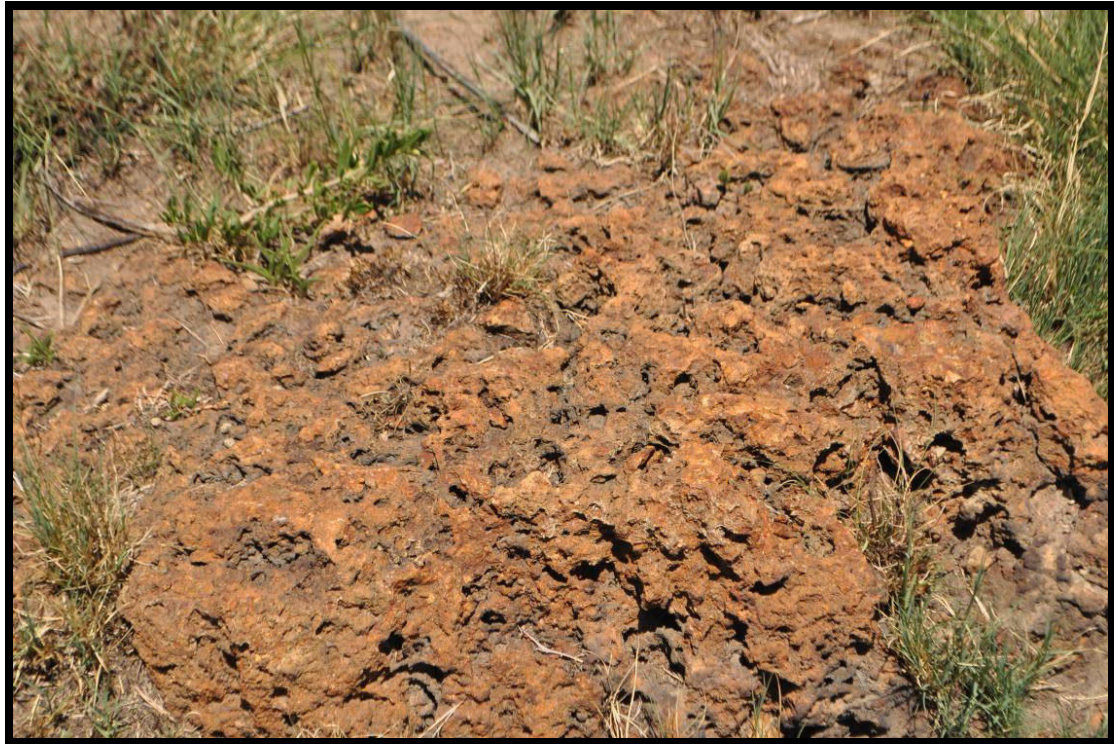
**Figure11.** Large sections along the central valley bottom wetland are situated on a hard plinthic B horizon or ferricrete layer with limited shallow sandy soils or exposed Dresden Soil Form which restricts and burrowing activities of smaller mammals.

Marginally suitable habitat occurs for Rough-haired Golden Mole in the form of the grassy margins and shallow sandy soils within the temporary wet zones of the seepage wetlands and central valley bottom wetland. Large sections are situated on a hard plinthic B horizon or ferricrete layer with limited shallow sandy soils or exposed Dresden Soil Form which restricts and burrowing activities.

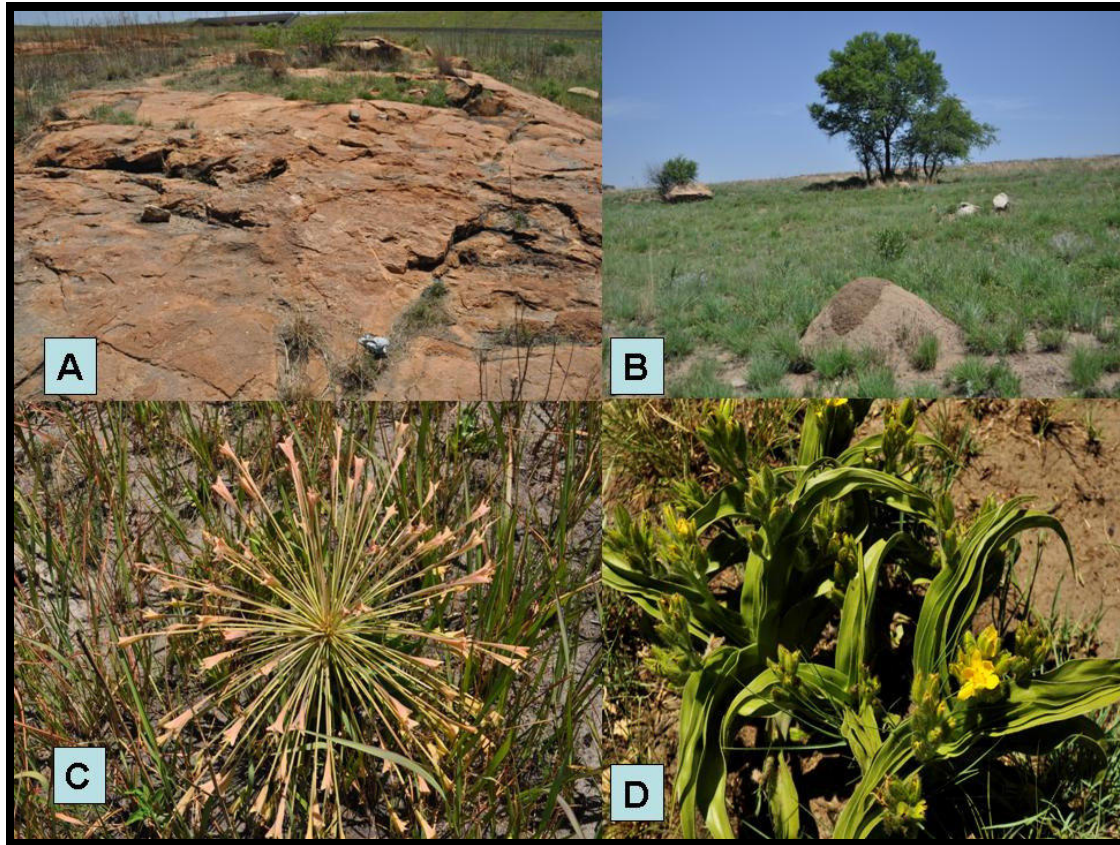
**Figure14. Sensitive microhabitats observed on the site included A:** Low-lying most embedded granite rock sheets; **B:** Large termite mounds on the southern banks of the Jukskei tributary on the northern portions of the site. **C:** A single red listed 'Declining' Cape Poison Bulb (*Boophone disticha*) was observed within the temporary wet zone of the southern seepage wetlands. **D:** Several (>100) Red Listed 'Declining' African Potatoes (*Hypoxis hemerocallidea*) were observed adjacent to the central valley bottom wetland as well as on the southern portion of the site. A rescue and recovery programme should be implemented prior to vegetation clearance and earthmoving activities. All remaining geophytes should be dug up and planted within the 30m GDARD grassland buffer zone (from the outer edge of the temporary wet zones of the seepage and valley bottom wetlands). See separate wetland report conducted by Wetland Consulting Services.

Egoli Granite Grasslands in the Gauteng Province are highly threatened and are listed as **Endangered**. More than two thirds of this vegetation unit has already undergone transformation mainly due to urbanization, road construction, industrialisation and agricultural activities (cultivation). Only a small fraction (3%) of this vital habitat has been formerly conserved. Conservation targets are the proposed conservation of 24%. These grassland areas form vital habitats for numerous animal species. The majority of suitable grassland habitat is usually severely fragmented resulting in road fatalities of species migrating between habitats. All primary Egoli Granite grassland should be classified as **Sensitive** and of **High Conservation Value** and adequately managed with a natural fire regime determined by a suitably qualified botanist or grassland ecologist (see separate vegetation report conducted by Dr. David Hoare). Access to surrounding open Egoli grassland to the south and south-west must be strictly managed to prevent possible poaching, harvesting of medicinal plants and disturbances to remaining fauna. No driving of vehicles through open grasslands.

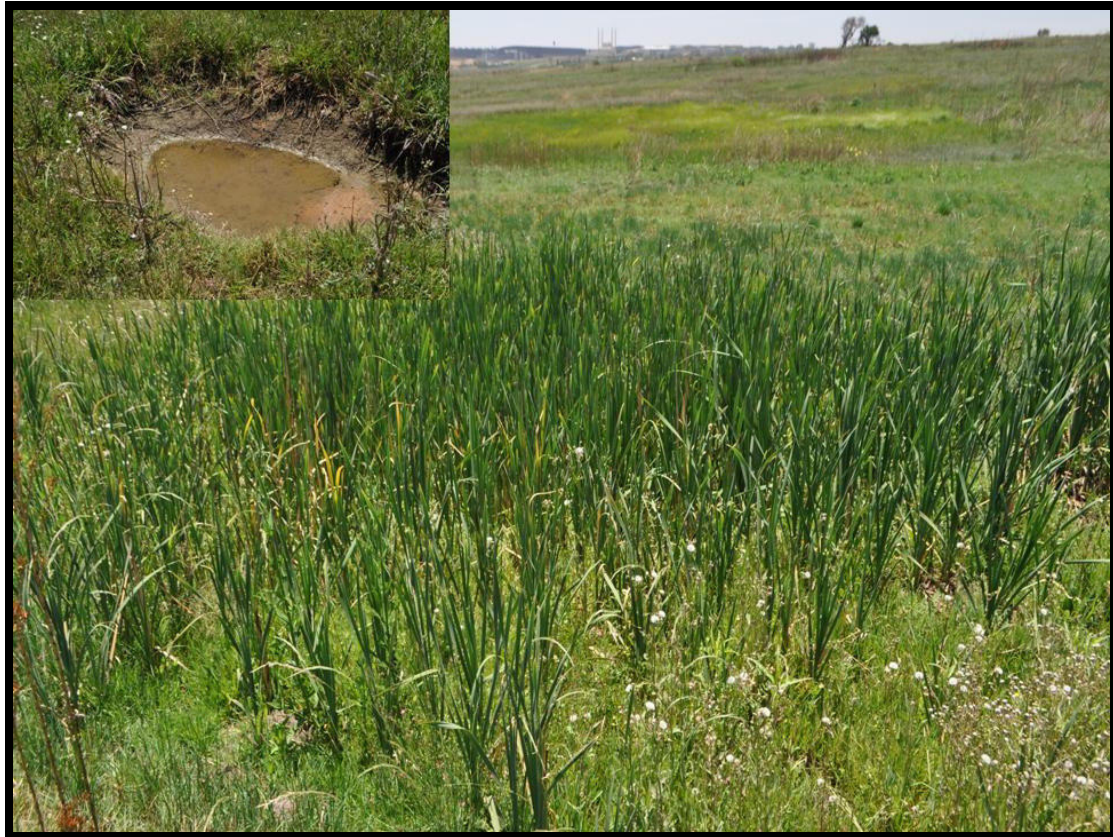
**Figure12.** The seasonal seepage wetlands along the central valley bottom wetland show a high diversity of plant and animal species and provide critical breeding habitat for the remaining frog species including the protected Giant Bullfrog.

The conservation status of many of the faunal species that are dependant on wetlands reflects the critical status of wetland nationally, with many having already been destroyed. In this study area wetlands, including seasonal seepage wetlands which feed into the central valley bottom wetlands and to a lesser extent the northern tributary of the Jukskei River are important habitats for remaining faunal species. All remaining wetlands (permanent and seasonal) and their associated indigenous grassland and sedge dominated vegetation must be considered as a sensitive habitat.

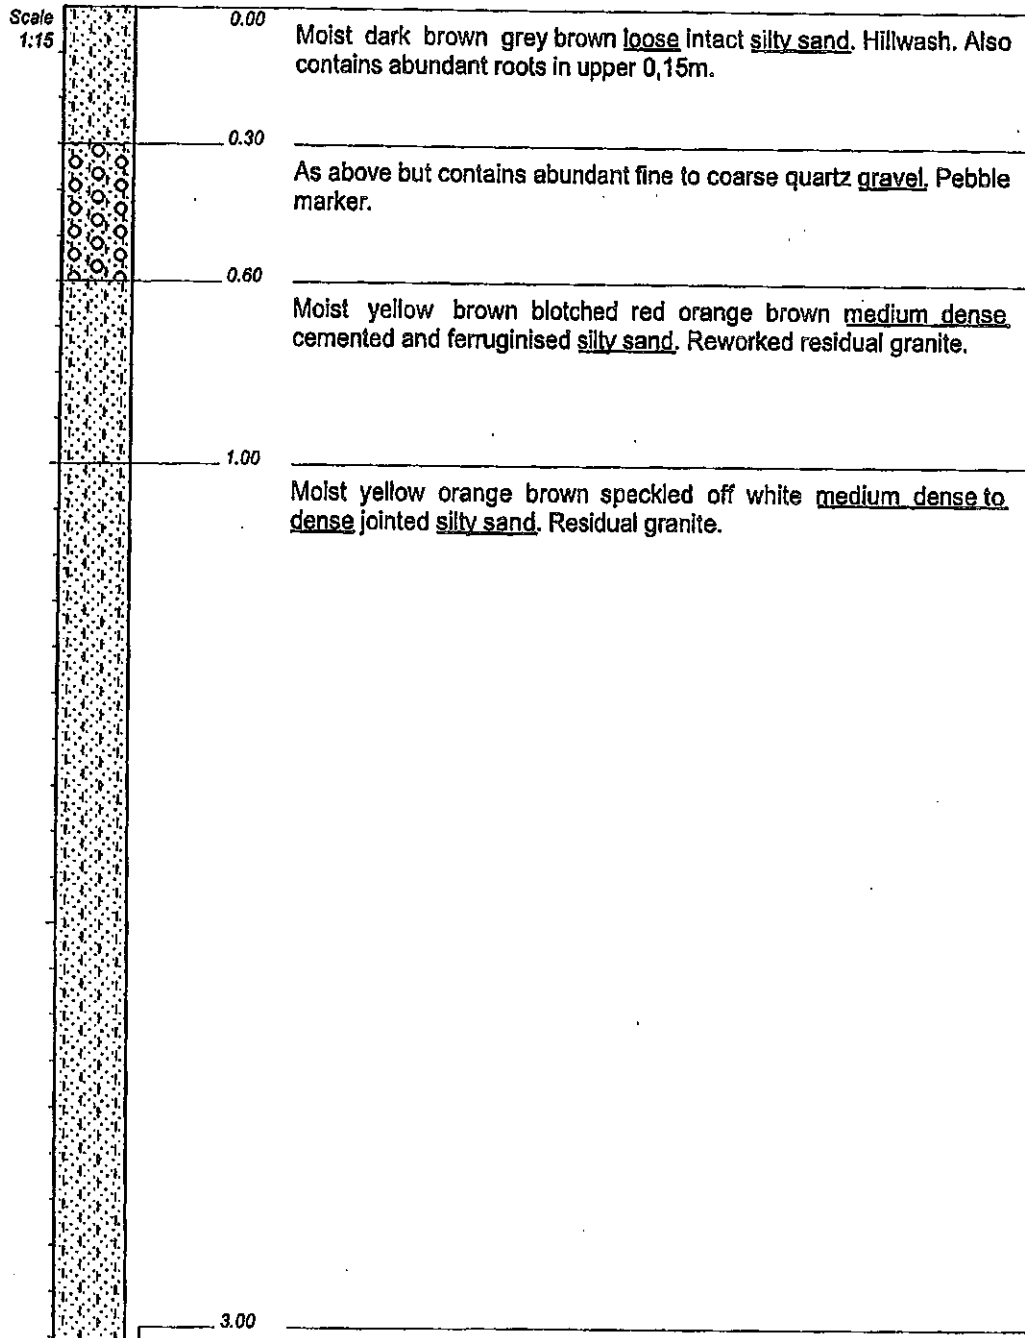
HOLE No: TP11

- 1) No refusal at 3,0m.
- 2) No evidence of water.

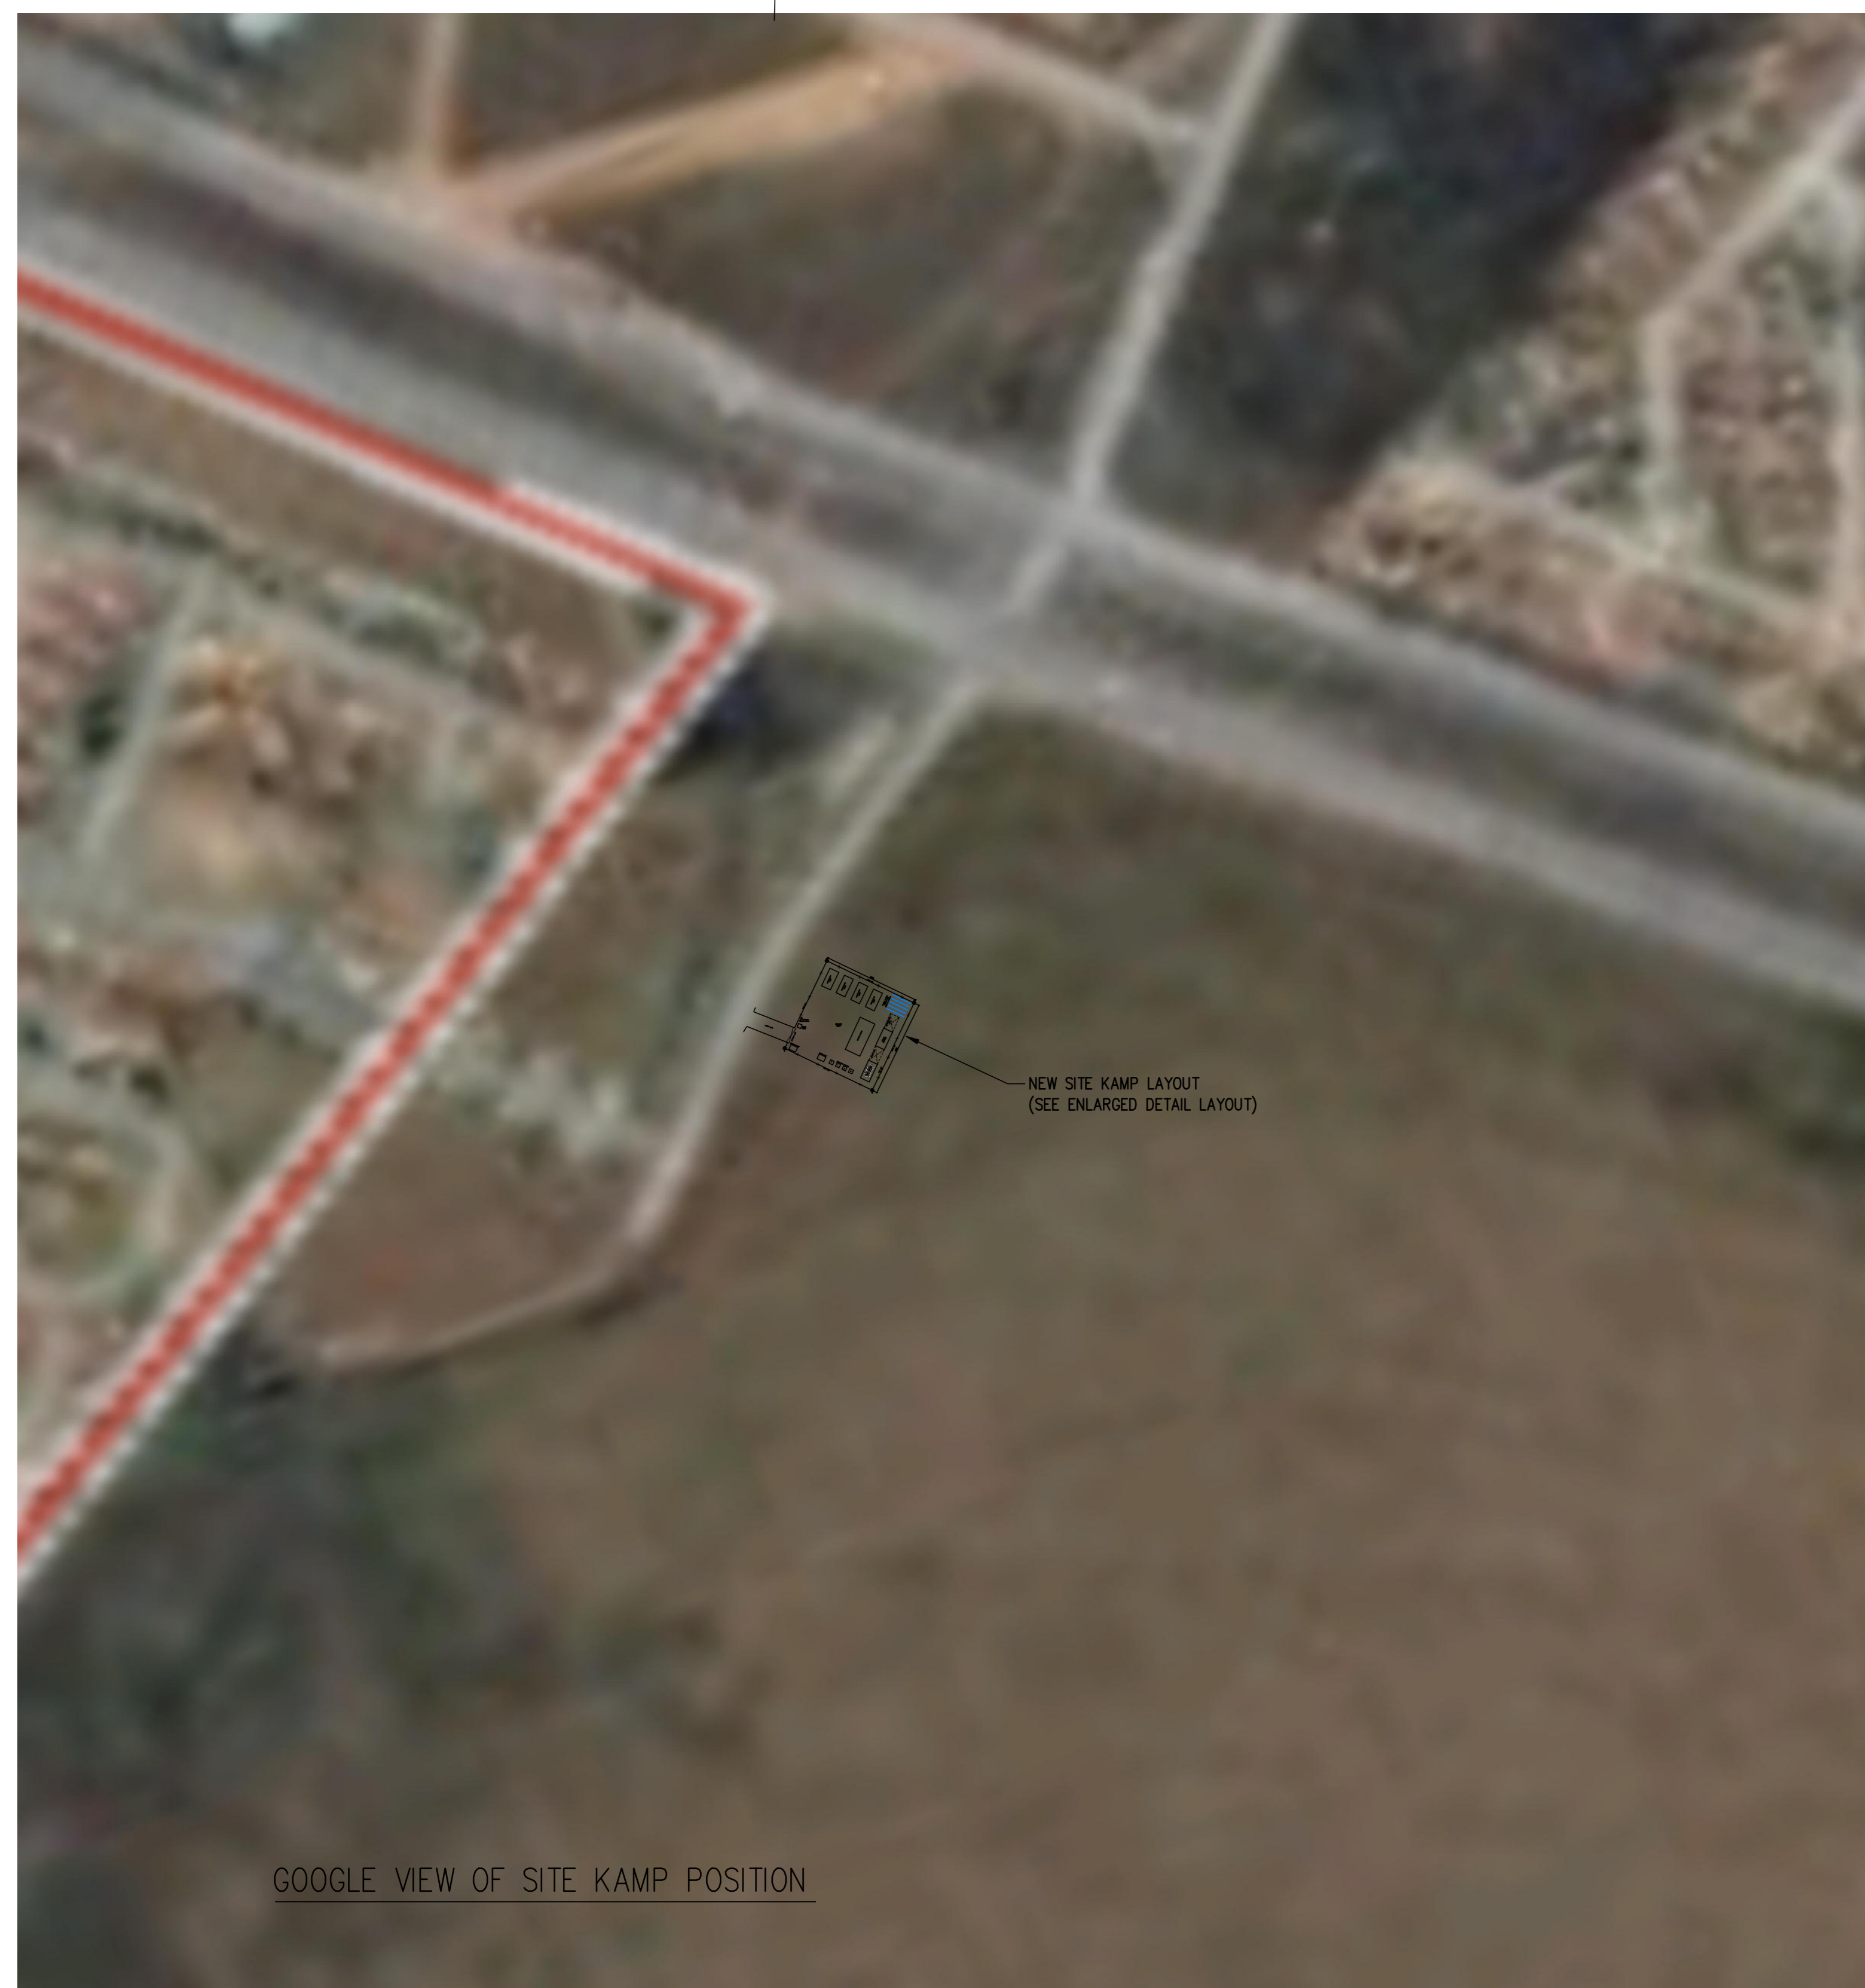
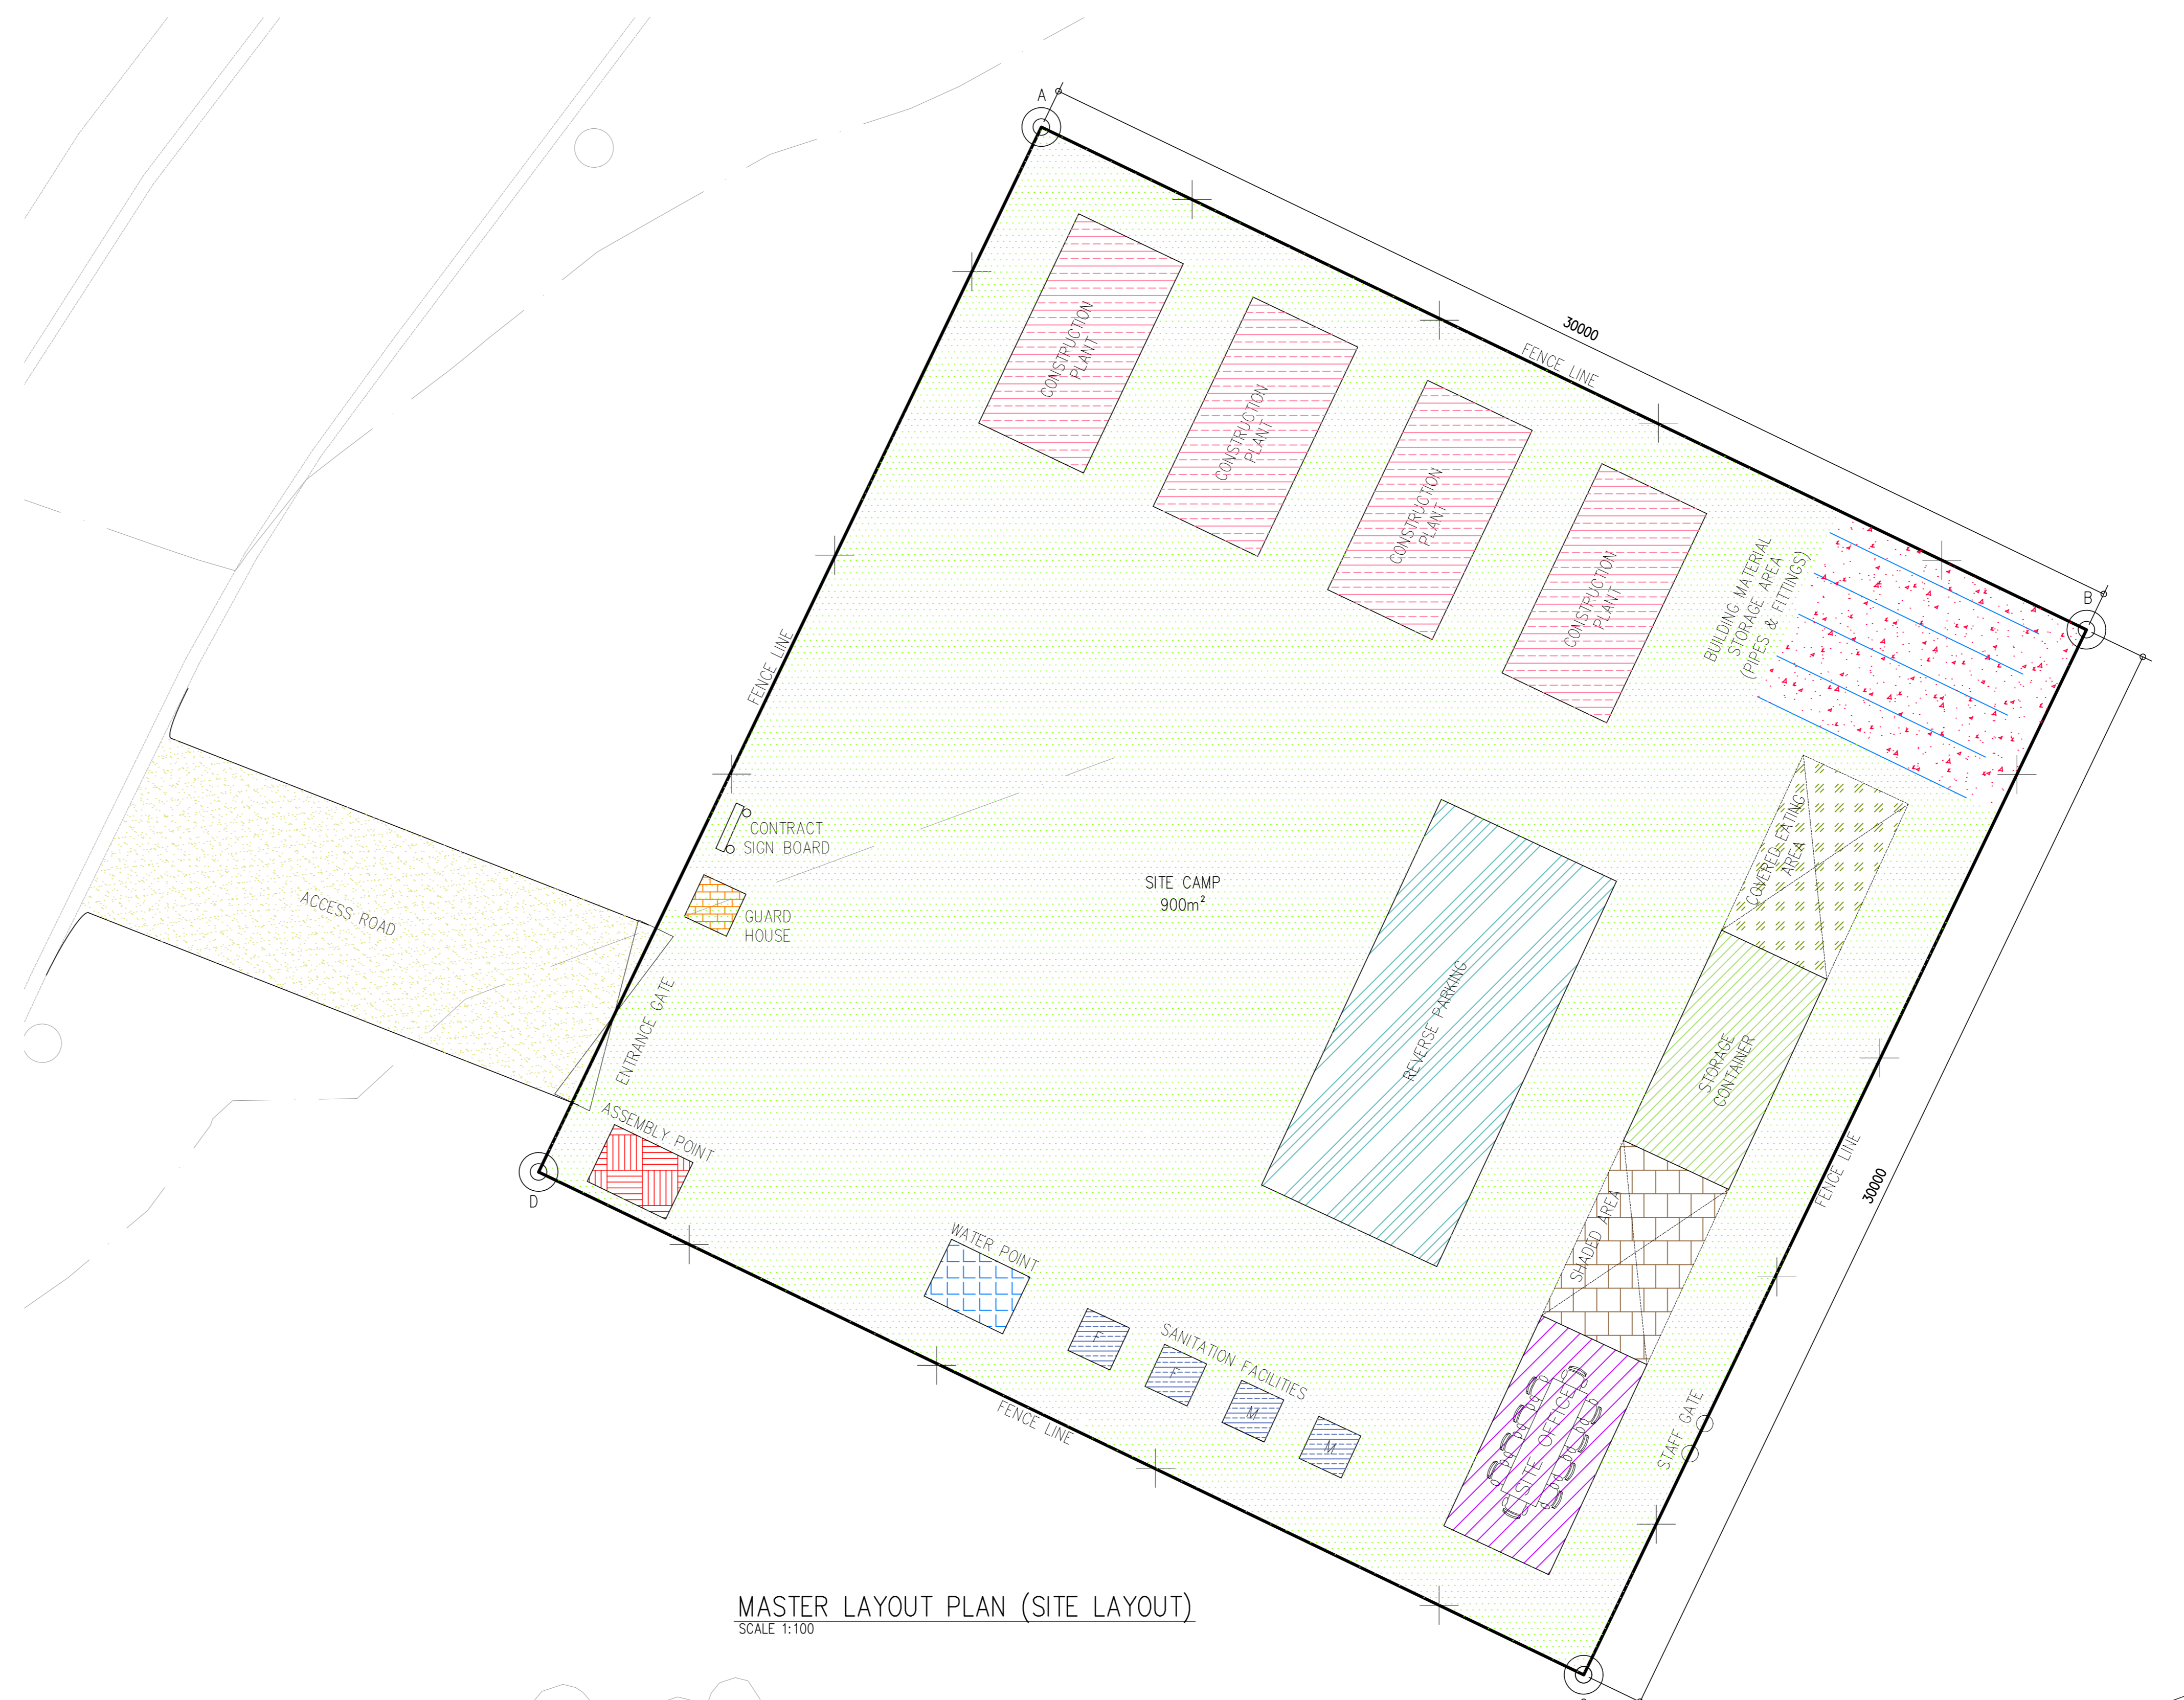
- LEGEND:**
- 1.8m HIGH DIAMOND MESH FENCE WITH RAZOR WIRE
  - 2 x 6m x 1.8m HIGH ACCESS GATE FOR VEHICLES
  - 1 x 1m x 1.8m HIGH ACCESS FOR STAFF
  - LIGHTS
  - ACCESS ROAD
  - SANITATION FACILITIES
  - CONSTRUCTION PLANT
  - WATER POINT
  - ASSEMBLY POINT
  - GUARD HOUSE
  - STORAGE CONTAINER
  - REVERSE PARKING
  - COVERED EATING AREA
  - SHADED AREA
  - SITE OFFICE
  - BUILDING MATERIAL STORAGE AREA
  - SITE CAMP (900m<sup>2</sup>)

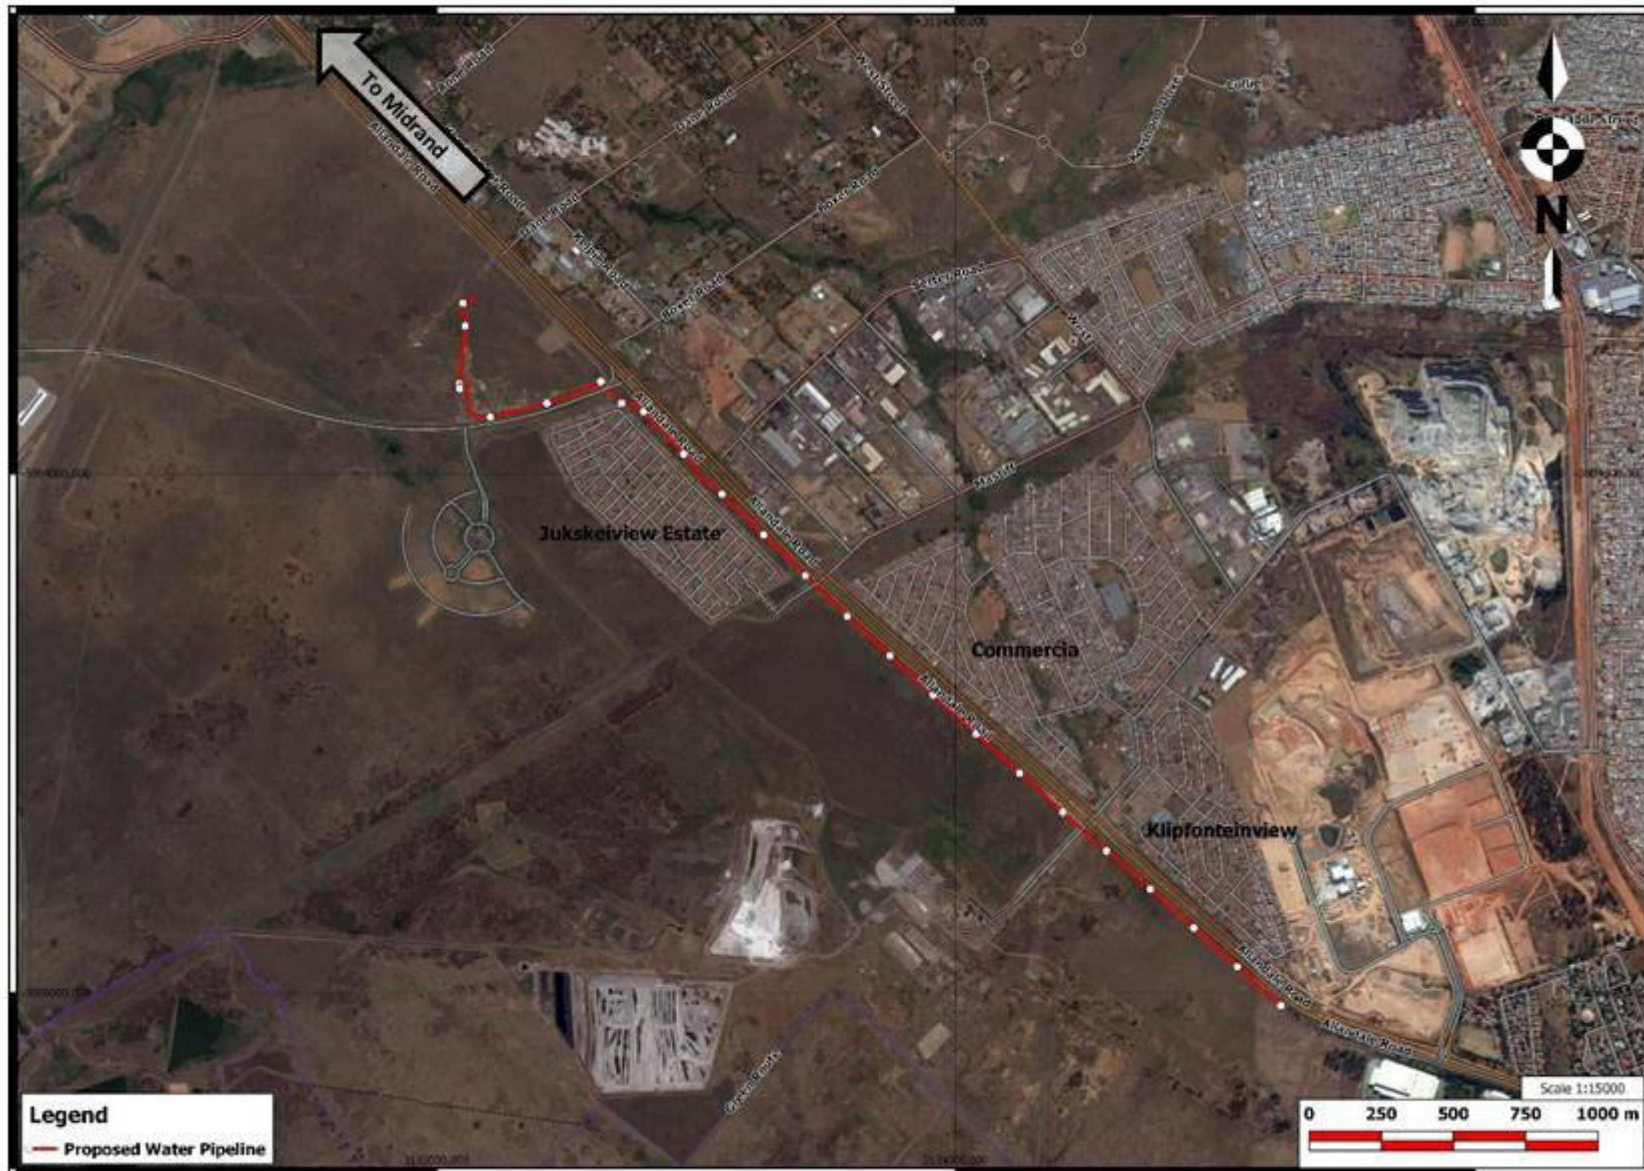
## Aerial Street Map

— Proposed Water Pipeline

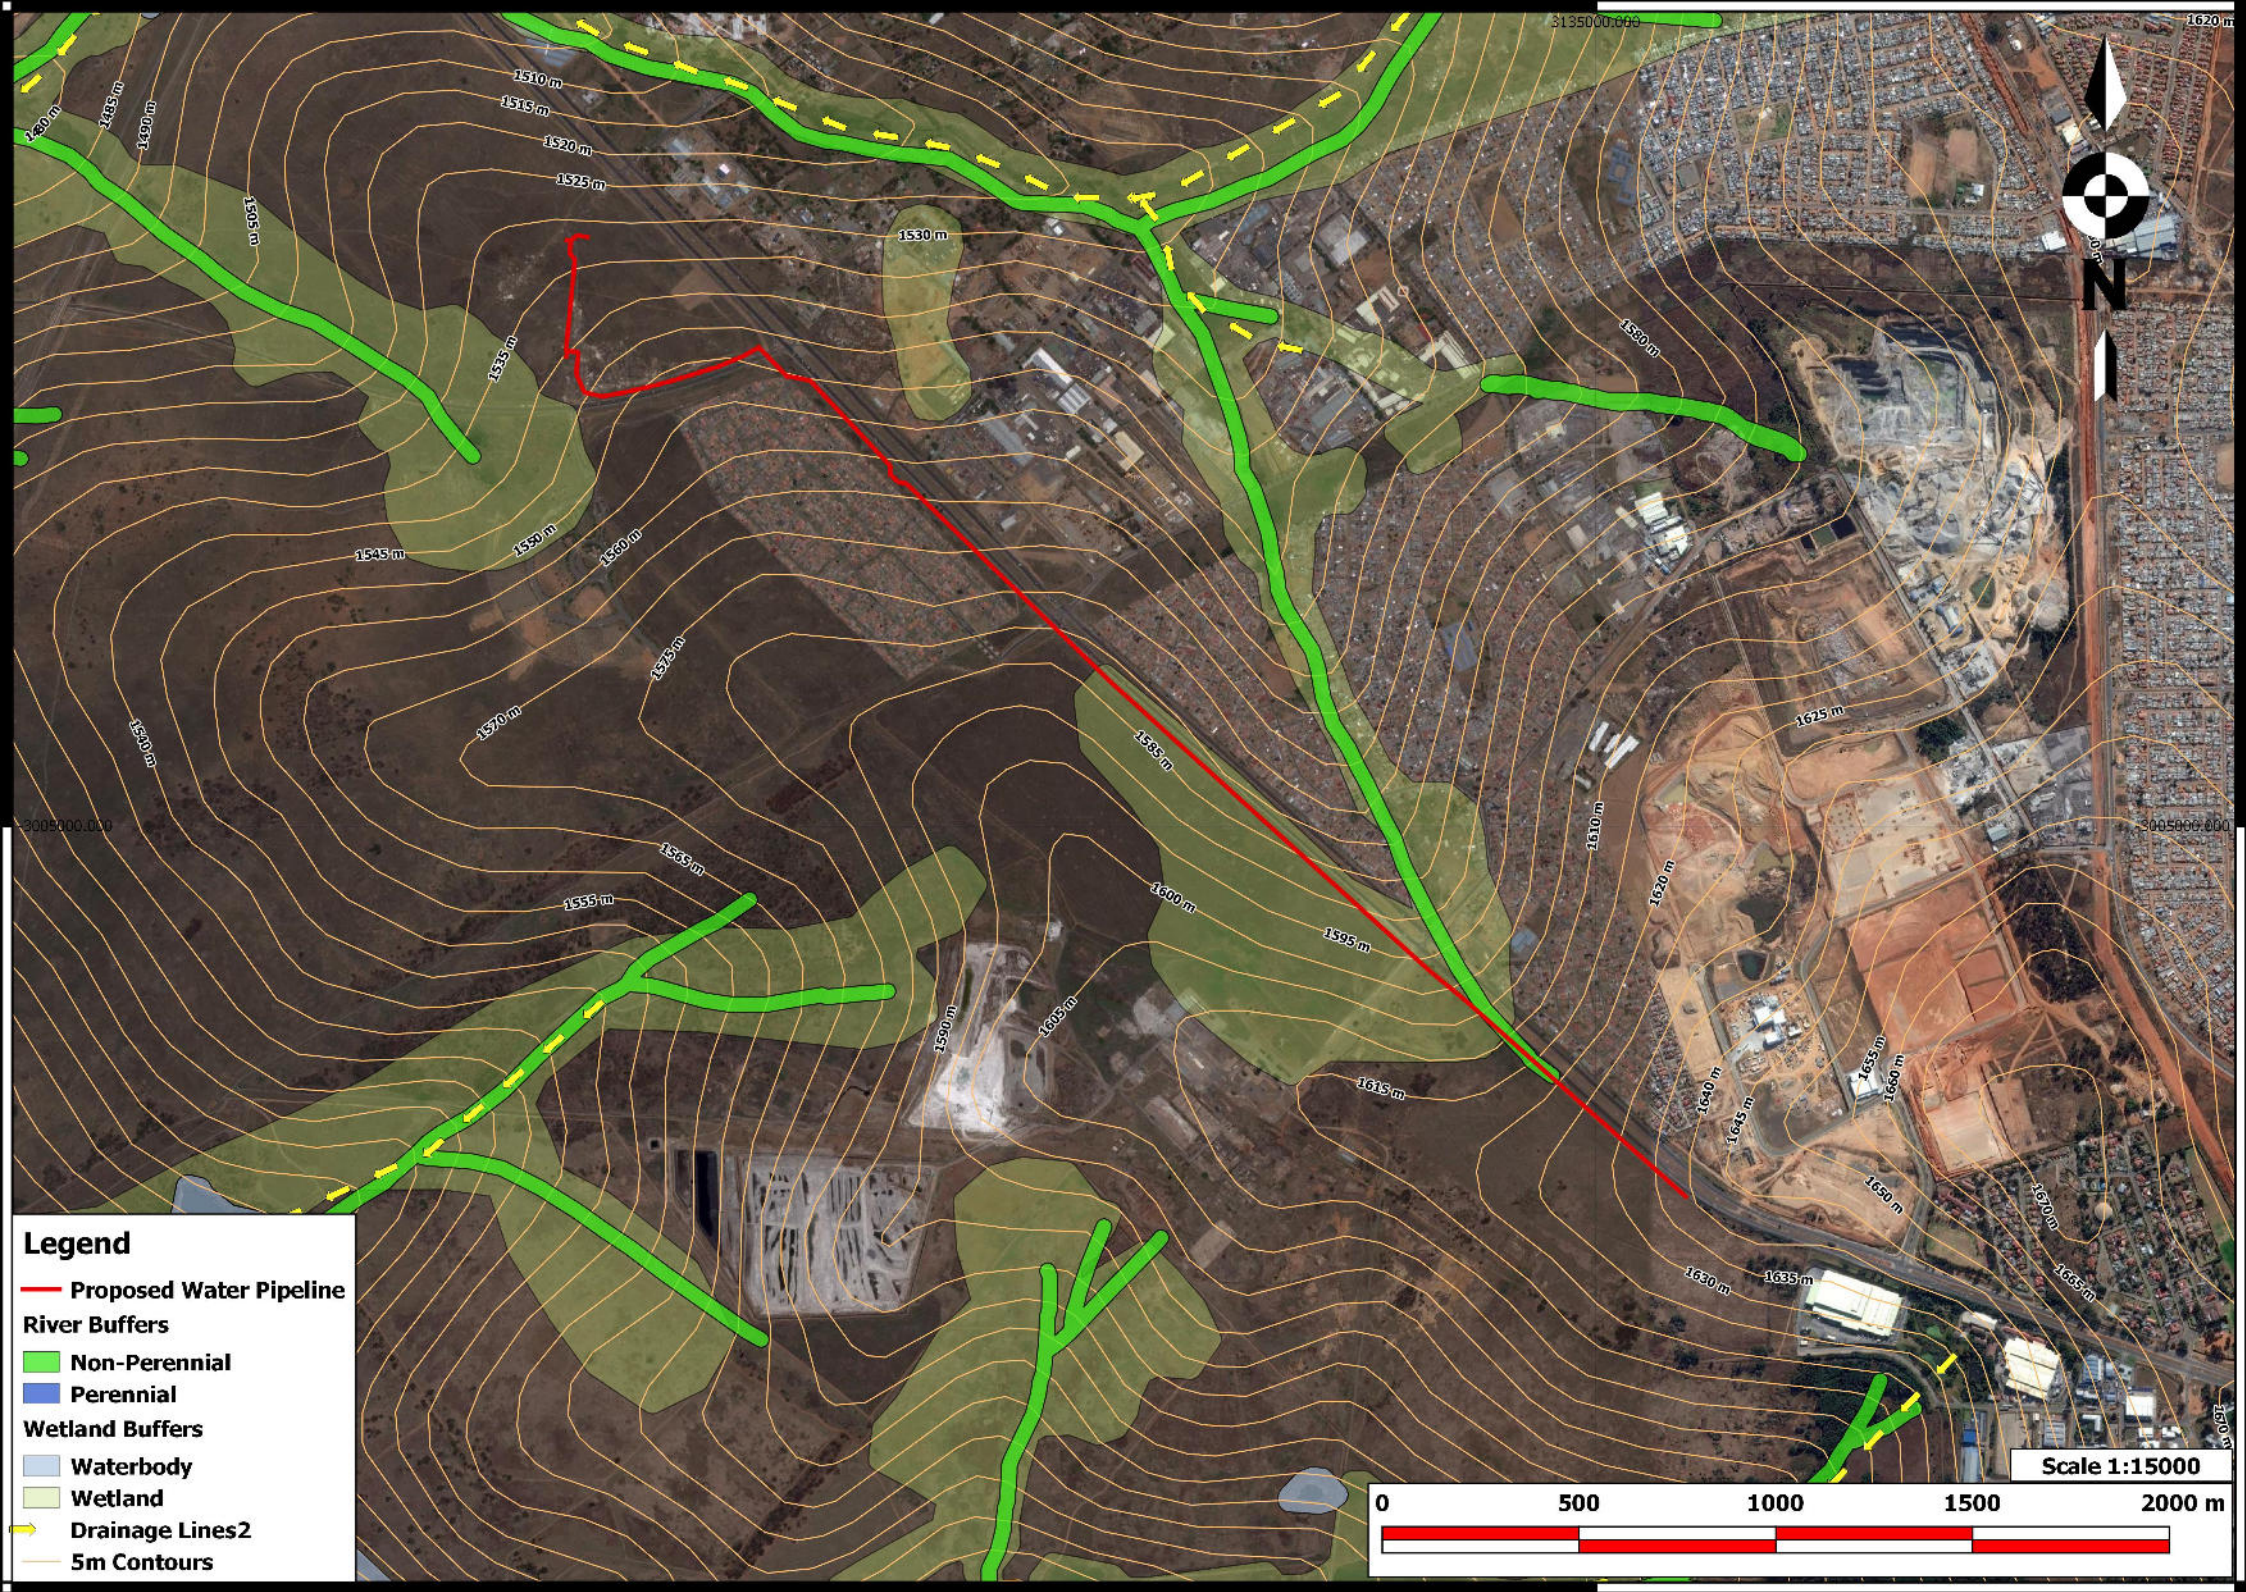
- Proposed Water Pipeline
- Soils**
- Impeded internal drainage, limiting soil depth
- Limiting soil depth
- Limiting soil depth, impeded internal drainage in subsoil
